Consumer Product Safety Alert

CPSC Warns That Tubular Metal Bunk Beds May Collapse

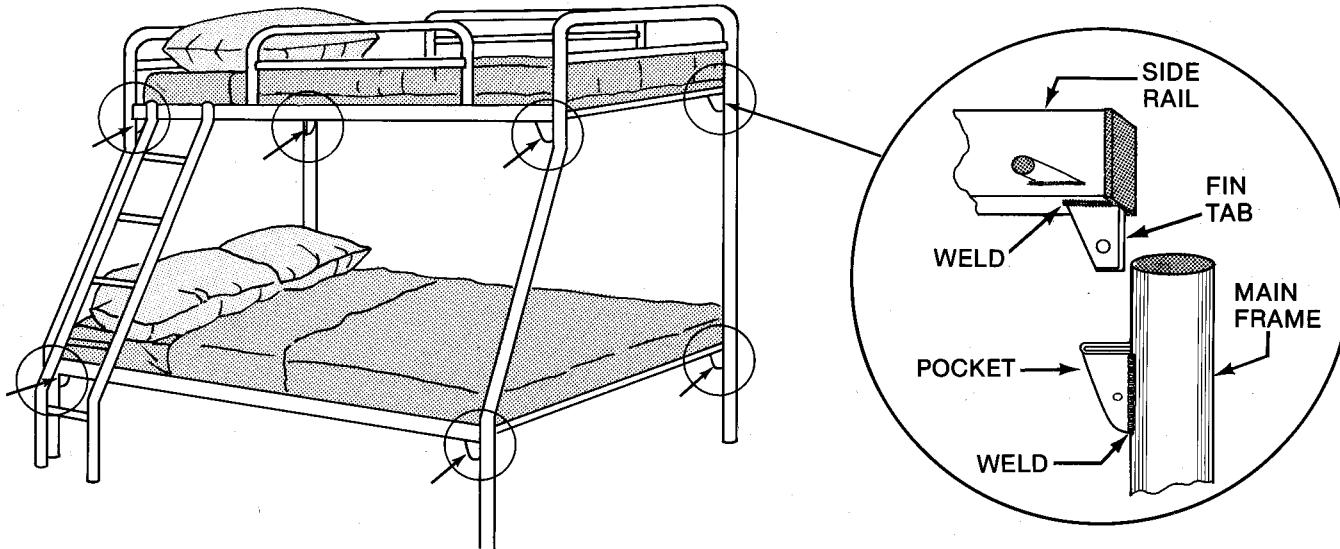
The U. S. Consumer Product Safety Commission (CPSC) advises owners of children's tubular metal bunk beds to inspect the beds for metal or weld cracks which may lead to collapse and serious injury. The bunk beds may have been welded poorly or have inadequate material thickness around the mattress support fins, which connect to the side rails.

To help avoid bunk bed collapse, CPSC urges consumers to inspect all eight mattress support fin tabs and pockets for breaks or cracks in the metal and welds. The fin tabs are inserted into pockets located near each of the bed's eight corners. Stop using damaged beds as bunks and contact the importer for repair or replacement.

- Inspect all eight mattress support corners for cracks in the paint or metal. If cracks are found, stop using it immediately. Do not wait for the bed to break.
- Whether or not cracks are present, call the retailer where the bed was bought to see if it is under recall. Get the telephone number of the importer and call for repair instructions. Consumers will receive a repair kit consisting of reinforcement brackets. In cases where the bed has cracks in the corner supports, consumers should receive a new bed.
