STUDY OF DETERIORATION OF SEPARABLE ELECTRICAL CONTACTS IN SMOKE DETECTORS

Contract No. CPSC-C-93-1139

IITRI Project No. A06393

Final Report

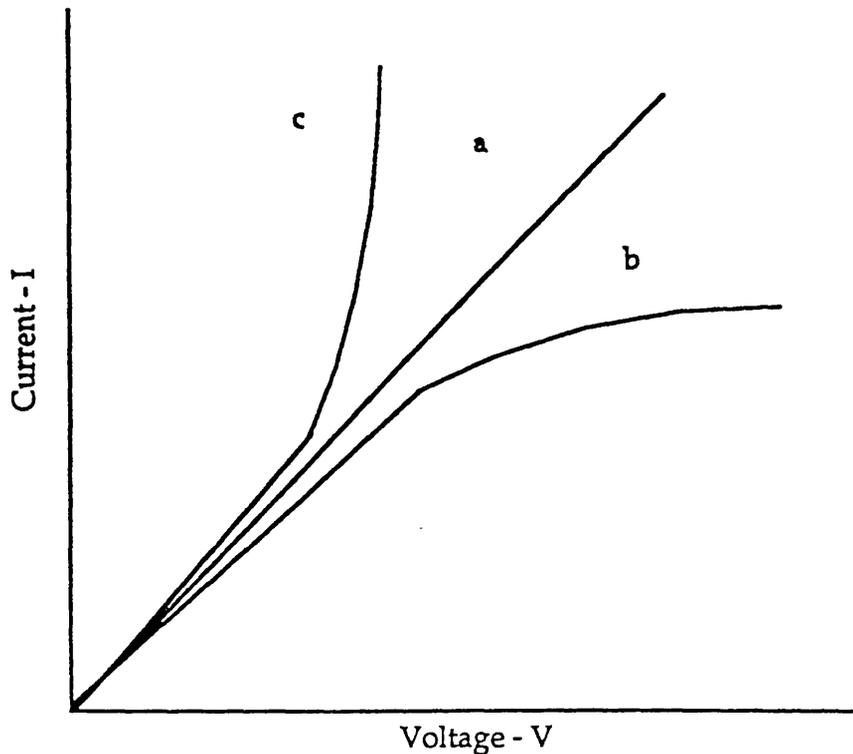
FIGURE 1: VOLTAGE/CURRENT CHARACTERISTICS OF SEPARABLE CONTACTS

Figure 1 shows the V/I characteristics of a separable contact interface. Curve (a) is the typical, expected, purely resistive interface. Curve (b) results when there are localized hot spots caused by only a very small area of purely metal contact that creates non-linear characteristics. Curve (c) illustrates the effect of instabilities that are caused by electron tunneling through a thin oxide, sulfide or polymer layer formed by corrosion at the contact interface. The curve tracer characteristics, as would be expected with this conduction mechanism, are highly unstable. They vary between curve (c) and an open circuit (a horizontal trace) and take on a snake-like appearance.

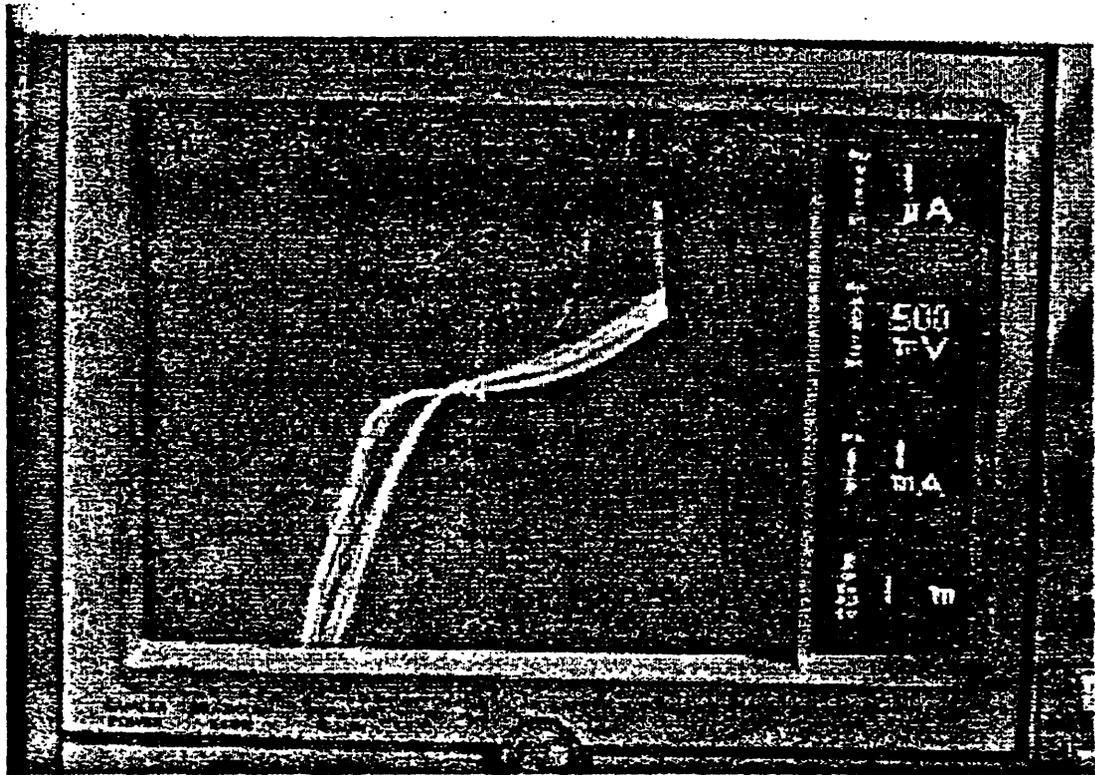
FIGURE 3: HORN V/I CHARACTERISTICS

Horns were then selected for additional curve tracer testing to further document photographically the non-linear contact characteristics of these horns that indicate the tunneling mechanism is predominant. A typical result appears in Figure 3.

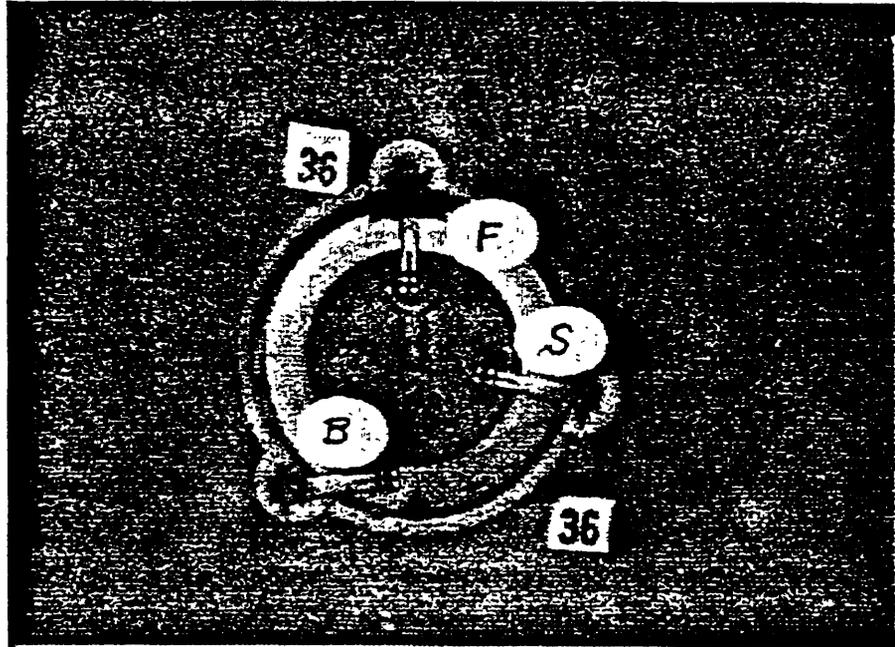
FIGURE 5: SEPARABLE CONTACTS ON A SMOKE DETECTOR HORN (1.25X)

Figure 5 shows the separable contacts on a typical smoke detector horn. The three contacts B, S and F are indicated on the photograph. The six smoke detectors

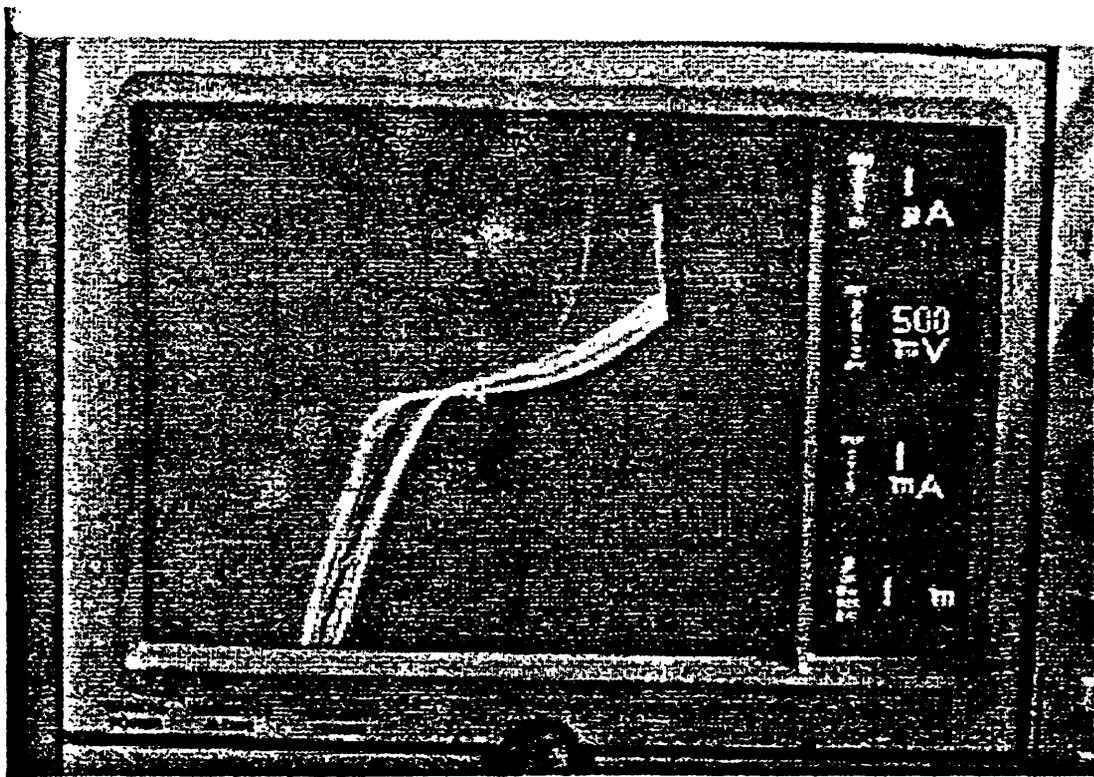
FIGURE 10: NON-LINEAR V/I CHARACTERISTICS OF A SMOKE DETECTOR HORN CONTACT

non-conductive layer has formed in the contact interface. Figure 10 is a photograph of a non-linear V/I characteristic exhibited by a horn contact. In this case the forward diode breaks down at about 1.75 volts and the reverse breakdown is at about 1 volt. As the voltage is increased by ± 5 volts, very little current (less than $.1\mu\text{A}$) flows through the contact in either polarity. Through tunneling [4, 5] and film rupture, the current increases rapidly. Figure 10 also shows the instability in the contact interface. If the current is increased, the film will rupture and the V/I characteristic will return to a linear characteristic. As a result, when the voltage across a non-linear contact in a horn circuit is not large enough to cause rupture of the film, the horn will malfunction. Units 16, 17, 36 and 39 had one or more non-linear contacts. Units 32, 35 and 39 had one or more open contacts. The remaining units 6, 14, 18, 21, 26, 29, 34, 37, 45, 49 and 50 had normal contacts.

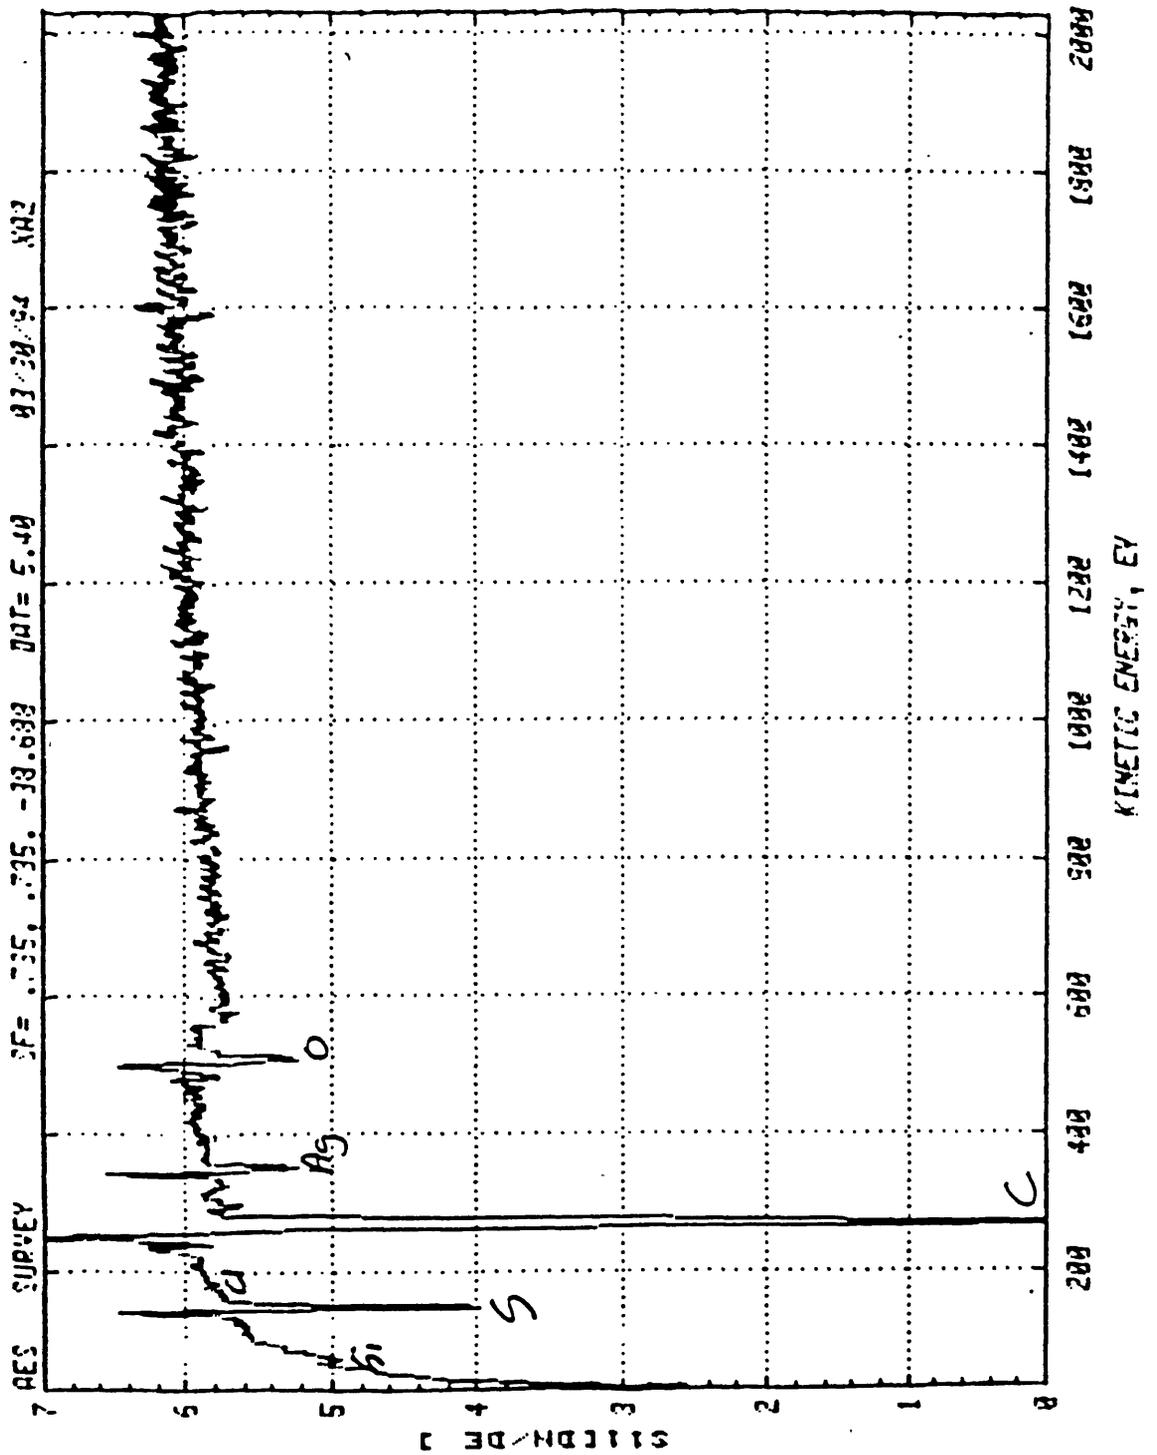
FIGURE 23: AUGER ELEMENTAL SURVEY OF SAMPLE X, TERMINAL S

As shown in Figure 23, the pre-sputtering surface analysis on terminal S of horn X shows only a slight trace of sulphur. Both silicon and chlorine have higher levels than the sulphur. Horn X which was exposed to both gases was selected for this testing because it should have had the thickest layer of contamination and to confirm the EDAX surface analysis on horn C (Figure 21). Comparison of this data with the Table 5 EDAX test results of field units, which identified significant levels of sulphur, shows that the UL 217 test environment does not represent field conditions.

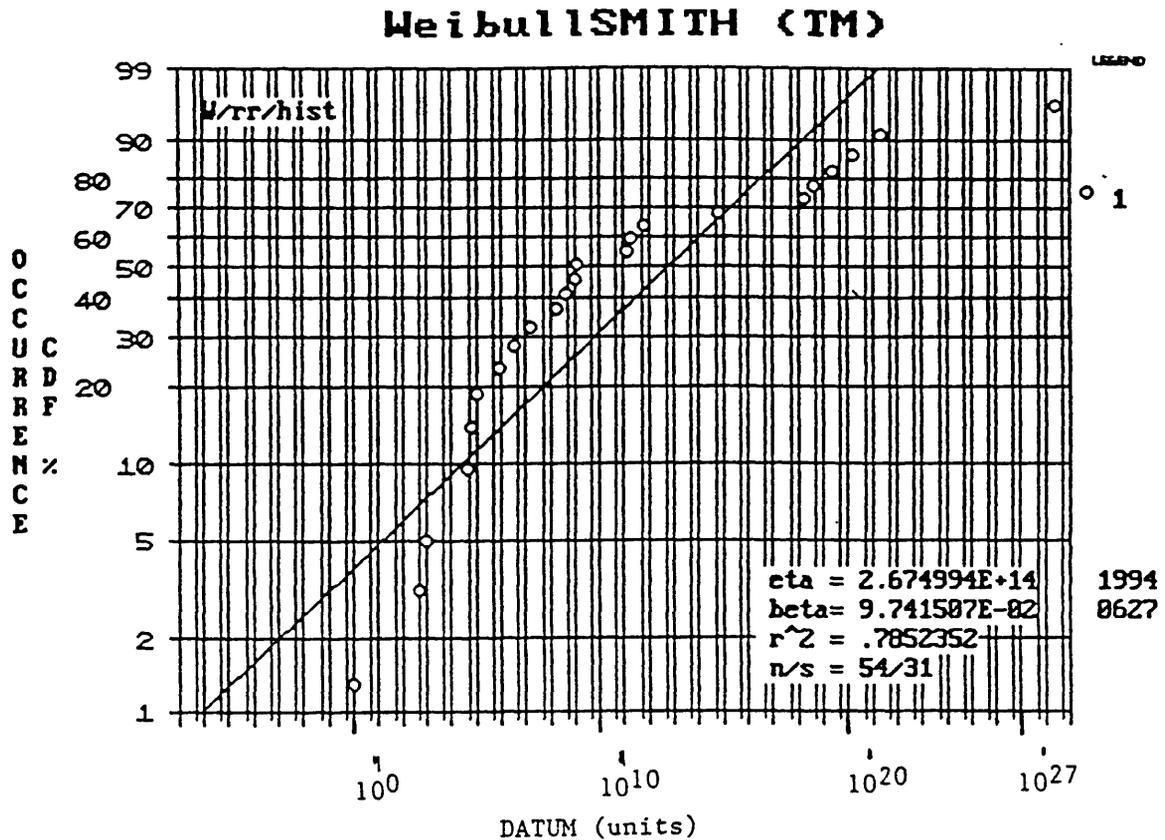
FIGURE 26: WEIBULL PLOT OF PREDICTED CYCLES TO FAILURE

These times to failure were then plotted on Weibull paper to determine the characteristic life (η) and the shape parameter (β). Figure 26 presents the Weibull plot for this data with the addition of the five actual failures, and indicates $\eta = 2.7 \times 10^{14}$ and $\beta = .097$.

This methodology extrapolated the observed resistance change over the 2000 cycle test to a number of cycles that might be expected to cause contact failure. This extrapolation distance, however, is very large and thus there is little confidence that the predicted cycles to failure is accurate. This is especially true given the highly variable behavior of the contact resistances. It is interesting to note, however, that for the 22 contacts exhibiting monotonically increasing resistance values, the exponents (x) were all less than one. This indicates that the rate of increase in contact resistance decreases with an increasing number of cycles.

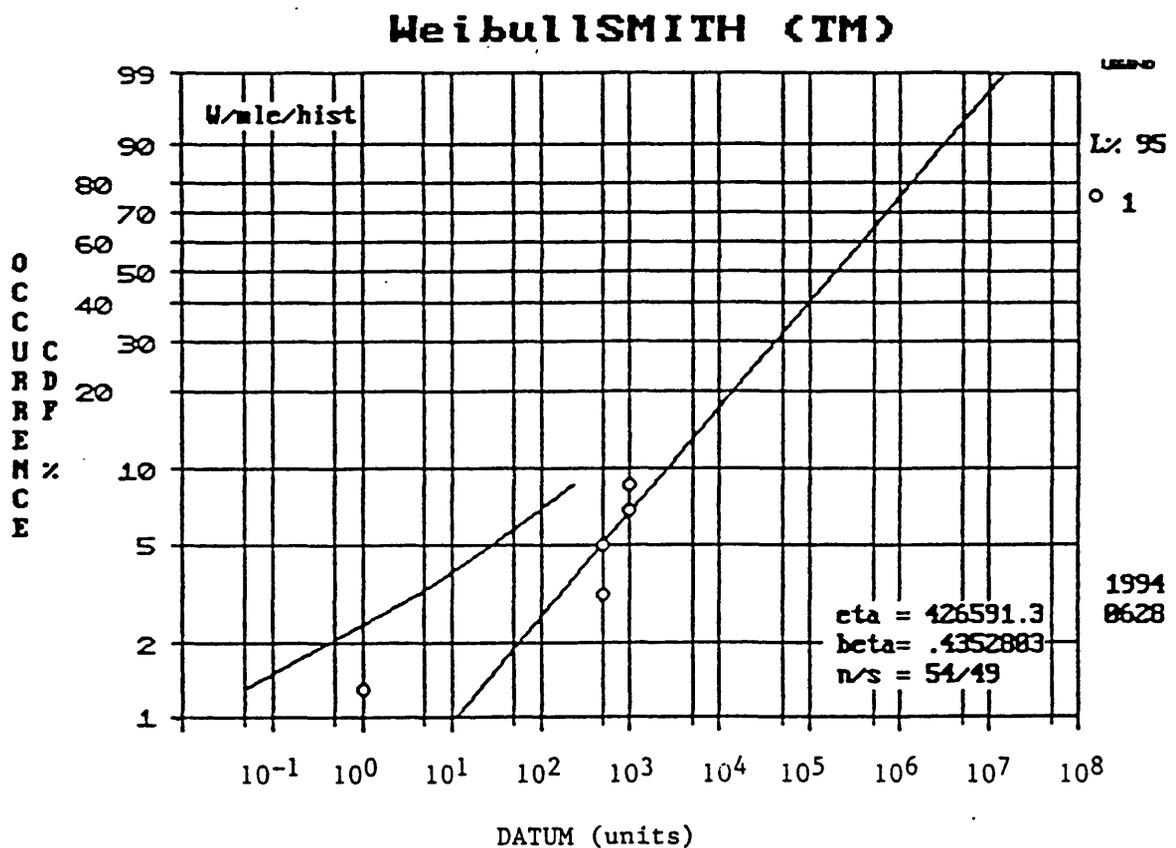
FIGURE 27: WEIBULL PLOT (WITH LOWER 95% CONFIDENCE LEVEL)

There is no obvious trend in the behavior of the contact resistance as a function of temperature cycling. Of the 54 contacts analyzed, 22 exhibited monotonically increasing resistances. It is interesting to note, however, that the exponent fit by the regression analysis that describes the rate of resistance change for the 22 contacts

analyzed was between 0 and 1. This indicates that the rate of resistance change slows as the number of cycles is increased. The remaining 36 contacts exhibited randomly fluctuating or decreasing resistance values. One of the objectives of this analysis was to determine if wearout characteristics were evident based on the limited data taken. From the analysis, there is no evidence of wearout based on the very low beta values observed. Values greater than one indicate wearout characteristics (failure rate increasing in time) and values less than one indicate infant mortality characteristics (failure rate decreasing in time). All of these observations are consistent with fretting corrosion.
