FIRE INCIDENT STUDY
NATIONAL SMOKE DETECTOR
PROJECT

JANUARY 1995

LINDA E. SMITH, EPHA
DIRECTORATE FOR EPIDEMIOLOGY
U.S. CONSUMER PRODUCT SAFETY COMMISSION
4330 EAST WEST HIGHWAY
BETHESDA, MD 20814

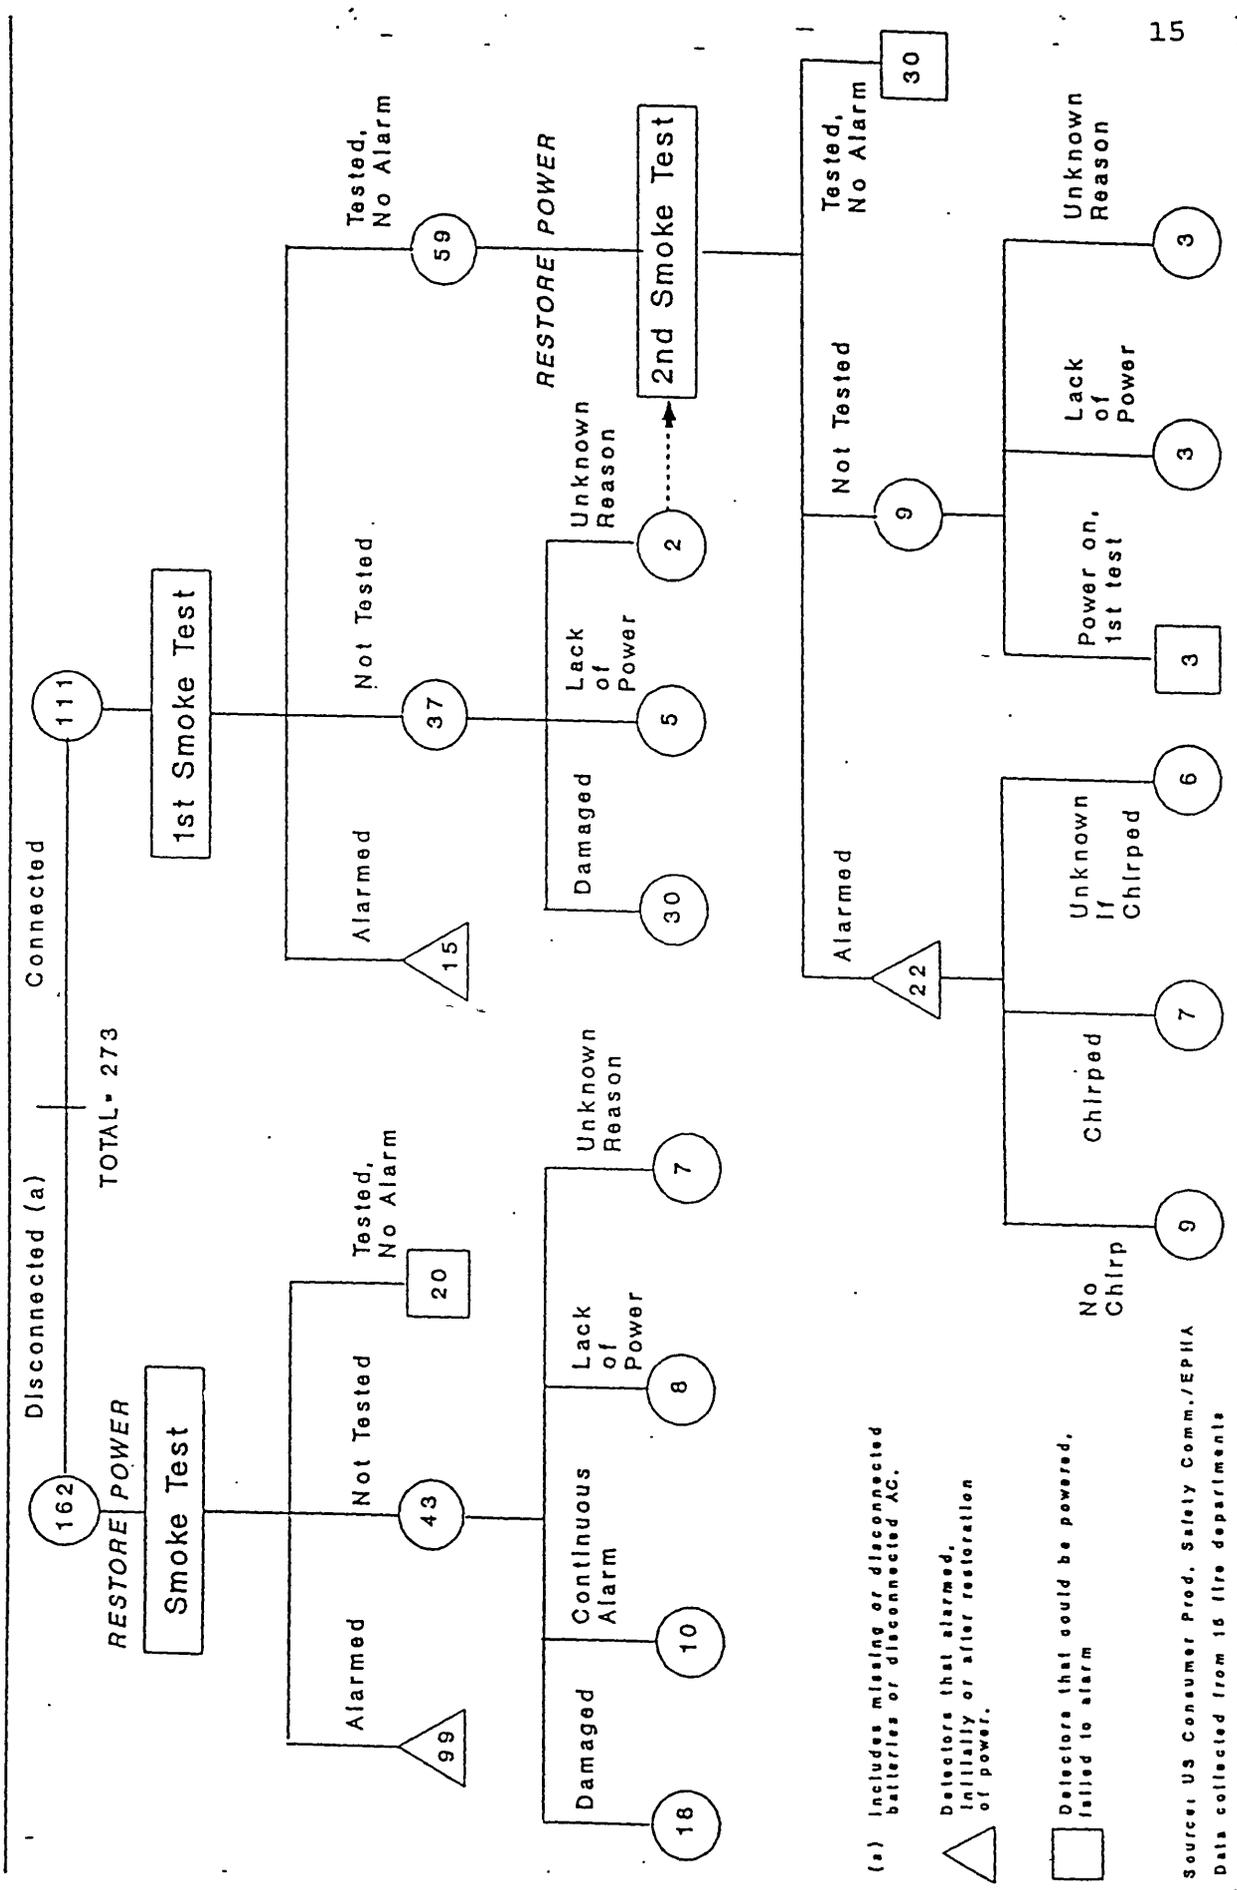
Figure 4
 Fire Incident Study
 Smoke Test Results
 Detectors That Should Have Alarmed

restored. A total of 53 detectors (19 percent) failed to alarm to the smoke test even after power was restored. A total of 84 (31 percent) could not be tested under conditions of a connected power source, predominantly due to damage from the fire. Of these 84, 10 could not be tested because they alarmed continuously when repowered. A total of 189 detectors were tested with aerosol smoke during the testing procedure. Among those that were tested, 72 percent alarmed to the smoke test; 28 percent did not alarm.

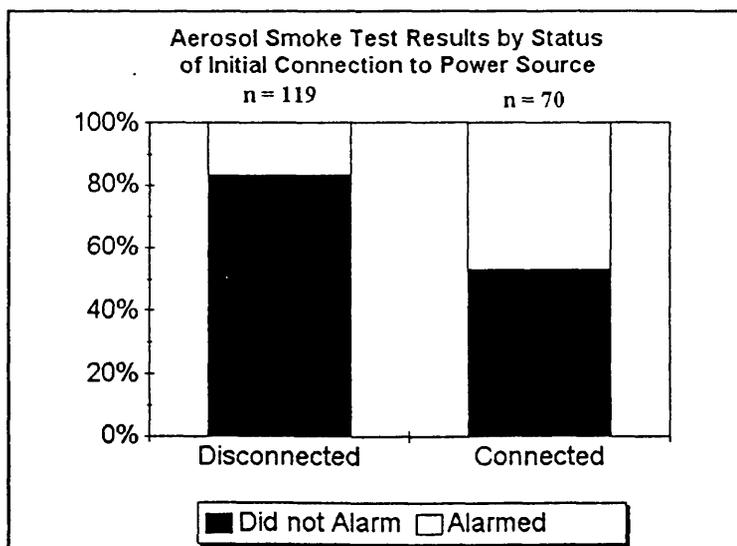
Figure 5

Results of testing in the field indicated that after power had been restored, a greater proportion of initially disconnected detectors than initially connected detectors responded to the aerosol smoke test (Figure 5). Among the initially disconnected detectors that could be tested, 99 of 119 (83 percent) responded to aerosol smoke. Among the initially connected detectors that could be tested, 37 of 70 (53 percent) responded to the aerosol smoke, a significant difference ($p < .005$).

Most of the detectors that failed to respond to aerosol smoke were collected for testing; 19 of the 20 in the disconnected group, and 30 of the 33 in the connected group. Among the 43 initially disconnected detectors that were not tested under power, 10 alarmed continuously when powered which prevented testing. Seven were collected as samples. Among the detectors in the initially connected group that were not tested, it is noted that 8 were AC detectors in dwellings in which the electrical power was not functioning at the time of the investigation.

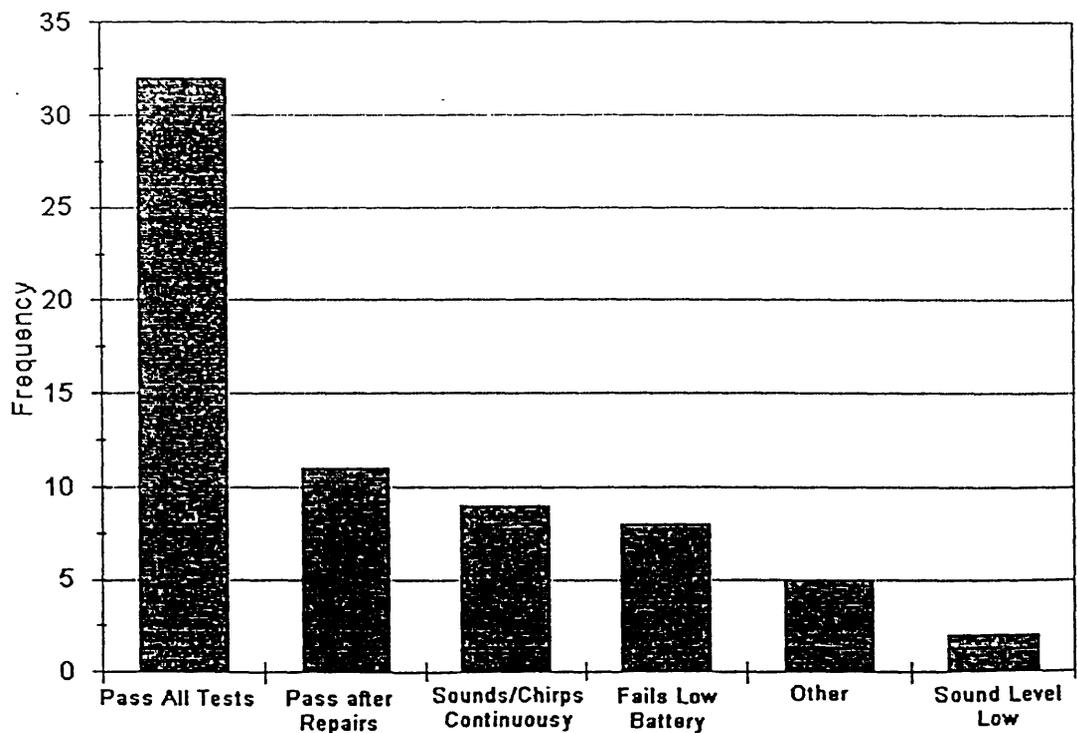
Figure 2. Laboratory results of detectors found disconnected after the fire.

Seventy-eight smoke detectors collected by fire personnel were found disconnected after the fire. Ten of these units had extensive fire damage, and no further testing was performed by the Engineering Laboratory. The remaining 68 detectors were examined, and the results are shown in Figure 2.

Thirty-three of the units passed all screening tests satisfactorily in the Engineering Laboratory. An additional 11 units were repaired in the laboratory and passed all retests satisfactorily. These repairs included:

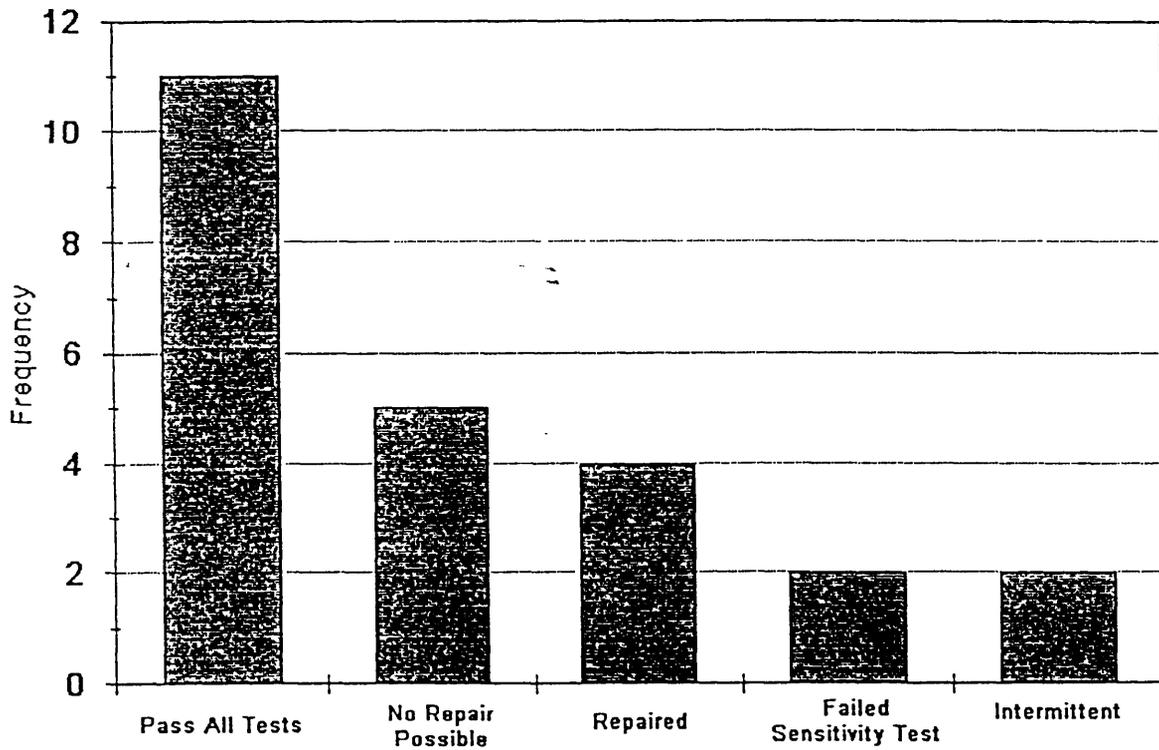
Figure 3. Laboratory results for smoke detectors found connected after the fire.

Thirty-two units were found with power connected after the fire; however, no one heard the alarm sound during the fire. Laboratory testing could not be performed on eight of the units received due to extensive fire damage. Test results for the remaining 24 units are summarized in the five categories below.

Ten smoke detectors passed all the tests outlined in Table 1 in the laboratory; an additional unit passed the testing protocol after handling. Handling the smoke detector in the laboratory may have restored continuity to a contact in the unit, resulting in a functional detector.

Repairs were successful in four units. Each detector passed the testing protocol after the following repairs:

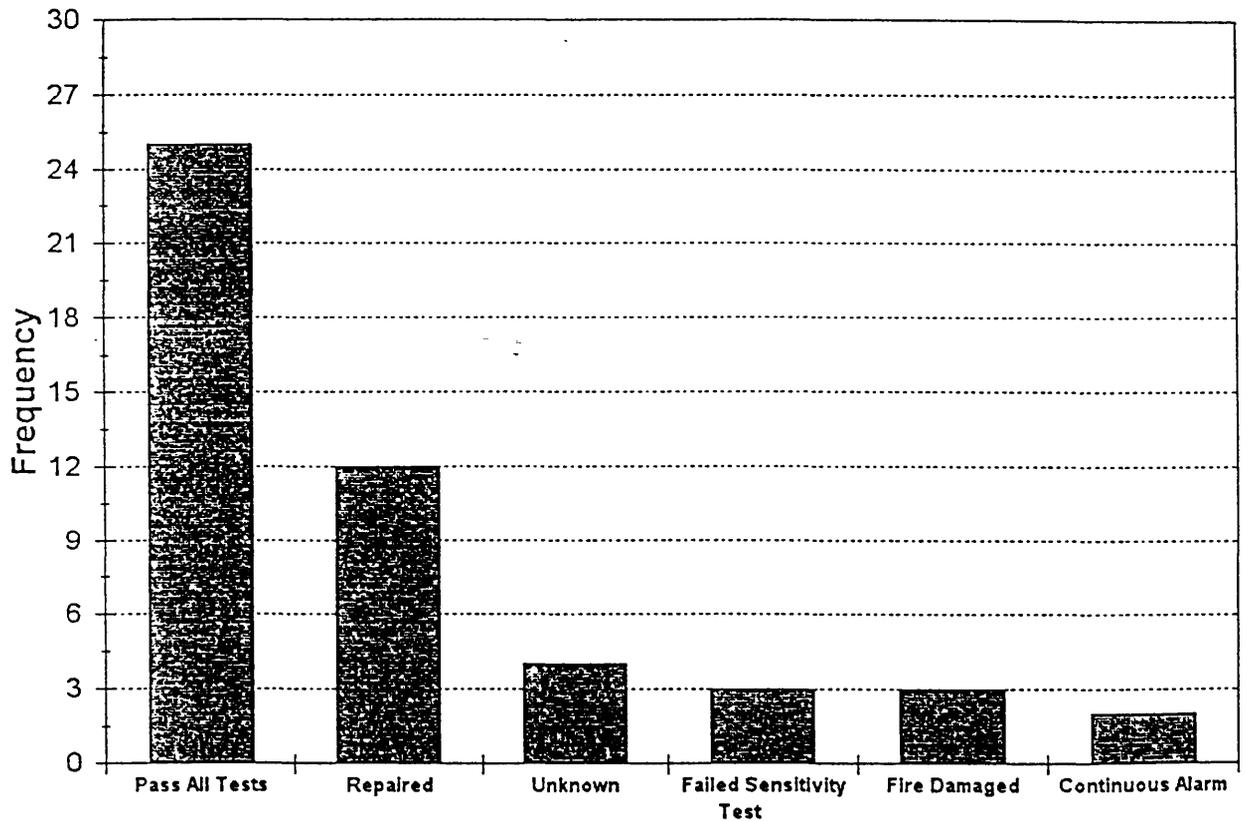
Figure 4. Laboratory results for smoke detectors collected for failing field testing.

Twenty-five of these units were able to pass the testing protocol in the

laboratory without any repairs. One possible reason other than excessive debris in the detector and the uncertainty of the power state of the detector is horn corrosion. Horn corrosion has been shown to account for detector failure [1]. The suspected detectors use a piezoelectric disk with three plated areas, typically made of silver, for the horn. Laboratory examination showed visible deterioration and corrosion on each of the horn contacts. Over time, the detector may become inoperative because the plated area in the horn element corrodes in the household environment. With corrosion and deterioration, the normally low electrical resistance of the pressure contact becomes higher until the horn can not sound an alarm signal.

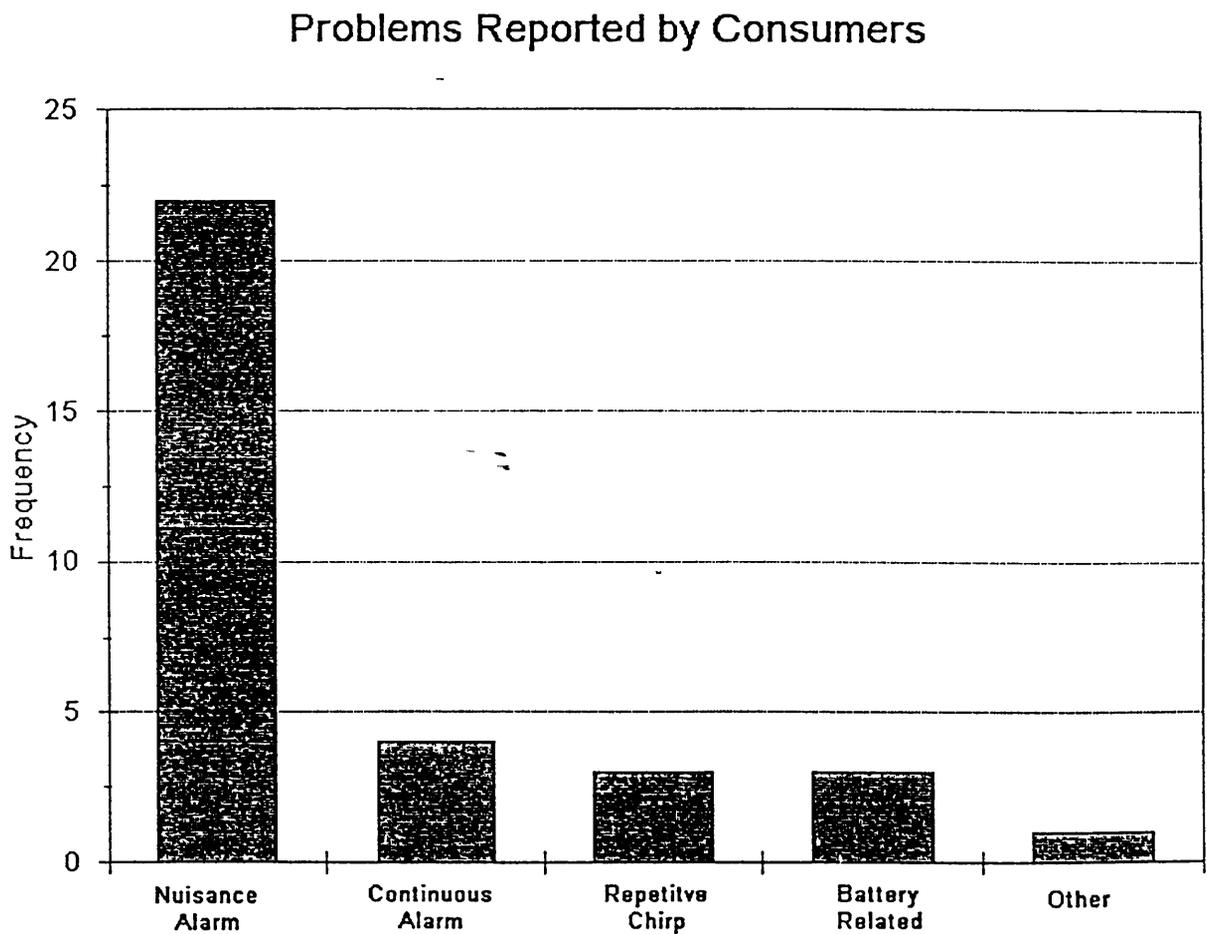
Figure 5. Problems with detector reported by consumers.

If the smoke detector had a disconnected power source, fire department personnel asked the consumer if they had a problem with the detector. Thirty-three smoke detectors were collected because of complaints, which are displayed in Figure 5.

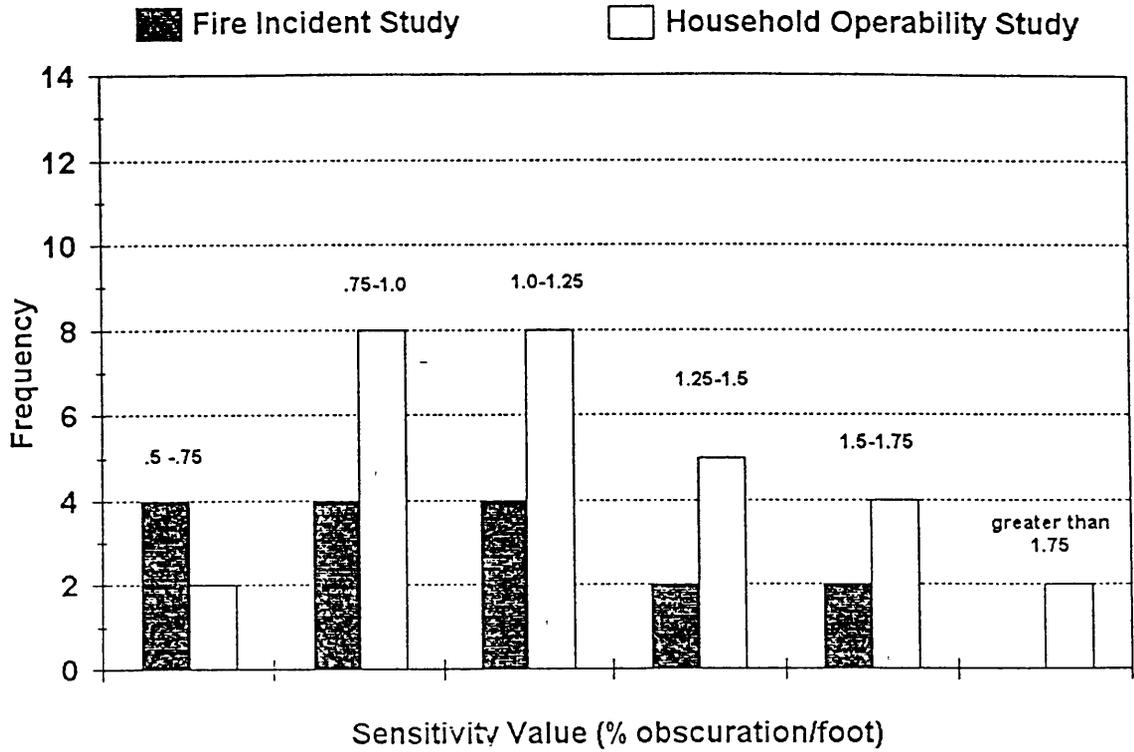
Figure 6. Sensitivity values of smoke detectors collected with which consumers complained of nuisance alarm problems.

Excessive dirt, dust and insect infestation can alter the sensitivity of the detector, causing an unusual number of nuisance alarms. The additional elements from the fire (e.g. soot, heat, and water) can adversely affect the detector's sensitivity. Thus, limited conclusions can be drawn from the information. An accurate assessment of the sensitivity values for detectors collected in the Fire Incident Study cannot be made since the condition of the unit before the fire is unknown.
