DALLAS SATELLITE OFFICE

PHOTO SHEET

LOCATION Austin, Texas
DOCUMENT NO. F/U to F9837026A
PRODUCT Himalaya Amusement Ride
IDI# 980320CWE7133

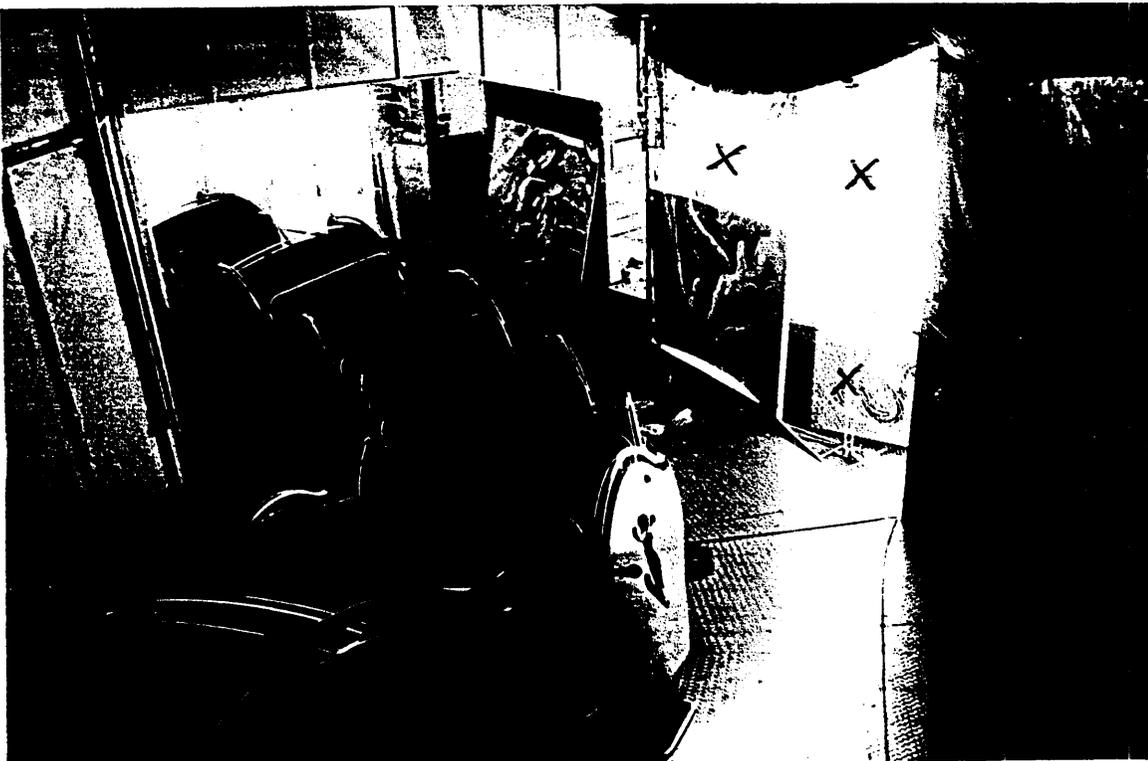
NO. 21

Photo shows the incident area from the twelve o'clock area looking back down onto the site. The panels missing from their usual location were removed to allow entry by paramedics. "X's" mark the area where panels were removed.

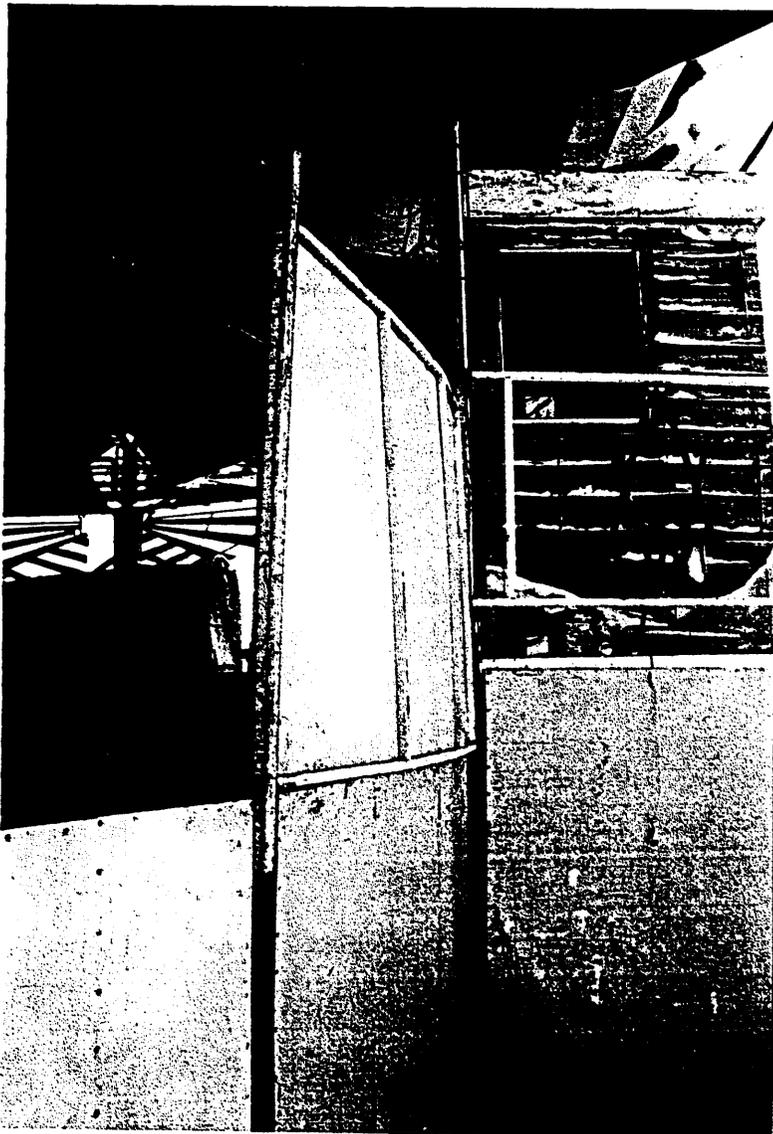
NO. 22

Photo shows panel the victim hit from the outside of the ride. Note the bulge at the bottom of the panel. The window in the photo part of the ride operator's station. As can be seen in this photo and photos 18-21, this incident occurred almost in front of the operator's station.

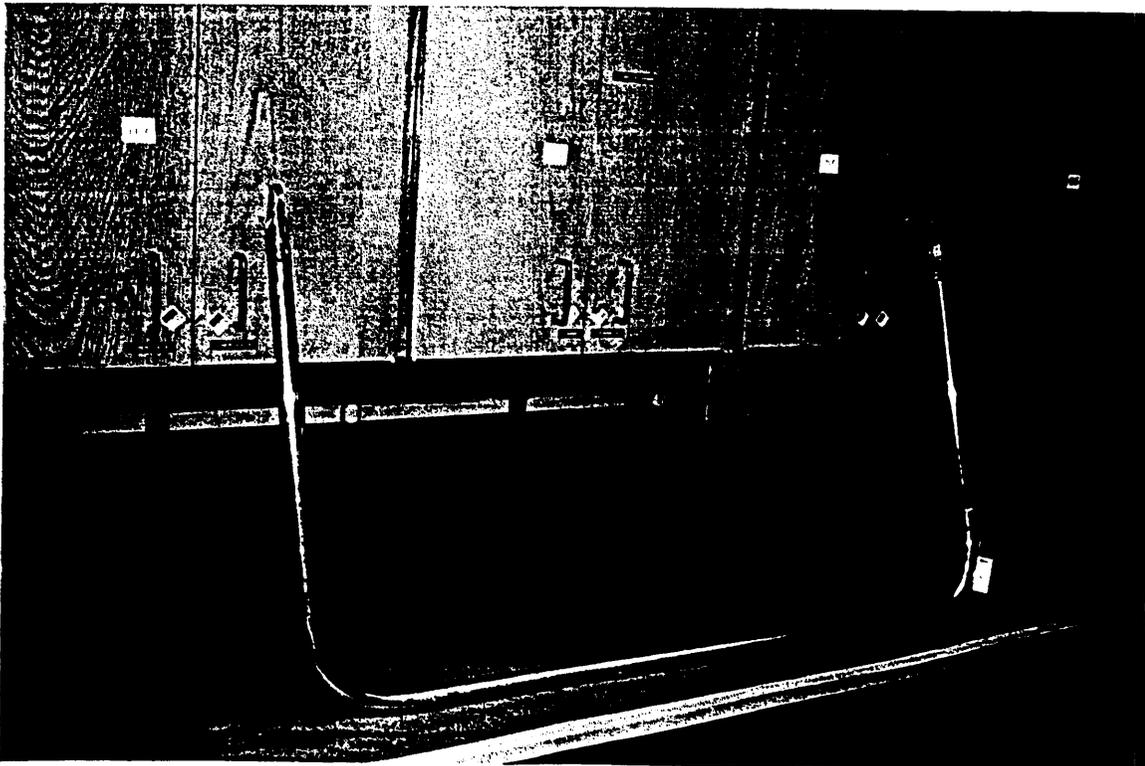
NO. 24

Photo shows the lap bar removed from the scene by local police. This photo was taken in the evidence room. The lap bar was part of car 19 the victims were in and came out of the car with the victims when they were ejected. The bar is 46 7/8 inches wide and the two short parts which attach to the inside of the cars are approx. 28 inches long.

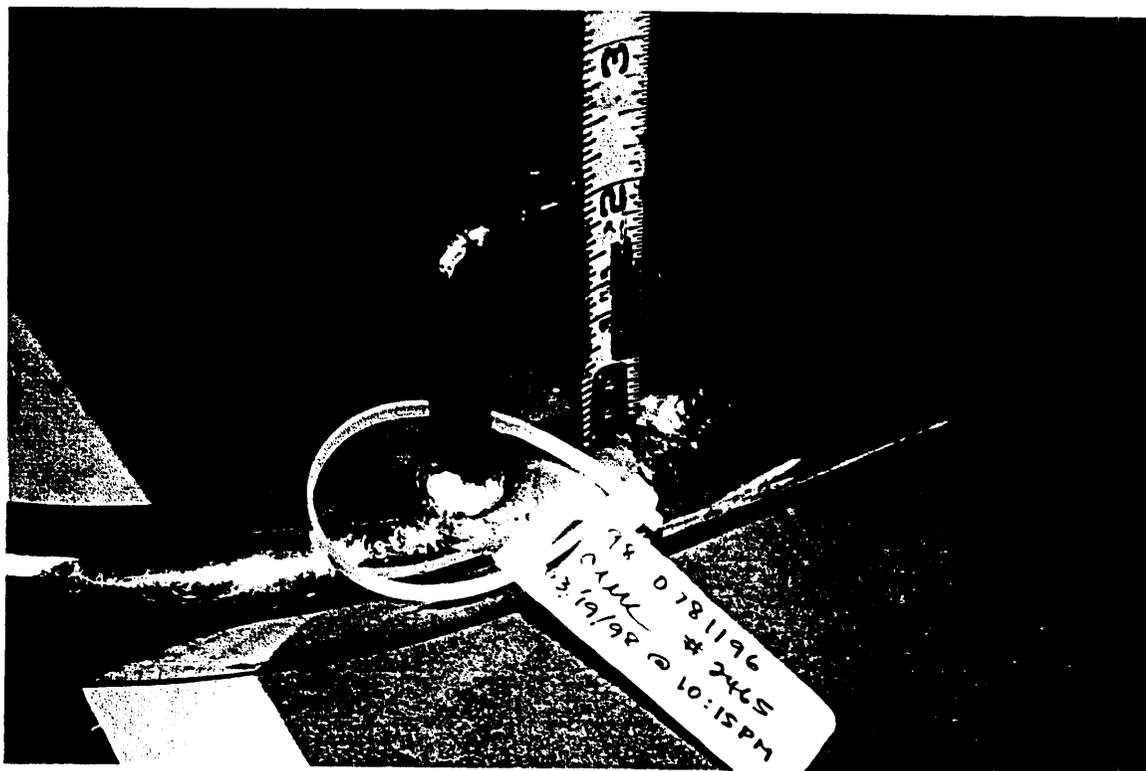
NO. 25

Photo shows the part of the lap bar which allows the bar to become secure in the locking mechanism of each car. The tape measure shows the approx. size. This photo was taken in the police evidence room.

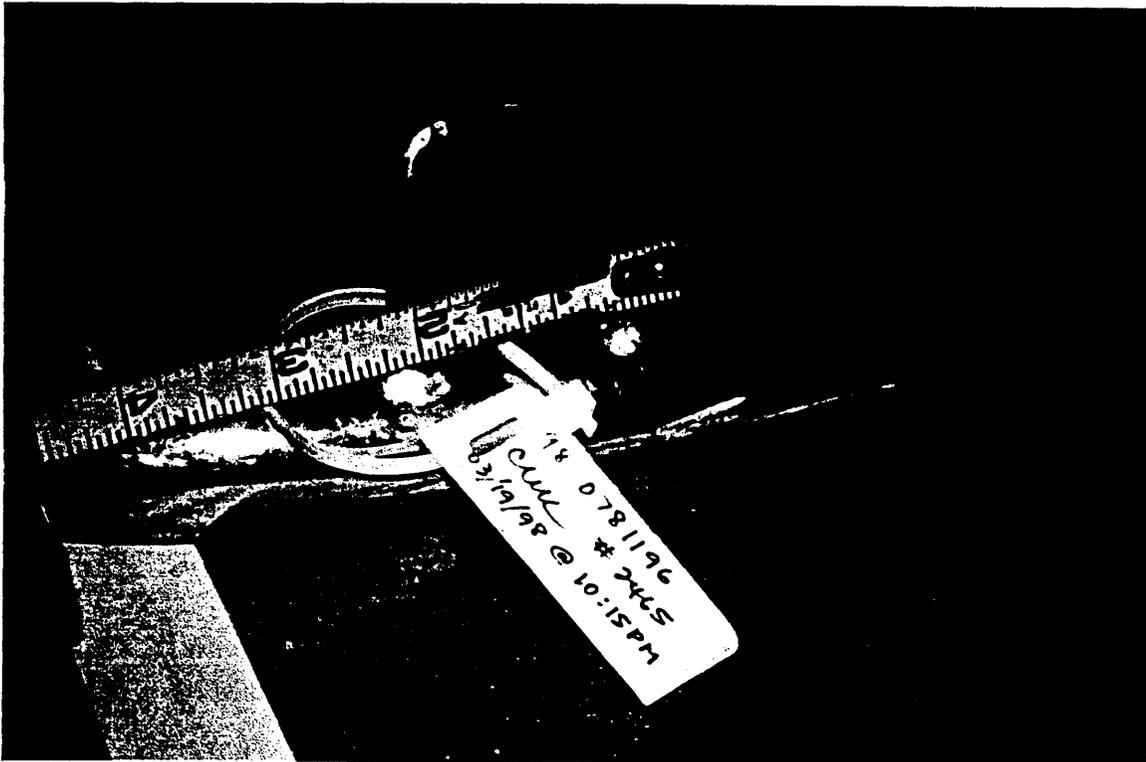
PICTURE
NO. 26
DESCRIPTION
Photo shows
another
measurement of the
part of the lap
bar shown in photo
25. This photo
was also taken in
the police
evidence room.
Other photos of
the lap bar are
attached with this
report.

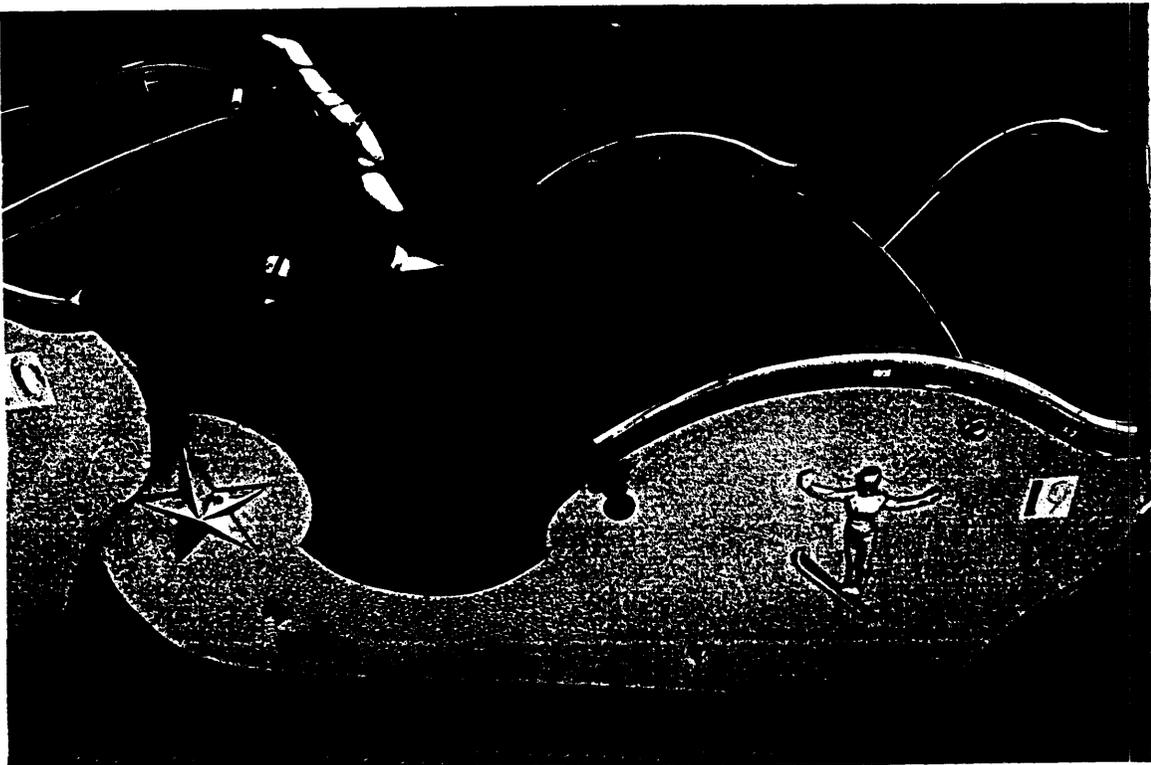
PICTURE
NO. 28
DESCRIPTION
Photo shows
overall view of
car 19 the victims
were in. Note the
lap bar is gone.
The ride was roped
off as a crime
scene and remained
under a 24 hour
guarded watch.
This photo is of
the car as it was
when it came to a
stop.

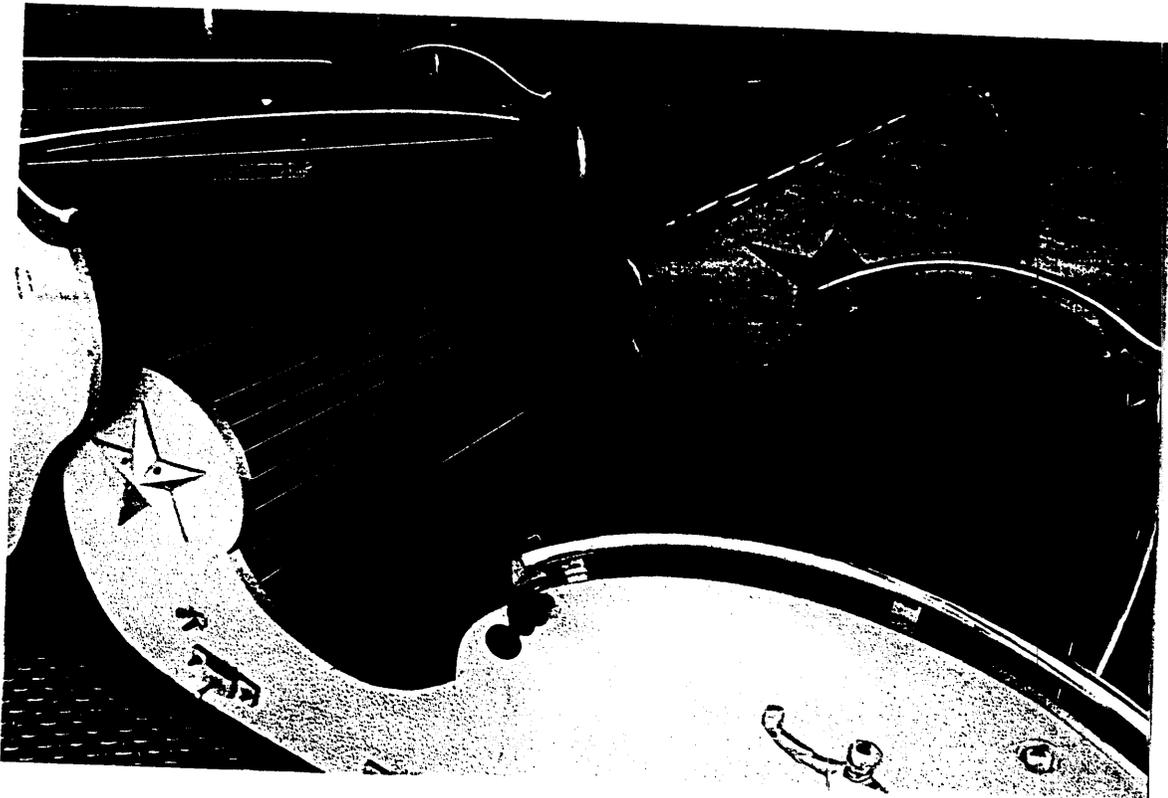
PICTURE
NO. 29
DESCRIPTION
Photo shows
another overall
view of car 19 the
victims were in.
Note the lap bar
is gone.

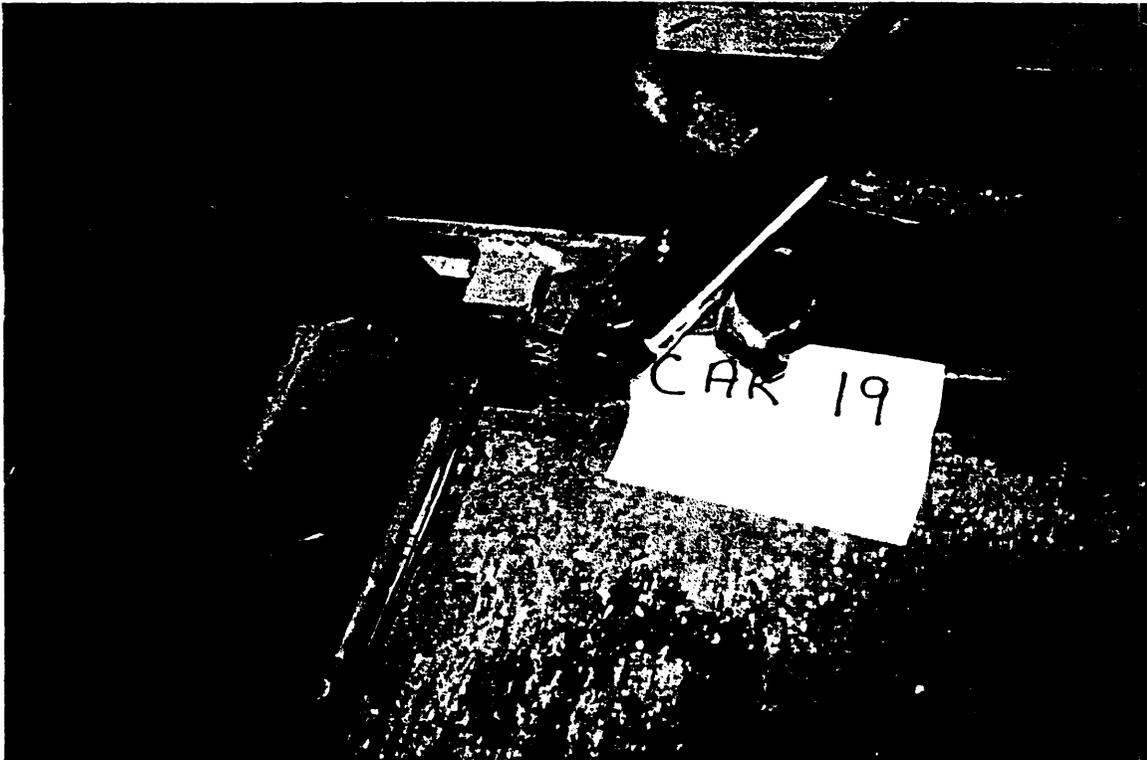
NO. 33

Photo shows another view of the lap bar of car 19 being reattached to the bottom right side of the car without the use of cotter pins.

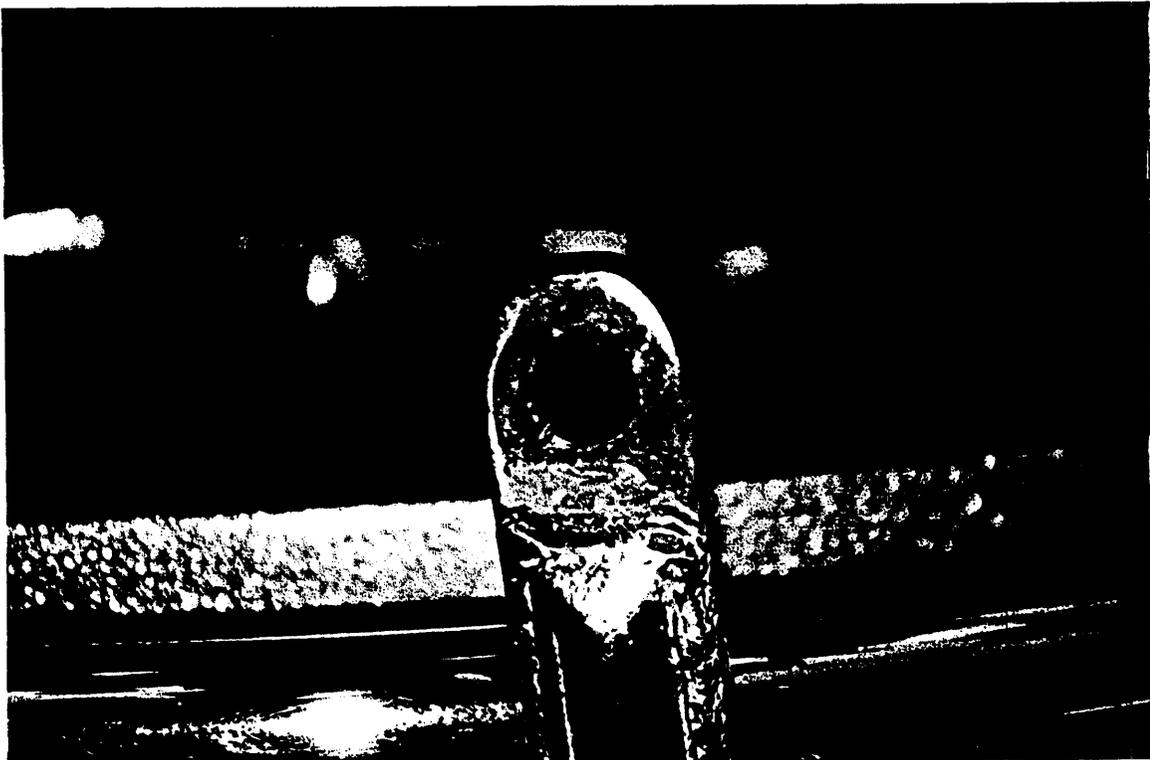
NO. 34

Photo shows the inside of the lap bar for car 19 where it attaches to the bottom of the car. Note the wear in the lap bar where the cotter pin rubbed against it. These worn areas line up directly with the holes where the cotter pin is inserted. (See arrows)

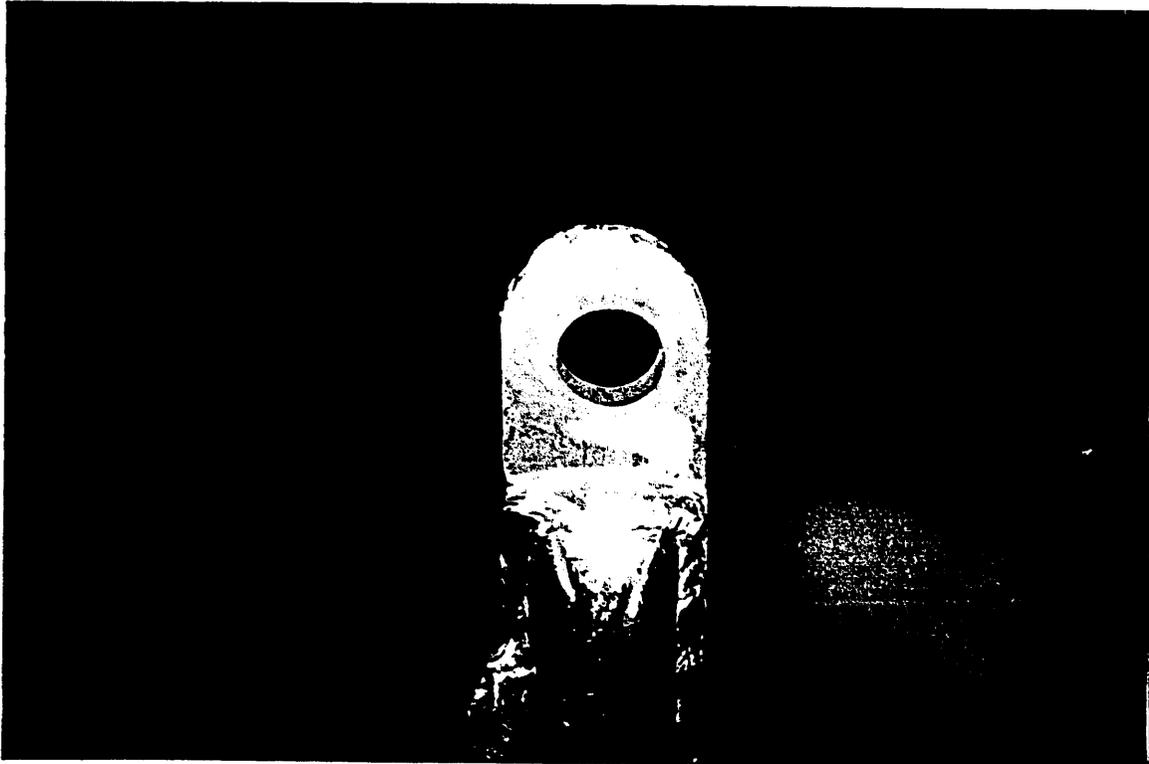
NO. 38

Photo shows the inside of the left side of the lap bar for car 19.

No excessive wear was noted like that on the right side. It should be noted that the 16 year old victim in the middle of car 19 stated the lap bar first became dislodged from the car on the bottom right side.

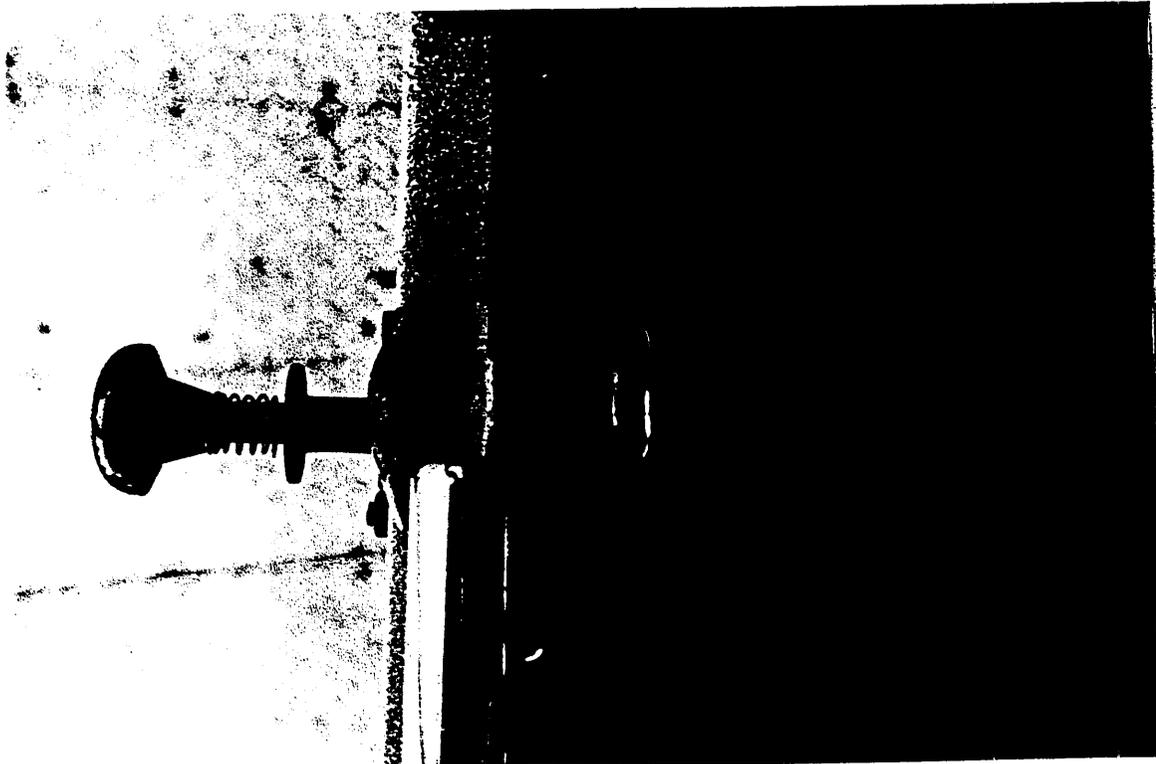
NO. 39

Photo shows the locking mechanism for the lap bar for car 19. This photo is taken from looking straight down into the locking area. Not only did the lap bar for car 19 become detached from the two points inside the car, it also had to become dislodged from this locking mechanism to be ejected from the car with the victims.

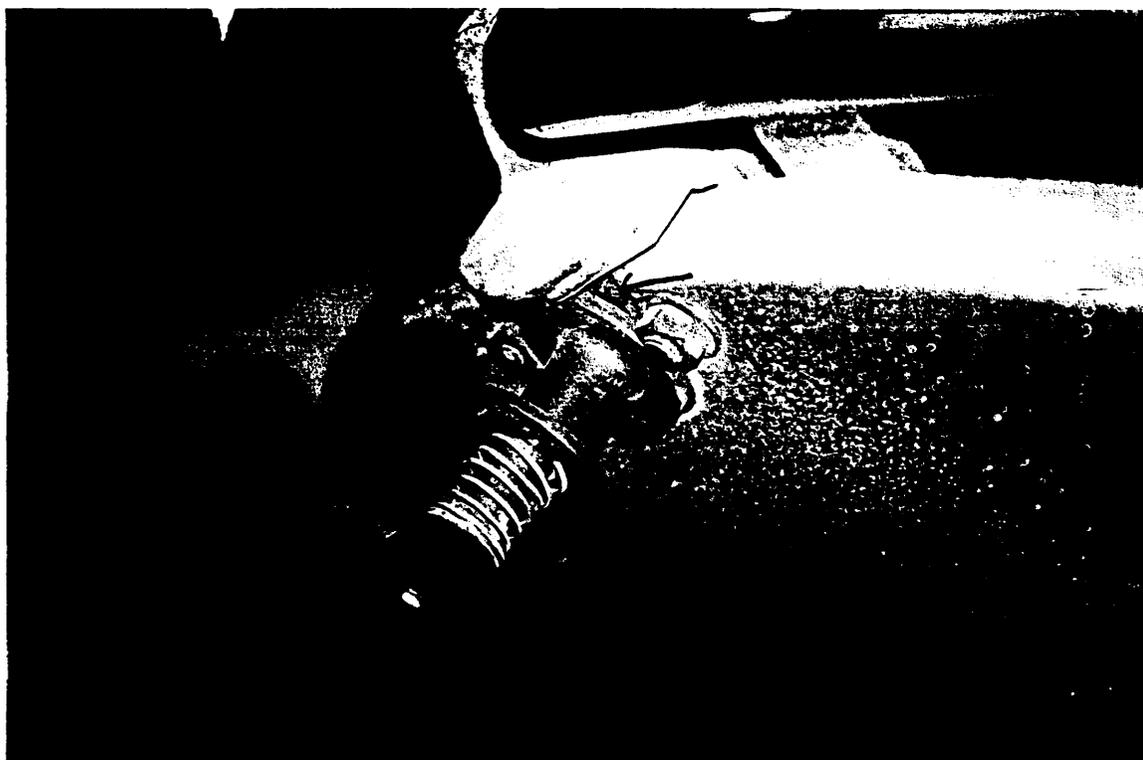
NO. 41

Photo shows the spring loaded knob for car 19. When the lap bar is secure the collar should fit underneath the metal cover and snug between the two nuts. (Note arrow) When the spring loaded knob is in this position, the lap bar appeared to be secure. See Photo 42 for another view of this area.

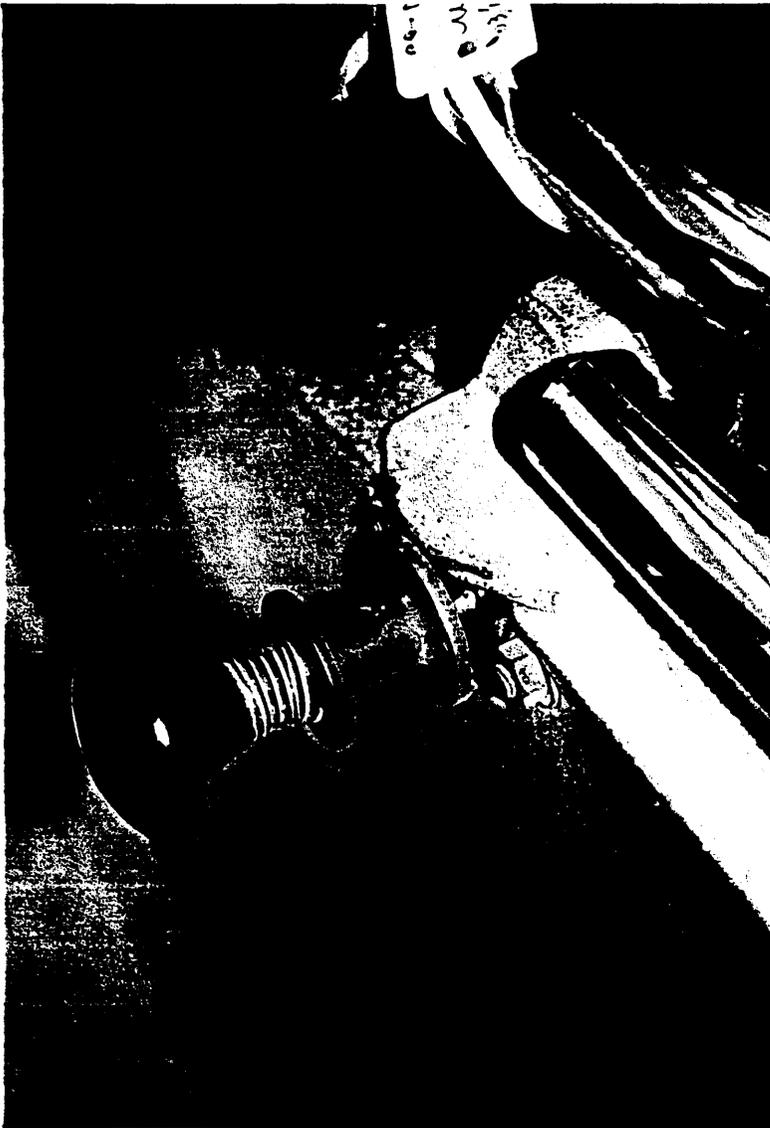
NO. 42

Photo shows the spring loaded knob for car 19 in a different position than that of photo 41. Note how the collar has not fit underneath the metal cover like it has in photo 41. When this happens, you can easily detach the lap bar by lightly lifting up on the knob. This mistake was easily made during several attempts to lock the lap bar. No other cars had this problem.

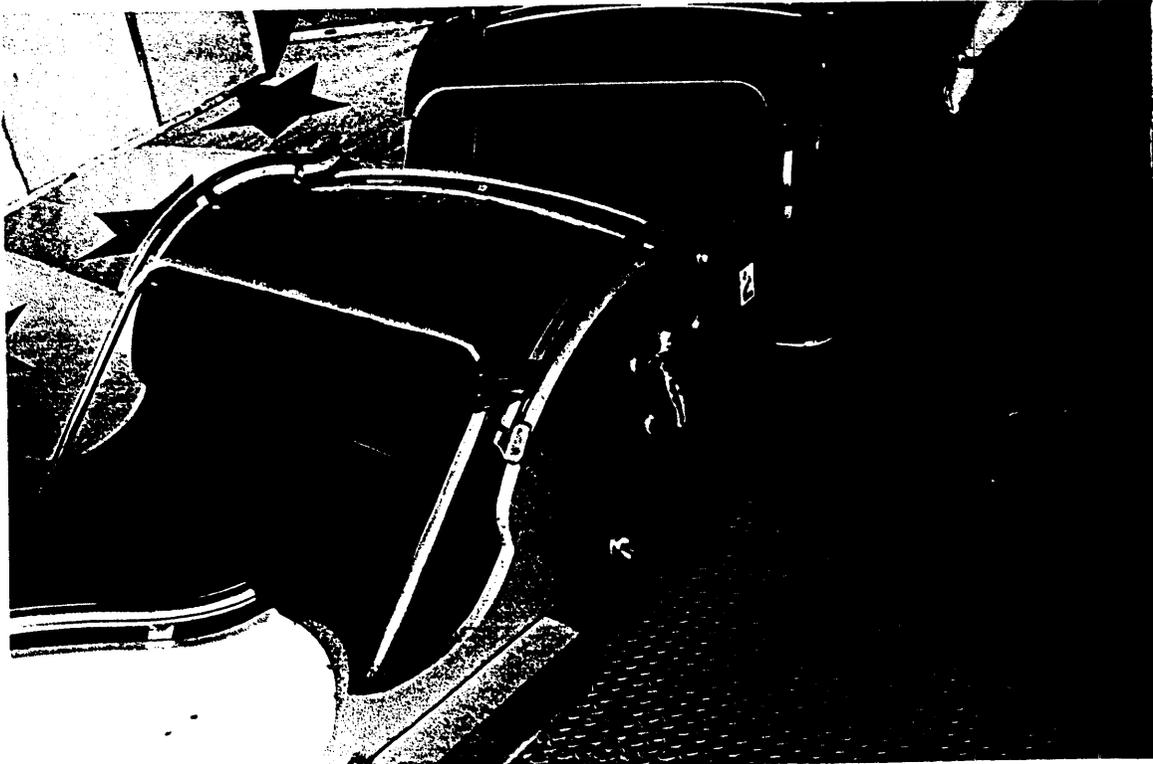
NO. 47

The inspection by Bob Gill prior to the opening of the ride listed cars 2, 6, 17, 24 as not to be used because of broken catches (locking mechanisms).

Photos 47-50 show these cars. This photo shows the lap bar for car 2 as having its lap bar taped down and not to be used.

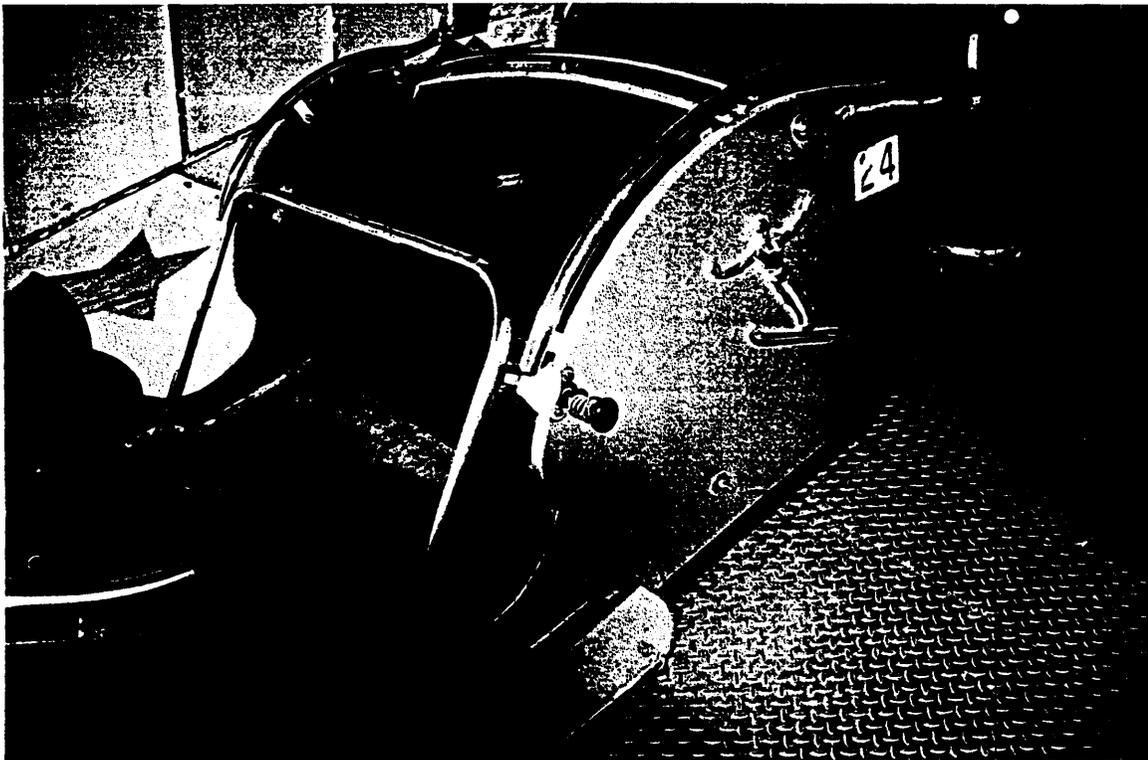
NO. 48

Photo of car 24.
The pre-inspection
listed this car as
not to be used;
however, it
appeared to
working okay when
checked. Note the
lap bar is not
taped down.

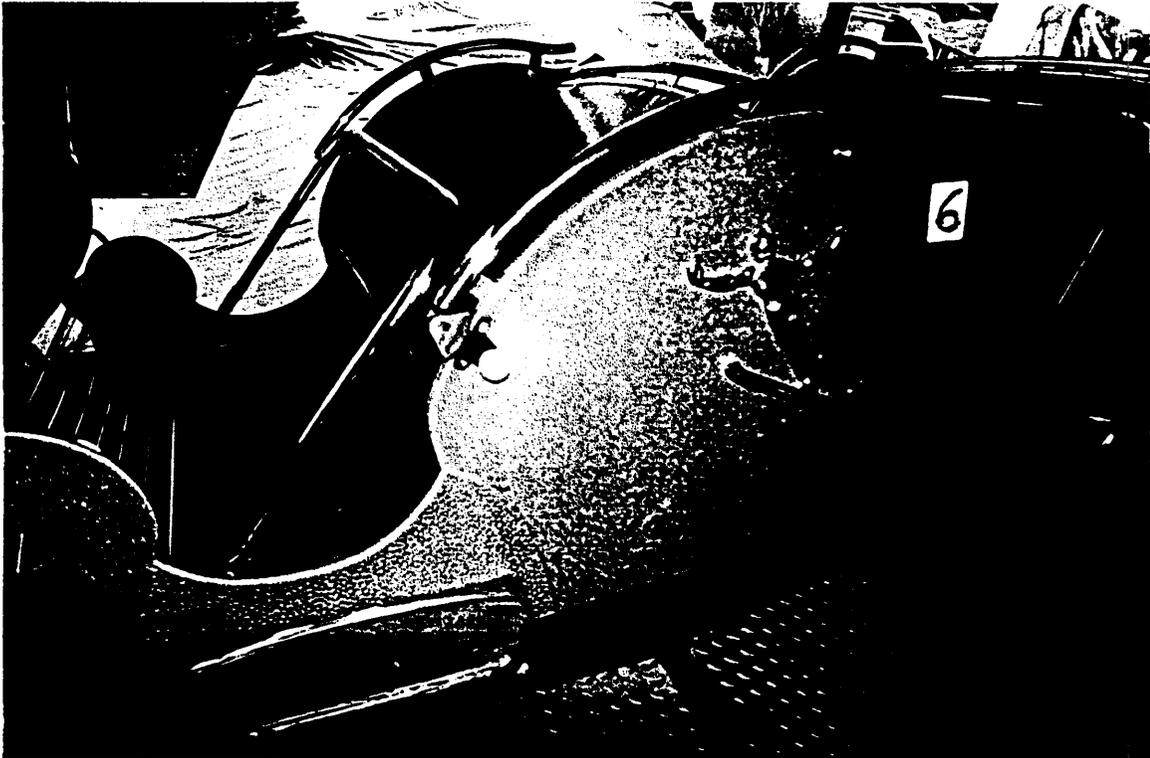
NO. 50

Photo of car 6.
The pre-inspection
listed this car as
not to be used;
however, it
appeared to be
working okay when
checked. Note the
lap bar is not
taped down.

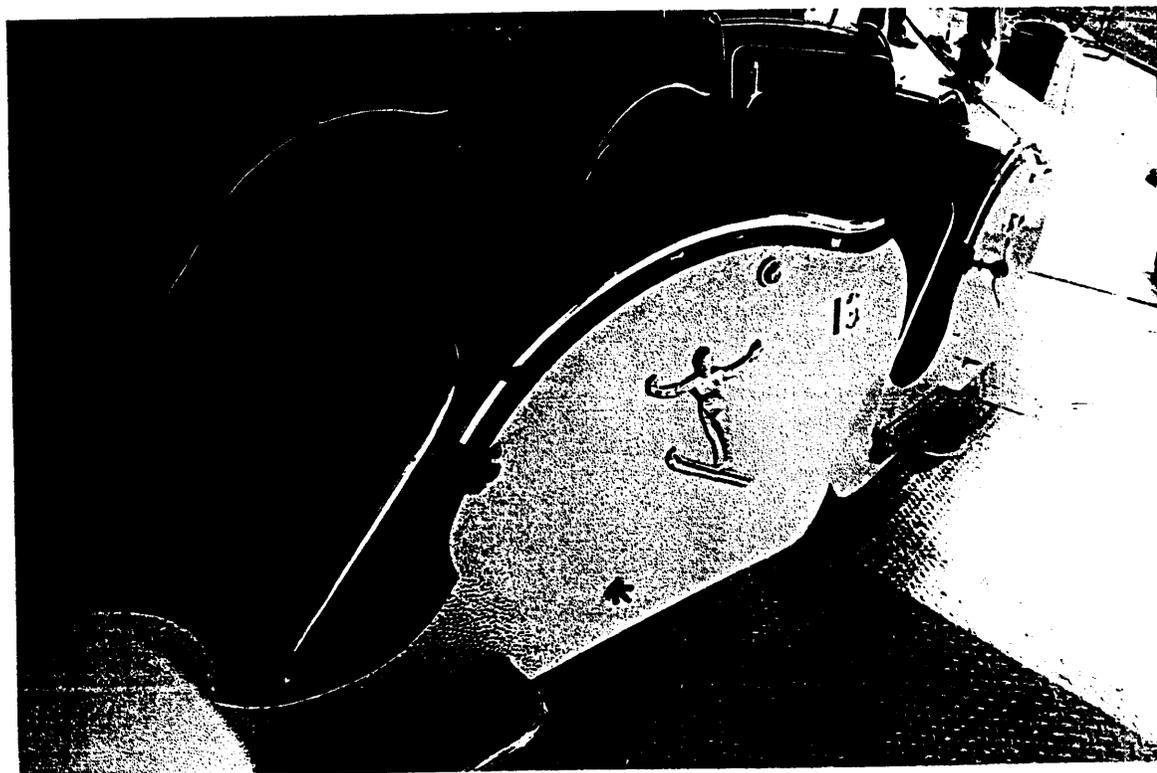
NO. 51

Photo of car 13.
The pre-inspection
did not list this
car as having a
broken locking
mechanism and not
to be used;
however, as can be
seen the lap bar
has been taped
down and the
locking mechanism
is missing.

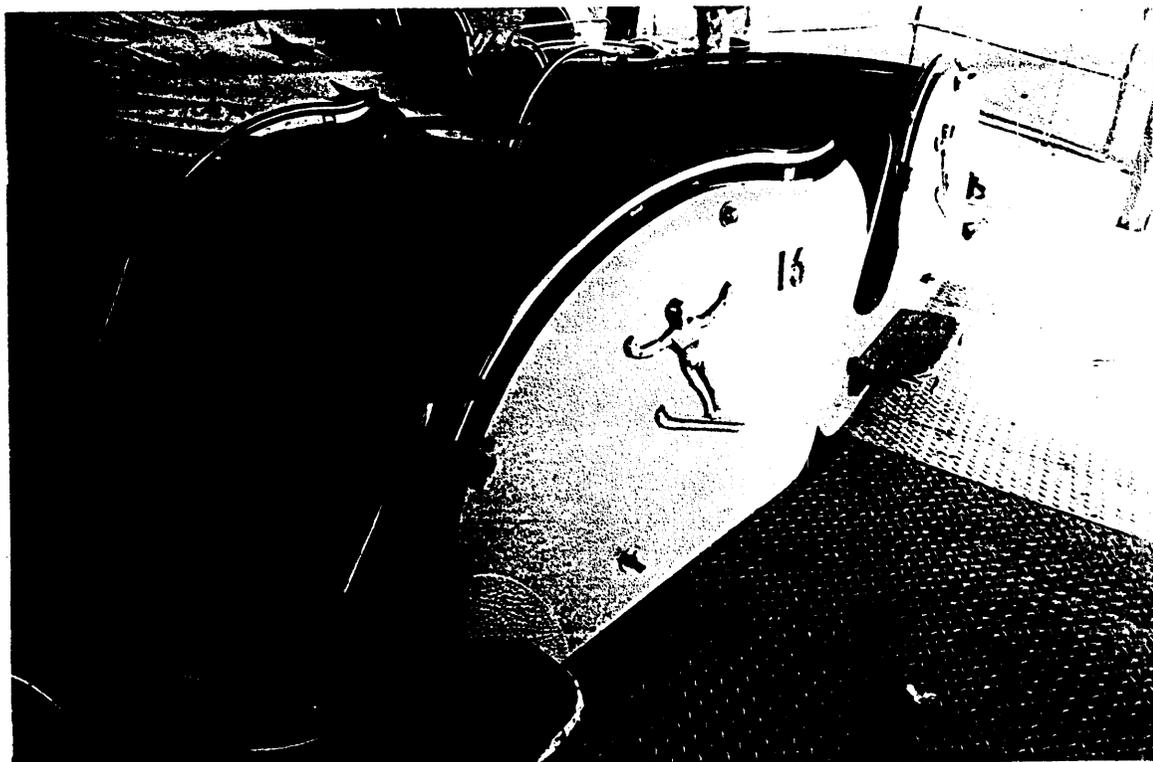
NO. 52

Photo of car 16.
The pre-inspection
did not list this
car as having a
broken locking
mechanism and not
to be used;
however, as can be
seen the lap bar
has been taped
down and the
locking mechanism
is missing.

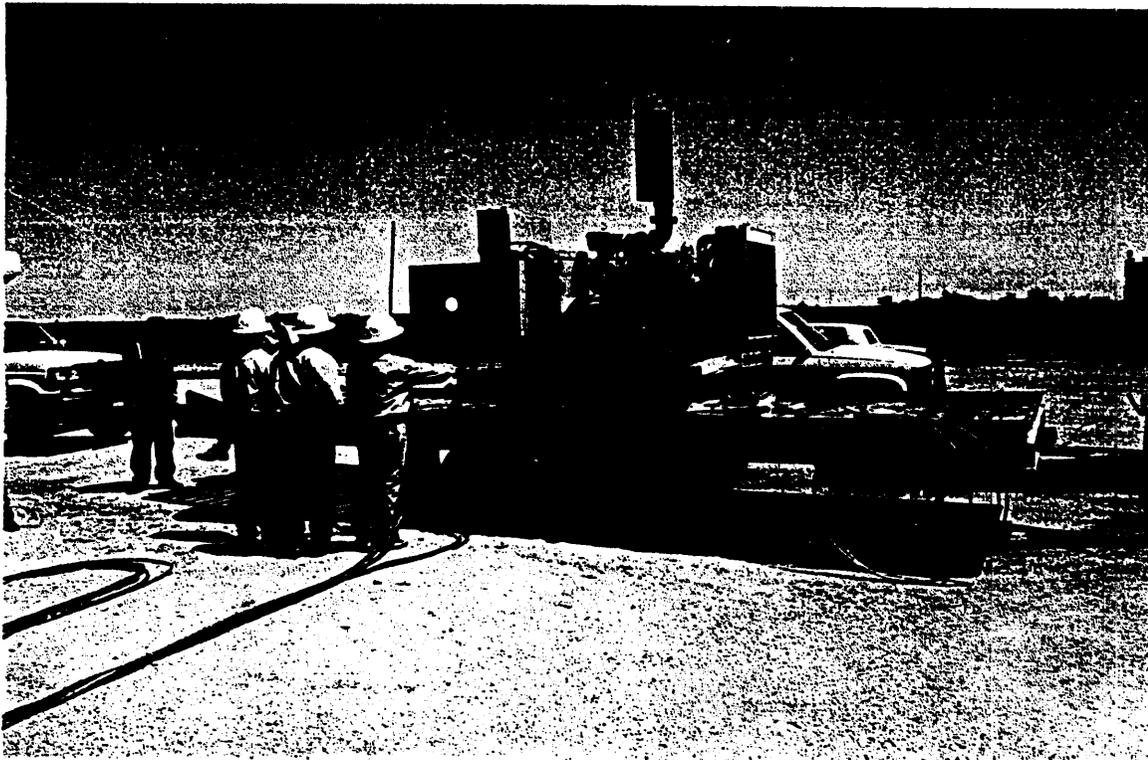
NO. 53

On March 27, 1998, the ride was run to check its performance. The main test was to count the number of RPMs. Photo shows a generator brought to the scene for the purpose of getting power to the ride. The generator was provided by the city of Austin.

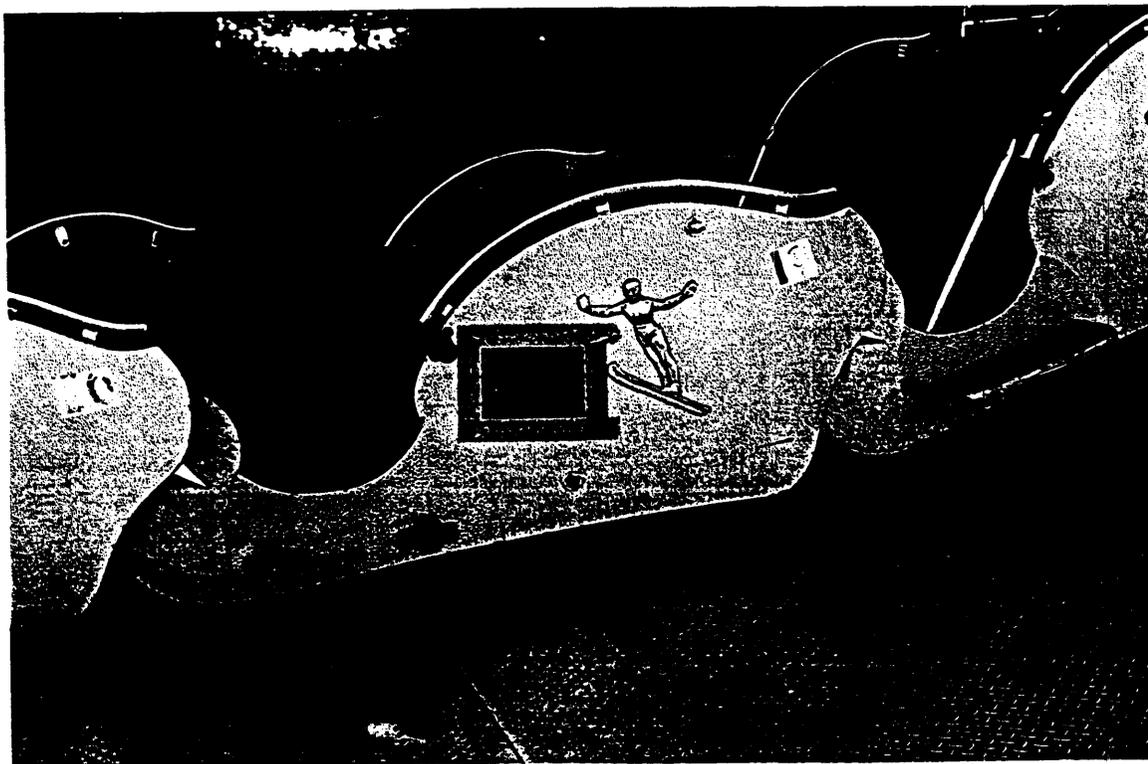
NO. 54

Car 19 was marked with the bright pink sign for the purpose of counting the car as it came. An operator was found to operate the ride who was not affiliated with B & B Amusements or the city of Austin. The ride was supposedly set to go 10 RPMs at maximum speed. The ride is designed to go forward or backward, but this ride would only go forward.

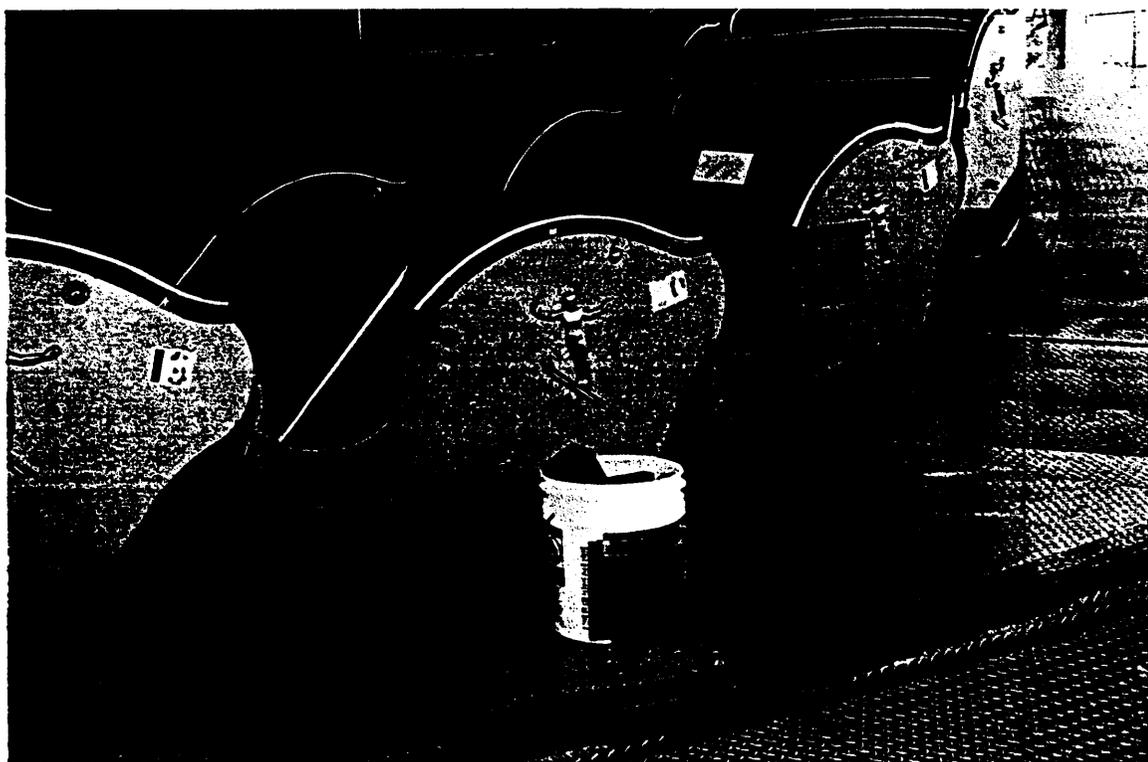
NO. 55

Car 19 was also marked with the bright yellow sign on the back of the seat. The white bucket with the pink sign was placed there to line up the marked car as it came by. The car was tested with a stop watch and counting revolutions and also by a video camera. At maximum speed the ride went constantly at 15.789 RPMs or one revolution every 3.8 seconds.

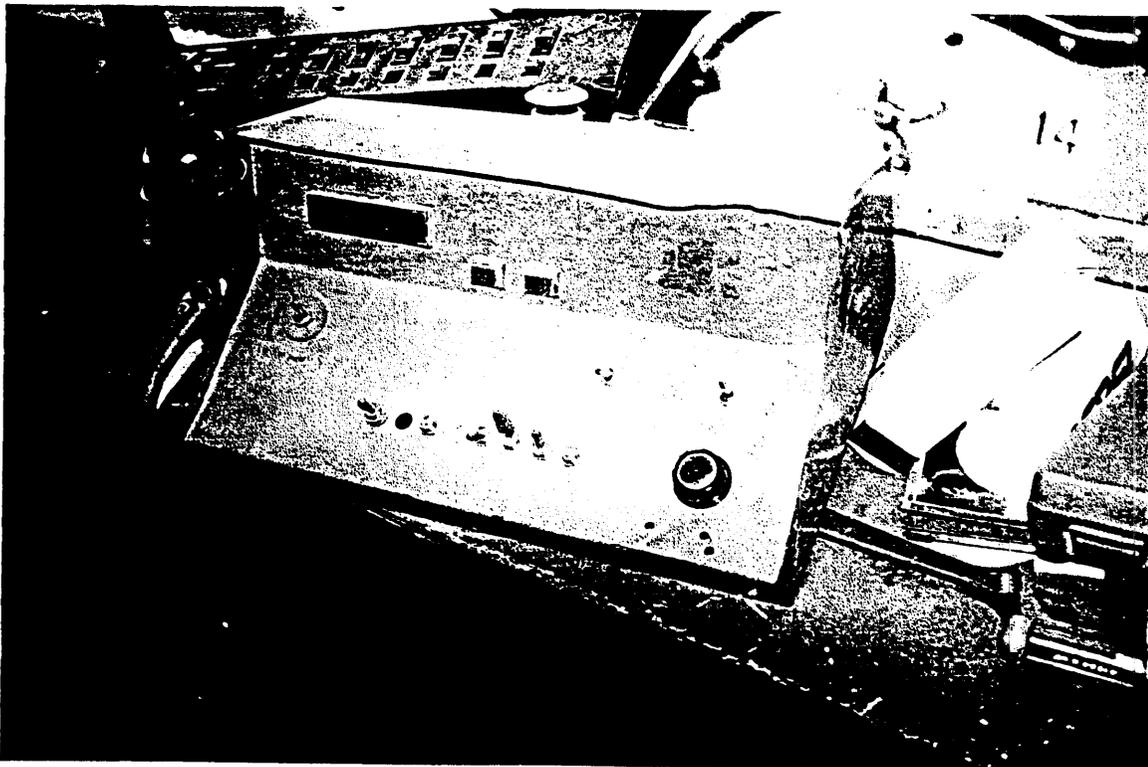
NO. 56

Photo shows the control box inside the ride operators station. The operator was watched by police and they also ran the ride at full speed. The ride was also clocked with a radar gun and it ran at a top speed of 23 mph. The ride went much faster than the 10 RPMs quoted by an official of Bob Gill & Associates.

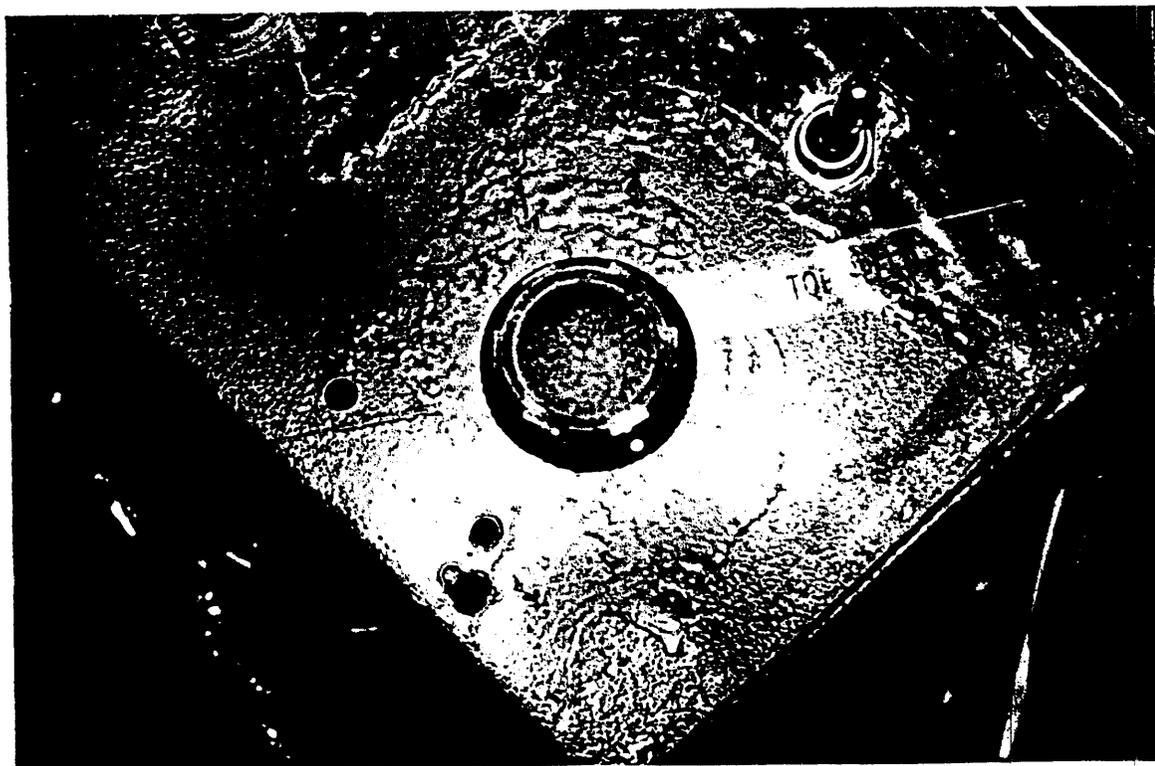
NO. 57

Photo shows a closeup of the control box inside the ride operators station. With force, the control knob would go past the TOP SPEED label because the inside of the knob appeared to be plastic and somewhat stripped. The white dot on the control knob is supposed to be the speed indicator. When the white dot went past the TOP SPEED label, it did not go faster.

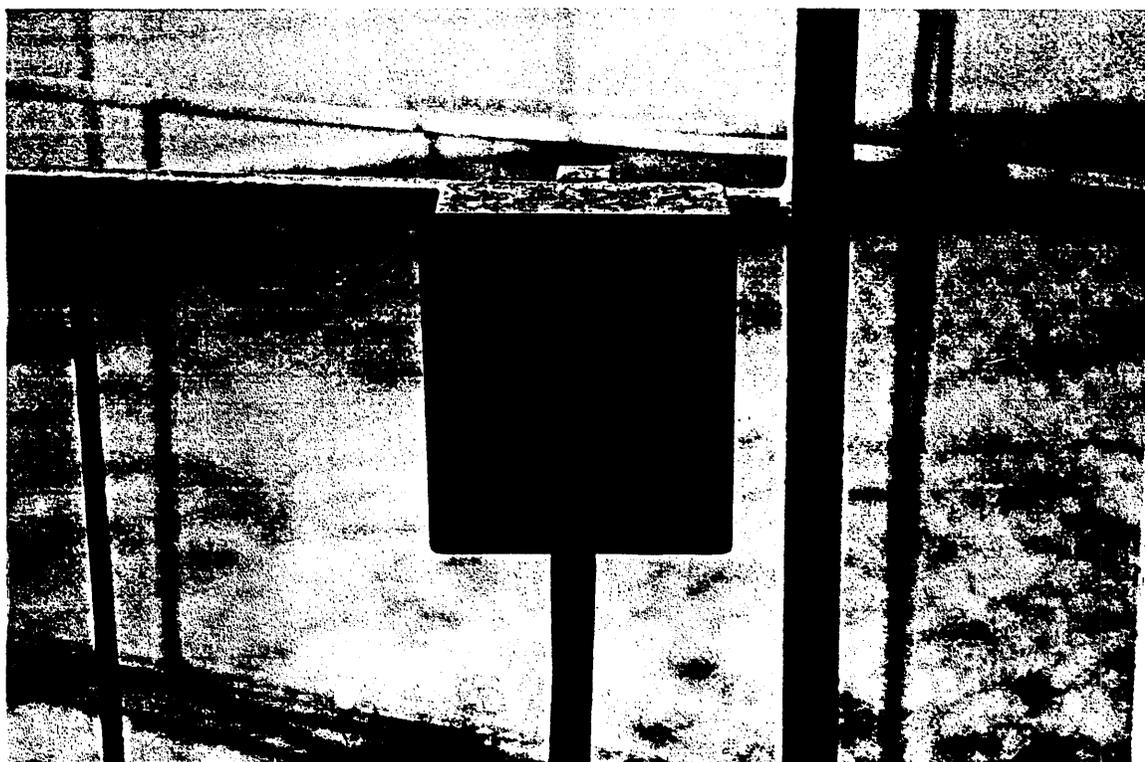
NO. 58

Photo shows a closeup of an emergency "kill switch" on the opposite side of the ride from the ride operator station. There were reports this "kill switch" was activated by one of the ride attendants. The ride also reportedly went around at least one revolution or maybe almost two before it came to a complete stop after being turned off.
