DALLAS SATELLITE OFFICE

PHOTO SHEET

LOCATION Austin, Texas
DOCUMENT NO. F/U to F9837026A
PRODUCT Himalaya Amusement Ride
IDI# 980320CWE7133

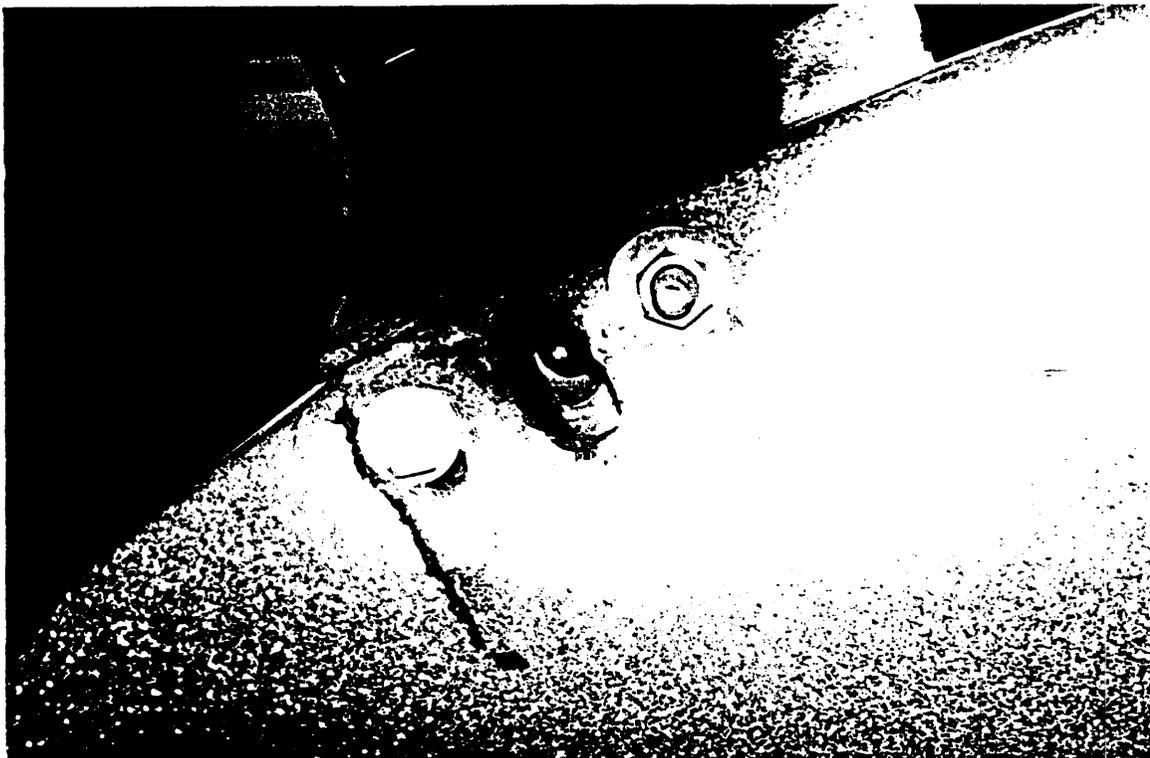
NO. 61

This photo shows the car the part in photo 60 came out of while it was being tested. It appears the shaft came unscrewed from inside the car wall.

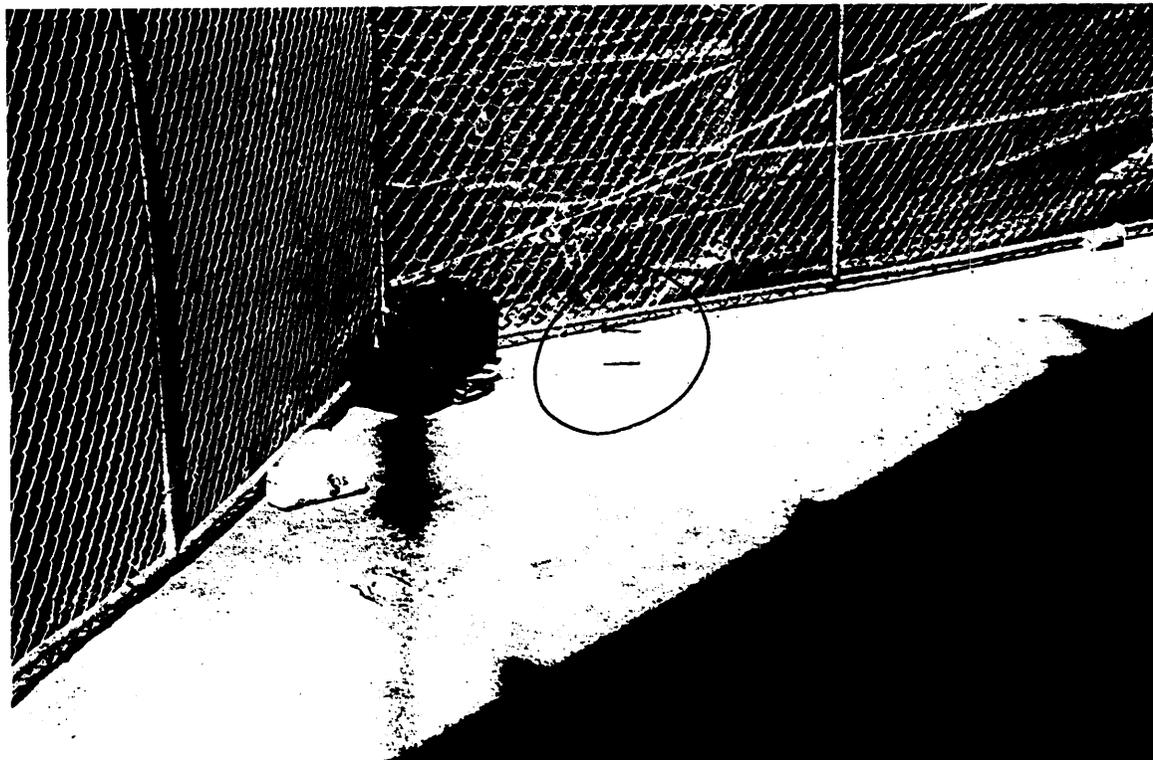
NO. 62

While conducting another test yet a third locking mechanism came flying off one of the ride's cars. This part narrowly missed this investigator and was traveling at an extreme high rate of speed. Photo shows the parts lying close by my camera case and brief case. (Note circle)

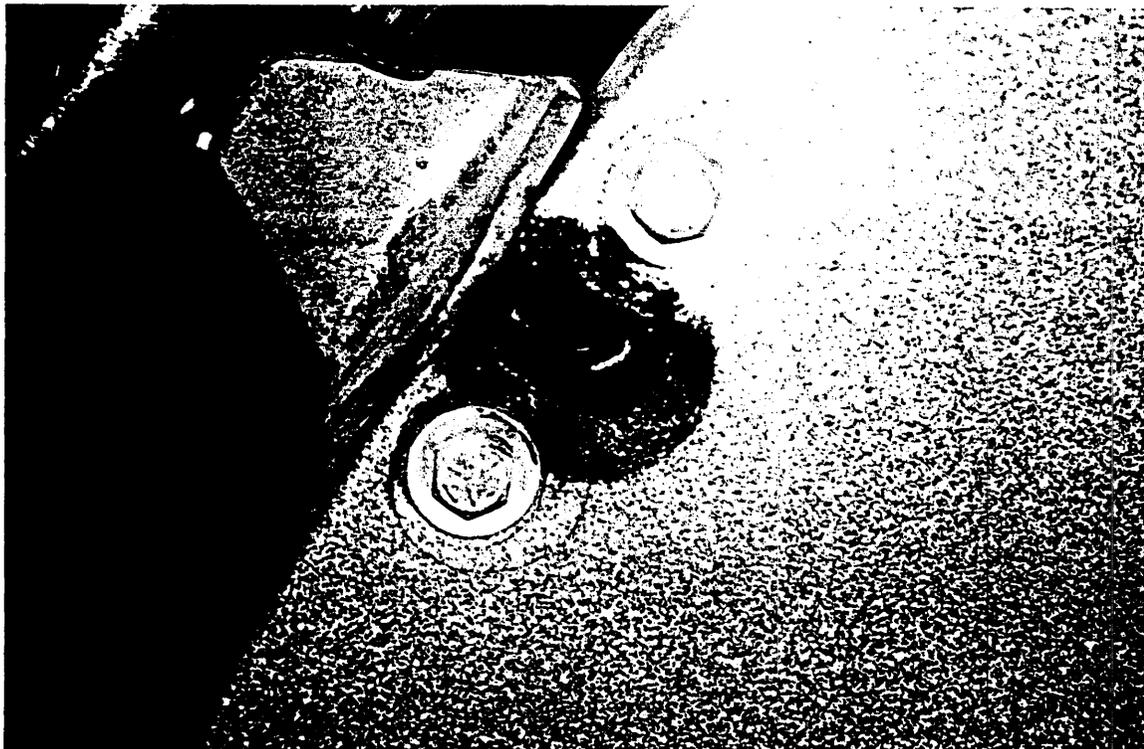
PICTURE
NO. 64

DESCRIPTION
Photo shows the
car the parts
shown in photos 63
and 63 came off
of.
