U.S. CONSUMER PRODUCT SAFETY COMMISSION  
WASHINGTON, D.C. 20207

**Re: FOIA Request S-712020: Information concerning Lennox Pulse Furnaces**

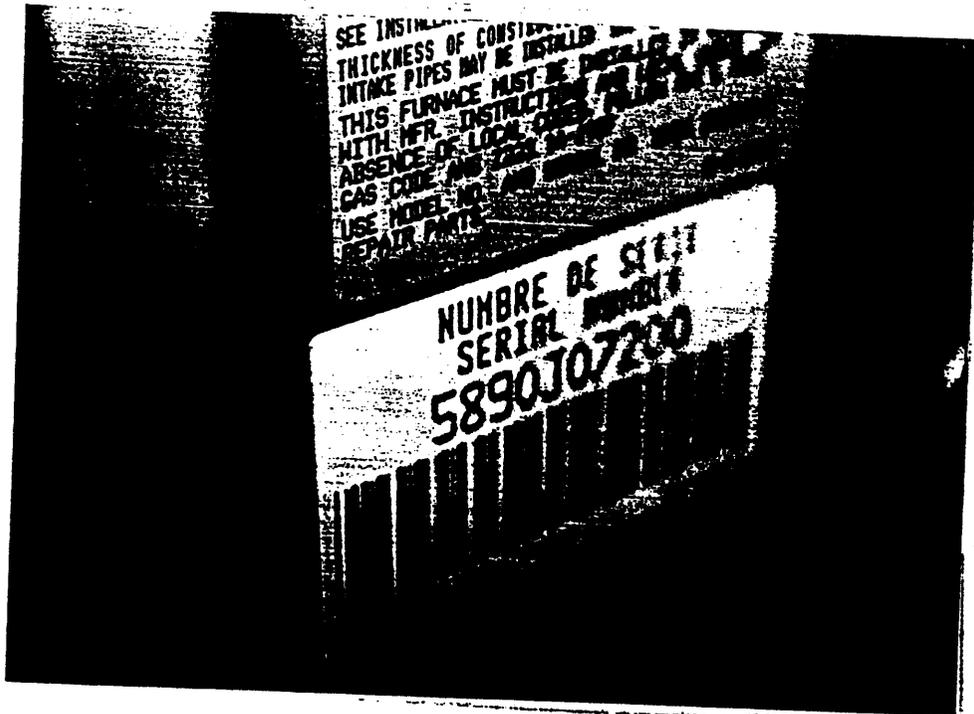
22. Serial number on unit.
