U.S. CONSUMER PRODUCT SAFETY COMMISSION  
5 RESEARCH PLACE  
ROCKVILLE, MD 20850

January 8, 2018

# CPSC Staff Assessment on Eutectic-Type Thermal-Cutoff Fuse Failures in Shaded-Pole Motors Used in Exhaust Fans

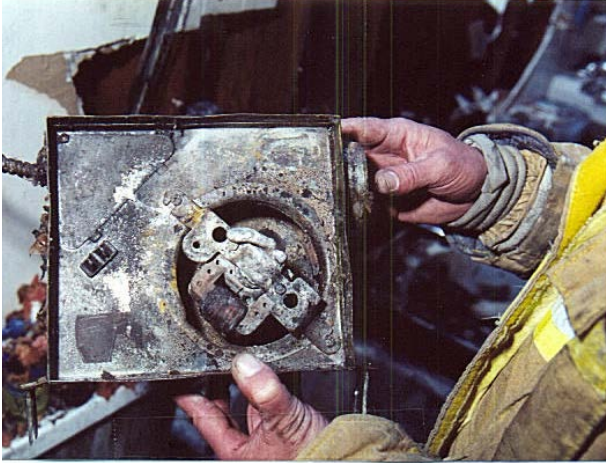
In March 2001, at about 6:50 a.m. the fire department responded to an apartment structure fire. Firefighters discovered fire in the walls and the attic above the bathroom where the incident exhaust fan was located. Fire had spread into the common bathroom wall between apartment units and in the adjacent bedroom walls. The fire department determined that the fire started from a 30-year-old exhaust fan located in the bathroom of the apartment.

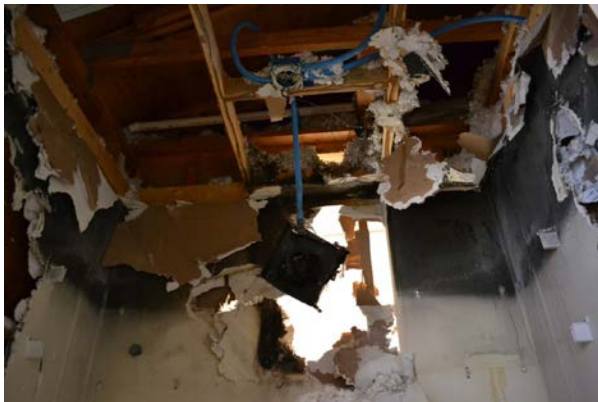
The incident occurred at a daycare facility. The building was built in 1995, and has been used as a daycare facility since its construction. The fans were original when the building was constructed. The lights and fans were controlled by a single switch. Five days a week, the switch was turned on at approximately 6:30 a.m. and turned off at about 7:00 p.m. The incident occurred in March 2011. After the daycare lights and fans were switched on, the daycare heat was also turned on. Approximately 1 hour later, a teacher and her assistant smelled something burning and assumed it was related to the heating system. Even though after the heating system was turned off, the burning smell persisted. The director went to the infant room and localized the burning smell to the changing room/bathroom. The director notified the owner of the daycare and was advised to disconnect the exhaust fans because they were old. The director was unplugging the exhaust fan when a “large fireball shot out” of the exhaust fan. The daycare was evacuated and the fire department was summoned to extinguish the fire.

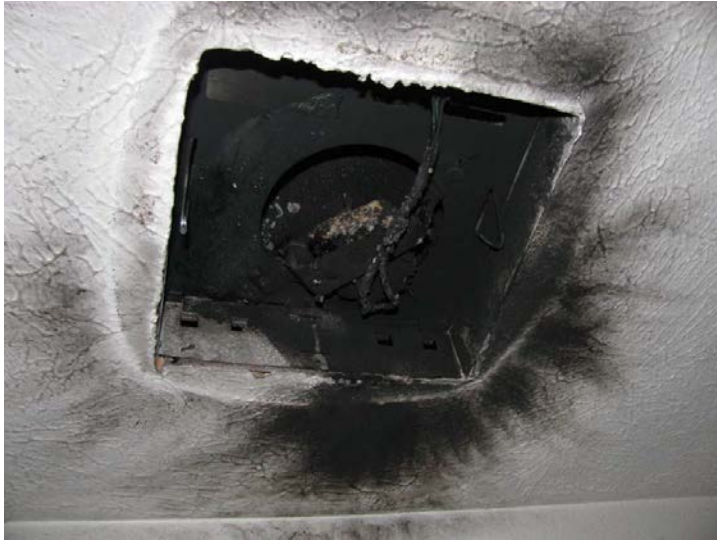
The June 12 incident occurred in a half bath in a single-family home. The Fort Riley Fire Department was dispatched to a structure fire at the residence. Upon arrival, the fire responders did not witness any signs of fire outside the home. Fire personnel entered the home to investigate and found water pouring from the first floor bathroom exhaust fan on the ceiling. The fire had been extinguished before fire fighters entered the home. The report identified that the plastic inside the fan had ignited, which then ignited the plastic vent hose. A plastic water line located above the fan had melted, which extinguished the fire. The cause of the incident was an overheated exhaust fan.

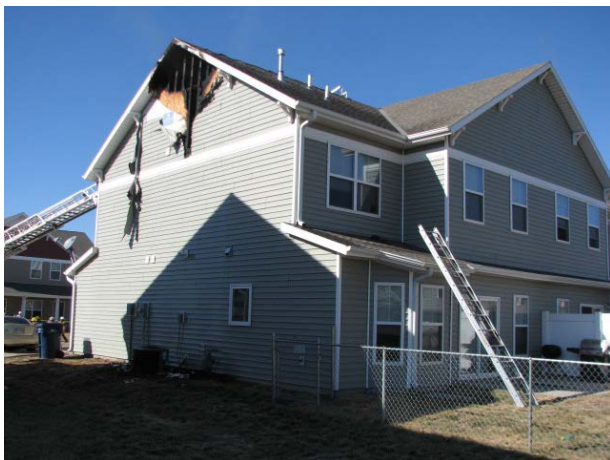
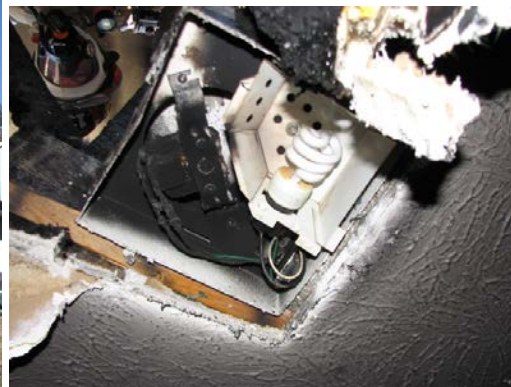
The February 5 incident occurred in a full bath on the second floor of a single-family home. There was extensive damage to the attic above the bathroom. The field investigator noted that the incident fan switch was in the “up” position, suggesting that the fan was on when the incident occurred. When the fire department arrived at the scene, fire personnel determined that the fire had spread into the attic area. An overheated exhaust fan caused the incident.

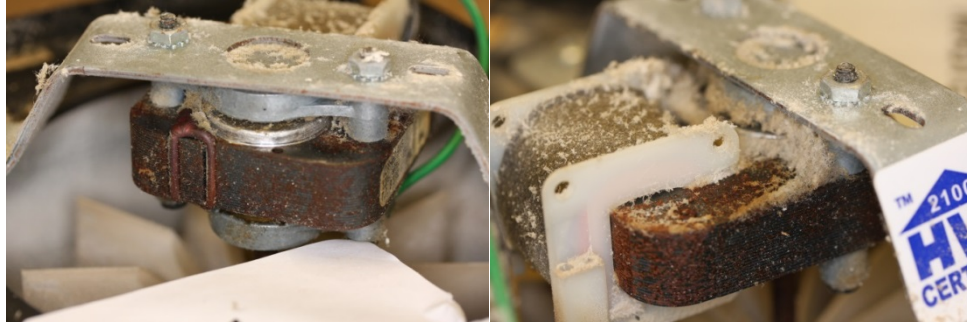
The fan was tested in its as-received condition, *i.e.*, locked-rotor condition. A single thermocouple was placed on the side of the winding, on the outside of the wrap, adjacent to the TCO location. After being energized, the TCO activated after 22 minutes, as shown by the temperature traces in Figure 13. For the location of this thermocouple, the temperature shows a maximum of 120°C, but this location is about 20°C cooler than the actual TCO or at the top of the winding. The actual TCO functioning temperature ( $T_f$ ) was calculated to be about 140°C (120°C + 20°C), which corresponds closely to the  $T_f$  of 136°C. This testing in lock-rotor condition also verified that the side thermocouple measurements on the paper wrap were about 20°C lower than the actual TCO or the top of the windings. Figure 14 shows the radiographs of the TCO’s fusible link after lock-rotor testing, which shows the thermal linkage melted or open.

Figure 12. Sub 45 with dust and surface rust on core

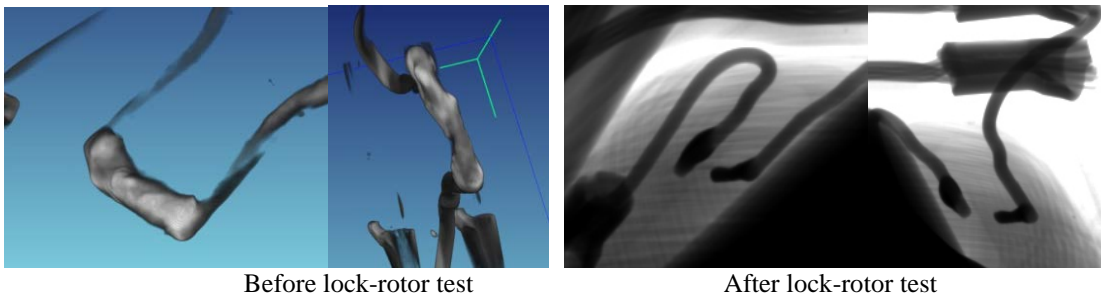
Figure 14. Radiograph and CT scans of the TCO before and after lock-rotor testing (Sub 45)

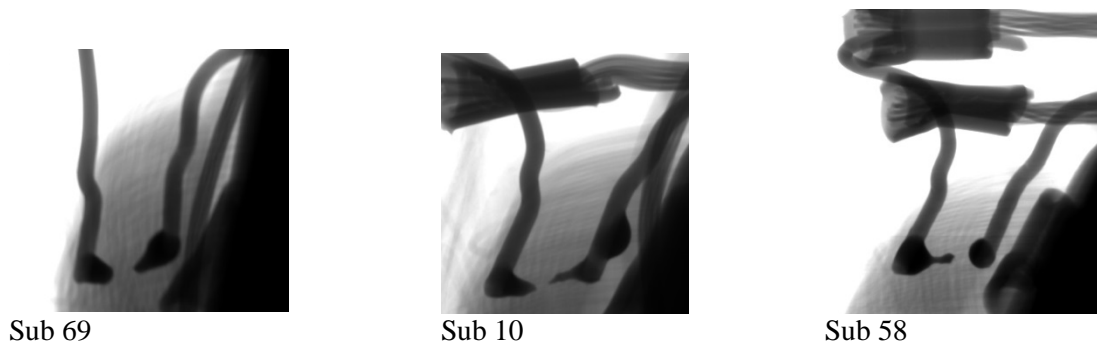
time was longer during the lock-rotor condition for the TCO to trip, and the temperature was higher than average, the thermal linkage would have inconsistent melting patterns, as shown in Figure 16. Staff expected that the delayed opening would result in a uniform temperature gradient within the TCO, thus causing the fusible linkage to melt completely or uniformly. But this was not the case, because the thermal linkage had irregularities, which suggests that other factors may be affecting the melting characteristics of the linkage.

Figure 16. Radiographs of TCOs after lock-rotor testing with unusual shapes

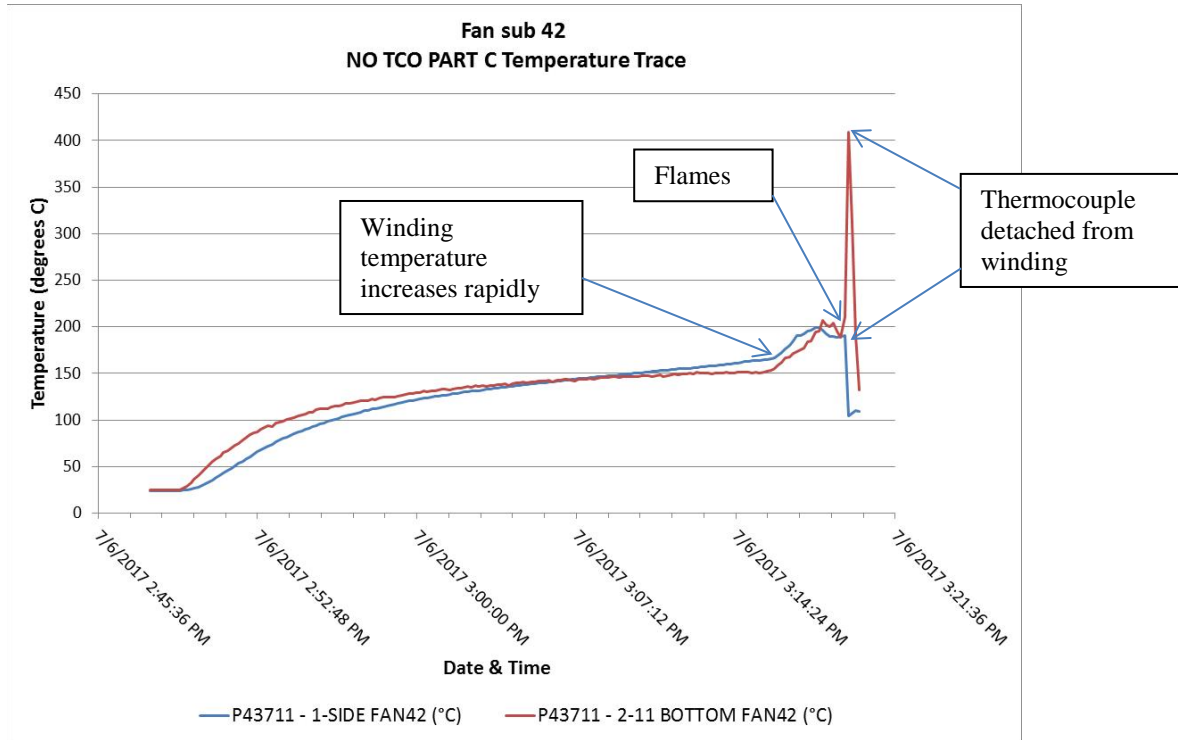
For the third test period, the fan was energized in the lock-rotor condition, and after about 30 minutes, the temperature increased rapidly, which resulted in smoke and flames. The thermocouple temperature traces are shown in Figure 18. The motor winding ignited, which then ignited the plastic impeller, as shown in Figure 19. The plastic impeller resulted in dripping, flaming plastic. The total lock-rotor test time was about 4.5 hours (period 1 + period 2 + period 3).

Figure 18. Sub 42 third test period Lock-Rotor Test with no TCO

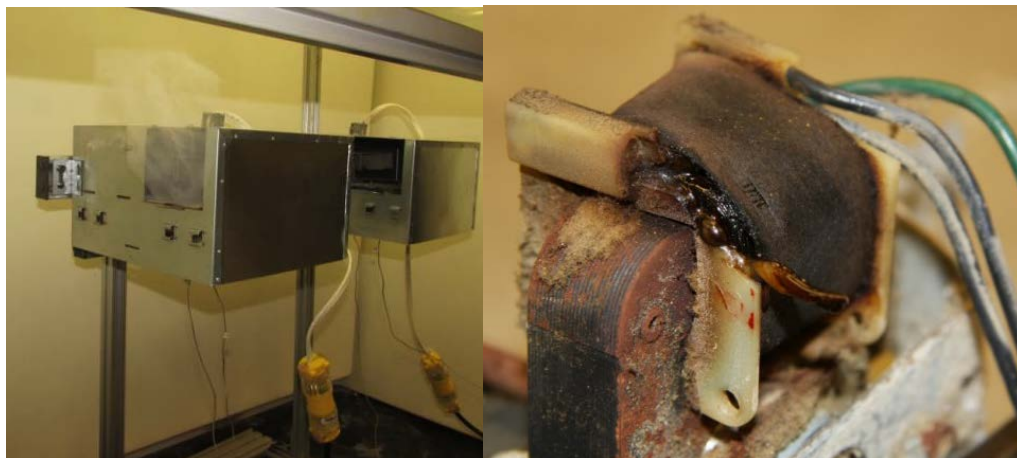
Figure 27 shows the fan producing significant smoke during the second lock-rotor testing. There were no visible flames during the testing. Examination of the motor shows localized overheating and arcing in the winding. The full elapsed time for the first and second lock-rotor tests was about 2 hours 40 minutes.

Figure 27. Sub 41 Test Group 3 - Lock-Rotor Test producing smoke and post examination

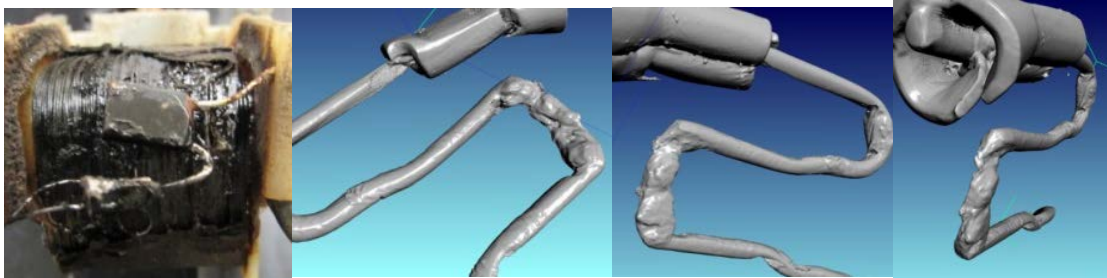
Post examination shows the TCO's fusible link to be intact, as shown by CT scans in Figure 28. During lock-rotor testing, the TCO failed to activate, but the event ended because the motor winding opened, thus de-energizing the motor.

Figure 28. TCO from Sub 41 after Lock-Rotor Test

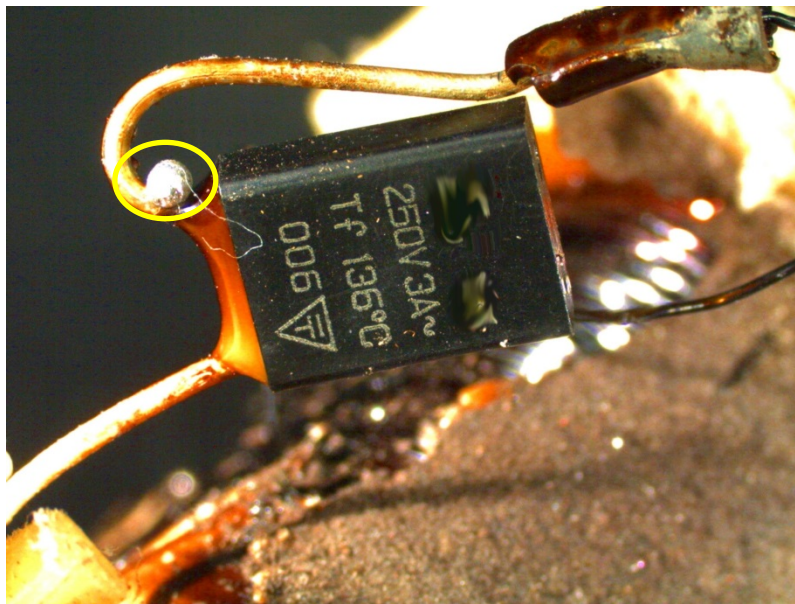
Post examination revealed a solder bead external to the TCO casing, as highlighted by the yellow circle shown in Figure 30. Microscopic images of the TCO show that the solder bead originated from inside the TCO because solder was located in cracks between the epoxy seal and the lead wire, as shown in Figure 31. Figure 32 shows the CT scans with the partially melted fusible link after the testing, thus, indicating the TCO did activate, but abnormally. Visible in the CT scan is the solder bead, highlighted by the yellow circles.

Figure 30. Solder bead on TCO lead from Sub 64 after second Lock-Rotor Test

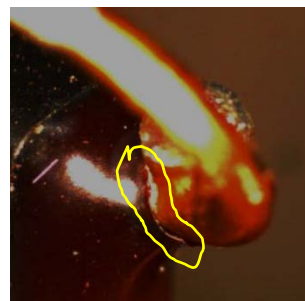
Solder in the cracks of the epoxy/electrode

Figure 31. Microscopic images of the solder bead and solder in the cracks (Sub 64)

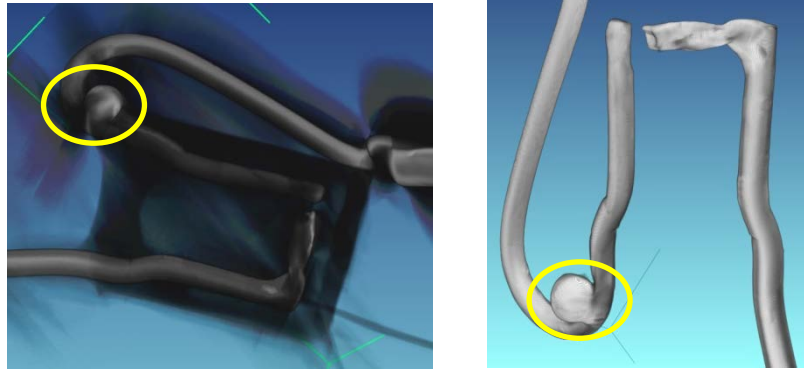
Figure 32. CT scans of the TCO showing the solder bead (Sub 64)

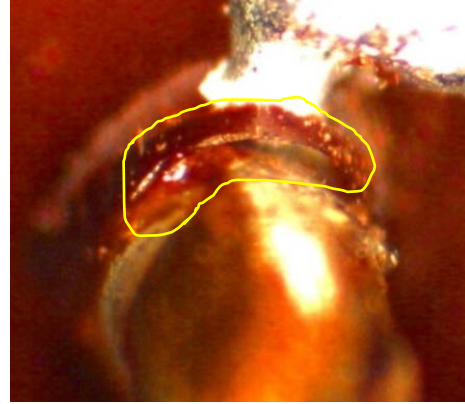
Post examination revealed the TCO had a solder bead external to the TCO casing. Figure 35 shows the CT scans with the partially melted fusible link after the testing, thus, indicating the TCO did activate, but abnormally. Microscopic images show that the solder originated from inside the TCO because of solder located within the cracks between the epoxy seal and the lead wires. Figure 36 shows the microscope images of the solder bead and solder in the cracks.

Solder in the cracks of the epoxy/electrode

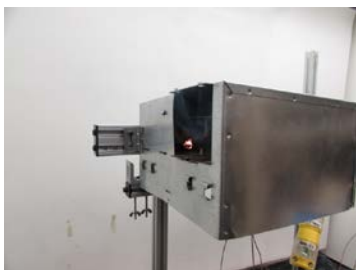
At sufficient temperatures, there appears to be an ignition of gases around the motor around 288°C

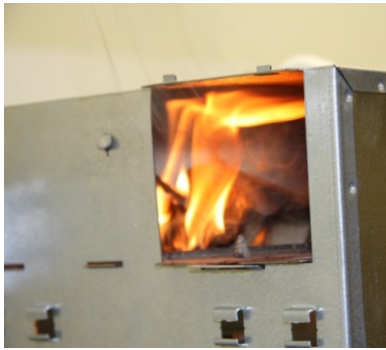
More of the winding wrap and the coating on the winding burns, thus creating a larger flame

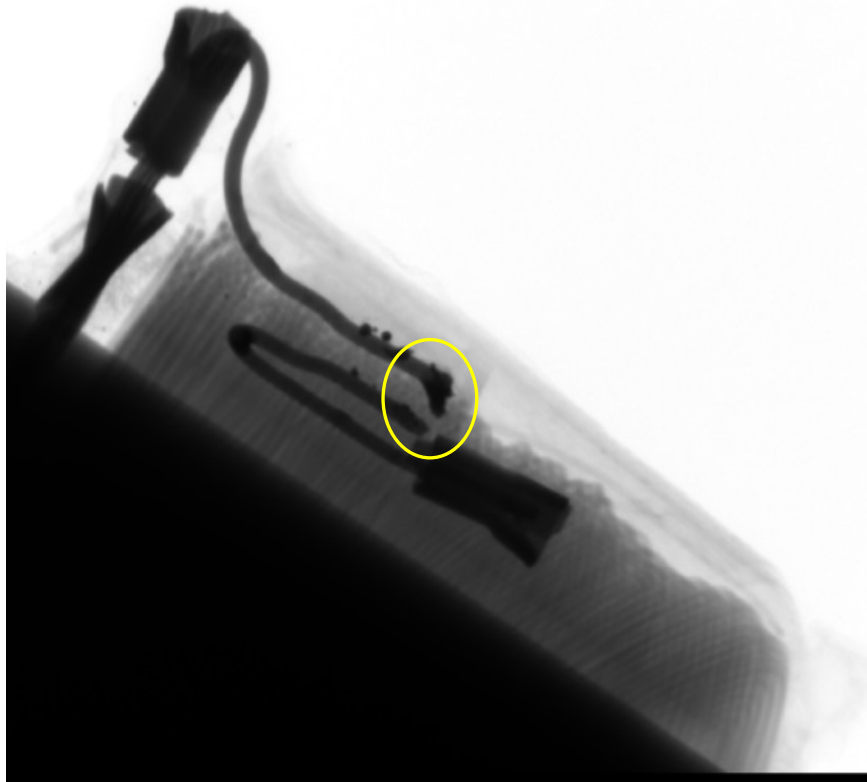
Figure 42. Radiograph of the TCO after the test (sub 73)

Figure 42 shows a radiograph of the TCO after the test. Post-test radiographs of the TCO show the TCO is open, which was caused by the intense heat from the flames. This would suggest that any analysis of a TCO after a fire incident does not necessarily indicate the status of the TCO during the incident.

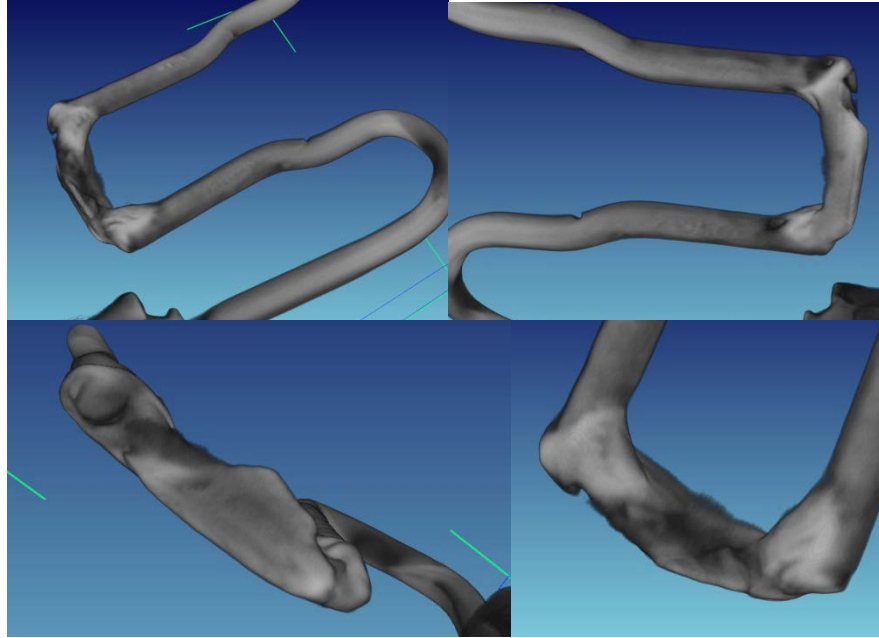
Figure 43. CT scans of the TCO before conditioning (sub 73)

CPSC staff reviewed the CT scans of the thermal linkage for fan sub 73. The thermal linkage shows abnormalities as shown in Figure 43. The CT scans appear to show the linkage to take partial form of the TCO case, such that a flat section had formed. In theory, temperatures below  $T_f$  may be causing the thermal linkage to soften. This may cause changes in the eutectic materials, where it may alter the eutectic temperature or  $T_f$ .

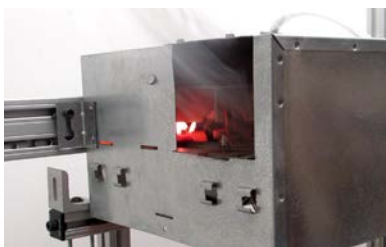
At approximately 340°C, there appears to be an ignition of gases around the motor

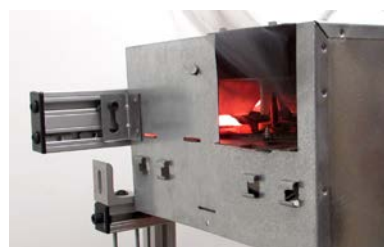
The large flames subside and the winding wrap and/or the winding coating appears to be burning

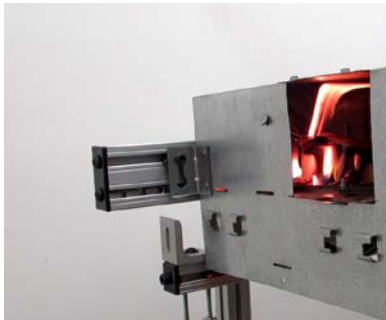
More of the winding wrap and the coating on the winding burns, thus creating a larger flame

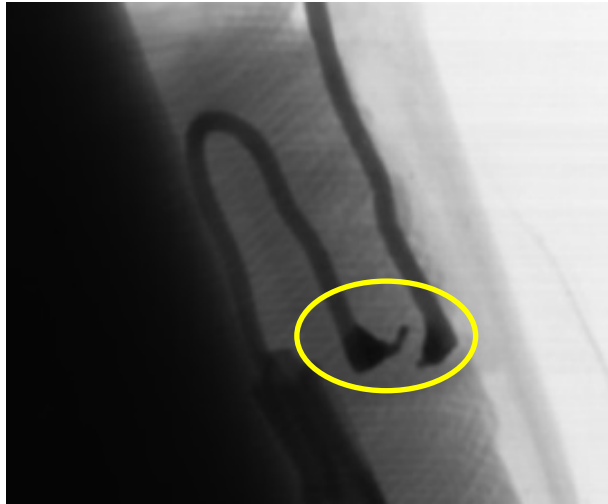
Figure 46. Radiograph of the TCO after the test (sub 23)

Figure 46 shows a radiograph of the TCO after the test. Post-test radiographs of the TCO show the TCO is open, which was caused by the intense heat from the flames. This would suggest that any analysis of a TCO after a fire incident does not necessarily indicate the status of the TCO during the incident. The radiograph shows a thin portion of the thermal linkage intact. It would appear even at the high temperatures when the motor ignited, portions of the eutectic material in the thermal linkage could not melt.

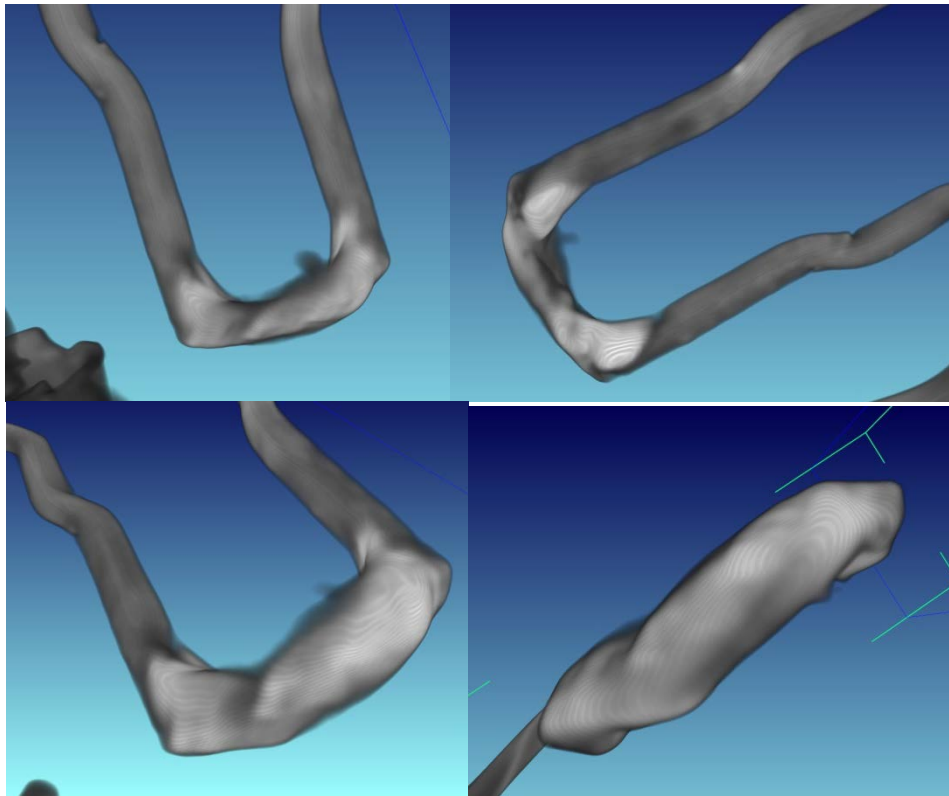
Figure 47. CT scans of the TCO before conditioning (sub 23)

The CT scans of the thermal linkage for fan sub 23 were reviewed. The thermal linkage shows some abnormalities, as shown in Figure 47. The CT scans appear to show the linkage uneven and bulging in some areas.
