EXHIBITS I29/30

Following the recent tragedy of the death of a 16 year old girl who drowned when suction from the drain of a health club spa held her to the bottom, the New Jersey Department of Health is issuing this *Public Health Advisory* to all spa, hot tub, whirlpool, and wading pool operators and local health officials.

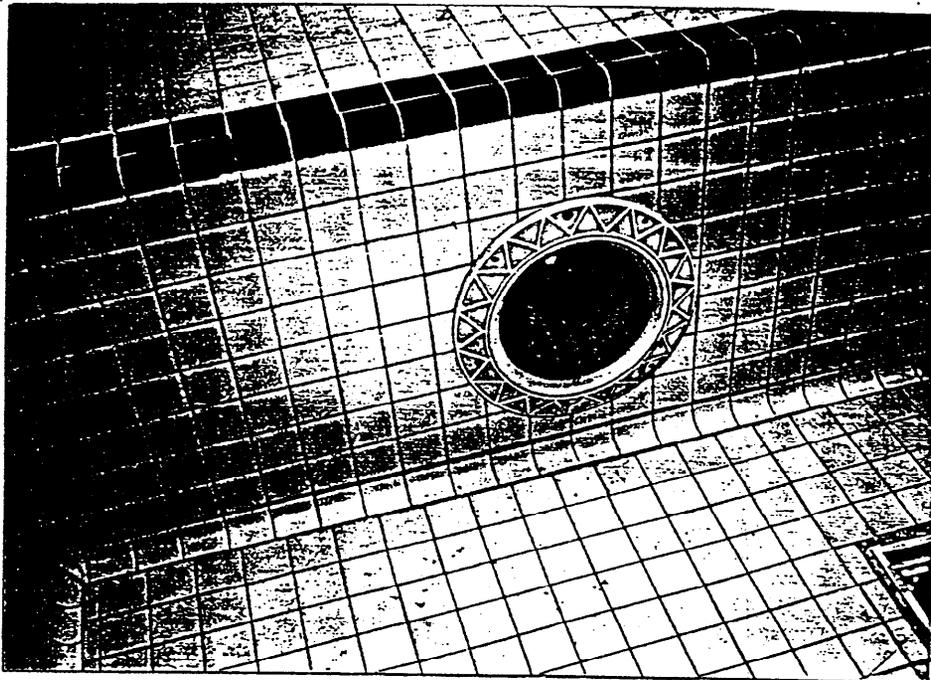
(29)

One of three circular lights in hot tub. This one is mounted on wall near involved drain at right.

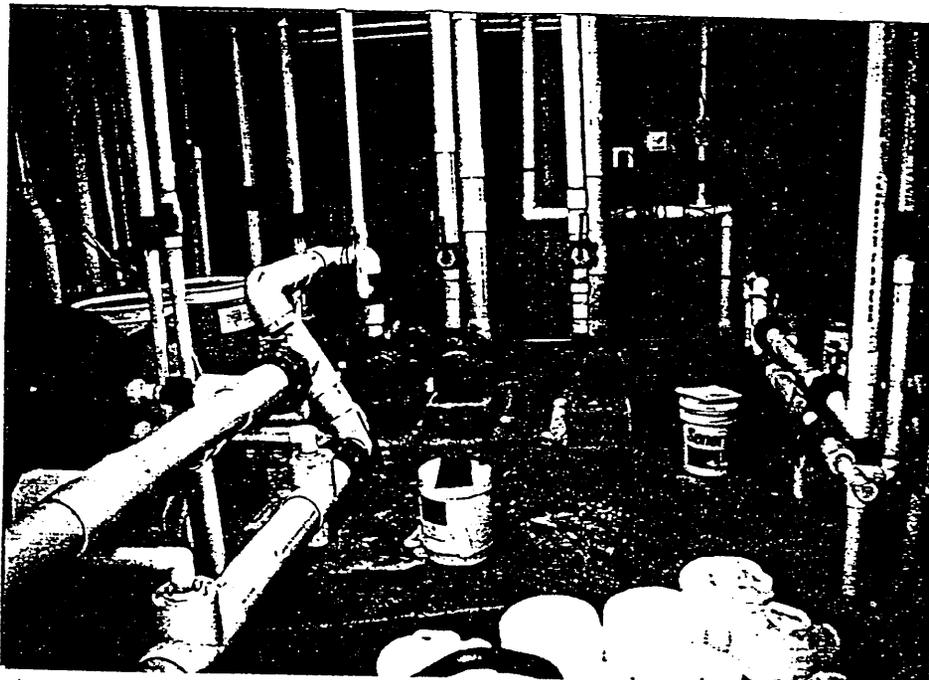
(30)

Pump room below hot tub. Piping and filters at left are for the swimming pool. Two pumps at center are the hydrotherapy pumps rated at 10 hp. each. The pump to the left is reportedly for the swimming pool. The center pump is reportedly connected to the involved drain above and is an original pump. The right pump is reportedly connected to the noninvolved drain and is a replacement pump. The 4" PVC pipe on wall between pumps goes from the main drain to the right where bromine, oxygenation and filtration are done. It has a separate pump reportedly rated at 10 hp.

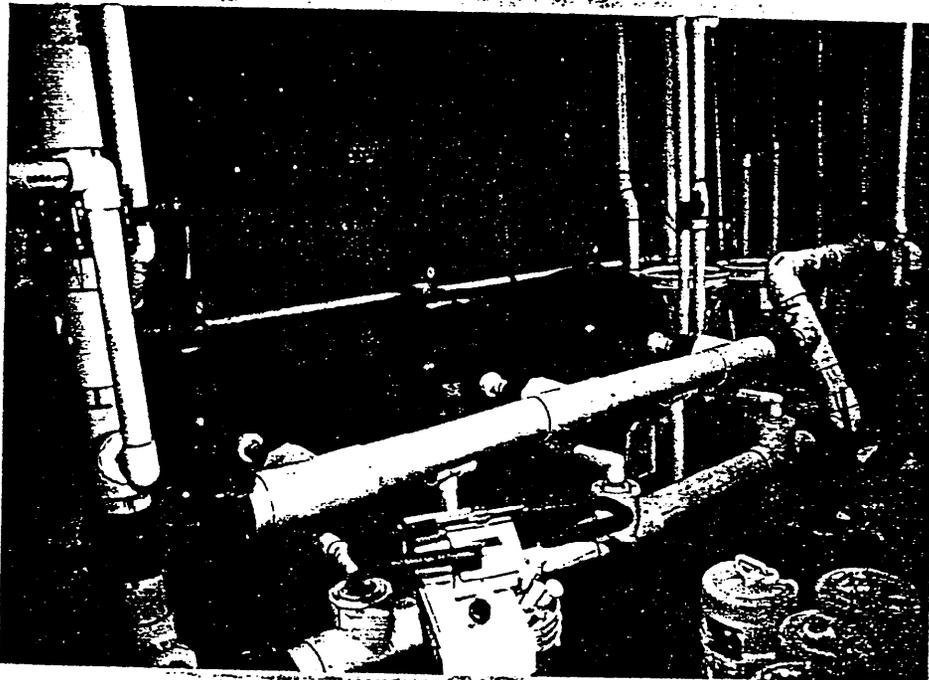
(32)

This photograph shows the filtration system for the swimming pool and none of this system was involved in the incident. The hot tub system in the pump room is at the right out of this photograph.

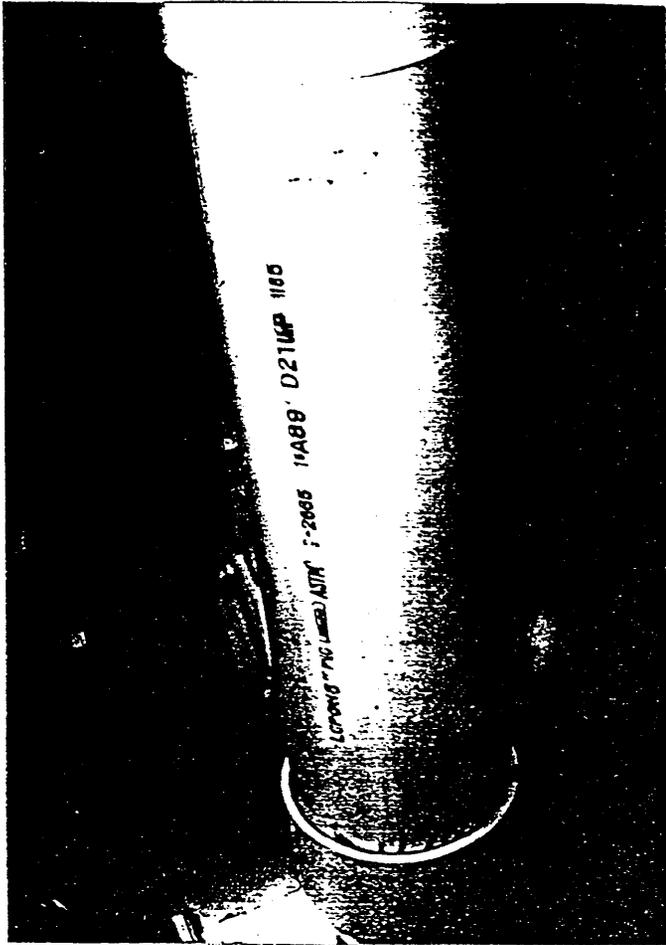
33

6" diameter PVC pipe from involved drain above goes directly to pump, there is no bypass.

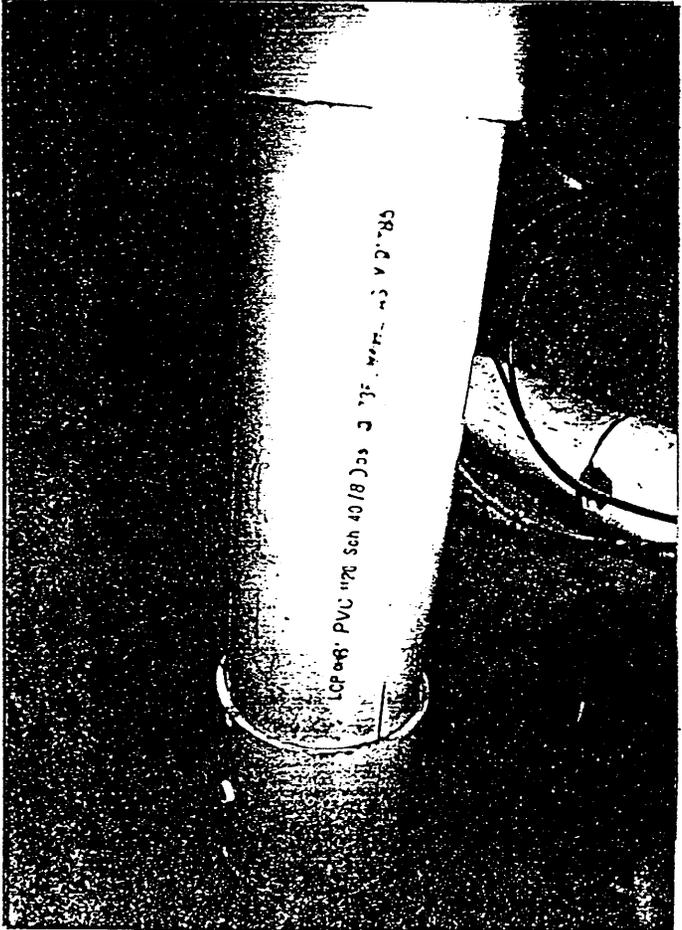
34

6" diameter PVC pipe from NON involved drain goes directly to pump, there is no bypass. Behind is the 4" diameter PVC drain pipe from center drain.

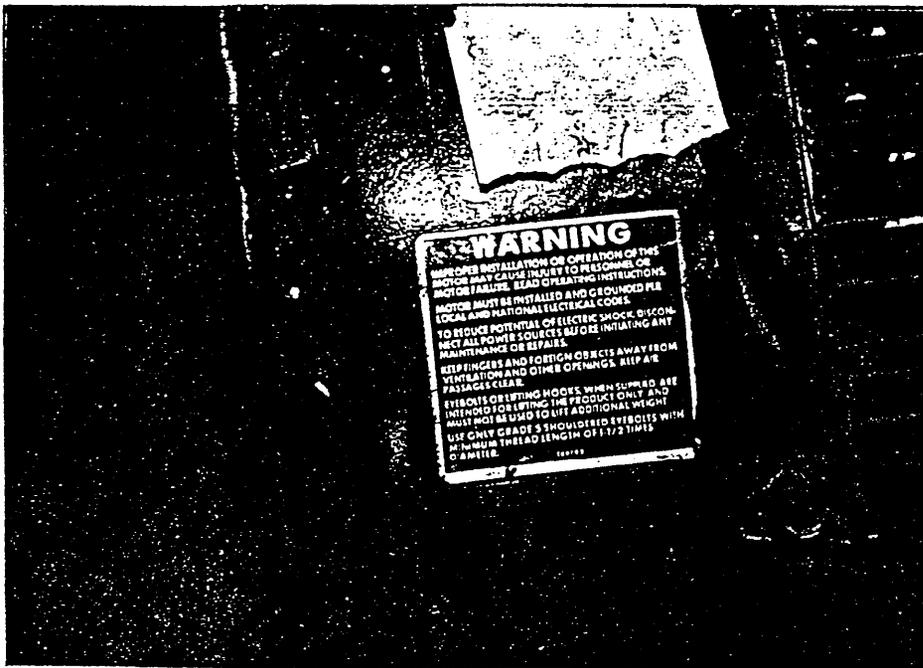
36

WARNING labeling on the involved motor.

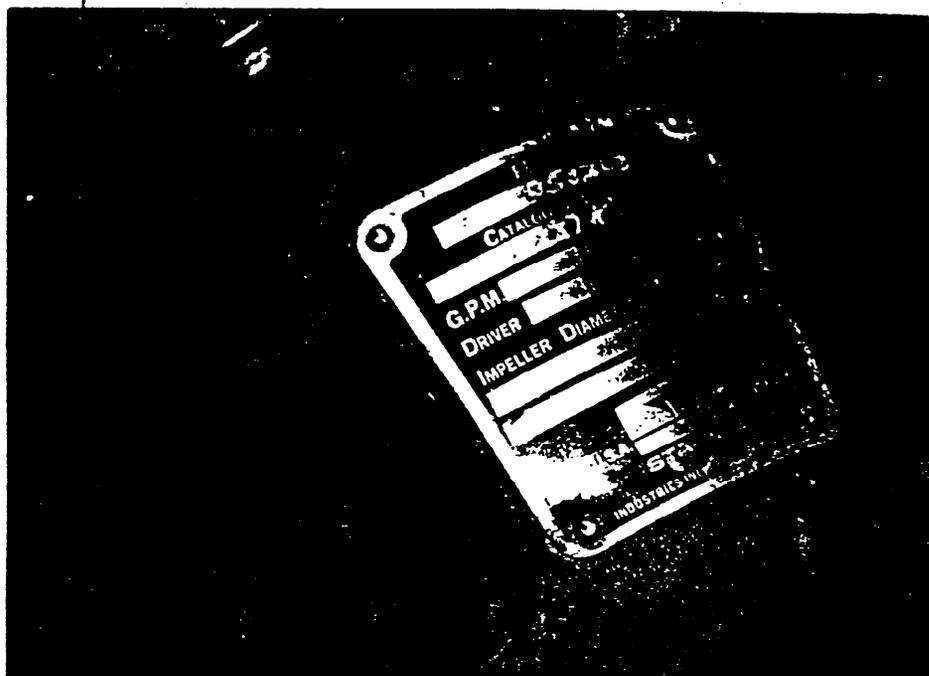
Pump is a STA-RITE, Sta-Rite Industries, Delavan, WI. It is catalog number 30E2BS55L3 and Series No. 6LXX7K.

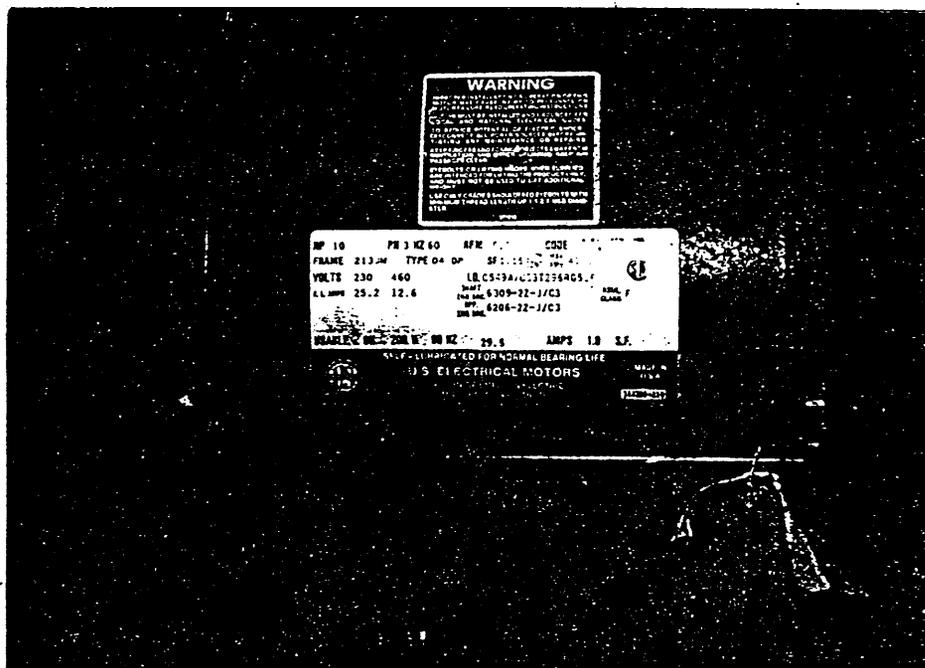
Labeling on NON involved motor. This was reportedly a replacement motor and has a much shorter housing requiring wood supports at the pump end. It is rated the same as the original and from U.S. Electric Motors as the original. When the motors were changed is not known.

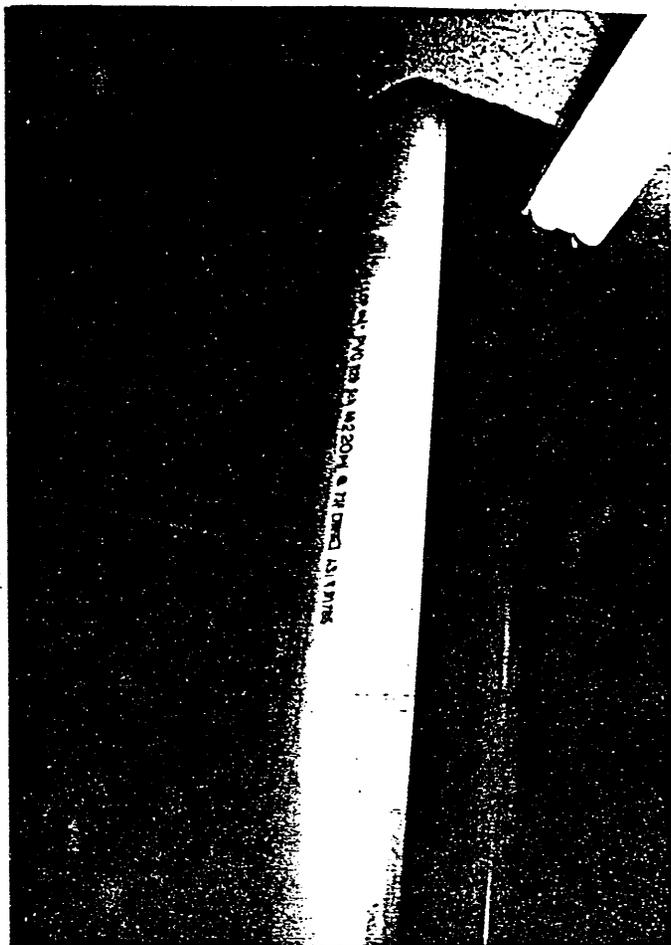
39

4" diameter PVC pipe from involved pump returns water to jets in hot tub.

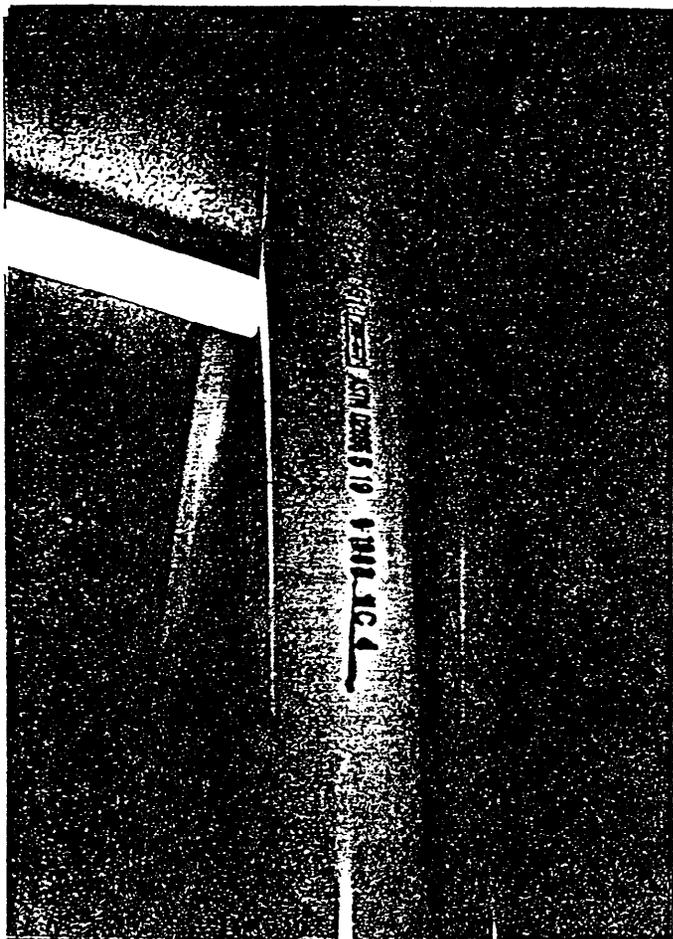
40

4" diameter PVC pipe from NON involved pump returns water to jets in hot tub. Note that ceiling panels were NOT removed.

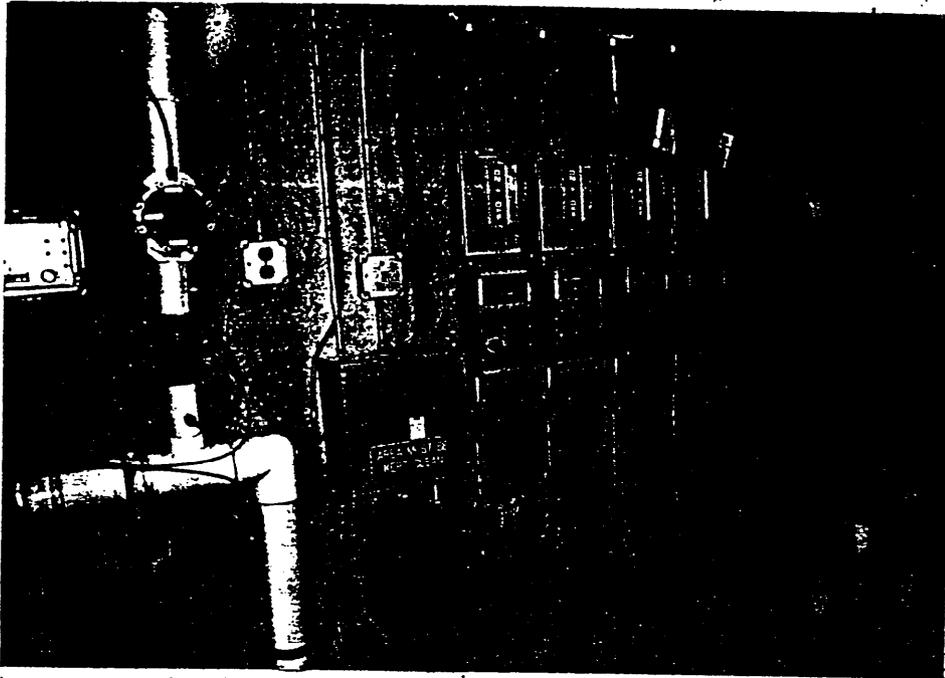
Panel boxes on wall of pump room. The 4" PVC drain/to hot tub^(horizontal pipe) is at left and vertical pipe appears to be used for taking samples or testing water quality. The three skimmers may also be connected to this vertical pipe. The drain has a bypass system with the 3 skimmers connected. NOTE that the panel box #4 is the shut off for the hot tub ("whirlpool").

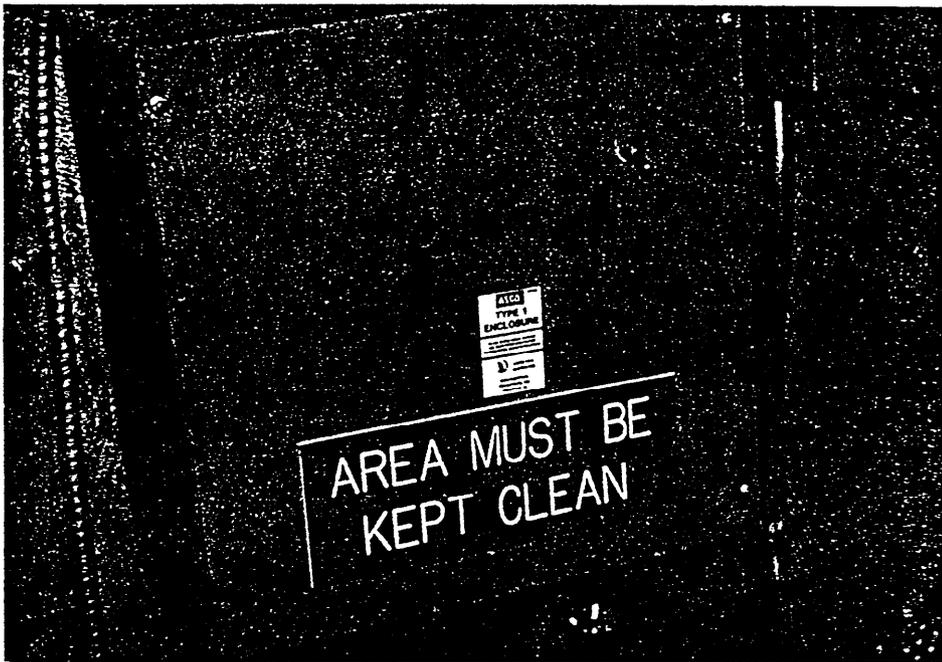
Timer box for hot tub. The code called for a maximum of 15 minutes operation of the hydrotherapy jets. The club had timer set for 10 minutes. The timer starts when the ON button upstairs is activated.

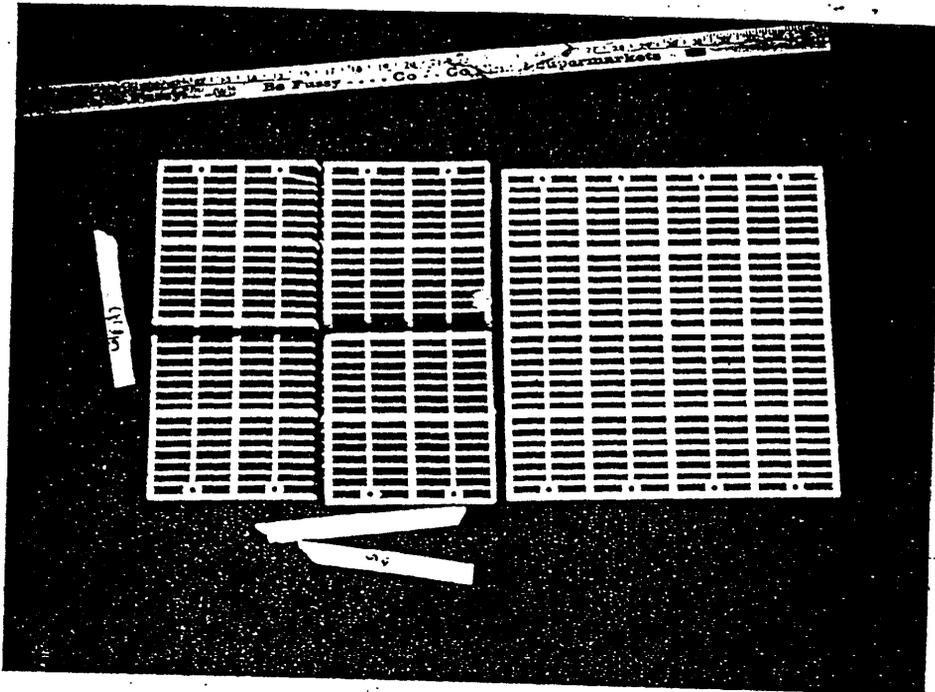
43

This photo shows the involved drain grate at left and the noninvolved drain grate at right. They appear identical but closer examination reveals the noninvolved drain grate is (1) not stained as much as the involved grate (presumably from bromine), (2) is a heavier plastic or with thicker slots and (3) has the "H SP-1032" identification and a partly illegible code whereas the involved grate has no apparent labeling. Note the involved grate is broken into almost 4 equal sized pieces.

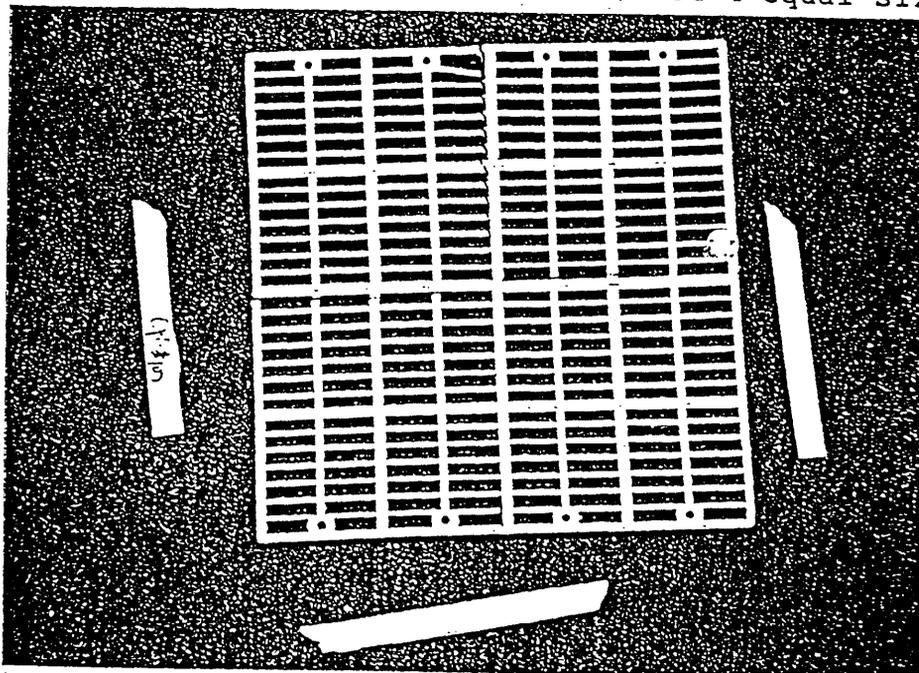
44

Closer view of involved grate with pieces of frame retrieved from sump.

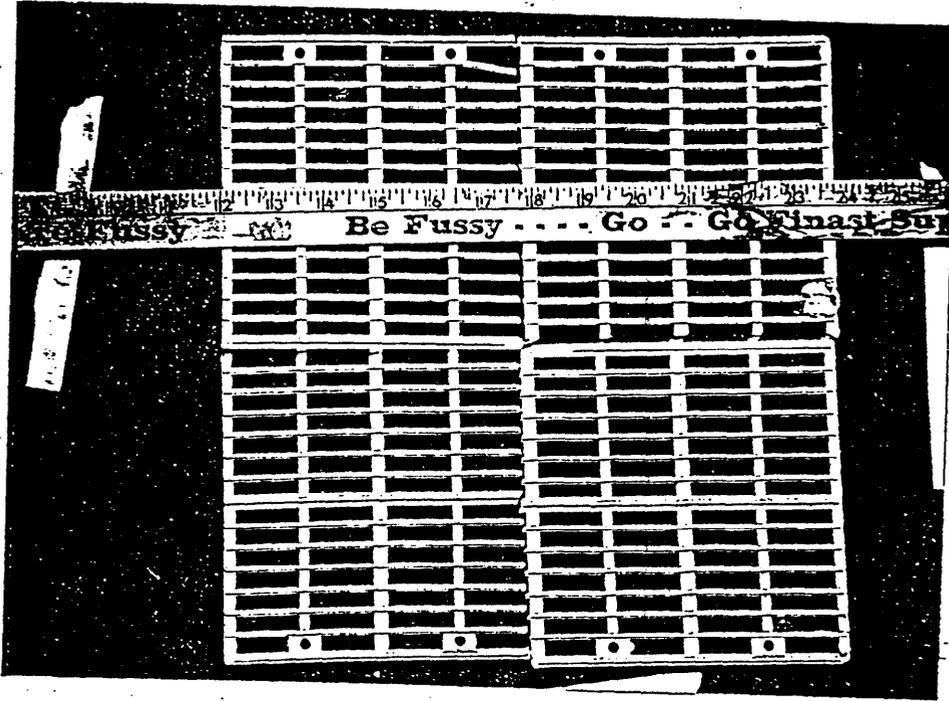
45

Involved grate is approximately 11 3/4" square. Note screw holes but police report no screws were found to secure grate to frame.

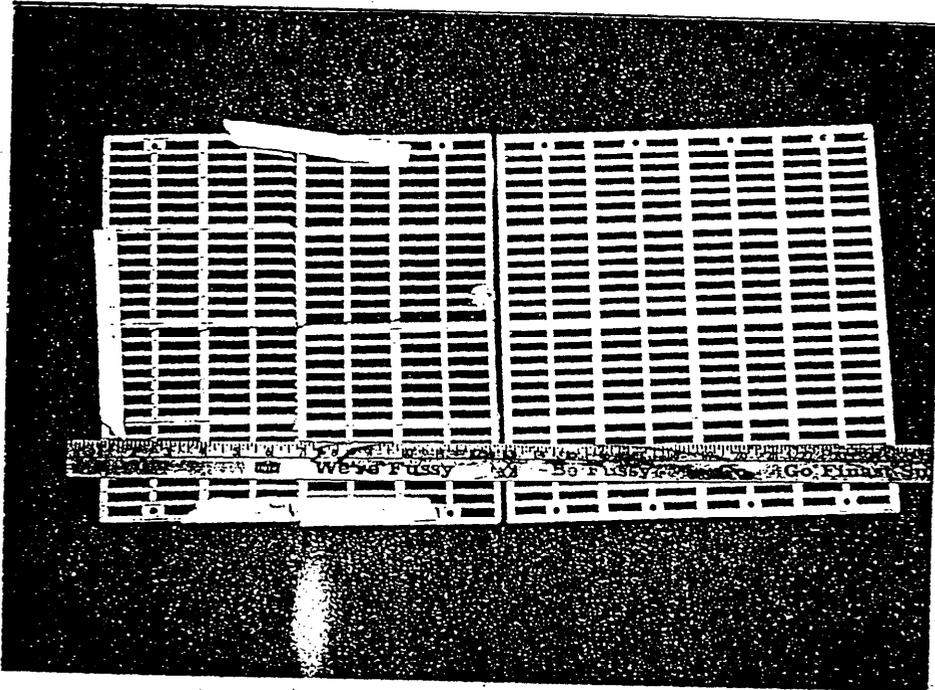
46

Another view of involved grate(left) and noninvolved grate(right).

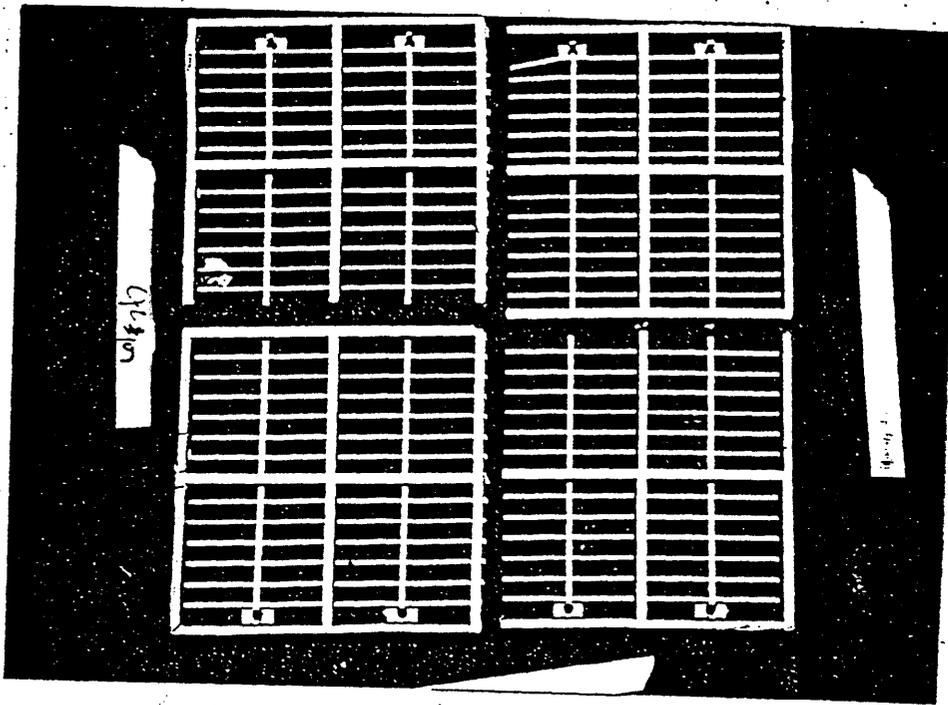
Reverse side of involved grate to show almost 4 equal sized pieces.

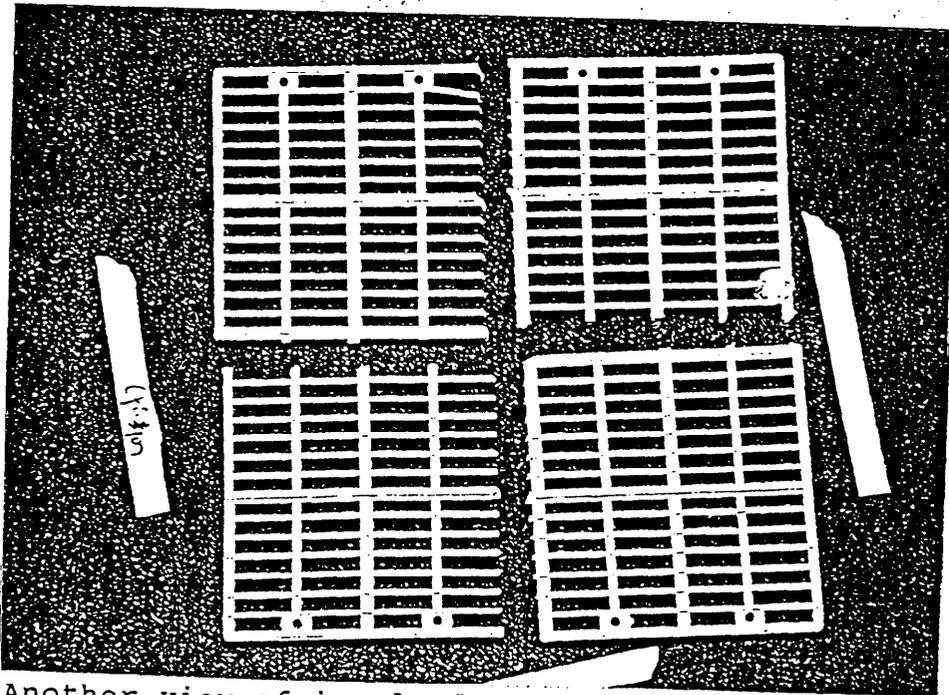
Another view of involved grate from top.

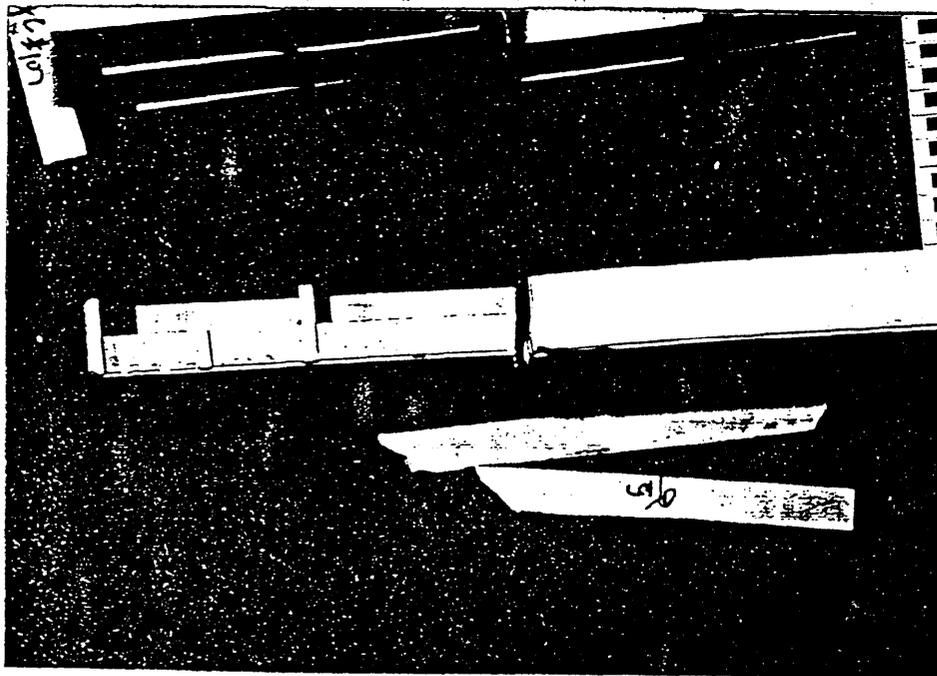
50

Breakage pattern of the involved grate.

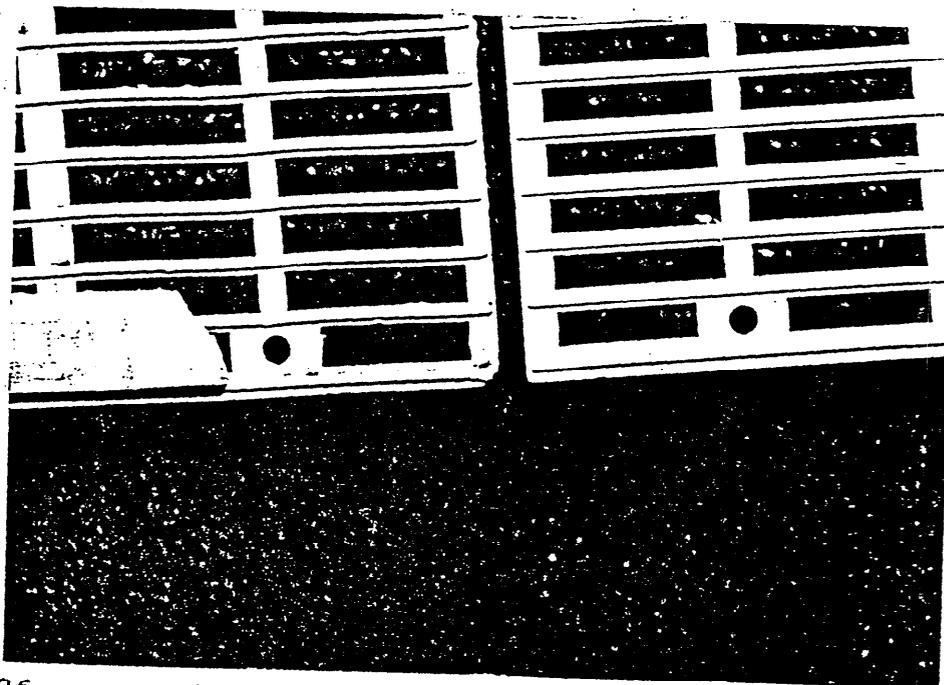
Points 1/2 from previous photo shows the involved grate at left and noninvolved grate at right. Note the heavier thicker construction of the noninvolved grate. Note that it is also less stained than involved grate.

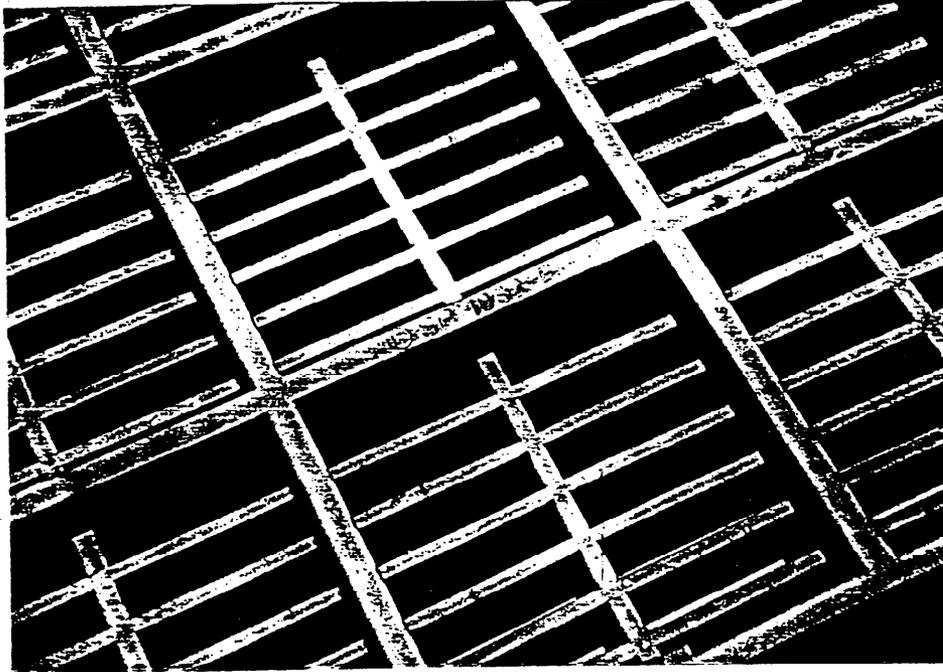
(53)

The noninvolved grate shown here with base up. Center crossmember has " (H) SP-1032 B" molded into the plastic. The (H) reportedly is for the manufacturer Hardaway, address unknown. Model No. SP-1032 is the 12" x 12" size calling for 4 securing screws. It has an open area of 78 square inches. No similar identification was observed on the involved grate.

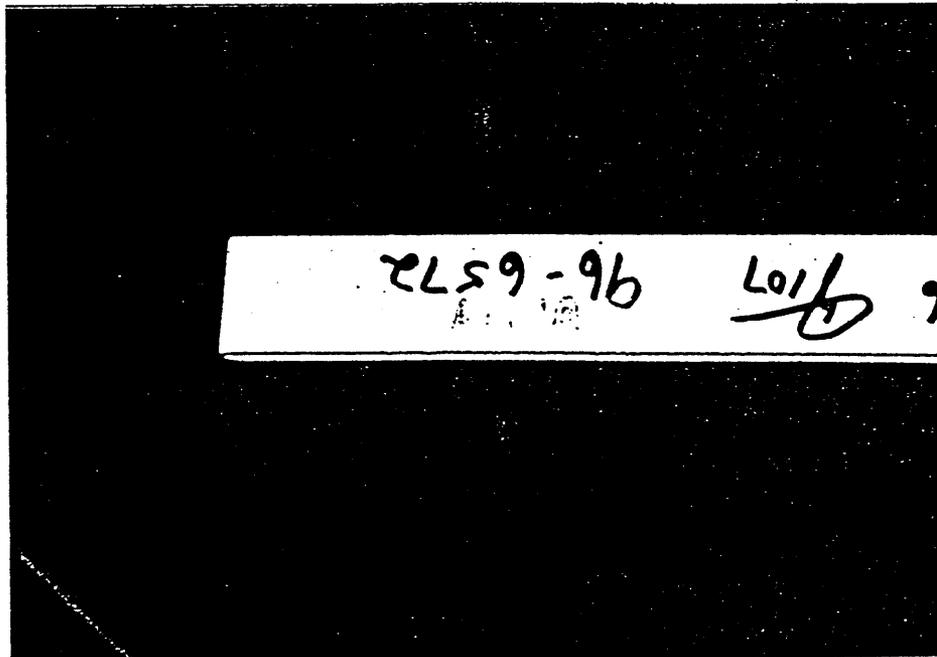
(54)

Stamped on the side of the noninvolved grate is a code that appears to be "AL016" but is not entirely legible.
