**ClearingHouse Format - With Manufacturer  
Reported Incidents  
U.S. Consumer Product Safety Commission  
National Injury Information ClearingHouse**

**Background**

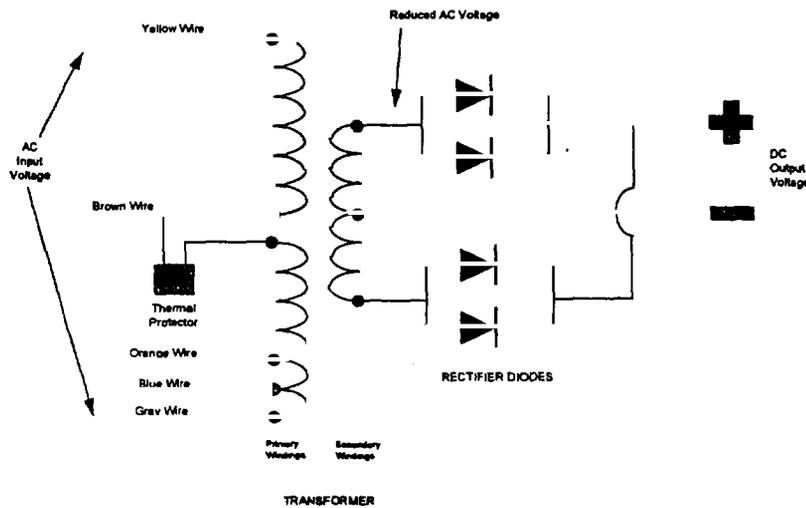
Figure 1. Original design schematic (selected parts only)

then rectifies it to DC power so that it can be applied to the battery for charging, as shown schematically in Figure 1. A control circuit monitors the charge state of the attached battery and controls the output (when the automatic mode is used). The AC voltage is reduced from 120 V by a multi-tapped, step-down transformer. The transformer has multiple taps (connection points) on the input so that various output voltages may be derived from the 120 V source merely by changing switch settings. Four diodes (two parallel pairs) convert the reduced AC voltage to DC voltage. The electrical circuitry is enclosed in a two-piece thermoplastic enclosure. The plastic material was soft enough that it could be cut with a sharp knife, but was sufficiently thick (1/8 inch) to be structurally rigid. A piece

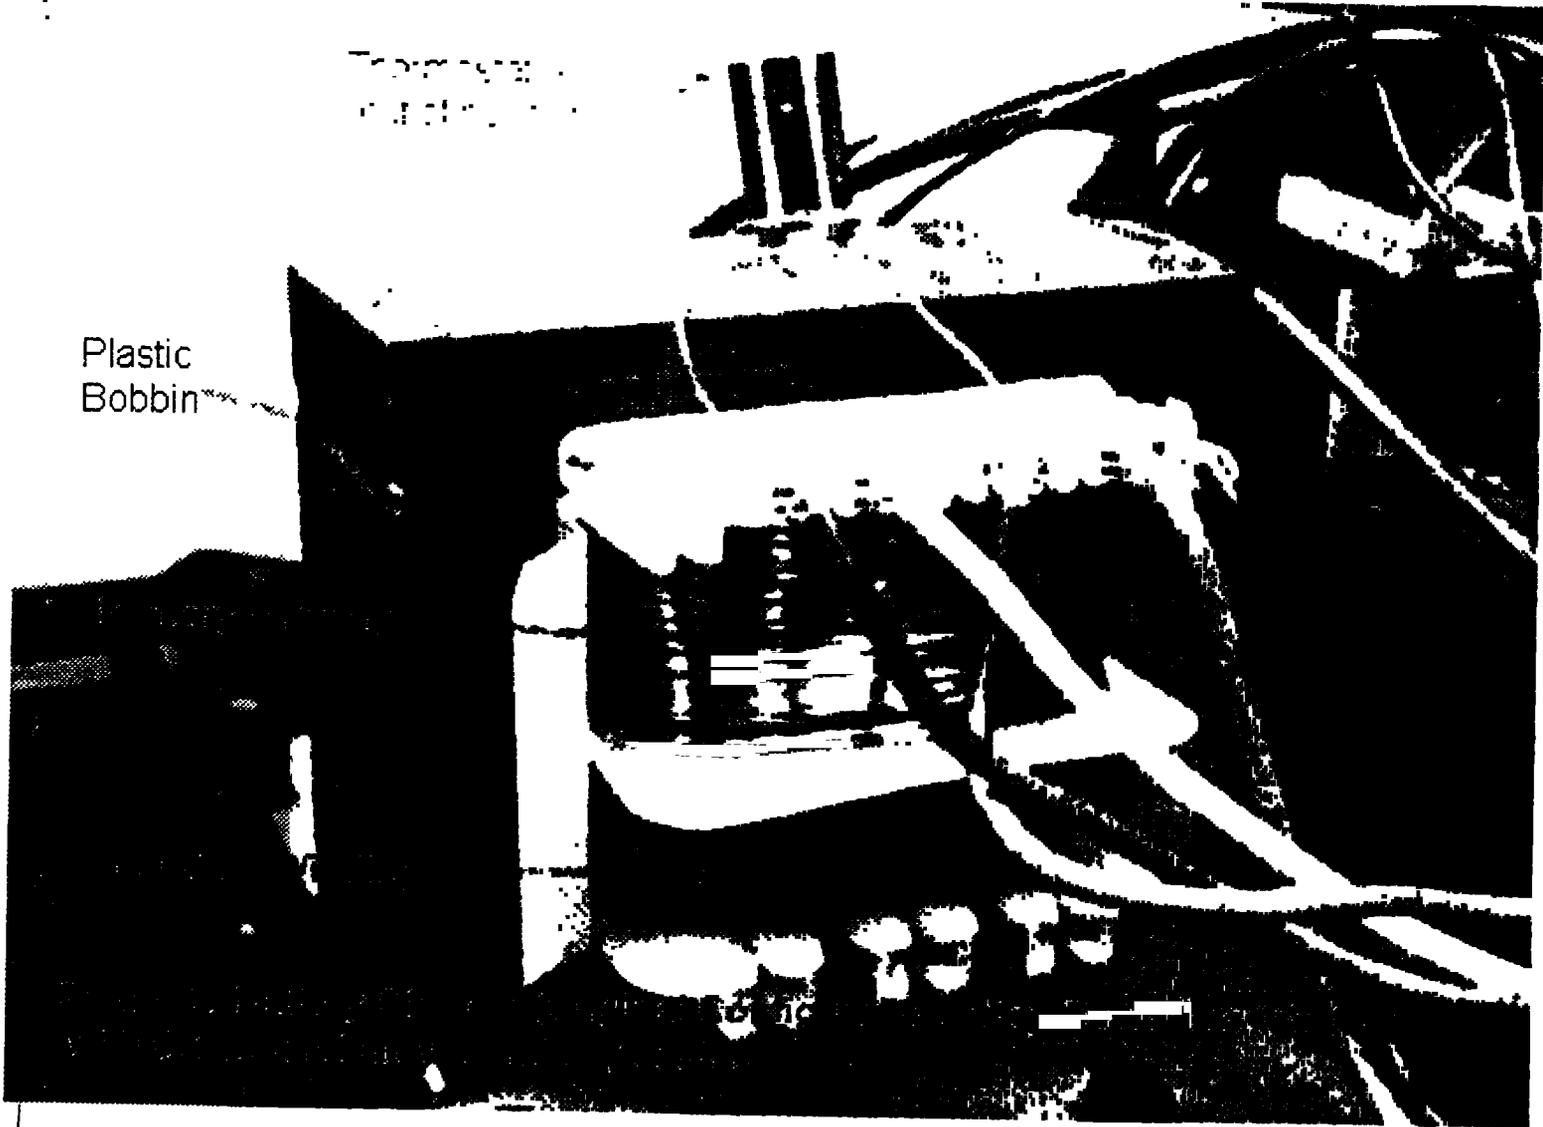
Figure 3. Top View of Battery Charger Transformer (Original Configuration) Showing Thermostat in Place in Plastic Bobbin.

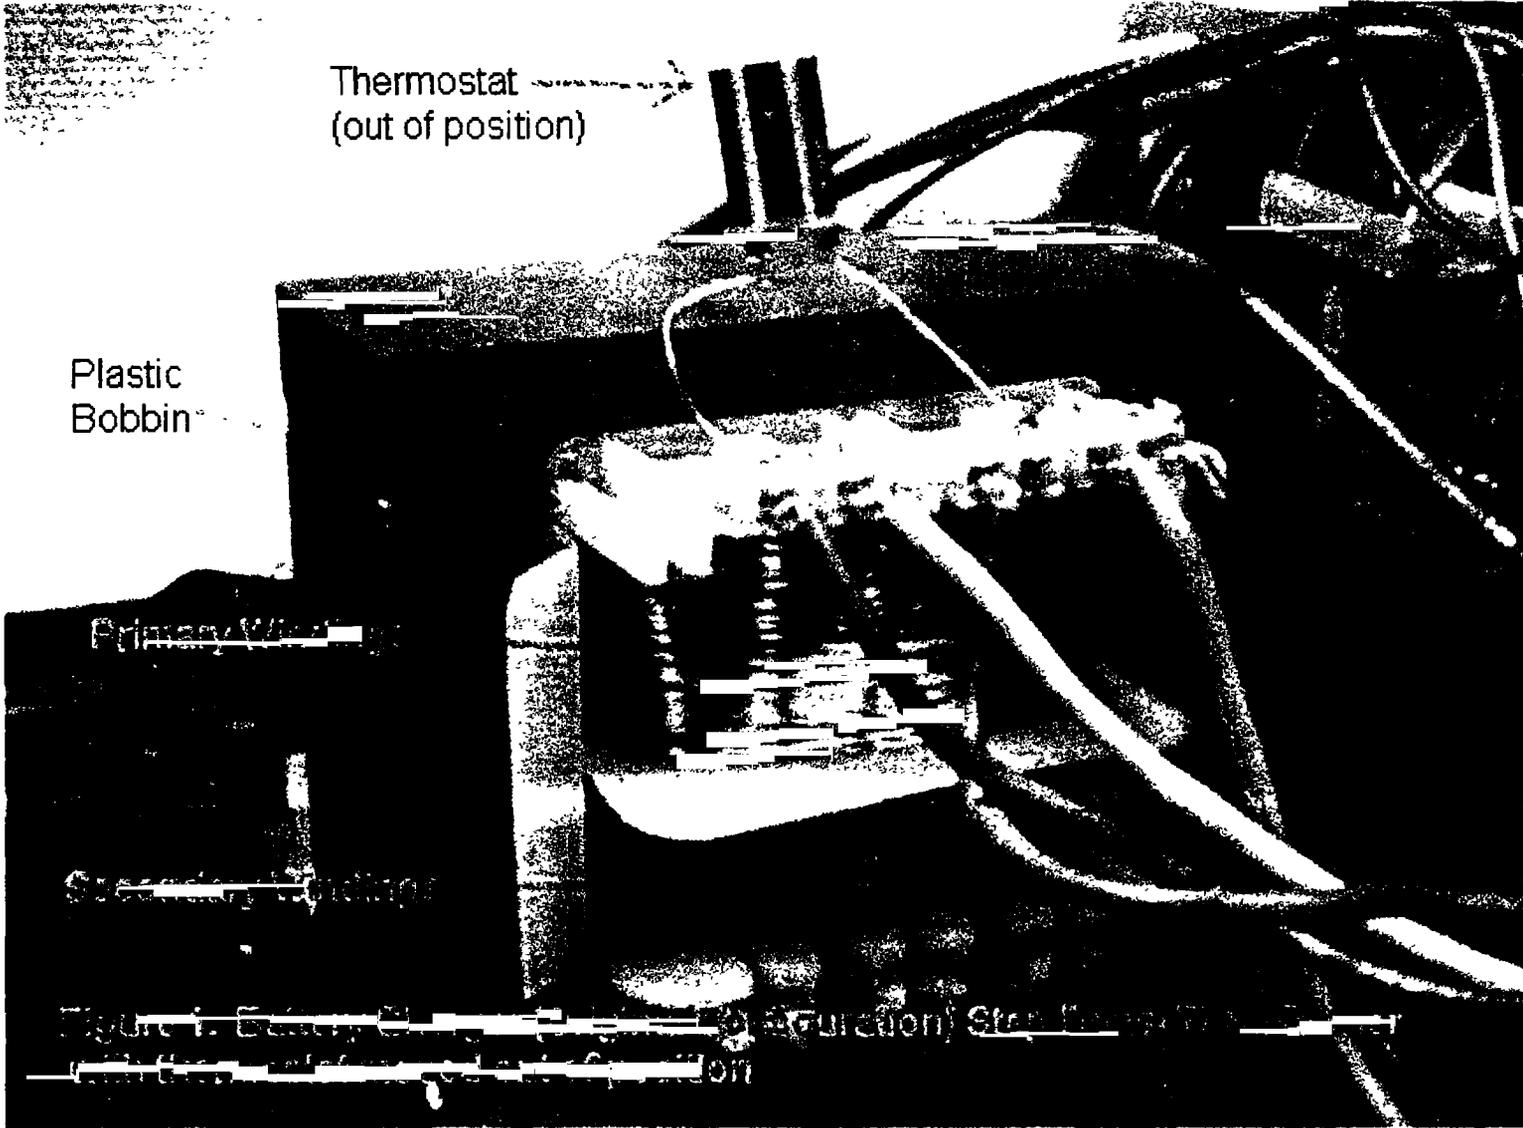
Figure 3 Top view of Battery Charger Transformer (Original Configuration) Showing Transformer in Place in Plastic Enclosure.
