United States
Consumer Product Safety Commission
cpsc.gov | info@cpsc.gov | 800.638.2772

December 7, 2021

Scott Lewis, Delta
Subcommittee Chair, F15.18, Bassinets and Cradles
ASTM
100 Barr Harbor Dr.
West Conshohocken, PA 19428-2959

Bassinet Incidents

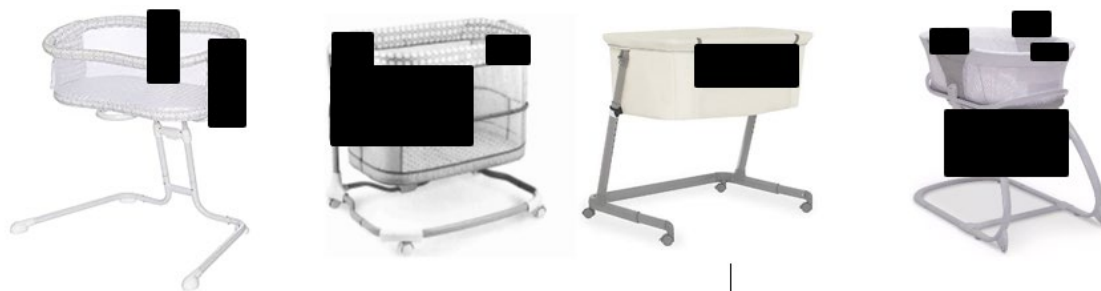
Figures 1-4. Bassinet examples

Cantilever-designed bassinets are supported on one side only. Figures 1 through 4 contain examples of these types of bassinets.

The incidents suggest that the sleep surface may tilt and cause an infant, during normal sleep movements, to roll from a supine to a side-lying position into the side of the product, or into a prone position, earlier than developmentally expected. Although ASTM F2933 – 16^{e1} allows a resting side-to-side angle of 7°, staff's analysis suggests that this allowance may increase the risk of unexpected rollover within a cantilever-designed bassinet.

Bassinets with cantilever designs may allow flexibility in the sleep area. Staff observed that the products can move and bounce in a manner that is unlike traditional bassinets with four legs. Staff is concerned that a child who is moving his/her arms and legs in the product may create enough movement to cause the sleep area to further tilt side-to-side and/or head-to-toe. This may increase the likelihood that a child can roll unexpectedly from a supine to a side lying or prone position.

Currently, ASTM F2194 – 16^{e1}, *Standard Consumer Safety Specification for Bassinets and Cradles*, does not contain any references to, nor performance requirements for, bassinets that have a sleep surface that tilts and is flexible, such as a cantilever design. CPSC staff requests that the ASTM F15.18 *Subcommittee on Bassinets* form a task group to review these incidents and consider developing performance requirements to reduce the likelihood that infants will roll over unexpectedly.
