December 7, 2021

Scott Lewis, Delta
Subcommittee Chair, F15.18, Bassinets and Cradles
ASTM
100 Barr Harbor Dr.
West Conshohocken, PA 19428-2959

CPSC staff¹ has become aware of incidents involving bassinets with a cantilever design, in which infants reportedly rolled into the side of the product, or into a prone position. These incidents occurred from 2016 to the present. Four incidents, which are identified in the attached spreadsheet, involved deaths that occurred in the period from 2019 to present.

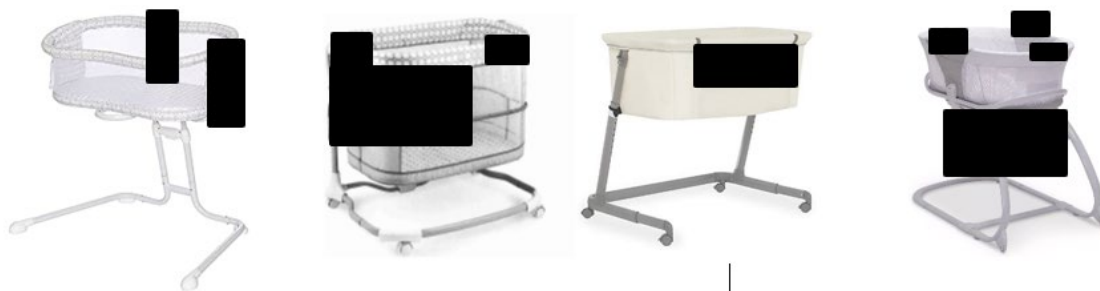
Figures 1-4. Bassinet examples

Cantilever-designed bassinets are supported on one side only. Figures 1 through 4 contain examples of these types of bassinets.

The incidents suggest that the sleep surface may tilt and cause an infant, during normal sleep movements, to roll from a supine to a side-lying position into the side of the product, or into a prone position, earlier than developmentally expected. Although ASTM F2933 – 16^{e1} allows a resting side-to-side angle of 7°, staff’s analysis suggests that this allowance may increase the risk of unexpected rollover within a cantilever-designed bassinet.

Bassinets with cantilever designs may allow flexibility in the sleep area. Staff observed that the products can move and bounce in a manner that is unlike traditional bassinets with four legs. Staff is concerned that a child who is moving his/her arms and legs in the product may create enough movement to cause the sleep area to further tilt side-to-side and/or head-to-toe. This may increase the likelihood that a child can roll unexpectedly from a supine to a side lying or prone position.

Currently, ASTM F2194 – 16^{e1}, *Standard Consumer Safety Specification for Bassinets and Cradles*, does not contain any references to, nor performance requirements for, bassinets that have a sleep surface that tilts and is flexible, such as a cantilever design. CPSC staff requests that the ASTM F15.18 *Subcommittee on Bassinets* form a task group to review these incidents and consider developing performance requirements to reduce the likelihood that infants will roll over unexpectedly.
