U.S. CONSUMER PRODUCT SAFETY COMMISSION
5 RESEARCH PLACE
ROCKVILLE, MD 20850

January 8, 2018

CPSC Staff Assessment on Eutectic-Type Thermal-Cutoff Fuse Failures in Shaded-Pole Motors Used in Exhaust Fans

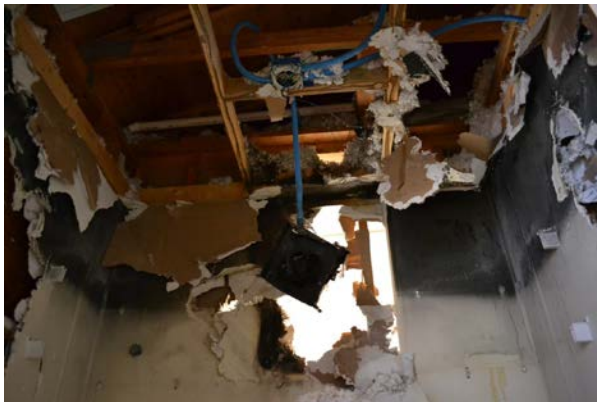
IDI 130208CCC3391 and IDI 130326HWE0001

The incident occurred at a daycare facility. The building was built in 1995, and has been used as a daycare facility since its construction. The fans were original when the building was constructed. The lights and fans were controlled by a single switch. Five days a week, the switch was turned on at approximately 6:30 a.m. and turned off at about 7:00 p.m. The incident occurred in March 2011. After the daycare lights and fans were switched on, the daycare heat was also turned on. Approximately 1 hour later, a teacher and her assistant smelled something burning and assumed it was related to the heating system. Even though after the heating system was turned off, the burning smell persisted. The director went to the infant room and localized the burning smell to the changing room/bathroom. The director notified the owner of the daycare and was advised to disconnect the exhaust fans because they were old. The director was unplugging the exhaust fan when a “large fireball shot out” of the exhaust fan. The daycare was evacuated and the fire department was summoned to extinguish the fire.

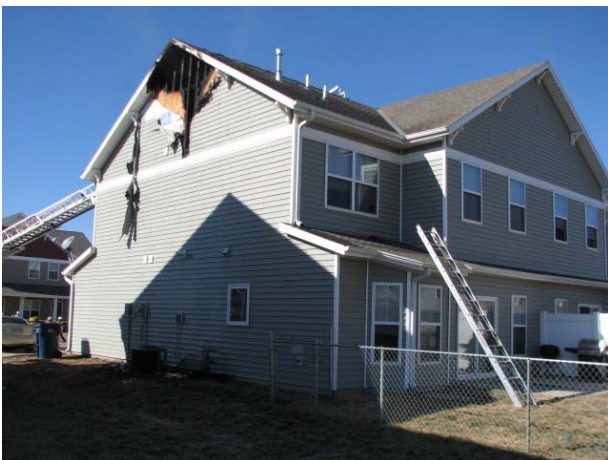
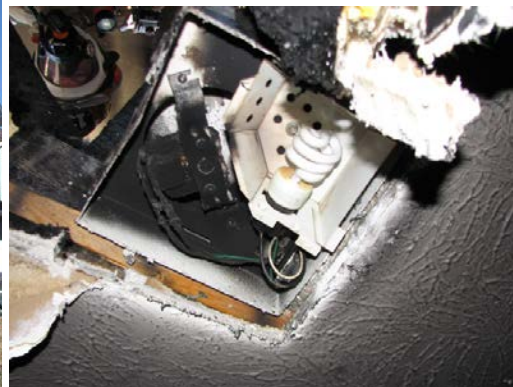
The February 5 incident occurred in a full bath on the second floor of a single-family home. There was extensive damage to the attic above the bathroom. The field investigator noted that the incident fan switch was in the “up” position, suggesting that the fan was on when the incident occurred. When the fire department arrived at the scene, fire personnel determined that the fire had spread into the attic area. An overheated exhaust fan caused the incident.

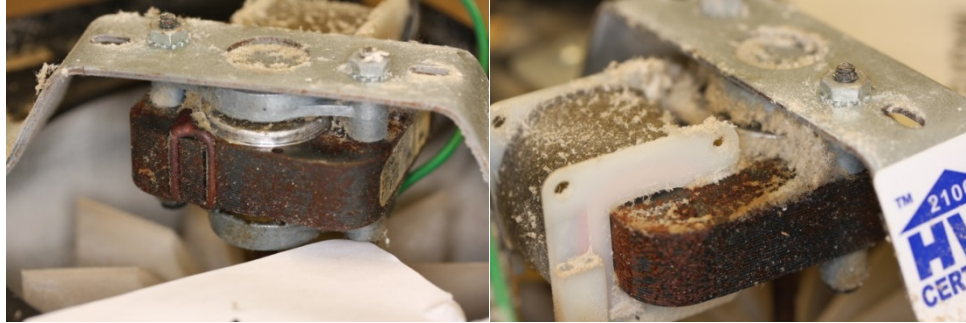
Figure 12. Sub 45 with dust and surface rust on core

The fan was tested in its as-received condition, *i.e.*, locked-rotor condition. A single thermocouple was placed on the side of the winding, on the outside of the wrap, adjacent to the TCO location. After being energized, the TCO activated after 22 minutes, as shown by the temperature traces in Figure 13. For the location of this thermocouple, the temperature shows a maximum of 120°C, but this location is about 20°C cooler than the actual TCO or at the top of the winding. The actual TCO functioning temperature (T_f) was calculated to be about 140°C (120°C + 20°C), which corresponds closely to the T_f of 136°C. This testing in lock-rotor condition also verified that the side thermocouple measurements on the paper wrap were about 20°C lower than the actual TCO or the top of the windings. Figure 14 shows the radiographs of the TCO’s fusible link after lock-rotor testing, which shows the thermal linkage melted or open.

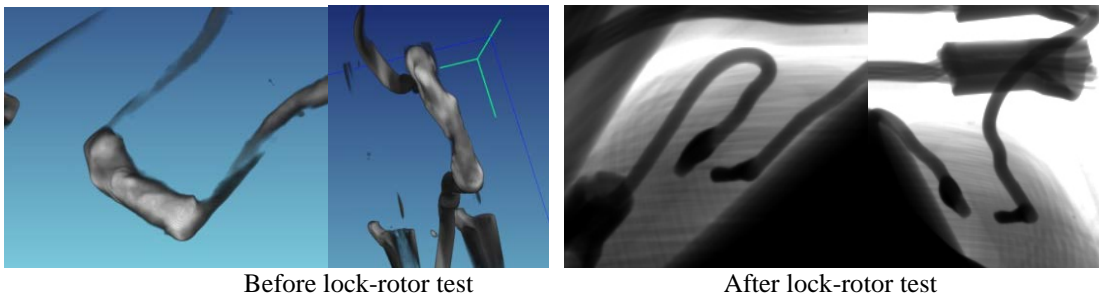
Figure 14. Radiograph and CT scans of the TCO before and after lock-rotor testing (Sub 45)

time was longer during the lock-rotor condition for the TCO to trip, and the temperature was higher than average, the thermal linkage would have inconsistent melting patterns, as shown in Figure 16. Staff expected that the delayed opening would result in a uniform temperature gradient within the TCO, thus causing the fusible linkage to melt completely or uniformly. But this was not the case, because the thermal linkage had irregularities, which suggests that other factors may be affecting the melting characteristics of the linkage.

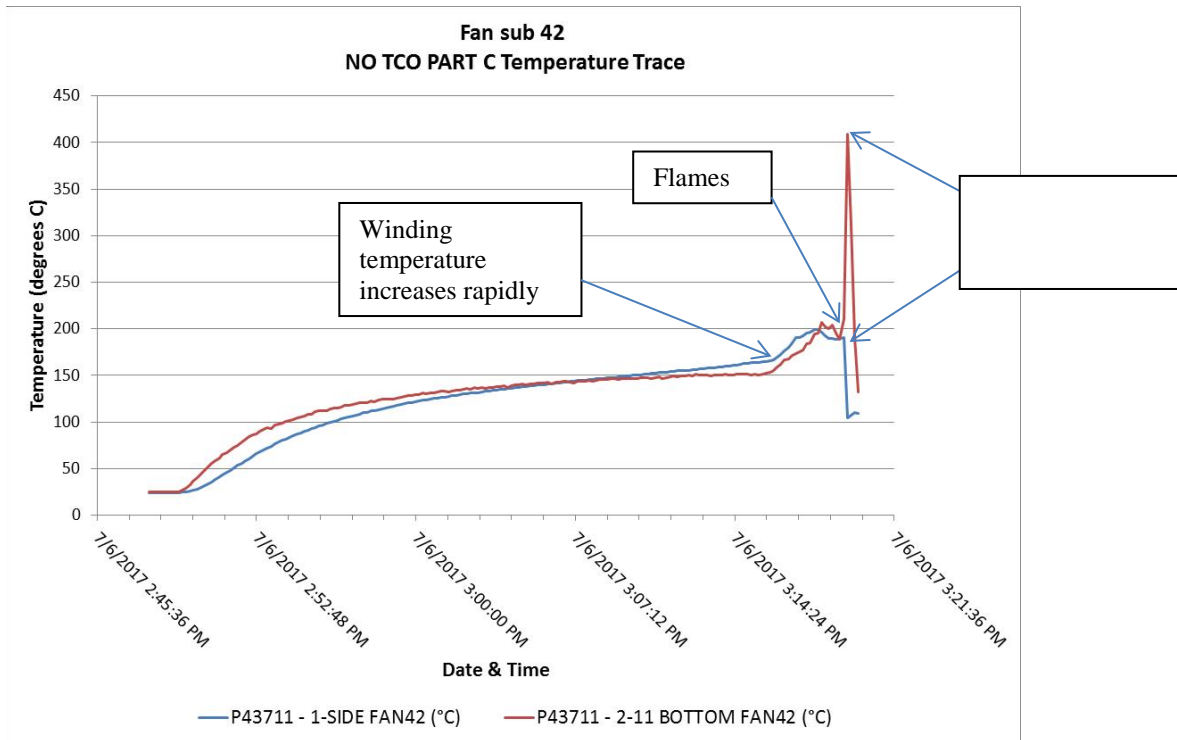
Figure 18. Sub 42 third test period Lock-Rotor Test with no TCO

For the third test period, the fan was energized in the lock-rotor condition, and after about 30 minutes, the temperature increased rapidly, which resulted in smoke and flames. The thermocouple temperature traces are shown in Figure 18. The motor winding ignited, which then ignited the plastic impeller, as shown in Figure 19. The plastic impeller resulted in dripping, flaming plastic. The total lock-rotor test time was about 4.5 hours (period 1 + period 2 + period 3).

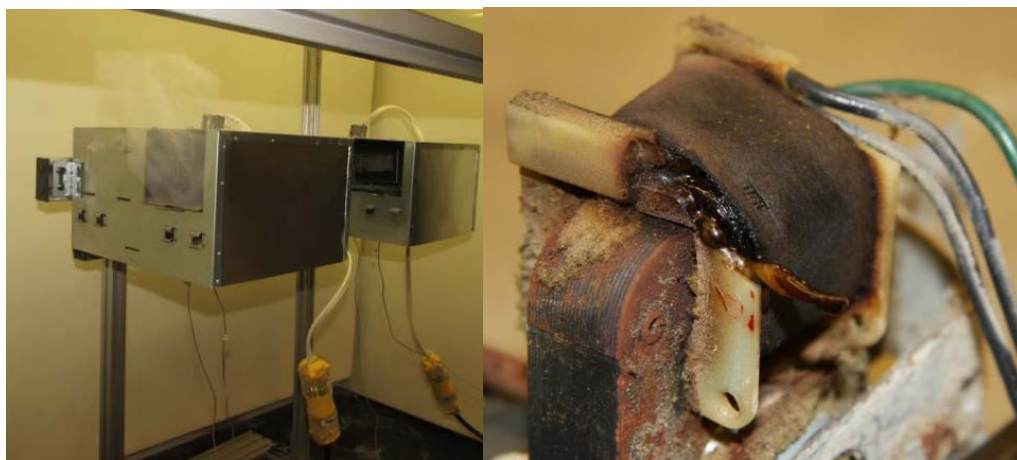
Figure 27. Sub 41 Test Group 3 - Lock-Rotor Test producing smoke and post examination

Figure 27 shows the fan producing significant smoke during the second lock-rotor testing. There were no visible flames during the testing. Examination of the motor shows localized overheating and arcing in the winding. The full elapsed time for the first and second lock-rotor tests was about 2 hours 40 minutes.

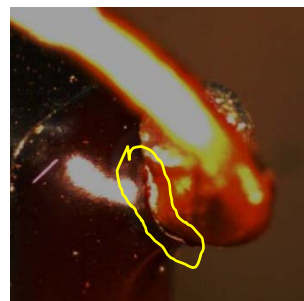
Figure 31. Microscopic images of the solder bead and solder in the cracks (Sub 64)

Post examination revealed a solder bead external to the TCO casing, as highlighted by the yellow circle shown in Figure 30. Microscopic images of the TCO show that the solder bead originated from inside the TCO because solder was located in cracks between the epoxy seal and the lead wire, as shown in Figure 31. Figure 32 shows the CT scans with the partially melted fusible link after the testing, thus, indicating the TCO did activate, but abnormally. Visible in the CT scan is the solder bead, highlighted by the yellow circles.

Solder in the cracks of the epoxy/electrode

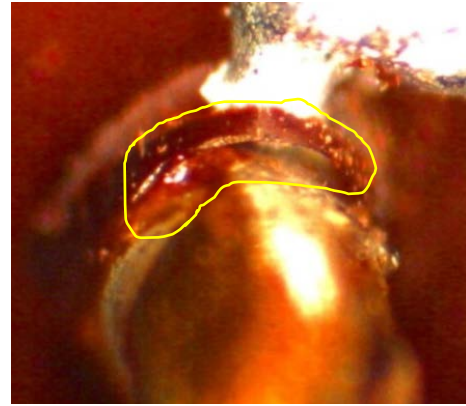
Post examination revealed the TCO had a solder bead external to the TCO casing. Figure 35 shows the CT scans with the partially melted fusible link after the testing, thus, indicating the TCO did activate, but abnormally. Microscopic images show that the solder originated from inside the TCO because of solder located within the cracks between the epoxy seal and the lead wires. Figure 36 shows the microscope images of the solder bead and solder in the cracks.

Solder in the cracks of the epoxy/electrode

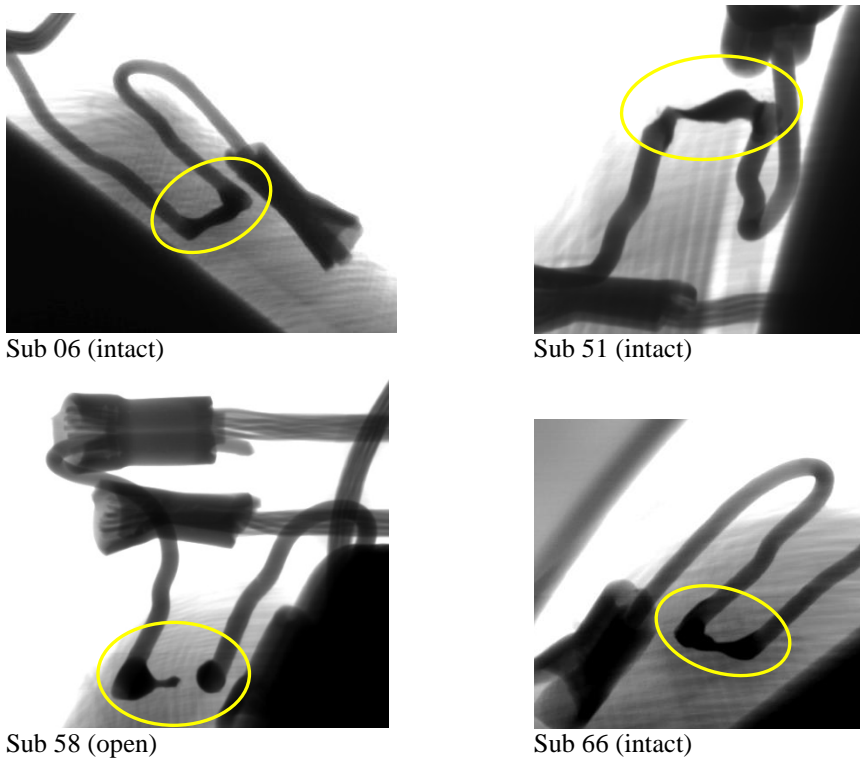
Figure 39. Radiograph of subs 6, 51, 58 and 66 after Lock-Rotor test

Figure 39 shows the TCO from sub 58, which tripped but took more than 2 hours. As seen in previous TCOs that had a long trip time, the melted linkage would bead to both wire leads; but in this case, the radiograph shows a thin portion of the fusible link still present.

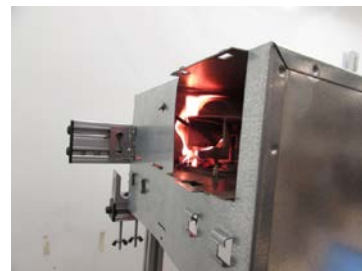
The large flames subside and the winding wrap and/or the winding coating appears to be burning

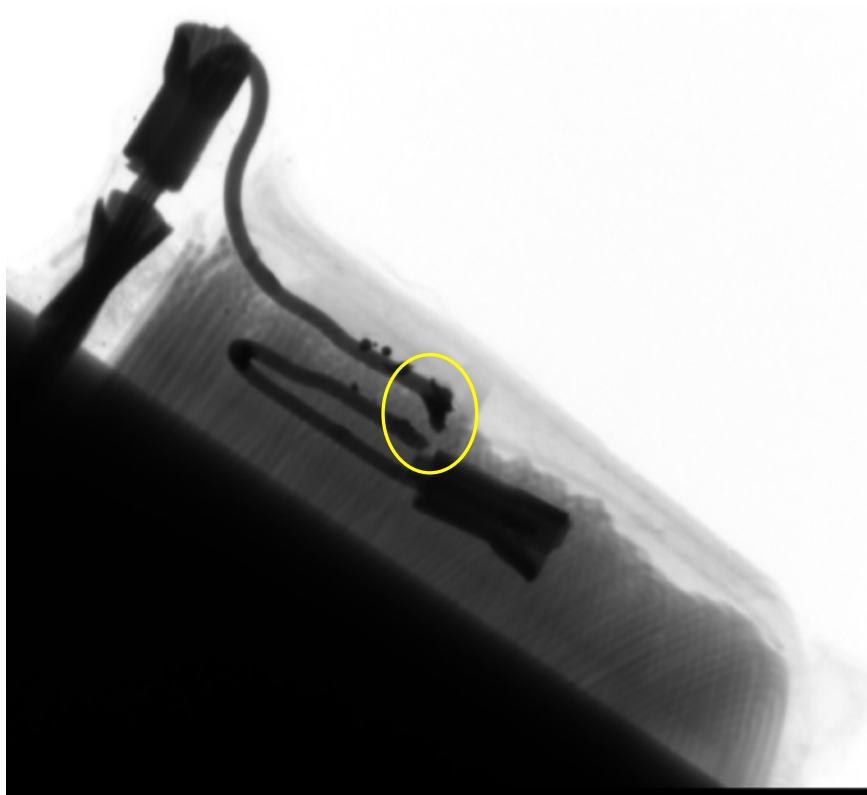
Figure 42. Radiograph of the TCO after the test (sub 73)

Figure 42 shows a radiograph of the TCO after the test. Post-test radiographs of the TCO show the TCO is open, which was caused by the intense heat from the flames. This would suggest that any analysis of a TCO after a fire incident does not necessarily indicate the status of the TCO during the incident.

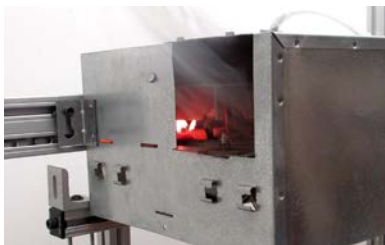
Fan sub 23 was in lock-rotor for about 2 hours and 40 minutes before the unit ignited, as shown in Figure 44. The fan's winding temperature, $\sim 186^{\circ}\text{C}$, was at steady state, above the TCO specified activation temperature, until the winding temperature began to increase rapidly. This rapid increase in temperature indicates shorting in the winding, which reduces the winding resistance. Before ignition, at about $\sim 292^{\circ}\text{C}$, the unit was producing visible white smoke. Similar to Fan sub 73, when the unit ignited at $\sim 340^{\circ}\text{C}$, it produced a large flash and flames for a brief moment. The large flames subsided slightly, until the flames ignited more of the wrap around the winding and/or the coating of the winding. The flames impinged on and ignited the plastic impeller. The burning impeller and bobbin resulted in dripping flaming plastic. Four layers of cheesecloth were placed under the fan to be used as an ignition indicator. The dripping flaming plastic ignited the cheesecloth, which indicates that the fan's plastic grill could also ignite in this type of situation. Figure 45 is a sequence of photographs during lock-rotor testing for sub 23.

At approximately 340°C, there appears to be an ignition of gases around the motor

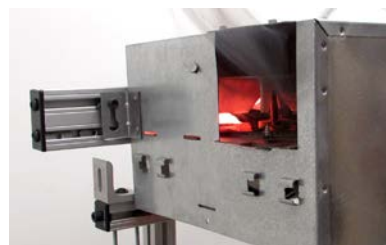
The large flames subside and the winding wrap and/or the winding coating appears to be burning

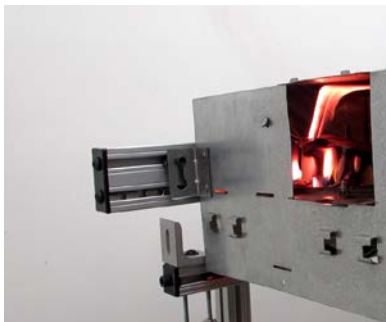
More of the winding wrap and the coating on the winding burns, thus creating a larger flame

The impeller has ignited and begins to sag onto the motor

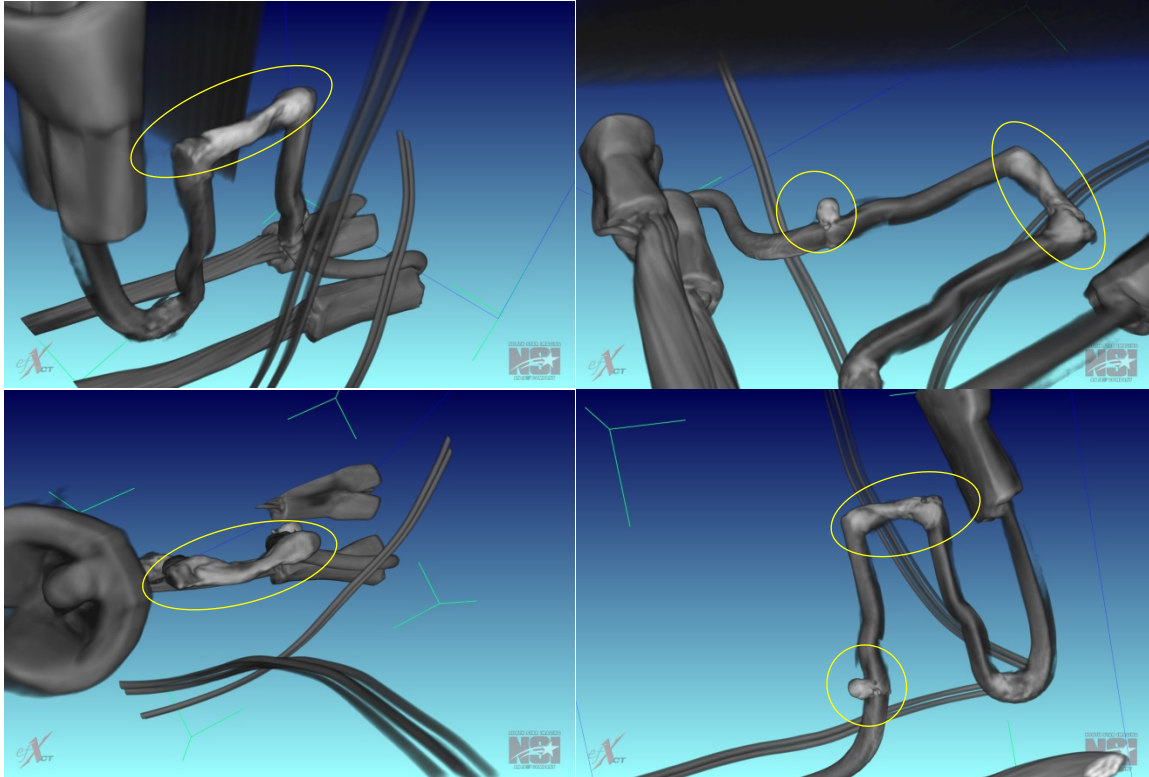
Figure 51. CT scans of the TCO after the test (sub 54)

Figure 51 shows CT scans of the TCO after the test. CT scans of the TCO confirm the solder link within the TCO is intact. The radiographs and CT scans show a solder bead has formed outside the TCO casing. This would suggest that the TCO is no longer hermetically sealed when thermally aged or placed under thermal stress. The reason that the windings were operating at such an elevated temperature for so long without eventually breaking down is not known, but it can be surmised that the winding coating would eventually deteriorate and cause shorts within the winding because the eutectic temperature has changed from T_f .
