U.S. CONSUMER PRODUCT SAFETY COMMISSION
5 RESEARCH PLACE
ROCKVILLE, MD 20850

March 7, 2022

STAFF'S EXAMINATION OF
HEATER POWER CORD PLUGS

Examination of Heater Power Cord Plugs

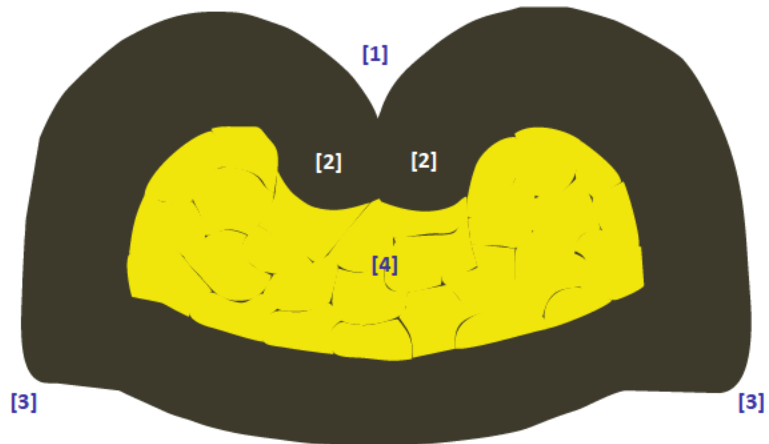
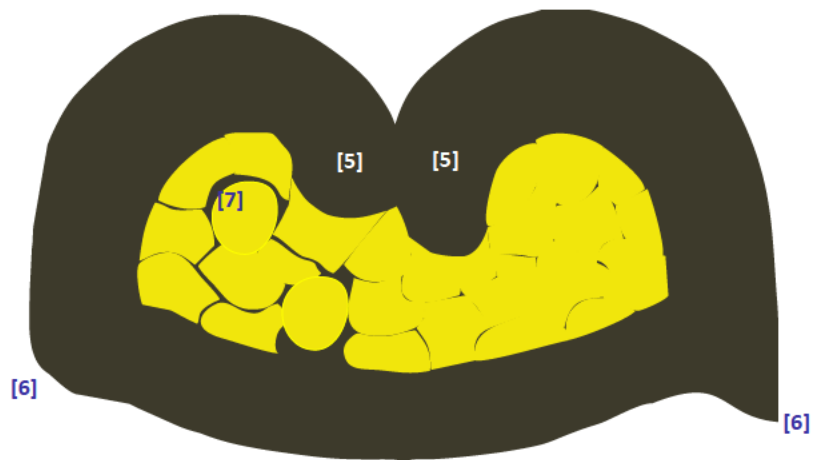
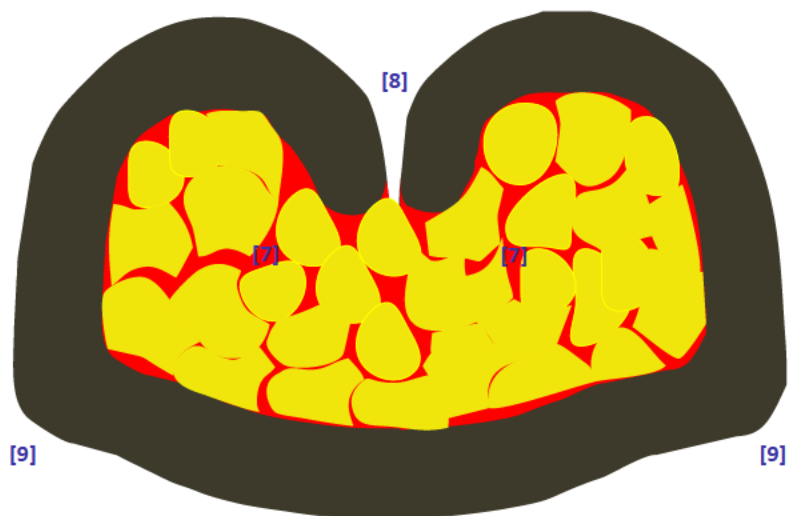
Illustrated Wire Crimp Cross-Section Examples

Best practice is that the crimp barrel is closed, wings support each other and that there is a sufficient gap between wings and bottom of the crimp. All strands need to be deformed to create maximum surface contact between wire strands and barrel.

[1] Crimp barrel fully closed. Crimp wings touching and even.

[2] Wings even and support each other.

[3] Burrs/extrusions are even on both sides of the crimp barrel.

[4] No voids in the crimp barrel and all wire strands are deformed.

[5] Asymmetric crimp barrel closure. Uneven wing closure.

[6] Asymmetric crimp. Uneven burrs/extrusions on the crimp barrel.

[7] Voids in the crimp barrel.

[8] Crimp barrel open. Crimp wings not touching.

[9] Lack or minimum burrs/extrusions on the crimp barrel

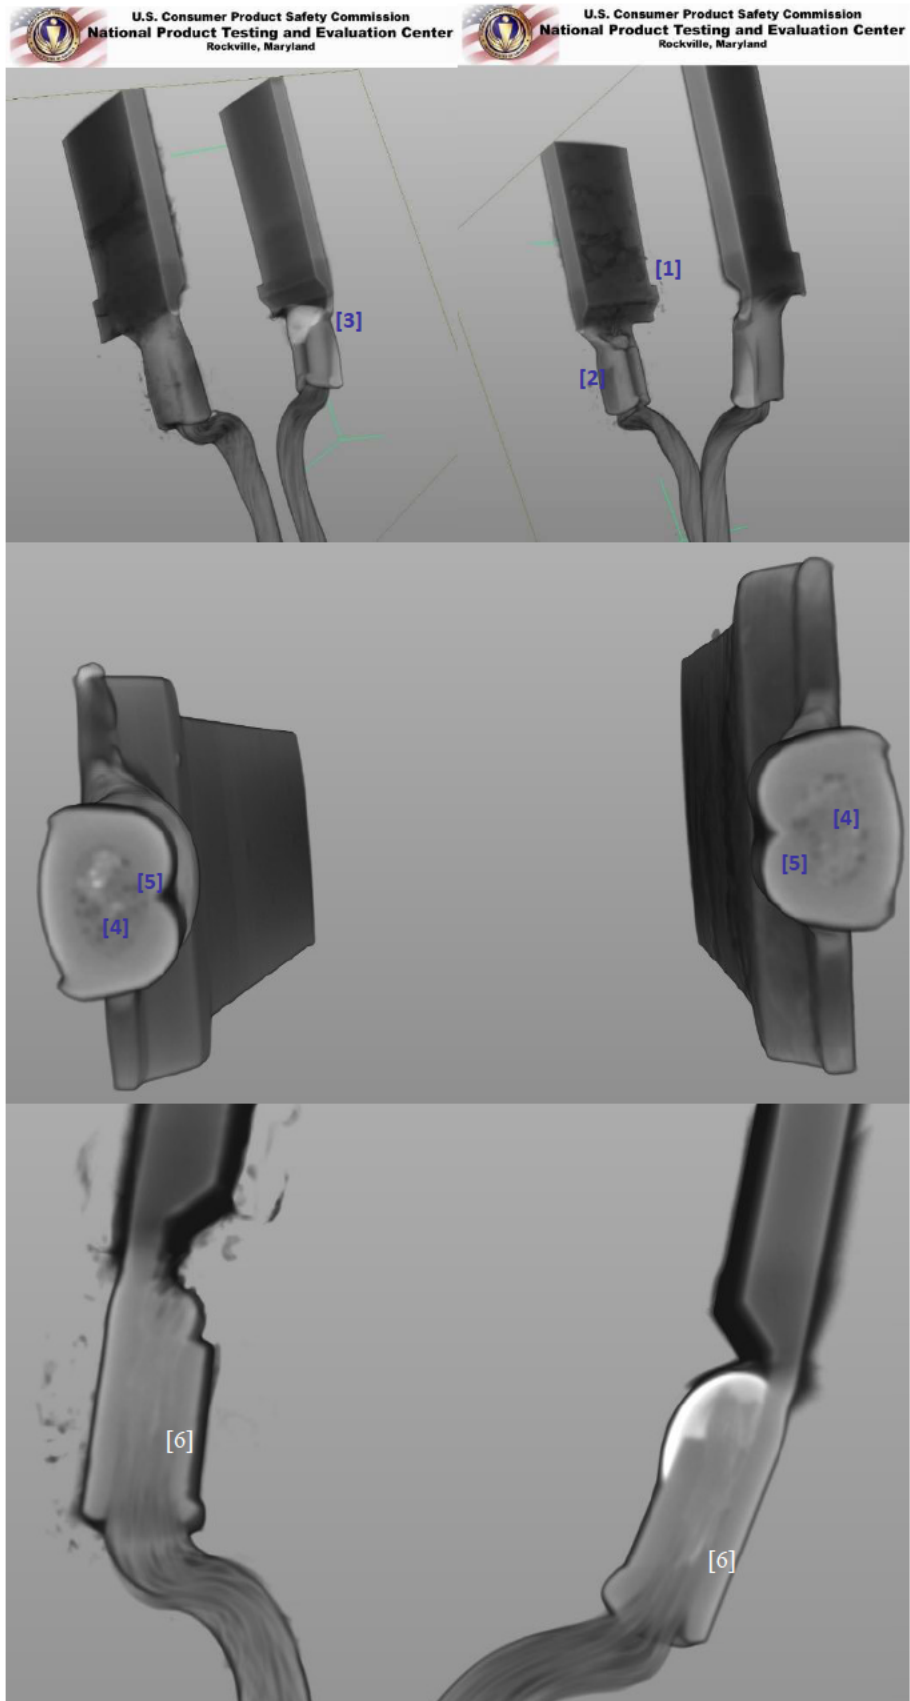
Incident - Sample 0803_02

This sample did not result in a fire.

One of the two blades showed signs of overheating, which resulted in deformation/melting of the plug overmold.

[1] Thermal damage surrounding the crimp connection (not visible on x-rays).

[2] Insufficient solder to bond the wire strands to the terminal surface.

[3] Solder above the crimp barrel location to bond the wire strands to the terminal surface.

[4] Voids in the crimp.

[5] Crimp wing closed but not turned inwards to complete fully closed/pressure crimp barrel.

[6] Solder flow into main crimp area is an indication of voids in the crimp barrel before soldering.

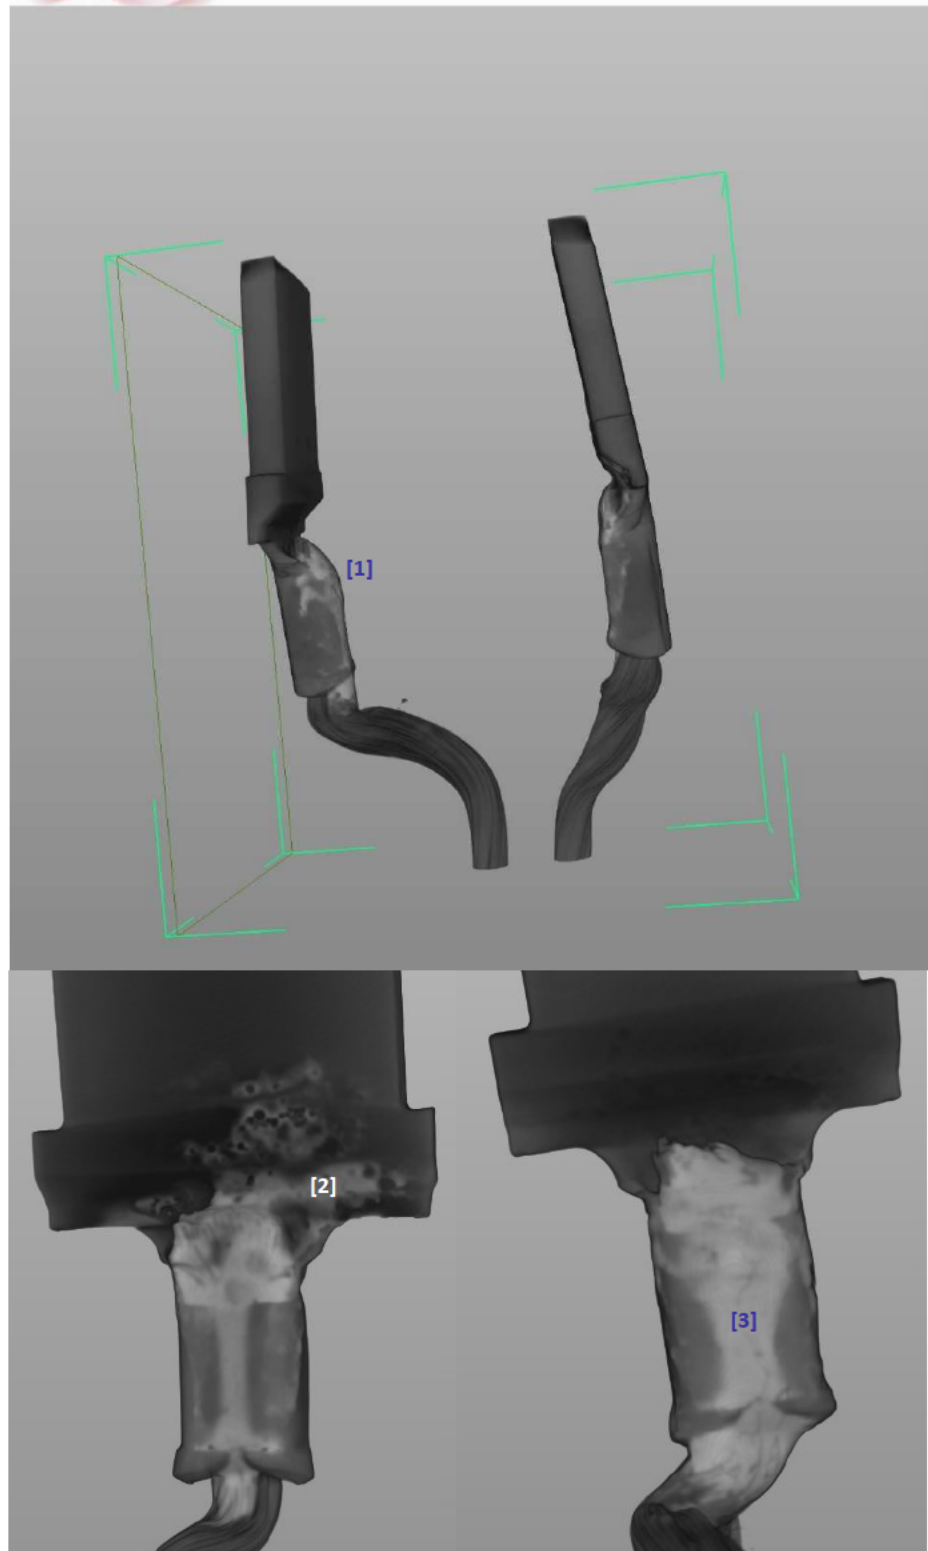
Incident - Sample 0087

This sample did not result in a fire.

One of the two blades showed signs of overheating, which resulted in deformation/melting of the molded plug.

[1] Thermal damage surrounding the crimp connection (not visible on x-ray).

[2] Thermal damage visible on the surface.

[3] Surface solder mainly covering the wings of the crimp barrel.

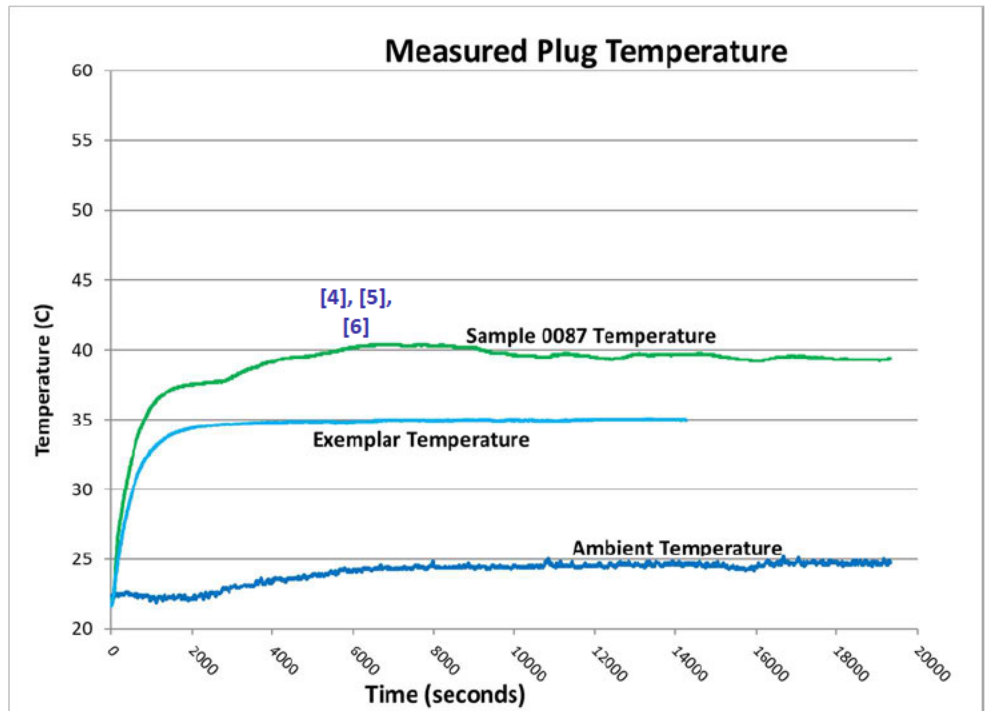
Incident - Sample 0087

A thermocouple was placed between the blades within a hole made in the plug overmold.

[4] The maximum temperature increase above ambient temperatures was 16.2°C @ about 1.8 hours (6460 seconds).

[5] The maximum temperature increase above exemplar sample temperatures was 5.5°C @ about 1.72 hours (6420 seconds).

[6] The maximum temperature for the incident sample was 40.4°C @ about 1.72 hours (6420 seconds).

[7] Thermocouple located between the crimp barrels within the molded plug.

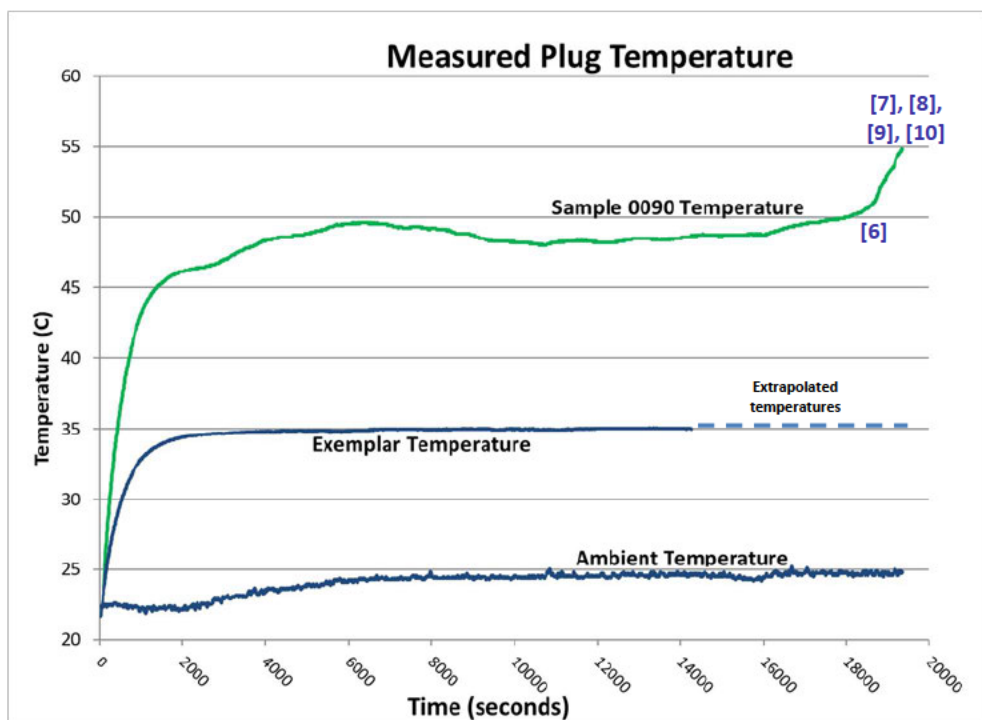
Incident - Sample 0090

This sample did not result in a fire during the temperature test.

[6] Steep rise in temperature after about 5 hours.

[7] The maximum temperature rise was 30.1°C @ about 5.4 hours (19340 seconds).

[8] The maximum temperature difference between incident and exemplar temperatures was 19.8°C @ about 5.4 hours (19340 seconds).

[9] The maximum temperature for the incident sample was 54.8°C @ about 5.4 hours (19340 seconds).

[10] The temperature leveled or declined after 19340 seconds.

[11] Thermocouple located between the plug blades within the plug overmold.

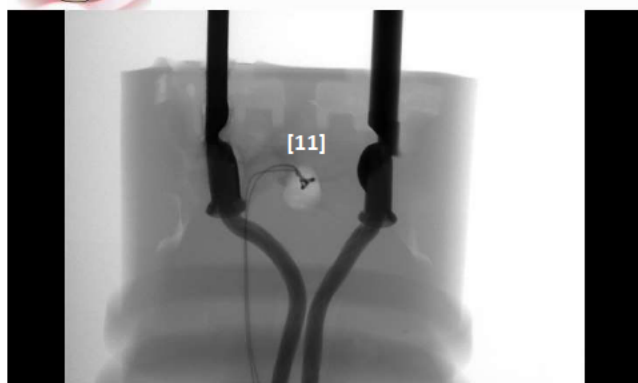
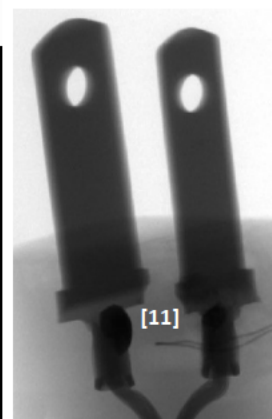
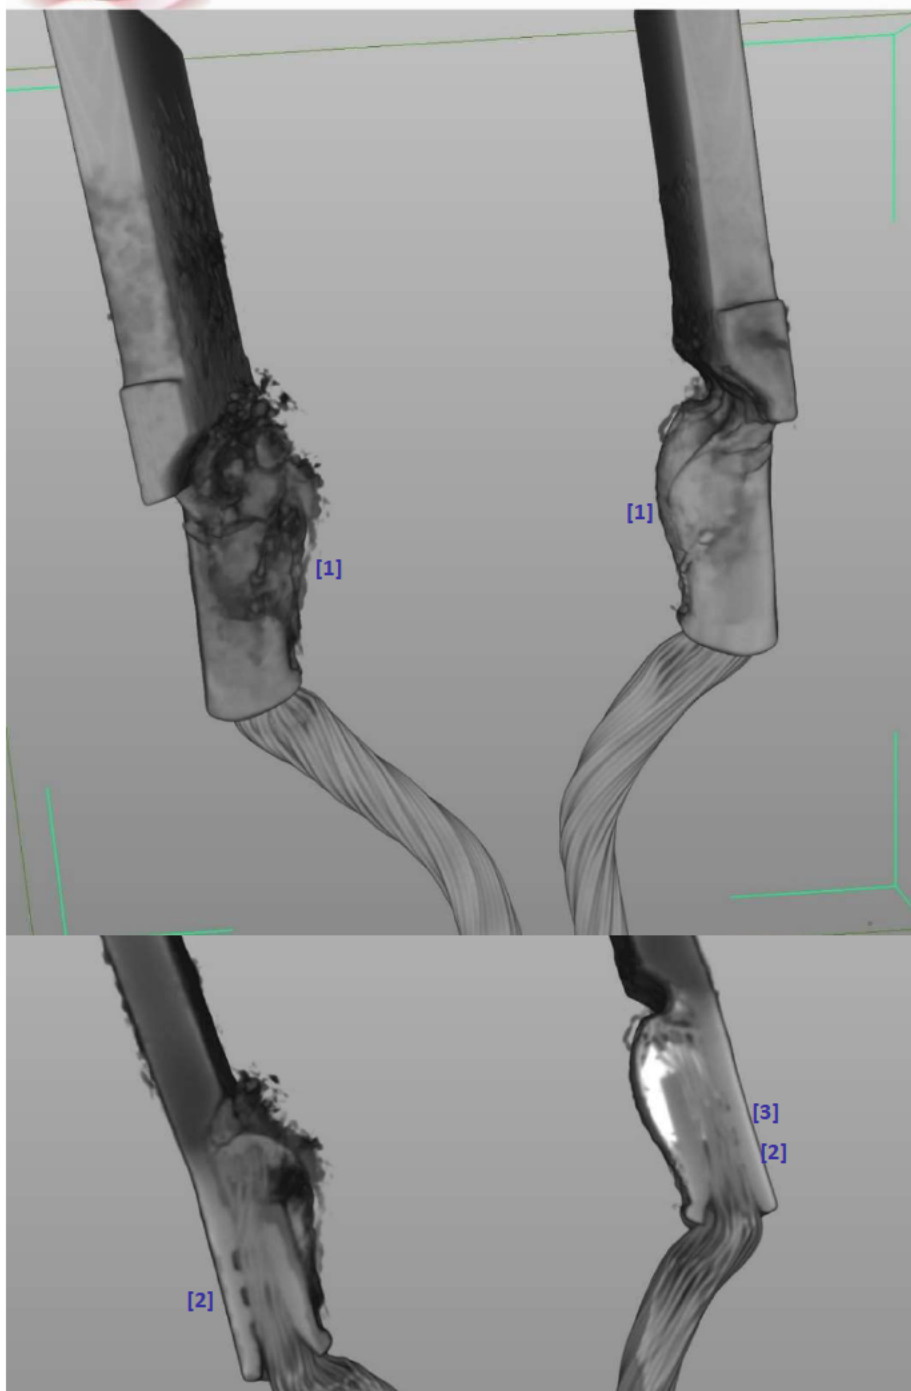
Incident - Sample
0803_01

This sample did not result in a fire.

One of the blades showed signs of overheating, which resulted in deformation/melting plug overmold.

[1] Thermal damage surrounding the crimp connection. Solder had melted and solidified.

[2] Voids in the crimp barrel.

[3] Solder flow into main crimp area is an indication of insufficient crimp barrel pressure.

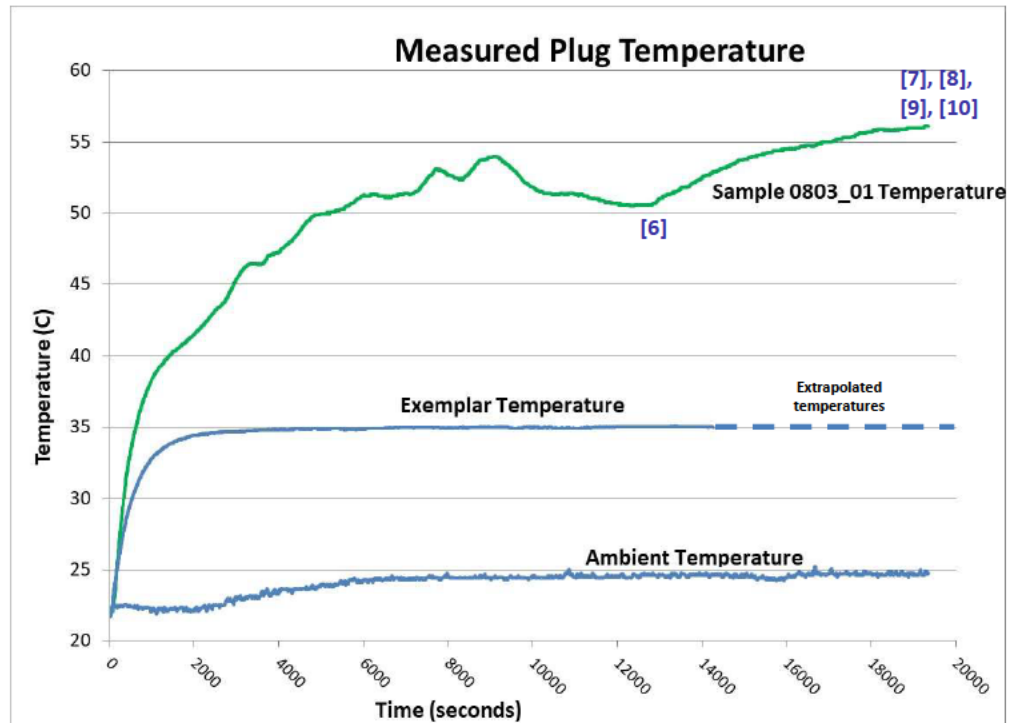
Incident - Sample 0803_01

This sample did not result in a fire during the temperature test.

[6] Steep rise in temperature after 3.5 hours.

[7] The maximum rise above ambient temperatures was 31.5° C @ about 5.4 hours (19260 seconds).

[8] The maximum rise above exemplar temperatures was 19.8° C @ about 5.4 hours (19260 seconds).

[9] The maximum temperature for the incident sample was 54.8° C @ about 5.4 hours (19260 seconds).

[10] The temperature leveled or declined after 19260 seconds.

[11] Thermocouple located between the plug blades within the plug overmold.

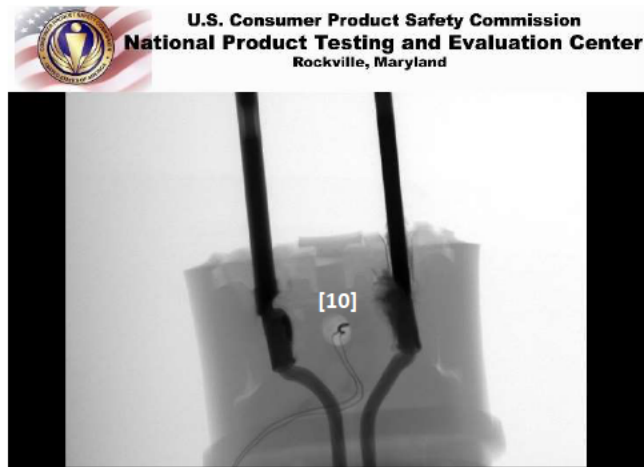
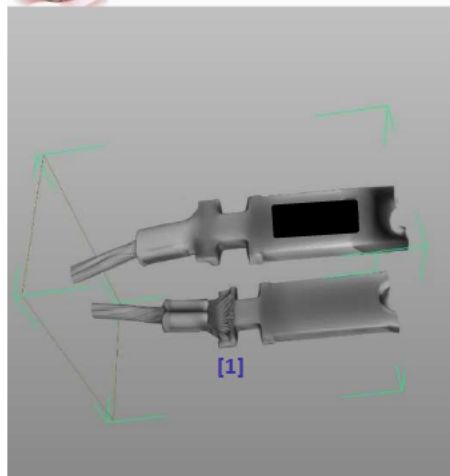
Exemplar - Sample 0447

This is an exemplar sample. Crimp and weld configuration.
(Note: Black box added to conceal manufacturer markings)

[1] For this sample, a bar weld is used across the wire strands.

[2] Voids in the crimp barrel.

[3] Uneven crimp barrel closure.

[4] Lack of burrs/extrusions is an indication of insufficient crimp pressure to close crimp barrel.

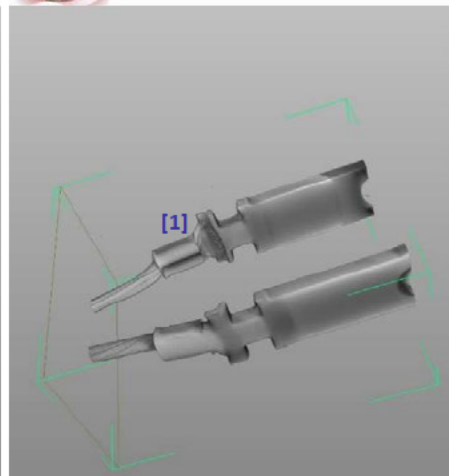
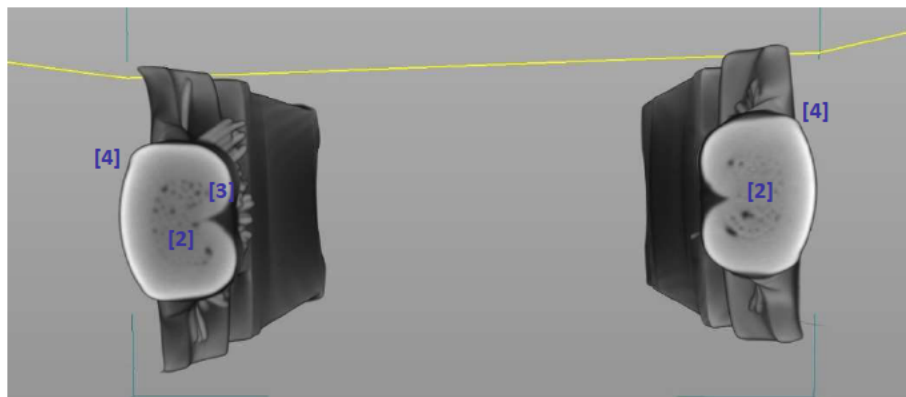
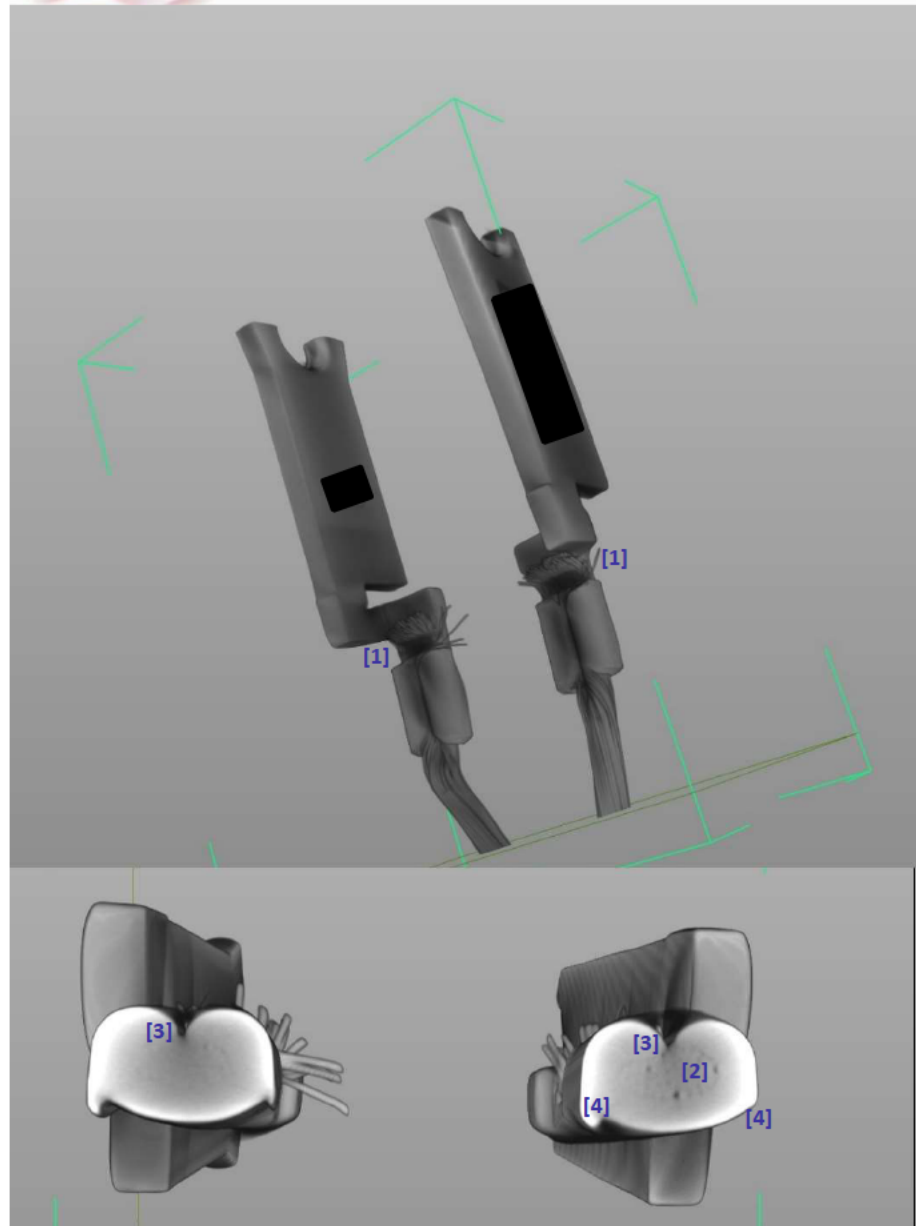
This is an exemplar sample. Crimp and weld configuration.
(Note: Black box added to conceal markings)

[1] For this sample, bar weld is used across the wire strands.

[2] Voids in the crimp barrel. Not all wire strands are deformed.

[3] Open crimp barrel. Crimp wings partially open and not touching.

[4] Asymmetric crimp. Uneven burrs/extrusions.

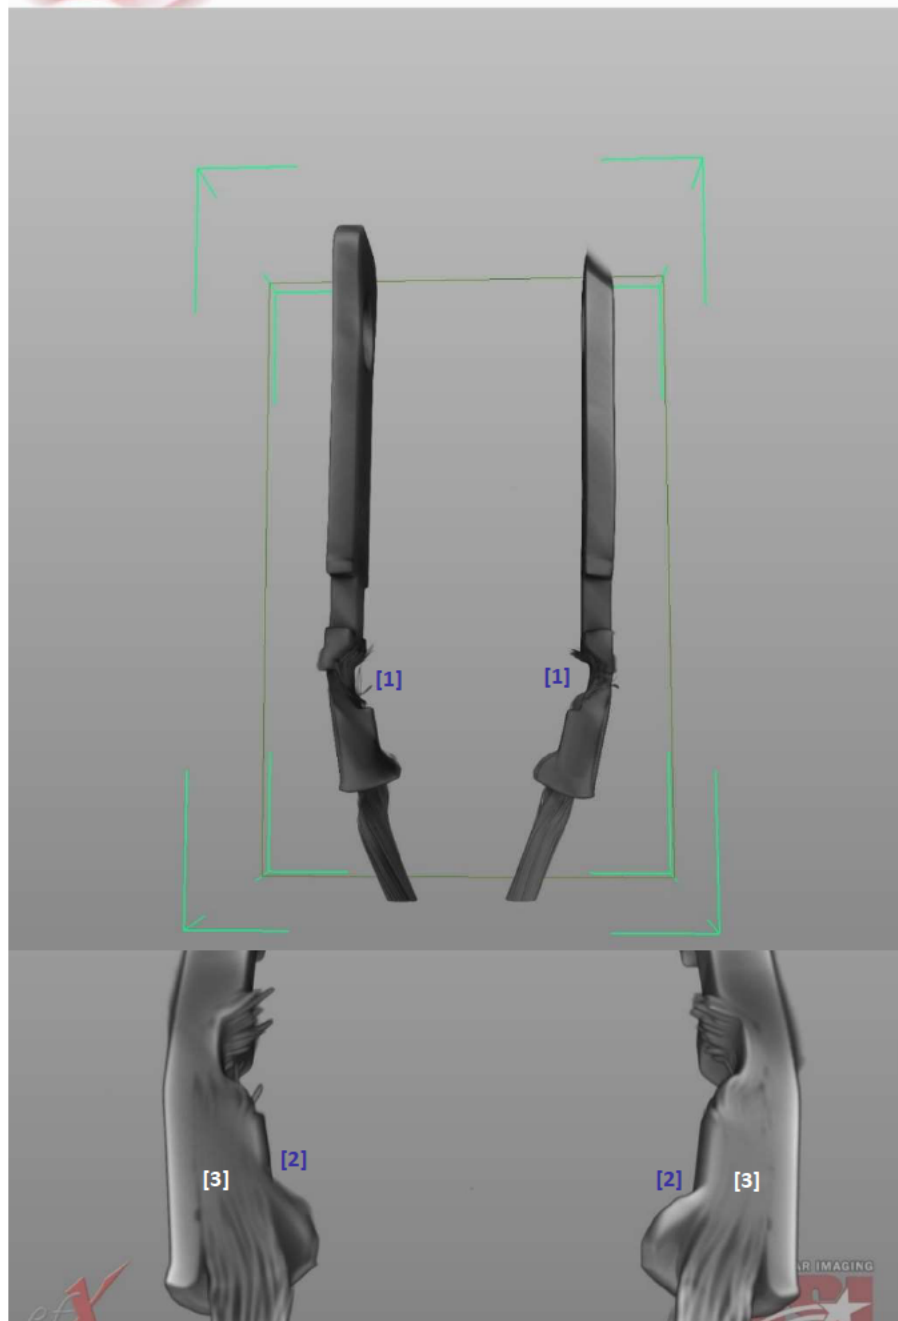
Exemplar - Sample 0446

This is an exemplar sample. Crimp and weld configuration.

[1] For this sample, bar weld is used across the wire strands.

[2] Crimp location not centered resulting in excessive bell formation.

[3] Voids in the crimp barrel.

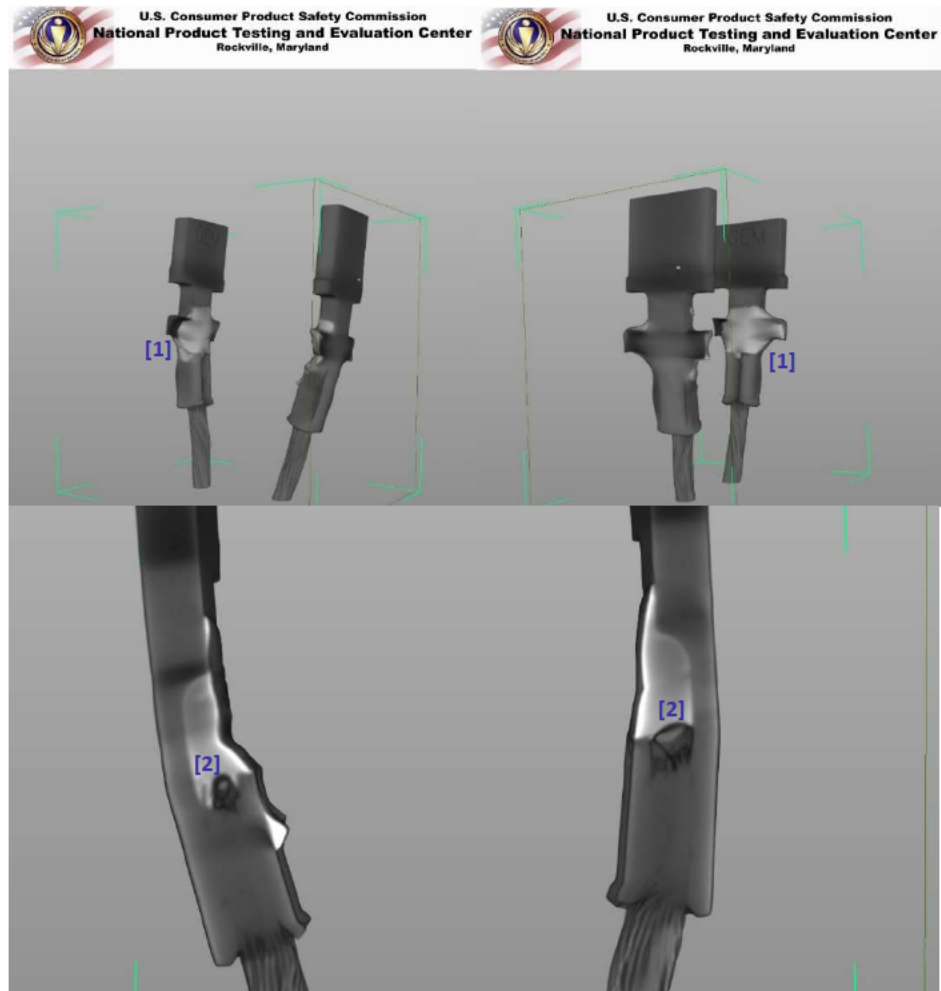
Exemplar - Sample 0689

This is an exemplar sample. Crimp and solder configuration.

[1] For this sample, solder is used to bond wire strands to terminal surface.

[2] Voids in the solder.

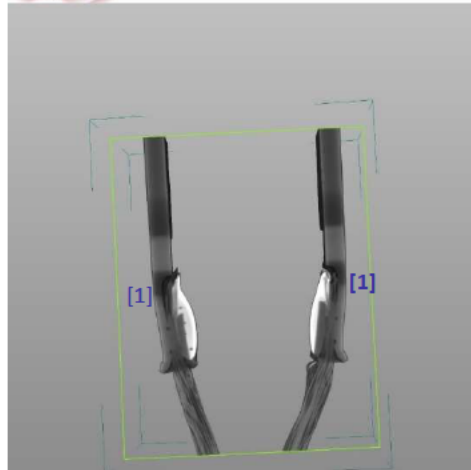
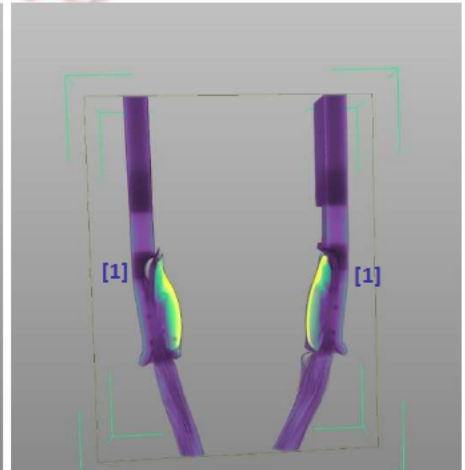
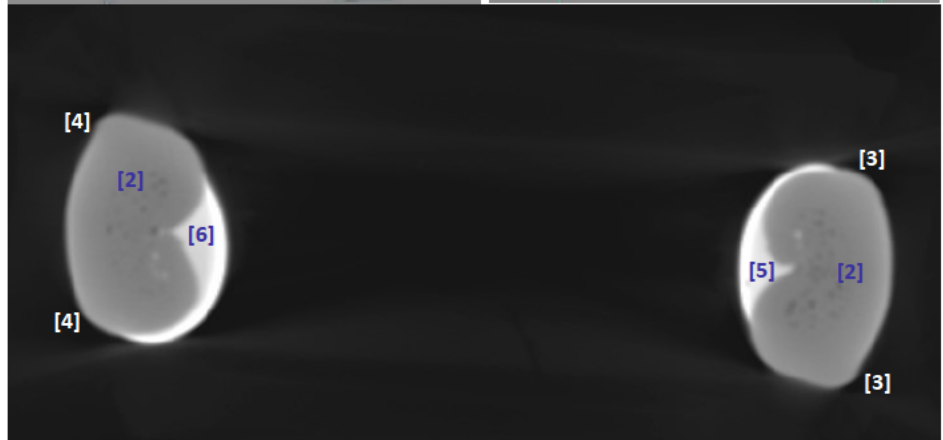
Exemplar - Sample 0869

This is an exemplar sample. Crimp and solder configuration.

[1] Surface solder. Solder does not penetrate through wire strands to terminal surfaces.

[2] Voids in the crimp barrel.

[3] No burrs.

[4] Asymmetric crimp. Uneven burrs/extrusions.

[5] Uneven crimp barrel closure.

[6] Open crimp barrel.

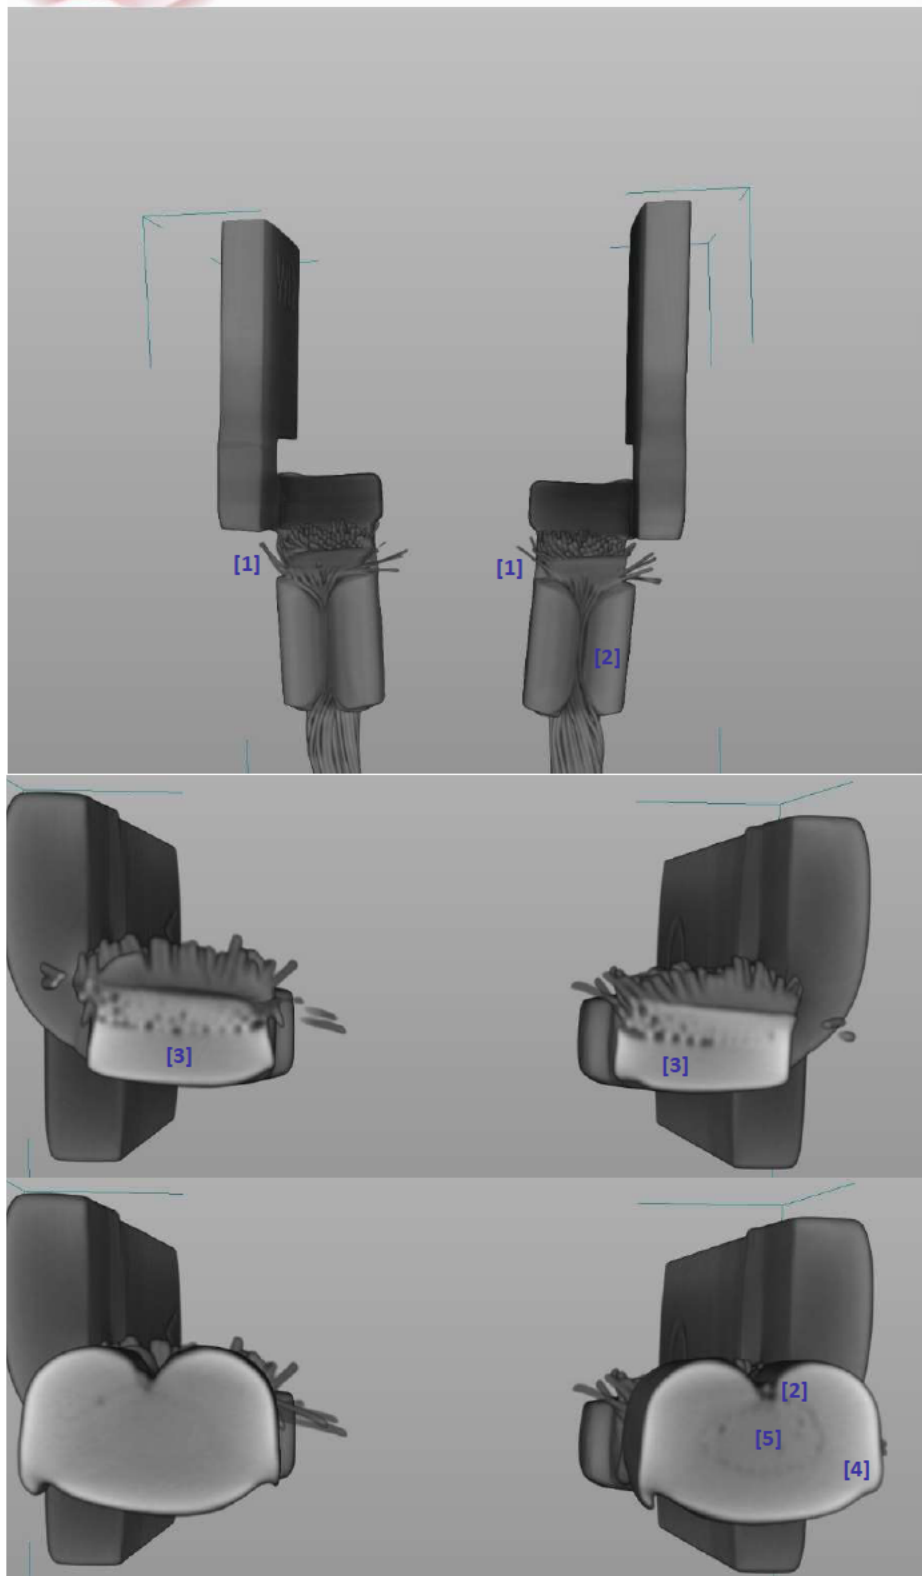
This is an exemplar sample. Crimp and weld configuration.

[1] For this sample, bar weld is used across the wire strands.

[2] Crimp barrel not fully closed.

[3] Voids in the weld. Not all the strands are welded to the terminal surfaces.

[4] Asymmetric crimp. Uneven burrs/extrusions.

[5] Voids in the crimp barrel.

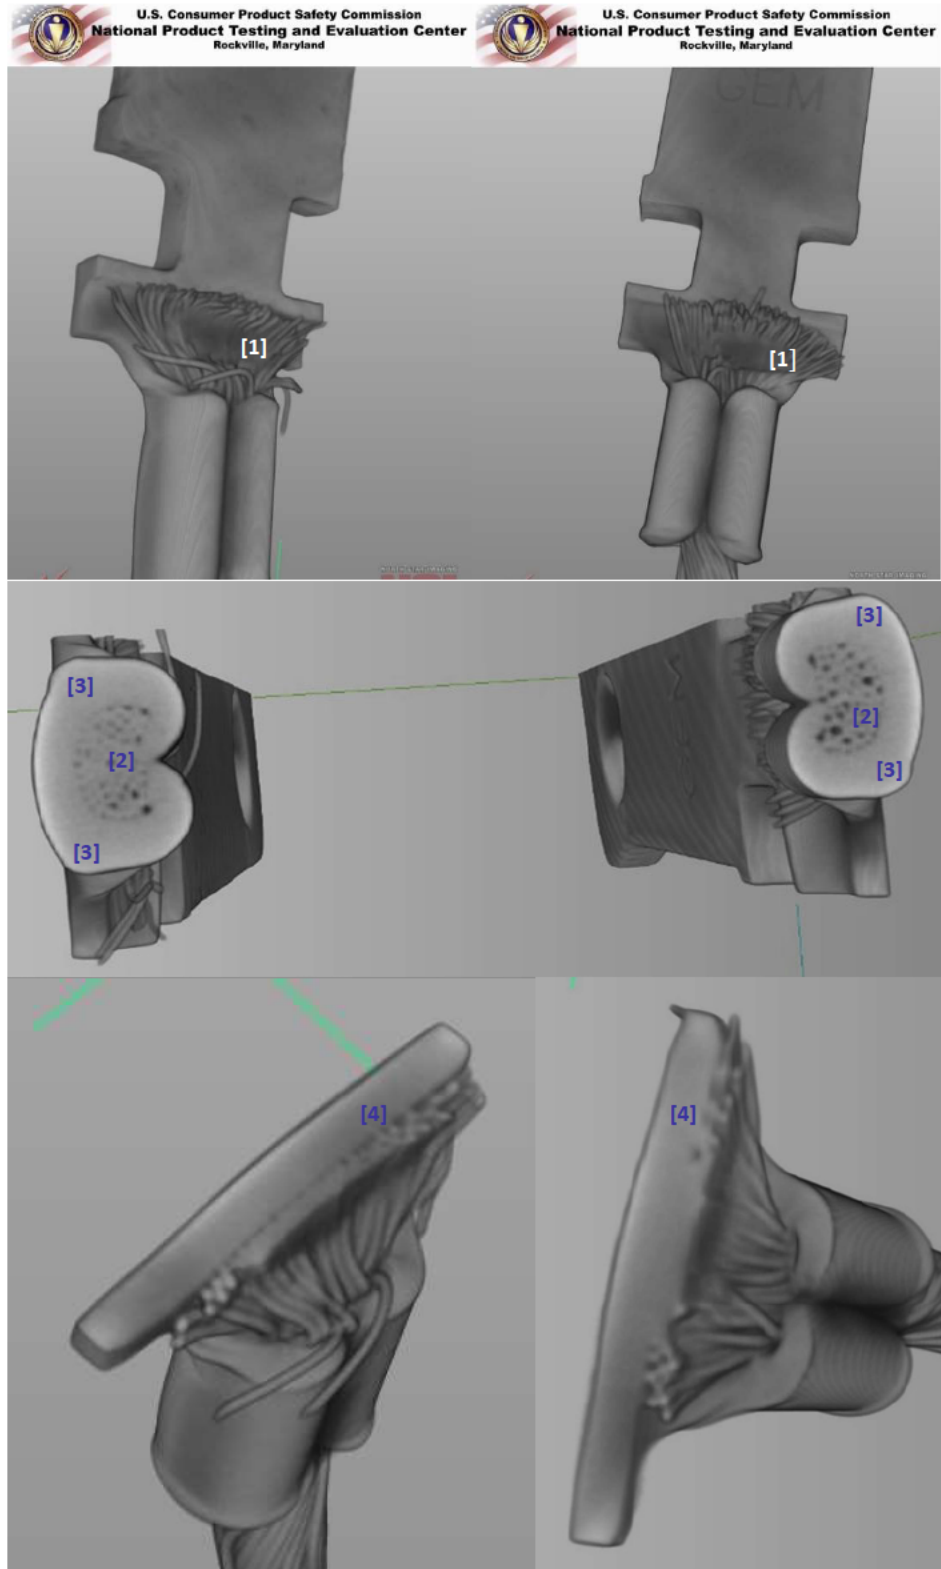
Exemplar - Sample 0020

This is an exemplar sample. Crimp and weld configuration.

[1] Bar weld does not span the width of the wire strands.

[2] Voids in the crimp barrel.

[3] Asymmetric crimp. Uneven burrs/extrusions.

[4] Not all the strands are welded to the terminal surfaces.

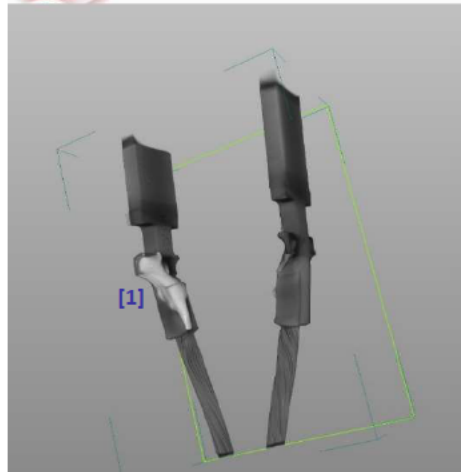
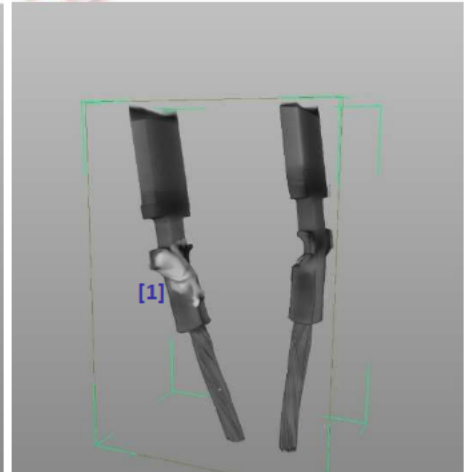
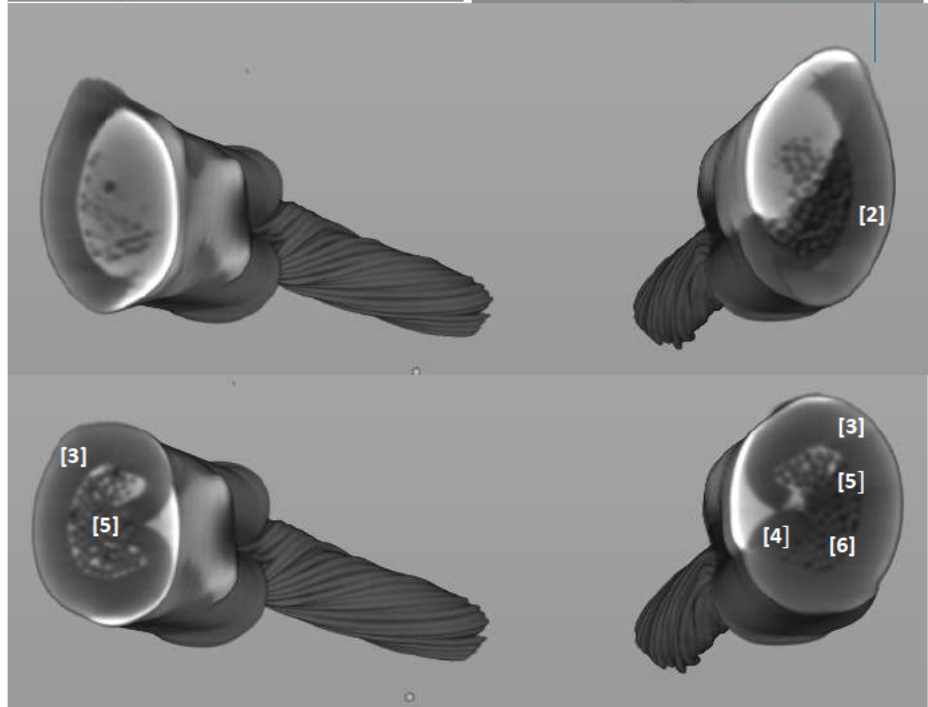
Exemplar - Sample 0200

This is an exemplar sample. Crimp and solder configuration.

[1] Uneven solder.

[2] Solder does not cover all the strands and insufficient bonding to the terminal surfaces.

[3] No burrs/extrusions.

[4] Asymmetric crimp barrel.

[5] Solder flow into main crimp area is an indication of insufficient crimp pressure.

[6] Voids in crimp barrel.

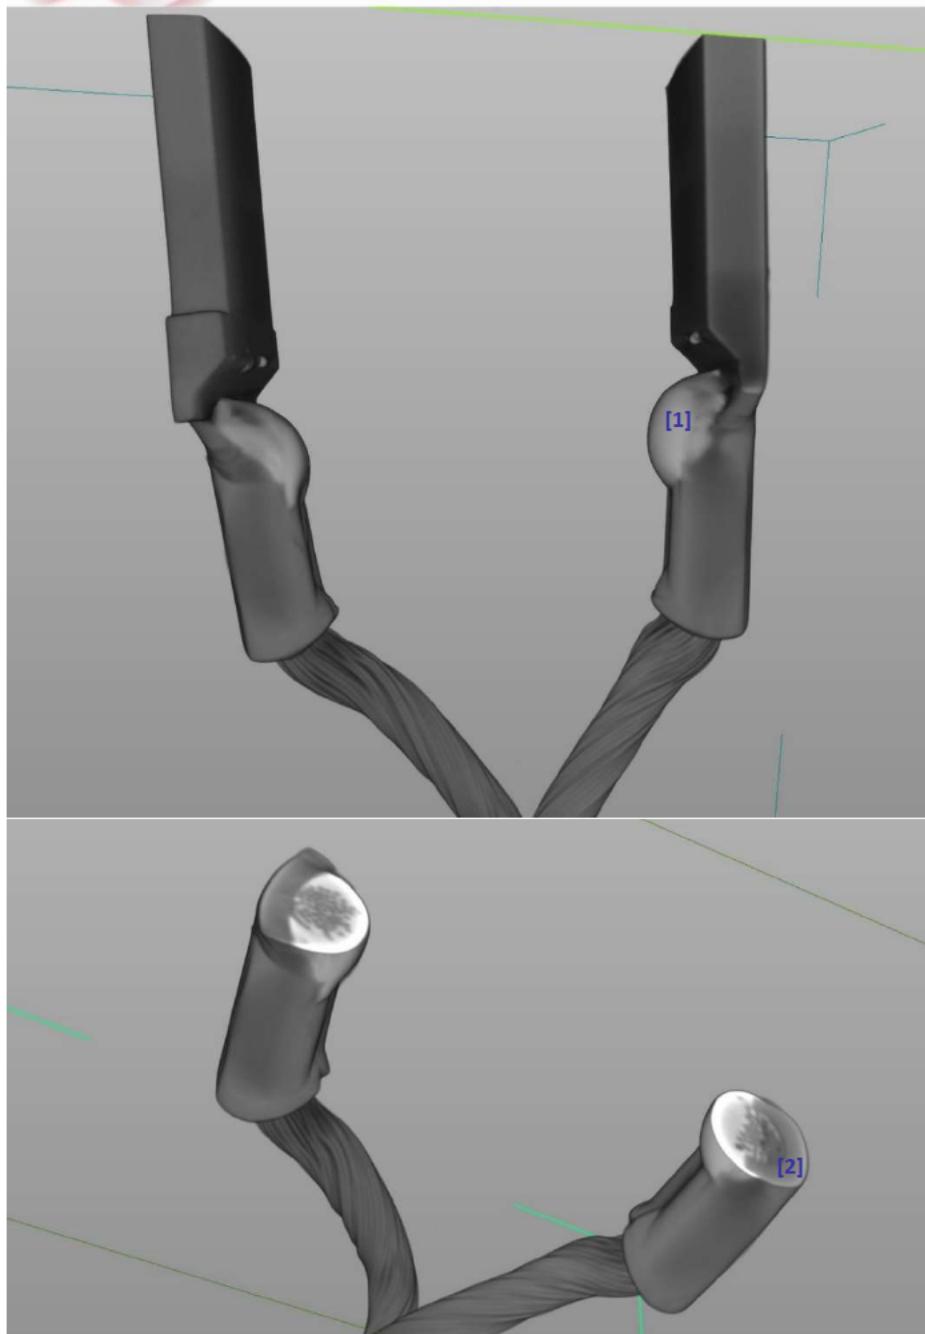
Exemplar - Sample 0718

This is an exemplar sample. Crimp and solder configuration.

[1] Solder beaded shape is an indication of insufficient heating of the crimp surfaces.

[2] Solder not fully penetrated into wire strands and not bonded to the terminal surfaces.
