U.S. CONSUMER PRODUCT SAFETY COMMISSION  
5 RESEARCH PLACE  
ROCKVILLE, MD 20850

**Re:** Ohio State Fair Fatal Ride Incident

1. Task Number 170727CFE0001		2. Investigator's ID 10837		<b>EPIDEMIOLOGIC INVESTIGATION REPORT</b>
3. Office Code 800	4. Date of Accident YR MO DAY 2017 07 26	5. Date Initiated YR MO DAY 2017 07 27

6. Synopsis of Accident or Complaint UPC The 18 year old victim was riding a high G-force pendulum swing amusement park ride when one of the 4 person gondolas suddenly detached from the main part of the ride, went airborne and finally landed on the ground approximately one foot from the base of the ride. The victim died at the scene and seven other riders were transported to the hospital.

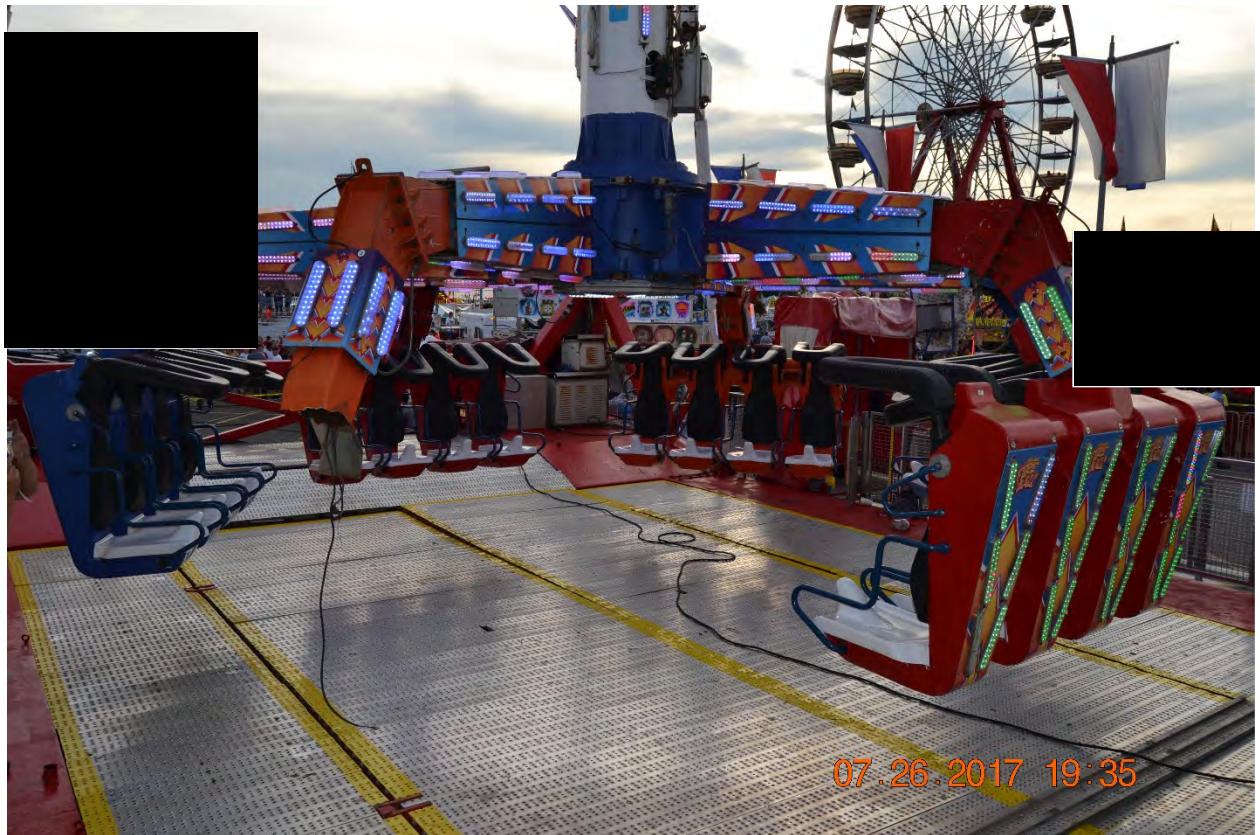
Photo #4 – Additional overall picture of the incident ride. Photo identifies broke arm and missing gondola. Photograph taken by the [REDACTED] State Highway Patrol on July 26, 2017 after the incident.

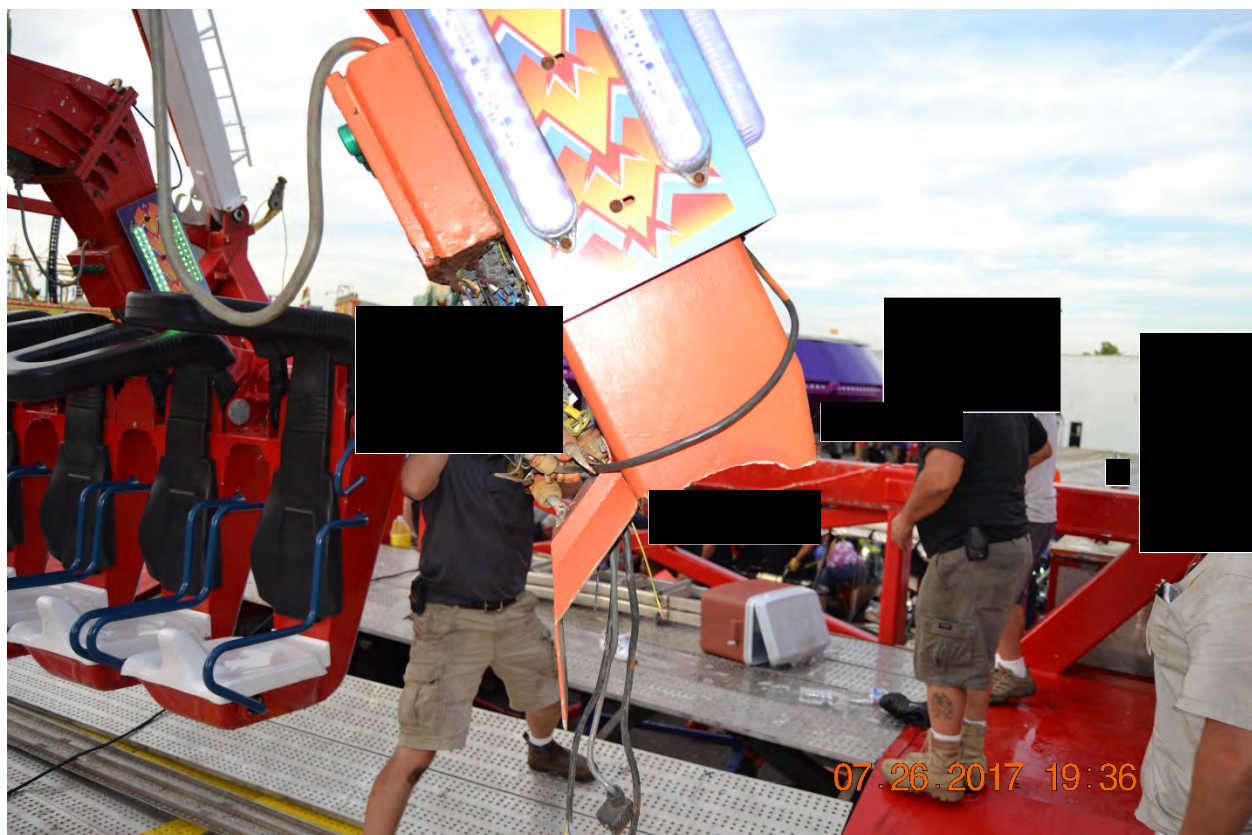
Photo #5 – Close up picture of the incident ride. Photo identifies broke arm and missing gondola. Photograph taken by the [REDACTED] State Highway Patrol on July 26, 2017 after the incident.

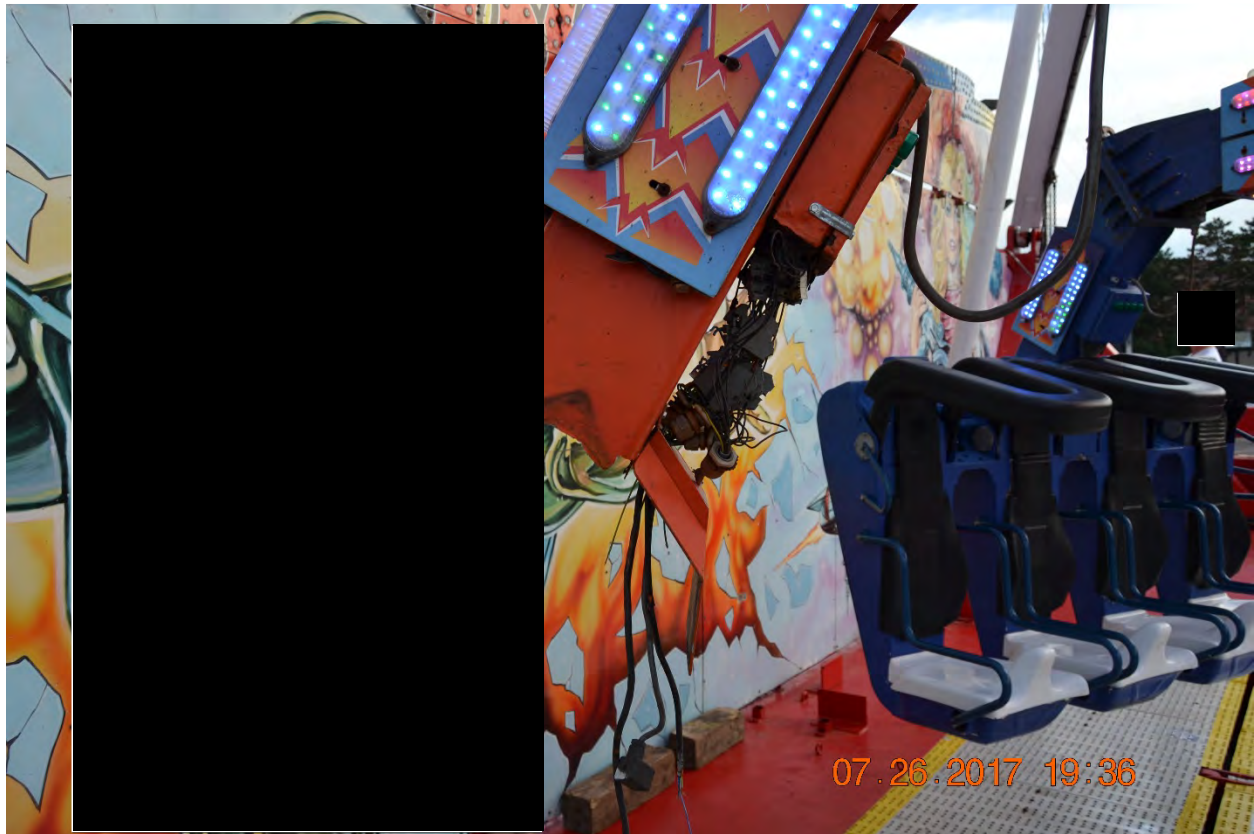
Photo #6 – Additional close up picture of the incident ride. Photo identifies broke arm and missing gondola. Photograph taken by the [REDACTED] State Highway Patrol on July 26, 2017 after the incident.

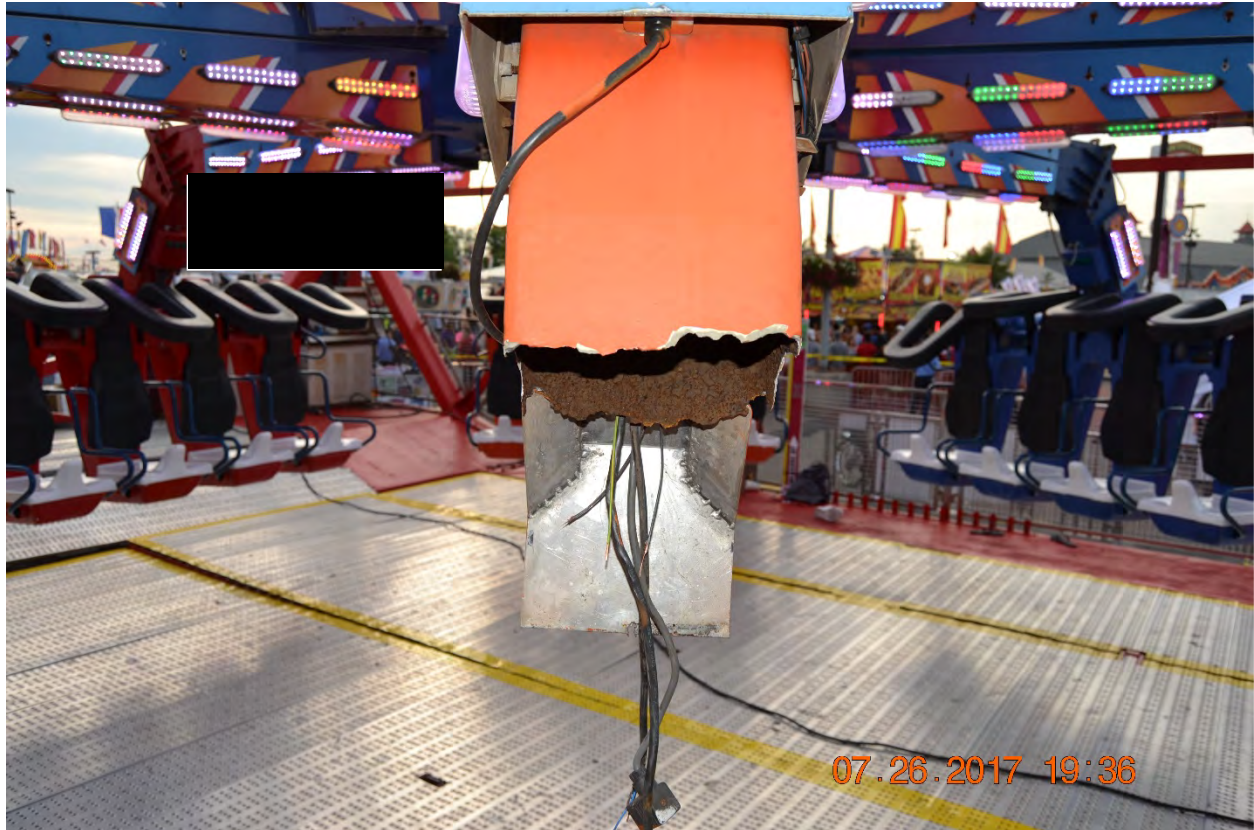
Photo #7 – Additional close up picture of the incident ride. Photo identifies broke arm and missing gondola. Photograph taken by the [REDACTED] State Highway Patrol on July 26, 2017 after the incident.

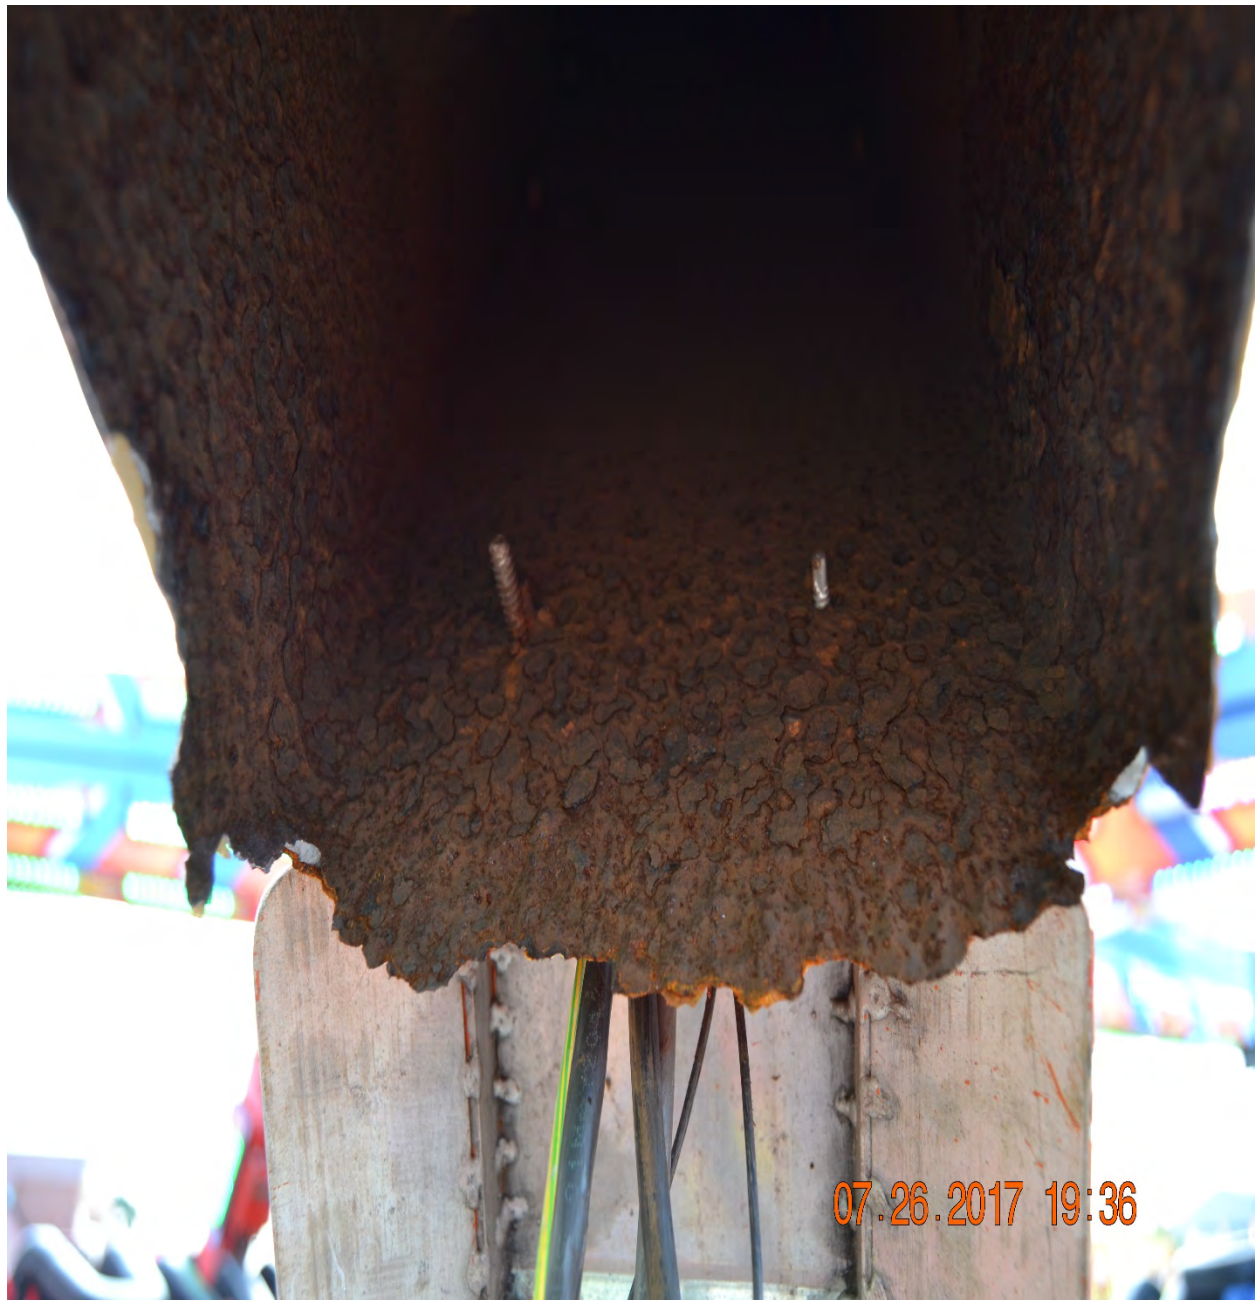
On July 28, 2017, this investigator and additional personnel from CPSC inspected the incident ride and the detached gondola. Rust was noted on the entire inside of the supporting sweep arm (Exhibit M, Photos 8, 21 & 23) that the gondola had detached from. All four sides of the break area connecting the supporting sweep arm and gondola appeared to be covered in rust. After inspection of the ride, CPSC staff went to a secure evidence facility where the detached gondola was being stored and inspected those components. We observed rust inside (Exhibit M, Photo 14) and around all four break sides (Exhibit M, Photos 16 & 19) of the gondola where it was detached from the supporting sweep arm. This inspection of the incident ride and detached gondola on July 28, 2017 was non-destructive and completed utilizing photography and visual observation.

Photo #8 – Additional close up picture of the incident ride. Photo identifies the inside of the broken arm. Photograph taken by the [REDACTED] State Highway Patrol on July 26, 2017 after the incident.

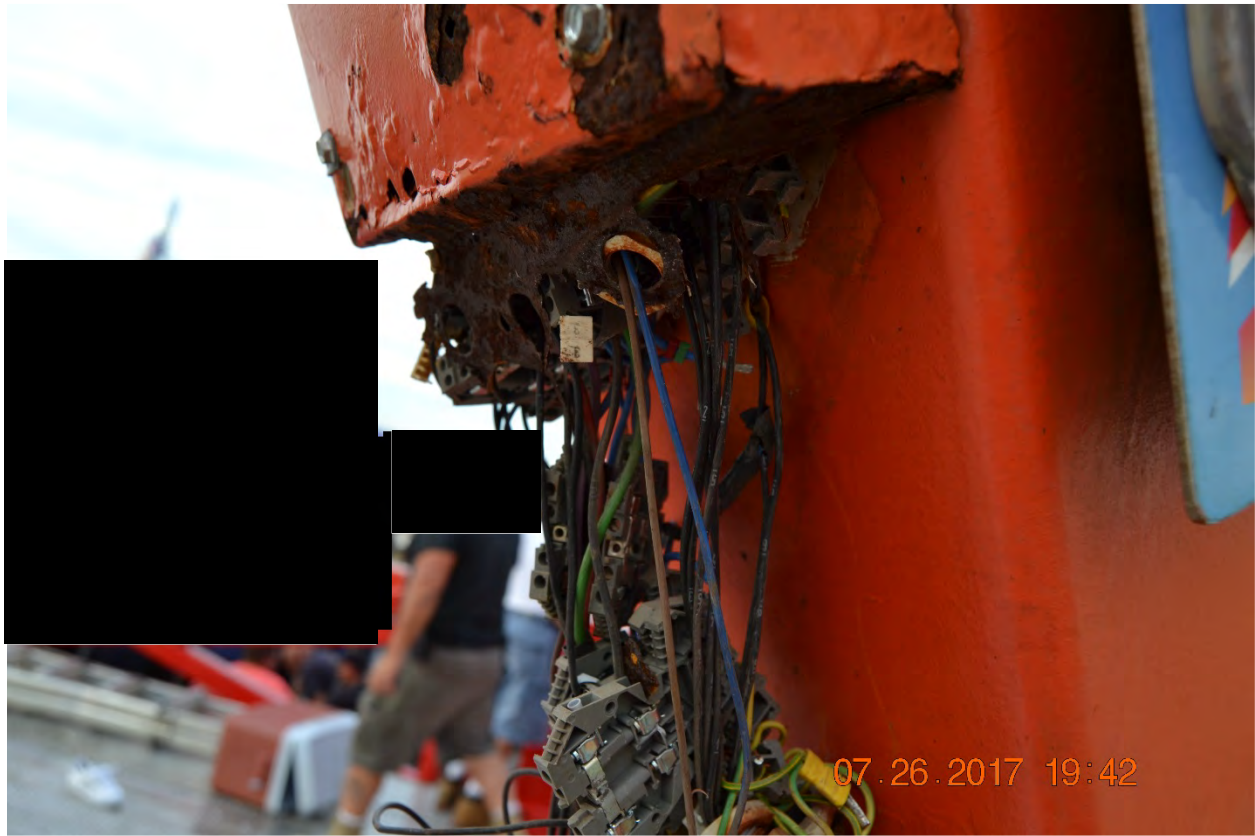
Photo #9 – Additional close up picture of the incident ride. Photo identifies the wires hanging off the broken arm. Photograph taken by the [redacted] State Highway Patrol on July 26, 2017 after the incident.

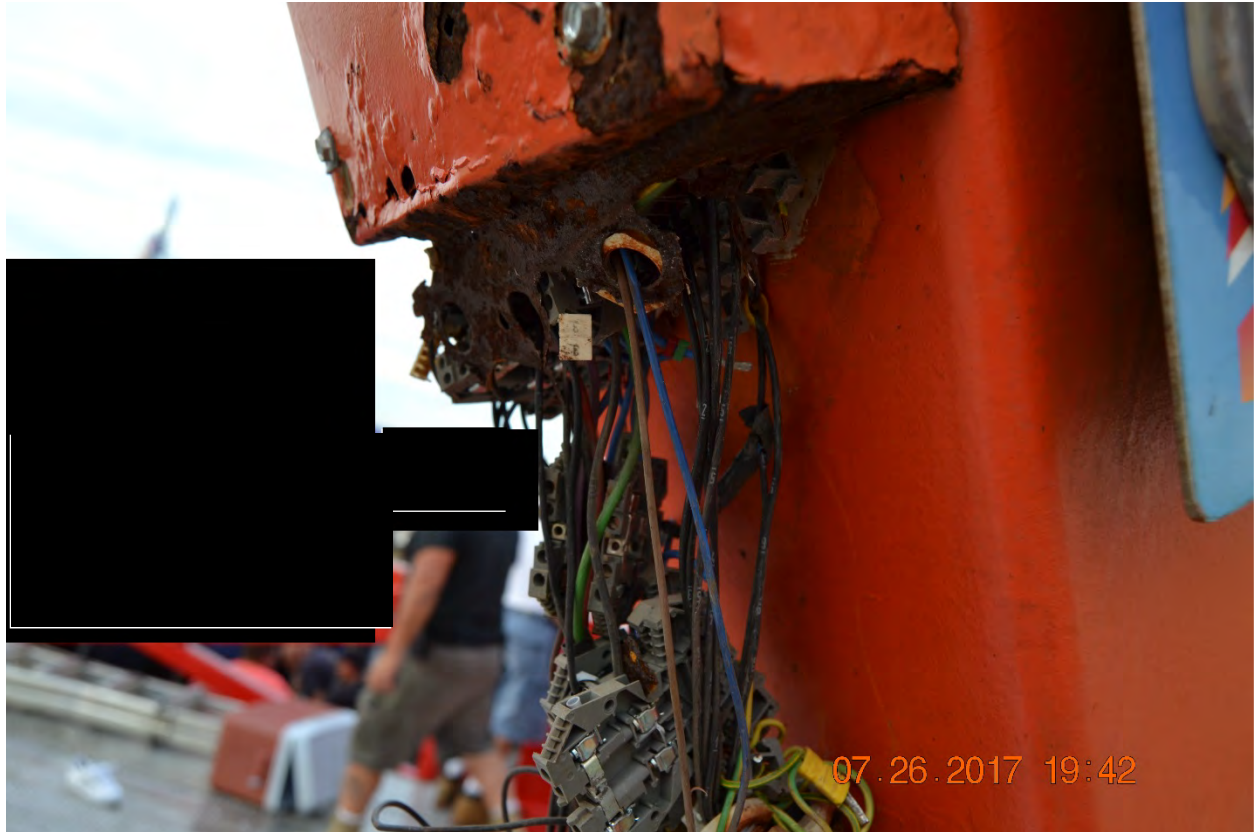
Photo #10 – Additional close up picture of the incident ride. Photo identifies the wires hanging off the broken arm. Photograph taken by the [REDACTED] State Highway Patrol on July 26, 2017 after the incident.

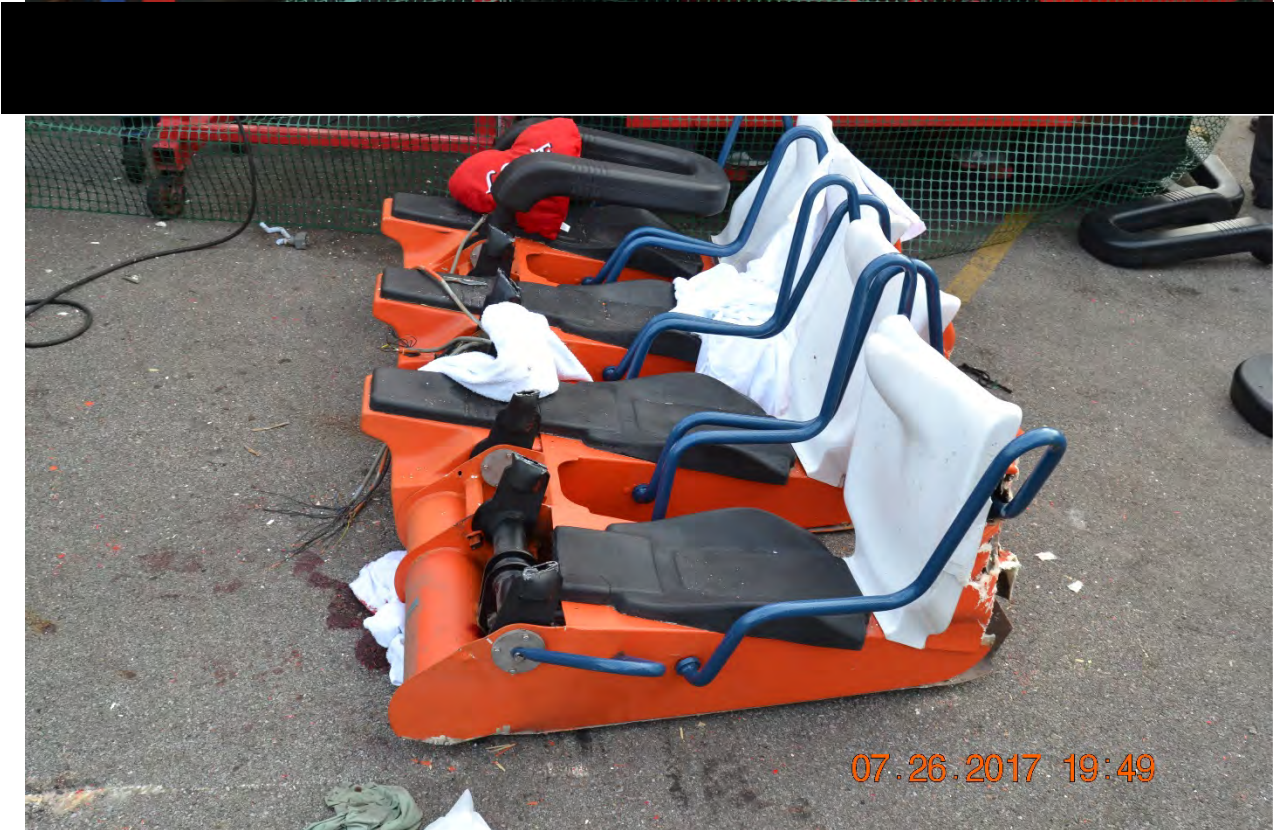
Photo #11 – Additional close up picture of the incident ride. Photo identifies the gondola that separated from the ride. Photograph taken by the [REDACTED] State Highway Patrol on July 26, 2017 after the incident.

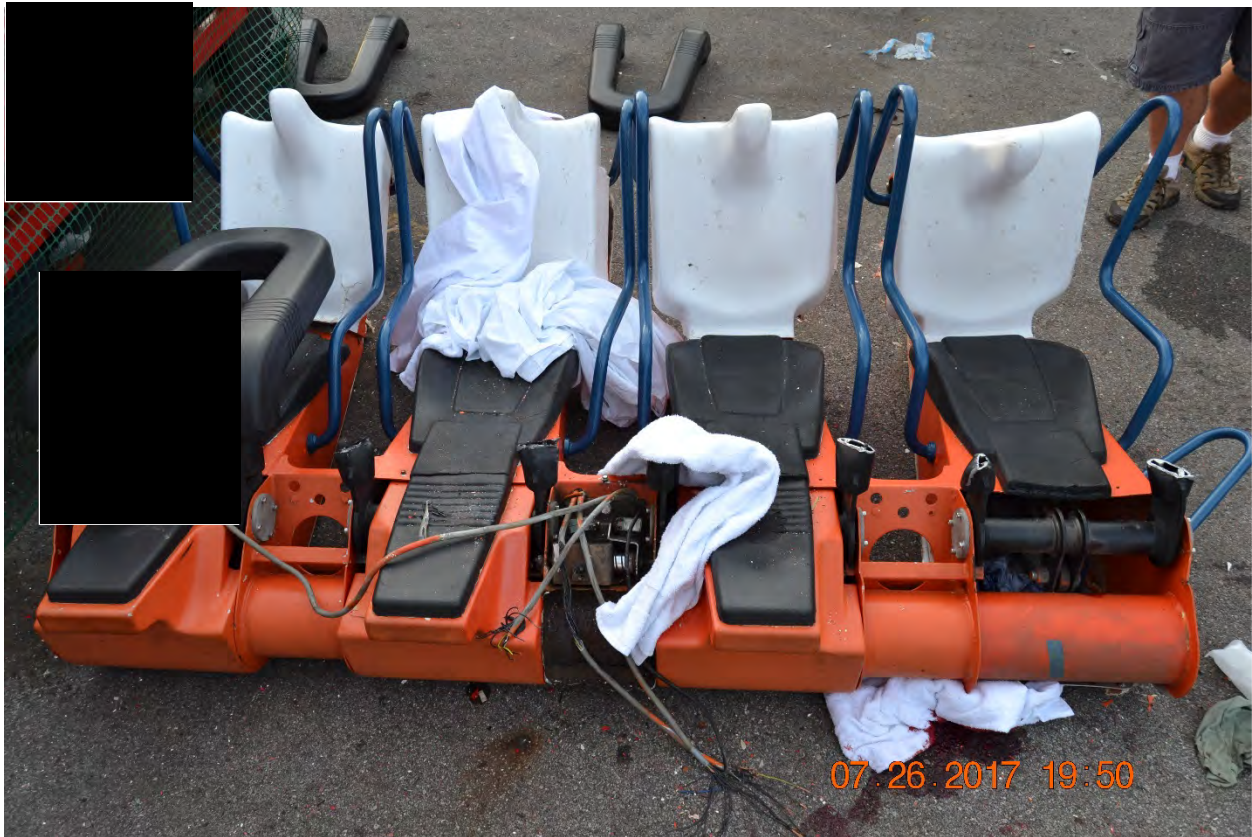
Photo #12 – Additional close up picture of the incident ride. Photo identifies the gondola that separated from the ride. Photograph taken by the [REDACTED] State Highway Patrol on July 26, 2017 after the incident.

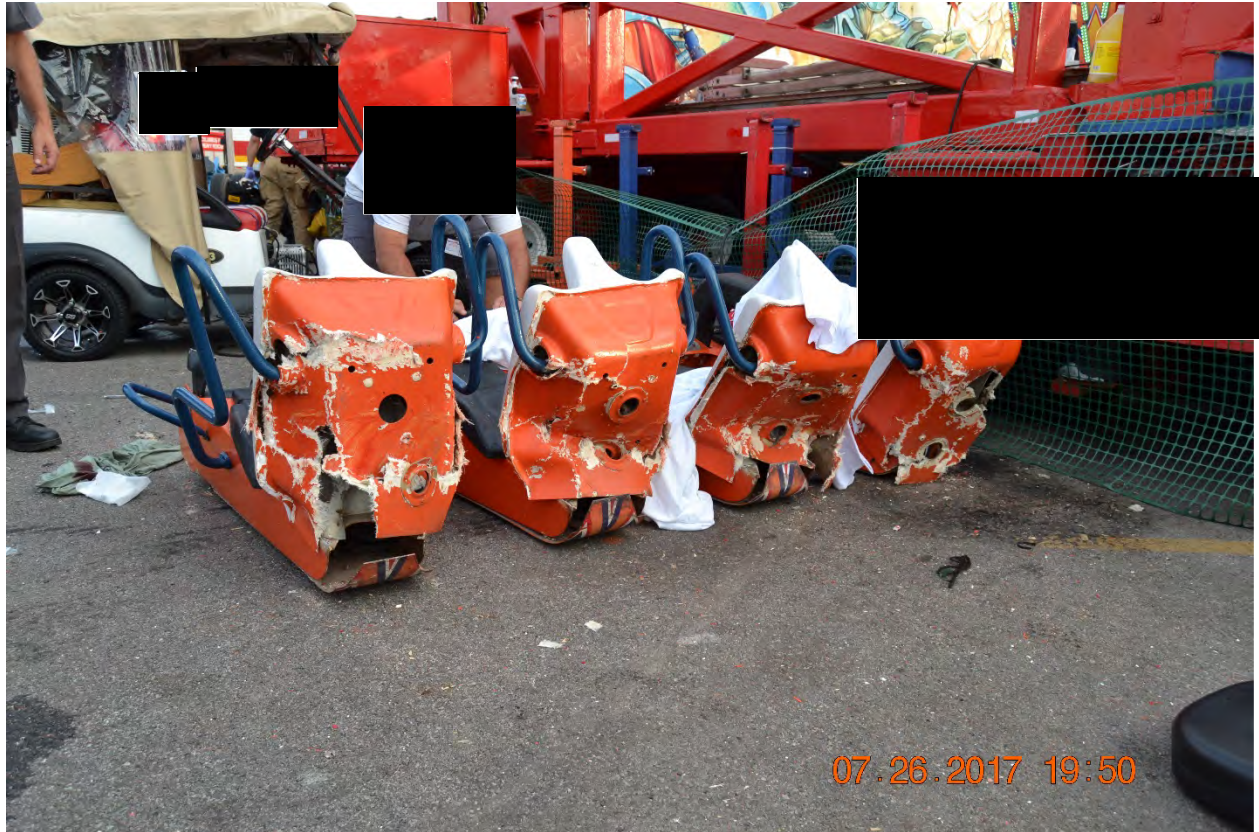
Photo #13 – Additional close up picture of the incident ride. Photo identifies the gondola that separated from the ride. Photograph taken by the [REDACTED] State Highway Patrol on July 26, 2017 after the incident.

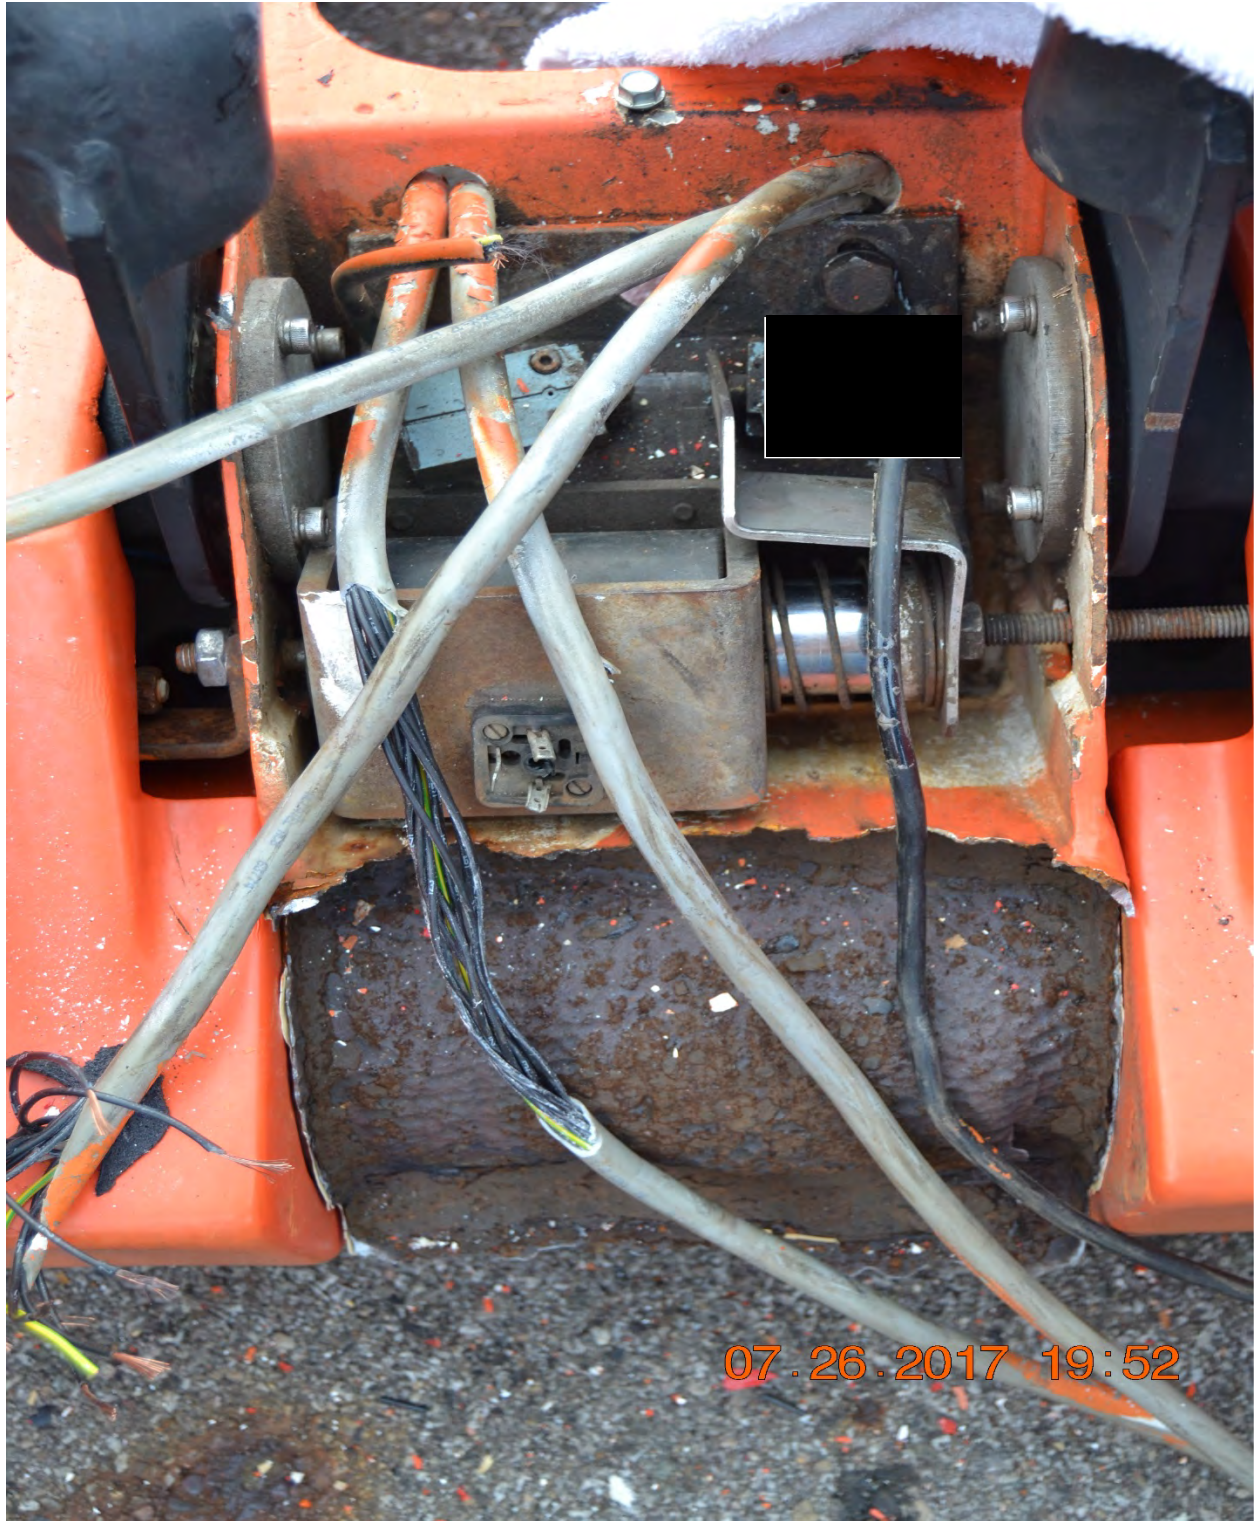
Photo #14 – Additional close up picture of the incident ride. Photo identifies the inside of the arm on the gondola that separated from the ride. Photograph taken by the [REDACTED] State Highway Patrol on July 26, 2017 after the incident.

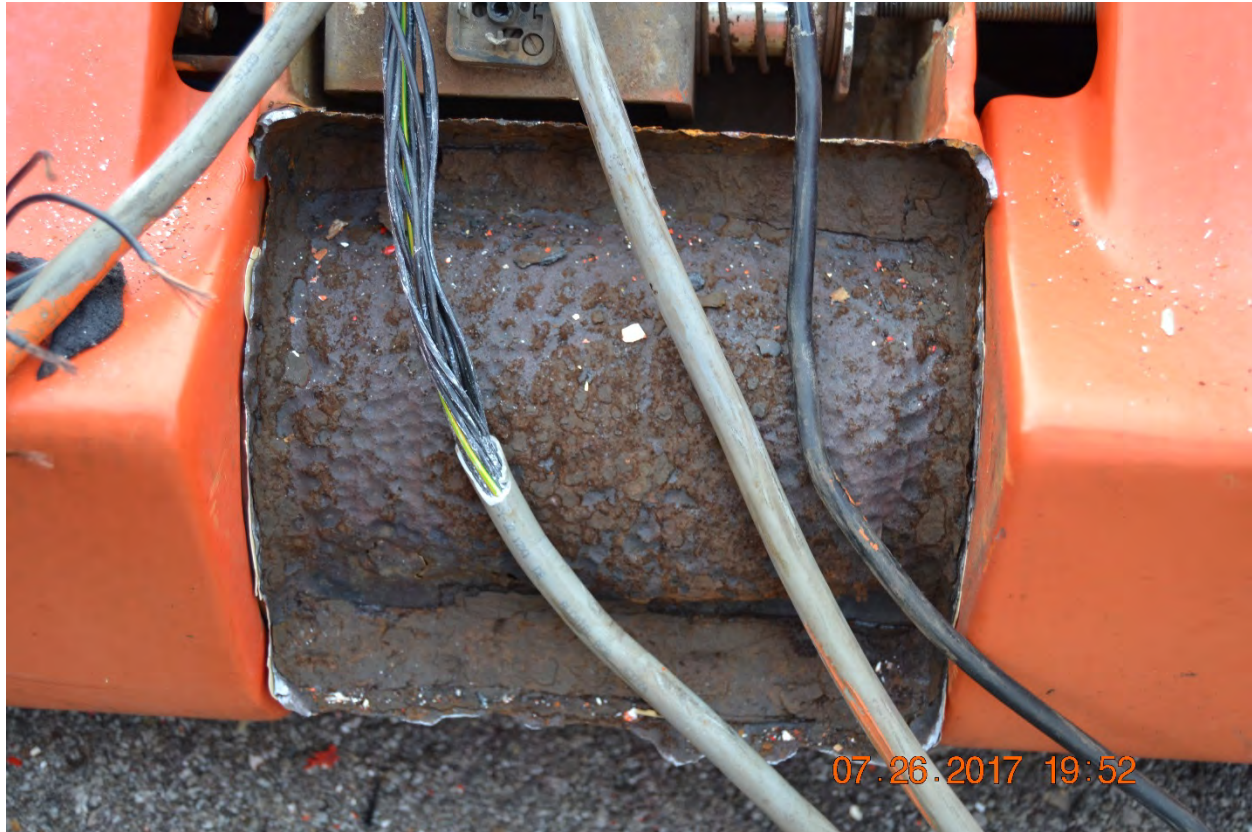
Photo #15 – Additional close up picture of the incident ride. Photo identifies the inside of the arm on the gondola that separated from the ride. Photograph taken by the [REDACTED] State Highway Patrol on July 26, 2017 after the incident.

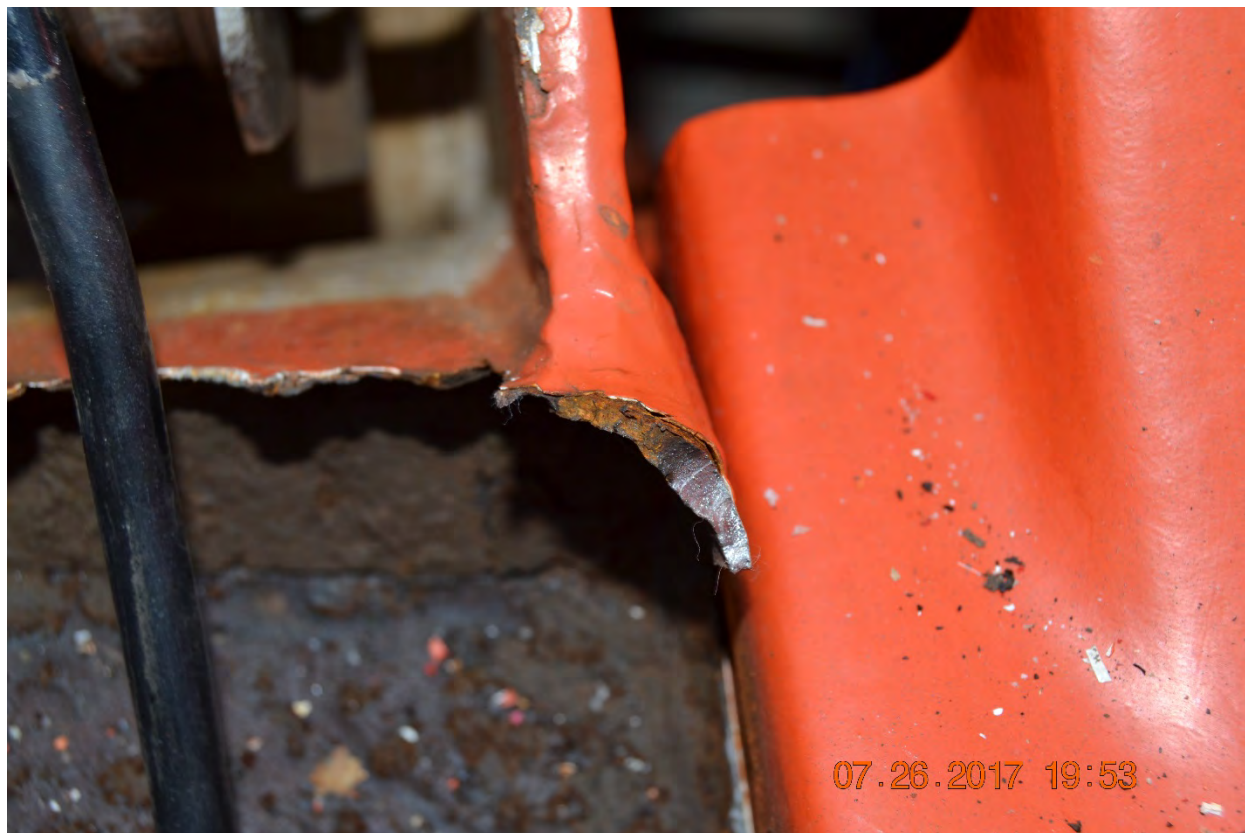
Photo #16 – Additional close up picture of the incident ride. Photo identifies the inside of the arm on the gondola that separated from the ride. Photograph taken by the [REDACTED] State Highway Patrol on July 26, 2017 after the incident.

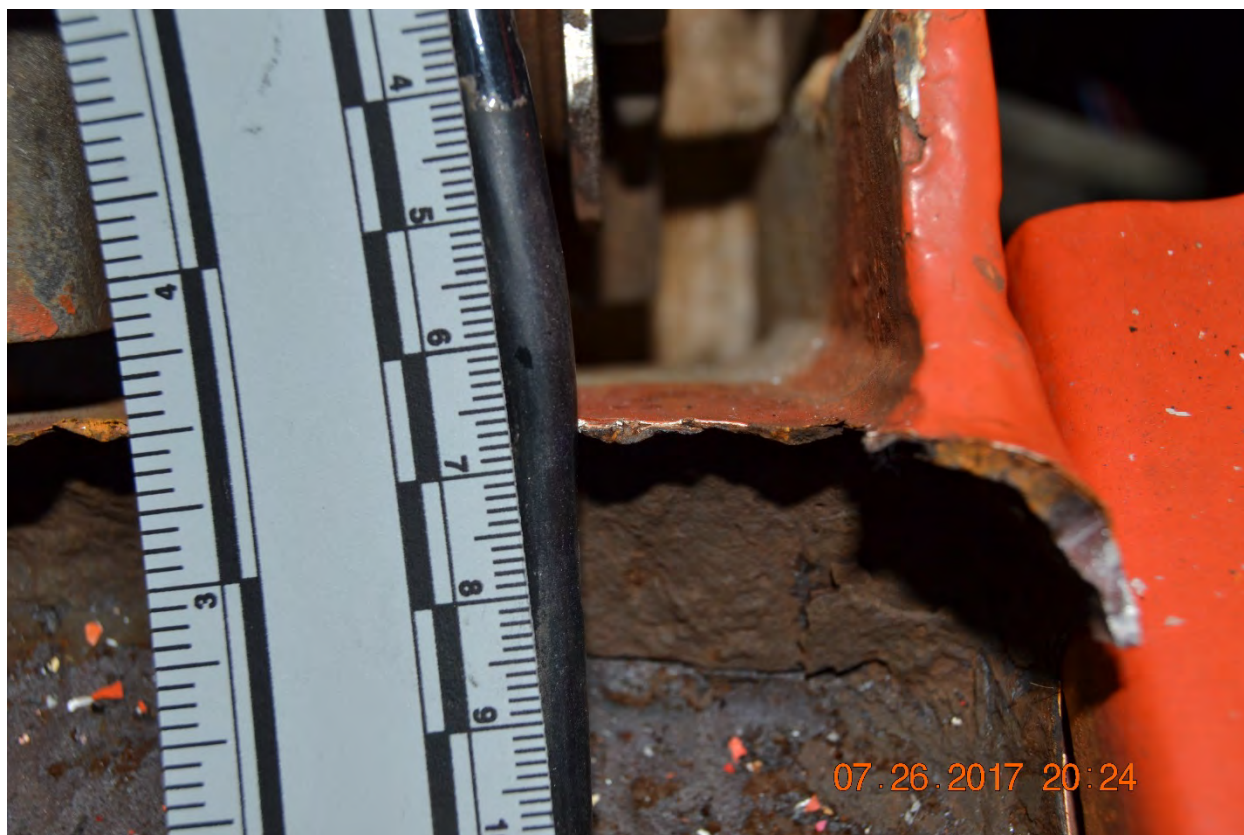
Photo #19 – Additional close up picture of the incident ride. Photo identifies the wall of metal around the arm of the broken gondola. Photograph taken by the [REDACTED] State Highway Patrol on July 26, 2017 after the incident.

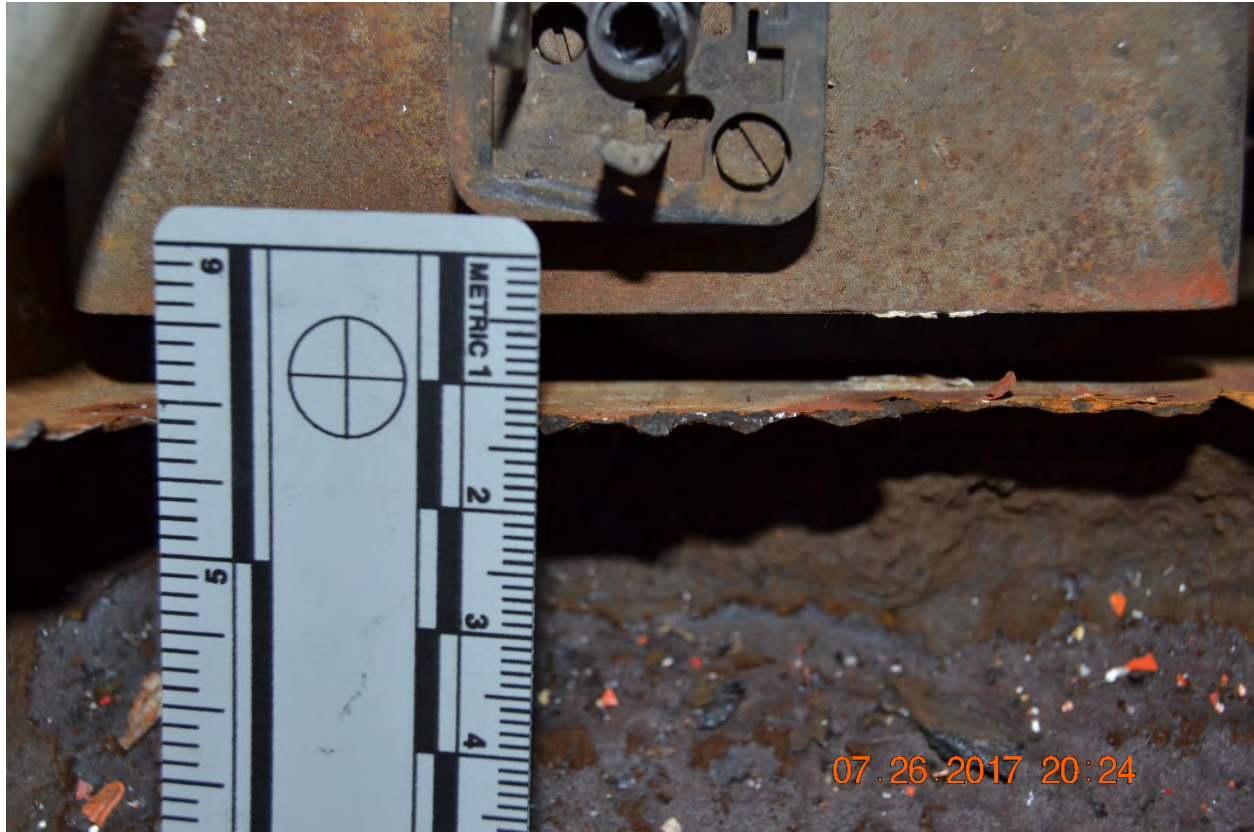
Photo #20 – Additional close up picture of the incident ride. Photo identifies the wall of metal around the arm of the broken gondola. Photograph taken by the [REDACTED] State Highway Patrol on July 26, 2017 after the incident.

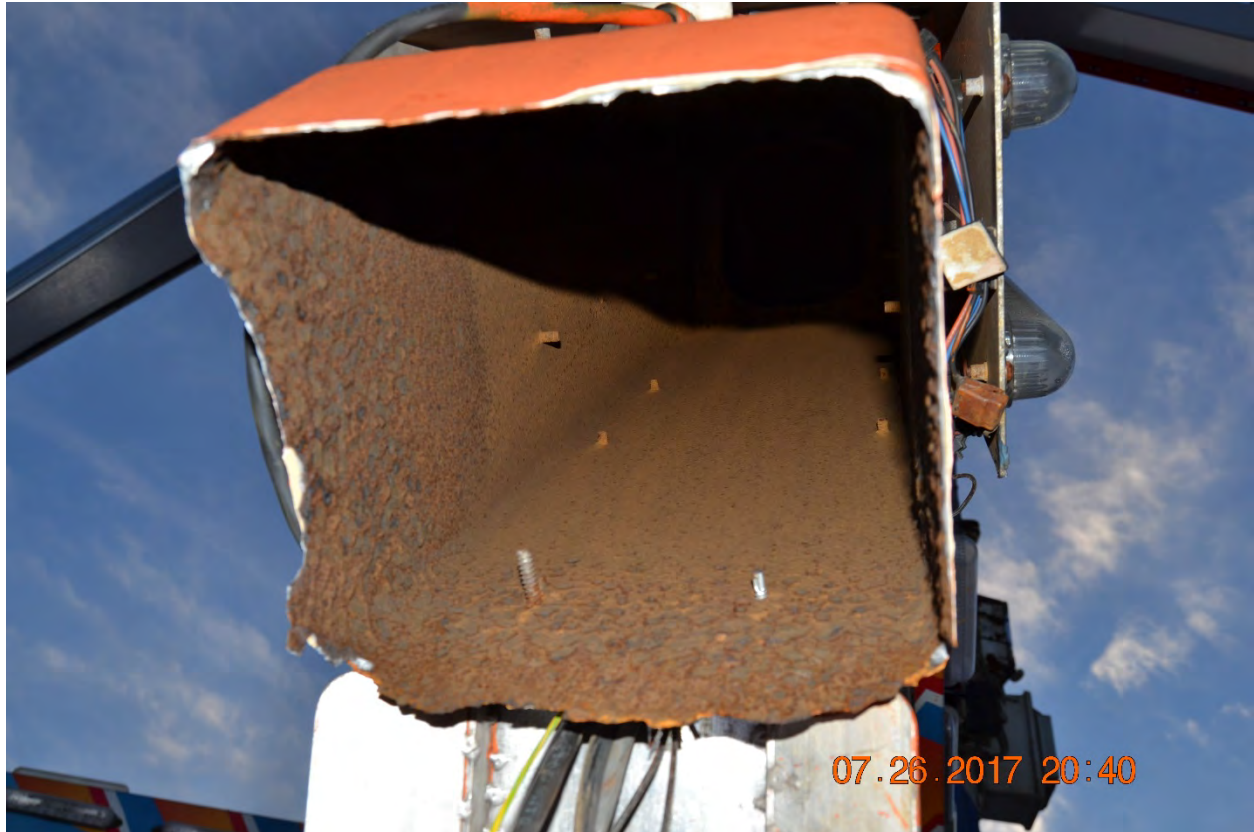
Photo #21 – Additional close up picture of the incident ride. Photo identifies the inside of the wall of metal around the arm of the broken gondola. Photograph taken by the [REDACTED] State Highway Patrol on July 26, 2017 after the incident.

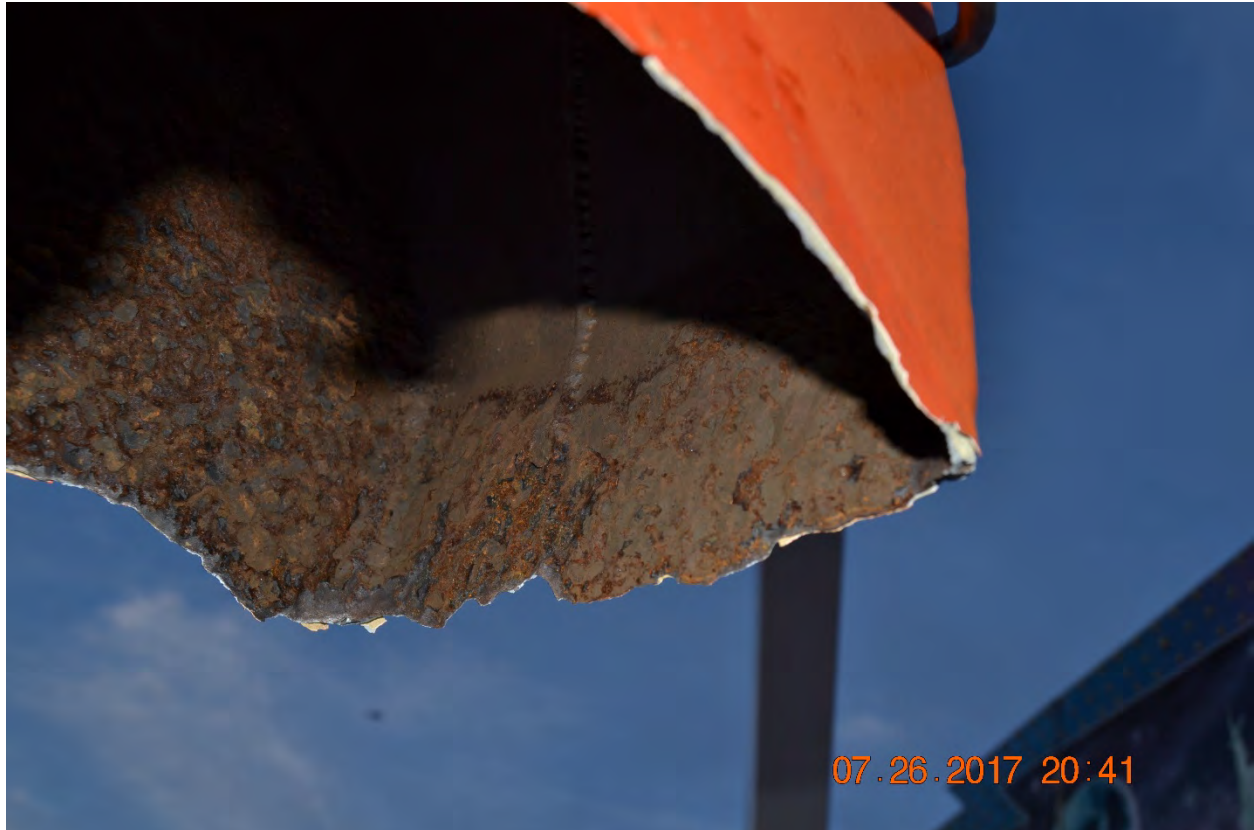
Photo #22 – Additional close up picture of the incident ride. Photo identifies the inside of the wall of metal around the arm of the broken gondola. Photograph taken by the [REDACTED] State Highway Patrol on July 26, 2017 after the incident.

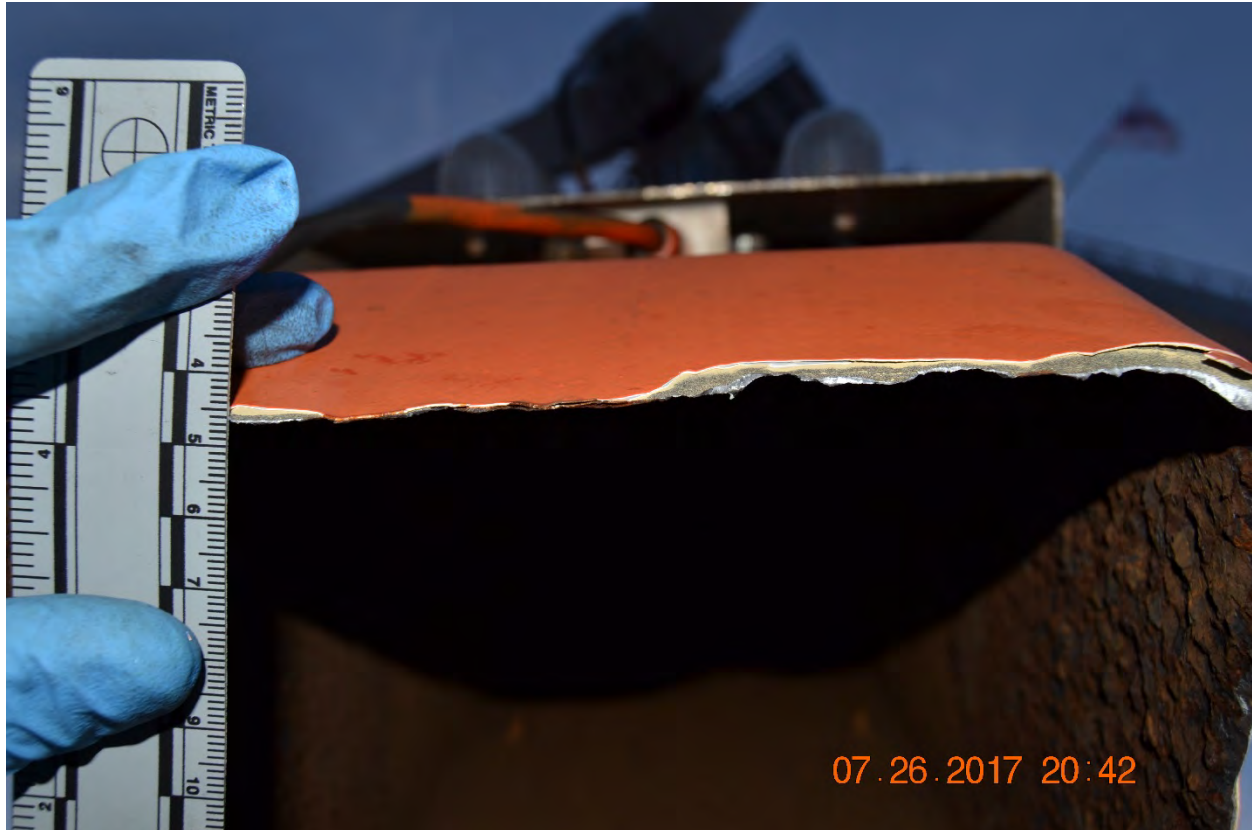
Photo #23 – Additional close up picture of the incident ride. Photo identifies the inside of the wall of metal around the arm of the broken gondola. Photograph taken by the [REDACTED] State Highway Patrol on July 26, 2017 after the incident.
