U.S. CONSUMER PRODUCT SAFETY COMMISSION  
5 RESEARCH PLACE  
ROCKVILLE, MD 20850

**Re:** Ohio State Fair Fatal Ride Incident

1. Task Number 170727CFE0001		2. Investigator's ID 10837		<b>EPIDEMIOLOGIC INVESTIGATION REPORT</b>
3. Office Code 800	4. Date of Accident YR MO DAY 2017 07 26	5. Date Initiated YR MO DAY 2017 07 27

6. Synopsis of Accident or Complaint UPC The 18 year old victim was riding a high G-force pendulum swing amusement park ride when one of the 4 person gondolas suddenly detached from the main part of the ride, went airborne and finally landed on the ground approximately one foot from the base of the ride. The victim died at the scene and seven other riders were transported to the hospital.

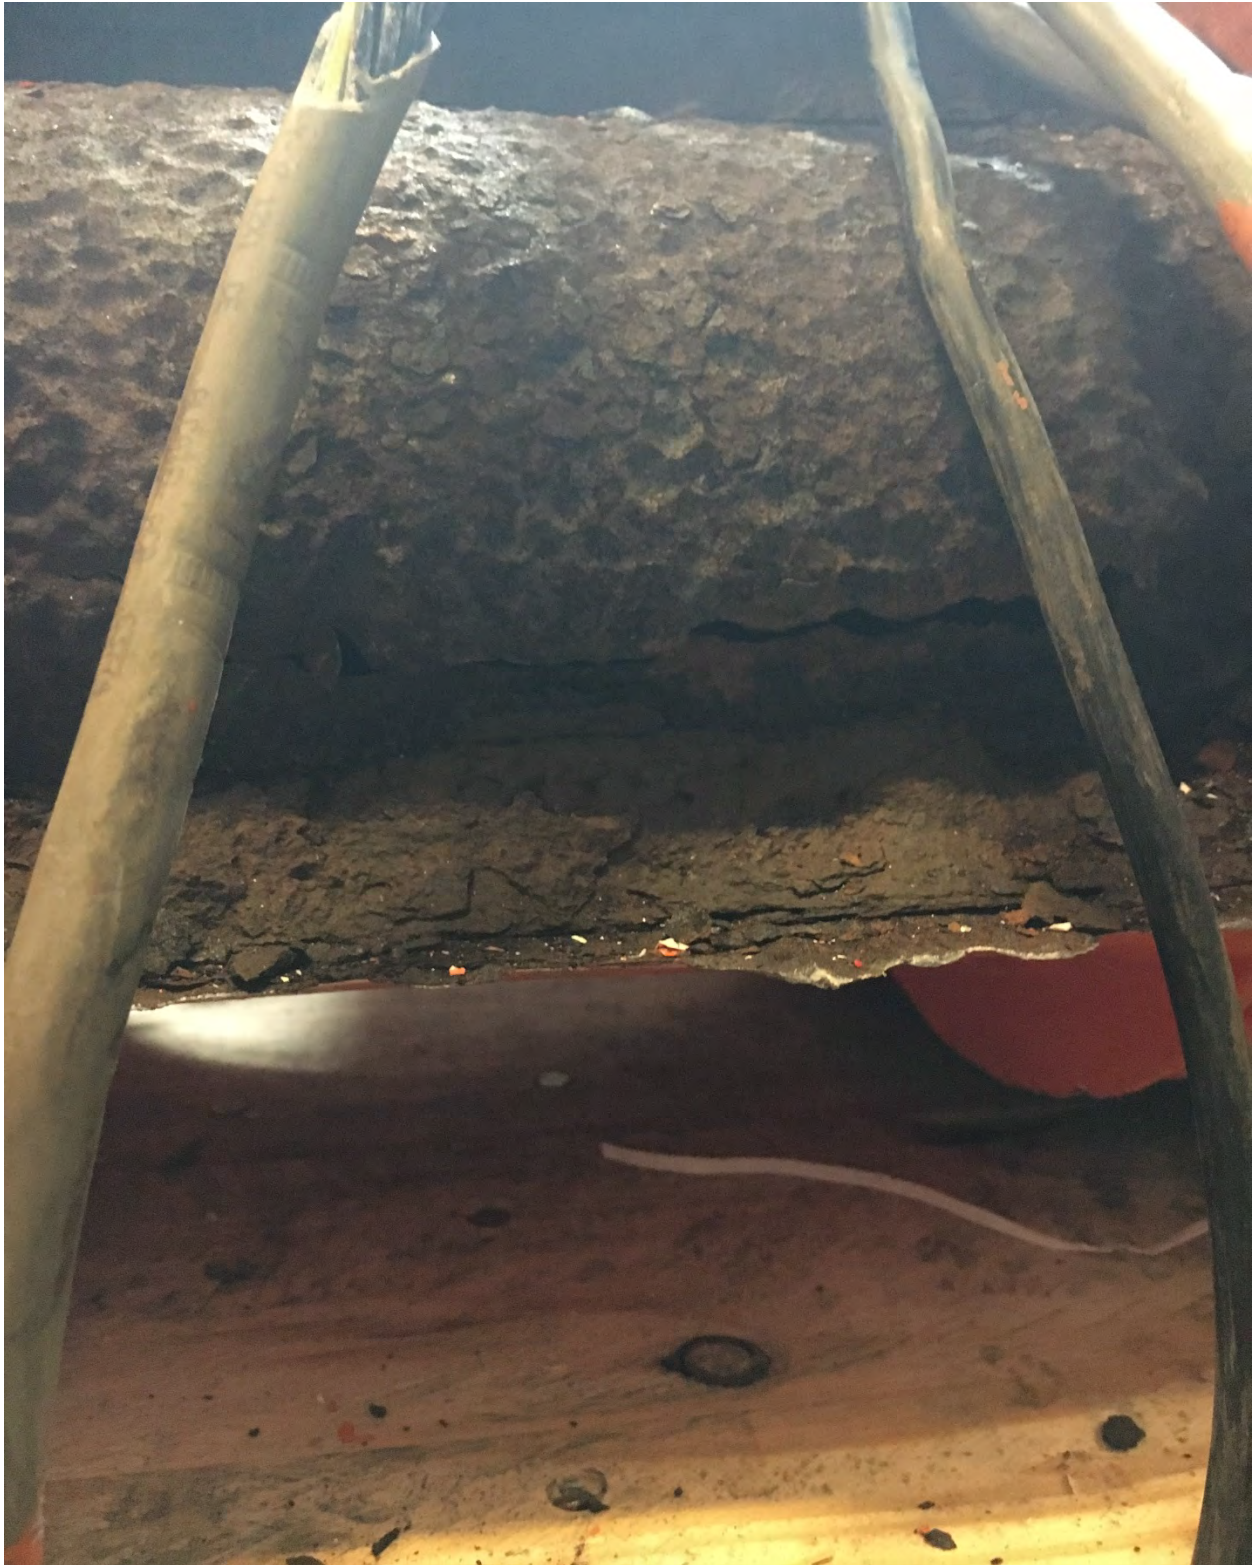
Photo #32 –Photo identifies inside of the gondola arm. Photograph taken by this investigator at the secure evidence facility on July 28, 2017.

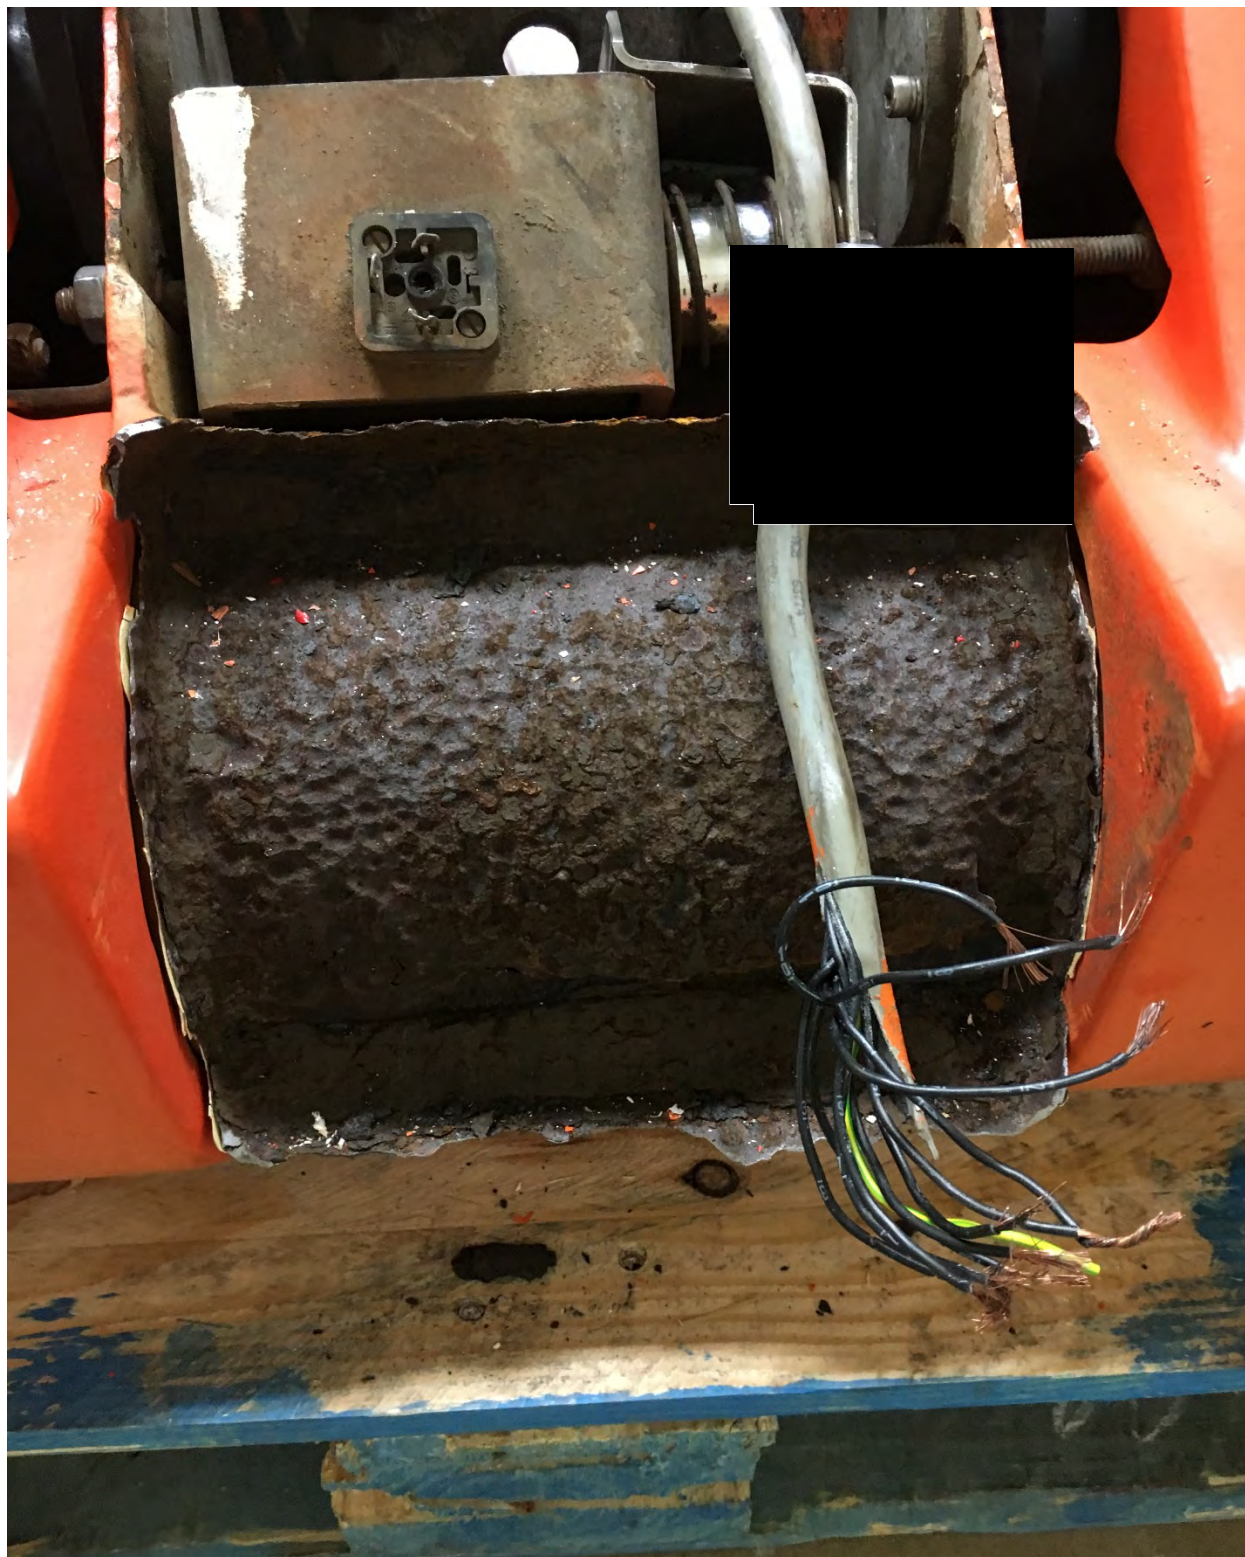
Photo #33 –Photo identifies inside of the gondola arm. Photograph taken by this investigator at the secure evidence facility on July 28, 2017.
