**Re:** Ohio State Fair Fatal Ride Incident

Attachment – IDI 170727CFE0001

Task Number: 170727CFE0001

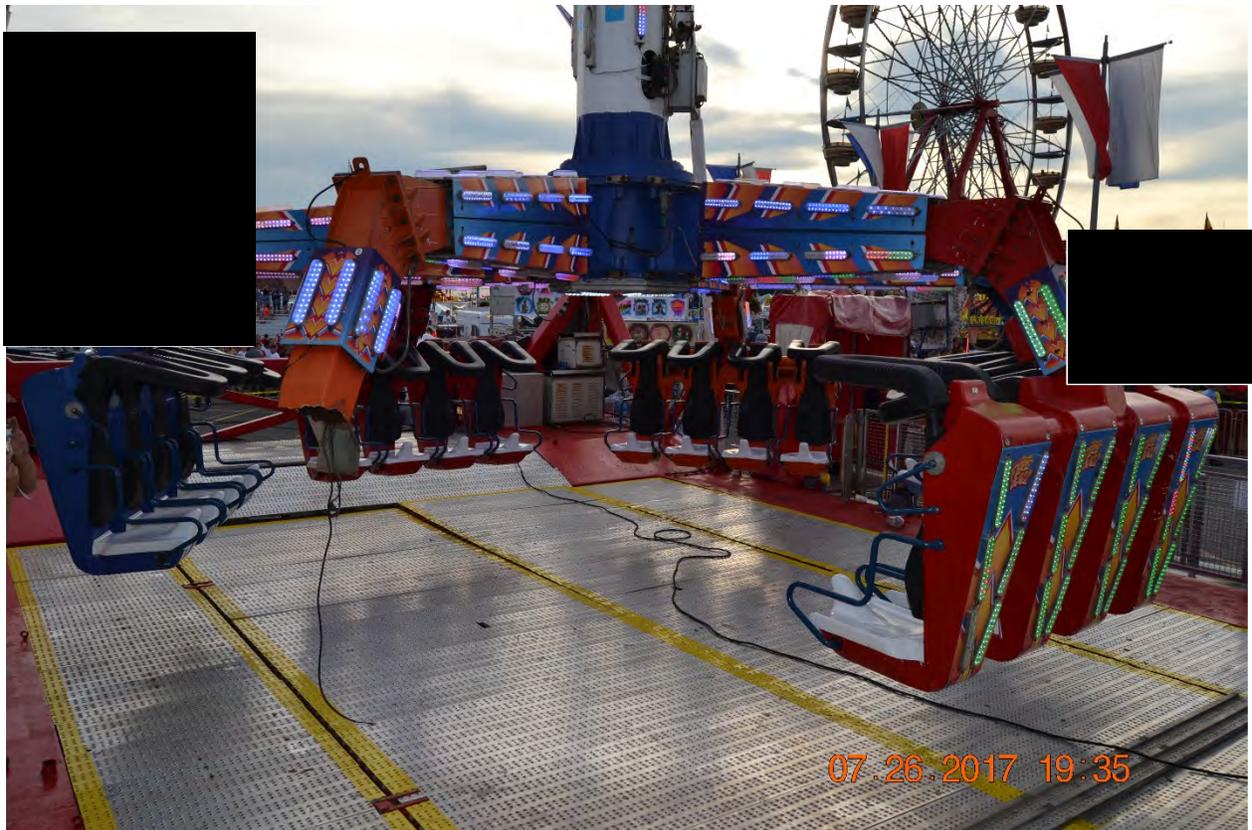
Photo #4 – Additional overall picture of the incident ride. Photo identifies broke arm and missing gondola. Photograph taken by the [REDACTED] State Highway Patrol on July 26, 2017 after the incident.

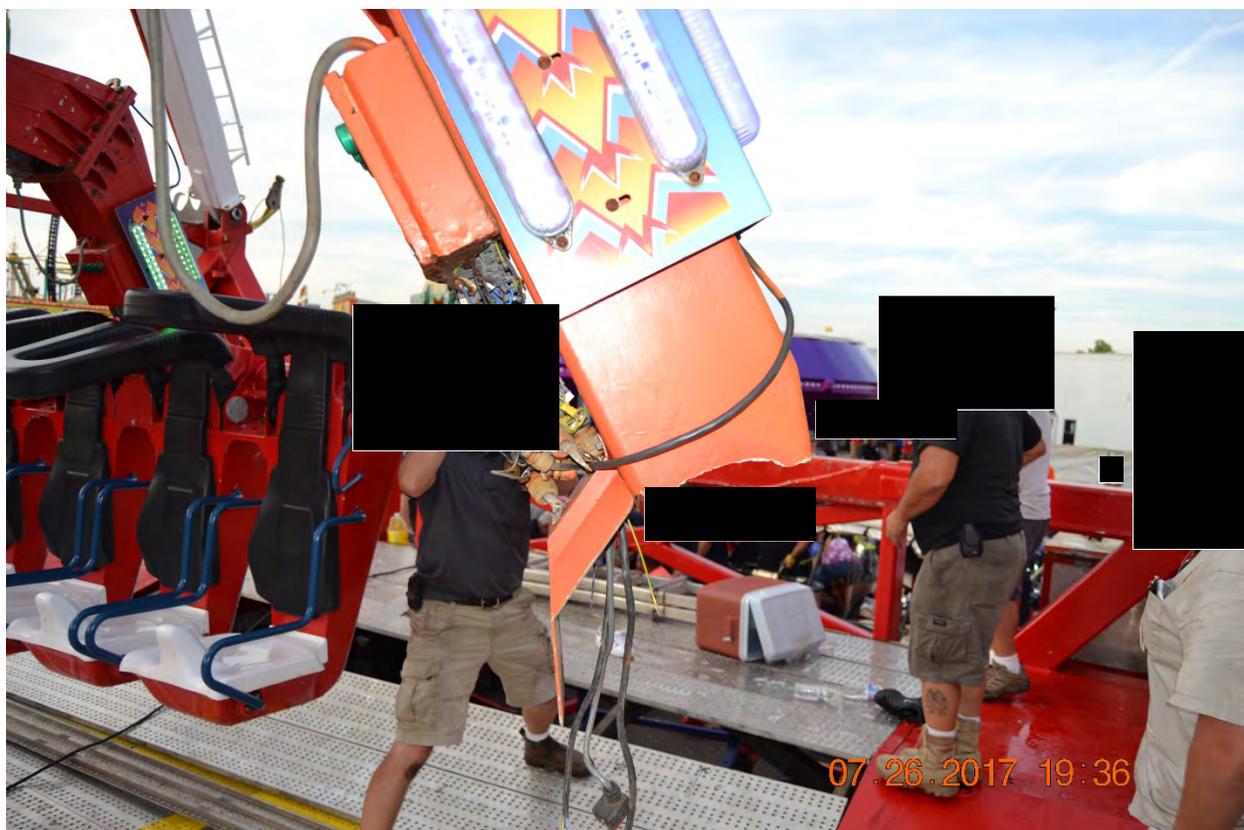
Photo #5 – Close up picture of the incident ride. Photo identifies broke arm and missing gondola. Photograph taken by the [redacted] State Highway Patrol on July 26, 2017 after the incident.

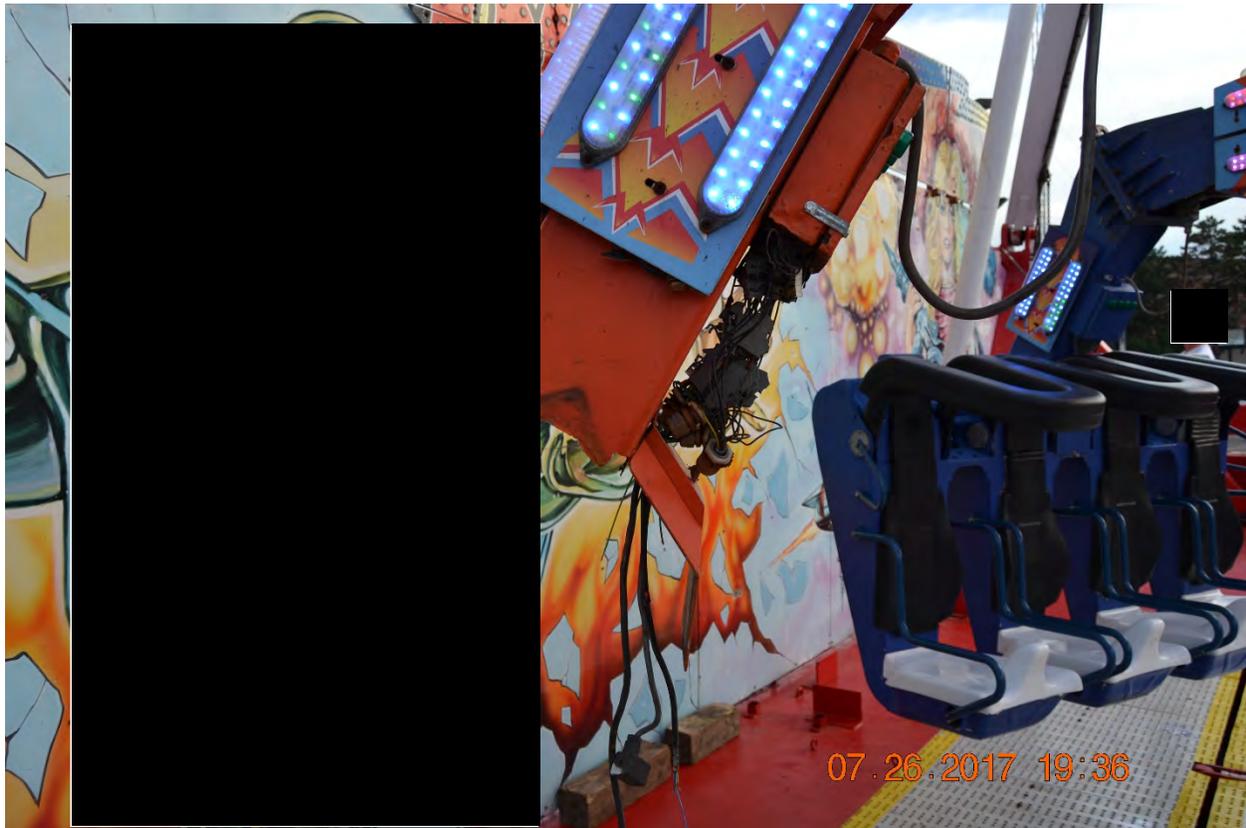
Photo #6 – Additional close up picture of the incident ride. Photo identifies broke arm and missing gondola. Photograph taken by the [REDACTED] State Highway Patrol on July 26, 2017 after the incident.

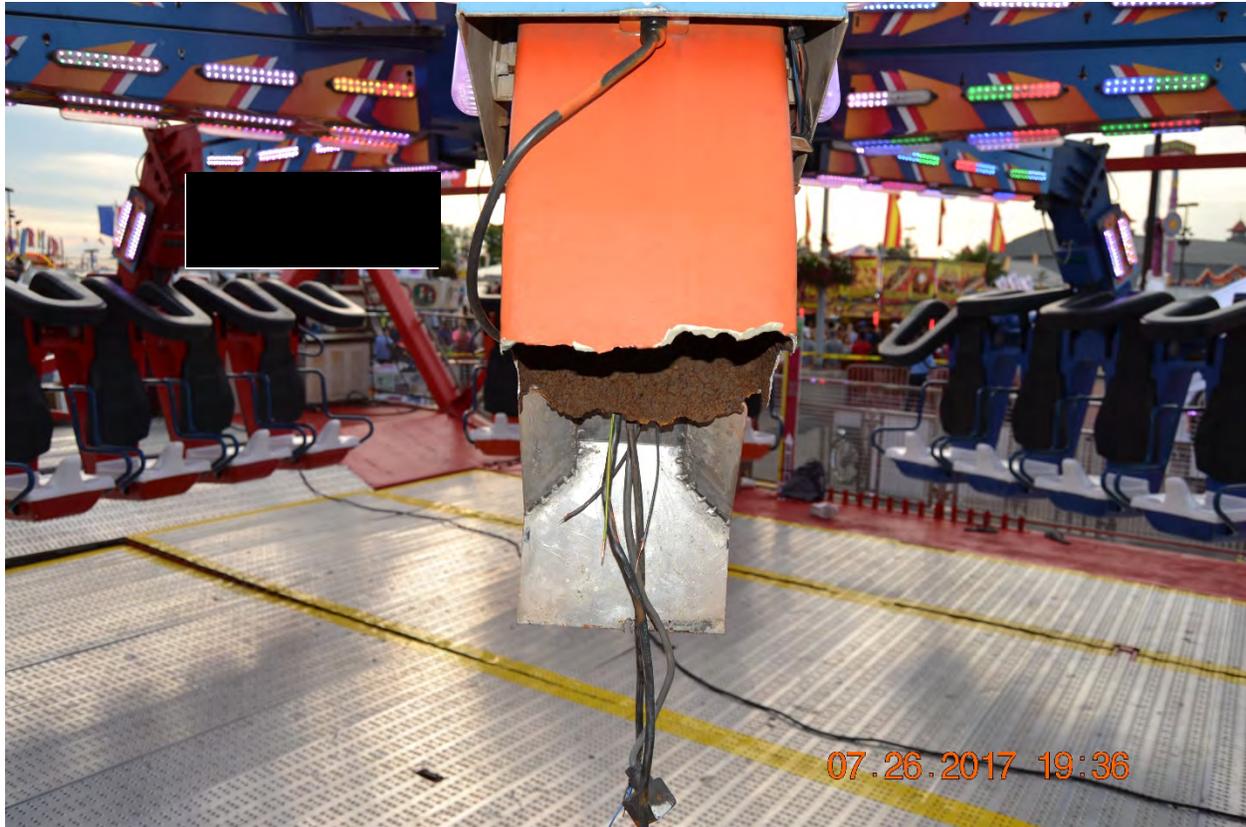
Photo #7 – Additional close up picture of the incident ride. Photo identifies broke arm and missing gondola. Photograph taken by the [REDACTED] State Highway Patrol on July 26, 2017 after the incident.

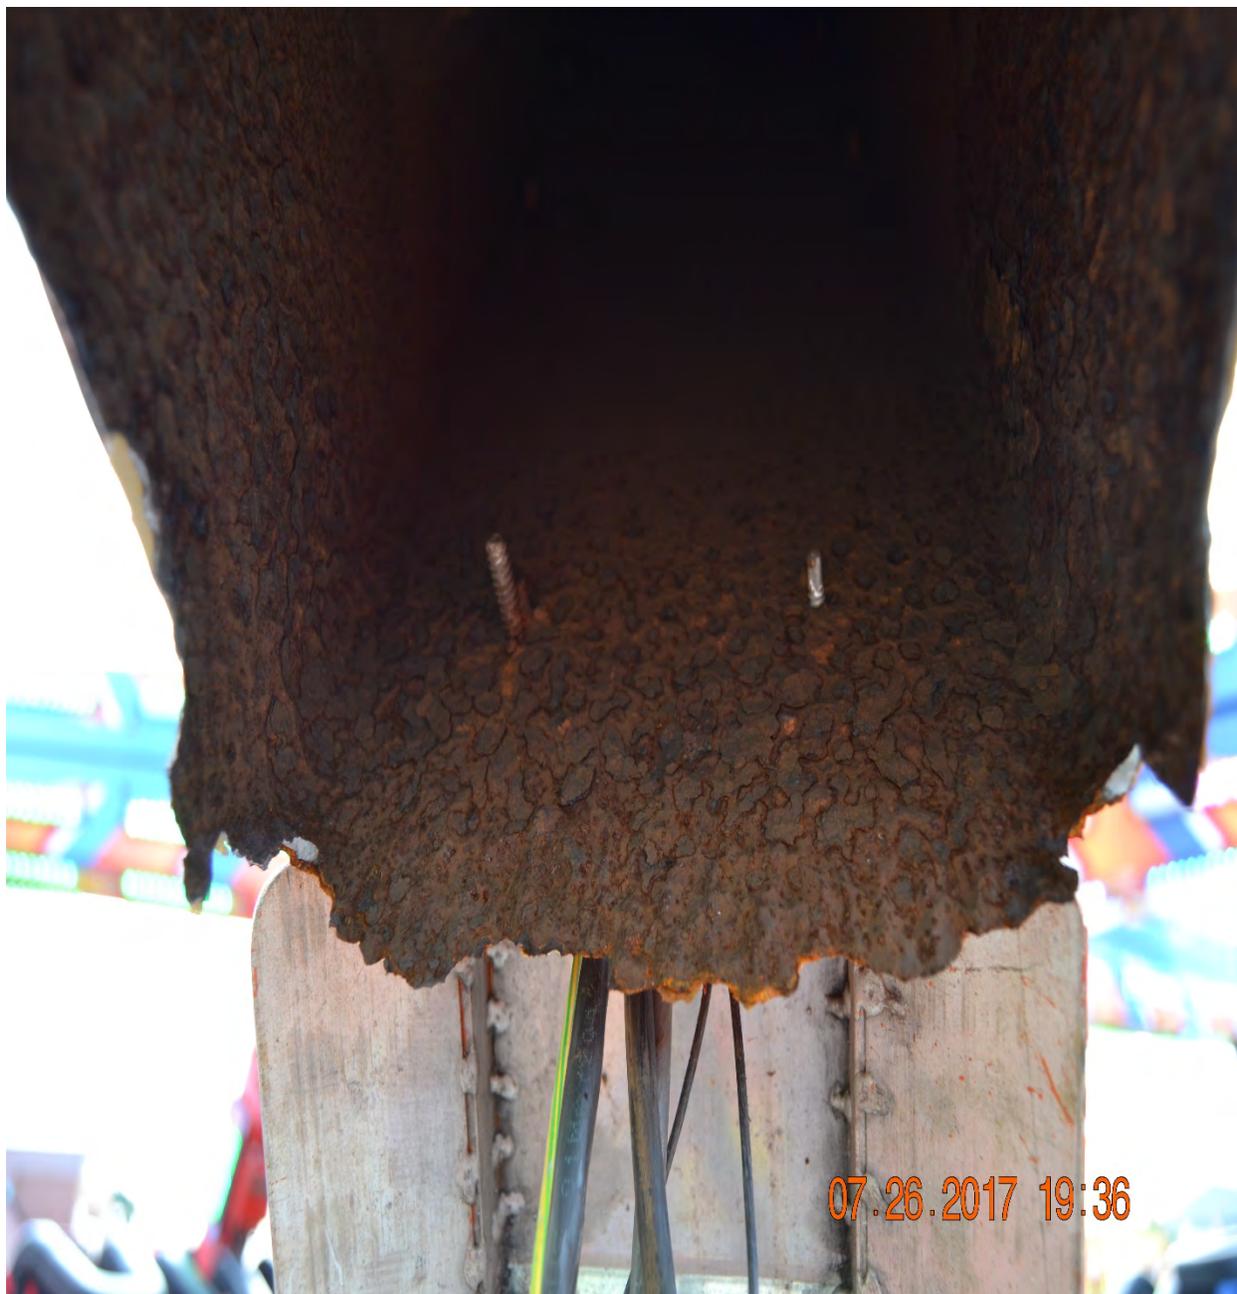
On July 28, 2017, this investigator and additional personnel from CPSC inspected the incident ride and the detached gondola. Rust was noted on the entire inside of the supporting sweep arm (Exhibit M, Photos 8, 21 & 23) that the gondola had detached from. All four sides of the break area connecting the supporting sweep arm and gondola appeared to be covered in rust. After inspection of the ride, CPSC staff went to a secure evidence facility where the detached gondola was being stored and inspected those components. We observed rust inside (Exhibit M, Photo 14) and around all four break sides (Exhibit M, Photos 16 & 19) of the gondola where it was detached from the supporting sweep arm. This inspection of the incident ride and detached gondola on July 28, 2017 was non-destructive and completed utilizing photography and visual observation.

Photo #8 – Additional close up picture of the incident ride. Photo identifies the inside of the broken arm. Photograph taken by the [REDACTED] State Highway Patrol on July 26, 2017 after the incident.

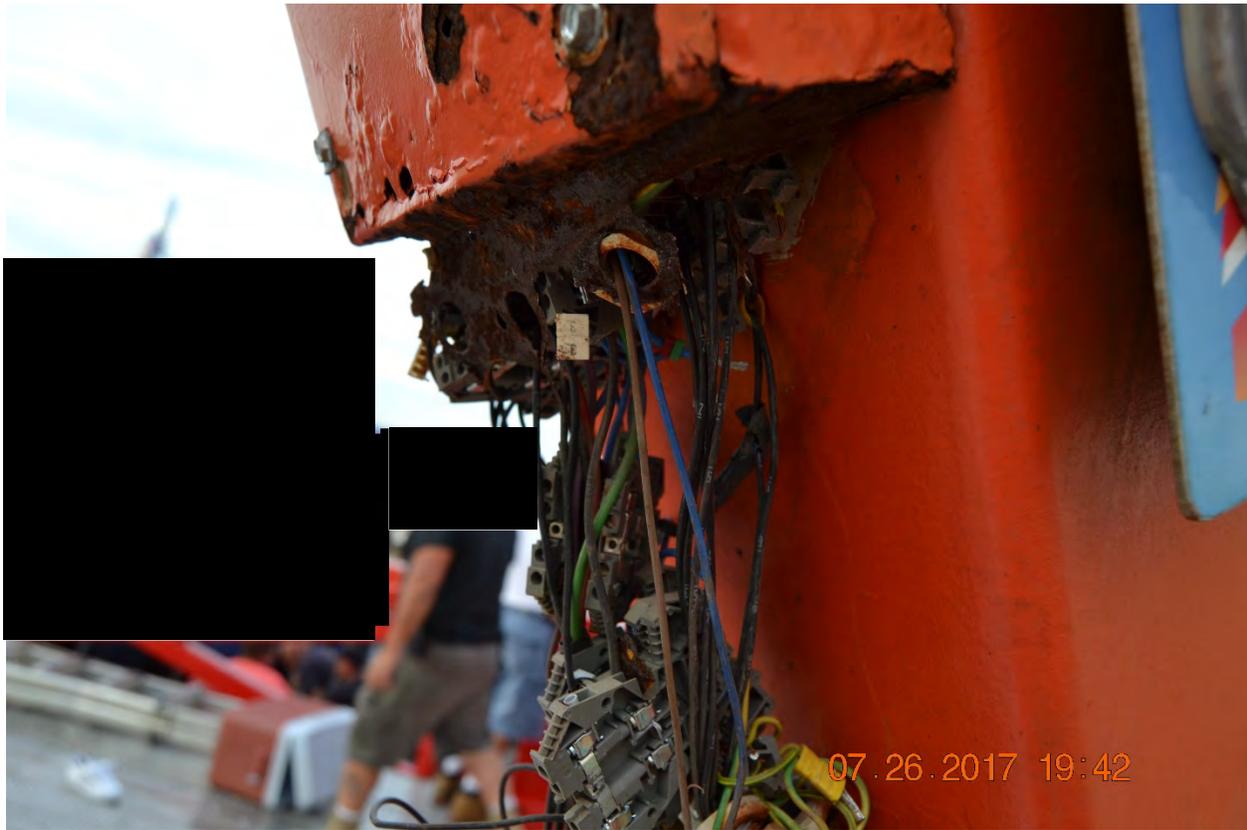
Photo #9 – Additional close up picture of the incident ride. Photo identifies the wires hanging off the broken arm. Photograph taken by the [REDACTED] State Highway Patrol on July 26, 2017 after the incident.

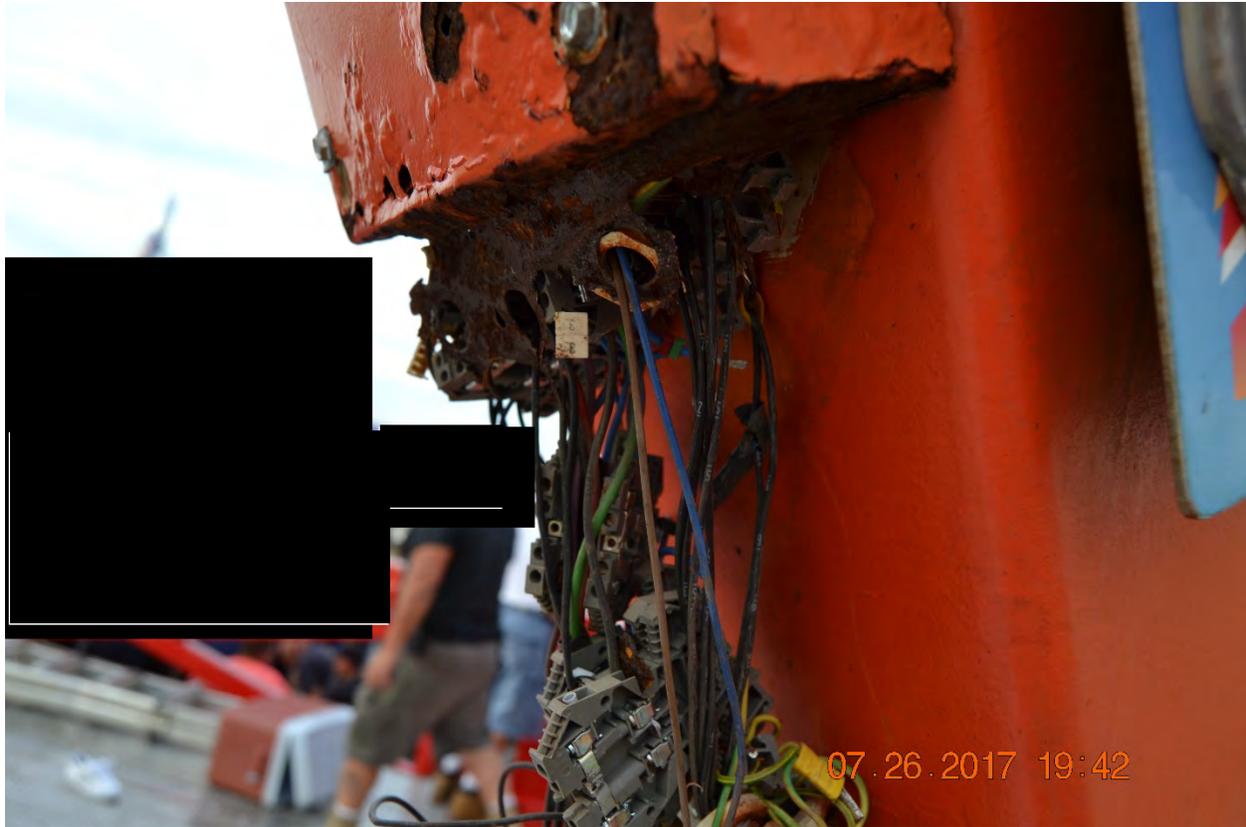
Photo #10 – Additional close up picture of the incident ride. Photo identifies the wires hanging off the broken arm. Photograph taken by the [REDACTED] State Highway Patrol on July 26, 2017 after the incident.

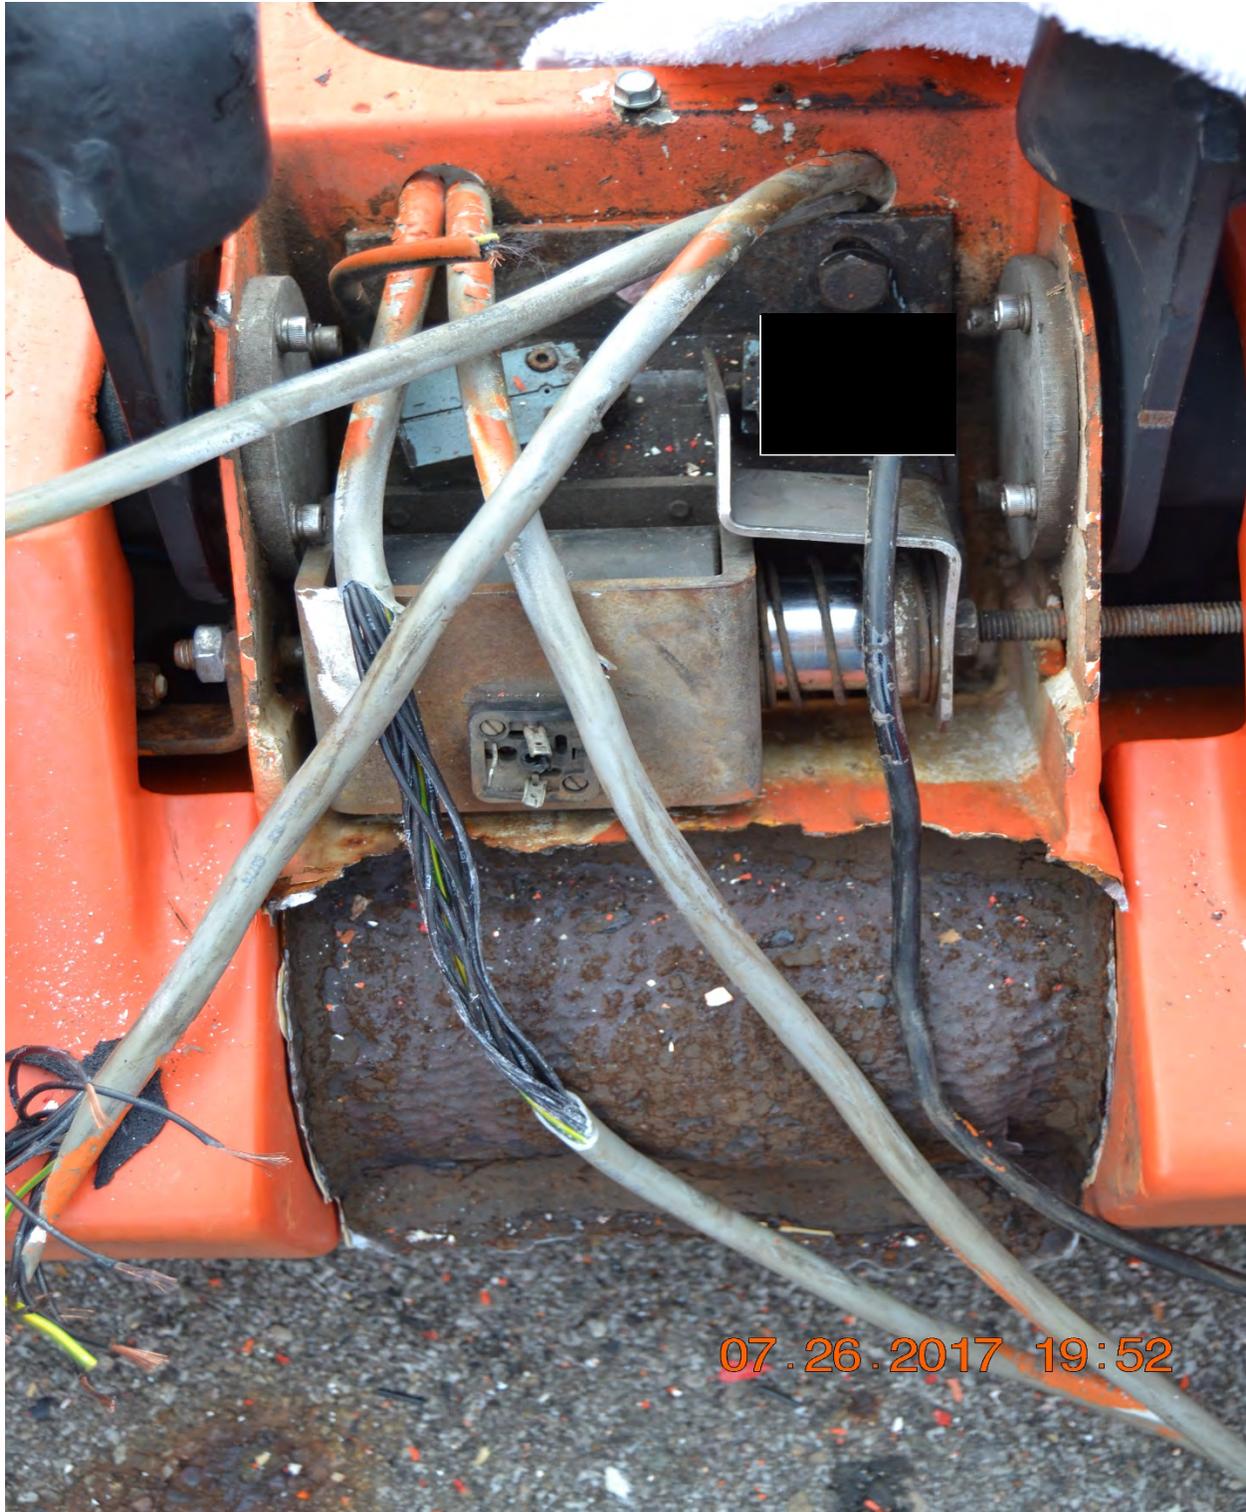
Photo #14 – Additional close up picture of the incident ride. Photo identifies the inside of the arm on the gondola that separated from the ride. Photograph taken by the [REDACTED] State Highway Patrol on July 26, 2017 after the incident.

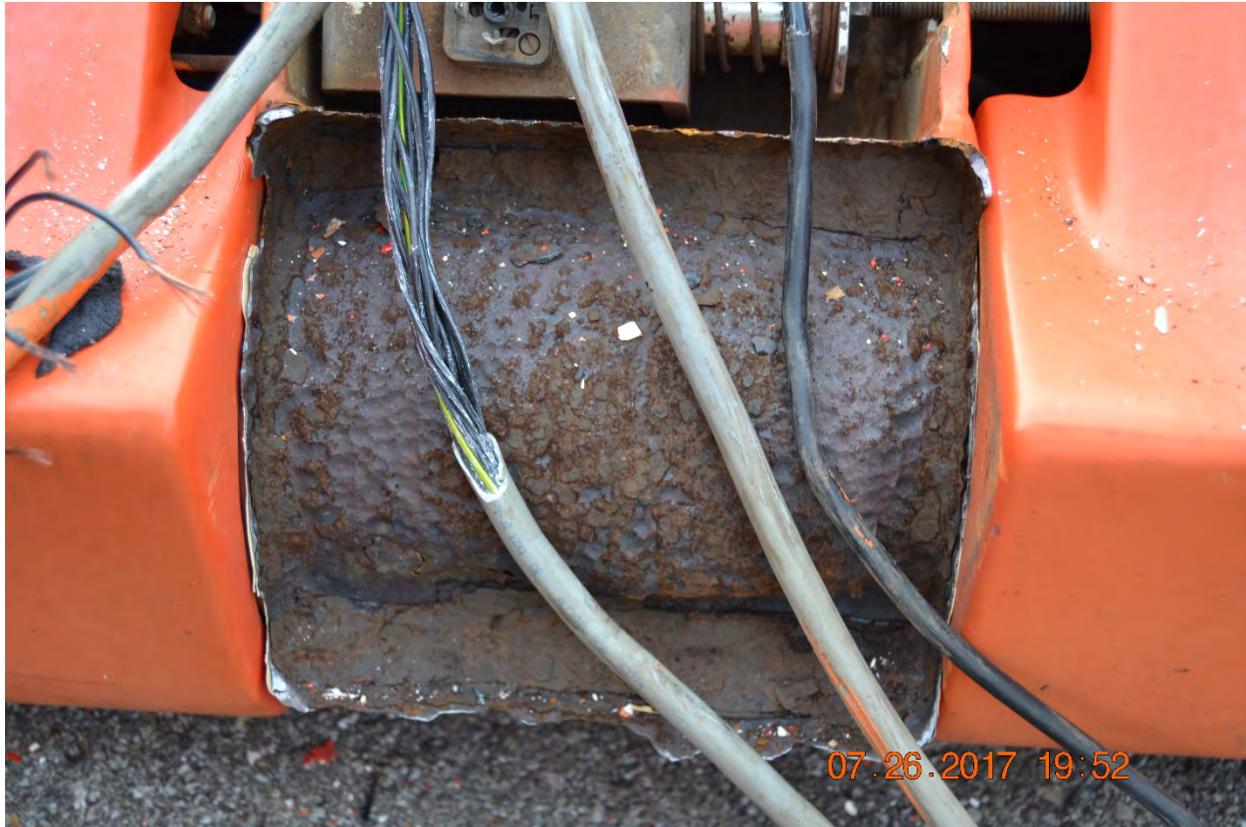
Photo #15 – Additional close up picture of the incident ride. Photo identifies the inside of the arm on the gondola that separated from the ride. Photograph taken by the [REDACTED] State Highway Patrol on July 26, 2017 after the incident.

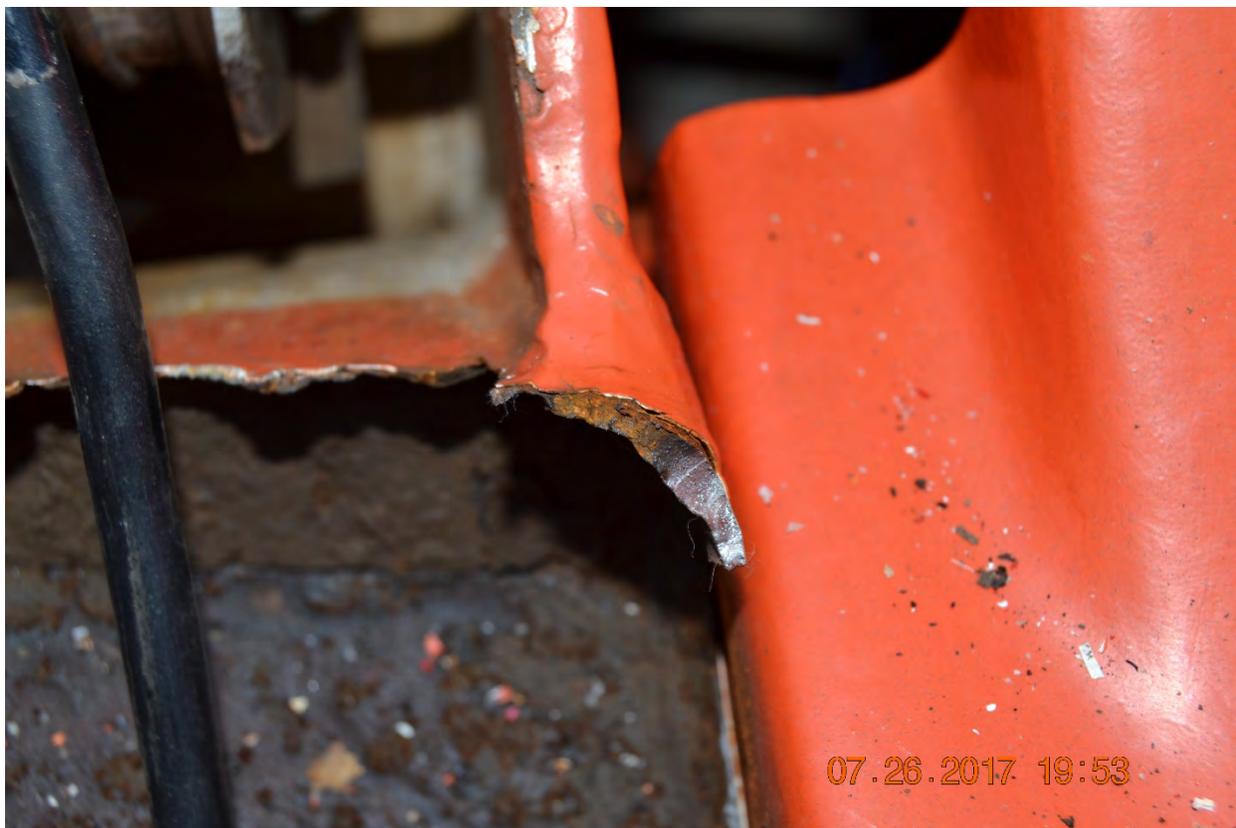
Photo #16 – Additional close up picture of the incident ride. Photo identifies the inside of the arm on the gondola that separated from the ride. Photograph taken by the [REDACTED] State Highway Patrol on July 26, 2017 after the incident.

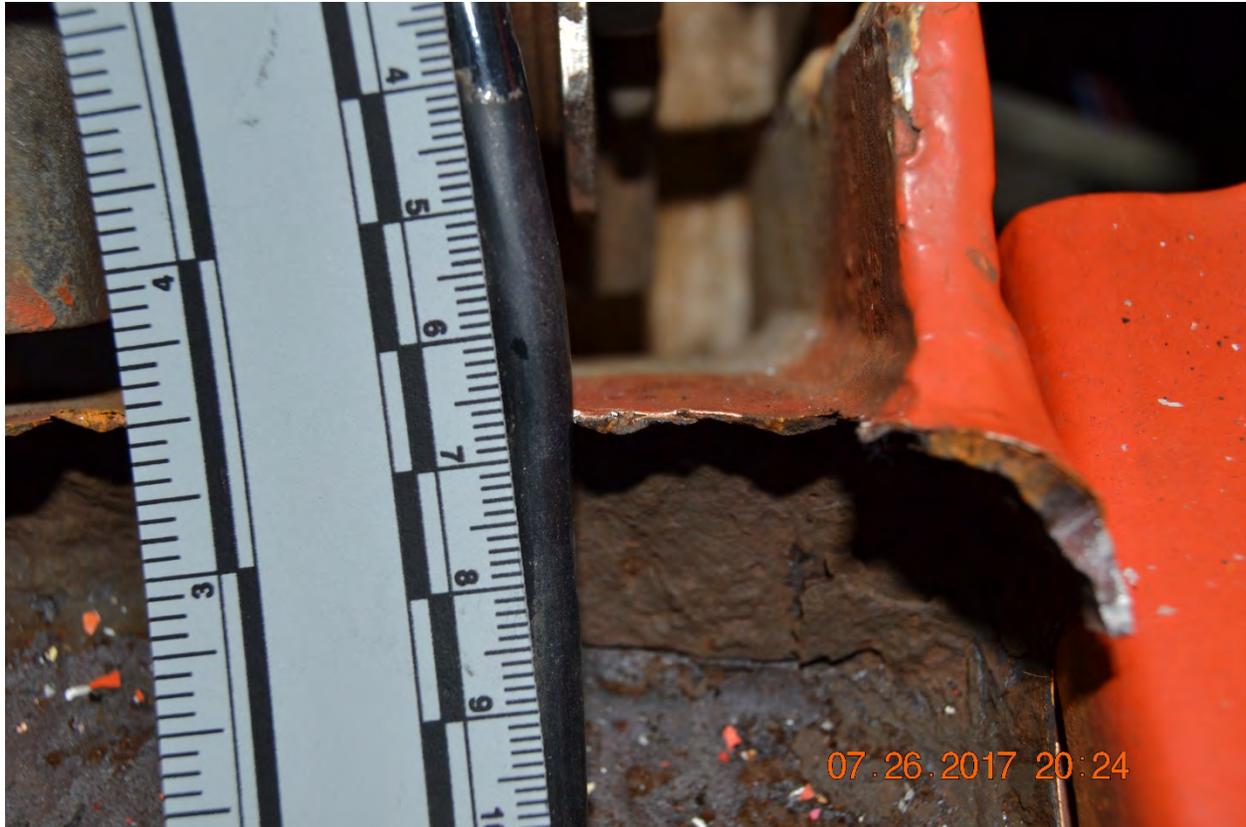
Photo #19 – Additional close up picture of the incident ride. Photo identifies the wall of metal around the arm of the broken gondola. Photograph taken by the [REDACTED] State Highway Patrol on July 26, 2017 after the incident.

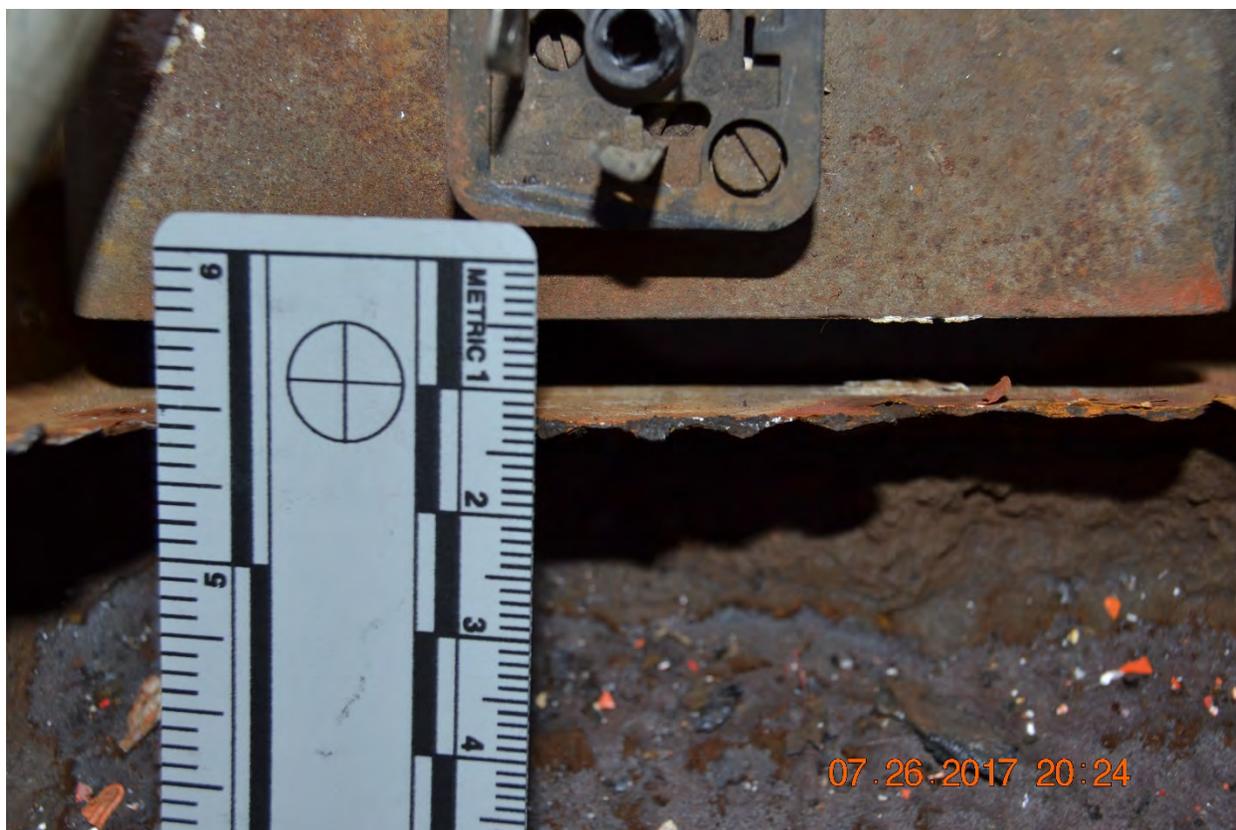
Photo #20 – Additional close up picture of the incident ride. Photo identifies the wall of metal around the arm of the broken gondola. Photograph taken by the [REDACTED] State Highway Patrol on July 26, 2017 after the incident.

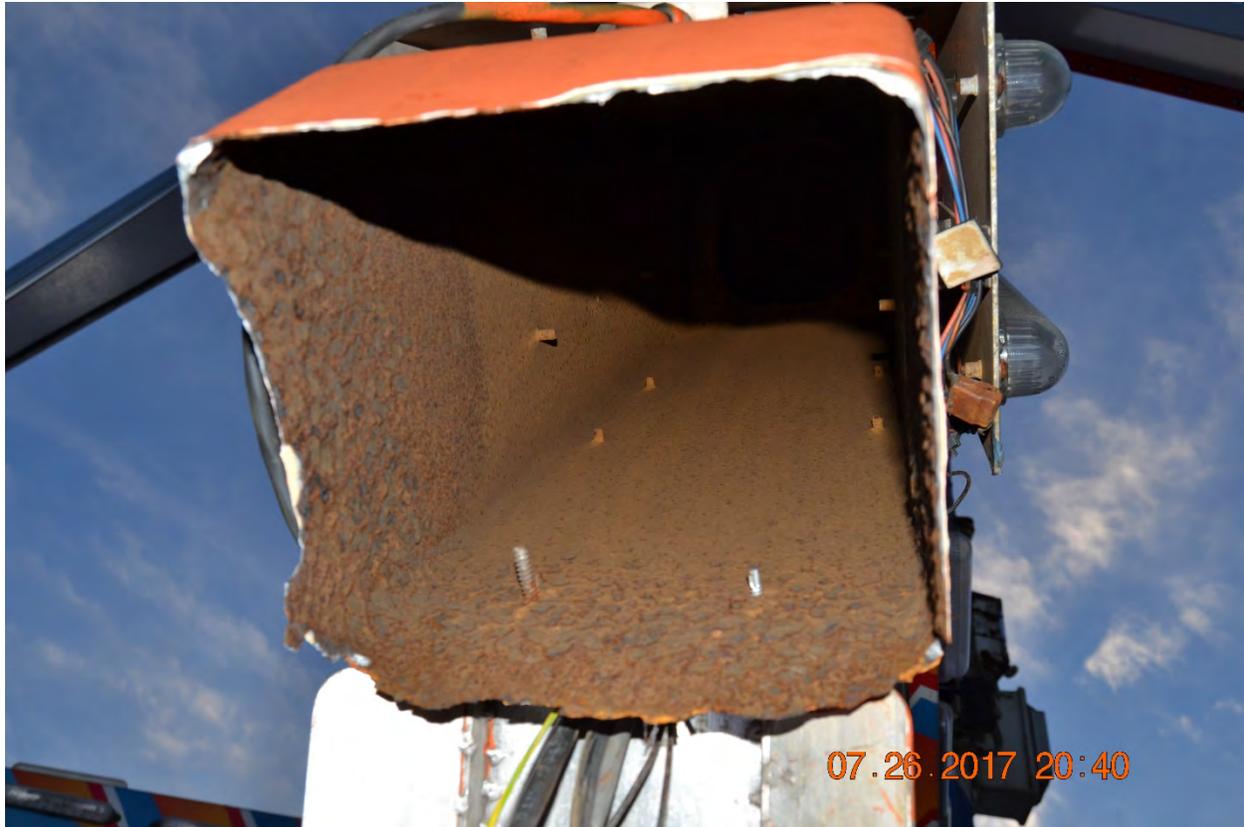
Photo #21 – Additional close up picture of the incident ride. Photo identifies the inside of the wall of metal around the arm of the broken gondola. Photograph taken by the [REDACTED] State Highway Patrol on July 26, 2017 after the incident.

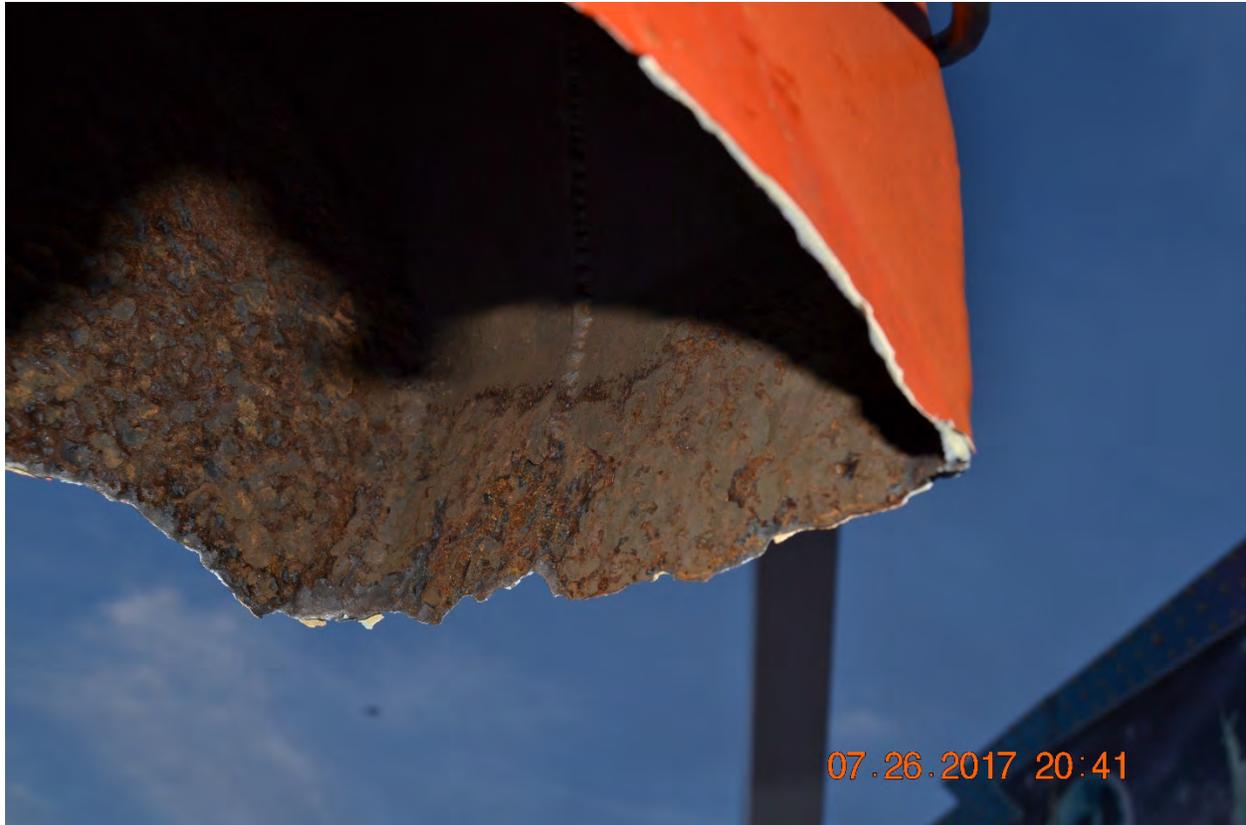
Photo #22 – Additional close up picture of the incident ride. Photo identifies the inside of the wall of metal around the arm of the broken gondola. Photograph taken by the [REDACTED] State Highway Patrol on July 26, 2017 after the incident.

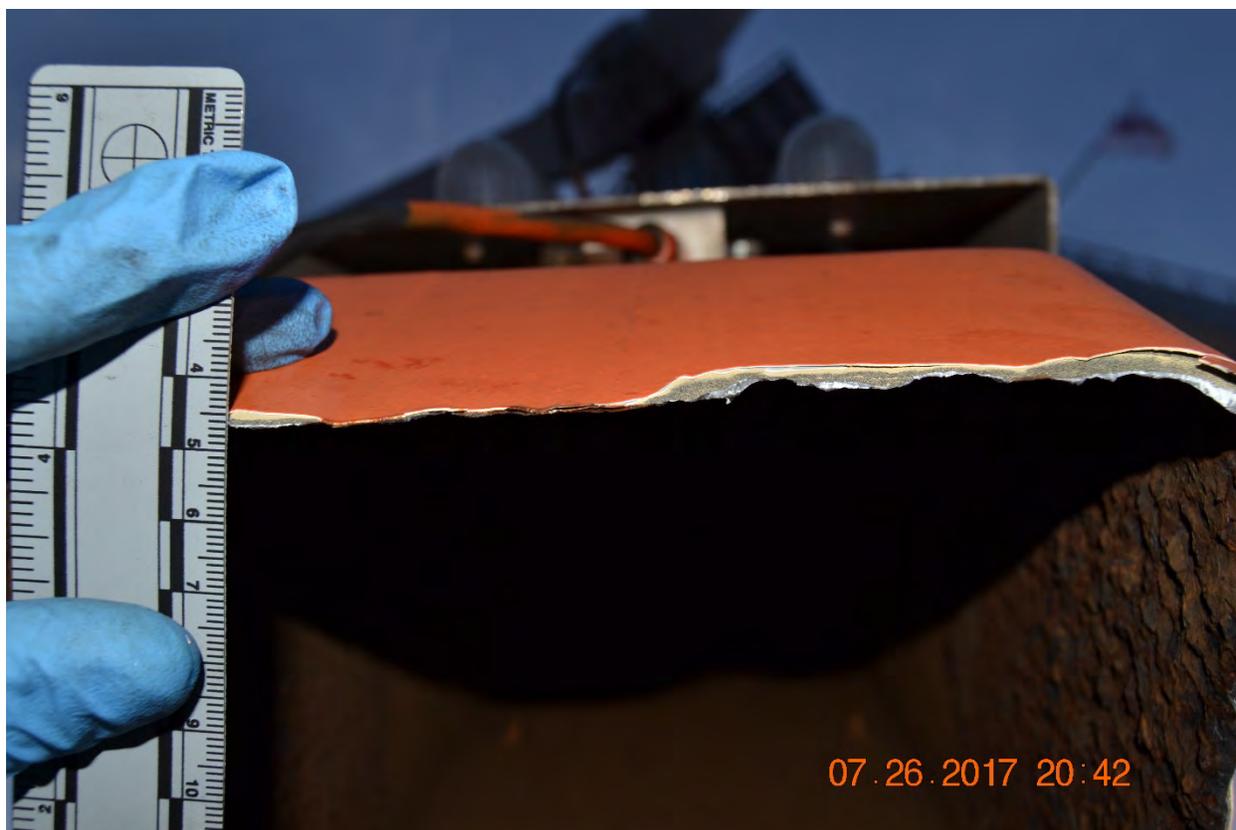
Photo #23 – Additional close up picture of the incident ride. Photo identifies the inside of the wall of metal around the arm of the broken gondola. Photograph taken by the [REDACTED] State Highway Patrol on July 26, 2017 after the incident.

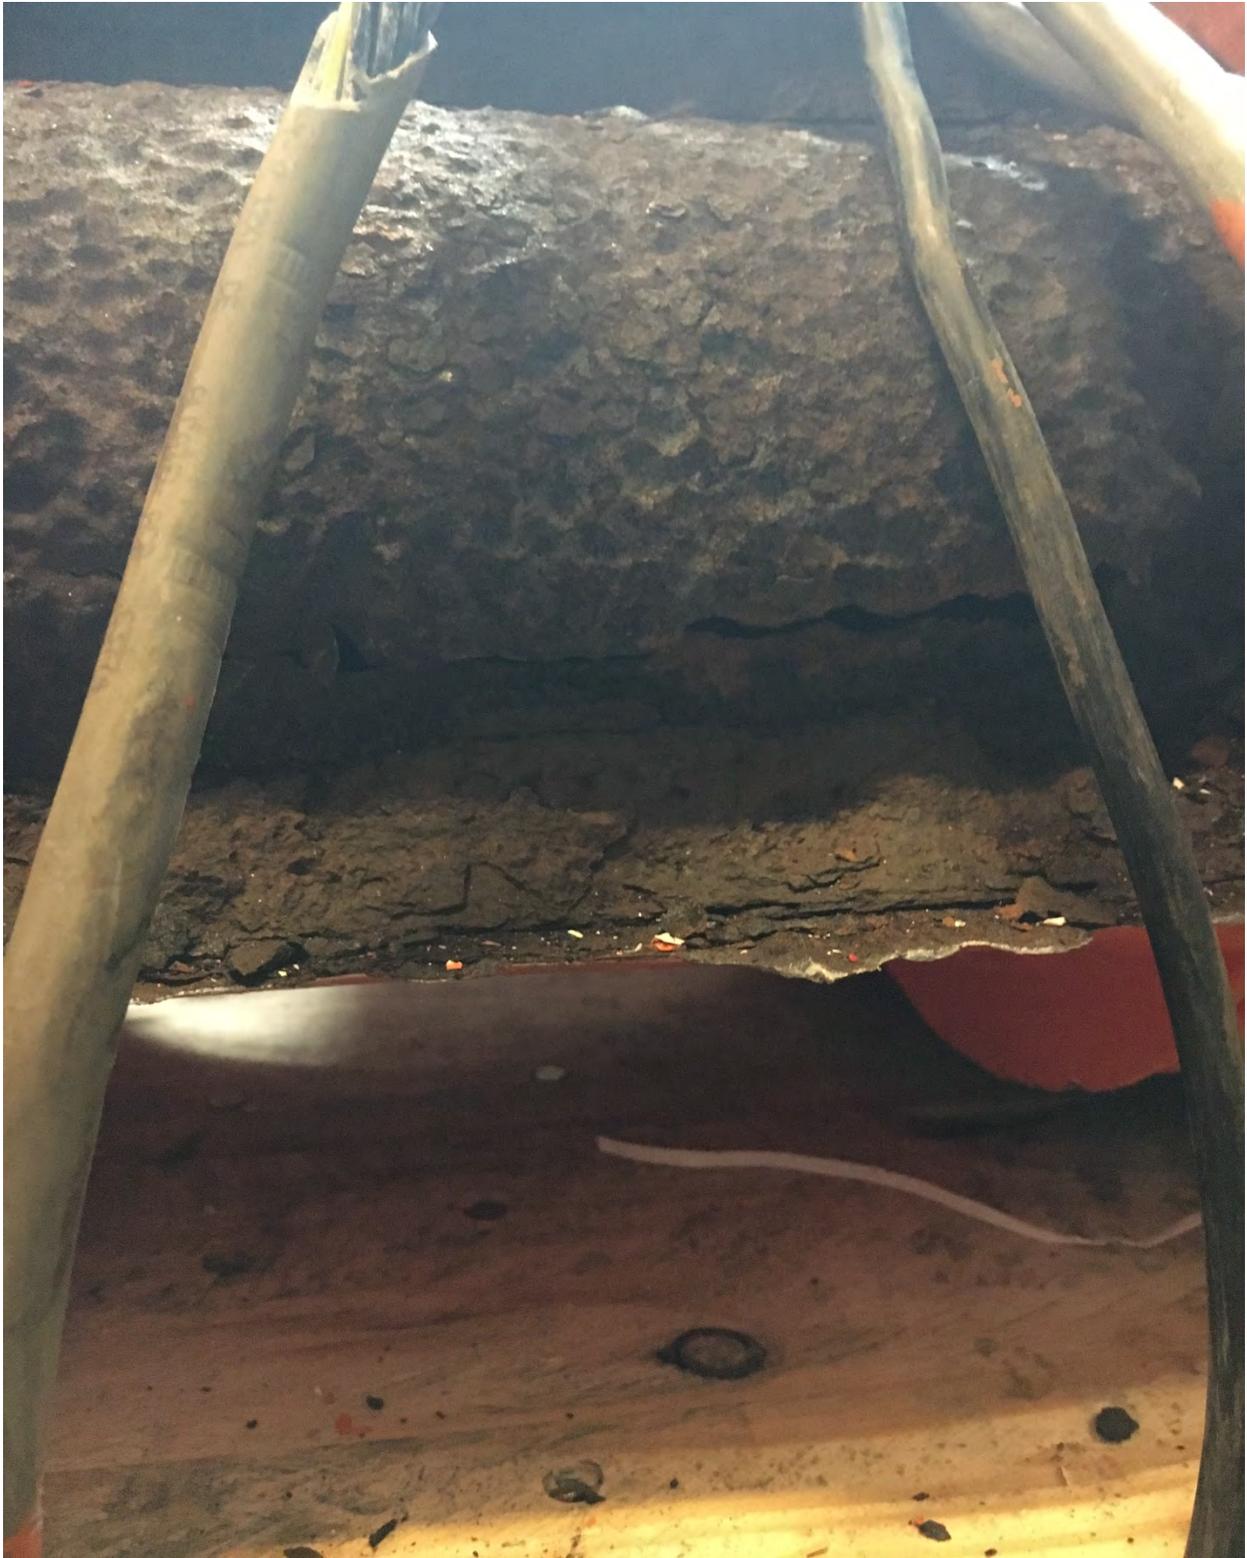
Photo #32 –Photo identifies inside of the gondola arm. Photograph taken by this investigator at the secure evidence facility on July 28, 2017.

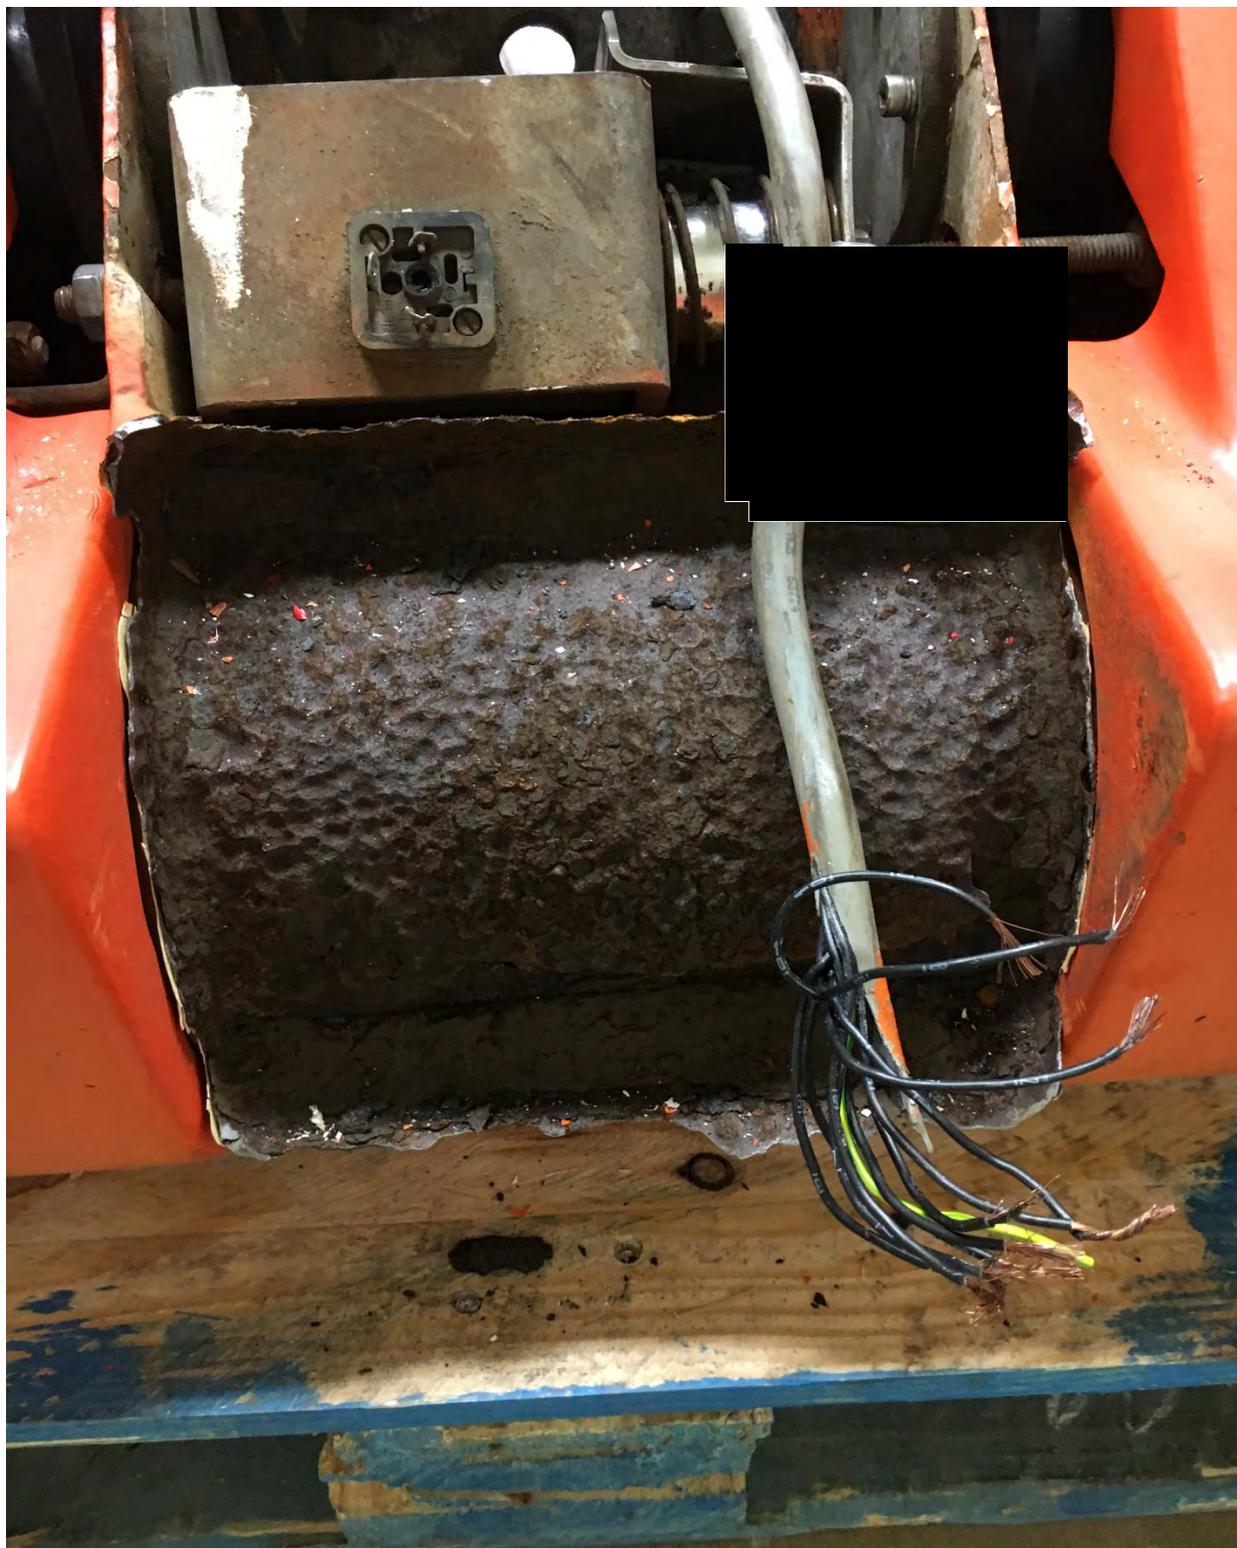
Photo #33 –Photo identifies inside of the gondola arm. Photograph taken by this investigator at the secure evidence facility on July 28, 2017.
