**CPSC Staff's Statement on SEA Ltd.'s (SEA's) Report, "Study of Debris Penetration
of Recreational Off-Highway Vehicle (ROV) Floorboards"
December 2021**

Study of Debris Penetration of Recreational Off-highway Vehicle (ROV) Floorboards

for:
Consumer Product Safety Commission

December 2021

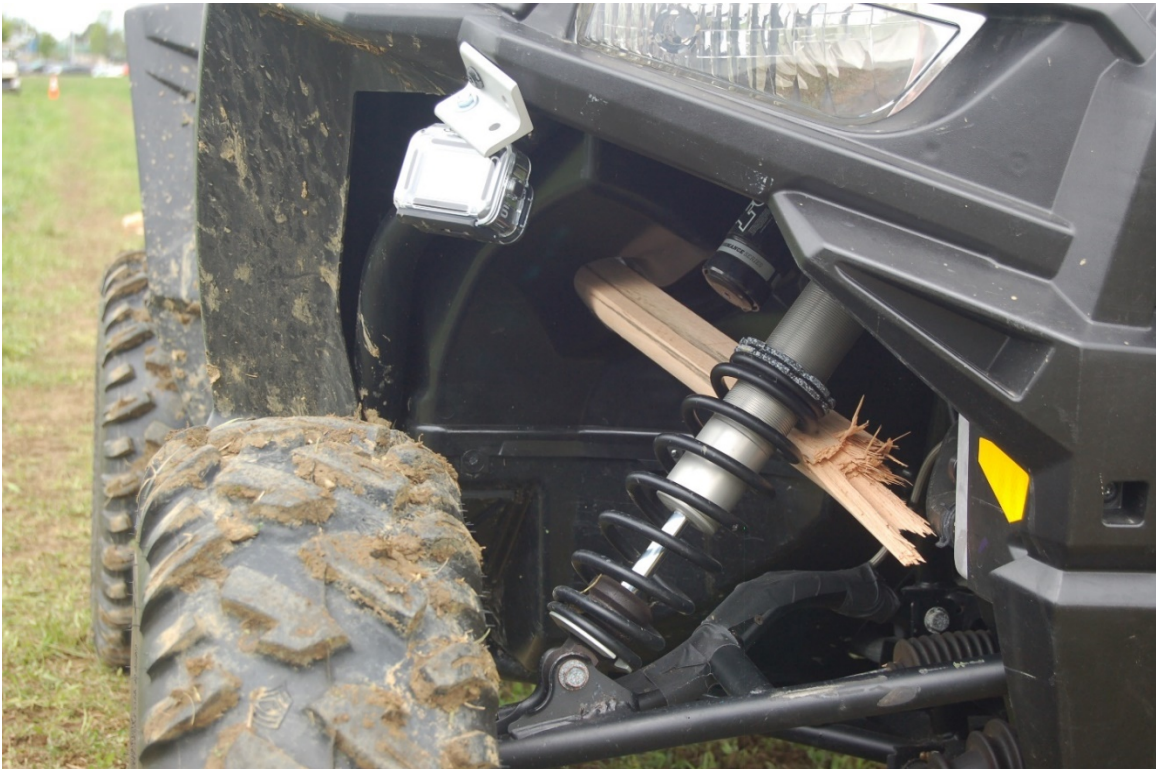
Figure 9: Run 1 Post-Impact Front View

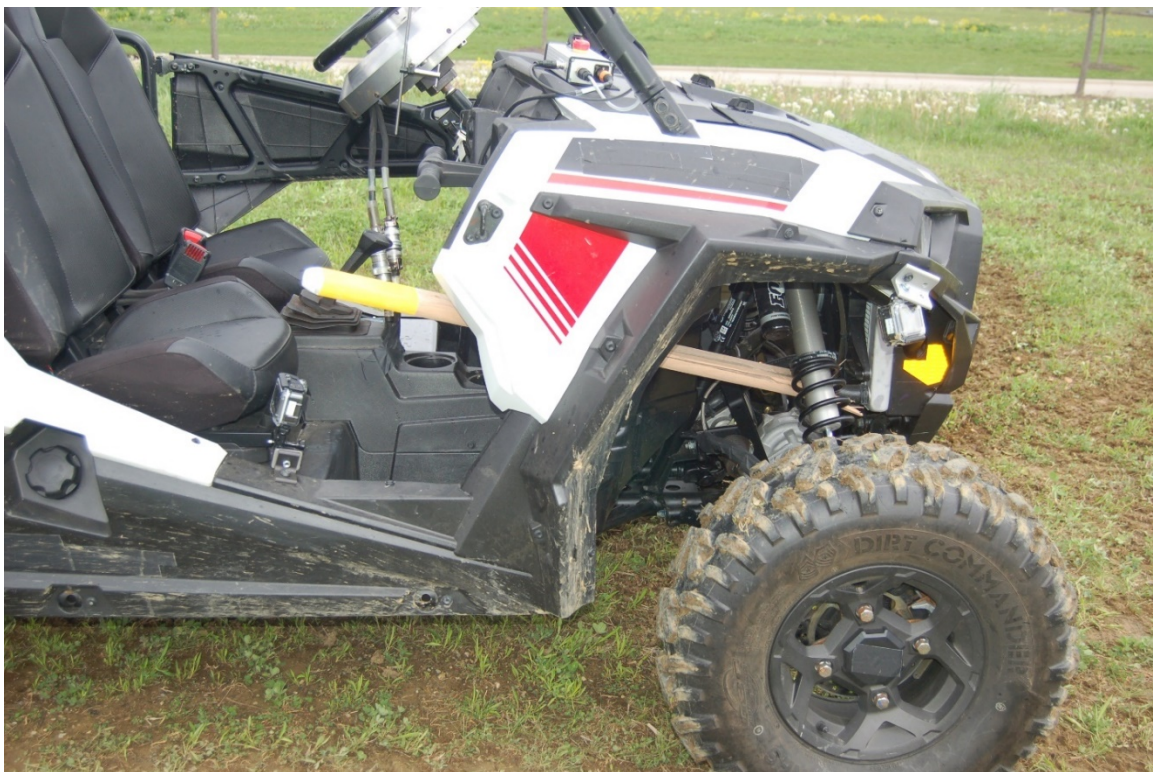
Figure 10: Run 1 Post-Impact Side View

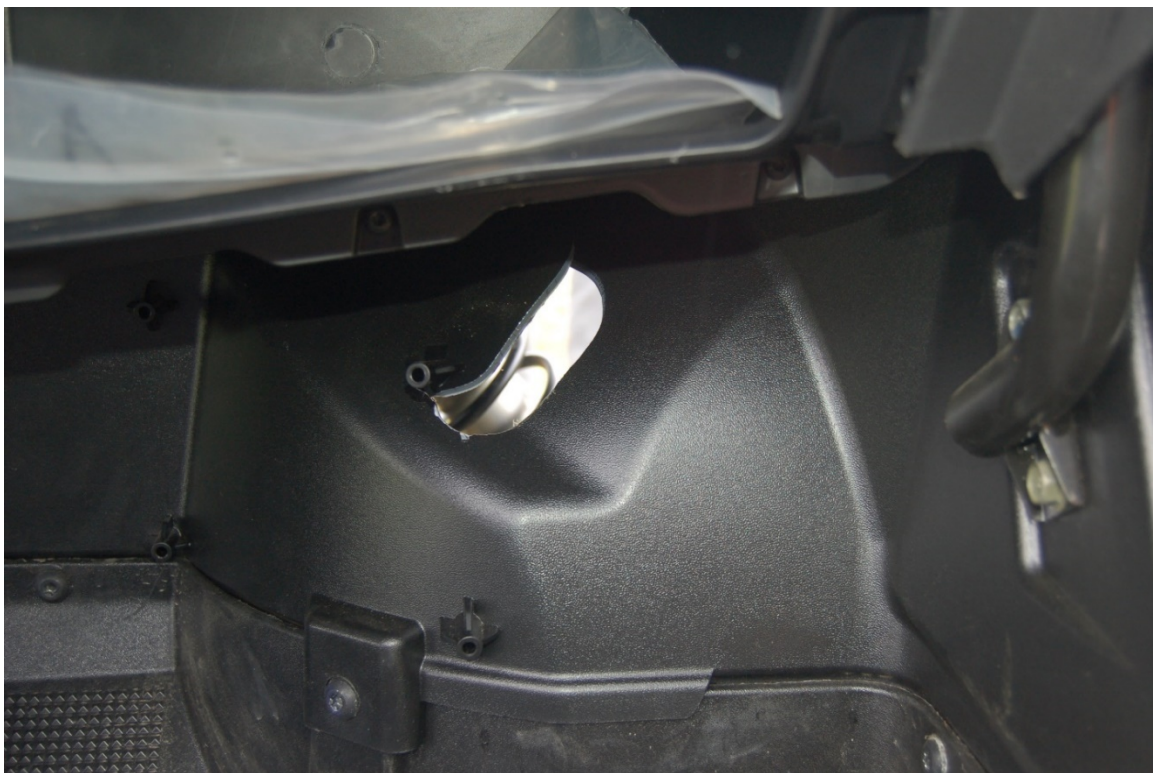
Figure 11: Run 1 Interior Photo Showing Hole in Firewall Where Stick Penetrated

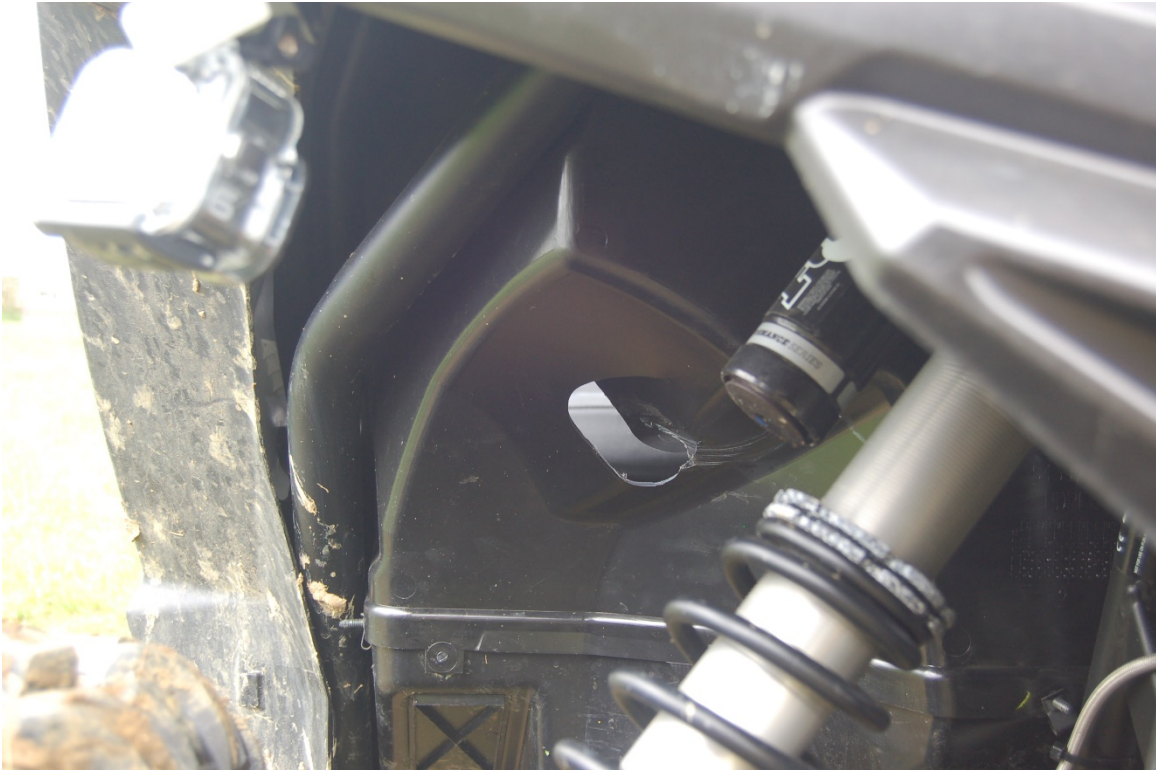
Figure 12: Run 1 Exterior Photo Showing Hole in Firewall Where Stick Penetrated

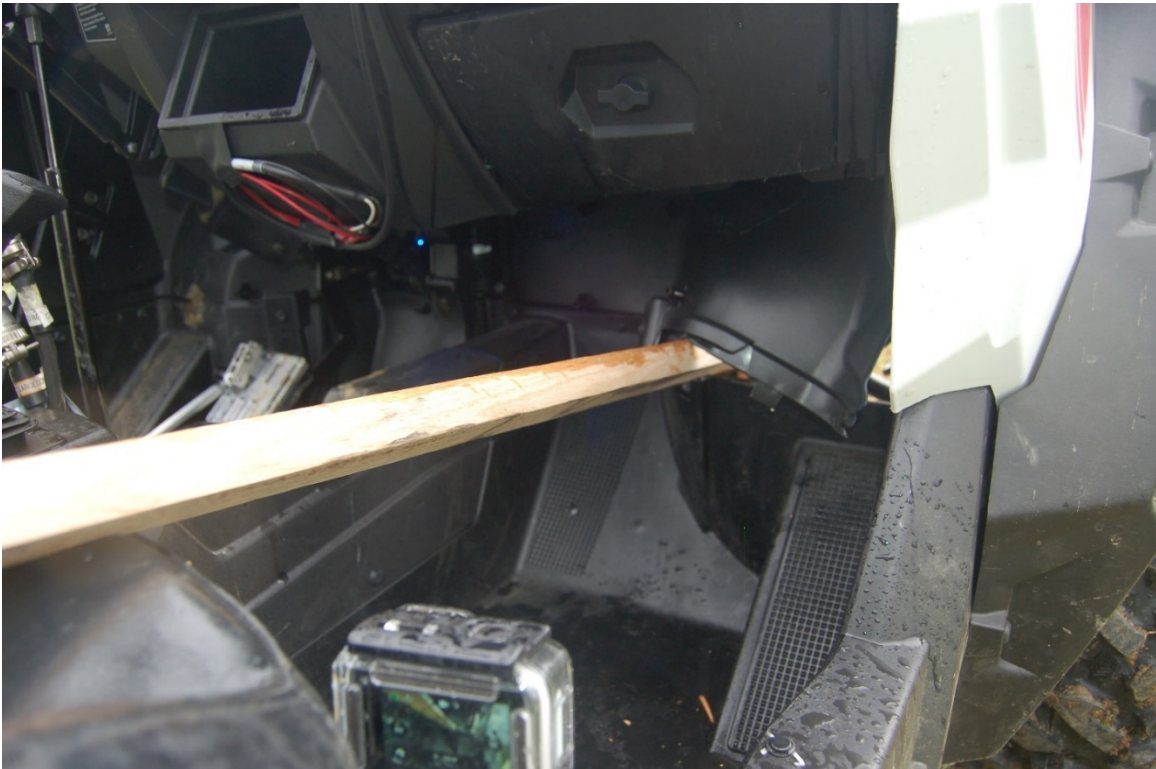
Figure 18: Run 2 Interior Photo Showing How Stick Passed Between Firewall and Floorboard

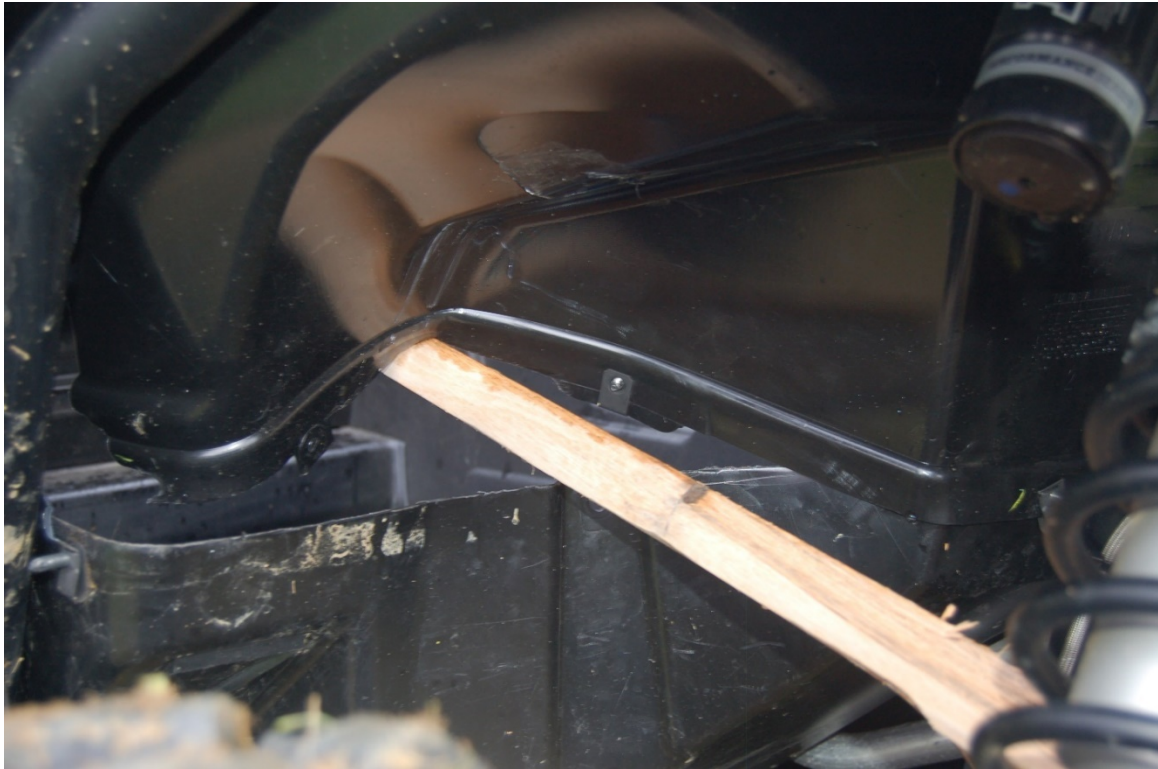
Figure 19: Run 2 External Photo Showing How Stick Passed Between Firewall and Floorboard

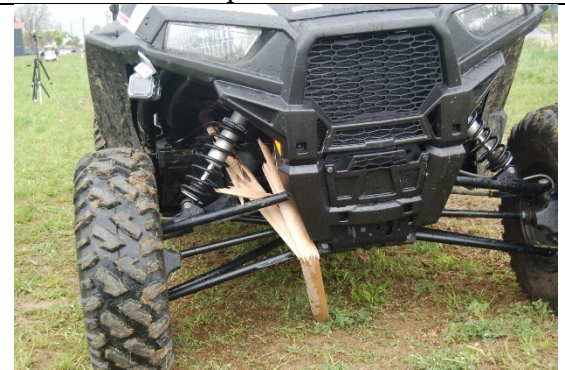
Post-Impact – Exterior View

Complete stick penetration through seam area between floorboard and firewall sections.

After penetrating the floorboard/firewall and becoming engaged with suspension components, the stick broke as the vehicle moved past the fixture holding the base of the stick.

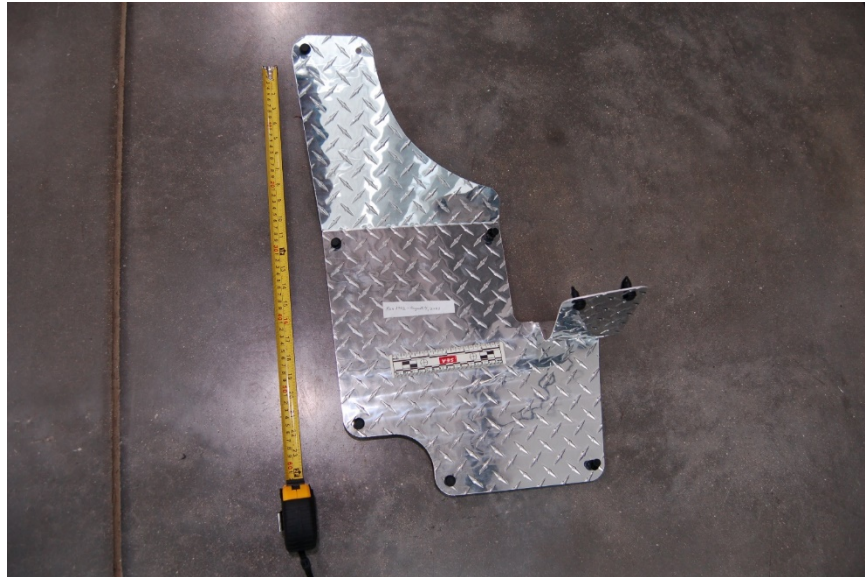
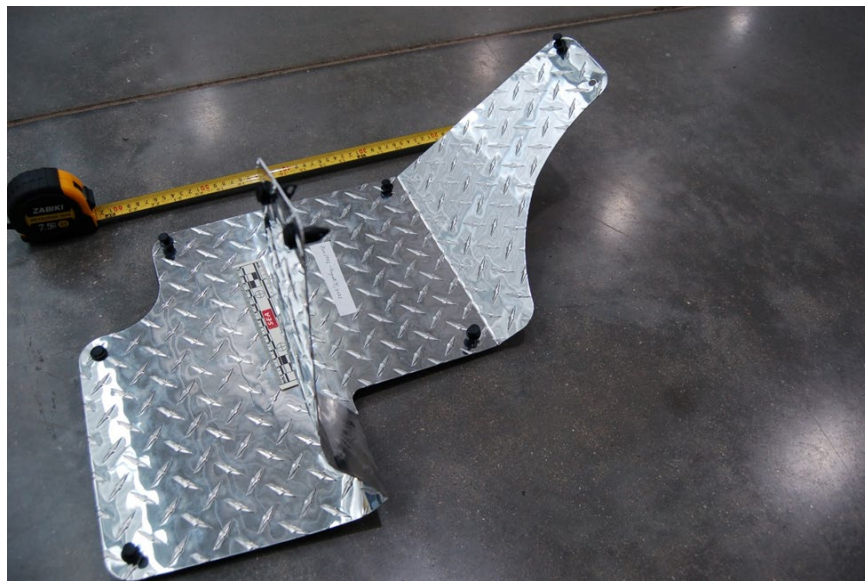
Table 6 (Continued): Vehicle A – Sled Impact Run #2 – Aftermarket Guard A1

This aluminum diamond plate floorboard (guard) was 0.062 inches thick, and it covers the floorboard and not the firewall. It was about 14 inches laterally by 24 inches longitudinally. The plastic rivets pulled through the plastic OEM floorboard of the vehicle, and a part of the diamond plate bent up substantially. This unit was from the passenger's side of the vehicle, and to the right in the top photos is to the right of the vehicle.

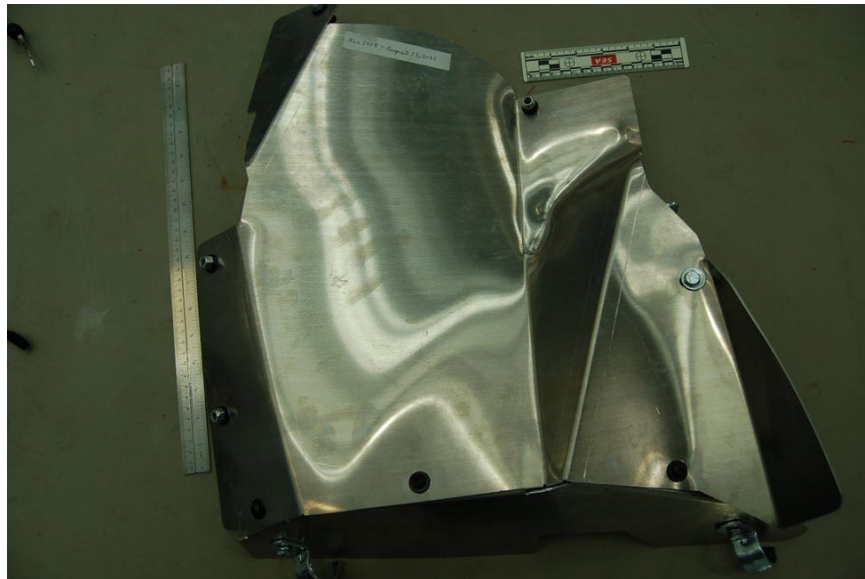
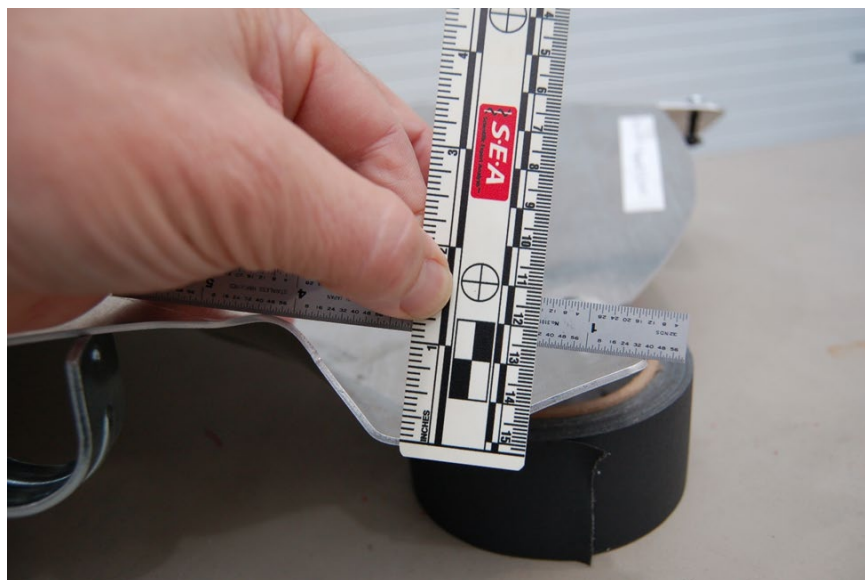
Table 7 (Continued): Vehicle A – Sled Impact Run #3 – Aftermarket Guard A2

In the top photo, the top of the photo is up and outboard to the vehicle is to the right, so this is from the driver's side of the vehicle. The material is aluminum plate, 0.075 inches thick. The maximum deflection shown is 1 1/8 inches.

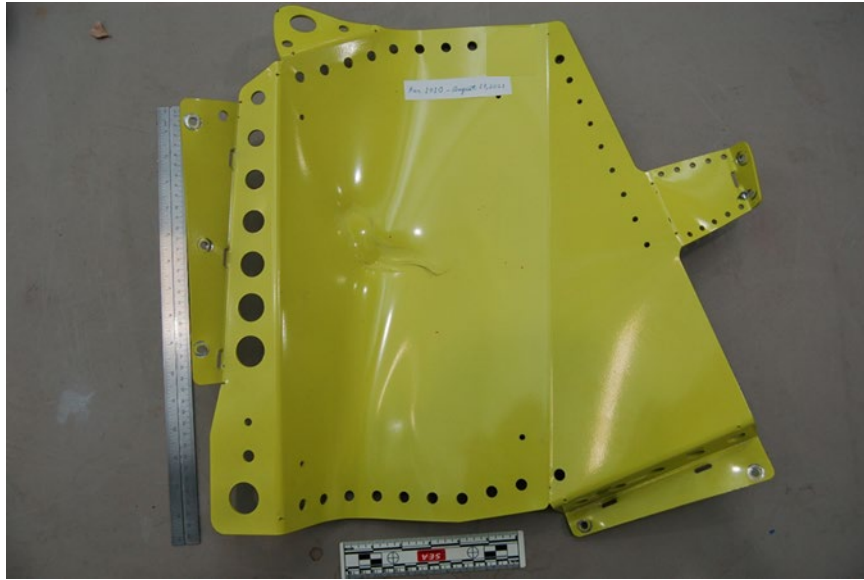
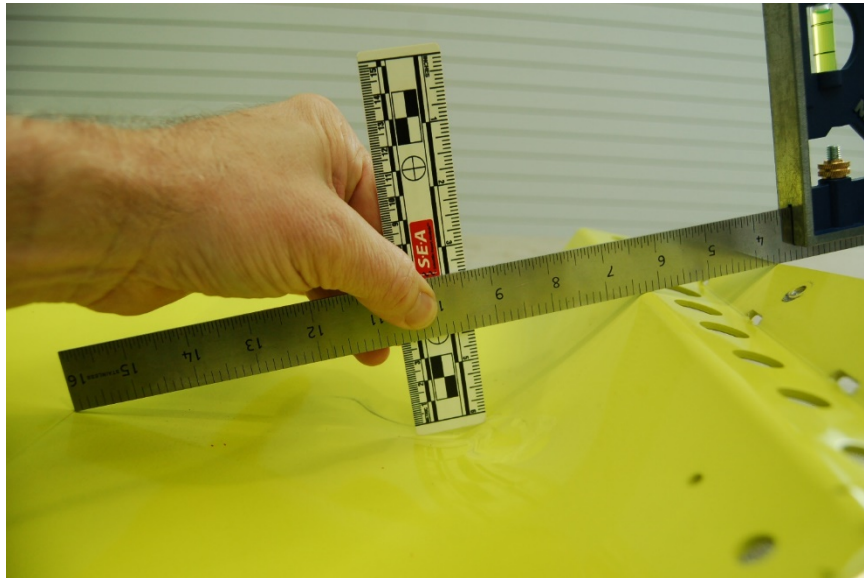
Table 8 (Continued): Vehicle A – Sled Impact Run #4 – Aftermarket Guard A3

This guard is made of aluminum plate 0.125 inches thick. The part tested was powder coated lime green and it covers an area of about 18 inches vertically by 14 inches laterally. In the top photo, to the left in the photo is to the outboard edge of the vehicle, therefore this guard is from the passenger's side of the vehicle.

The bottom photo shows the maximum deformation, 1 $\frac{3}{4}$ inches, in the middle of the guard. The deflection at the lower edge of the guard was slightly greater, about 2 inches.

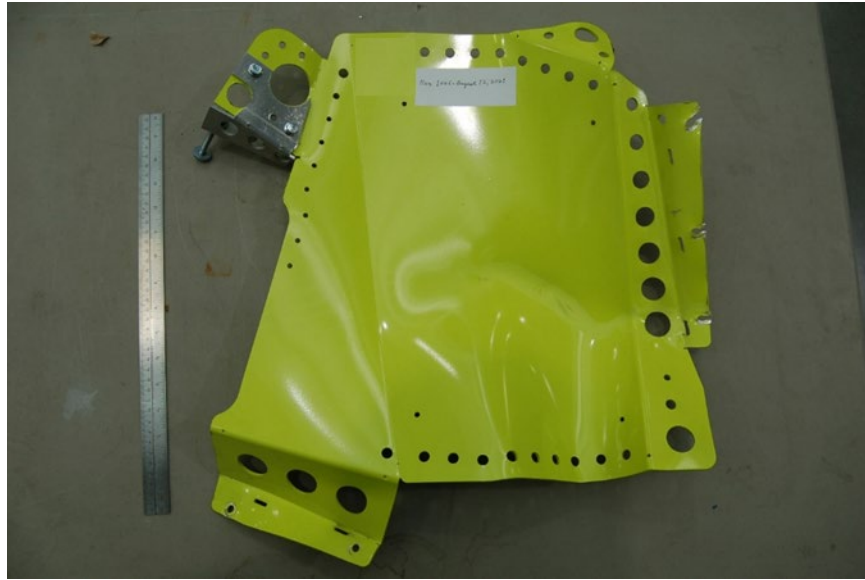
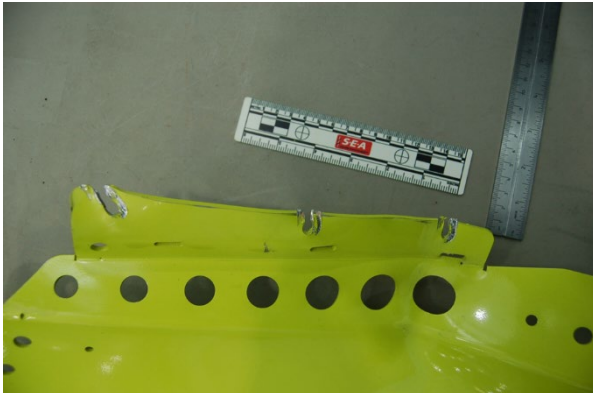
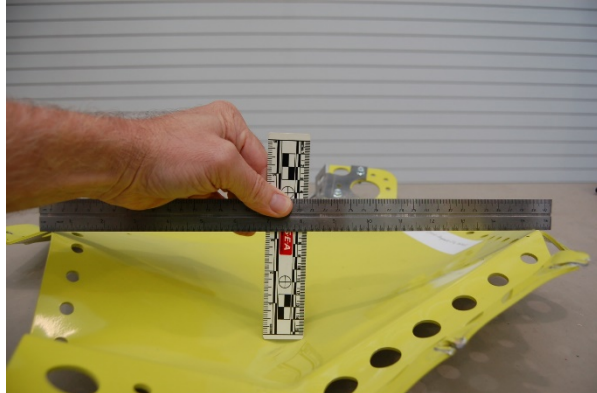
Table 9 (Continued): Vehicle A – Sled Impact Run #5 – Aftermarket Guard A3

The guard deformed and the guard material around the holes for the three outside guard fasteners failed, allowing the guard to release from the outside fasteners. The fasteners themselves did not fail.

This guard is made of aluminum plate 0.125 inches thick. The part tested was powder coated lime green and it covers an area of about 18 inches vertically by 14 inches laterally. In the top photo, to the right in the photo is to the outboard edge of the vehicle, therefore this guard is from the driver's side of the vehicle.

The bottom left photo shows the failed guard material around the holes for the three outside guard fasteners. The bottom right photo shows the maximum deflection in the middle of the part, about 3 3/8 inches.

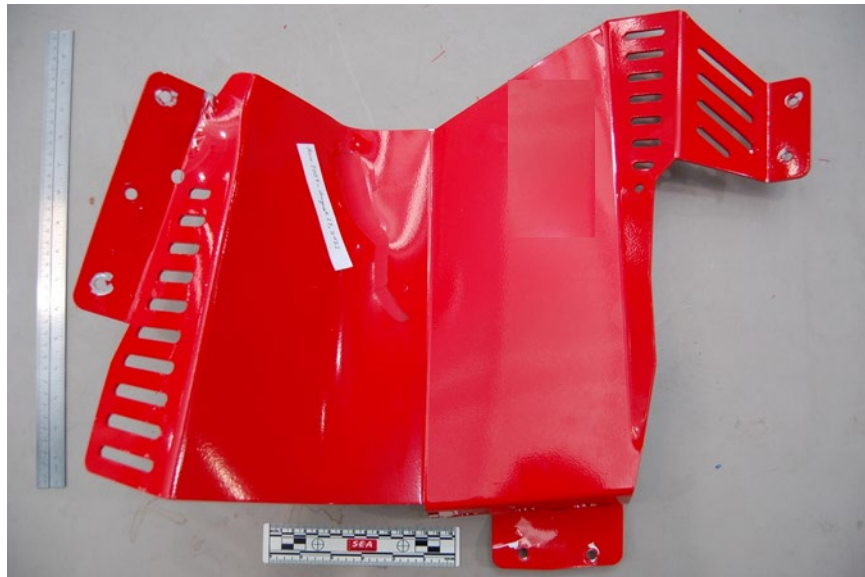
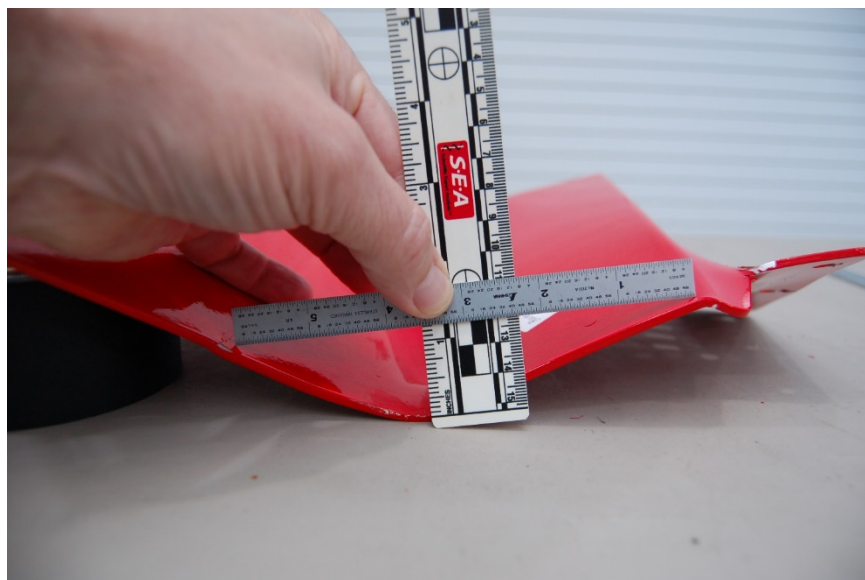
Table 10: (Continued) Vehicle A – Sled Impact Run #6 – Aftermarket Guard A4

This guard is made of aluminum plate 0.130 inches thick. The part tested was powder coated red and covers an area of about 13 inches laterally and 17 inches vertically. In the top photo, to the left in the photo is to the outboard edge of the vehicle, therefore this guard is from the passenger's side of the vehicle.

The bottom photo shows the maximum deflection at the top edge of the guard is 1 ¼ inches.

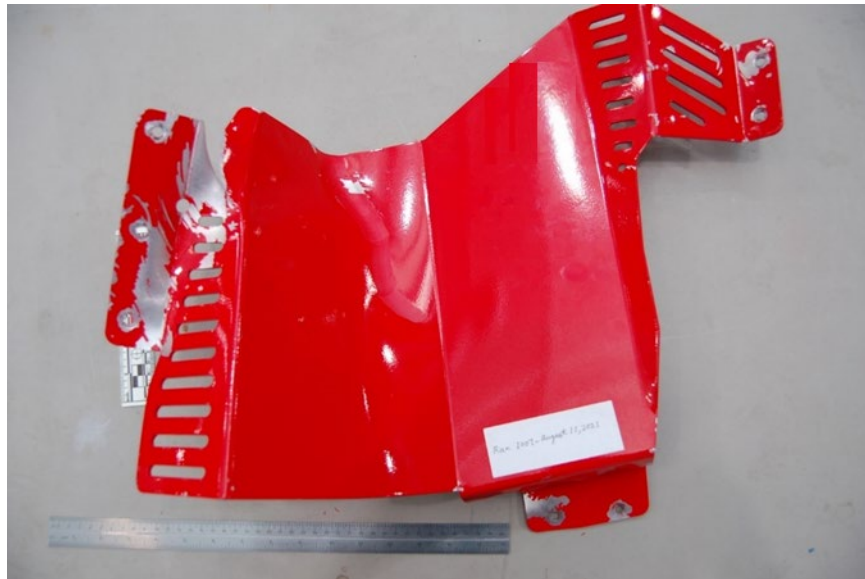
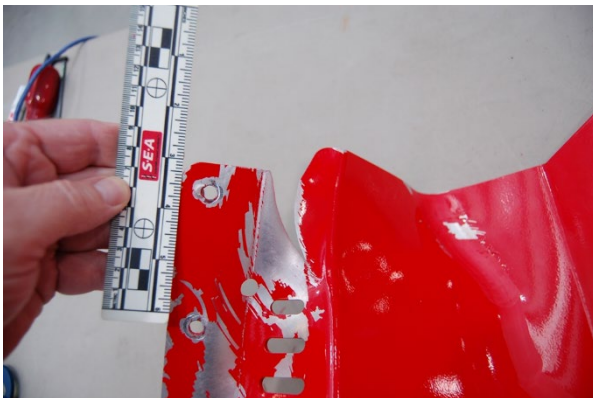
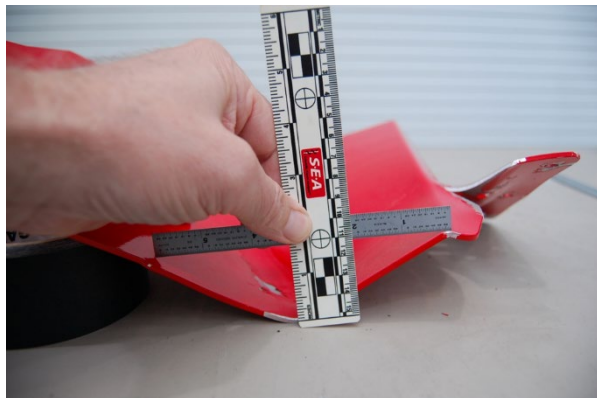
Table 11 (Continued): Vehicle A – Sled Impact Run #7 – Aftermarket Guard A4

The guard deformed and the guard material ripped near the top outer edge of the guard. None of the guard fasteners failed.

This guard is made of aluminum plate 0.130 inches thick. The part tested was powder coated red and covers an area of about 13 inches laterally and 17 inches vertically. In the top photo, to the left in the photo is to the outboard edge of the vehicle, therefore this guard is from the passenger's side of the vehicle.

The bottom left photo shows the guard material ripped near the top outer edge of the guard. The bottom right photo shows the maximum deflection at the top edge of the guard is 1 5/8 inches.

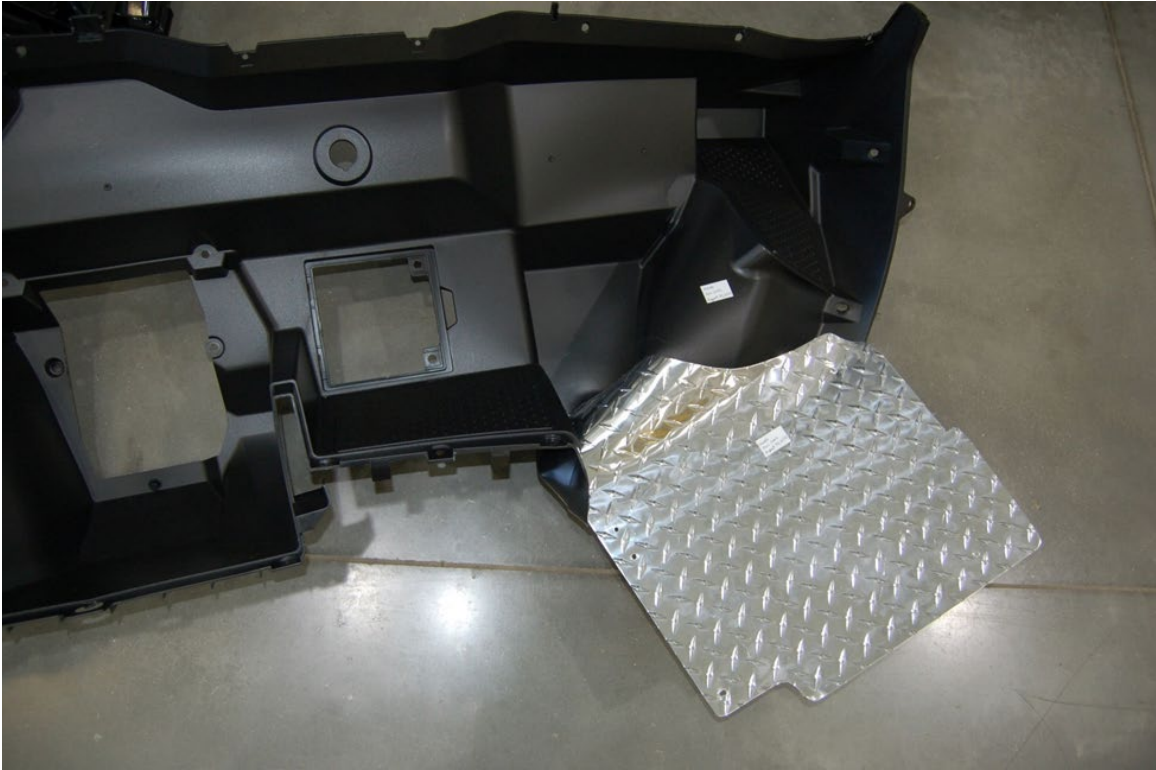
Table 13 (Continued): Vehicle B – Sled Impact Run #2 – Aftermarket Guard B1

This guard is made of aluminum diamond plate 0.061 inch thick. This is an internal guard, with a diamond thread plate pattern. It was about 17 ½ inches laterally by 23 ½ inches longitudinally. The guard used is for the passenger's side of the vehicle. It is shown intermeshed with the deformed plastic floorboard. The parts cannot be separated without damaging them further. No measurements of the deformation were made, but the deformation is clearly very large.

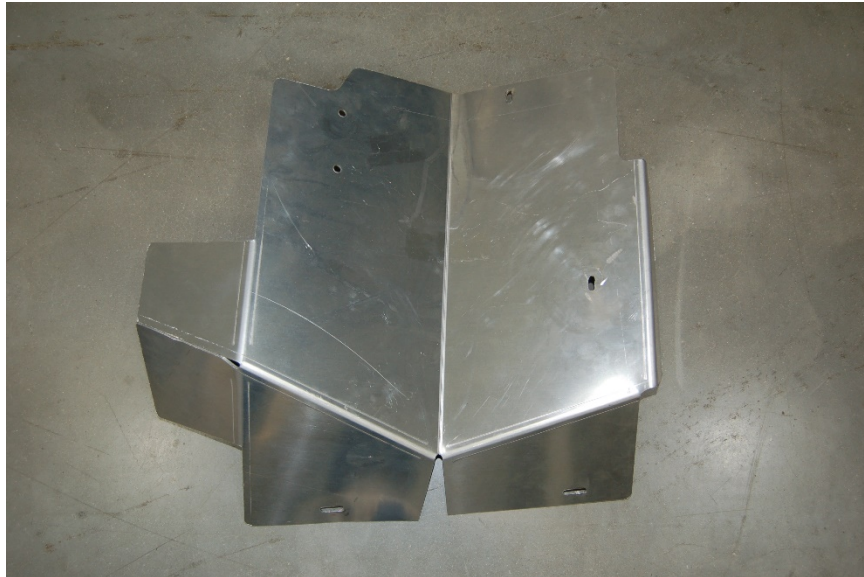
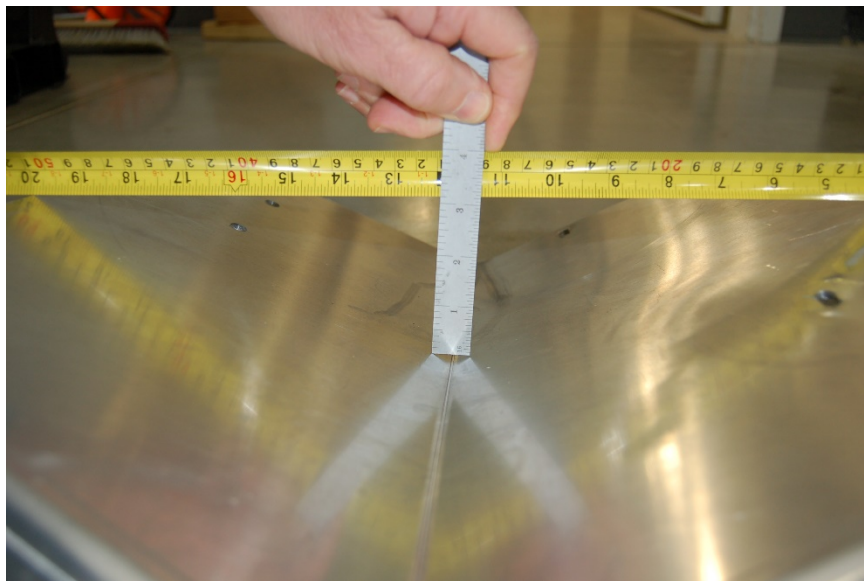
Table 19 (Continued): Vehicle D – Sled Impact Run #2 – Aftermarket Guard D1

This guard is made of aluminum plate 0.156 inches thick. It covers an area of about 17 inches laterally and 20 inches vertically. In the top photo, to the right in the photo is to the outboard edge of the vehicle, therefore this guard is from the driver's side of the vehicle.

The guard has a natural bend, which was increased in the test. After this run, the dimension was 3 1/8 inches, as seen in the bottom photo. On an undamaged guard the same measurement was 2 1/2 inches, therefore the deflection caused by this run was 5/8 inch.

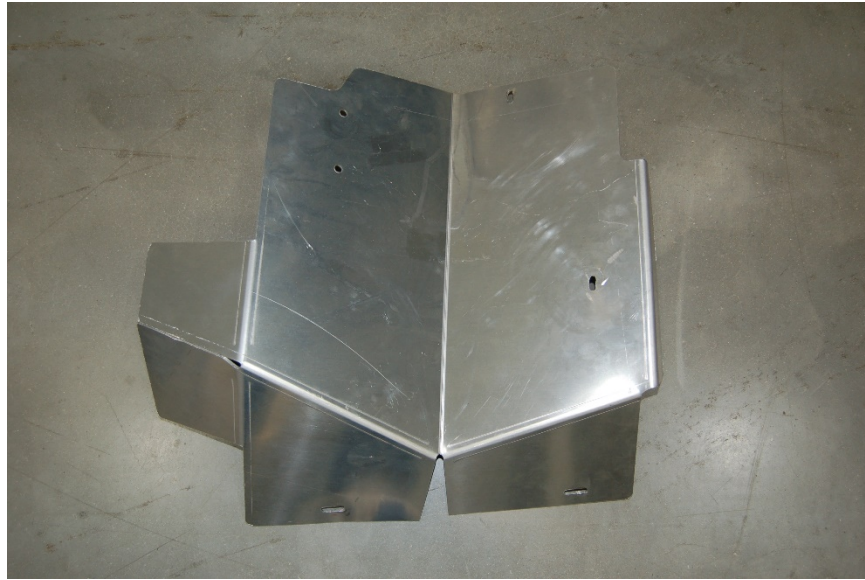
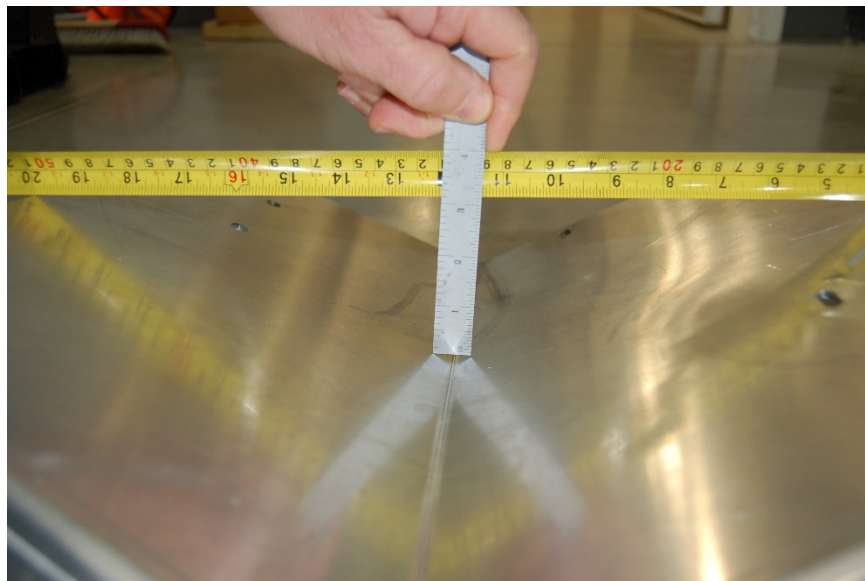
Table 20 (Continued): Vehicle D – Sled Impact Run #3 – Aftermarket Guard D1

This guard is made of aluminum plate 0.156 inches thick. It covers an area of about 17 inches laterally and 20 inches vertically. In the top photo, to the right in the photo is to the outboard edge of the vehicle, therefore this guard is from the driver's side of the vehicle.

The deflection in the guard after this run was measured to be the same as after the previous run using this same guard, about 5/8 inch.

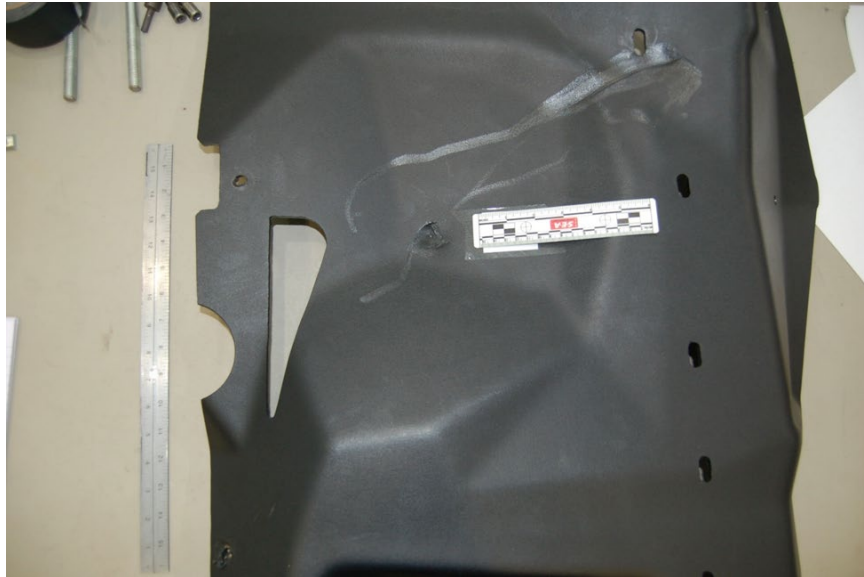
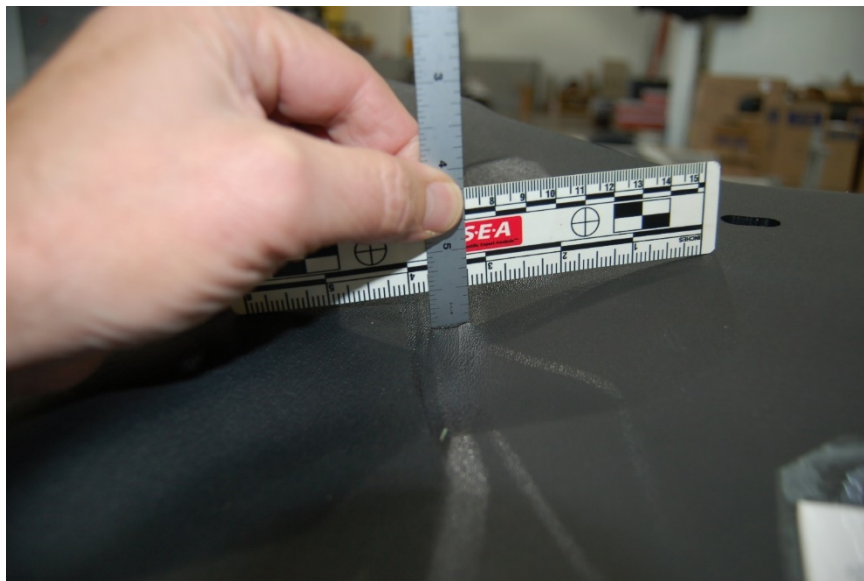
Table 22 (Continued): Vehicle E – Sled Impact Run #2 – Aftermarket Guard E1

This is a black plastic guard made of High Molecular Weight Polyethylene (HMWPE). Per the manufacturer of this guard, its starting thickness is 0.30 inches and after forming/stretching it into shape it will be less in some areas. Its thickness varies somewhat but averages about 0.270 inches. It covers an area of about 24 inches laterally and 27 inches vertically. The top photo shows the driver's side guard tested in this run.

The forming process for this guard allows for making complex curves, and the guard shape is not a series of planes. This makes the deflection more difficult to measure. However, the maximum depth of damage was estimated at $\frac{1}{2}$ inch, as shown in the bottom photo.

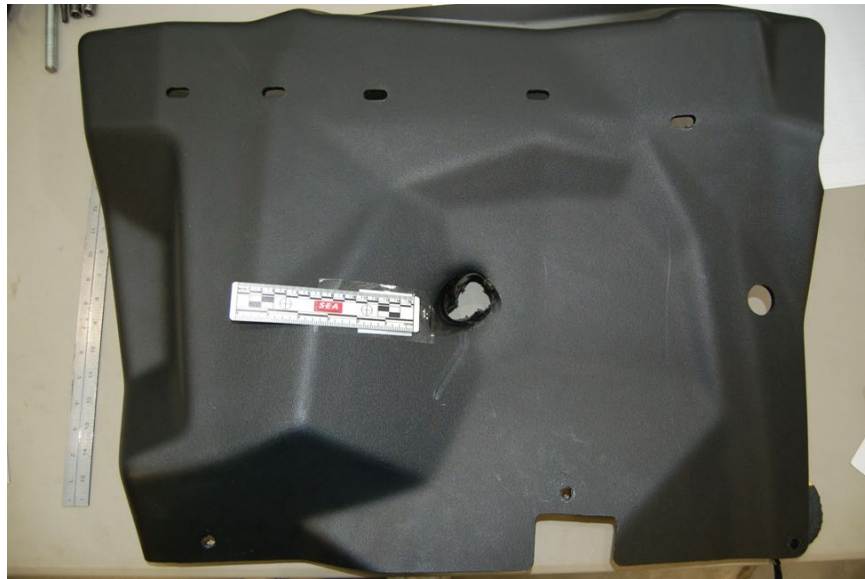
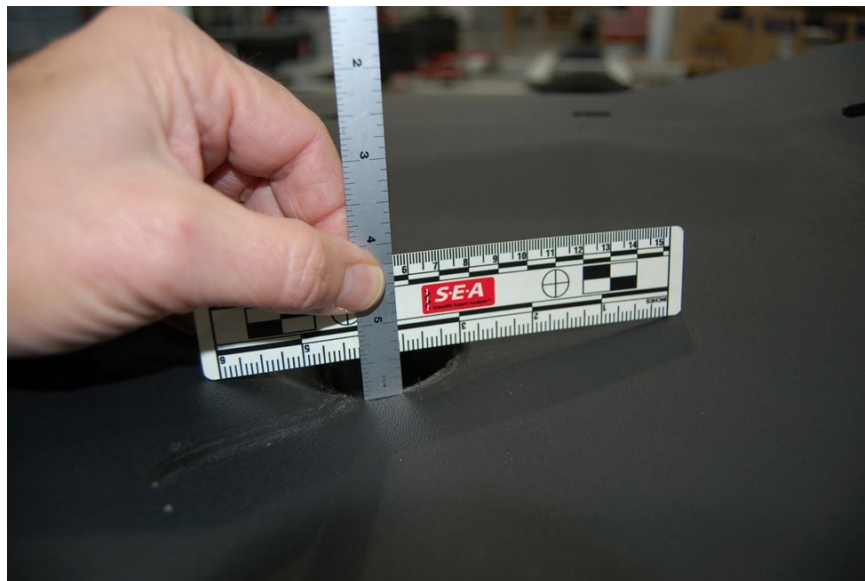
Table 23 (Continued): Vehicle E – Sled Impact Run #3 – Aftermarket Guard E1

This is a black plastic guard made of High Molecular Weight Polyethylene (HMWPE). Per the manufacturer of this guard, its starting thickness is 0.30 inches and after forming/stretching it into shape it will be less in some areas. Its thickness varies somewhat but averages about 0.270 inches. It covers an area of about 24 inches laterally and 27 inches vertically. The top photo shows the passenger's side guard tested in this run. The slightly greater than 2 inch diameter through hole in the guard was caused by the 2 inch diameter stick penetration.

The depth of maximum damage at the point of maximum damage, near but not at the penetration, is shown in the bottom photo. This is 9/16 inch.

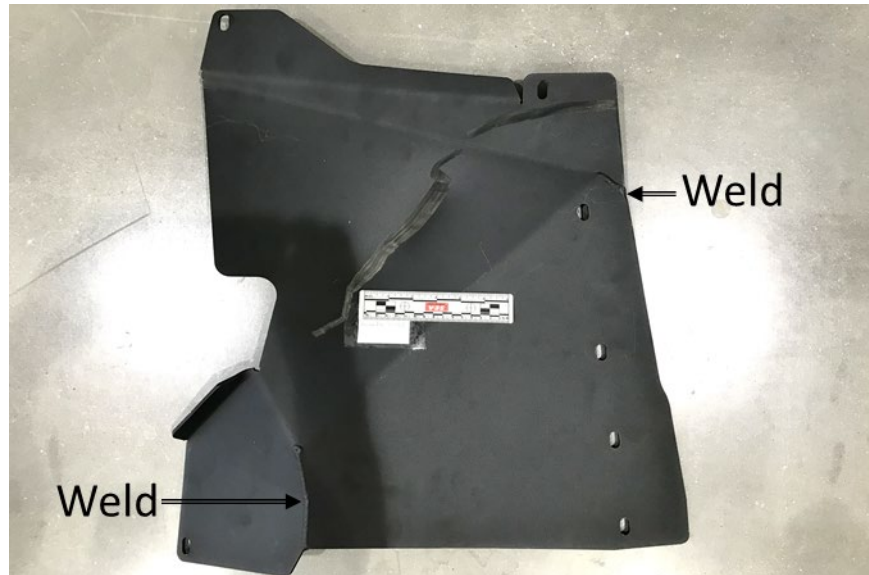
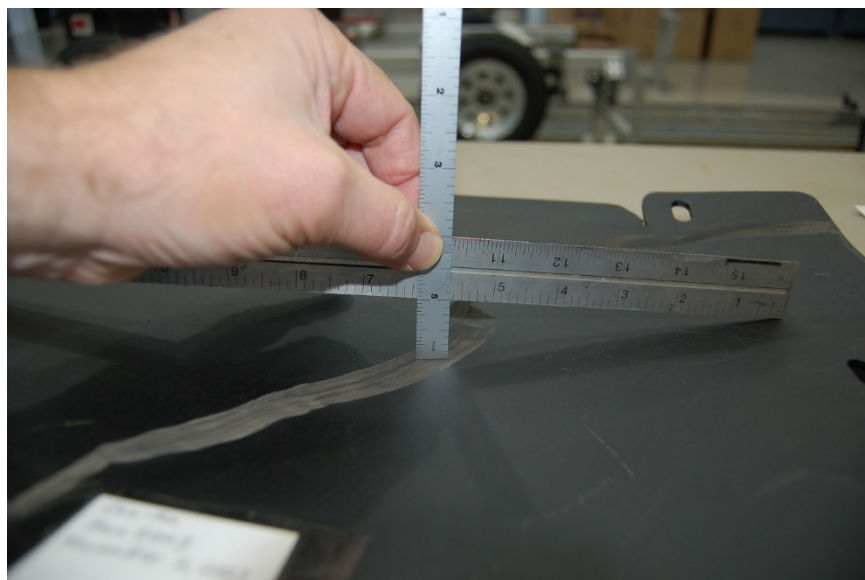
Table 24: Vehicle E – Sled Impact Run #4 – Aftermarket Guard E2

This is a powder coated black aluminum guard with thickness of 0.171 inches. It covers an area of about 17 ½ inches laterally and 22 inches vertically. This guard has two welded seams, as shown in the top photo of the driver's side guard tested in this run.

The depth of maximum damage at its deepest point is about 1 inch, as shown in the bottom photo.

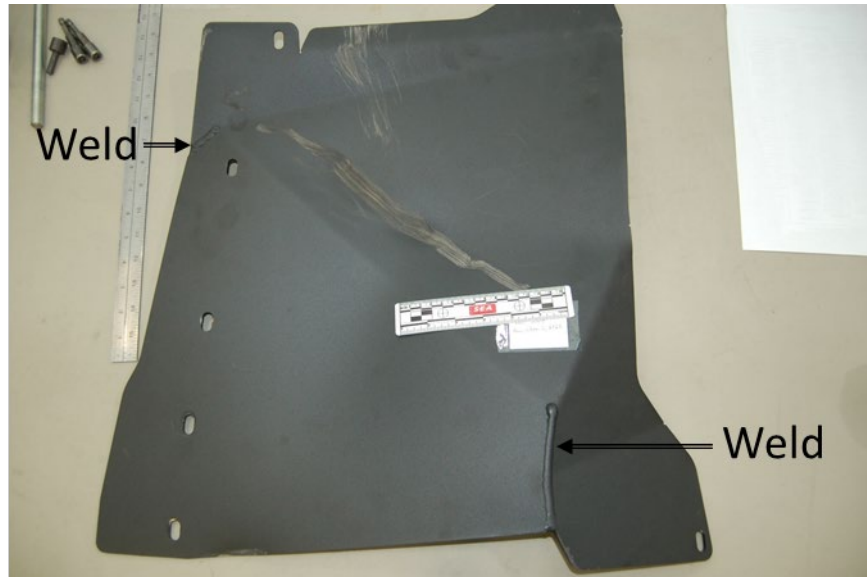
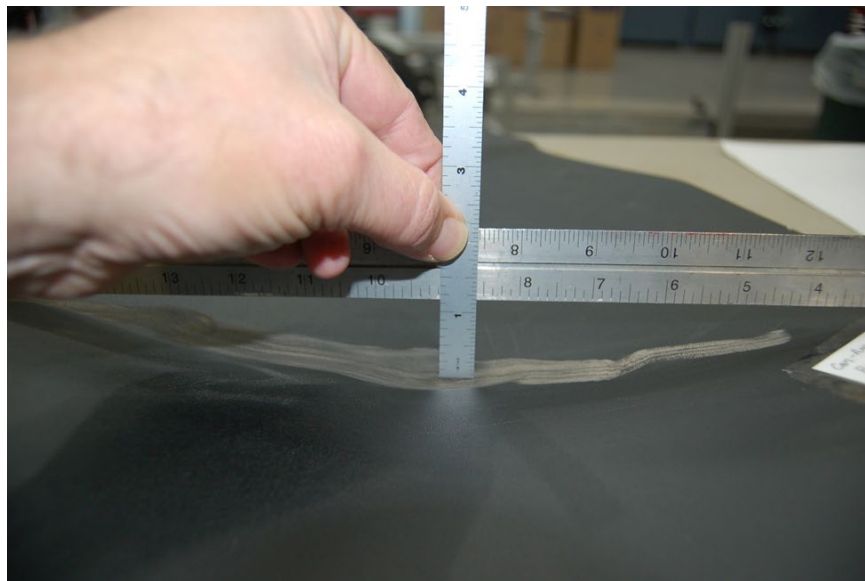
Table 25 (Continued): Vehicle E – Sled Impact Run #5 – Aftermarket Guard E2

Stick shattered. Indentation in guard of about 1 3/16". The guard covered an area extending beyond the outside frame of the vehicle, and there was no failure of the guard material or guard fasteners. No damage to OEM firewall or fasteners.

This is a powder coated black aluminum guard with thickness of 0.171 inches. It covers an area of about 17 ½ inches laterally and 22 inches vertically. This guard has two welded seams, as shown in the top photo of the passenger's side guard tested in this run.

The depth of maximum damage at its deepest point is about 1 3/16 inch, as shown in the bottom photo.
