CPSC Staff Statement on the University of Northern Iowa (UNI)'s "Report for National Study of Public Playground Equipment and Surfacing"¹
October 2019

Final Report for CPSC on the National Study of Public Playground Equipment and Surfacing

February 2018

Heather Olsen, Ed.D., & Eric Kennedy, Ph.D.²³⁴
The National Program for Playground Safety
University of Northern Iowa

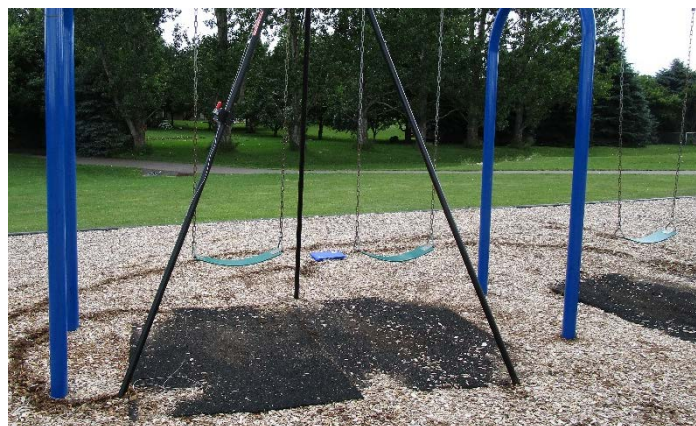
The data showed that kick mats have been installed under heavy use equipment (e.g. swings and slide exits) at 17.5% of playgrounds. The findings revealed both public schools and public parks utilize rubber mats under a variety of equipment. Analysis of the impact attenuation performance of kick mats will be conducted in further stages.

Figure 3. Rubber mats installed under the swing exit use zone region

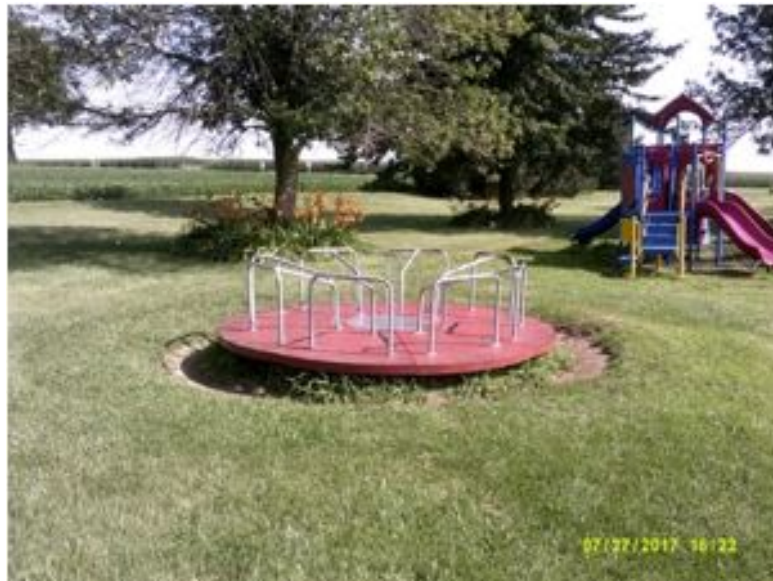
Inappropriate surfacing (e.g. grass, dirt, or concrete) under and around the use zone of the play structure needs to be further monitored as the dataset grows. Given that no impact test is performed in situations where these surfaces pose a risk to the testing equipment, the interpretation of inappropriate surfaces results should be approached with caution. Along with the influence of kick mats, the influence of inappropriate surfacing encountered in the field will continue in future analysis efforts.

Figure 23. Inappropriate to perform the impact attenuation test

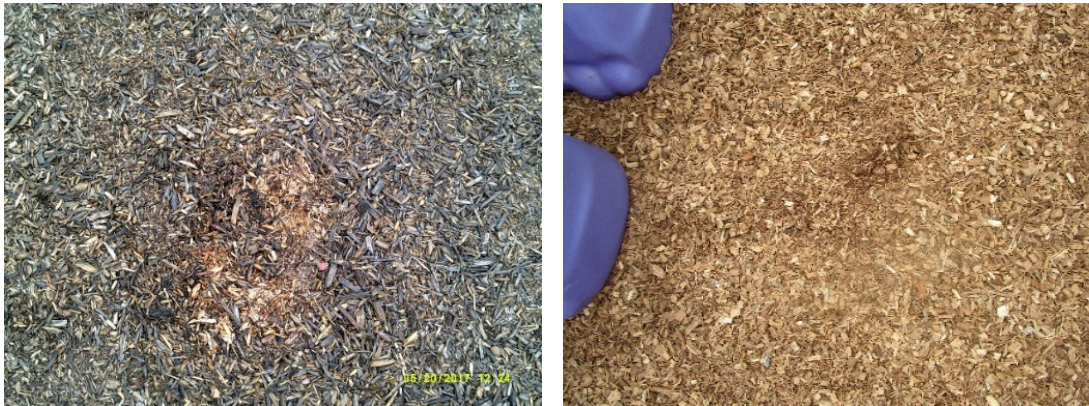
Ninety-eight percent (98%) of all wood products tested (specifically engineered wood fiber, wood chips, and wood mulch) were found to fall below 200 *g* at all three test sites. Furthermore, 94% of all wood products (specifically engineered wood fiber, wood chips, and wood mulch) were found to fall below 1000 HIC at all three test sites.

Figure 24. Different types of wood products that were tested

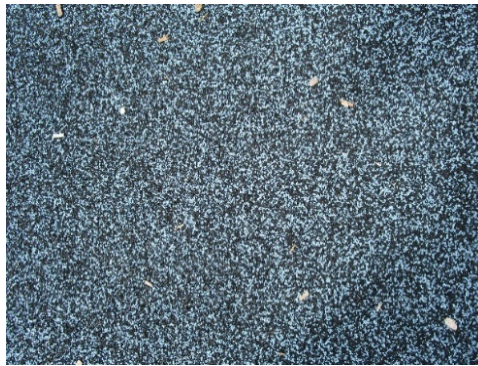
Eighty-five percent (85%) of unitary products (specifically poured-in-place and rubber tile) were found to fall below 200 *g* at all three test sites. Furthermore, 76% of all unitary products (poured-in-place and rubber tile) were found to fall below 1000 HIC at all three test sites.

Figure 25. One example of poured-in-place rubber tested

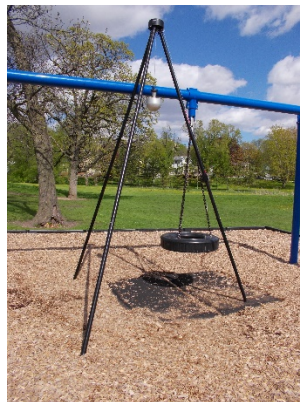
Kick mats were present at 17.5% of the playgrounds. They were either installed on top of the playground surface or underneath the playground surface material. The analyses, to date, have not included the effects of kick mats on top of or underneath the playground surface, this will be conducted in the future.

Figure 26. Kick mat under the tire swing. Both kick mat and wood product was tested
