CPSC Staff Statement on the University of Northern Iowa (UNI)'s "Report for National Study of Public Playground Equipment and Surfacing"¹
October 2019

Final Report for CPSC on the National Study of Public Playground Equipment and Surfacing

February 2018

Heather Olsen, Ed.D., & Eric Kennedy, Ph.D.²³⁴
The National Program for Playground Safety
University of Northern Iowa

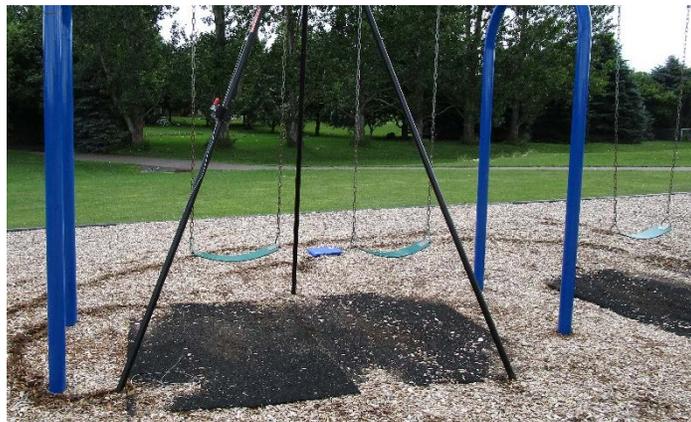
The data showed that kick mats have been installed under heavy use equipment (e.g. swings and slide exits) at 17.5% of playgrounds. The findings revealed both public schools and public parks utilize rubber mats under a variety of equipment. Analysis of the impact attenuation performance of kick mats will be conducted in further stages.

Figure 3. Rubber mats installed under the swing exit use zone region

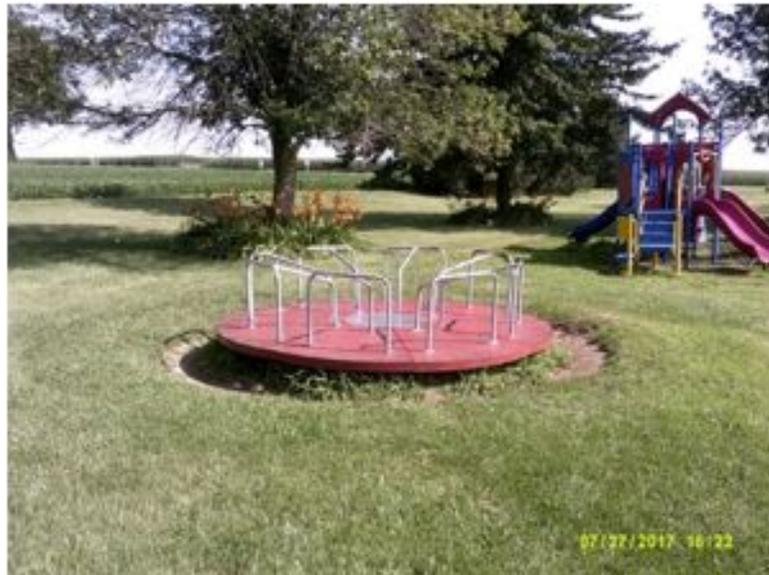
Inappropriate surfacing (e.g. grass, dirt, or concrete) under and around the use zone of the play structure needs to be further monitored as the dataset grows. Given that no impact test is performed in situations where these surfaces pose a risk to the testing equipment, the interpretation of inappropriate surfaces results should be approached with caution. Along with the influence of kick mats, the influence of inappropriate surfacing encountered in the field will continue in future analysis efforts.

Figure 23. Inappropriate to perform the impact attenuation test

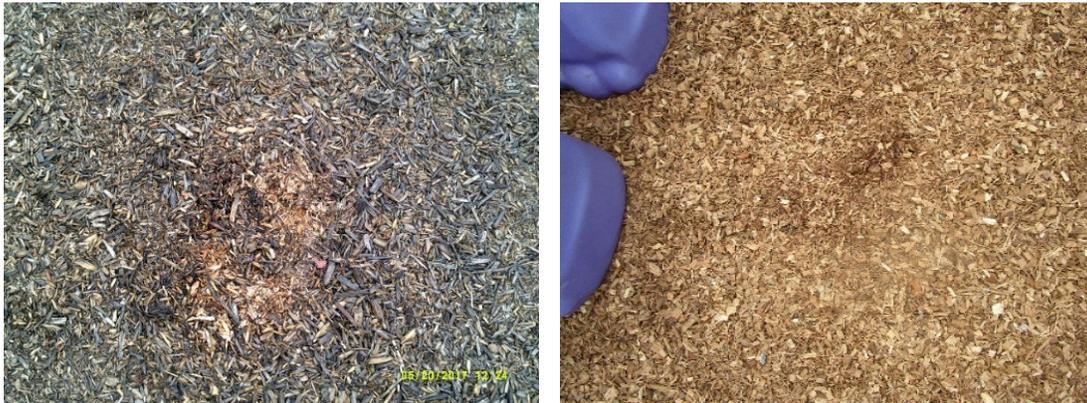
Ninety-eight percent (98%) of all wood products tested (specifically engineered wood fiber, wood chips, and wood mulch) were found to fall below 200 g at all three test sites. Furthermore, 94% of all wood products (specifically engineered wood fiber, wood chips, and wood mulch) were found to fall below 1000 HIC at all three test sites.

Figure 24. Different types of wood products that were tested

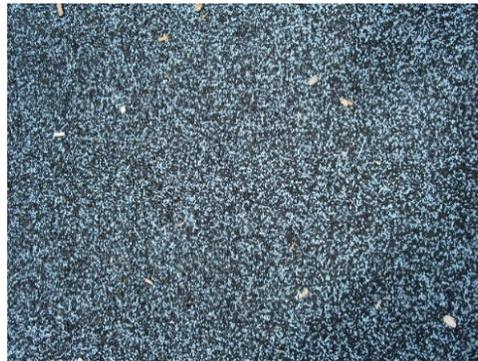
Eighty-five percent (85%) of unitary products (specifically poured-in-place and rubber tile) were found to fall below 200 g at all three test sites. Furthermore, 76% of all unitary products (poured-in-place and rubber tile) were found to fall below 1000 HIC at all three test sites.

Figure 25. One example of poured-in-place rubber tested

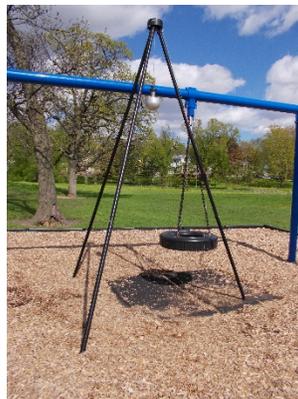
Kick mats were present at 17.5% of the playgrounds. They were either installed on top of the playground surface or underneath the playground surface material. The analyses, to date, have not included the effects of kick mats on top of or underneath the playground surface, this will be conducted in the future.

Figure 26. Kick mat under the tire swing. Both kick mat and wood product was tested
