**U.S. CONSUMER PRODUCT SAFETY COMMISSION
DIRECTORATE FOR ENGINEERING SCIENCES**

**EVALUATION OF
ELECTRIC LIGHTING PRODUCTS**

December 2007

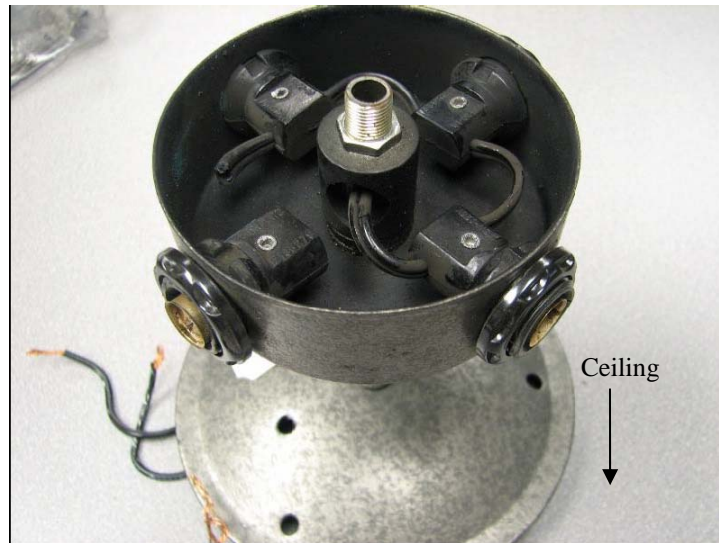
Figure 5. Lampholders in Incident Sample

The incident sample had one burned-out 25W bulb and two severely damaged 60W bulbs. The only remnants of the two 60W bulbs were two brass-colored screw shells that still remained in the two light sockets. The lighting fixture was rated for four 60W bulbs; the four lampholders were UL Recognized Components rated at 75W. The glass lens/cover and manufacturer's labels were missing. Figure 5 shows a view of the fixture base that encloses the wiring. Soot deposits were found on all surfaces inside the fixture base.

Examination of the incident lighting fixture showed thermal damage from overheated electrical connections within the lighting fixture base. There was evidence of a localized flame in one lampholder or socket (No. 4). The likely causes of the incident may have been from insufficient cooling from the radiant heat generated by the four light bulbs (total 240W), a poor wire-piercing connection, a short within the lampholder, or a combination of these.

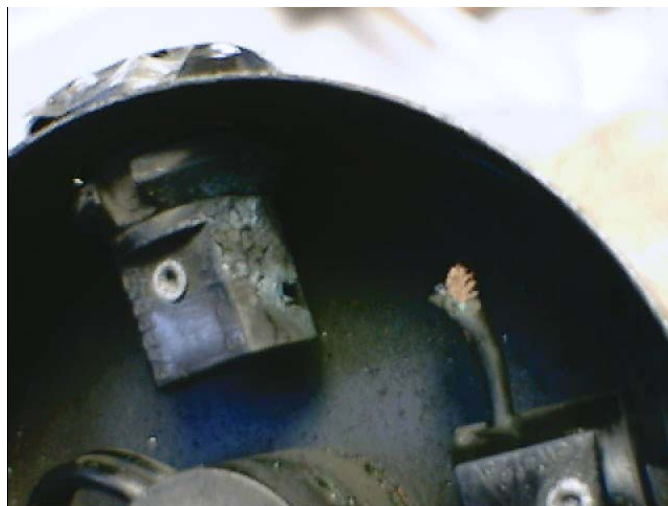
Figure 6. Damaged Fourth Socket of Incident Sample

The fourth socket was damaged from overheating; it appeared that a portion of the wiring to that socket was consumed in a local fire, as shown in Figure 6.

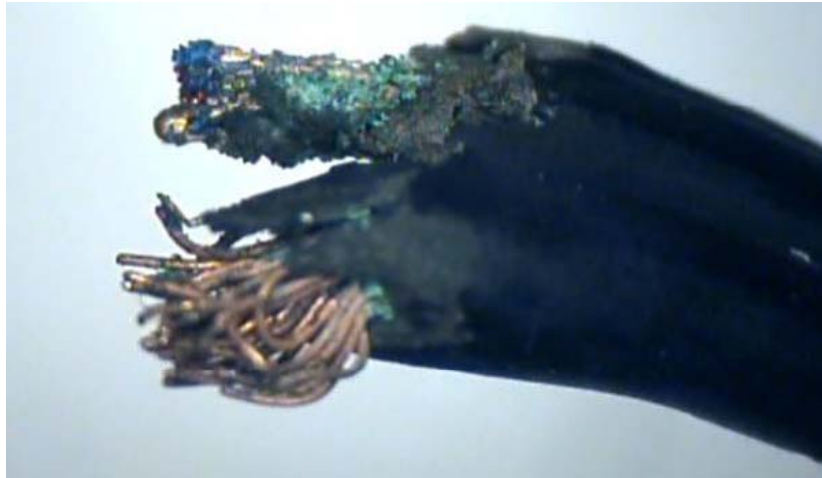
Figure 7. Close-up of Wiring to the Fourth Socket

A close-up view of the wiring leading to the fourth socket showed a ball of re-solidified copper on the “hot” conductor (a small amount of insulation was trimmed away for examination), as shown in Figure 7. In addition, the condition of the exposed wiring inside the fixture base showed signs of thermal damage. The wiring to the damaged fourth socket was brittle; the exposed wiring that connected the other three sockets was quite stiff and not pliable. However, the rest of the wiring, including the portion that was inside a rod leading to the ceiling disk, retained its pliability and did not show any signs of thermal damage.

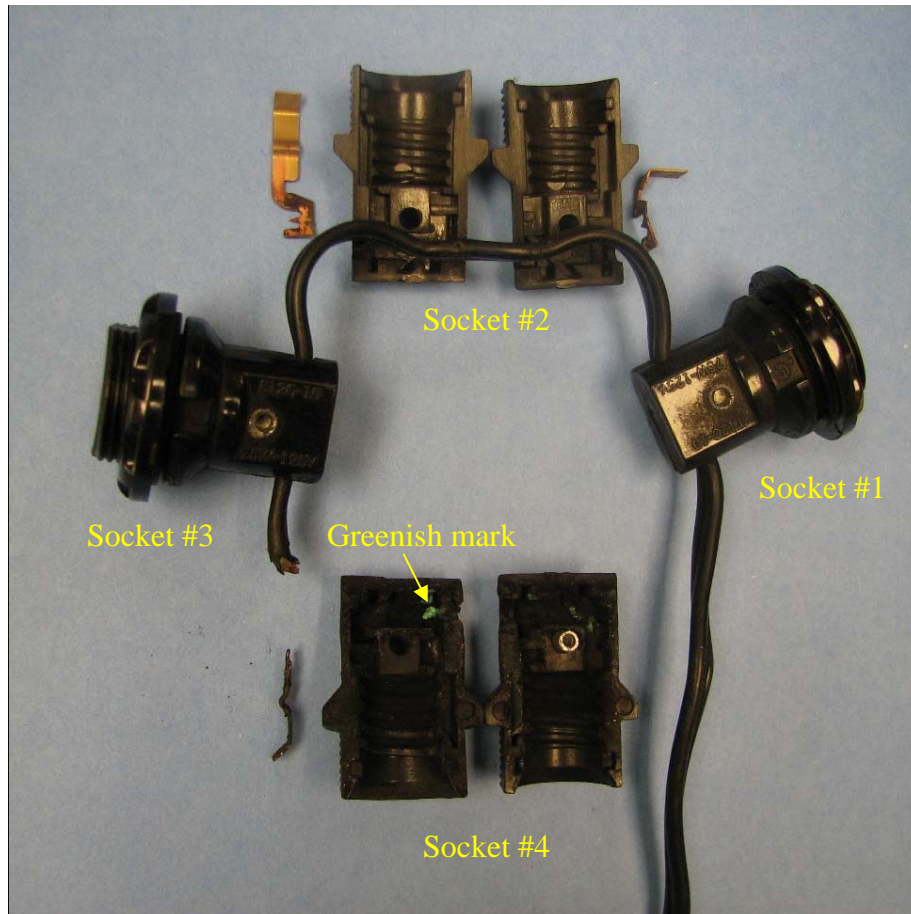
Figure 8. Four Sockets Removed from Fixture with Socket Nos. 2 and 4 Disassembled

Figure 8 shows the interior conditions of sockets No. 2 and No. 4. As shown, both insulation-piercing terminals of socket No. 2 were still intact and undamaged. Socket No. 4 had only part of its vertical insulation-piercing terminal (neutral contact); the lower portion that had a sharp triangular tip for piercing the insulation was missing and perhaps consumed by the localized overheating. The horizontal insulation-piercing terminal (hot contact) was completely consumed and only a greenish mark was left where the electrical wire entered the socket. The remains of this socket were charred and brittle.

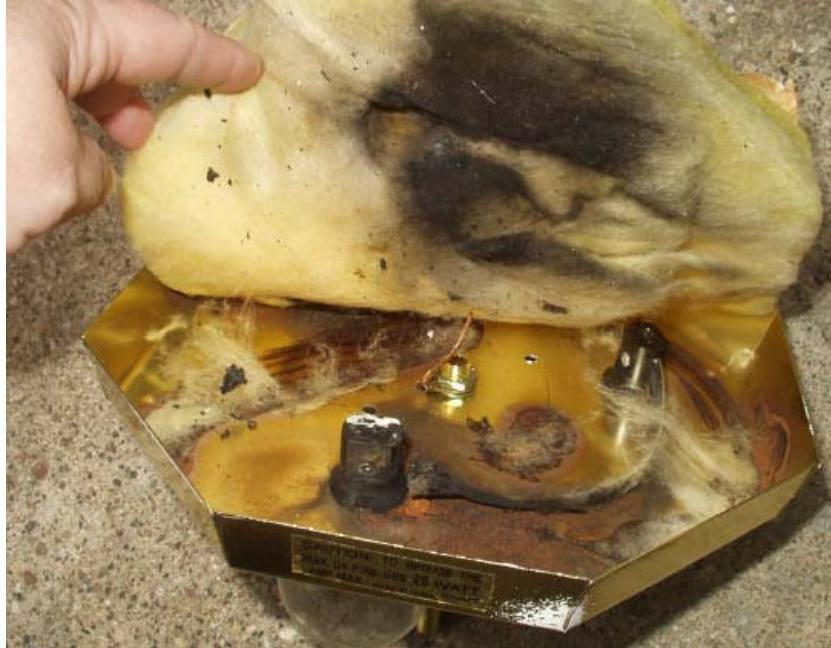
Figure 9. Incident Sample “Old Design”

Figure 9 shows the thermal damage on the incident “old design” sample. Soot deposits were seen on the fiberglass insulation. The parallel-conductor power supply cord, which had a temperature rating of 125°C, was separated from the last socket. Copper balls were observed on each conductor at the last socket terminal; the socket was brittle. The thermal damage appeared to be the result of localized arcing.

It appears that overlamping of the incident sample may have contributed to the failure. The bulbs installed in the lampholders were 25W, 40W, and 60W; the bulbs should have been 25W maximum. The markings on the lampholders were not consistent with the markings on the socket or the fixture, which could be misinterpreted by a user.

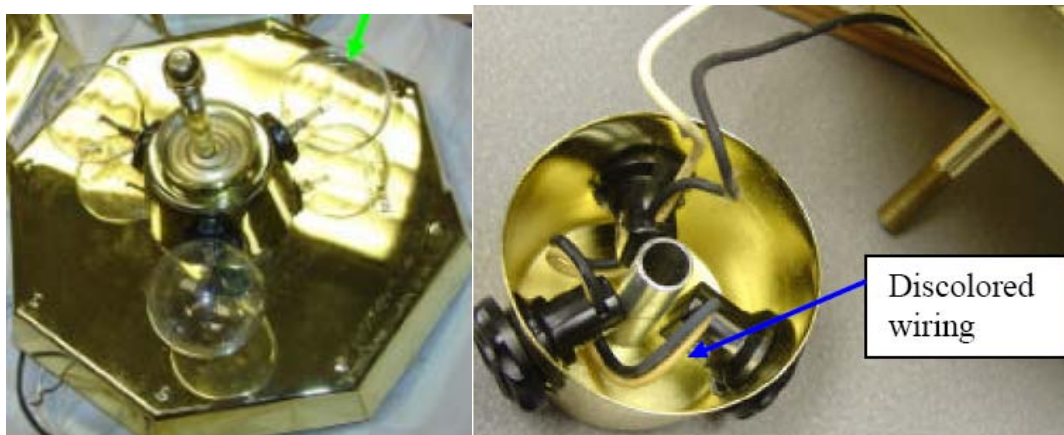
Figure 10. The Exemplar “New Design”

The new design fixture had three sockets mounted horizontally into an extension at the center of the fixture, as shown in Figure 10. The wiring in this fixture had a temperature rating of 150°C. This fixture contained two burned-out 60W bulbs (broken filaments and/or detached glass bulb) and one operational 25W bulb. The sockets of the fixture appeared normal, but the white insulation of the wiring was discolored.

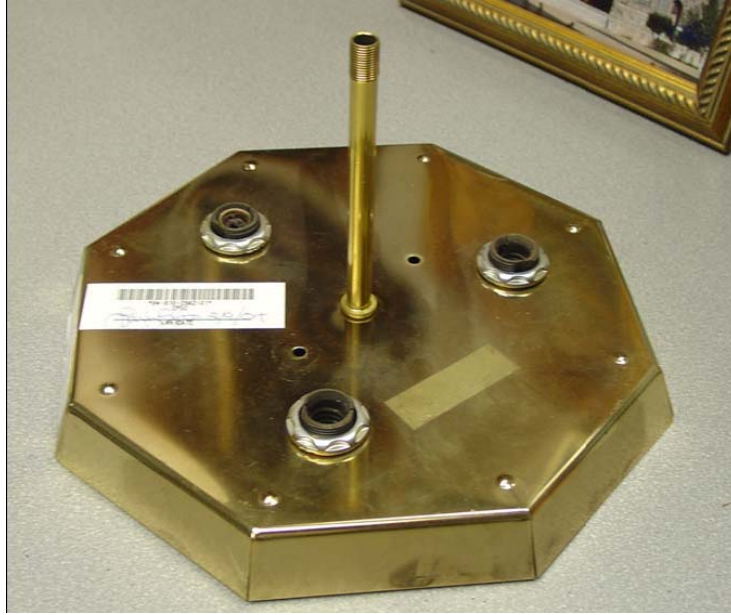
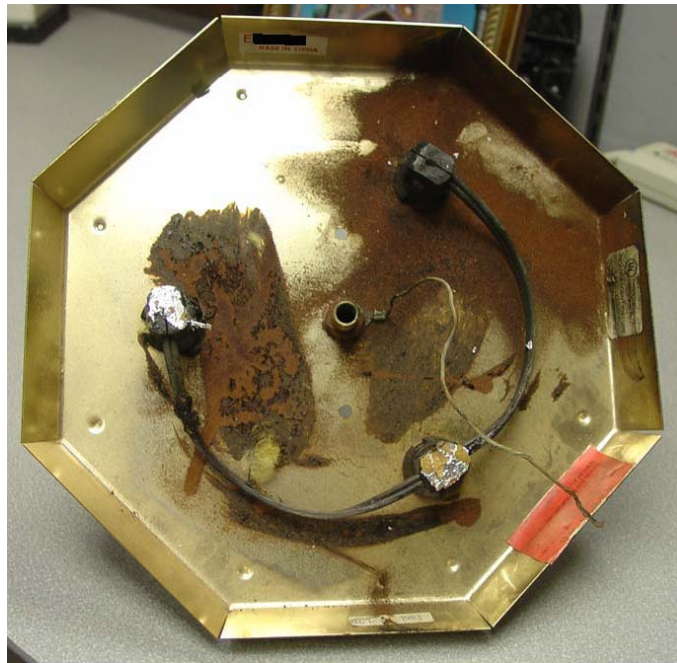
Figures 11 and 12 show the lighting fixture as received. The glass cover was not included in the sample. One socket contained the base of a bulb. The housing/plate was slightly rusty in two areas but was otherwise intact. On the exposed surface of the plate, there was a warning label to use only 25-watt bulbs or lower; the label was faded and nearly illegible. The bare ground conductor was firmly attached to the plate on the top (ceiling side) of the fixture.

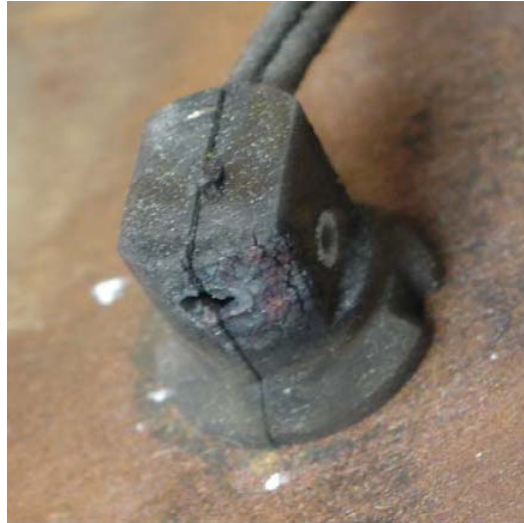
Figure 13. Overheated Socket

The plastic sockets were overheated and cracked. The interior of one socket (physically, the first one attached to the electrical wiring as it entered the fixture from the house wiring) was blackened and sooty inside. When this socket was split open, it was found that one of the insulation-piercing terminals had burned away. The other terminal was burned and corroded.

Most likely, the initial assembly of the socket/insulation piercing terminals to the wiring resulted in a poor electrical connection. Over a period of use, the poor connection resulted in overheating of the connection and socket. The three bulbs likely exacerbated the problem by providing additional heat, which would be trapped between the metal disk

and the fiberglass. The wiring insulation degraded, and the copper conductors became corroded and embrittled.

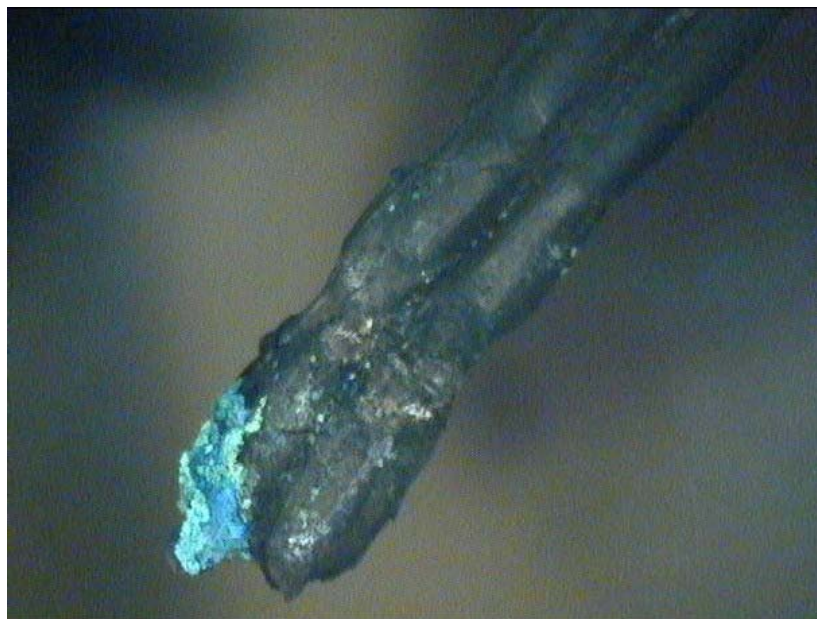
Figure 14. Electrical Wiring in Socket

The foil insulation (the side that is positioned against the plate) was covered with soot in the area next to the socket. Inside the burnt socket, the input power wiring was burned and melted and had green/blue corrosion on the copper wire strands. Figure 13 shows a close-up picture of the socket. Figure 14 shows a picture of the wiring after its removal from the socket. The wires showed no sign of arcing or beading.
