**Status Report on the Preliminary Analysis of HVAC, Gas
Distribution, and Fire Safety Equipment Installed in Homes with
Chinese Drywall**

U.S. Consumer Product Safety Commission

November 2009

**Interim Report on the Examination of Corrosion Damage in
Homes Constructed with Imported Wallboard
I. Examination of Samples Received September 28, 2009**

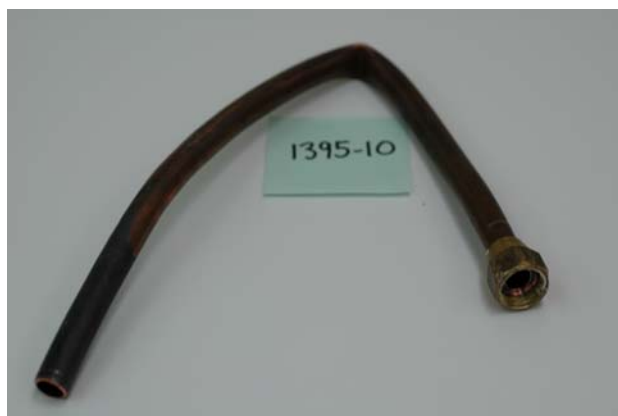
Figure 6 – Fireplace Gas Supply

All samples of natural gas copper tubing exhibited varying degrees of discoloration. This discoloration was due to the presence of a thin layer of a black substance (Figures 6 and 7). The extent of discoloration appeared to vary with the thickness of the layer of this black substance.

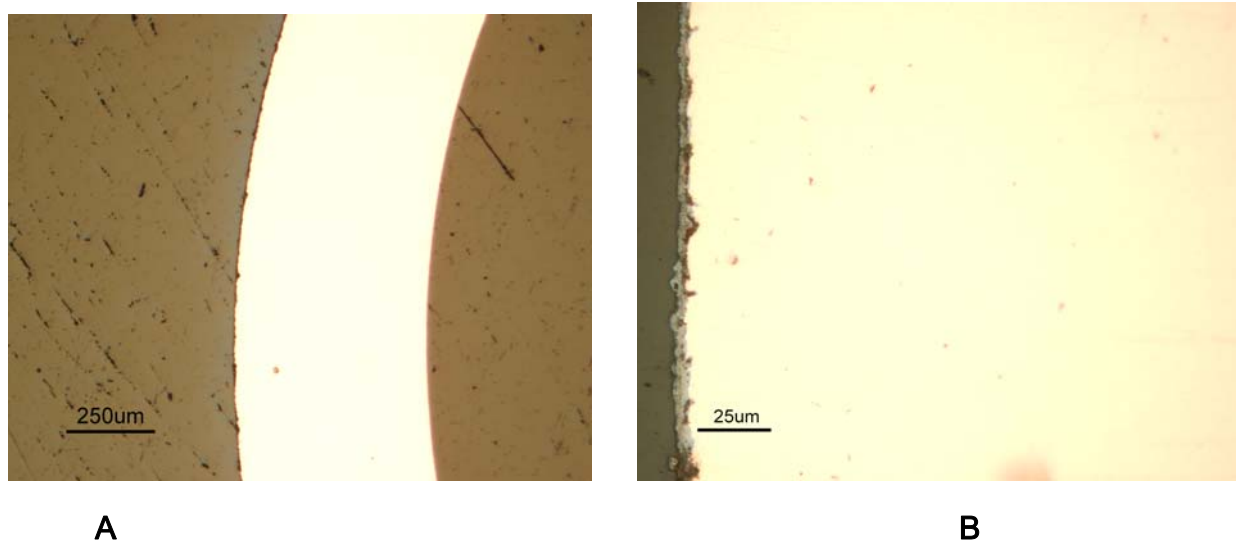
The thickness of the black corrosion product was measured using optical microscopy of sample prepared in cross section. For this analysis, a natural gas supply line was cut perpendicular to the axis of the tube and mounted in epoxy and polished down using standard metallurgical practice exercising care to maintain the edge of the sample with the corrosion products in place. Figures 8a and 8b show optical micrographs of this sample. The measurements indicate that the corrosion product layer varied from 5 to 10 μm thick.

Figure 8a and 8b – Optical micrographs of the wall of a copper natural gas supply line and the corrosion product layer at two magnifications.

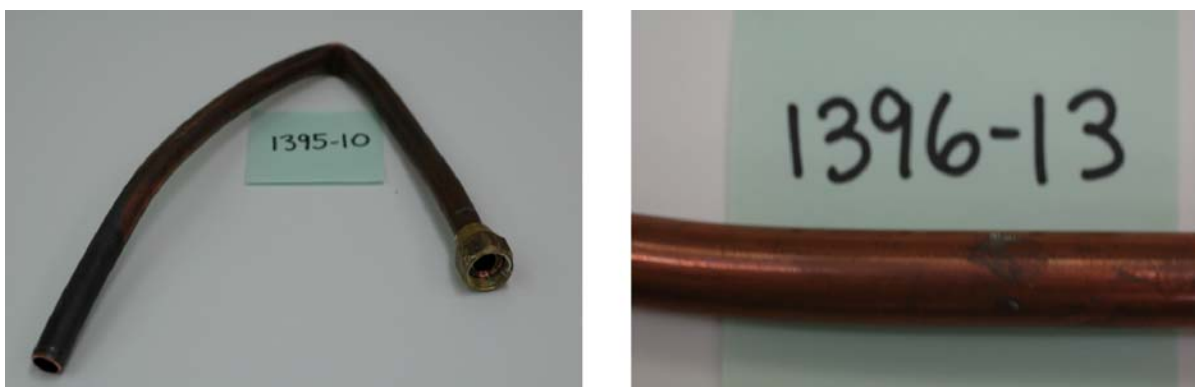
The lengths of copper tubing were discolored to varying degrees. This discoloration, which is illustrated in Figure 1, was found to be due to the presence of a thin adherent layer of a black substance. This is clearly illustrated in Figure 2 where the sample number has been scribed into the sample exposing fresh bare copper. The contrast in this figure is obvious. While this film adhered to the surface, physical contact would result in the transfer of a small quantity of a fine black powder from the film. In some cases, the discoloration was found to be very uniform, but in other cases it was irregular. The extent of discoloration varied with the thickness of the layer.

Figure 1 – Photographs of two representative samples of copper natural gas supply tubing.

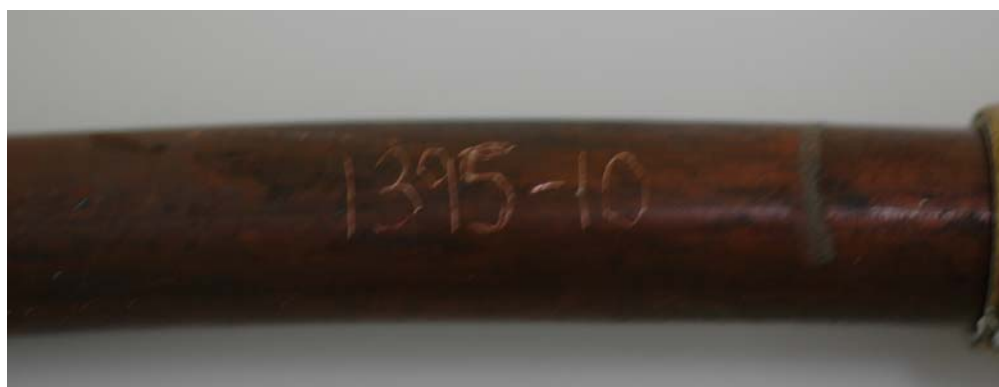
Figure 2 – Scribe marks illustrating the contrast between the color of bare copper and a sample of copper natural gas line tubing.

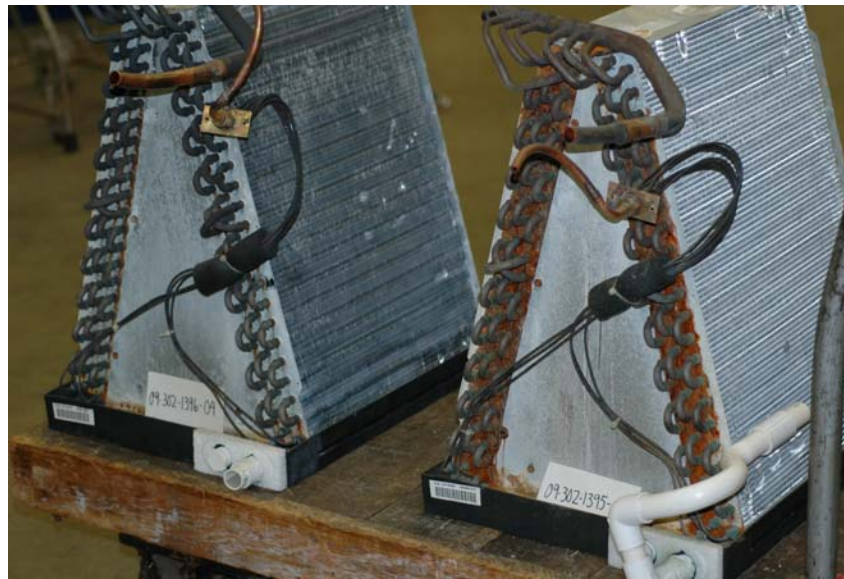
The air conditioner evaporator coils were also examined, Figure 3. From the two coils in this figure it can be seen that all exposed copper surfaces have turned dark. These coils are constructed out of parallel lines of copper tubing placed through thin sheets of aluminum that

serve as the heat transfer fins. The copper tubing is linked together by soldered U-bends to the ends of adjacent lengths of copper tubing. The end plates that hold this assembly in place are made out of galvanized steel. Copper manifolds and valves complete the assembly. Figure 4 is a close-up of the end plates and the U-bend region. In this figure, brown and orange corrosion products can be seen on the galvanized end plates, while black and green corrosion products can be seen on the copper tubing. The normal patina that forms on copper in the cyclically wet and dry environment of an air conditioner evaporator coil would be expected to contain copper (I) or copper (II) ions in oxides (black to brownish-red), carbonates (green to blue), sulfates (bright blue), and chlorides (greenish white to blue-green) [1,2]. Again, the black color was found to be due to the presence of a thin layer of a loose black powder.

Figure 3 – Photograph of the two air conditioner evaporator coils showing the black discoloration of the copper U-bends and corrosion of the end plate.

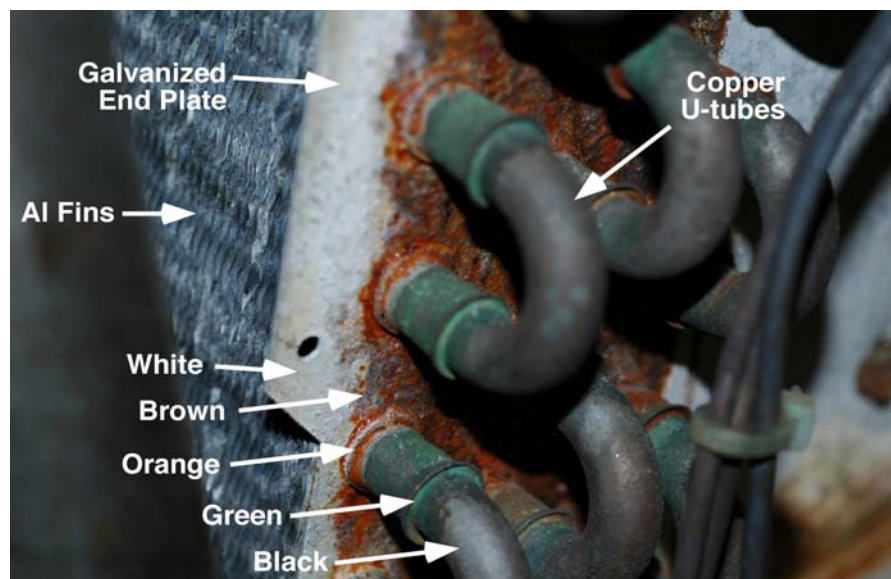
Figure 4 – Close-up photograph of the U-tubes and end plate of an air conditioner evaporator coil showing that there appears to be 5 colors associated with the corrosion products: white, brown, orange, green, and black.

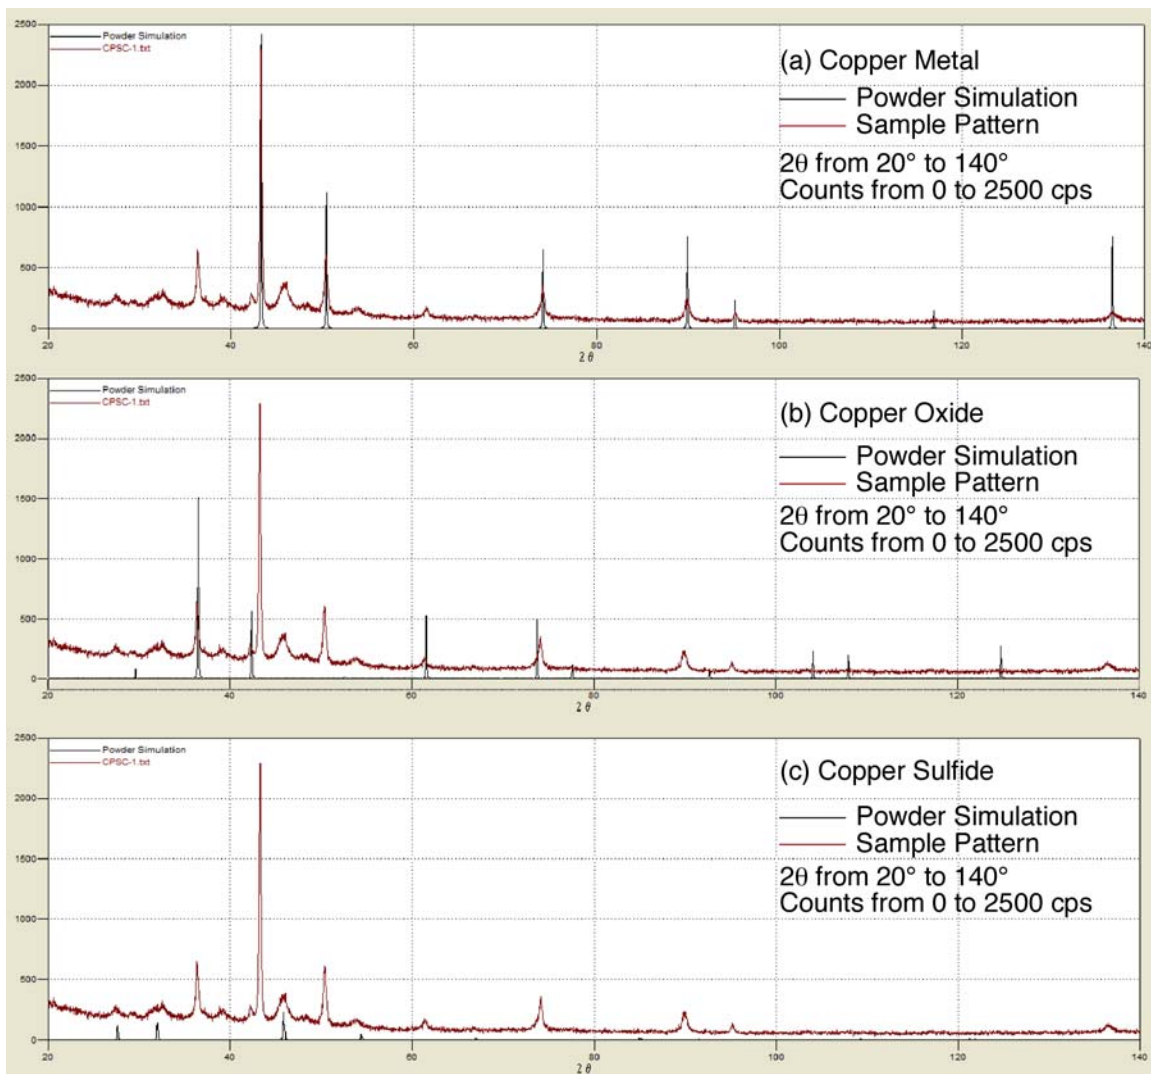
Figure 6 shows the results of these measurements in red along with the peak locations in black for copper metal (Figure 6a), copper (I) oxide (Figure 6b) and copper (I) sulfide (Figure 6c) as listed in the International Crystal Structure Database (ICSD). This figure shows that peaks corresponding to all three of these phases are present in the sample of scrapings from the surface of the copper natural gas supply line. Given that the sample was collected by scraping the surface of copper metal with a sharp razor blade, the peaks for copper and copper oxide were expected since copper is a soft metal compared to the steel of the razor blade and will normally form copper oxide when exposed to air. The third phase, copper sulfide (Cu_2S) is not a typical atmospheric corrosion product as the concentration of the reduced sulfur species, such as H_2S , required to form this product is usually very low under normal atmospheric conditions. [1, 3-5] Figure 7 is a summary of the XRD results showing that all but two small peaks, indicated by question marks, are accounted for by these three phases.

Figure 6 Powder diffraction patterns for the sample of corrosion products scraped off a copper natural gas supply line (red) with, identified in black, the peaks for (a) copper, (b) copper (I) oxide (ICSD #38233), and (c) copper (I) sulfide (ICSD #95395).

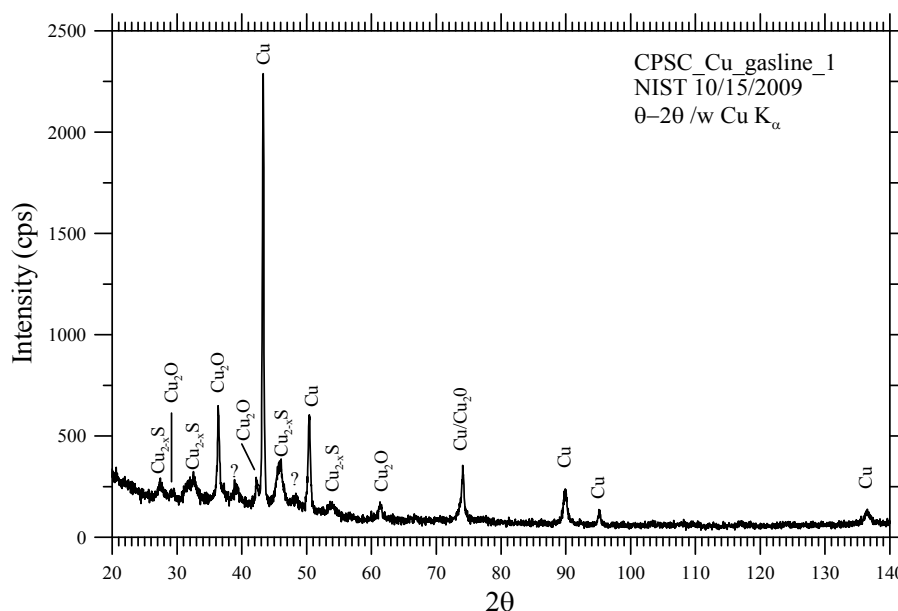
Figure 7 – Summary of peaks found in the corrosion product sample and their identification for showing that only two small peaks were unidentified by the three phases.

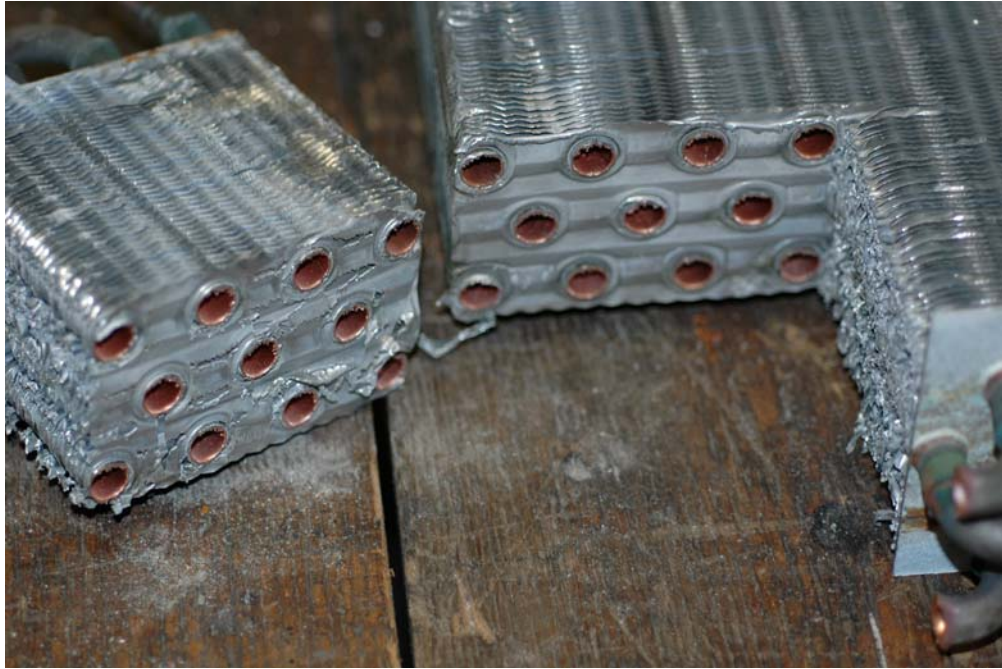
To evaluate the possibility of corrosion damage occurring between the aluminum heat transfer fins and the copper tubing inside them, the heat exchanger unit was sliced with a band saw as shown in Figure 8, to expose these internal surfaces for examination of the copper. No evidence of localized attack was found, and the black corrosion product layer was not detected by visual examination.

Figure 8 – Air conditioner evaporator coil after slicing to allow for examination for corrosion damage between the aluminum sheets and the copper tubing.

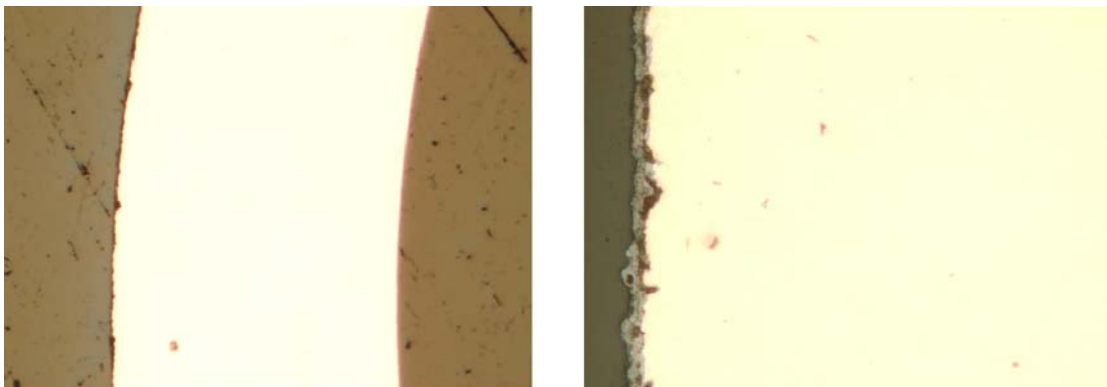
The thickness of the black corrosion product was measured using optical microscopy of samples prepared in cross section. For this analysis, samples of natural gas supply lines were cut, mounted in epoxy, and polished using standard metallurgical practice, exercising care to maintain the edge of the sample with the corrosion products in place. Figure 9 shows optical micrographs of this sample where the corrosion product layer varied from 5 μm to 10 μm thick.

Figure 9 – Optical micrographs of the wall of a copper natural gas supply line and the corrosion product layer at two magnifications (wall \approx 1.2 mm thick).
