# **Report on Study of Electrical Component Corrosion Related to Problem Drywall**

Division of Electrical Engineering  
Directorate for Engineering Sciences  
U.S. Consumer Product Safety Commission

March 2011

## **Report on Accelerated Corrosion Studies of Electrical Components**

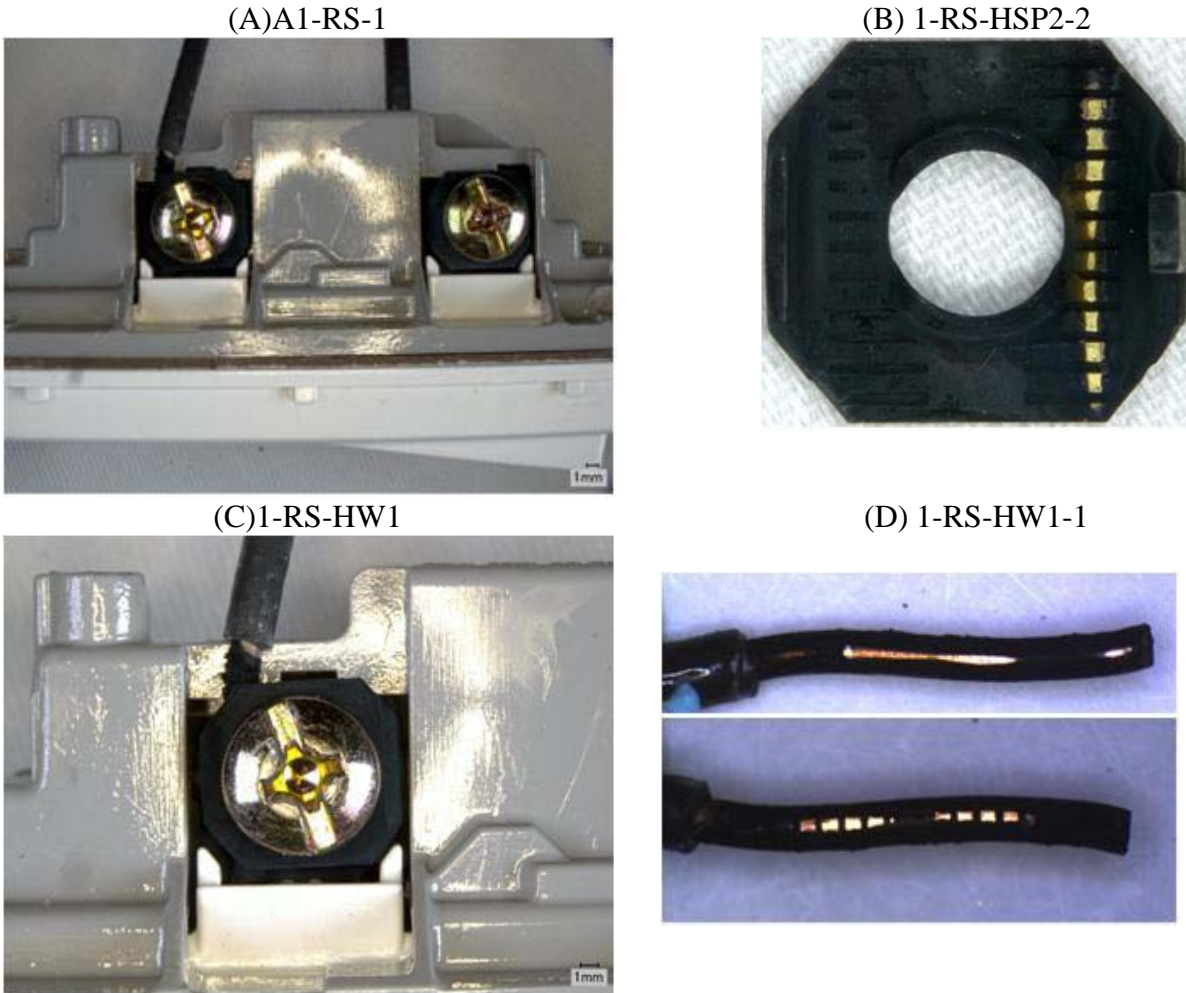
Figure 11 shows macro images for the rocker switch. The image in (A) shows one set of electrical connections to the switch. The image in (B) is of the contact plate under one of the screws. The image in (C) shows a close-up of one of the connections, and (D) shows both sides of the hot wire that was connected to the switch. The black color of the metal parts is the result of the sulfidation process. The contact plate is tarnished completely. Importantly, a row of shiny contact points is visible where the wire contacted the plate. There is a corresponding set of similar features on the wire, where the wire was in intimate contact with the screw. Note that bare metal is visible, indicating that the interface was shielded from the active species in the gas. The screws exhibit less attack. The wire shows considerable corrosion, with “furry” growth observed next to the insulation. Additionally, there is a band of bare metal adjacent to the insulation that appears to have suffered less attack. That is likely the result of slight movement of the wire, exposing fresh surface that had been protected previously by the insulation. This does point out the fact that the insulation shields the underlying metal from exposure to the gas. However, it is also important to note that this accelerated test is designed for boldly exposed metals. It is not designed to accelerate transport of aggressive species through the insulation. Thus, it does not represent 40 years relative to sulfide diffusion and cannot be used to assess the ability of the insulation to protect the wire over a 40-year life.

Figure 11. Optical images from sample 1-RS (rocker switch). The contact plate is shown in B, and one of the hot wires is shown in D (both sides of the same wire are shown). Note the presence of extensive corrosion product on the copper hot wire and contact plate.

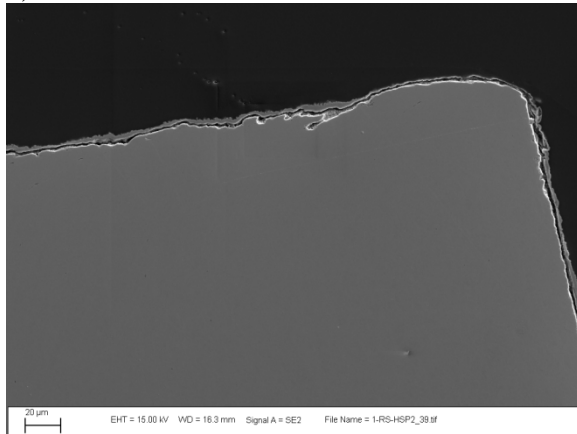
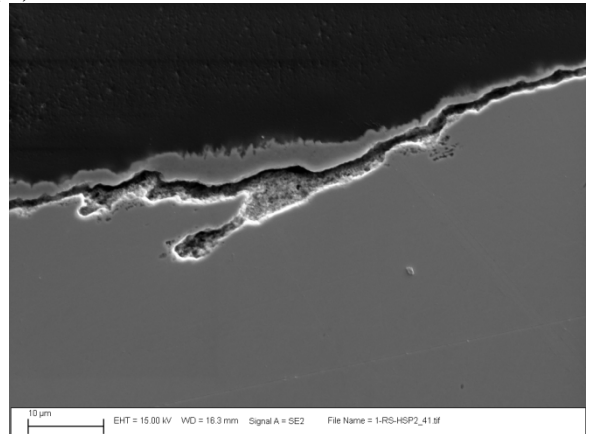
Figure 12. SEM cross section of the hot screw plate (HSP2) from the rocker switch in Circuit No. 1.

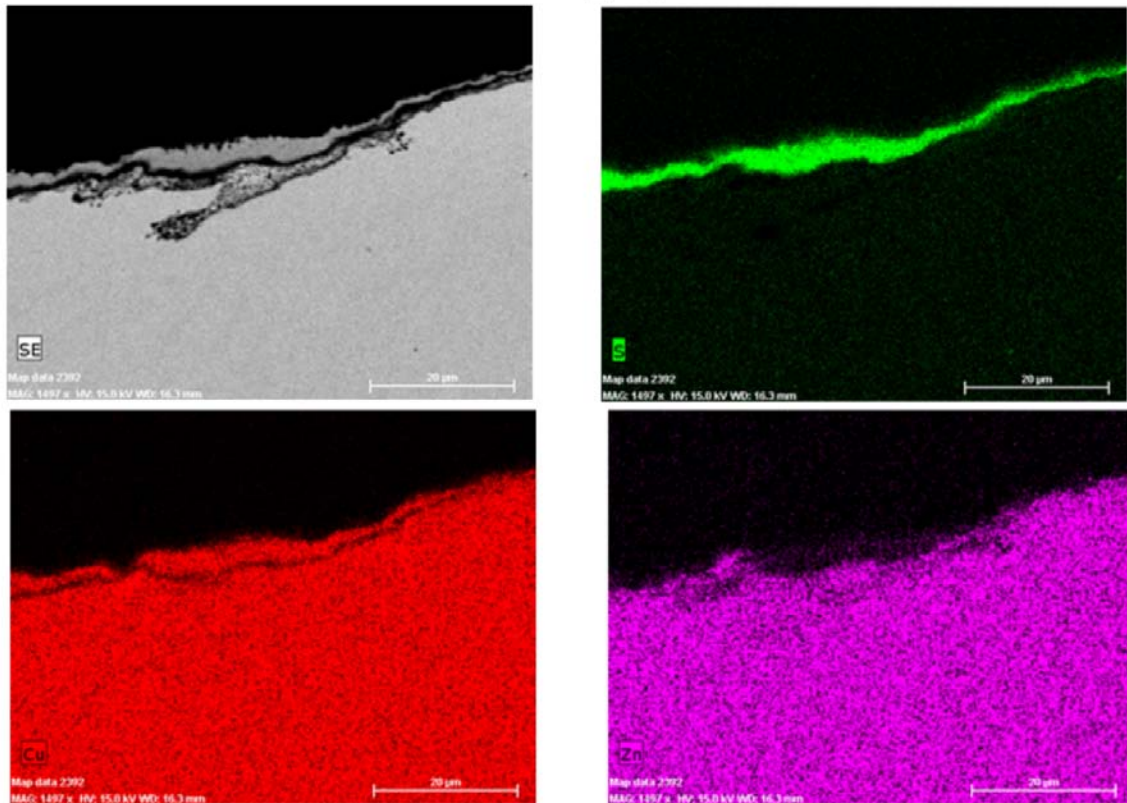
Figure 13. SEM image (top left) and elemental maps using EDS of HSP2: sulfur (green), Cu (red), and Zn (purple).

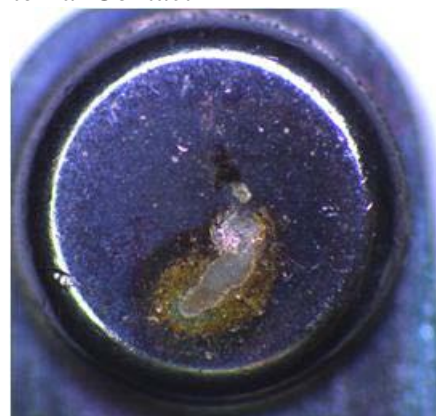
Figure 17. Photos of inside of GFCI receptacle from Circuit 1.

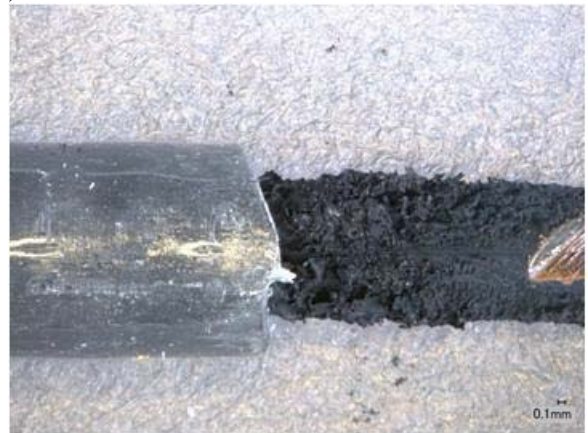
Figure 20. Optical photographs of hot wire removed from receptacle from Circuit 1.

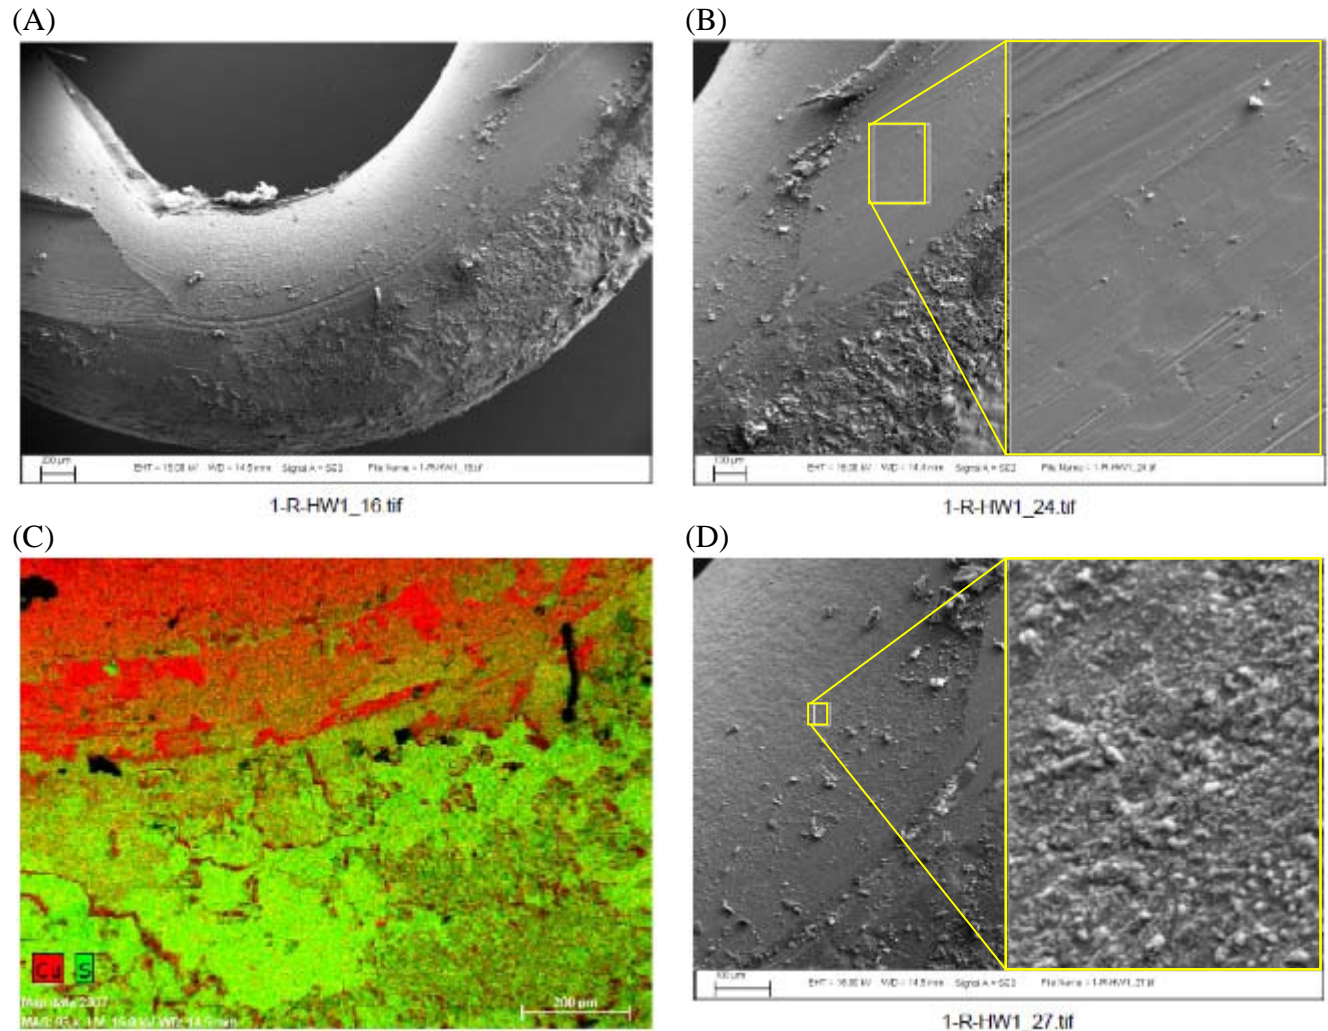
SEM analyses of the hot wire are shown in Figure 21. The location of these analyses is the bend in the wire. Note that the corrosion is significantly more extensive on the outside of the bend. The elemental maps clearly show the difference in corrosion product thickness, clearly a result of shielding the inner portion of the bend from the corrosive gasses.

Figure 21. SEM image (A) of hot wire 1-R-HW1; (B) SEM image of screw contact surface with zoomed area (top right); (C) EDS elemental map showing copper (red) and sulfur (green) distribution; and (D) SEM image ~300  $\mu\text{m}$  from contact (all with 100  $\mu\text{m}$  measurement bars).

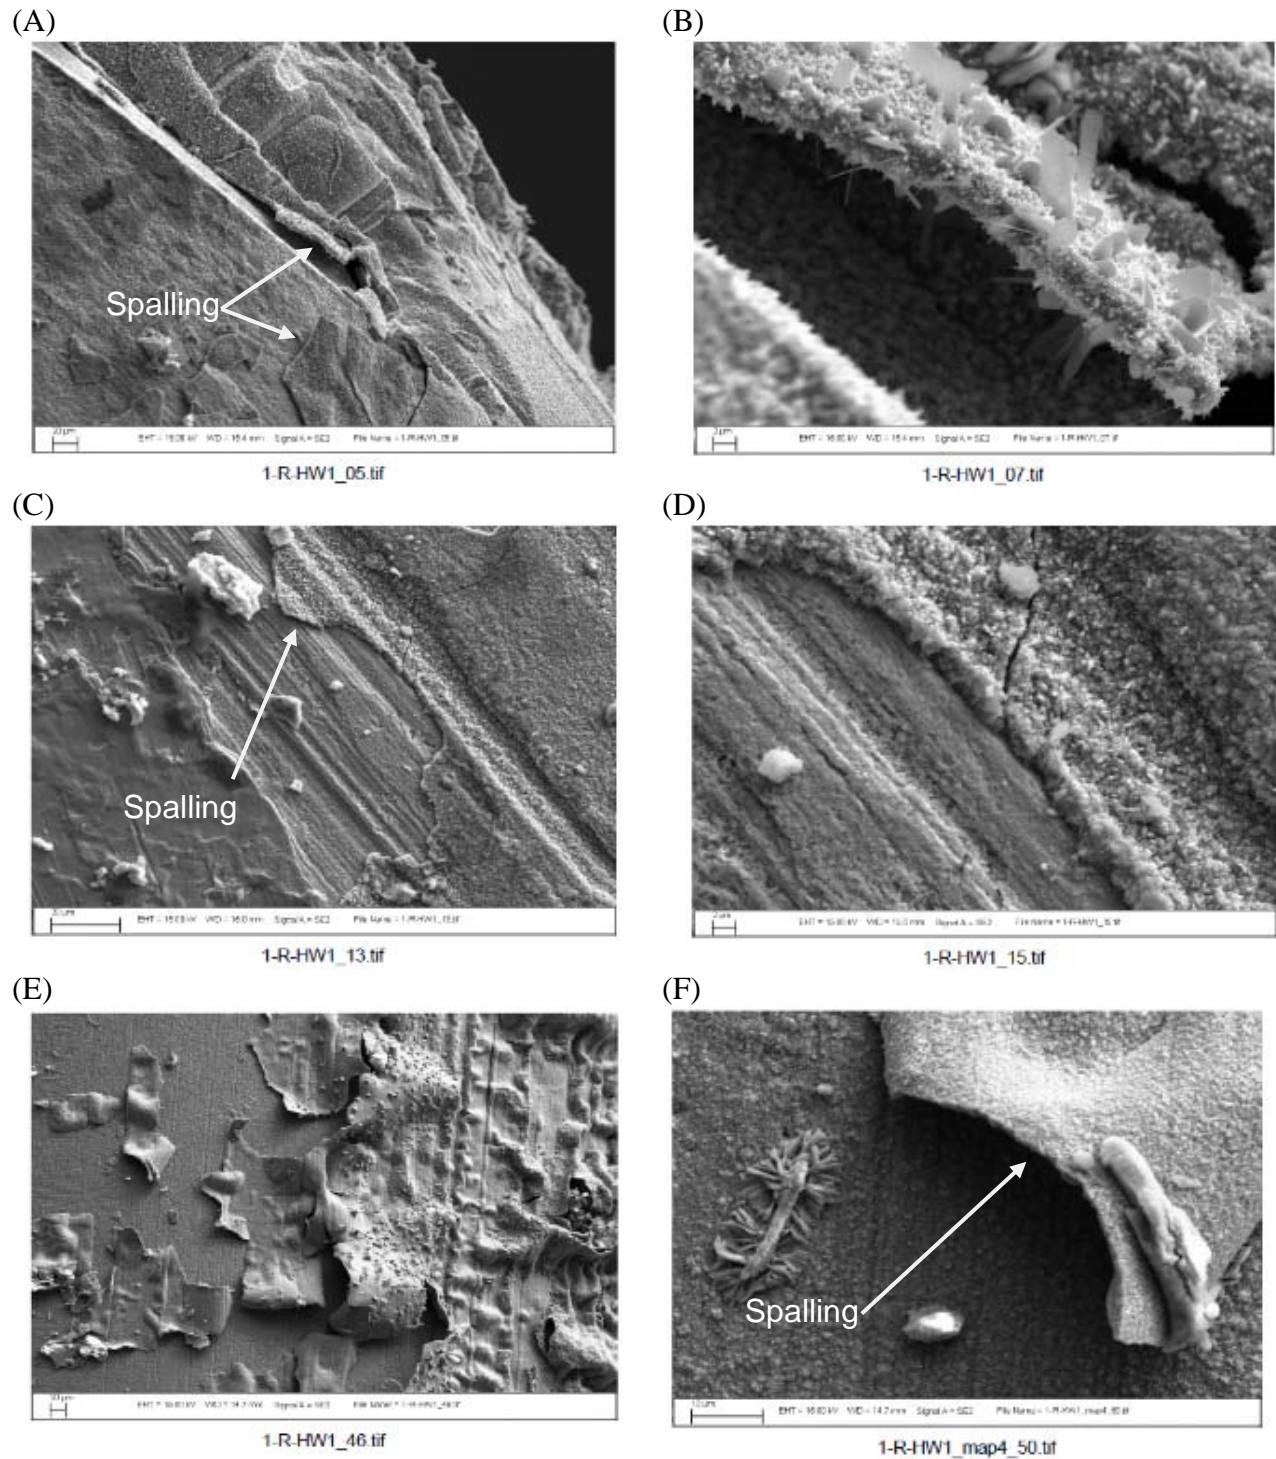
Figure 22 presents SEM images from various locations on the hot wire. Several corrosion product morphologies can be seen. In addition, there is evidence of spalling of the film. Once the film ruptures, it reforms below the previous layer.

Figure 22. SEM images showing the different morphologies of corrosion products on the hot wire from the receptacle in Circuit 1.

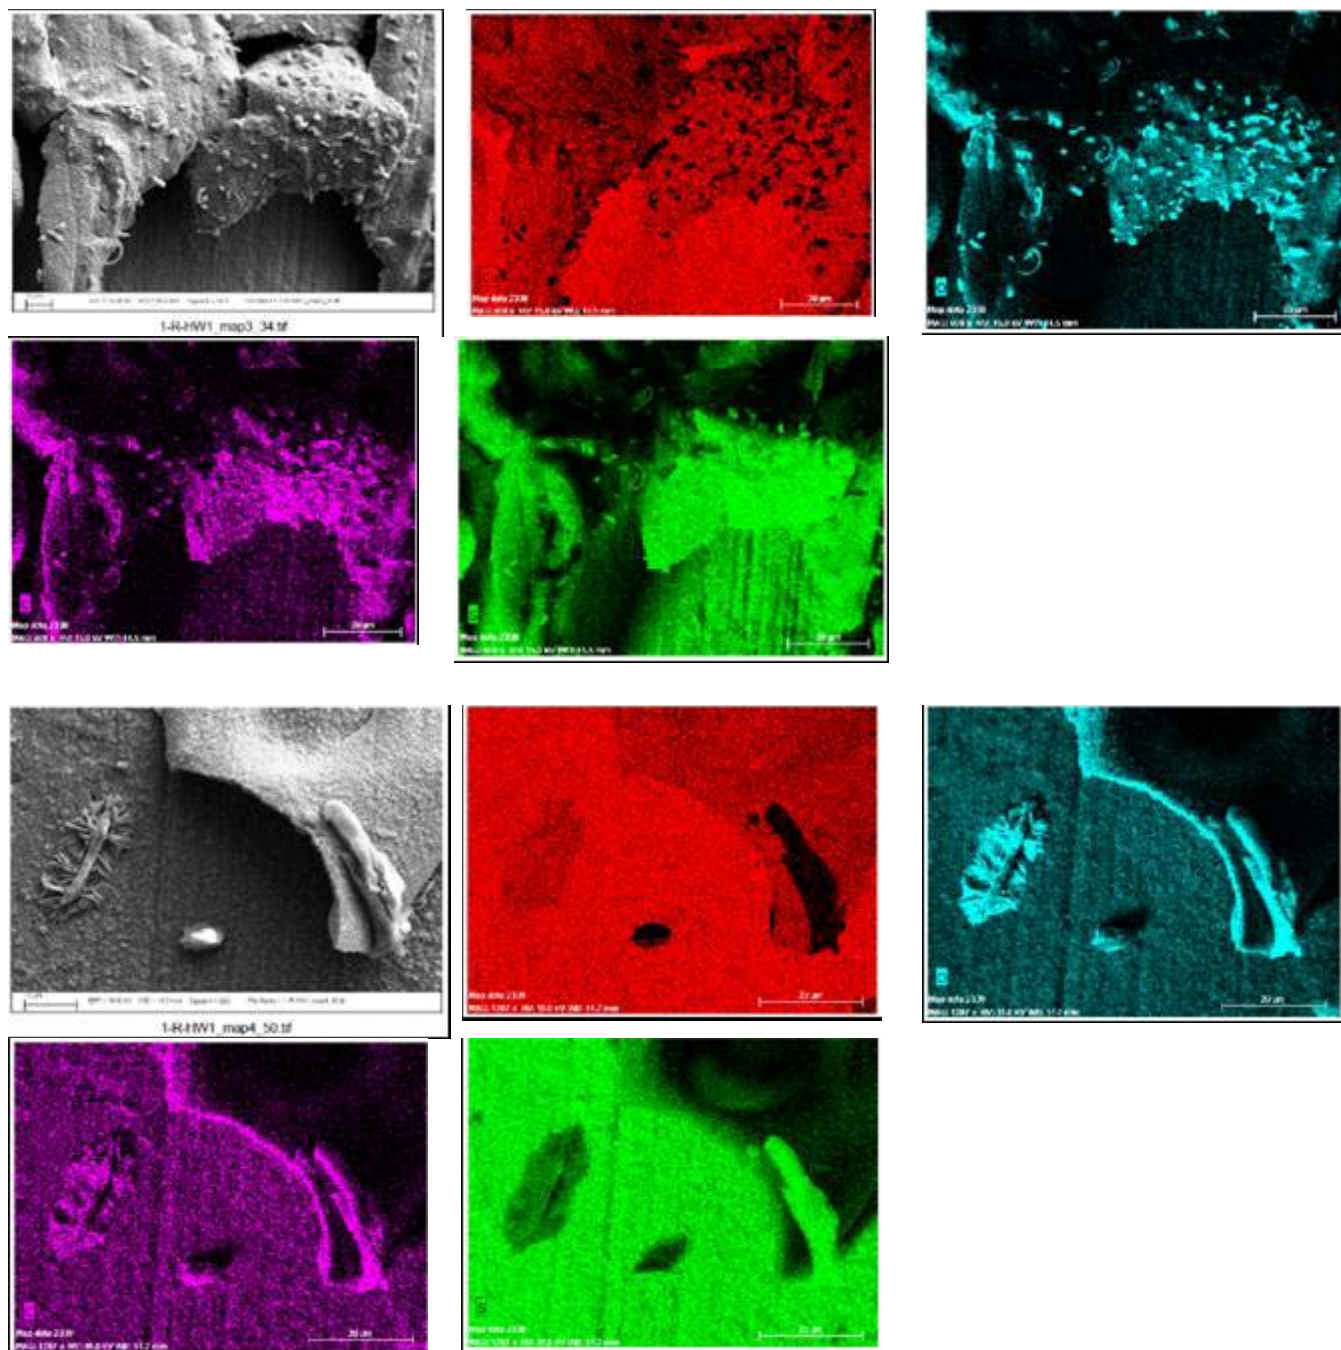
In addition to differences in film morphology across the surface, there is also evidence of differences in film composition. An example is shown in Figure 23. Clearly, certain features are oxygen rich, while others are sulfur-rich. The oxygen-rich features are on the outer surface of the film, and are likely due to oxidation of the surface of the copper sulfide.

Figure 23. SEM images and elemental maps for two areas on wire 1-R-HW-1, showing copper (red), oxygen (blue), carbon (purple), and sulfur (green) distributions.

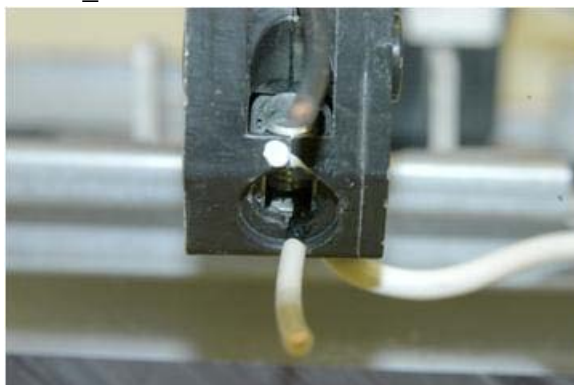
Figure 24. Optical images of the load center and AFCI for Circuit 1.

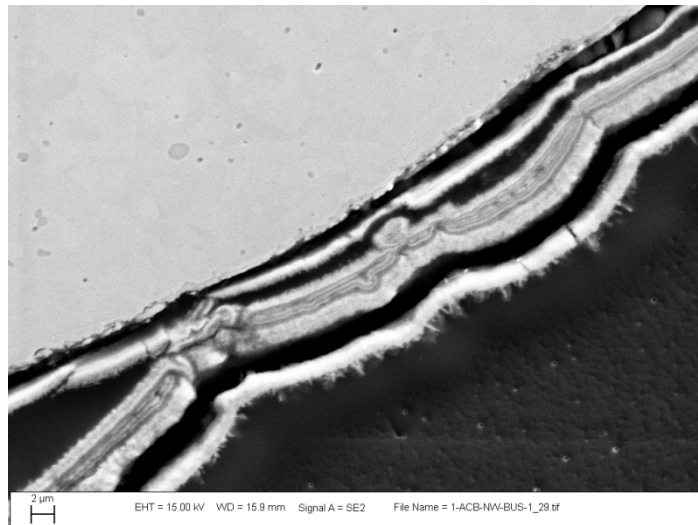
Figure 25. SEM image of the cross section of the neutral wire from the arc-fault circuit breaker from Circuit 1.

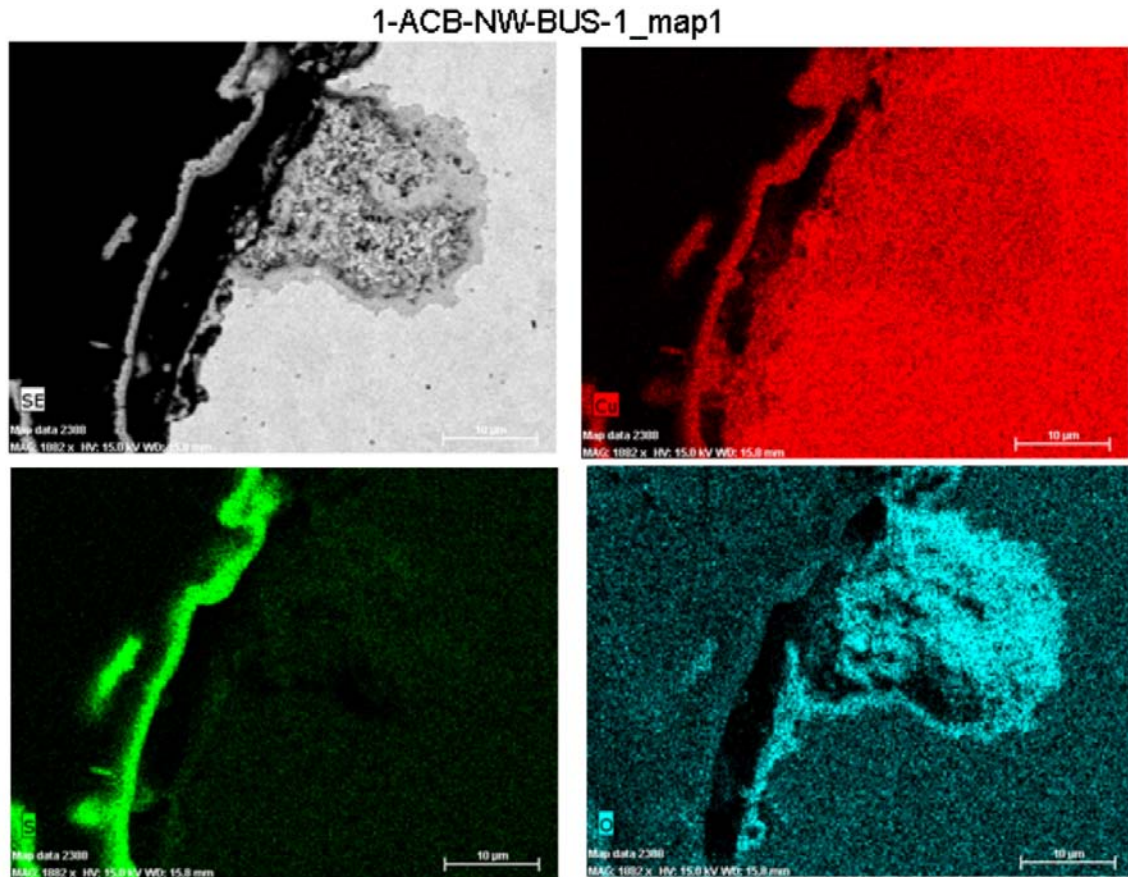
Figure 26. EDS map of wire cross section showing oxygen in “pocket. The elemental maps for Cu (red), S (green), and oxygen (blue) are shown.

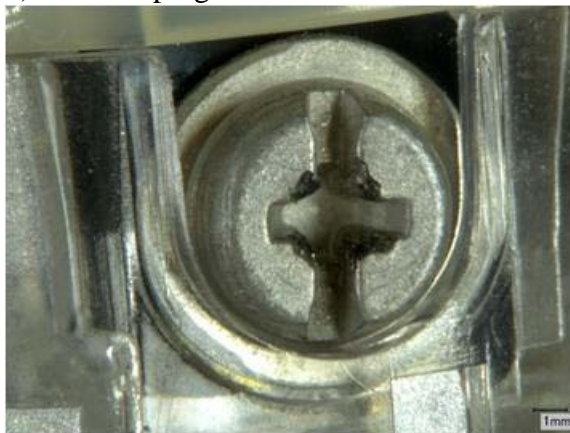
Figure 30. Optical images of the plug used to connect the standard receptacle to the GFCI receptacle in Circuit 1. The prongs and screws are blackened relative to those on a new, as-received, unexposed plug.

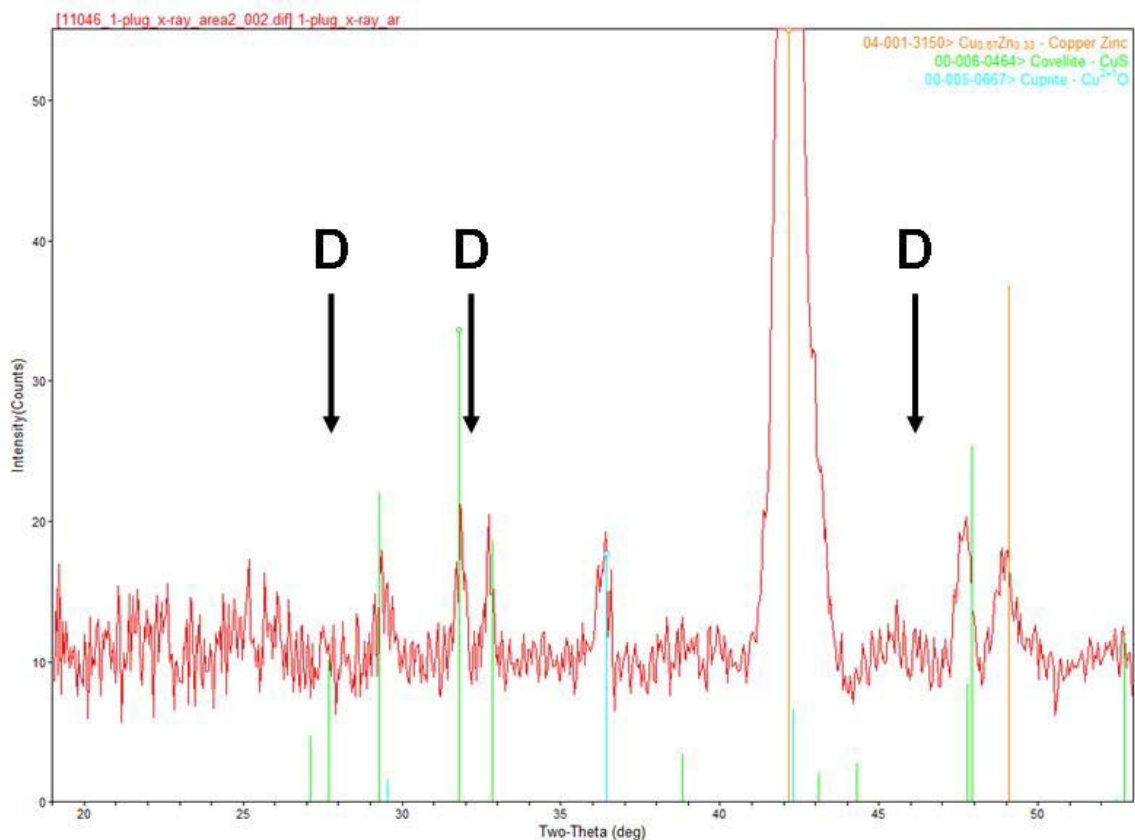
Figure 31.  $\mu$ -XRD data for ground prong of plug from Circuit 1, showing cuprite (blue), covellite (green), and copper/zinc (orange) peaks observed and labels where digenite (D) peaks would occur, if present.

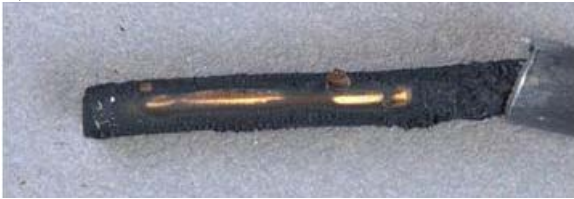
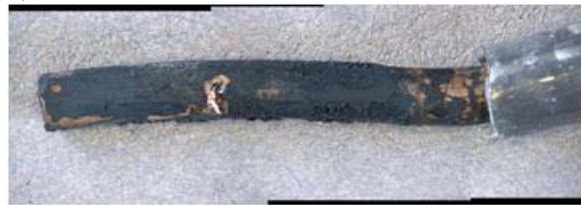
Figure 35. Optical images of wires from the rocker switch in Circuit 2. Both the standard wire connection and the push-in connection are shown.

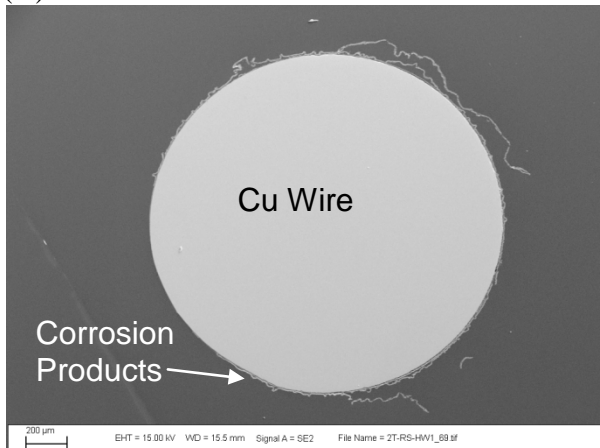
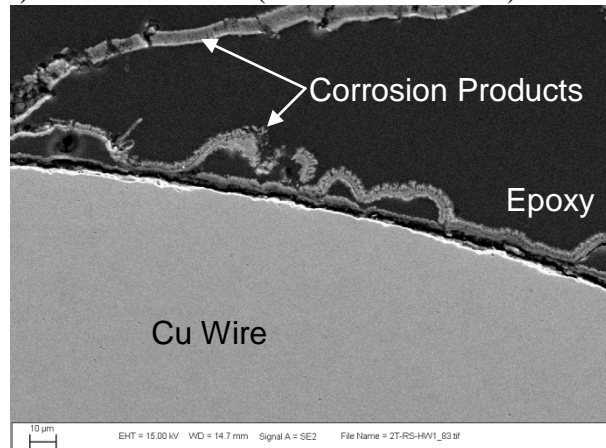
Figure 36. SEM images of the cross section of the rocker switch hot wire from Circuit 2. The image on the left shows a low magnification image of the wire, with a high magnification image showing details of the corrosion product layer presented in the figure on the right.

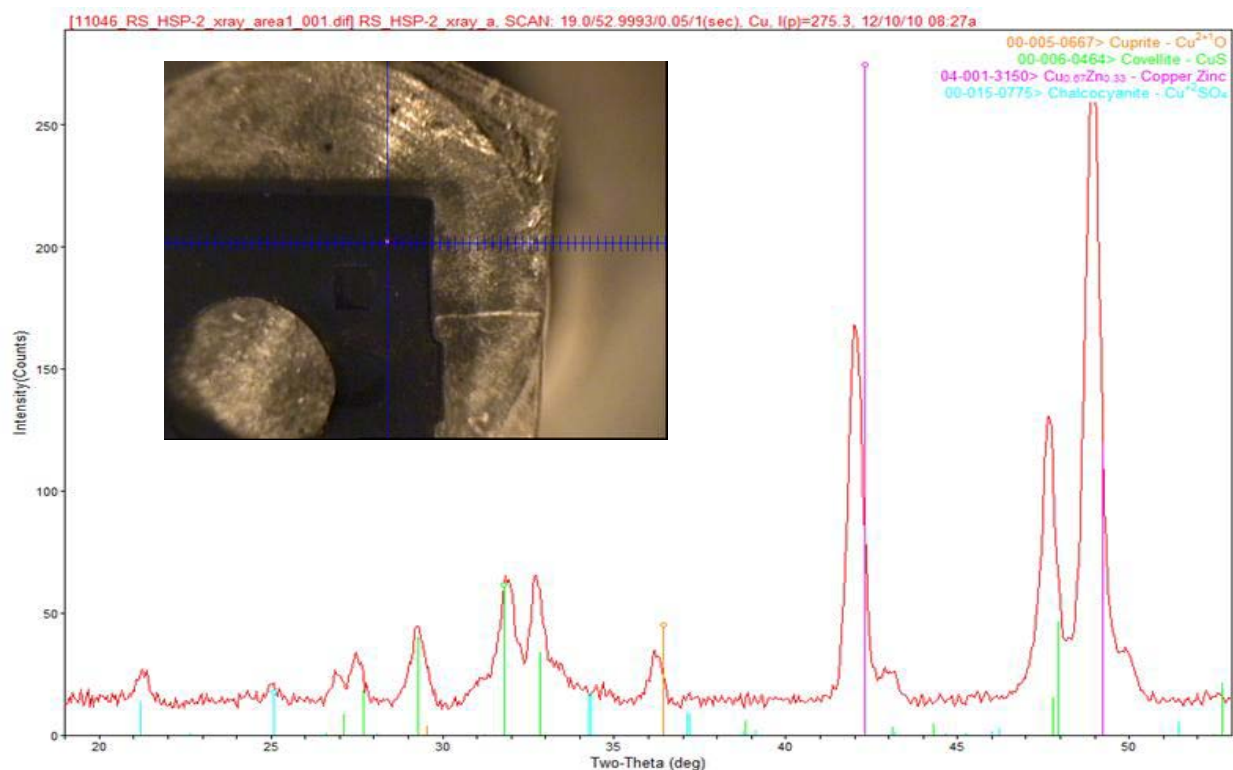
Figure 38. Video image (inset) and  $\mu\text{-XRD}$  data for 2-RS-HSP-2 (contact plate), showing cuprite (orange), covellite (green), and copper/zinc (purple), and chalcocyanite ( $\text{Cu}^{2+}\text{SO}_4$ -light blue) peaks observed.

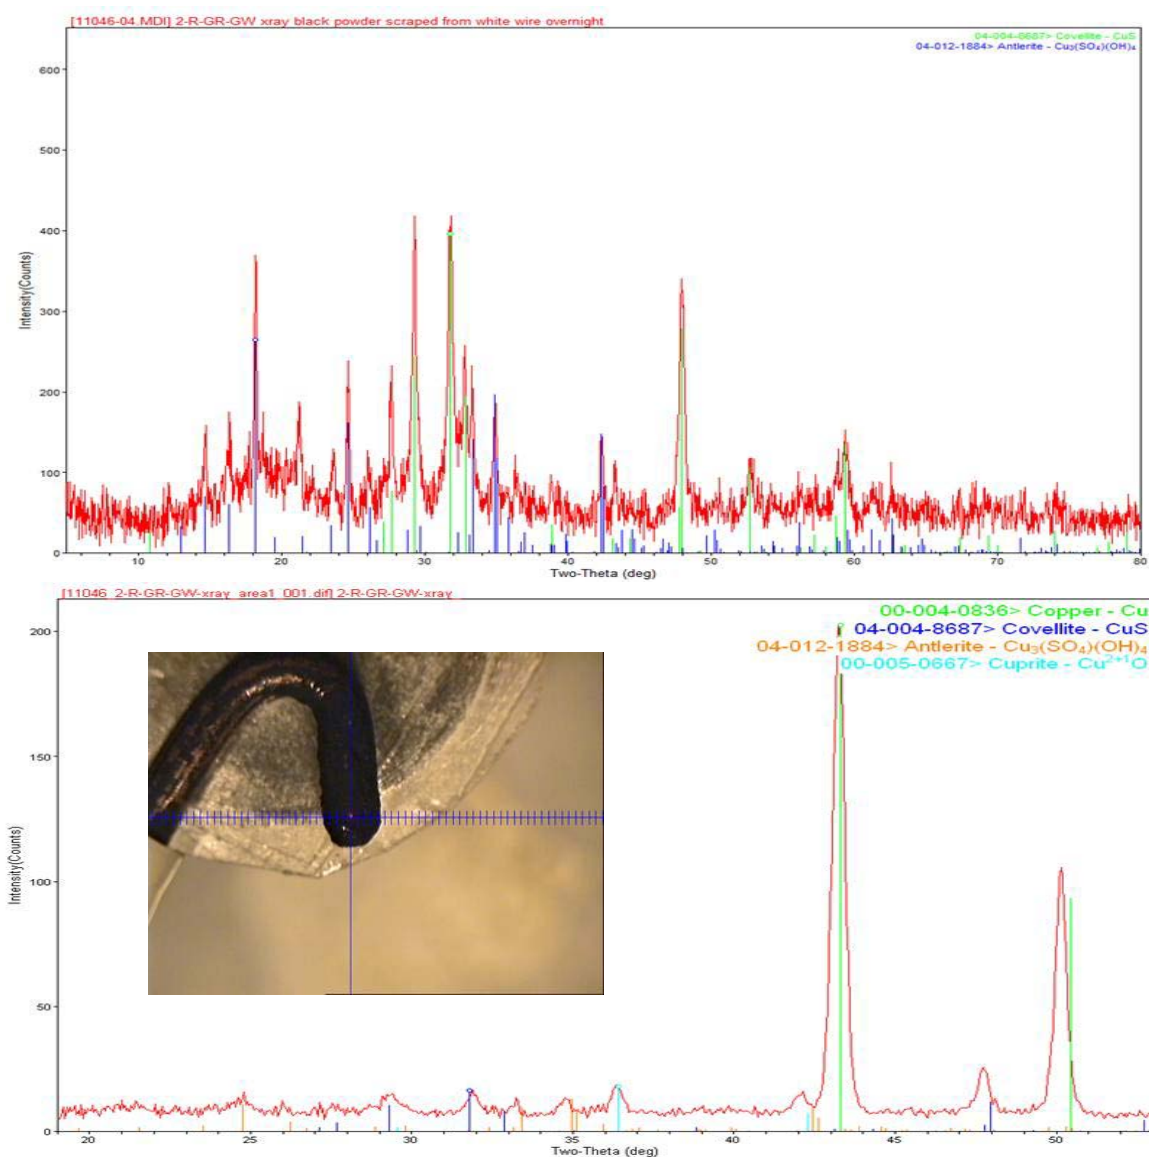
Figure 39. XRD data (top) for powder scraped from wire 2-R-GR-GW showing covellite (green) and antlerite (blue), and  $\mu$ -XRD data (bottom) showing antlerite (orange), cuprite (light blue), covellite (dark blue), and copper (green) peaks.

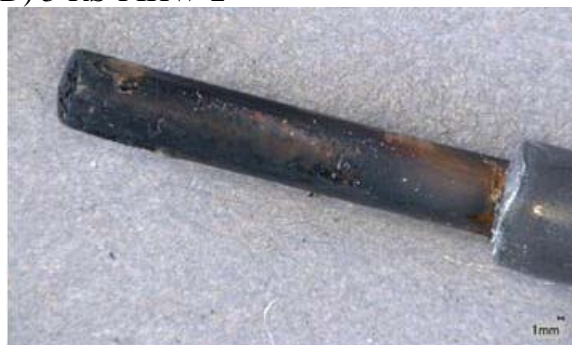
Figure 40. Optical images of the rocker switch and hot wires from Circuit 3.

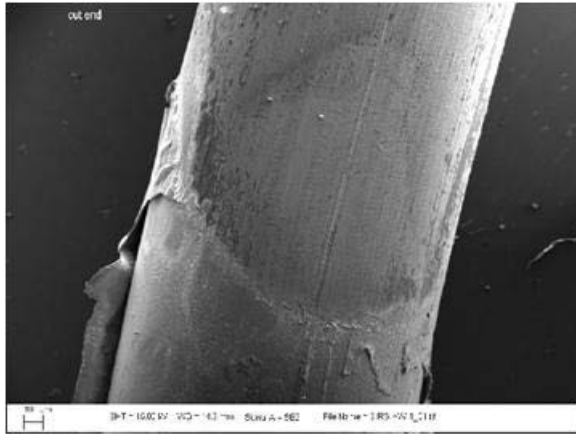
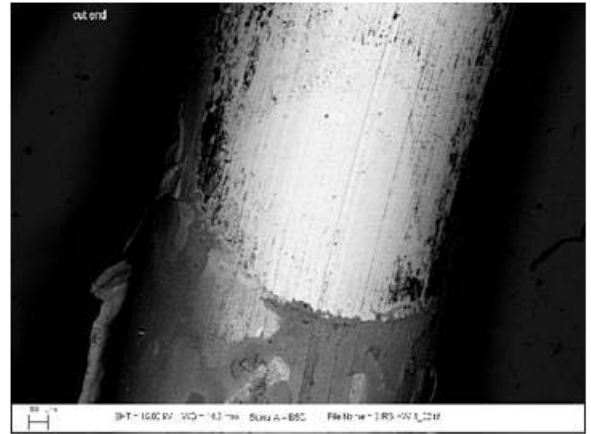
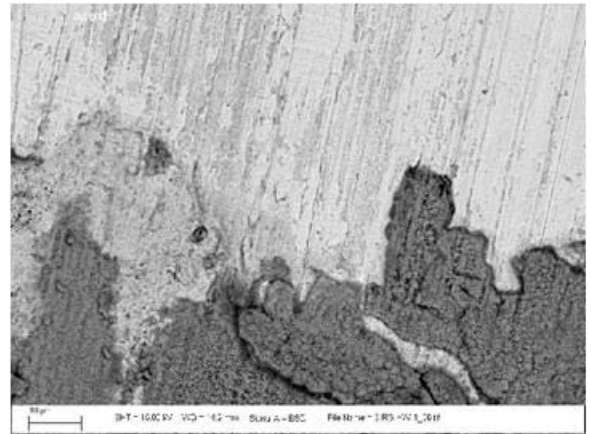
Figure 41. SEM images of the hot wire from the rocker switch in Circuit 3. The figures on the left are secondary electron images, which show topography. The images on the right are back-scatter images. In these images, brightness is a function of the atomic number, with higher brightness indicating elements of higher atomic number.

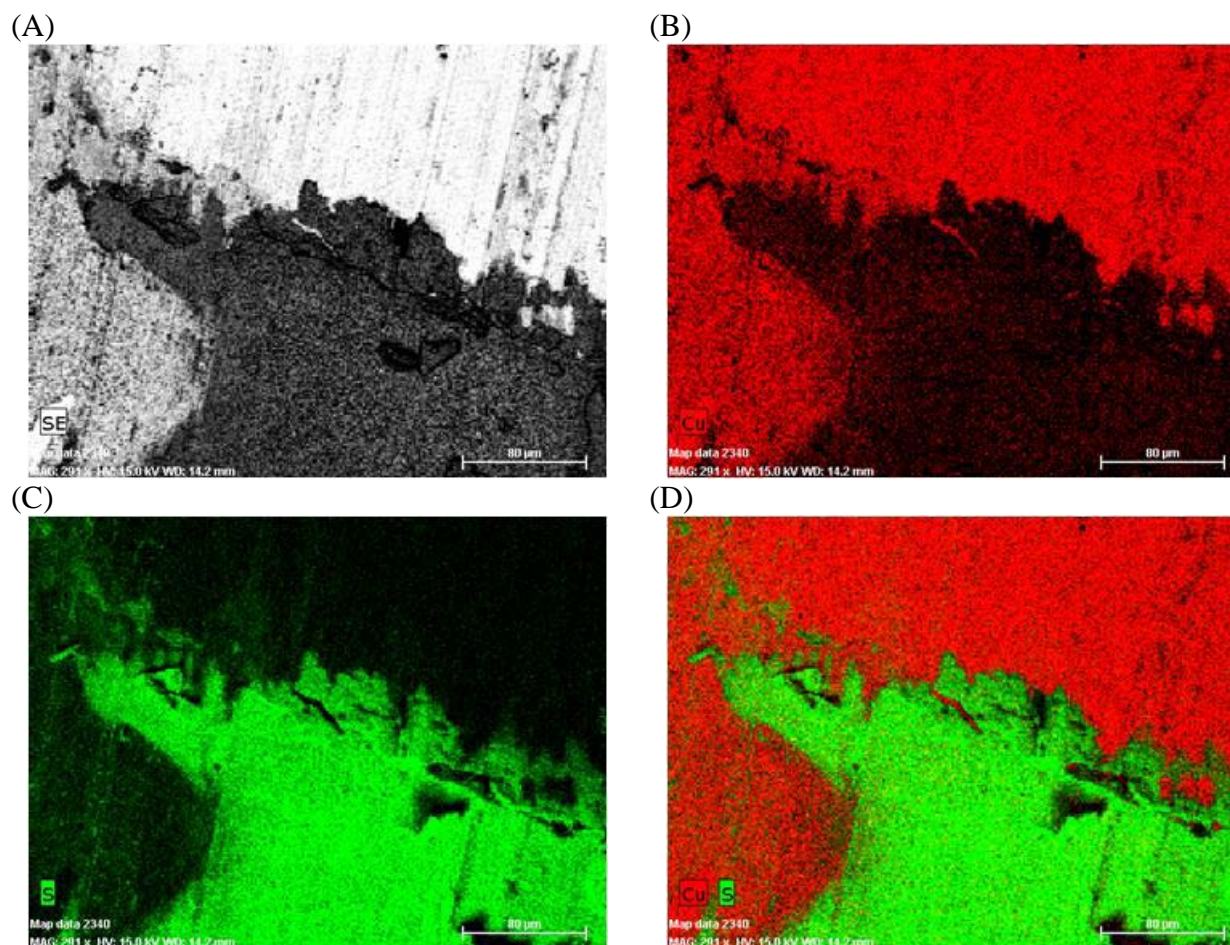
Figure 42. EDS elemental maps of the hot wire from the rocker switch in Circuit 3. Images include A the SEM image, (B) a copper map (red), (C) a sulfur map (green), and (D) a combined copper/sulfur map (red and green).

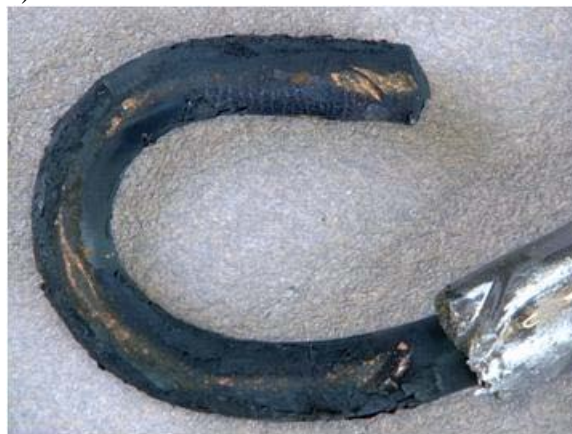
Figure 43. Optical images of the toggle switch in Circuit 3. The figure on the left shows the inside of the switch. Note the extensive corrosion product on some of the components. The image on the right is of the hot wire connected to the toggle switch (screw side).

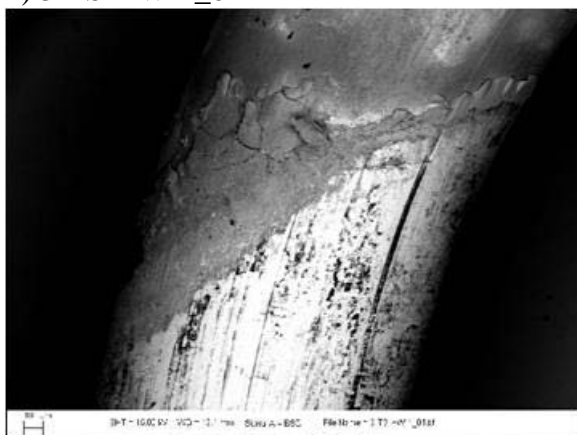
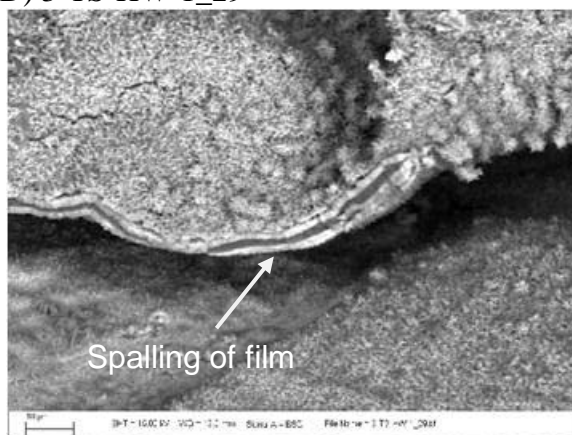
Figure 44. SEM images of the hot wire from the toggle switch in Circuit 3. Note the spalling of the corrosion product film. The contact areas can be seen in the upper two images (bright areas) where the contact shielded the surface from the corrosive gasses.

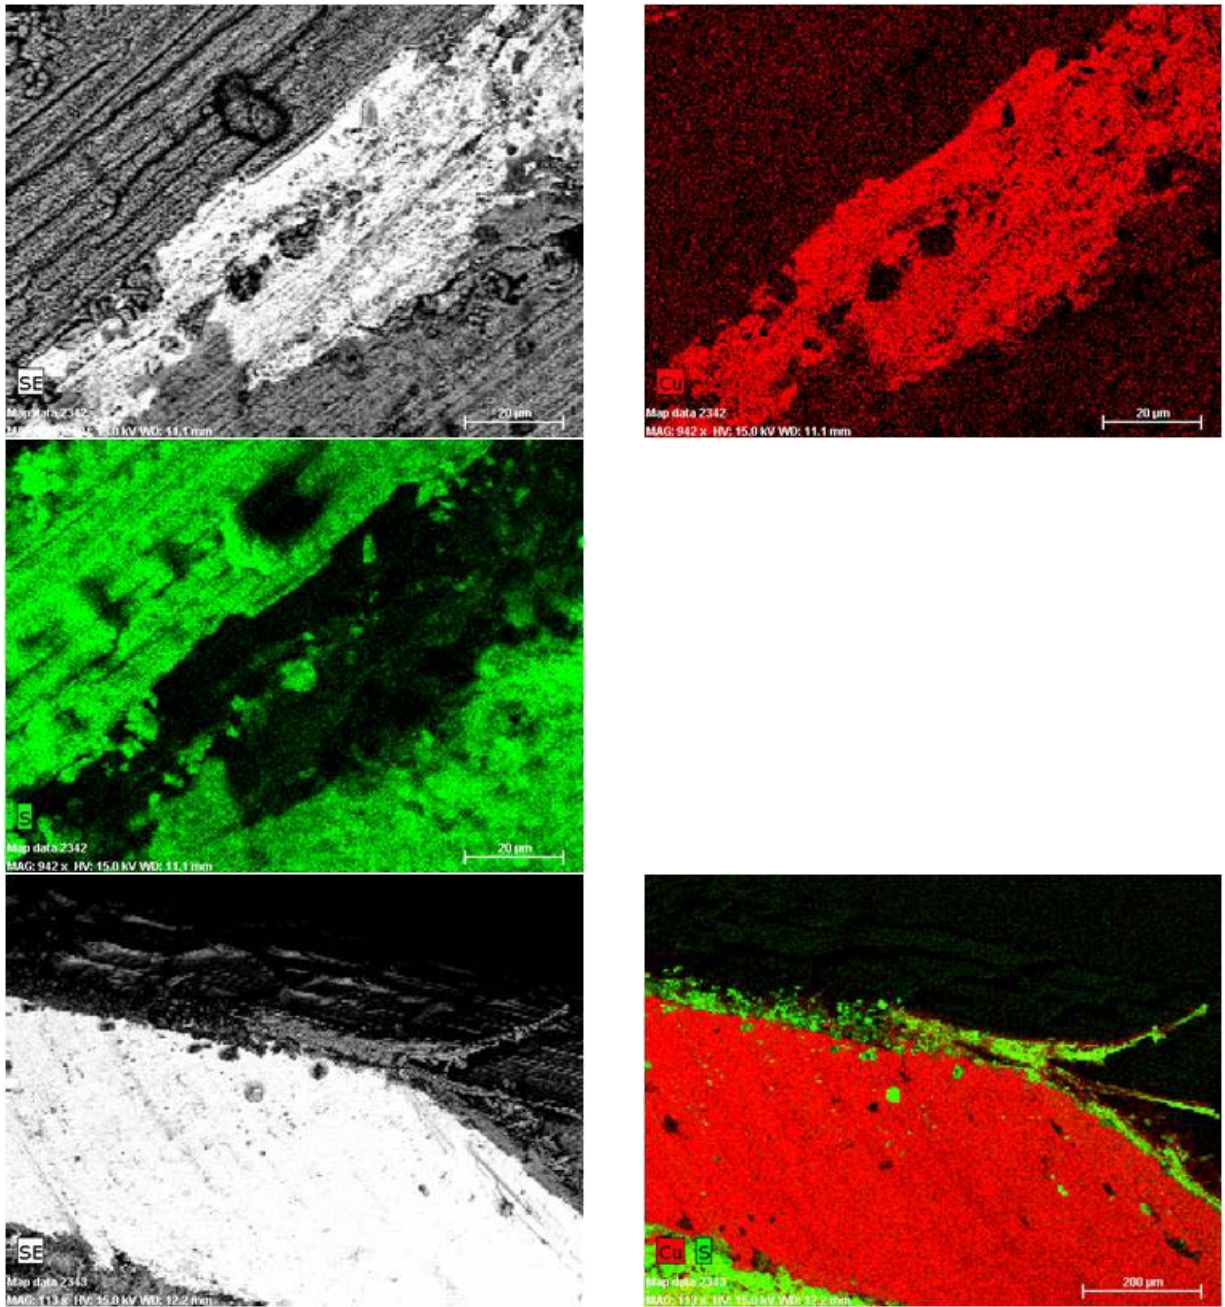
Figure 45. SEM images and EDS elemental maps of the hot wire from the toggle switch in Circuit 3. Sulfur is shown in green, and copper is shown in red.

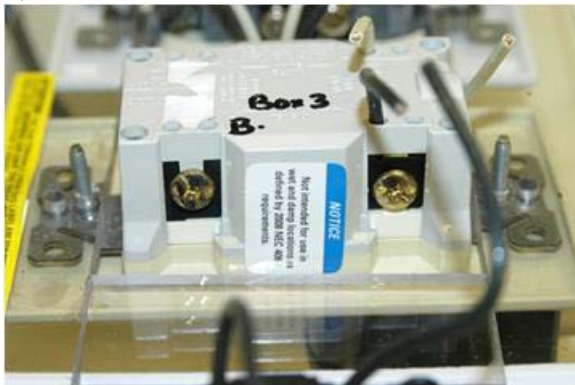
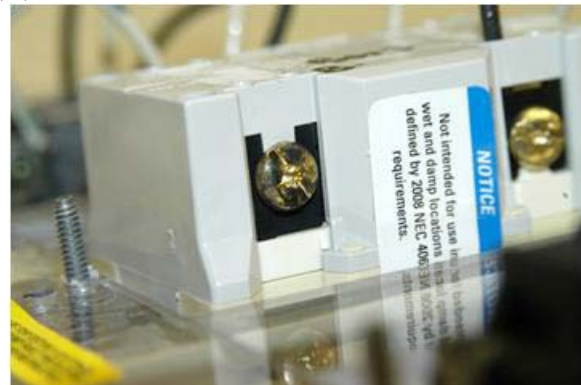
Figure 52. Optical images of the GFCI receptacle. Note the darkening of the normally shiny contact pads and slight corrosion (discoloration) of the screws.

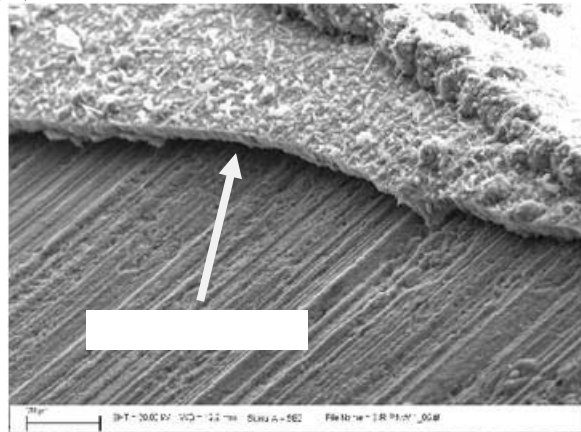
Figure 54. SEM images of the surface of the neutral wire from the receptacle in Circuit 3. The connection was a push-in connection. (B) shows the contact point, which is brighter due to the presence of Cu without S. The end of the wire is shown in the lower images at two magnifications. Note the spalling of the corrosion product film. It is believed that the spalling occurred during the test, but is it possible that it occurred after exposure and prior to analysis.

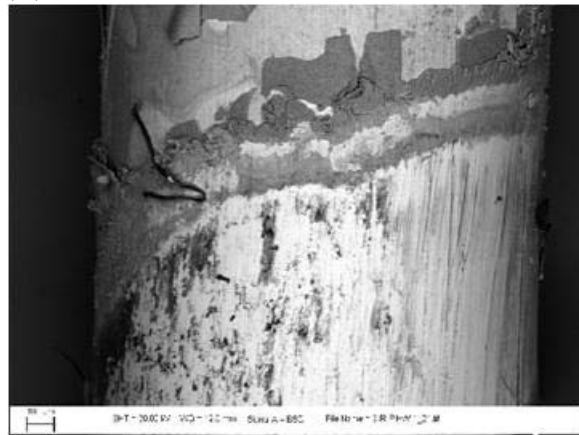
Figure 59. SEM images of the hot wire from the receptacle in Circuit 3. The connection was a push-in connection. The contact point is shown in the image on the left. The image on the right shows a region of a hot wire that was covered by insulation on the bottom.

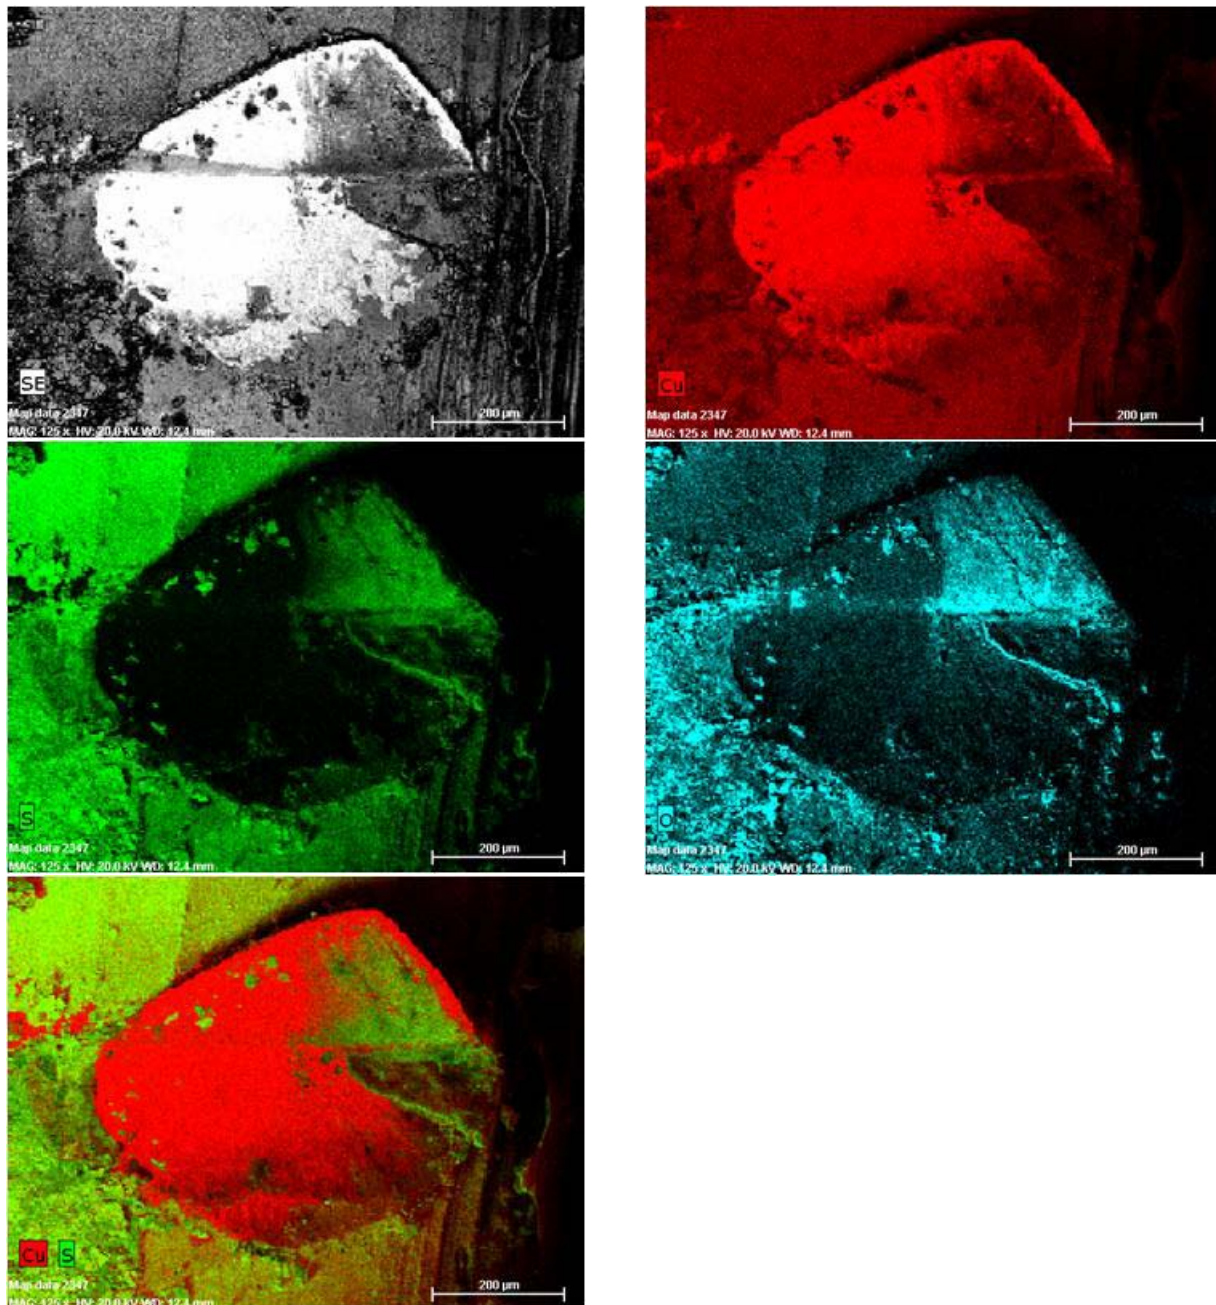
Figure 60. EDS elemental maps of the wire shown in Figure 59. Copper (red), sulfur (green), and oxygen (blue) are shown.
