## **Interim Report on the Status of the Analysis of Electrical Components Installed in Homes with Chinese Drywall\***

Division of Electrical Engineering

U.S. Consumer Product Safety Commission

November 23, 2009

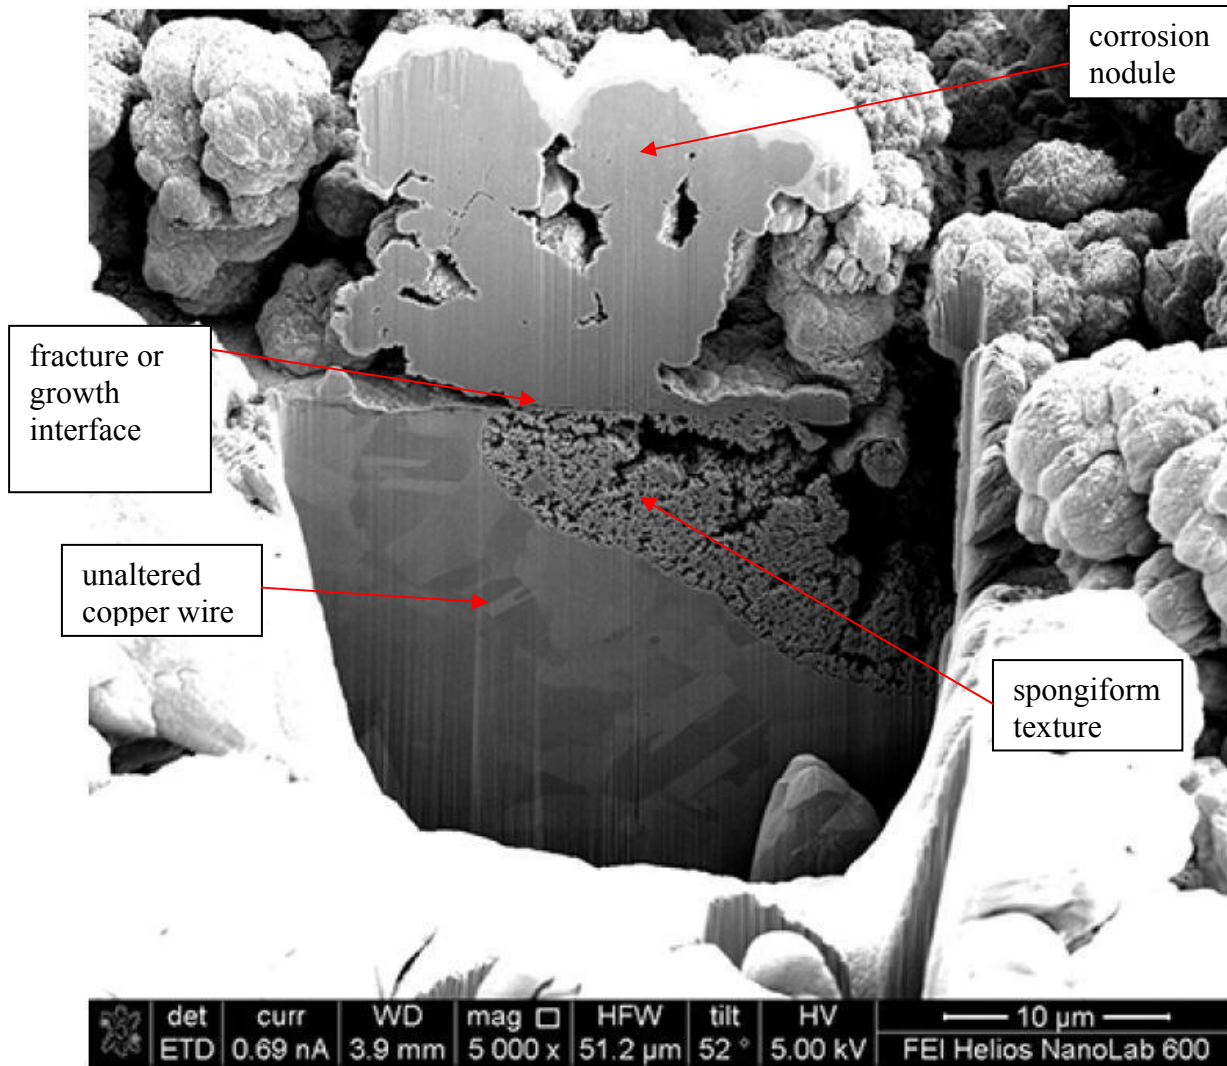
Examination of wires attached to the six receptacles revealed several morphologies, or forms of copper corrosion products, but due to time constraints only two morphologies were able to be analyzed from one wire in time for this interim report: cauliflower-shaped nodules and spongiform (sponge-like) texture. Figure 1 shows a scanning electron microscope (SEM) image of the surface corrosion including a cross-sectional view created by removing a section of the corrosion and wire with a focused ion beam. The corrosion nodules are readily found on the surface of the exposed copper wires, while the spongiform texture appears in micro-cavities that underlie the corrosion nodules. The sequence of events understood at this time suggests that as the corrosion nodules grow, micro-cavities form under the corrosion nodules as copper is transported from the unaltered, underlying copper wire to the overlying nodules. After the micro-cavities form, corrosive gases may then penetrate into the cavities, creating the spongiform texture. The overall thickness of the corrosion layer varies from nearly zero to twenty thousandths of a millimeter. The micro-cavities also show depths of a similar magnitude. Analyses of other samples could reveal greater thicknesses of corrosion product and cavity depths.

Figure 1. SEM-magnified view of surface corrosion on a ground wire.

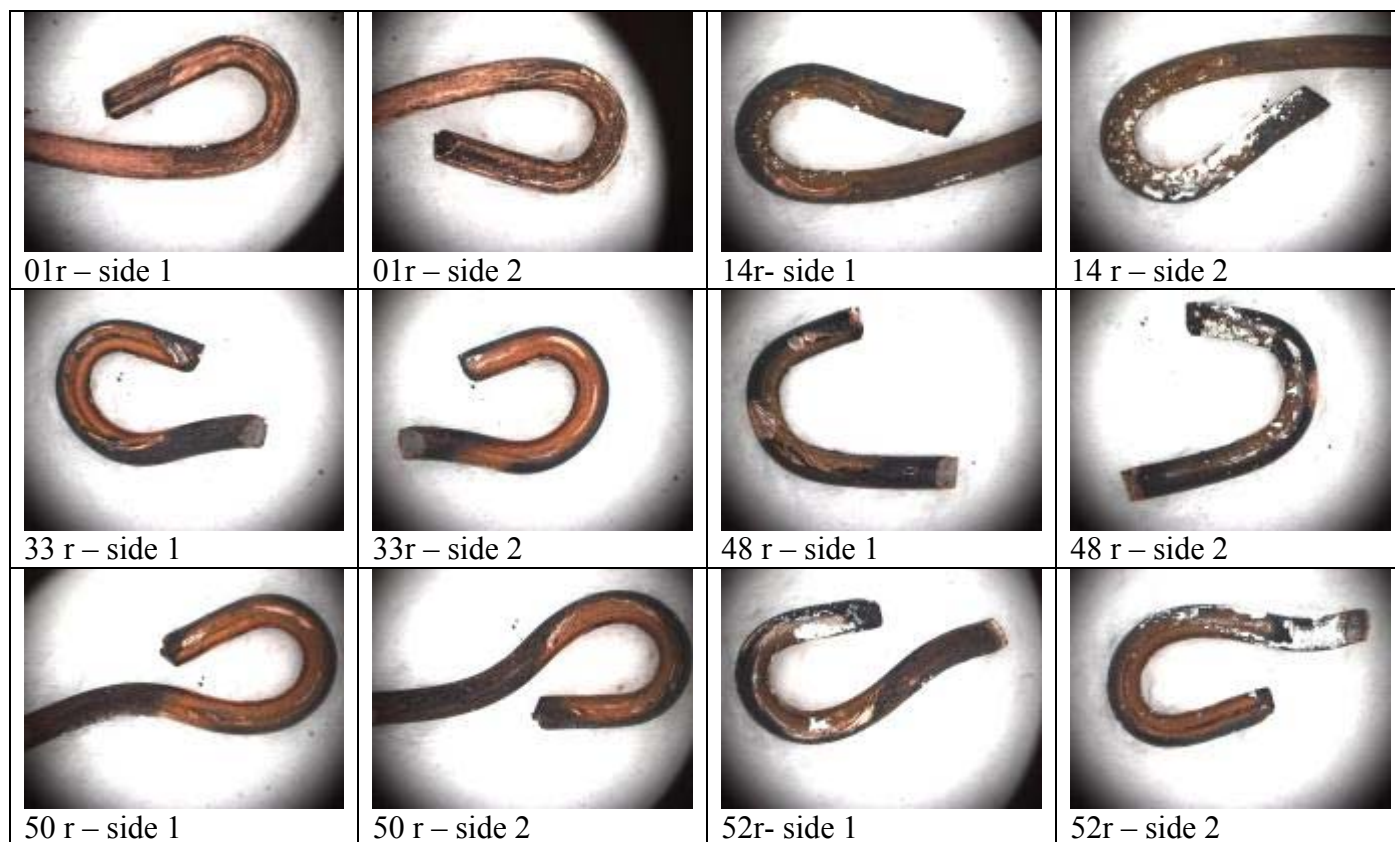
Each of the six 110V rated, screw-type connection receptacles (5 duplex, 1 single pole) had paint or plaster splatter on various surfaces including the wires. There was visible corrosion on the ground, neutral, and hot wire surfaces as well as on the contact plate surfaces for the neutral and hot wire connections. Figure 5 shows the corrosion (blackened regions) that is observed on both sides of ground wires from the six receptacles examined to date. Each of these wires was originally fastened to the receptacle with a screw at the curved section of the wire. The areas where the wire made contact with its screw or contact plate show less blackening or no blackening compared to other regions of the wire where it was not in contact with another material. The lack of corrosion in these areas is likely due to this region being somewhat shielded from any corrosive gasses that are present. Some of the wires also show a white material (likely paint, texturing material, or drywall debris). Some of this appears to have been introduced prior to it being fastened to the receptacle as it is located in a region that was under the screw when it was fastened to the receptacle. Blackening was observed on neutral and hot wires as shown in the examples in Figure 6.

**Figure 5: Optical images showing ground wire corrosion as evidenced by black layer. The looped section of the wire, which had been in contact with the screw or contact plate, has little or no blackening in some cases (for example, see 33r – side 2).**

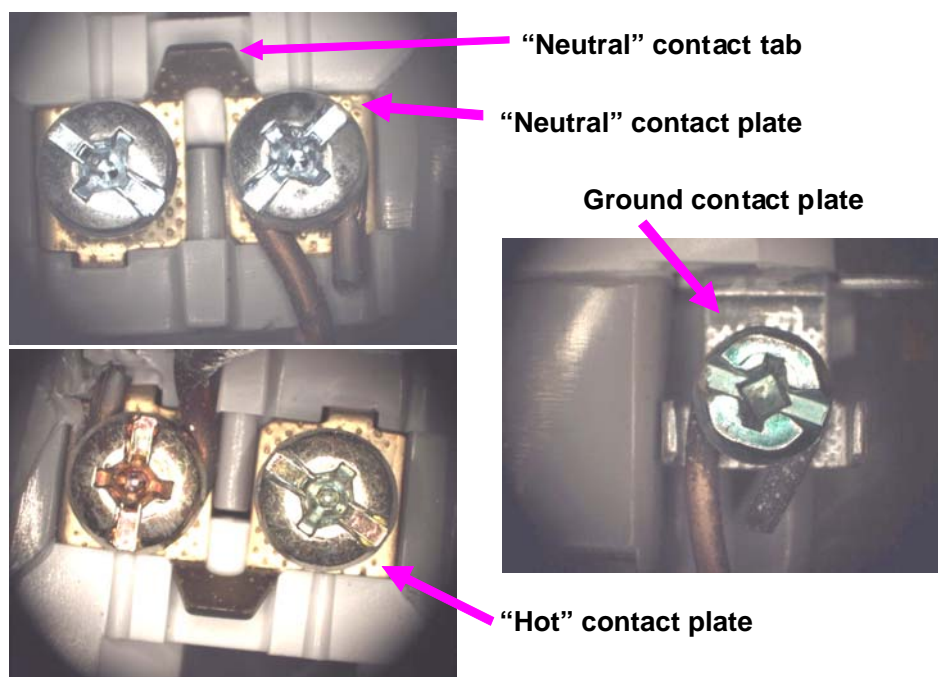
For the group of six examined receptacles some tarnishing and/or corrosion products was observed on the (1) ground screws, (2) neutral screws, and (4) hot screws as shown in Figure 7. Hot and neutral screws have a yellow and silver appearance respectively to distinguish them from each other, and the ground screws are green in appearance. The extent of corrosion of the screws examined to date was significantly less than that observed on the various wires examined to date.

**Figure 7: Optical photographs of connection terminals including the contact plate, screws, and wires before disassembly. Ground screws have a green appearance, hot screws appear yellow, and neutral screws appear silver.**

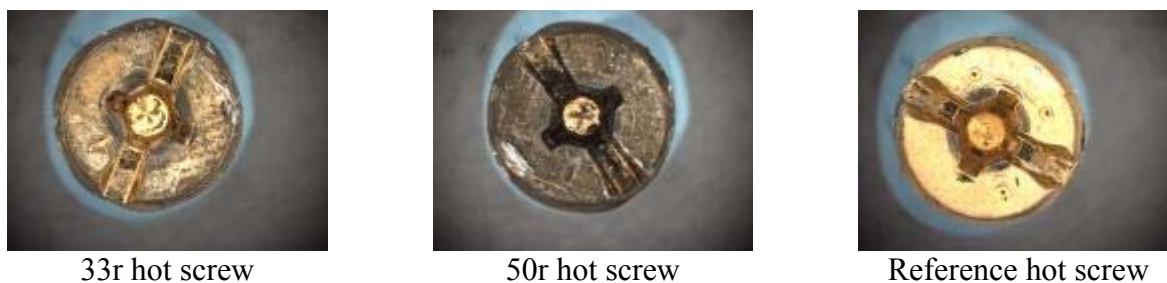
shiny luster indicate that the screw surfaces have changed in some manner, likely due to corrosion.

**Figure 8: Comparison of the appearance of hot screws from receptacles harvested from components 33 and 50 to the appearance of a reference hot screw (never installed in a home).**

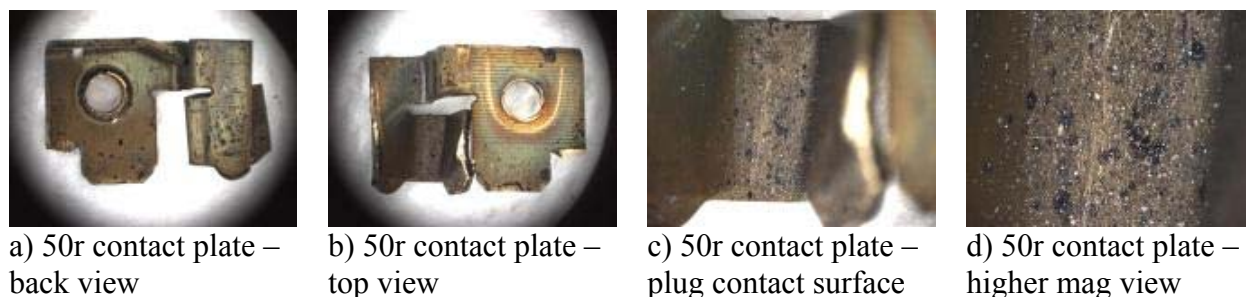
The appearance of a tarnished contact plate from receptacle number 50 is shown in Figure 9. The top and bottom surfaces of the contact plate and a close-up of the plug contact surface are all shown to demonstrate how corrosion has changed the appearance of the surface. Black specks (mounds of corrosion products) can be seen on the surface of the contact plate especially in the region shown in Figure 9d) at higher magnification. It is important to note that these surfaces are interior to the receptacle, and suggest that the corrosive gasses penetrated the receptacle in this case.

**Figure 9: Optical image showing corrosion on side 1 (a) and side 2 (b) of a 50r hot wire contact plate. b) The shiny U-shaped region is the location of a wire that was originally in contact with the contact plate. Images c) and d) show higher magnification views of corrosion in the plug contact surface**

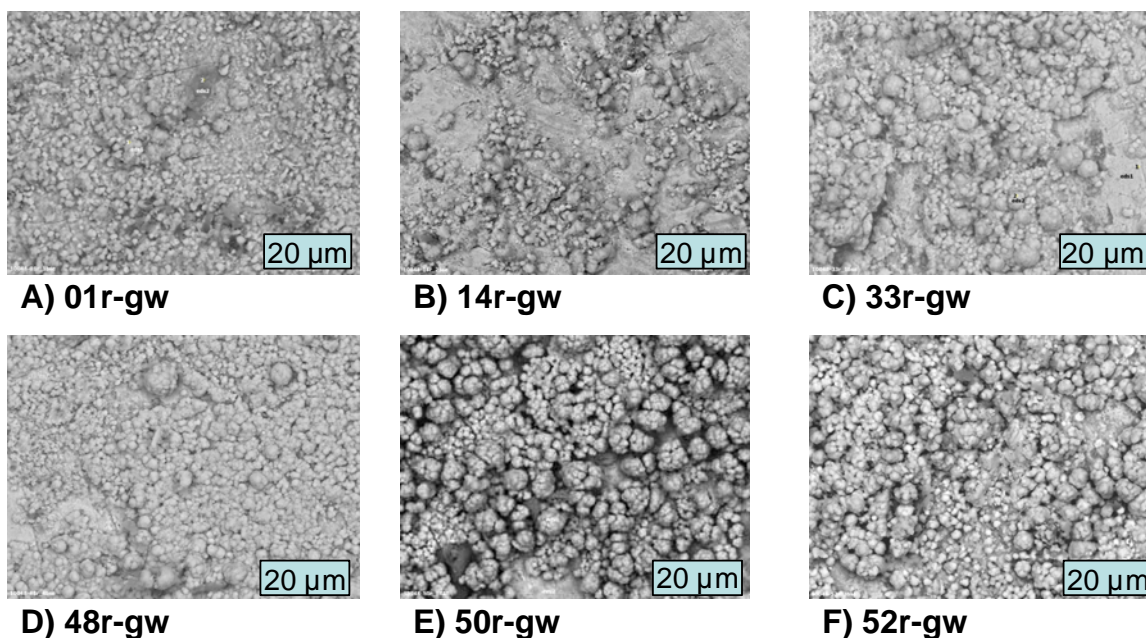
Figure 10 shows the plan view Scanning Electron Microscope (SEM) images of the corroded copper ground wires from six receptacles. The corrosion product layers are similar for the six receptacles. The layers have a nodular appearance with varying degrees of coverage of the Cu wire, and differences in the apparent corrosion product thickness. In some regions small cracks are observed in the layer. Further analysis of each wire and analysis of additional wires would be needed to determine whether there are real differences in the corrosion product coverage on wires from different locations, or between locations within a home. The residence time of the receptacle in a home would also need to be considered to be able to determine that the corrosive environment in one home was more severe than in another.

**Figure 10: SEM plan view images of six corroded ground wires. All samples show the growth of a layer on the copper wire. The morphology in these images shows what appear to be individual particles or clusters of particles.**

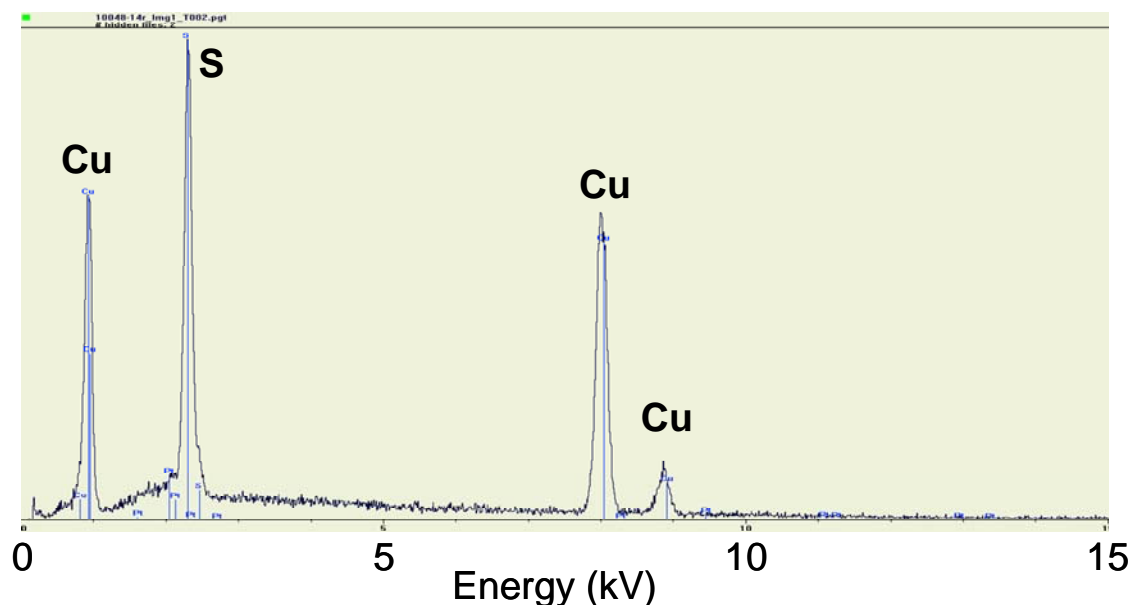
The elemental composition of the corrosion product layer on ground wires observed to date is primarily copper and sulfur (indicating a copper sulfide rather than a copper sulfate) as shown in the Energy Dispersive Spectrum in Figure 11. The presence of Cu and S was confirmed with both X-ray Photoelectron Spectroscopy (XPS) and Auger Electron Spectroscopy (AES) analyses.

**Figure 11: EDS spectrum showing elemental composition of the ground wire corrosion product shown in Figure 10. (From component 14)**

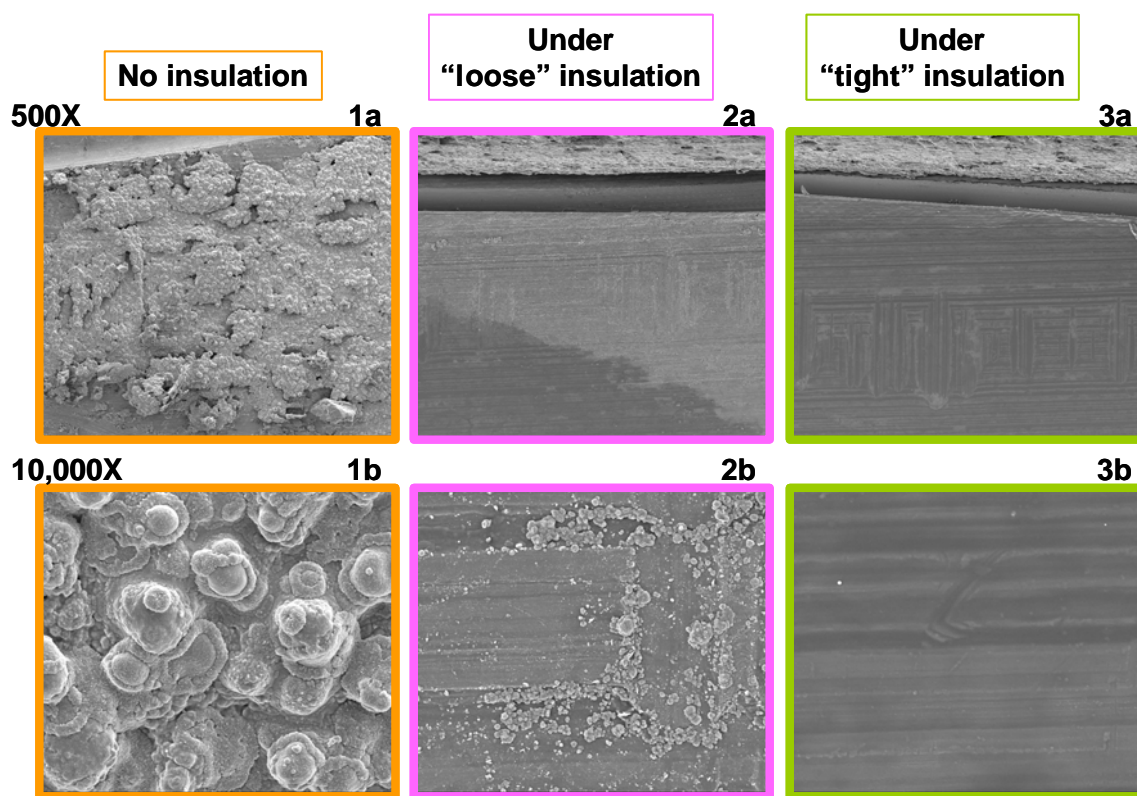
To assess the ability of the wire insulation to prevent corrosion of the copper wire, the insulator was carefully cut from one sample and the wire surface was analyzed. Figure 12 shows a comparison of three regions of a single hot wire near the edge of the electrical insulation. Location 1 is the boldly exposed copper surface near the edge of the insulation. Location 2 was originally under the insulation (after a strip of insulation was removed) at a distance of approximately 0.2 cm from the edge. Location 3 was originally under the insulation at a distance of approximately 0.7 cm from the edge. There is a clear difference in the extent of the surface corrosion with the boldly exposed region showing a substantial layer, the middle region showing the start of a surface layer (which seems to begin along surface features on the underlying copper), and the region under the tight insulation showing no corrosion, only bare copper. There is no corrosion product on the wire at a distance of approximately 0.3 cm away from the interface between the originally bare and covered regions of the wire. The act of stripping the insulation from the wire may produce a separation between the wire and the insulation, allowing access to the copper by the atmosphere. These observations indicate that the electrical insulation acts as a barrier to the corrosive gasses and protects the underlying copper.

**Figure 12: Comparison of SEM images at 500X and 10,000X magnification showing a hot wire in (1) an area that was not covered by electrical insulation (2) an area originally covered by "loose" electrical insulation prior to Sandia's analysis (3) and an area tightly covered by the electrical insulation prior to Sandia's analysis. The copper in this area exhibits no corrosion.**

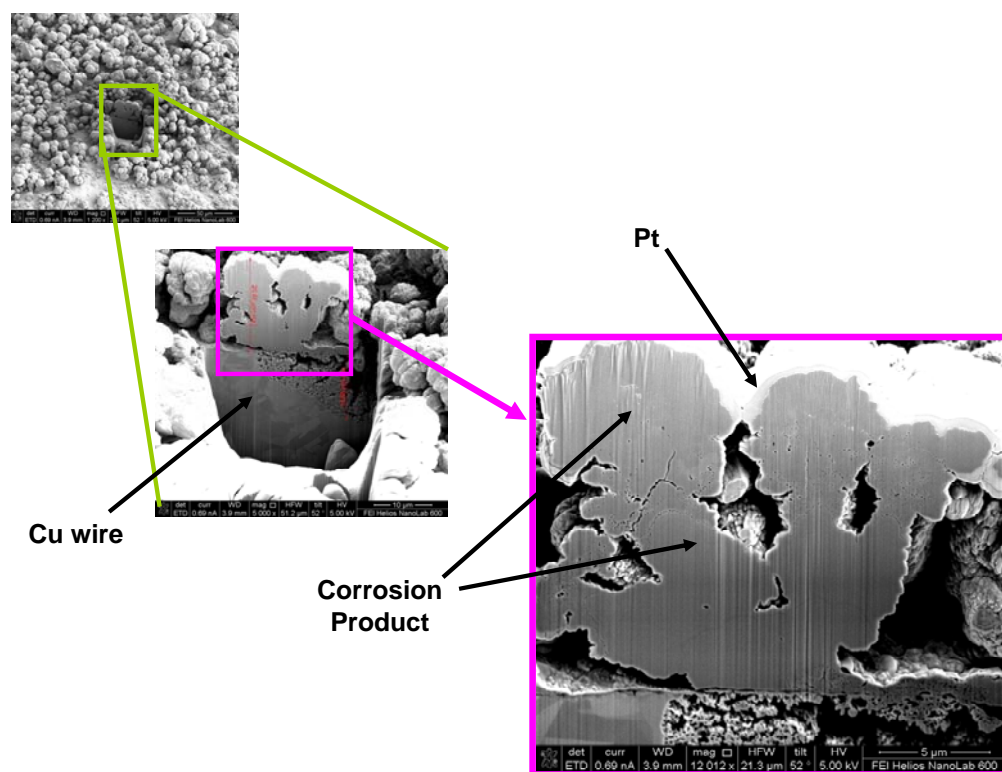
**Figure 13: SEM images at increasing magnification of FIB cut into a corroded ground wire showing “cauliflower” morphology of corrosion product and porous region in the base copper. The cauliflower feature is approximately 20 microns in height. The very bright region seen on top of the cauliflower feature is platinum used to coat and protect the sample during the FIB cutting process.**

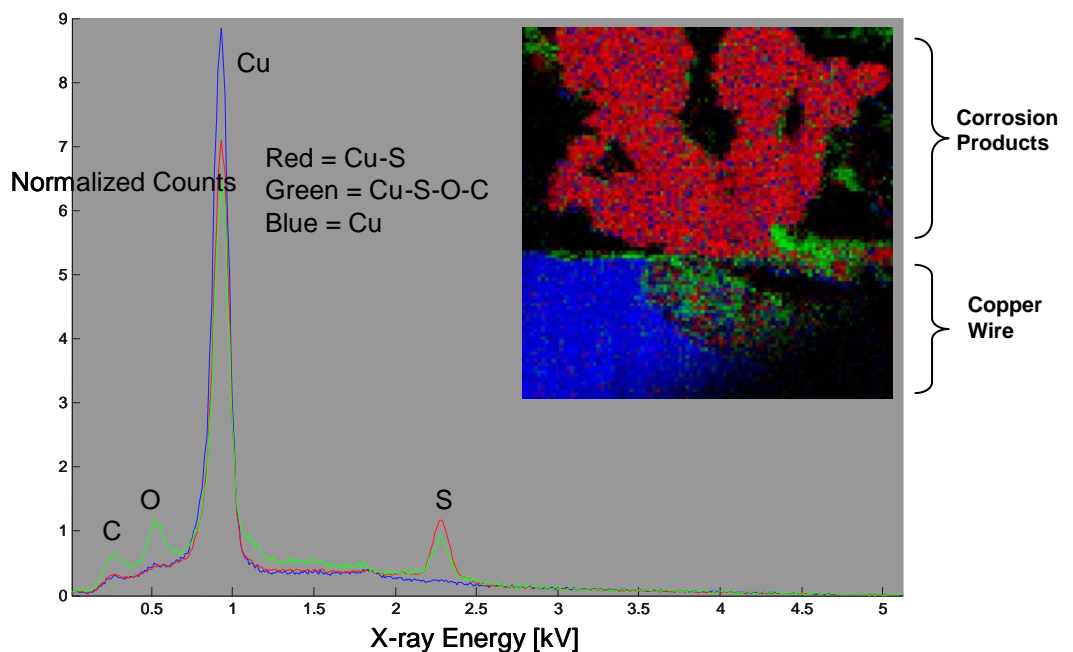
Spectral imaging was performed on the FIB cross section shown in Figure 13. In essence, spectral imaging uses EDS techniques to identify “phases” or “components” present in a sample. Figure 14 shows the hyperspectral image and spectrum for the FIB cross section of the corroded ground wire shown in Figure 13. For this region three components were identified: a Cu-S component, a Cu-S-O-C component, and Cu. Colors are used in the figure to identify the location of the components. Individual representative spectra for the components are also shown. Note that the tree-like nodule (red) is basically a copper sulfide. The copper substrate shows up as the blue area. The spongy material below the copper sulfide appears to be a mixture of copper sulfide and something containing Cu, S, O, and C. While these results represent only a single sample and cannot therefore be used to arrive at a general conclusion, they do provide insight into the nature of the corrosion product and possible corrosion mechanism.

**Figure 14: Hyperspectral image and spectrum showing the elemental make-up of various regions of the FIB cross-section of the corroded ground wire shown in Figure 13.**

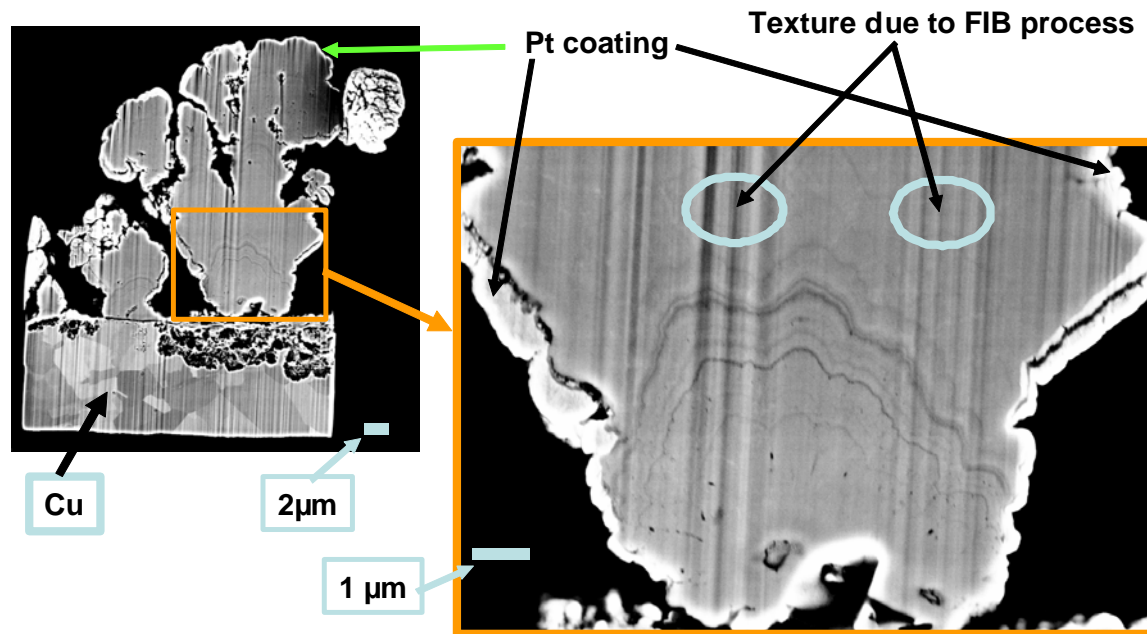
The grain (or crystal) structure of the underlying copper can be seen by slight contrast differences (darker or lighter) that are produced by different grain orientations. This kind of contrast is normal and expected for imaging of the copper.

**Figure 15: SEM images of section cut from corroded ground wire showing “tree-ring” morphology in the cauliflower-like corrosion product. The underlying copper shows regions of light and dark contrast that are produced by different orientations of the copper grains. Vertical lines seen in the images and highlighted with blue oval are artifacts of the FIB cutting process.**

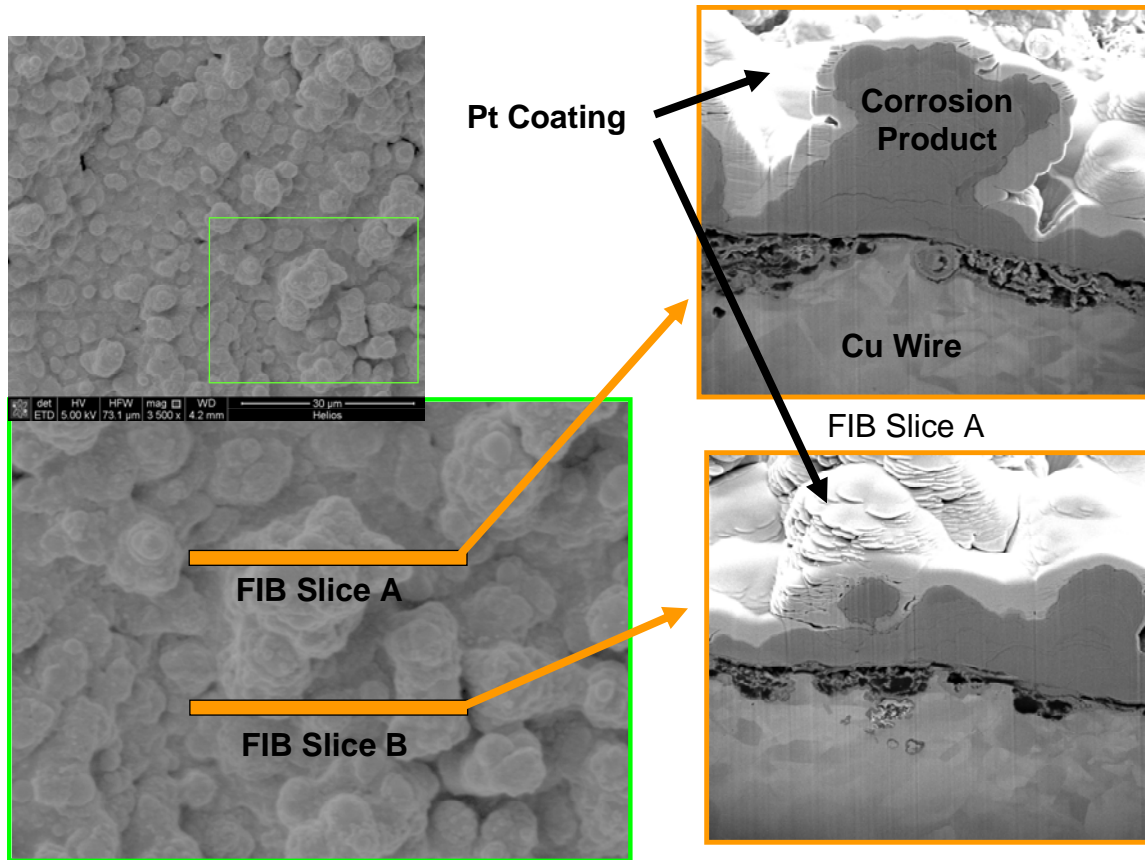
A series of FIB slices were made through the corrosion product on a copper hot wire. Two of the slices are shown on the right in Figure 16 along with the corresponding plan view SEM images (left) showing the region from which they were taken. The bright layers on top of the corrosion product are platinum used to protect the underlying material during the FIB cutting process.

**Figure 16: SEM images (left) and two FIB slices (right) of a corroded copper hot wire.**

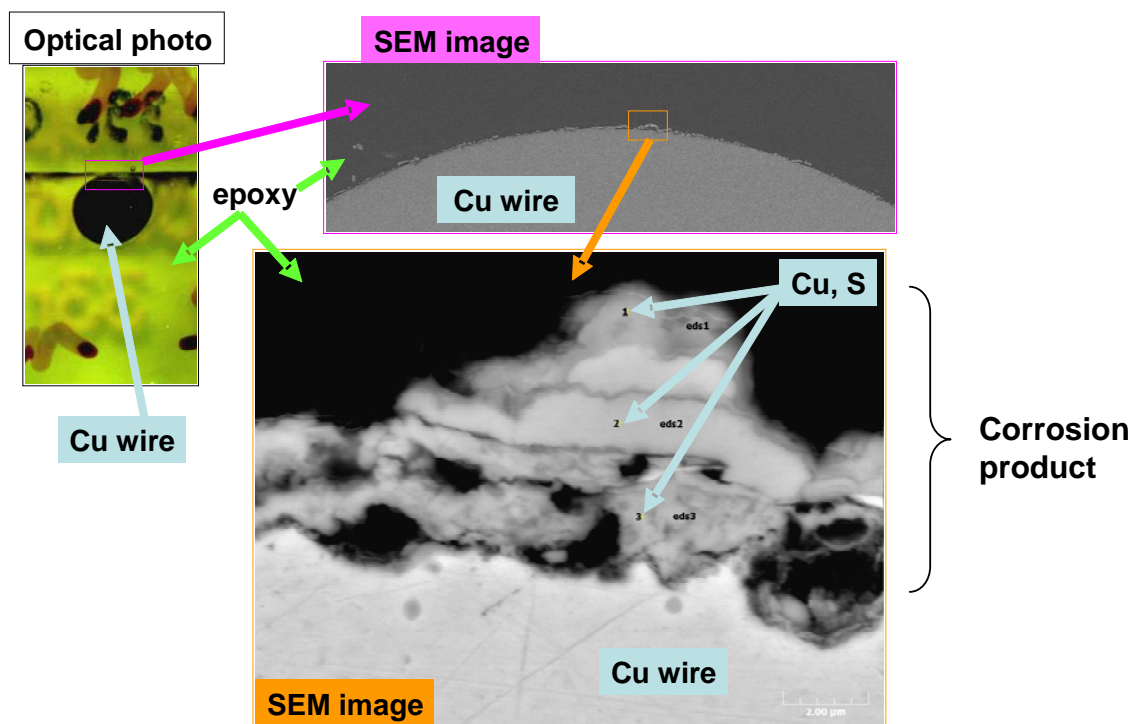
Figure 17 shows an optical micrograph and two SEM images of a cross sectioned ground wire used to identify the thickness and elemental composition of the corrosion layer or layers. Consistent with previous images, this sample exhibits a layered structure. The difference in contrast seen in the highest magnification SEM image could be due to changes in density or elemental composition. These differences suggest that there may have been periods of growth of the corrosion product during which conditions varied. The corrosion product layer was not of a consistent thickness over the circumference of the wire. The range of corrosion layer thicknesses observed on cross sectioned ground wires from six homes are shown in Table 4. The values range from 0-18 microns, the highest values being consistent with the observations made on FIB slices. The purpose of the layer thickness measurement was only to obtain an estimate of the corrosion product layer – it is not a statistically valid measurement from which inferences can be made about the entire population.

**Figure 17: Optical (left) and SEM images (right) of the cross section of receptacle ground wire at increasing magnification used to estimate corrosion layer thickness and determine elemental composition. EDS was used to identify the primary elements (Cu, S) in the regions shown in the highest magnification image (bottom right).**

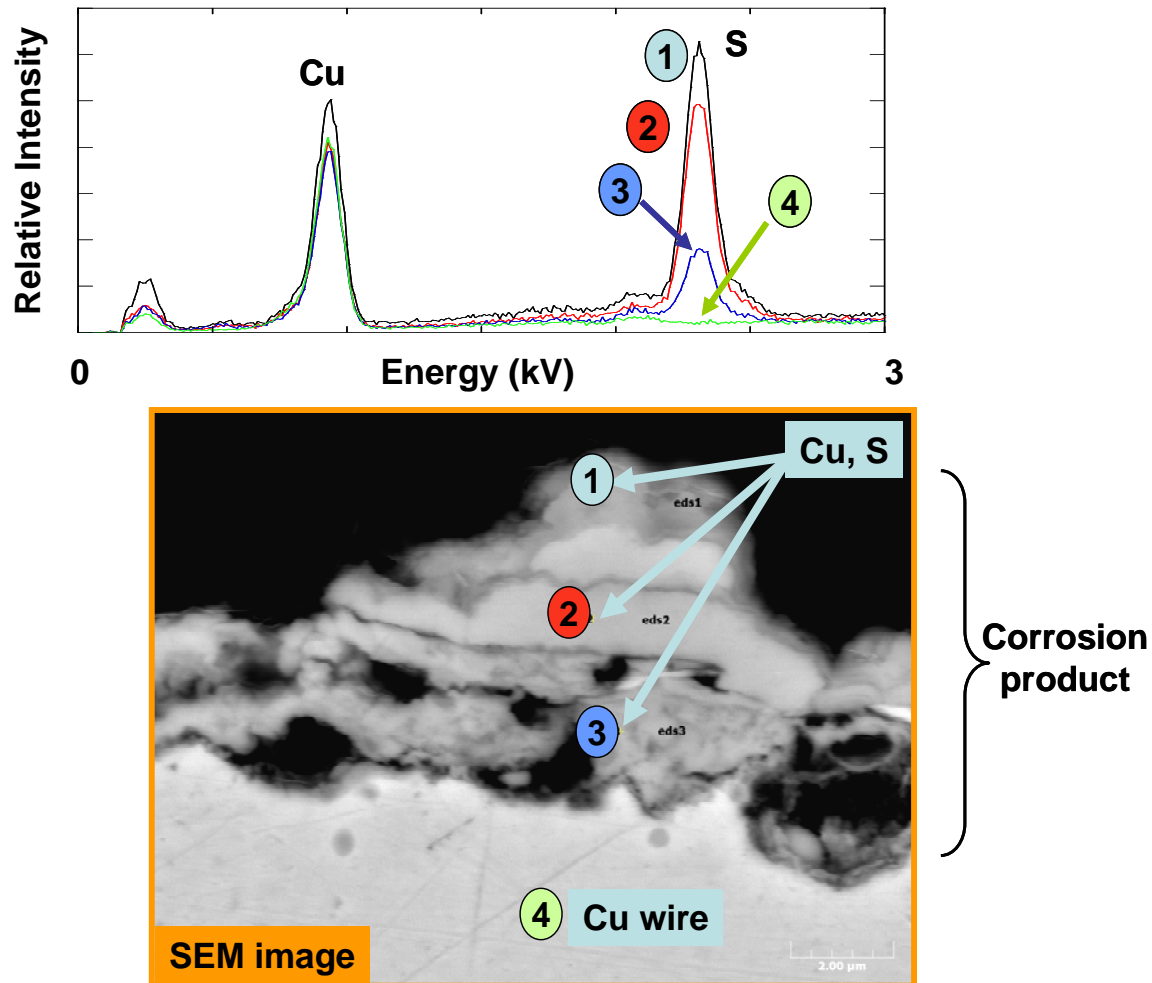
Individual spectra were obtained for several of the layers shown in Figure 17. The spectra were normalized to the Cu peak and are plotted in Figure 18. Only sulfur and copper were identified by EDS, indicating that the corrosion product is a form of copper sulfide. The difference in Cu/S ratio for the various layers suggests that the corrosion products are not a single sulfide (for example  $\text{Cu}_9\text{S}_5$ ), but are likely a mixture of sulfides.

Figure 18: Qualitative comparison of changes in the sulfur content relative to the copper across the corrosion layer thickness as measured by EDS (normalized to Cu peak at 8 kV) for a corroded ground wire.

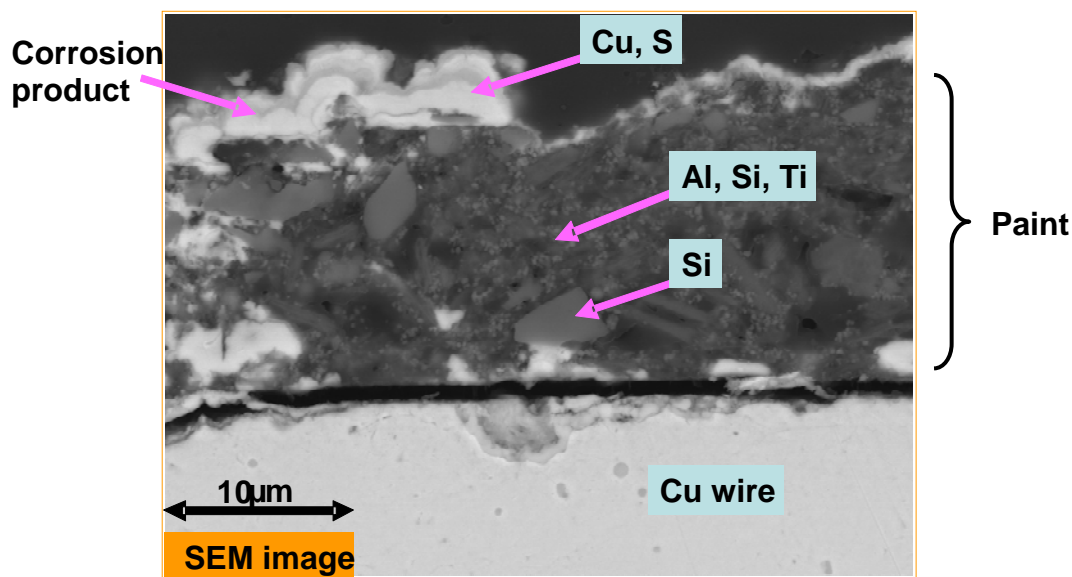
Ground wires and other subcomponents from the set of analyzed receptacles often showed white particles or paint on their surfaces during optical examination. Cross sections of the ground wires often cut through these particles on the surfaces of wires. EDS analyses were used to identify the elemental composition of these materials and to distinguish them from areas of corrosion product. Figure 19 shows the SEM image of a cross section that cut through a region of the wire that appears to be covered by paint. The EDS spectra in Figure 20 show the differences in composition between the darker and lighter regions that are located above (on top of) the copper wire in Figure 19. The spectrum in Figure 20 **a**) shows that the elemental composition of the darker contrast region consists of aluminum (Al), silicon (Si) and titanium (Ti), typical constituents of pigments or pigment extenders in paint. Figure 20 **b**) shows the spectrum for the light region, which consists of Cu and S, on top of the paint layer. This observation of corrosion product on top of paint indicates that the corrosion product formed after the paint was spattered on the wire surface and that it occurred after installation of the receptacle. In addition, the observation of creep corrosion supports the claim that the actual corrosion conditions were more aggressive than Battelle Class II, and likely Class III, IV or higher.

**Figure 19: SEM cross sectional image of corroded copper ground wire, showing corrosion product growth on top of paint layer. Elements detected by EDS are shown at particular spots.**

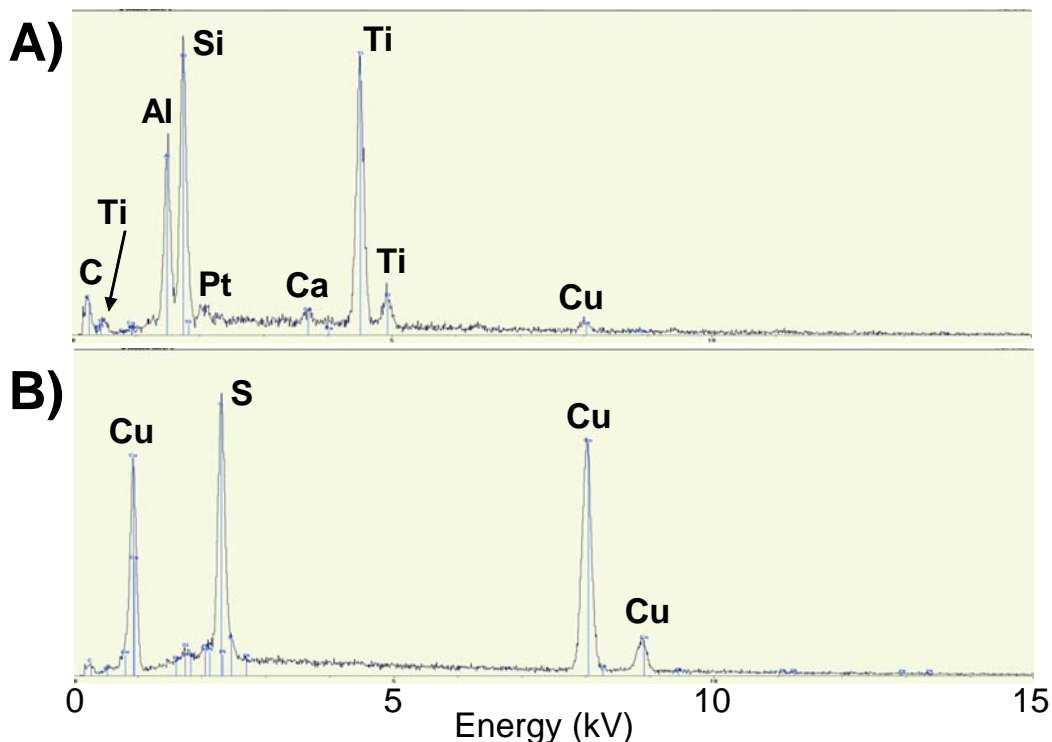
**Figure 20: EDS spectrum (signal intensity versus energy in kV) showing major elements detected in areas attributed as A) paint and B) corrosion product shown in Figure 19.**

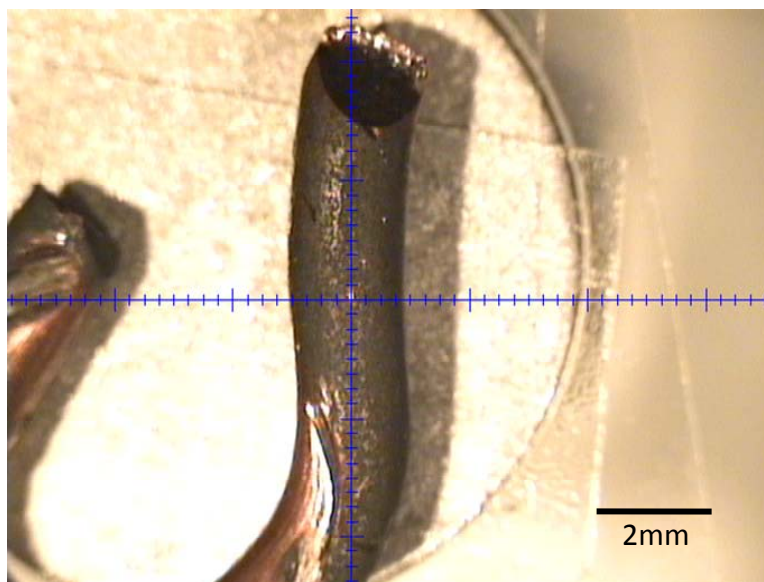
X-ray diffraction (XRD) analysis was conducted on two spots on a single corroded ground wire to gain an initial understanding of the chemical compound (or compounds) present in the corrosion layer. The analysis used a spot on the sample that was approximately 300 microns (0.3 mm) in size and was located on a region of interest as shown by the cross hairs in Figure 21. The XRD spectrum (Figure 22) showed peaks identified as Cu, Cu<sub>2</sub>O (cuprite), and Cu<sub>9</sub>S<sub>5</sub> (digenite). Other elements or compounds may be present, but at small concentrations relative to the species identified above. A 300 micron diameter X-ray spot provides information about an area that is large relative to the size of the particles (or clusters of particles) in the corrosion product layers shown in the SEM images in Figure 10. The XRD analysis cannot be used to identify the chemical identity of individual particles, but provides information averaged over the entire spot. The analysis provides chemical information from a 10-20 micron depth, but most of the X-ray signal comes from the top 5 microns. The large Cu peak in the spectrum suggests that there is incomplete coverage of the surface or that the corrosion product depth is not large on this sample. To enhance the identification of other minor phases and to increase the relative peak heights of the cuprite and digenite additional XRD analyses will be performed on material scraped from the surface of the wire and collected for analyses.

**Figure 21: Optical photographs of corroded ground wire used for XRD analysis. The intersection of the blue cross hairs indicates the region of the wire that was analyzed.**

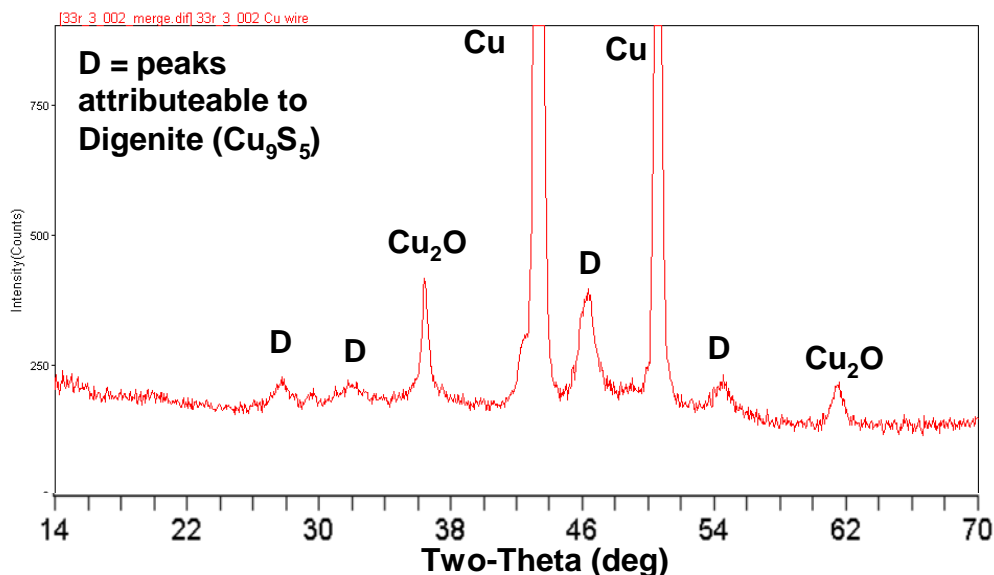
**Figure 22: XRD data (signal intensity versus diffraction angle) showing peaks attributable to copper (Cu), cuprite ( $\text{Cu}_2\text{O}$ ) and digenite ( $\text{Cu}_9\text{S}_5$ ).**

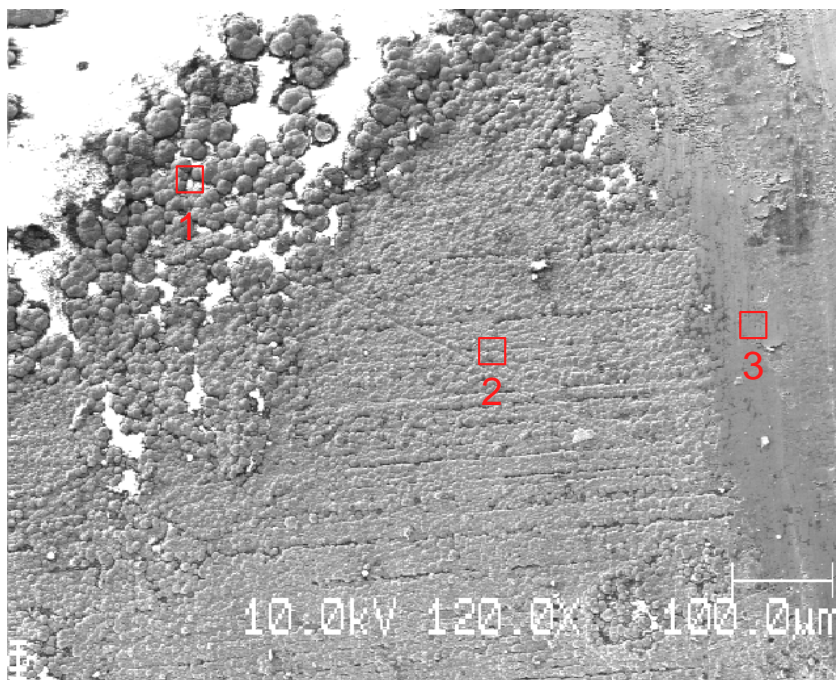
analyzed are indicated in Figure 23. These three spots illustrate the three different surface morphologies observed: “nodular”, “smooth”, and “smeared”. The smeared area was likely generated in prior handling of the component as extra care was taken during disassembly to leave corrosion undisturbed.

**Figure 23: SEM image of ground wire showing three different morphologies and three spots indicating where Auger sputtering was performed.**

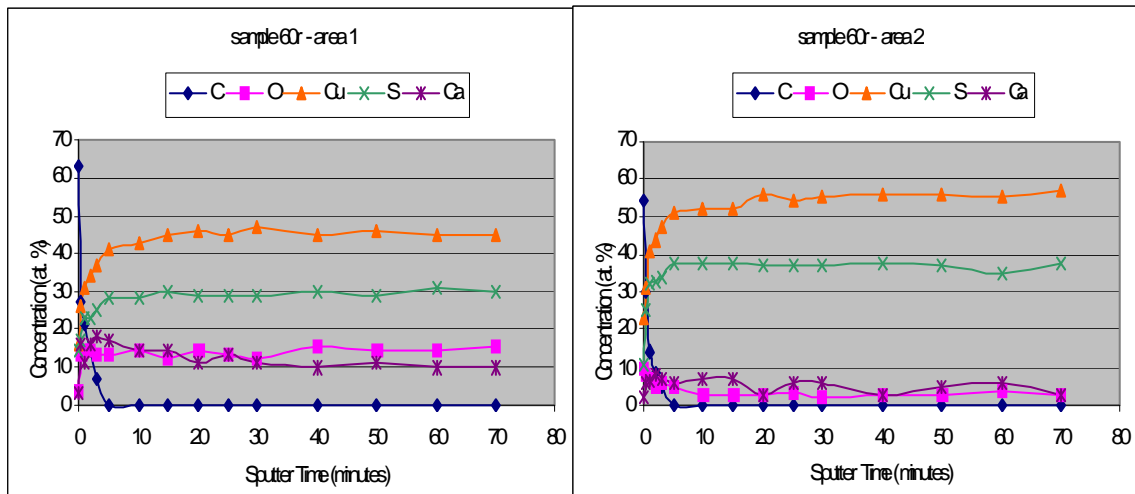
Auger depth profiles were performed in each of the three spots shown in Figure 23 to obtain a preliminary indication of whether there are differences in the elemental make-up of corrosion product for corroded regions of the same wire, with different morphologies. The depth profiles for spots 1 and 2 are shown in Figure 24. Carbon, which is detected at high levels at the surface but rapidly decreases with depth, is believed to be surface contamination from transport, handling, etc. Both spots show high levels of Cu and S, and lower levels of Ca and O. Spot 1 shows higher levels of Ca and O than Spot 2, not surprising since this spot clearly include a non-conductive substance (white in the image), possibly gypsum ( $\text{CaSO}_4 \cdot 2\text{H}_2\text{O}$ ) dust. These results demonstrate that on this particular wire, despite clear morphological differences, the corrosion product is similar in elemental composition.

**Figure 24: Comparison of Auger elemental analysis results versus sputter time for spot locations 1 and 2 shown in Figure 23.**

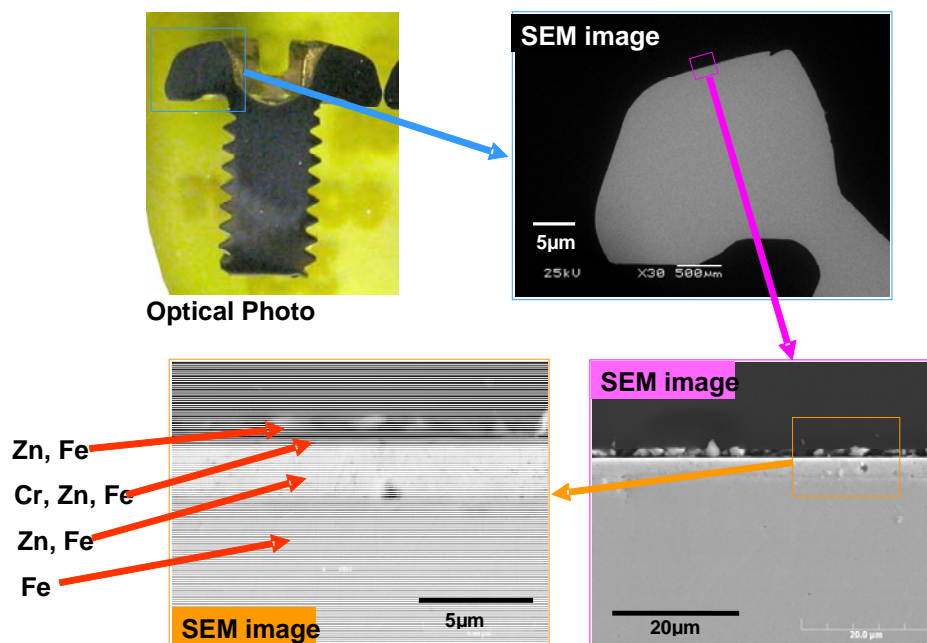
Figure 25: Optical and SEM images of a cross sectioned hot screw. Elemental analyses results are shown in the bottom left image for the bulk metal (Fe) and the plating layer (Zn, Fe, and Cr).
