# PURAFIL ENVIRONMENTAL CORROSION REPORT

21-Oct-2010

CCC Panel #: P68025

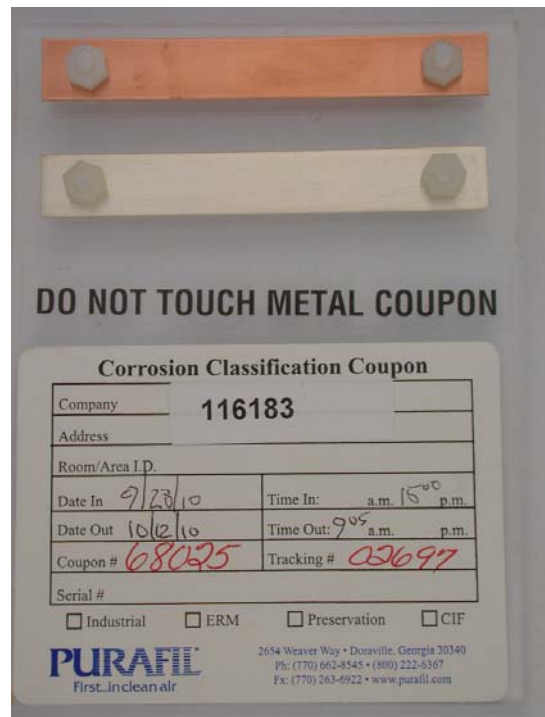
<b>CCC Panel # P68025</b>
<b>ISA Class G2</b>
Moderate

<b>Copper Corrosion</b>
333 Å/30 Days
<b>Silver Corrosion</b>
321 Å/30 Days

The electrolytic reduction analysis on Corrosion Classification Coupon #P68025 shows the presence of moderate concentrations of contaminants in the environment tested. The hydrogen sulfide level is expected to range between 3 and 10 ppb and the sulfur dioxide level between 10 and 100 ppb. The effects of corrosion are measurable and may be a factor in determining equipment reliability.
