TECHNICAL BULLETIN

Subject: SPECTRUM REGULATOR REWORK INFORMATION

IMPORTANT SAFETY NOTICE PRODUCT RECALL

TITLE: REGULATOR HIGH PRESSURE SEAT INSPECTION/STATUS REPORT

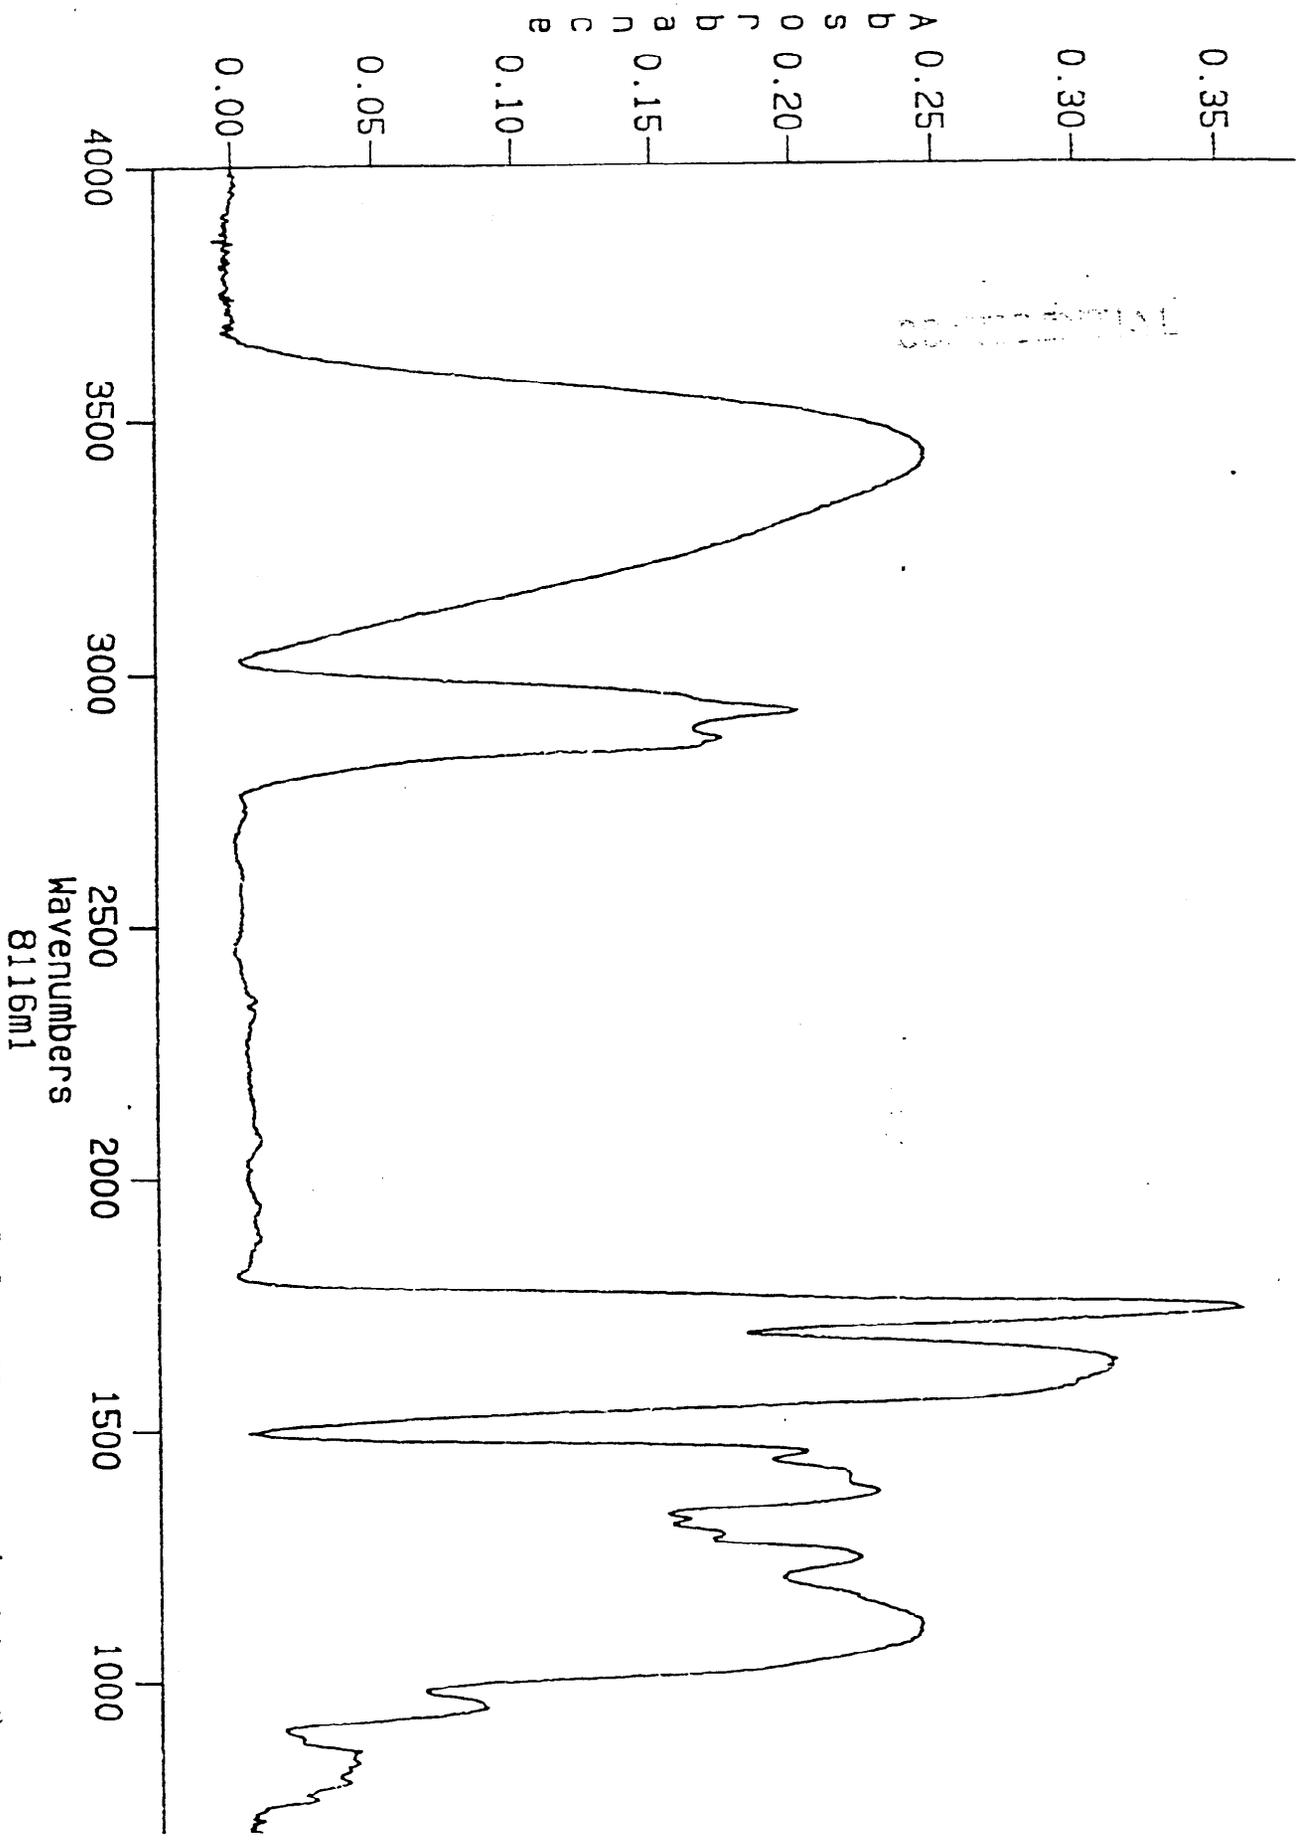
Figure 1. FTIR Spectrum of Green Material on Brass Seat "A" - ID: Ester + Amine

Please find a copy of the laboratory analysis for the two high pressure seats from Japan. It is more than likely that the glue (type loctite) found on top of the brass and in the bottom of the rubber disk had a negative effect on the bonding.

- Sample #1: greenish material on top of seat "A"
- Sample #2: clear material underneath the rubber disk of seat "B"

Figures 1 and 2 show the FTIR spectra of Samples #1 and #2, respectively. Through our library search, they have both been identified as a combination of an ester and an amine. This is very similar to a Loctite sealant formulation.
