CPSC Staff's Statement on SEA Ltd.'s (SEA's) Report, "Study of Debris Penetration of Recreational Off-Highway Vehicle (ROV) Floorboards"
December 2021

*Study of Debris Penetration of Recreational
Off-highway Vehicle (ROV) Floorboards*

for:
Consumer Product Safety Commission

December 2021

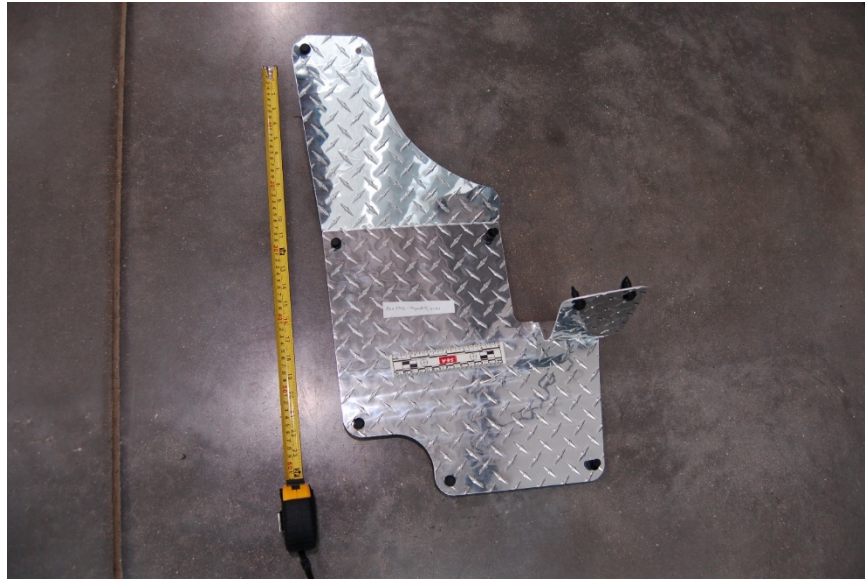
Table 6 (Continued): Vehicle A – Sled Impact Run #2 – Aftermarket Guard A1

This aluminum diamond plate floorboard (guard) was 0.062 inches thick, and it covers the floorboard and not the firewall. It was about 14 inches laterally by 24 inches longitudinally. The plastic rivets pulled through the plastic OEM floorboard of the vehicle, and a part of the diamond plate bent up substantially. This unit was from the passenger's side of the vehicle, and to the right in the top photos is to the right of the vehicle.

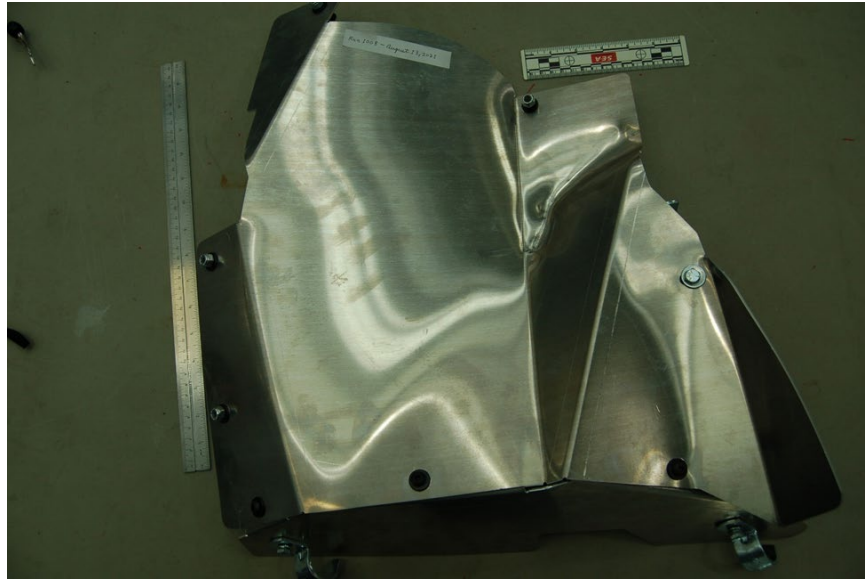
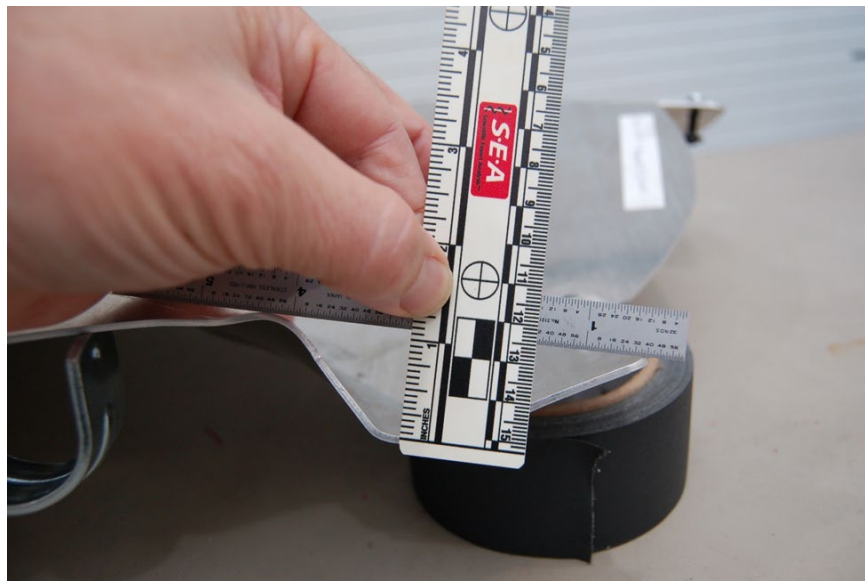
Table 7 (Continued): Vehicle A – Sled Impact Run #3 – Aftermarket Guard A2

In the top photo, the top of the photo is up and outboard to the vehicle is to the right, so this is from the driver's side of the vehicle. The material is aluminum plate, 0.075 inches thick. The maximum deflection shown is 1 1/8 inches.

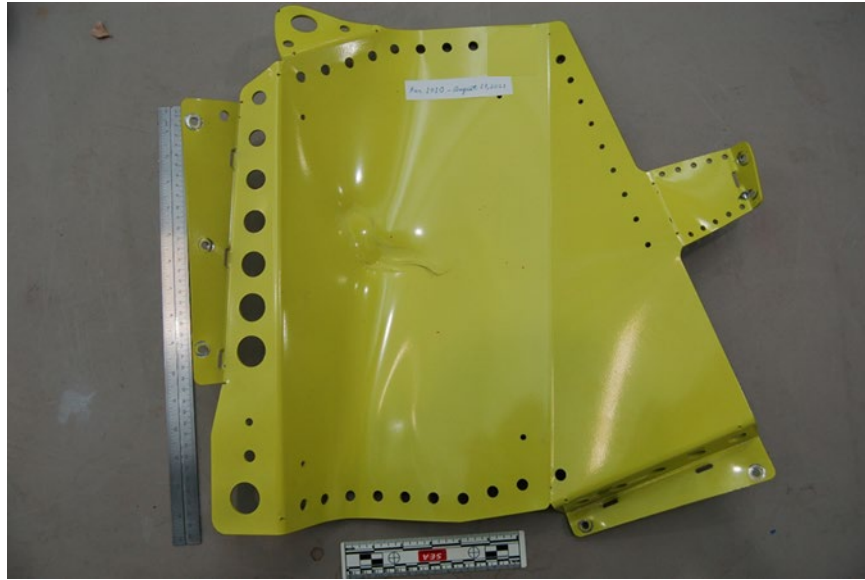
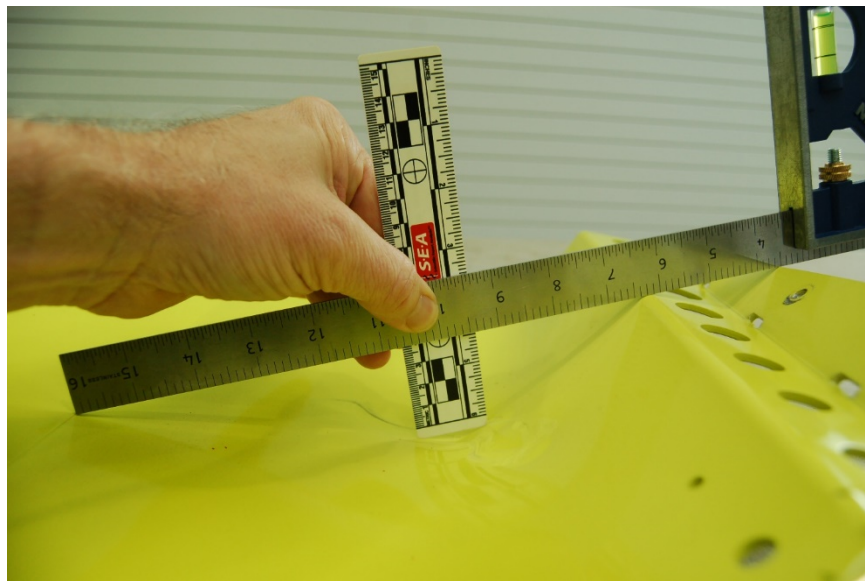
Table 8 (Continued): Vehicle A – Sled Impact Run #4 – Aftermarket Guard A3

This guard is made of aluminum plate 0.125 inches thick. The part tested was powder coated lime green and it covers an area of about 18 inches vertically by 14 inches laterally. In the top photo, to the left in the photo is to the outboard edge of the vehicle, therefore this guard is from the passenger's side of the vehicle.

The bottom photo shows the maximum deformation, 1 $\frac{3}{4}$ inches, in the middle of the guard. The deflection at the lower edge of the guard was slightly greater, about 2 inches.

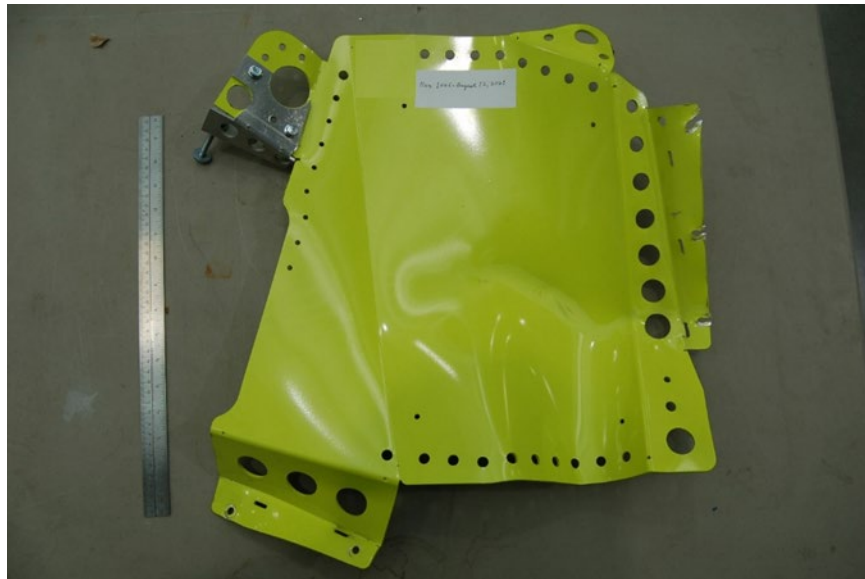
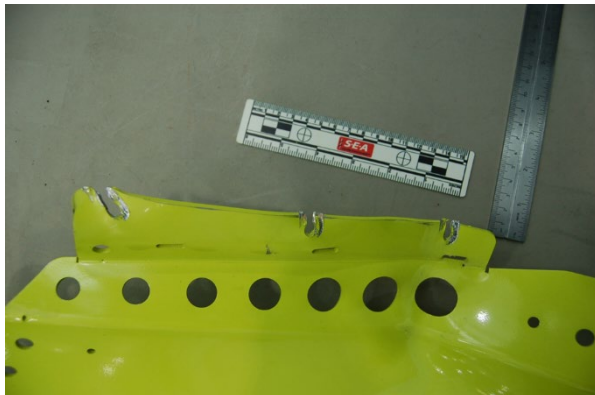
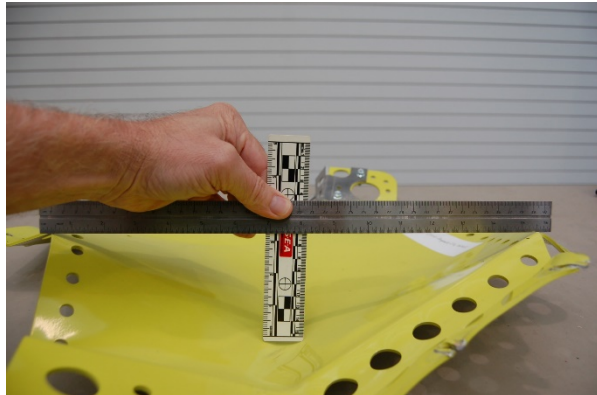
Table 9 (Continued): Vehicle A – Sled Impact Run #5 – Aftermarket Guard A3

The guard deformed and the guard material around the holes for the three outside guard fasteners failed, allowing the guard to release from the outside fasteners. The fasteners themselves did not fail.

This guard is made of aluminum plate 0.125 inches thick. The part tested was powder coated lime green and it covers an area of about 18 inches vertically by 14 inches laterally. In the top photo, to the right in the photo is to the outboard edge of the vehicle, therefore this guard is from the driver's side of the vehicle.

The bottom left photo shows the failed guard material around the holes for the three outside guard fasteners. The bottom right photo shows the maximum deflection in the middle of the part, about 3 3/8 inches.

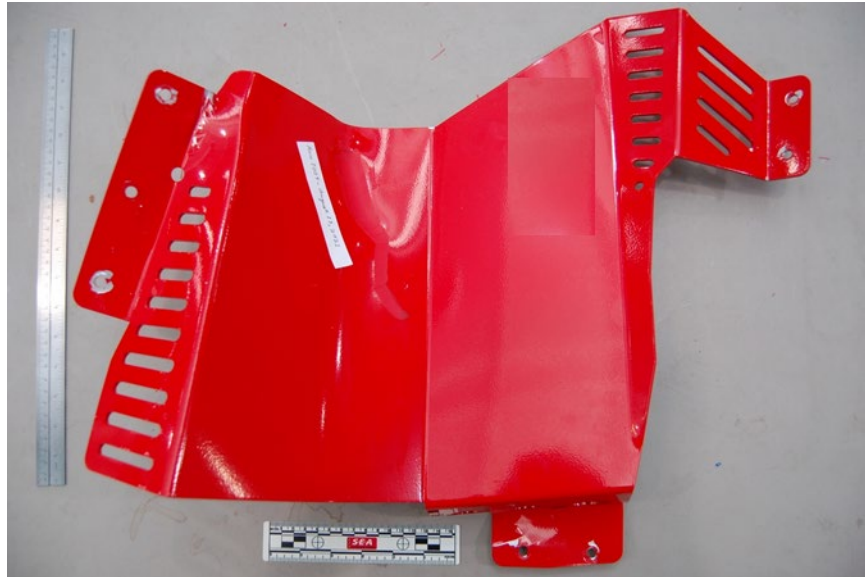
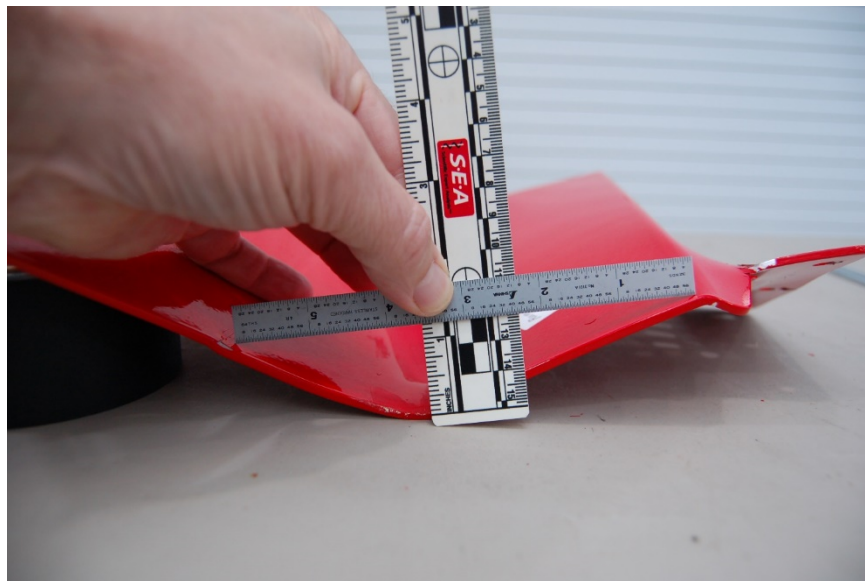
Table 10: (Continued) Vehicle A – Sled Impact Run #6 – Aftermarket Guard A4

This guard is made of aluminum plate 0.130 inches thick. The part tested was powder coated red and covers an area of about 13 inches laterally and 17 inches vertically. In the top photo, to the left in the photo is to the outboard edge of the vehicle, therefore this guard is from the passenger's side of the vehicle.

The bottom photo shows the maximum deflection at the top edge of the guard is 1 ¼ inches.

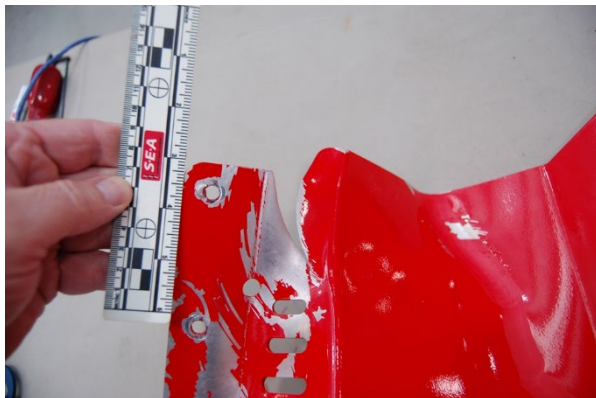
Table 11 (Continued): Vehicle A – Sled Impact Run #7 – Aftermarket Guard A4

The guard deformed and the guard material ripped near the top outer edge of the guard. None of the guard fasteners failed.

This guard is made of aluminum plate 0.130 inches thick. The part tested was powder coated red and covers an area of about 13 inches laterally and 17 inches vertically. In the top photo, to the left in the photo is to the outboard edge of the vehicle, therefore this guard is from the passenger's side of the vehicle.

The bottom left photo shows the guard material ripped near the top outer edge of the guard. The bottom right photo shows the maximum deflection at the top edge of the guard is 1 5/8 inches.

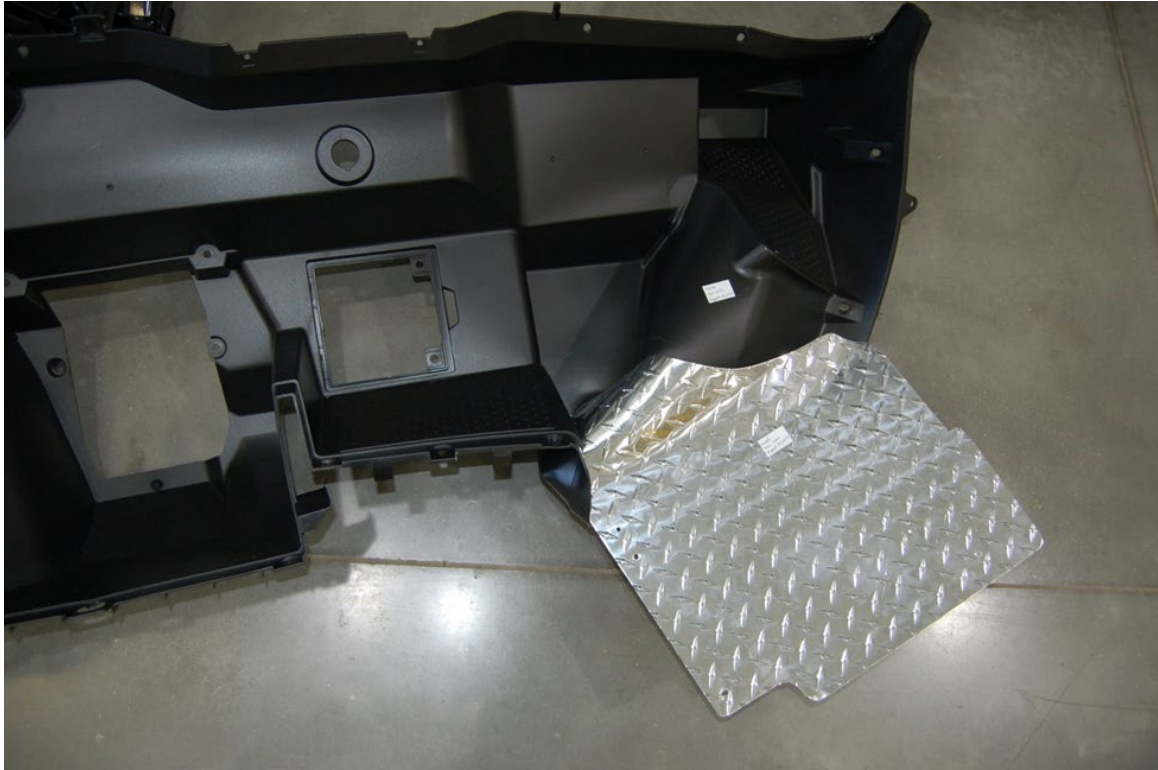
Table 13 (Continued): Vehicle B – Sled Impact Run #2 – Aftermarket Guard B1

This guard is made of aluminum diamond plate 0.061 inch thick. This is an internal guard, with a diamond thread plate pattern. It was about 17 ½ inches laterally by 23 ½ inches longitudinally. The guard used is for the passenger's side of the vehicle. It is shown intermeshed with the deformed plastic floorboard. The parts cannot be separated without damaging them further. No measurements of the deformation were made, but the deformation is clearly very large.

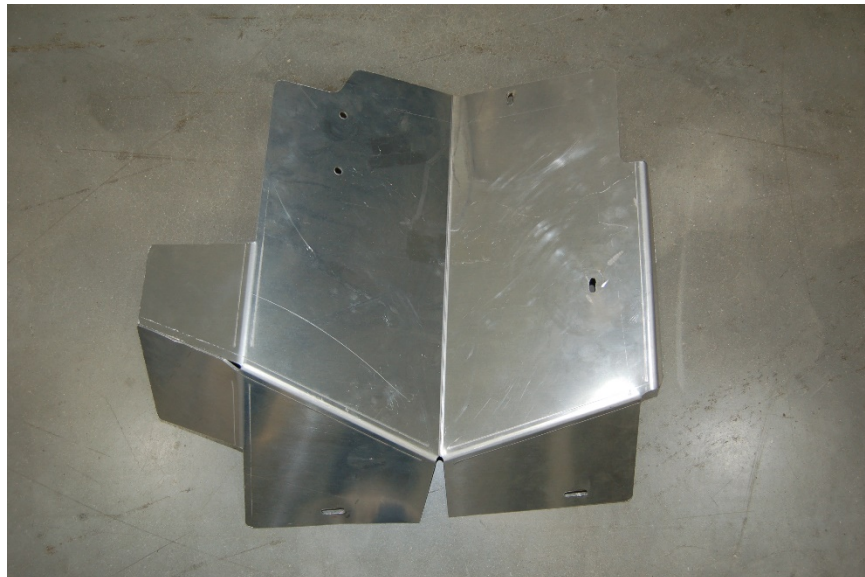
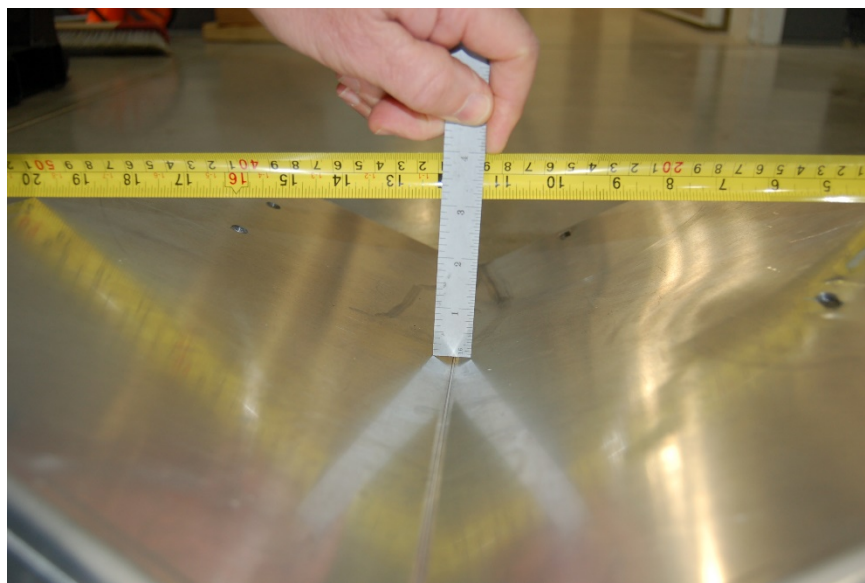
Table 20 (Continued): Vehicle D – Sled Impact Run #3 – Aftermarket Guard D1

This guard is made of aluminum plate 0.156 inches thick. It covers an area of about 17 inches laterally and 20 inches vertically. In the top photo, to the right in the photo is to the outboard edge of the vehicle, therefore this guard is from the driver's side of the vehicle.

The deflection in the guard after this run was measured to be the same as after the previous run using this same guard, about 5/8 inch.

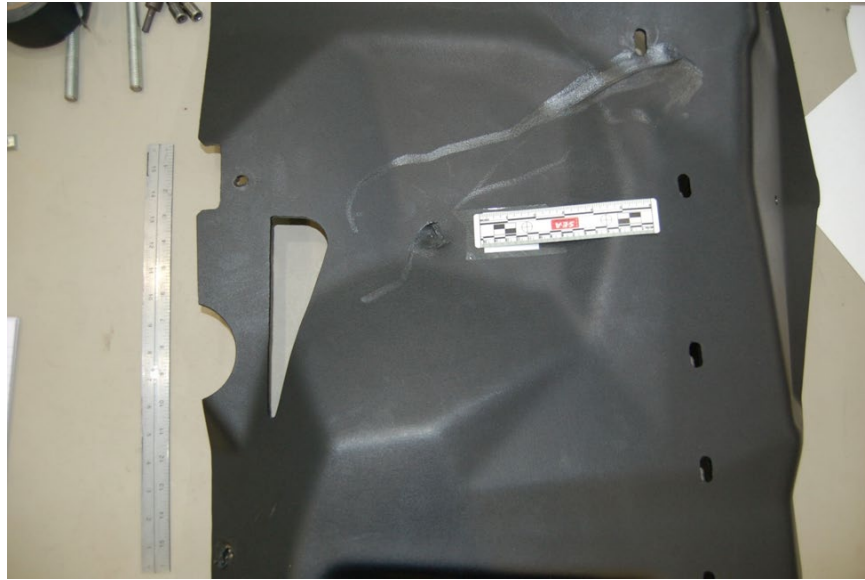
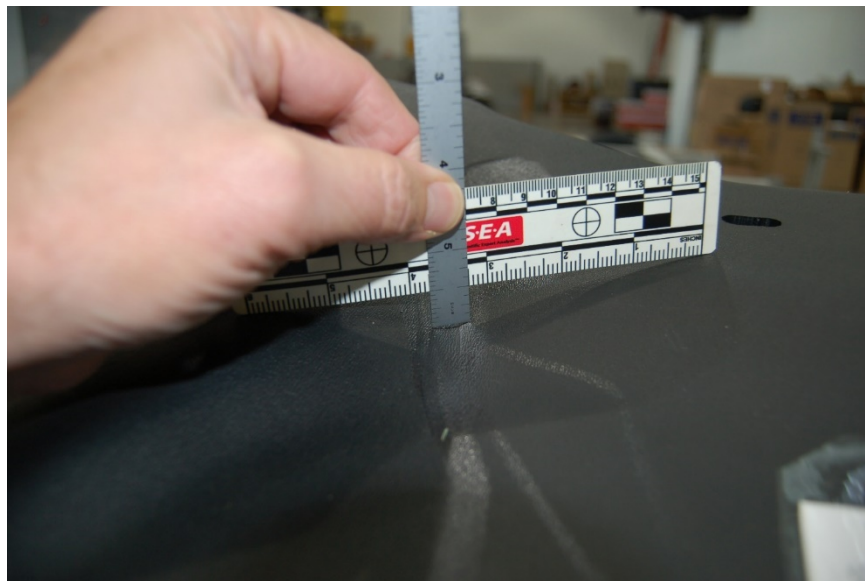
Table 22 (Continued): Vehicle E – Sled Impact Run #2 – Aftermarket Guard E1

This is a black plastic guard made of High Molecular Weight Polyethylene (HMWPE). Per the manufacturer of this guard, its starting thickness is 0.30 inches and after forming/stretching it into shape it will be less in some areas. Its thickness varies somewhat but averages about 0.270 inches. It covers an area of about 24 inches laterally and 27 inches vertically. The top photo shows the driver's side guard tested in this run.

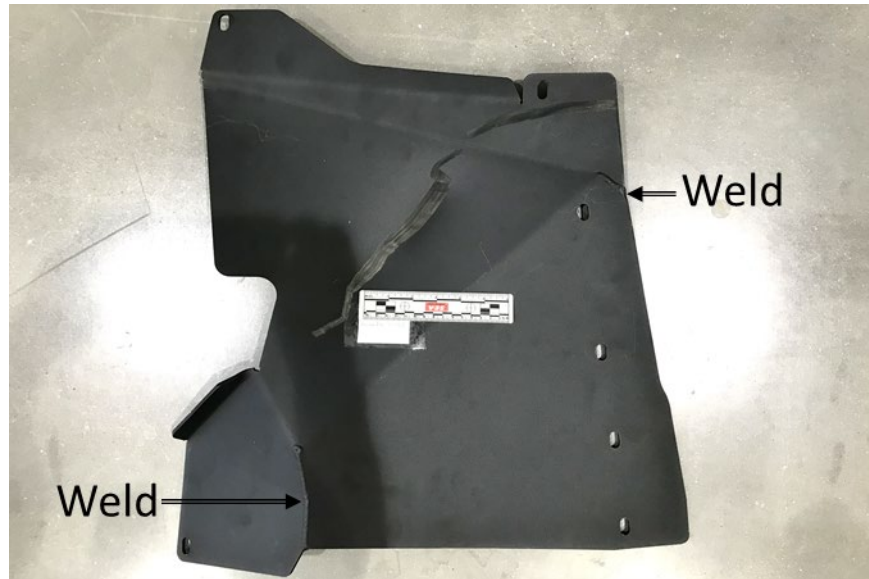
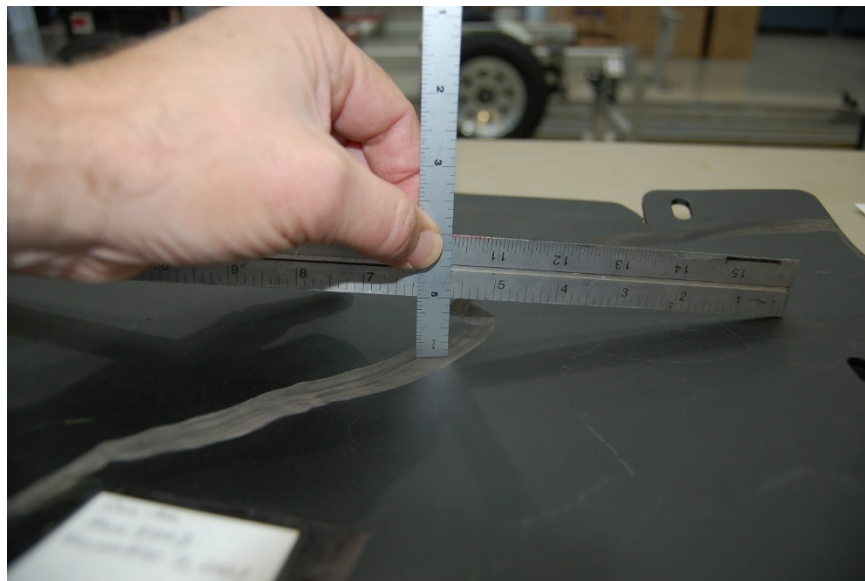
Table 24: Vehicle E – Sled Impact Run #4 – Aftermarket Guard E2

This is a powder coated black aluminum guard with thickness of 0.171 inches. It covers an area of about 17 ½ inches laterally and 22 inches vertically. This guard has two welded seams, as shown in the top photo of the driver's side guard tested in this run.

Stick shattered. Indentation in guard of about 1 3/16". The guard covered an area extending beyond the outside frame of the vehicle, and there was no failure of the guard material or guard fasteners. No damage to OEM firewall or fasteners.

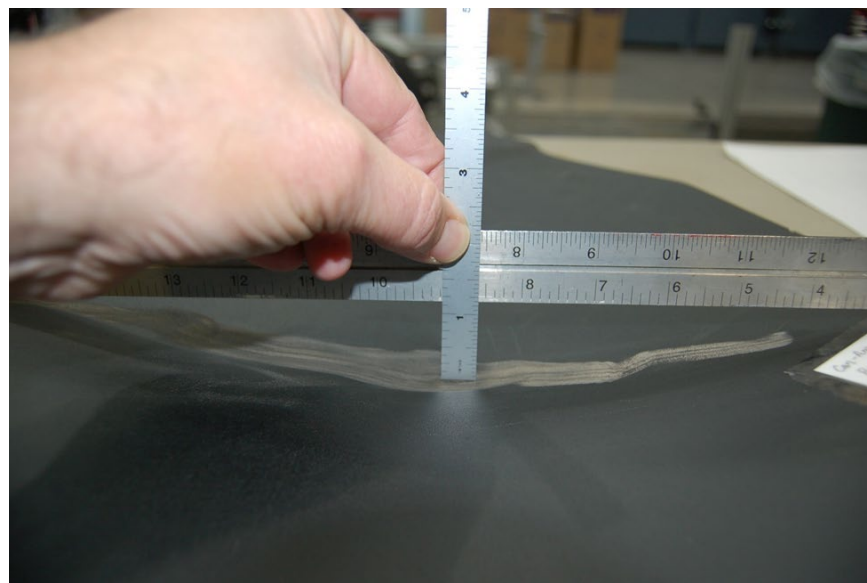
Table 25 (Continued): Vehicle E – Sled Impact Run #5 – Aftermarket Guard E2

Guard E2 (Table 25) passed the run at 10 mph, it prevented the stick from penetrating the occupant compartment. During this impact, the tip of the stick was forced upward and outward along the guard, and eventually the stick shattered. The guard covered an area extending beyond the outside frame of the vehicle, and there was no failure of the guard material or guard fasteners.

This is a powder coated black aluminum guard with thickness of 0.171 inches. It covers an area of about 17 ½ inches laterally and 22 inches vertically. This guard has two welded seams, as shown in the top photo of the passenger’s side guard tested in this run.
