COVER SHEET -- NPTEC TEST PLAN

Fiberglass Analysis of Ticking and Barrier Fabrics in Mattresses

Paige Witzen, Textile Technologist

July 2023

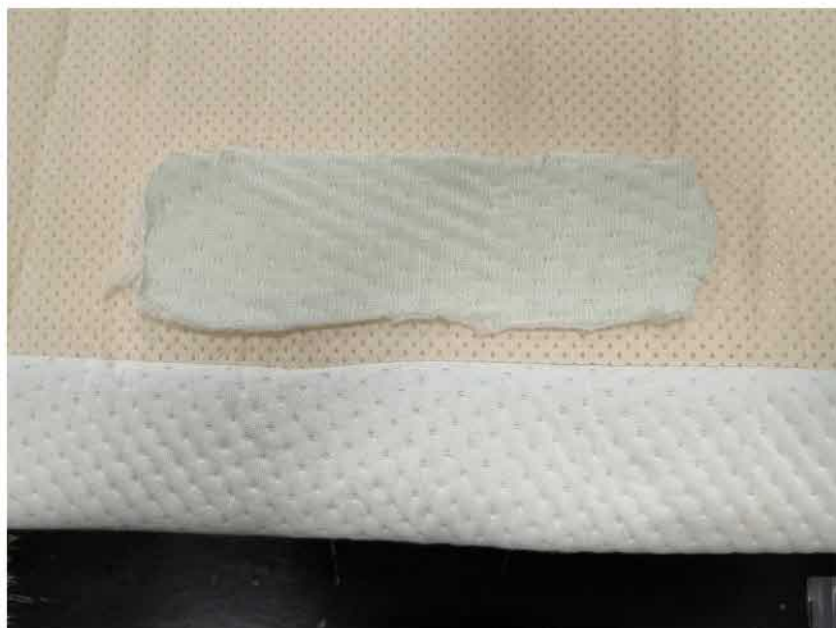
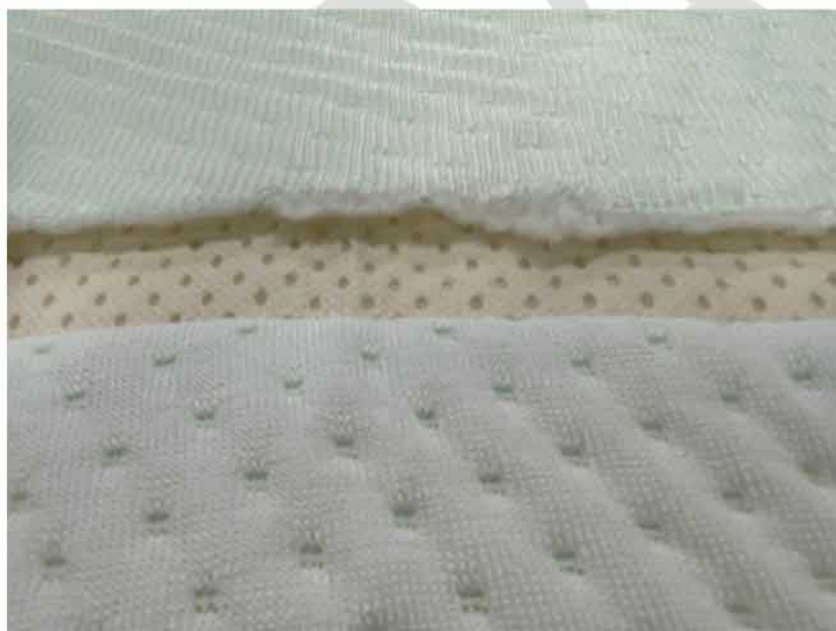
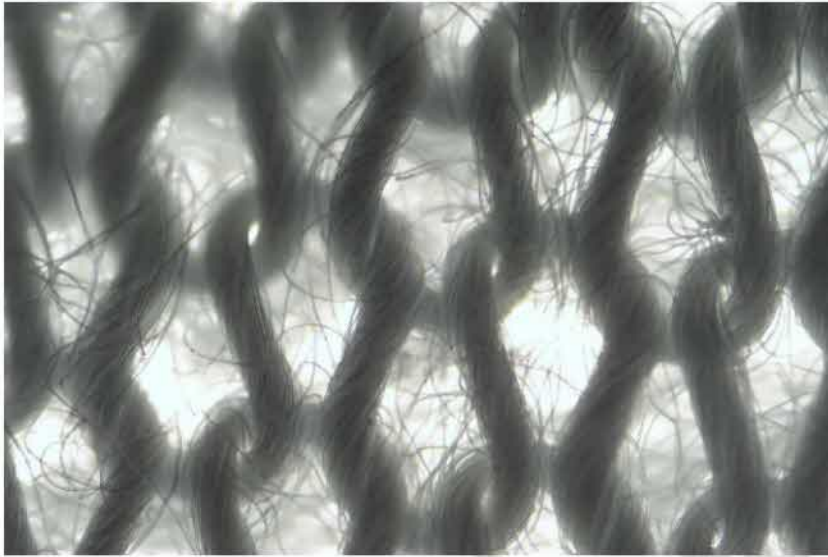
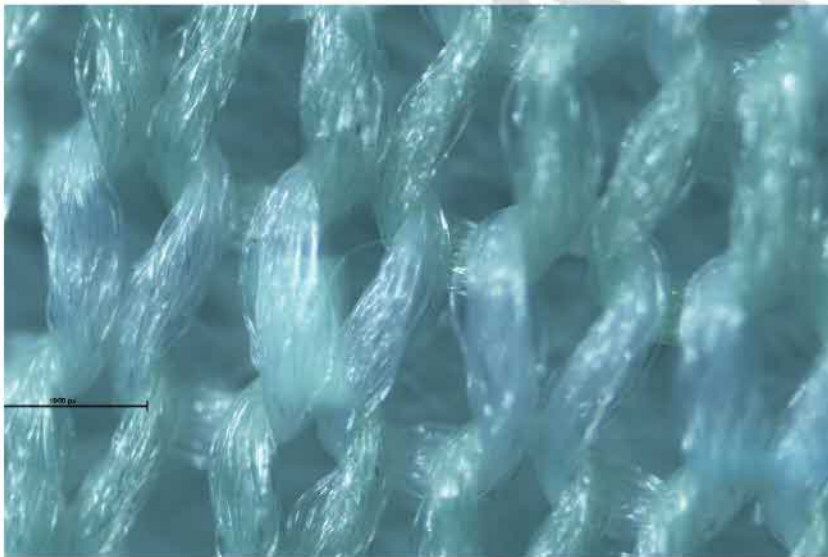
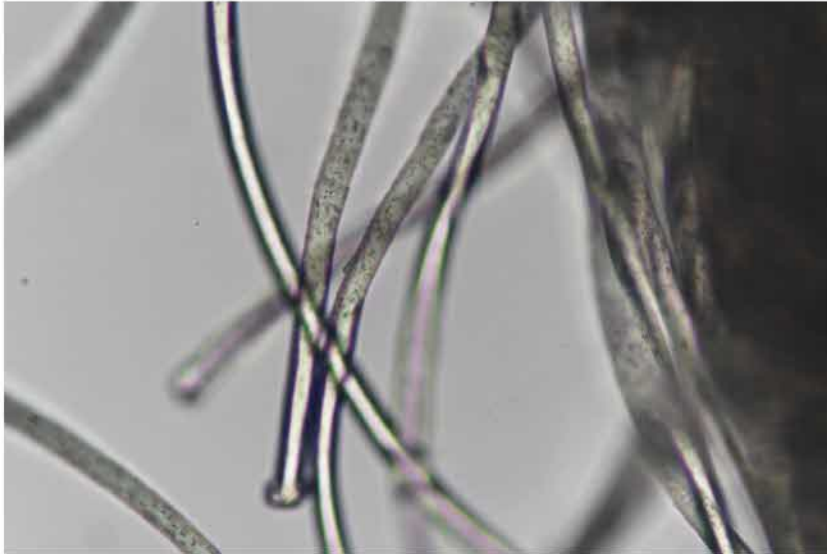
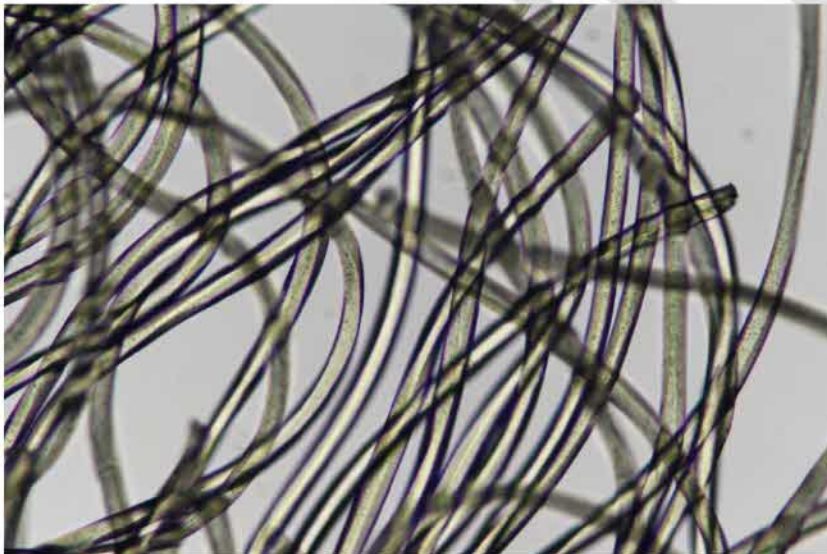
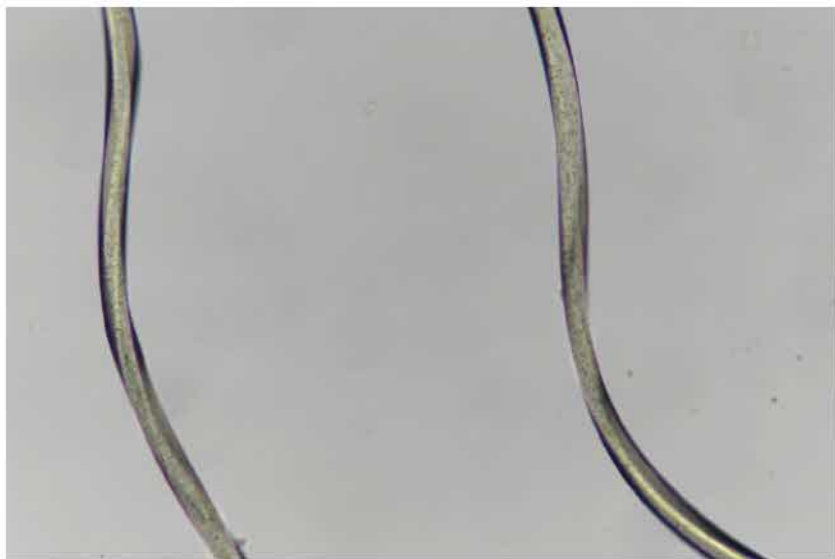
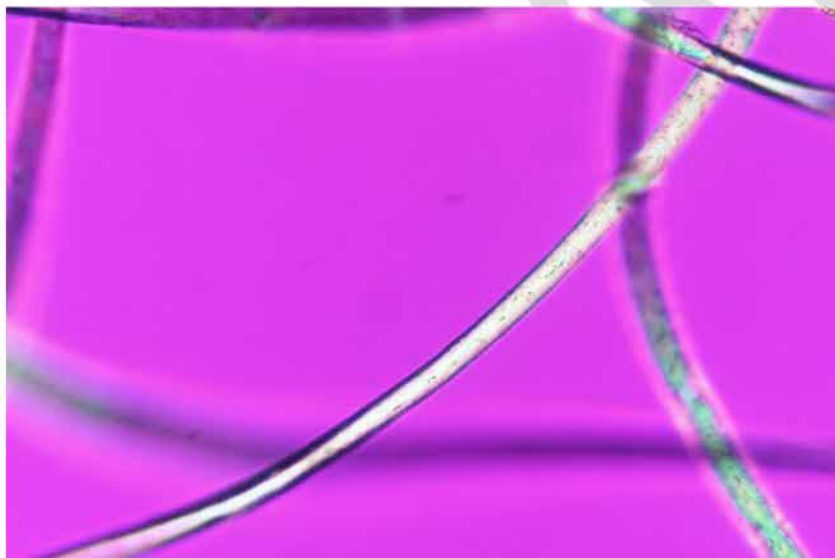
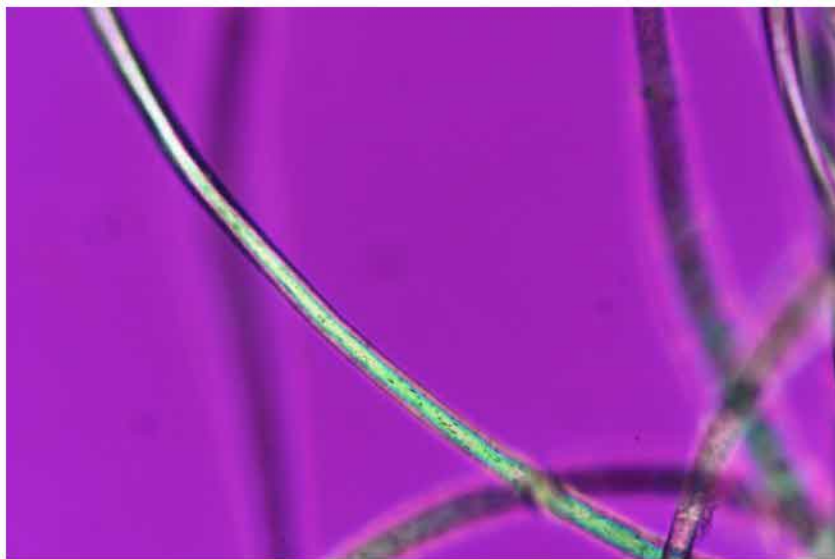
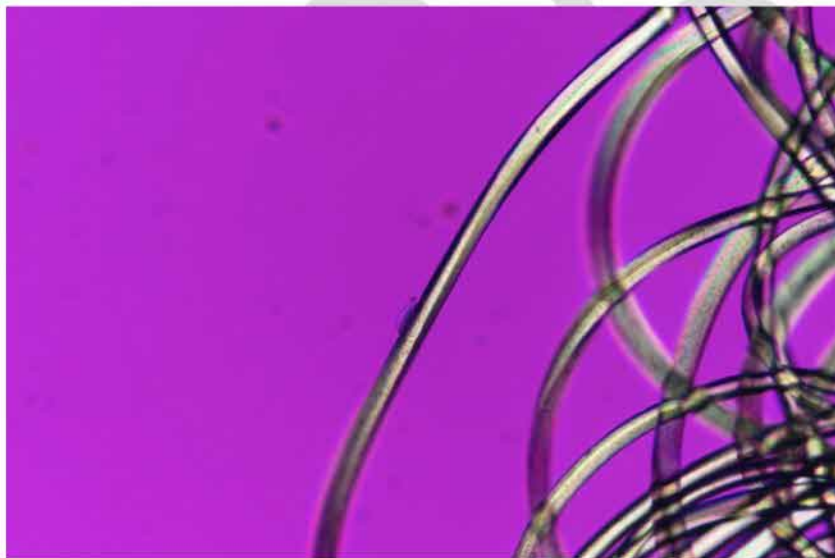
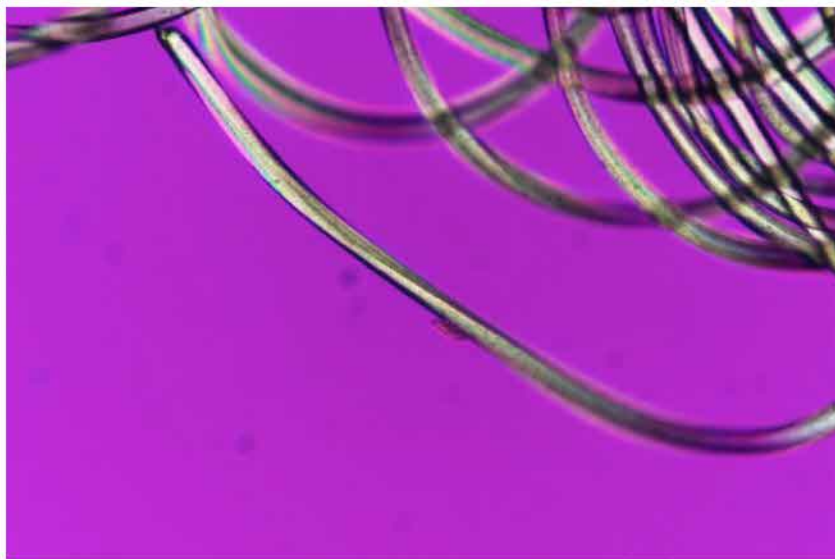
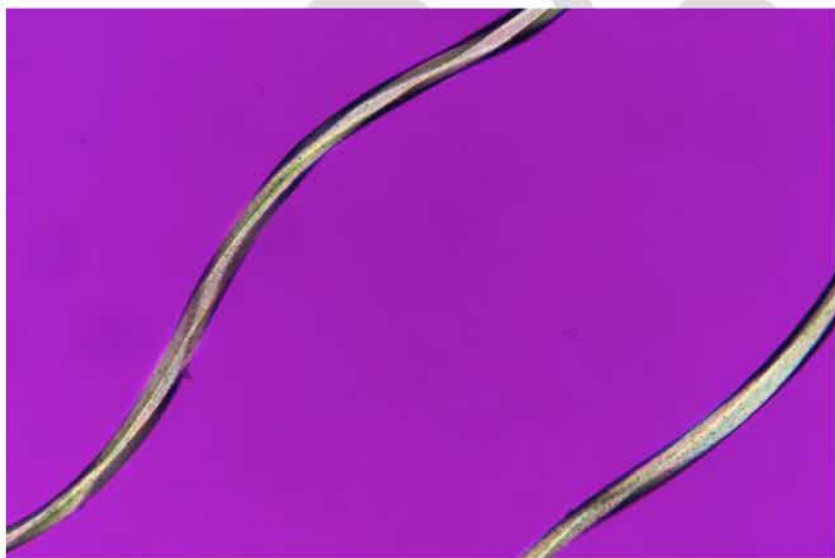
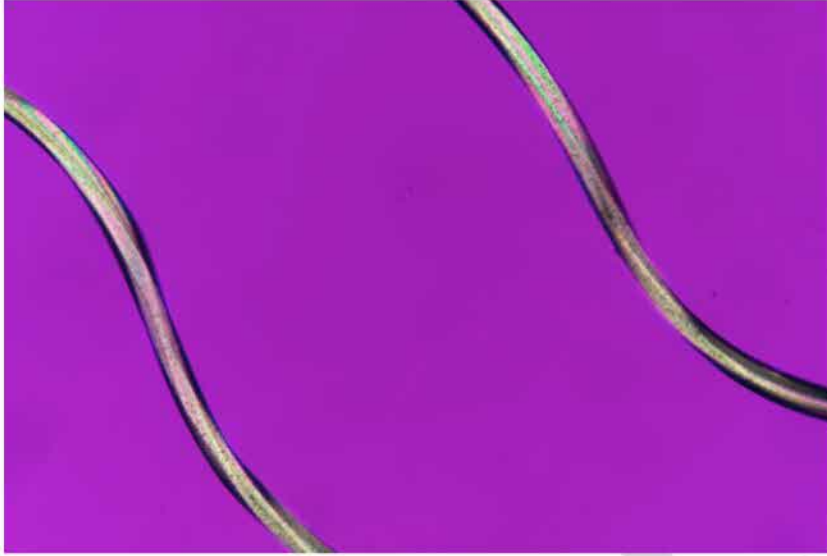
22-800-1442-03 ticking fabric was determined to be 100% polyester for the outer surface, inner surface and fill fibers. Under the red plate all parts of the ticking fabric were light yellow in the North-East to South-West direction and light blue in the North-West to South-East direction. This indicates that they are polyester fiber.

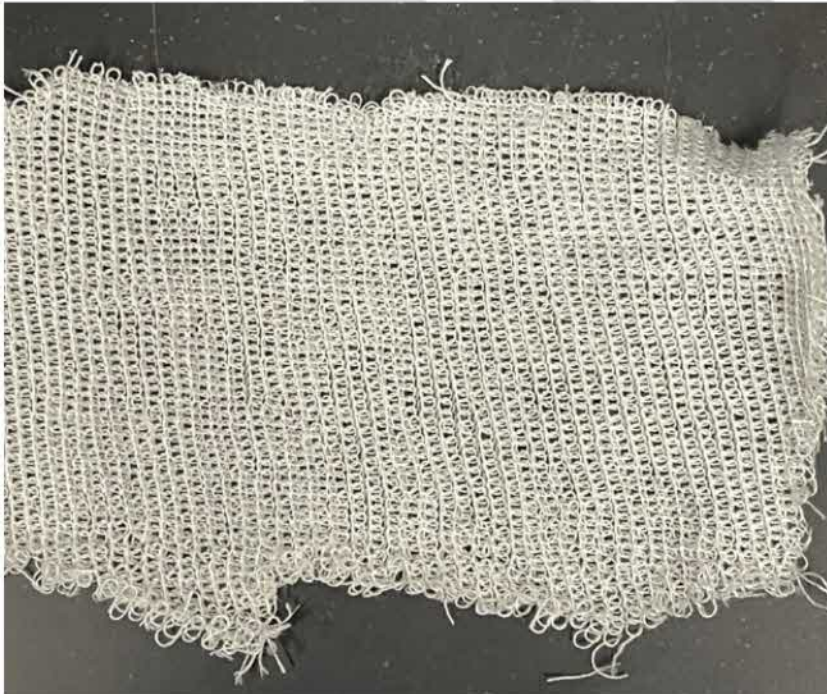
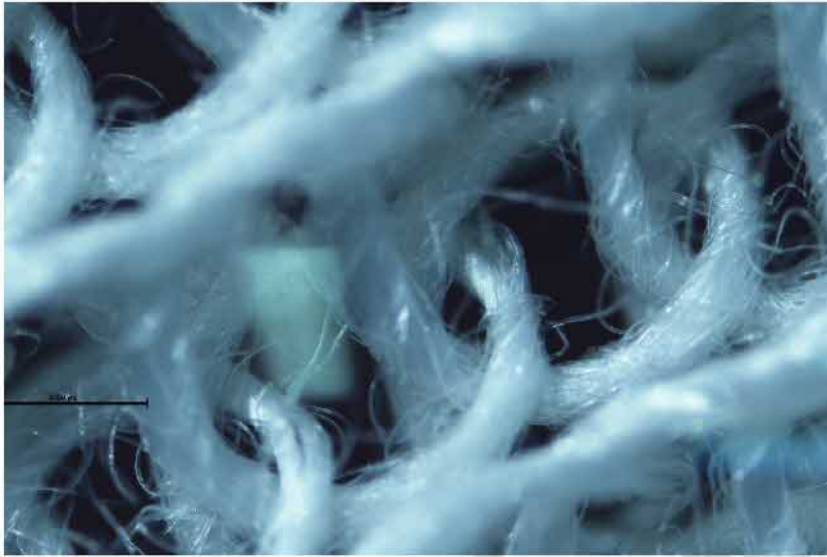
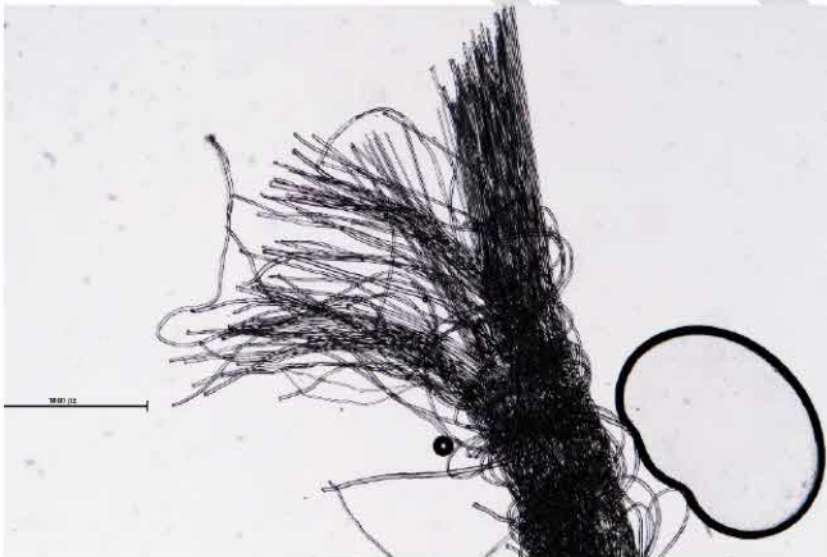
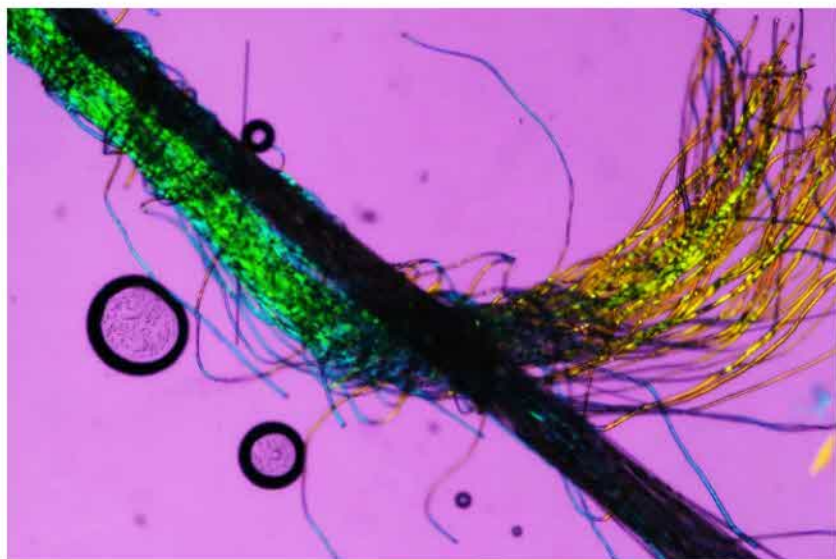
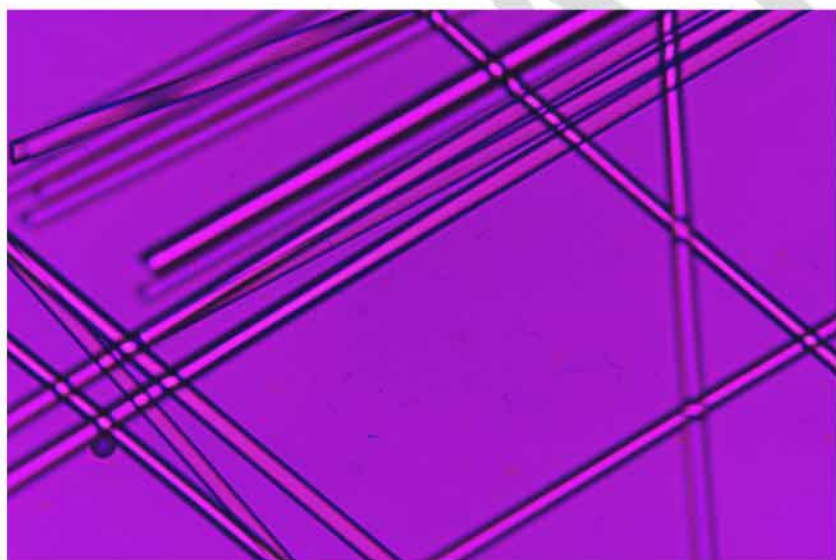
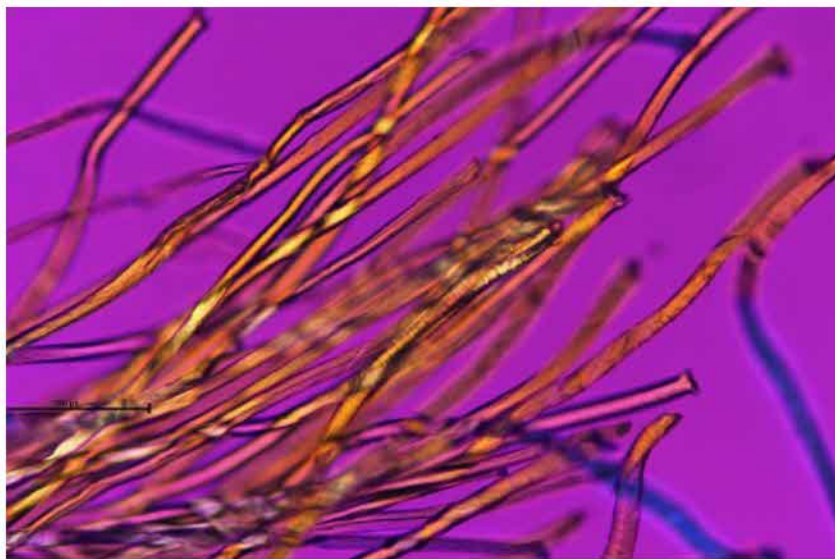
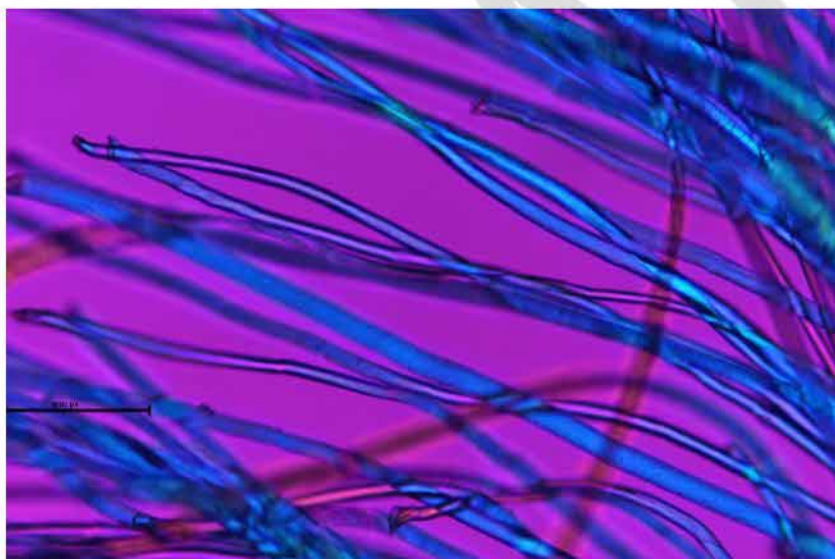
Figure 7: 22-800-1442-03 Barrier Fabric

22-800-1442-03 barrier fabric was determined to be fiberglass core fibers wrapped with acrylic or polypropylene fibers. The core fibers were extinguished in both the North-East to South-West direction and the North-West to South-East direction confirming fiberglass fibers. The wrapped fibers were determined that the fibers are either acrylic or polypropylene. The fiberglass had an average fiber length of 11.3 mm and average diameter of . The yarns were spun using an air-wrap spinner with a Z twist. Looking at the fabrics from this sample in original state there was no evidence of fiberglass fibers breaking or moving through the ticking fabric.

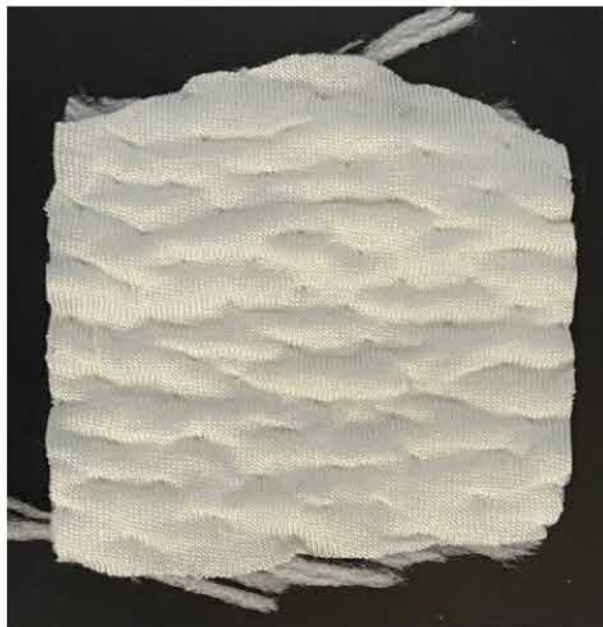
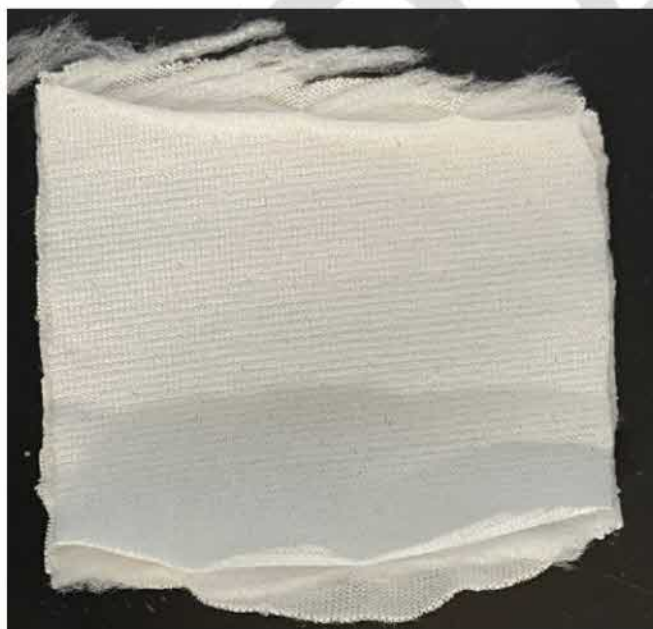
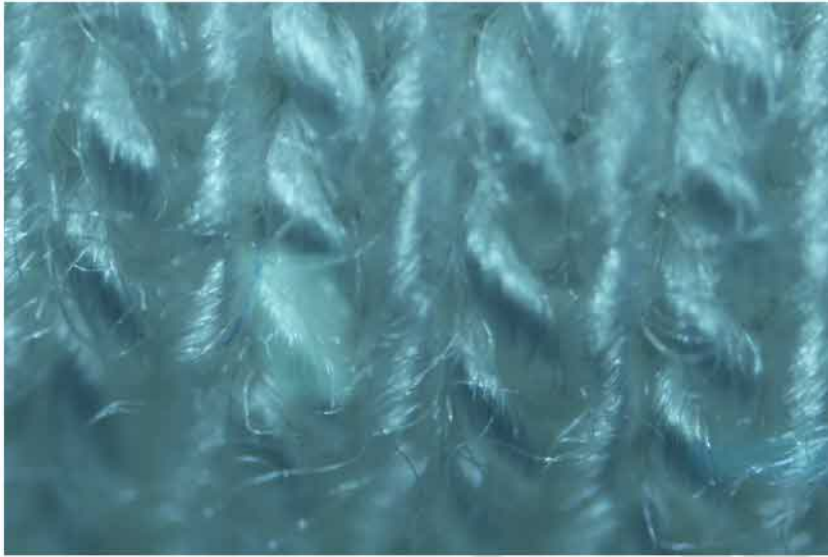
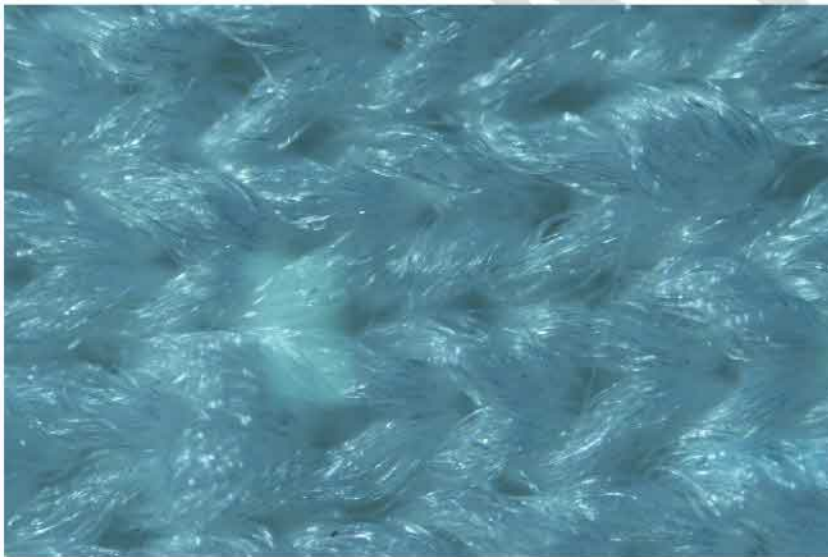
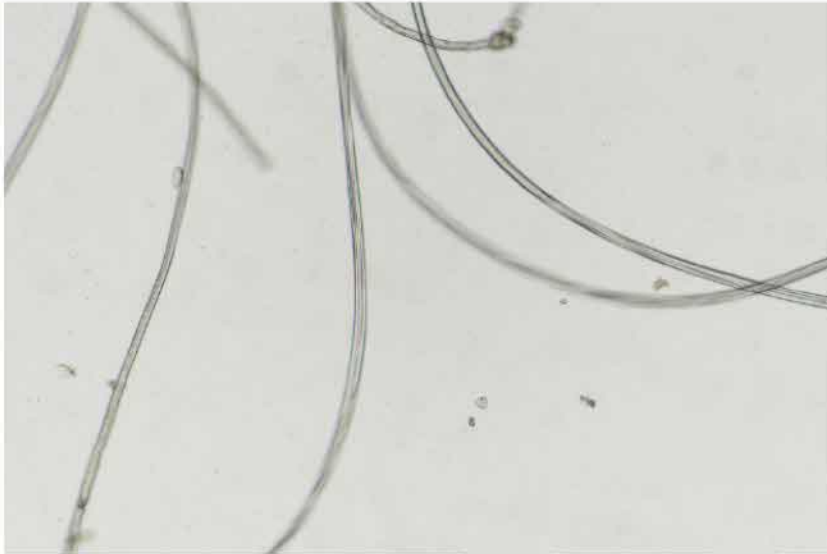
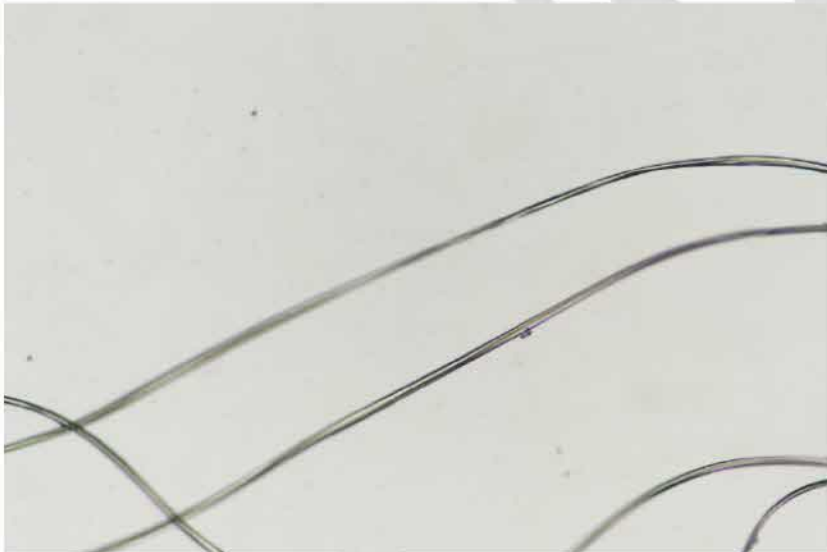
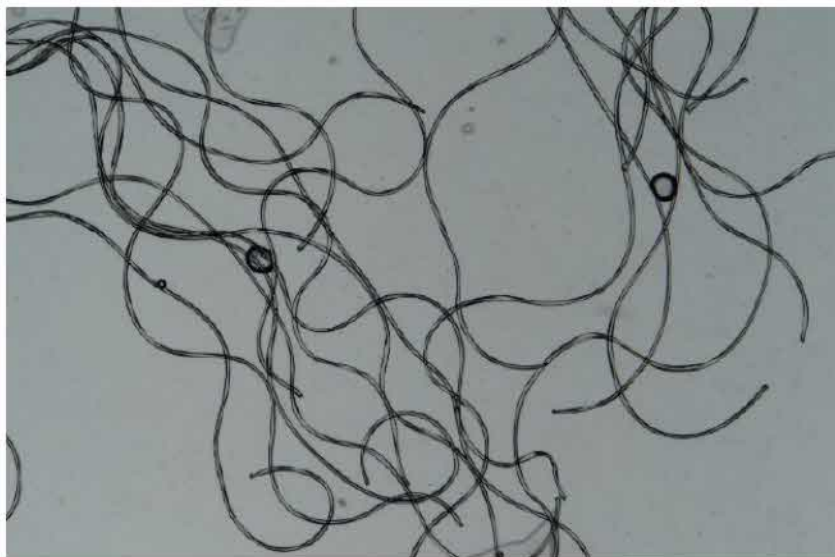
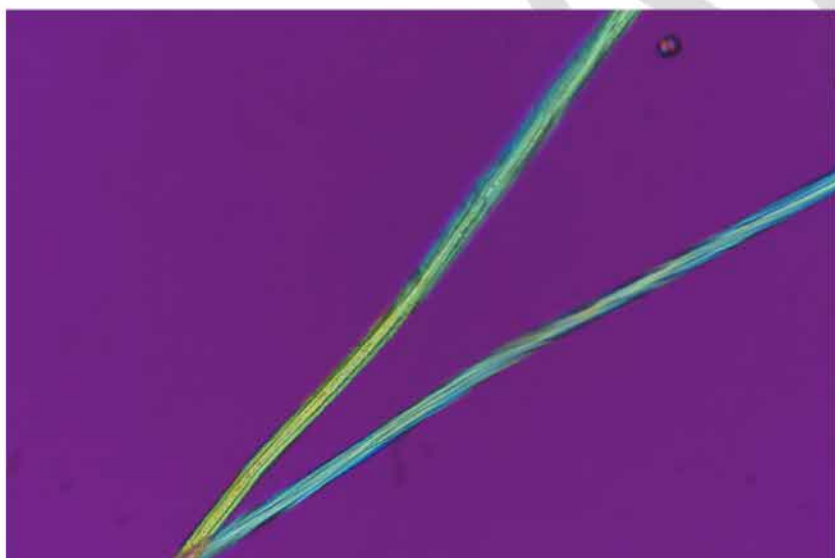
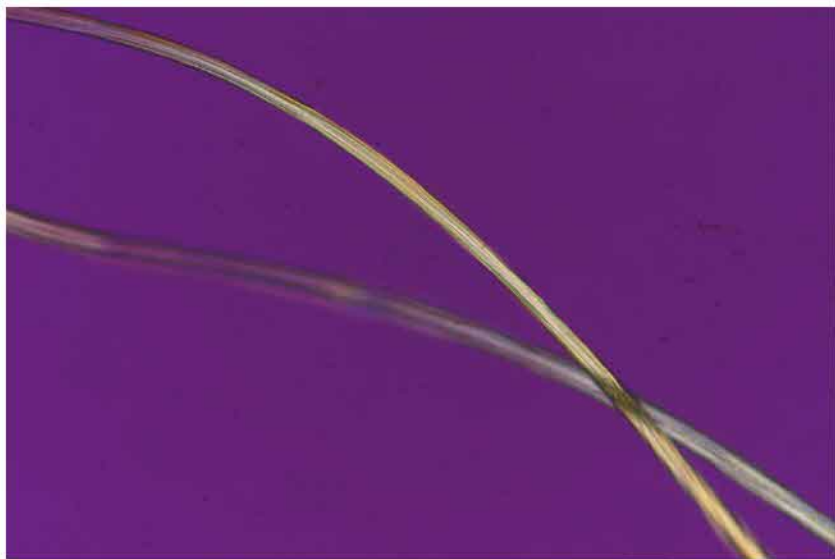
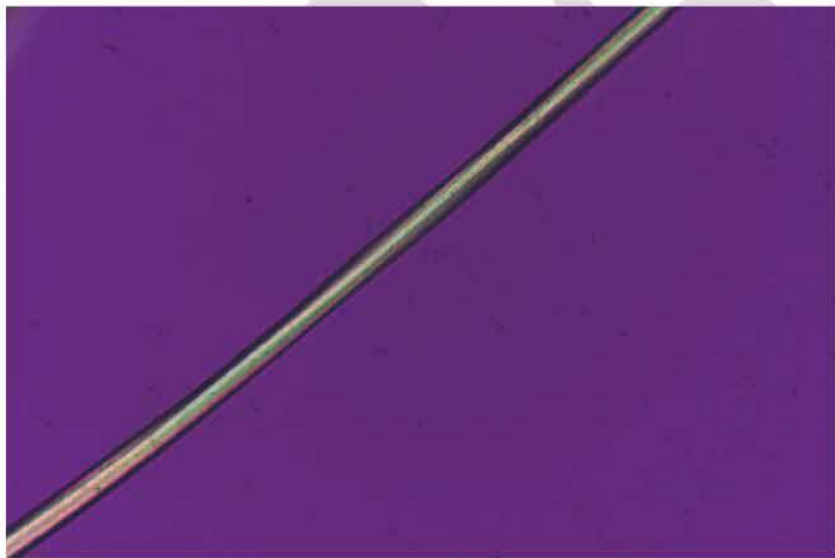
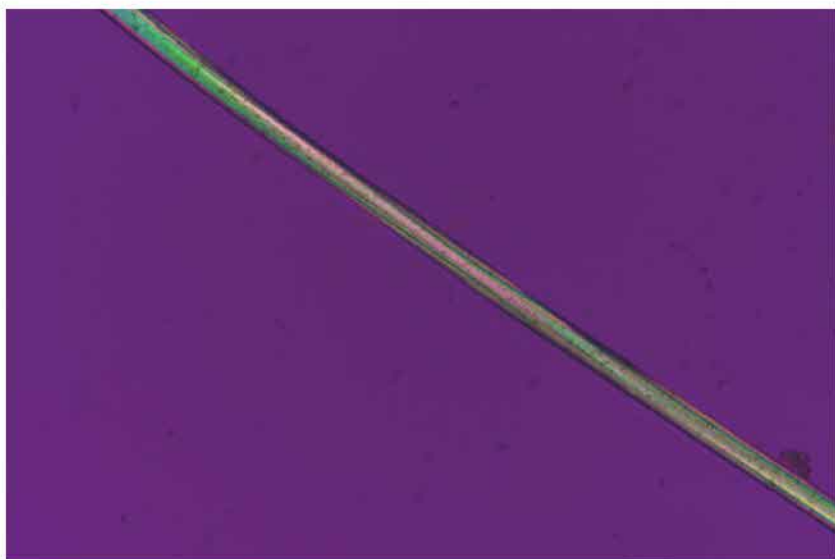
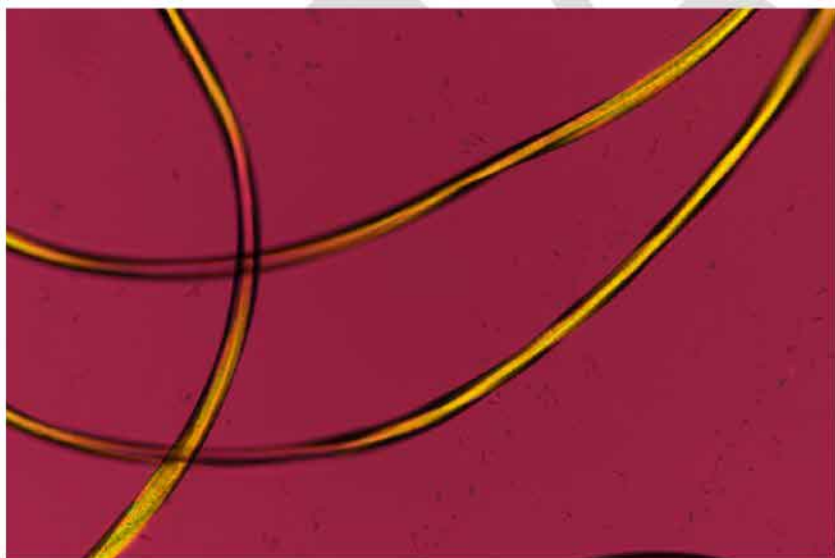
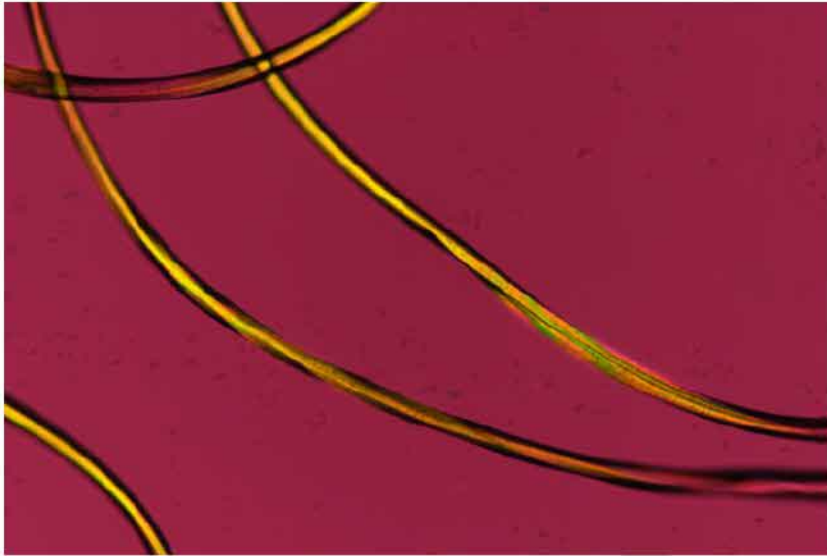
22-800-1443-03 ticking fabric was determined to be 100% polyester for the outer surface and inner surface fabrics. Under the red plate all parts of the ticking fabric were light yellow in the North-East to South-West direction and light blue in the North-West to South-East direction. This indicates that they are polyester fiber. The ticking fill fiber was determined to be 100% nylon by the yellow color of fibers under red plate in both the North-East to South-West direction and the North-West to South-East direction.

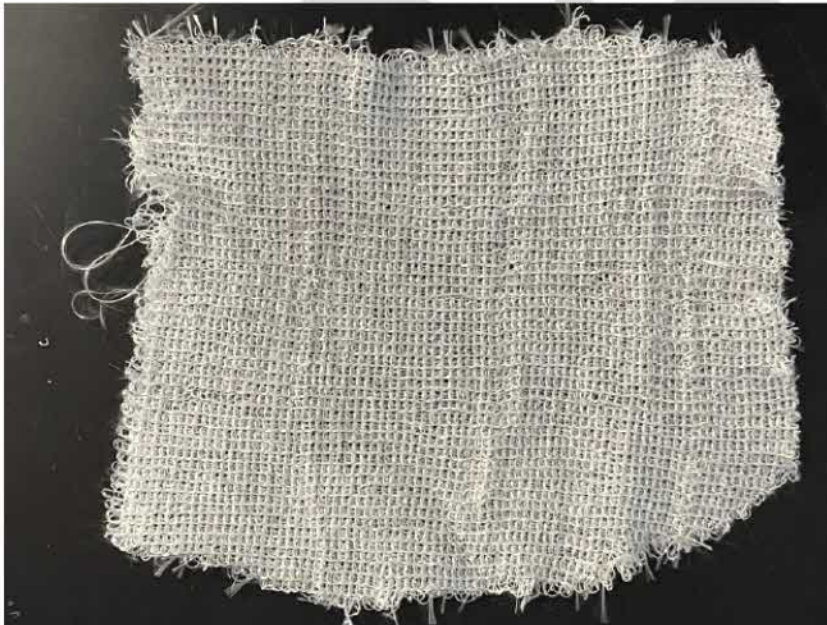
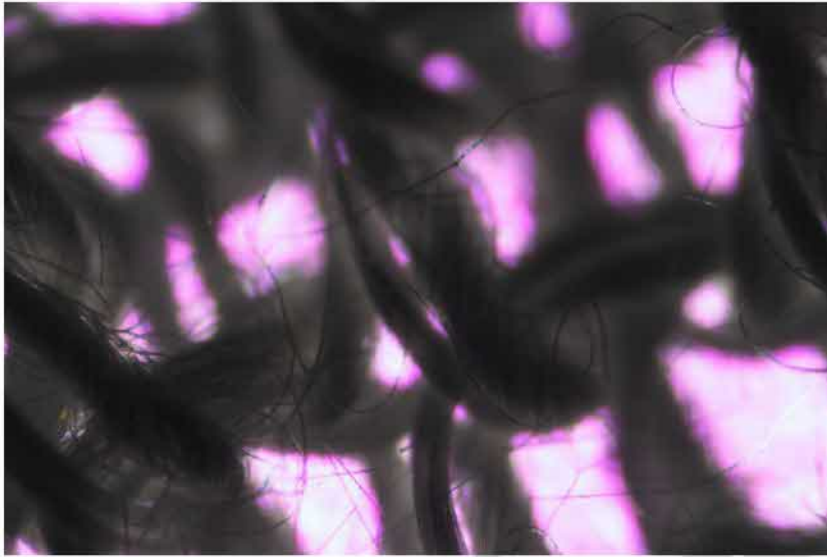
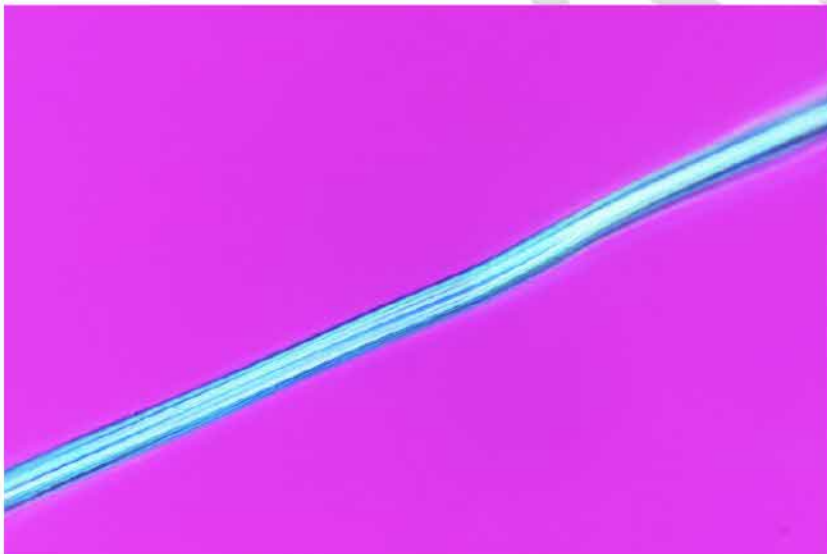
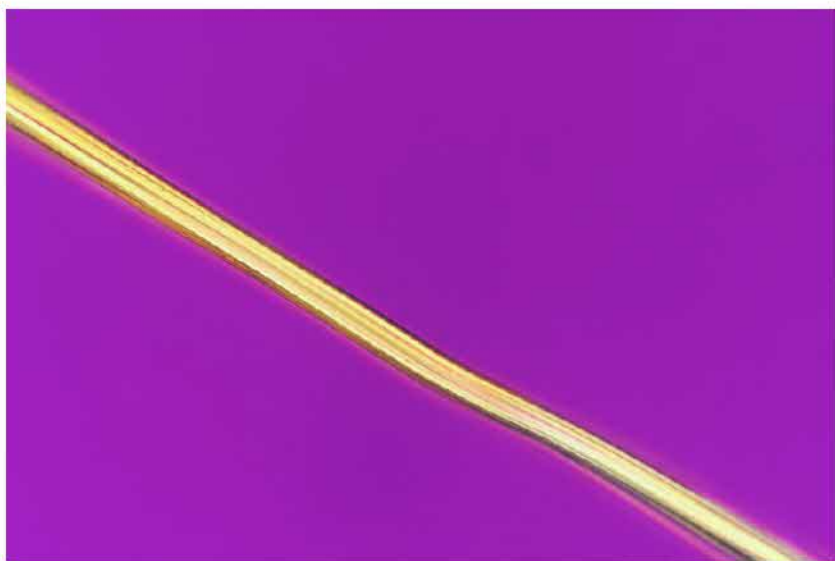
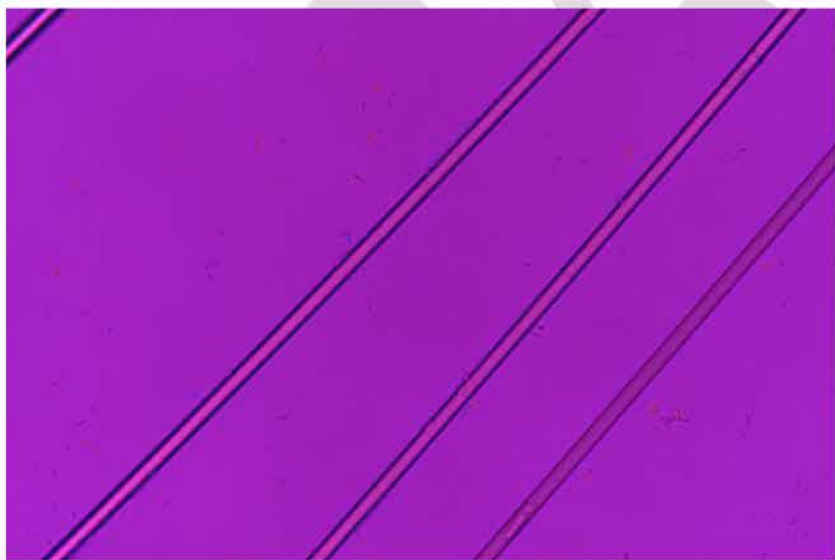
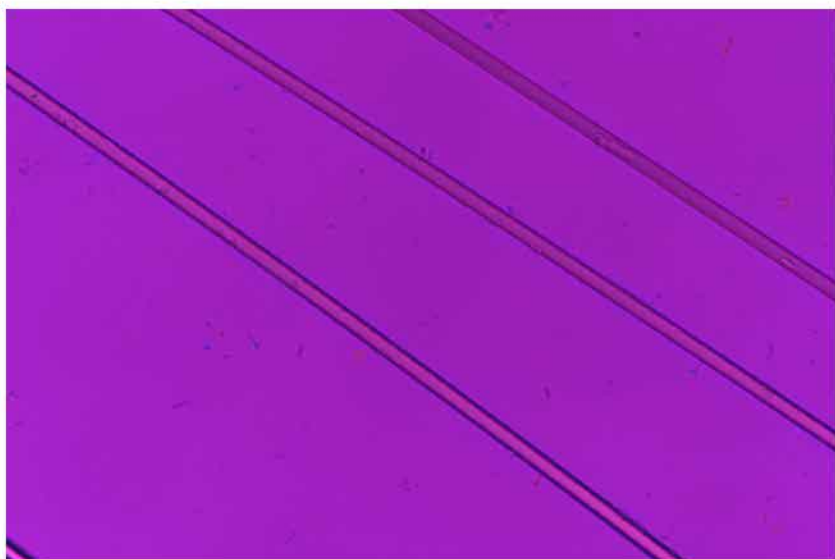
Figure 16: 22-800-1443-03 Barrier Fabric

22-800-1443-03 barrier fabric was determined to be fiberglass fibers with rayon scaffolding or support yarn for the fabric. The scaffolding fibers were blue in the North-East to South-West

direction and yellow in the North-West to South-East direction, indicating either acrylic or polypropylene fibers. The fill set of fibers were extinct in both the North-East to South-West direction and the North-West to South-East direction confirming fiberglass fibers. The fibers were too brittle to separate from the scaffolding yarn and get fiber length measurements. The average fiber diameter was around 2 microns.

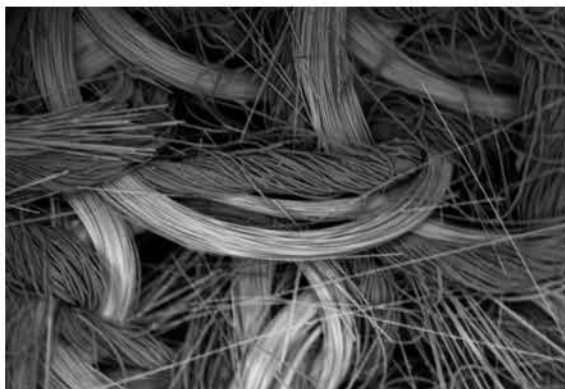
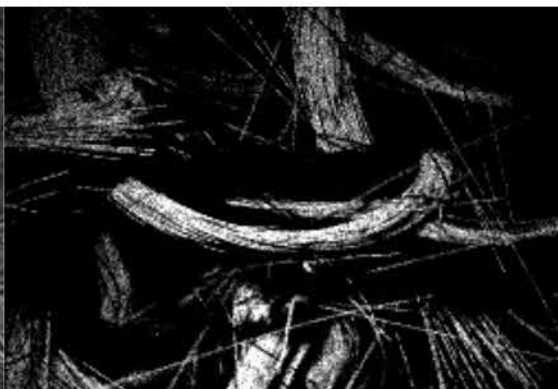
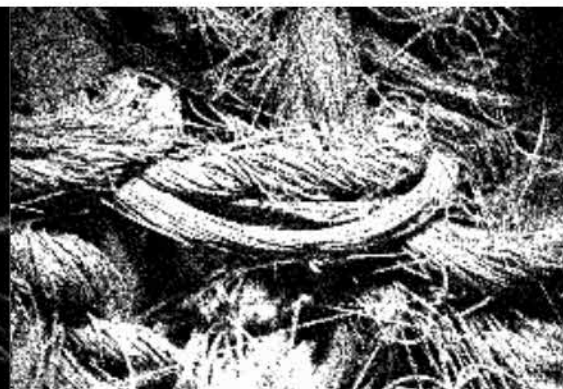
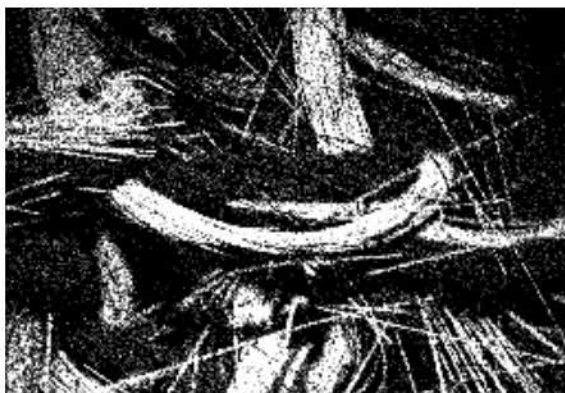
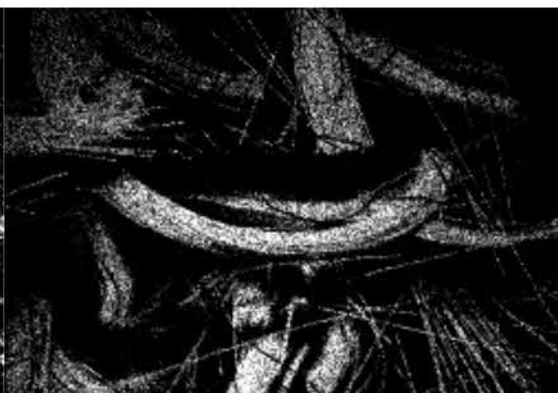
Comment: 22-800-1443-03 barrier

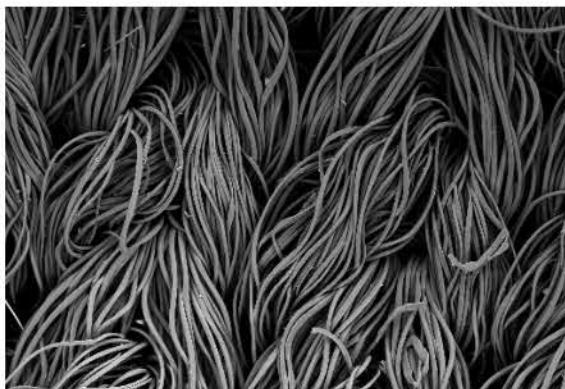
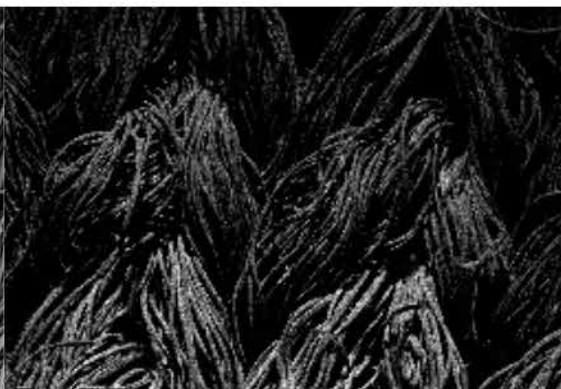
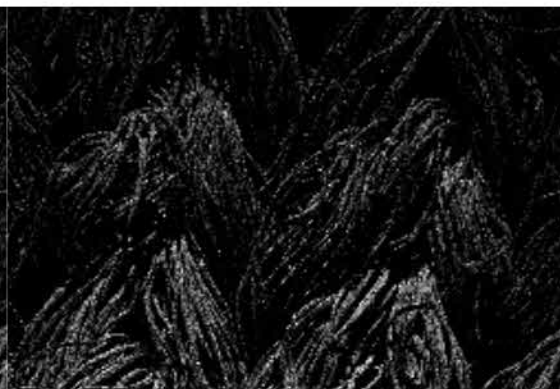
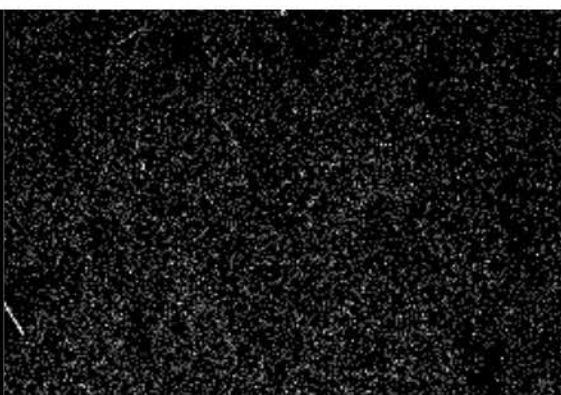
Comment: 22-800-1443 ticking side A
