SUBJECT: Options to Address Crib Slat Disengagement Hazards

OPTIONS TO ADDRESS CRIB SLAT DISENGAGEMENT HAZARDS

November 1996

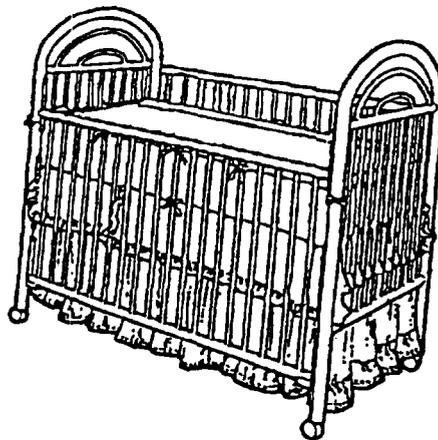
COSCO
Model T14

The cribs are made of welded red, white, blue or multicolored tubular metal. The crib has both a fixed side rail and a drop side rail which can be lowered or fully raised and locked into place. The majority of the cribs were sold nationwide between January 1991 and April 1994 at leading retail stores and juvenile furniture stores, including Sears, J.C. Penny and Toys R Us, for about \$95 to \$150. The unassembled cribs were packaged in a box labeled in part, "COSCO."

The recall program involves crib models 10T01, 10T04, 10T05, 10T06, 10T09, 10T11, and 10T14. The manufacturer's identification, which includes the model number, is located at the bottom of the horizontal rail of either the drop side or fixed side rail of the

Consumers who own the recalled cribs should stop using them and contact Cosco at (800) 314-9327 for a free repair kit.
