UNITED STATES
Consumer Product Safety Commission

GAS RANGE DELAYED IGNITIONS Tests and Examinations of Ranges

Mark G. Eilbert, Mechanical Engineer
Directorate for Laboratory Sciences
Division of Mechanical Engineering

July 15, 2002

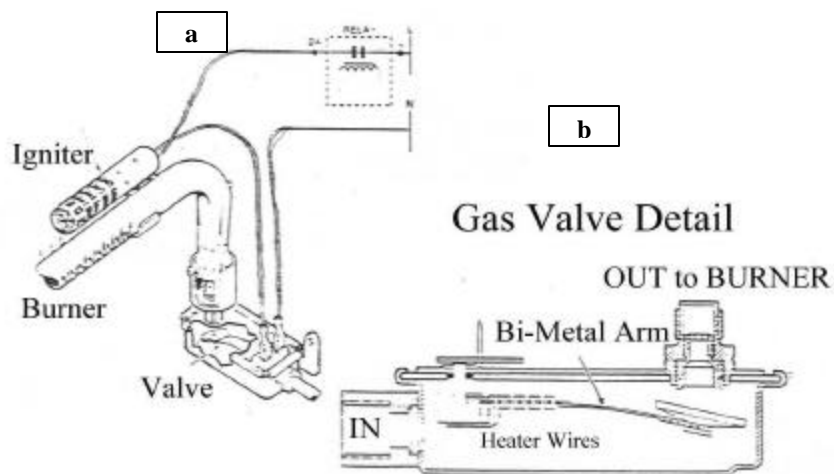
Figure 2 shows the self-proving circuit comprising the igniter and valve and typical details of the valve. In a properly functioning system, the heating of the igniter and the opening of the valve are matched so that the igniter will have reached combustion temperature before the valve opens. The valve seat opens as depicted in Figure 2(b) after the “heater wires” sufficiently warm the bi-metal arms. The electric current to cause that heating is restricted by the electrical properties of the igniter. To achieve the desired current rise, the composition of the silicon carbide igniter is “doped” with special chemicals.

Figure 2. Self-Proving Ignition System: Assembly (a) and Gas Valve (b)

The hot surface igniter (HSI) functions both as an ignition source and as an effective timing switch for the gas valve. As an ignition source, the HSI reaches a maximum temperature of over 2000 °F (1100 °C), greater than the ignition temperature for natural gas (1300 °F, 700 °C) or for propane (920-1125 °F, 500-600 °C). As a switch, the HSI limits the current through itself and through the gas valve, which itself requires internal heating to open. The term “self-proving” refers to a requirement in ANSI Z 21.20 that an ignition source be established or proven before the gas valve opens. A failed HSI igniter will not pass current or, presumably for a degraded igniter, enough current to heat the gas valve actuator. The circuit is thus self-proving and requires no active feedback to the thermostat.

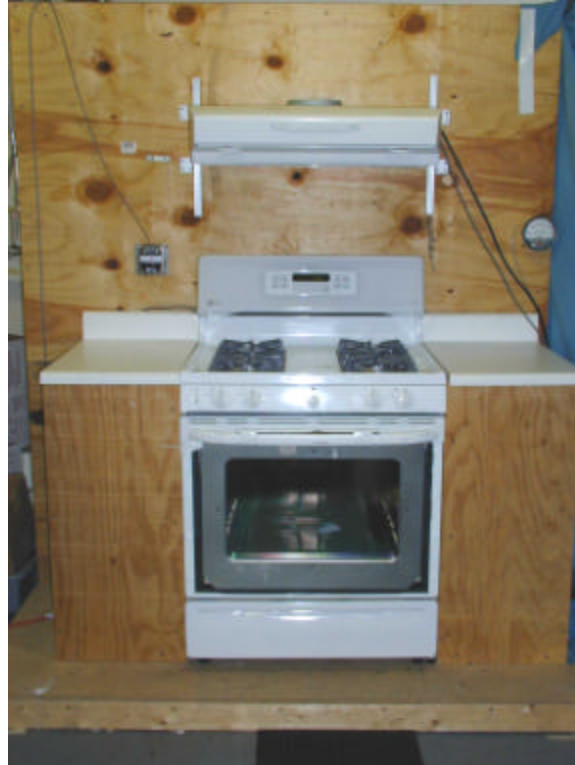
A kitchen mockup was constructed with a back wall, side cabinets, and a floor (Figure 3). The sample ranges and range hood were installed according to the clearances reported in the incident investigations. The gas hose, IR cooling tubes, and instrument wires were routed through an access door in the rear wall. The access door and all gaps in the mockup surfaces were sealed.

Figure 3. Kitchen Mockup

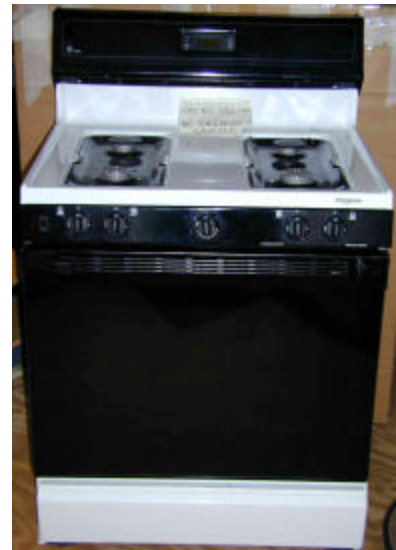
The Delayed-ignition range (Figure 4) was collected during an investigation. The range has a single oven burner, with a configuration similar to Figure 1b. The oven has a spiral-type igniter.

Figure 4. Gas Range used in Delayed-Ignition Tests

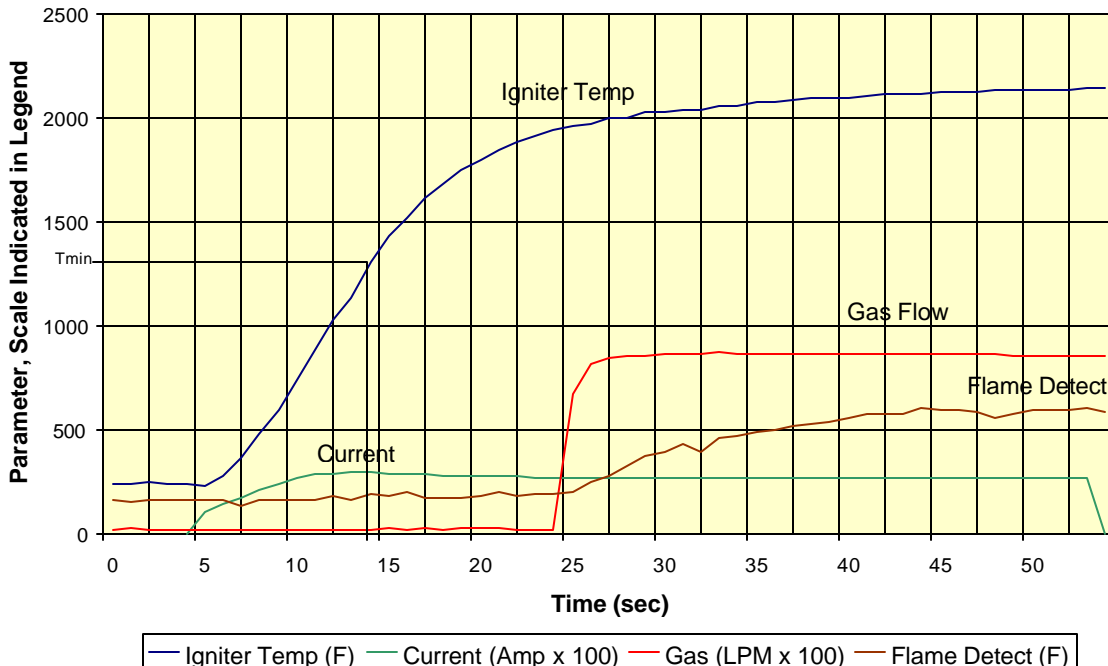
Figure 6 shows a typical baseline test of the Delayed-ignition range with various parameters plotted and identified in the graph and caption. The initial start cycle is shown. At the start (5 sec), the current rises rapidly, and then stabilizes at 2.67 amps. The igniter temperature rises more slowly, reaches the nominal gas combustion temperature of 1300 °F (T_{min}) at 14 sec, and later levels at 2149 °F (T_{max}). The gas valve opens fully after 25 sec, 11 sec after T_{min} . Combustion is evident as the Flame Detect graph begins to rise after the gas valve opens. Note that Flame Detect is intended to show presence of flame and is not an accurate measure for rate or temperature, as the thermocouple data depended on its exact placement near the flame.

Figure 6. Baseline Test of Delayed-Ignition Range

Later in the test, during oven cycling, the oven thermostat turned the igniter/gas valve circuit on and off to maintain the selected oven bake setting of about 350 °F. The average cycle time was 108 sec with a 127-sec maximum and a 91-sec minimum time (108/127/91). The time for the igniter to reach T_{min} averaged 5 sec with a 7-sec

maximum and a 3-sec minimum time (5/7/3). The gas valve opened an average 9 sec after T_{min} (9/11/8). The average T_{max} for the igniter was 2192 °F (2192/2205/2175). This baseline test of the incident oven indicates that the ignition system functions. The expected sequence of igniter heating and gas valve operation is evident.

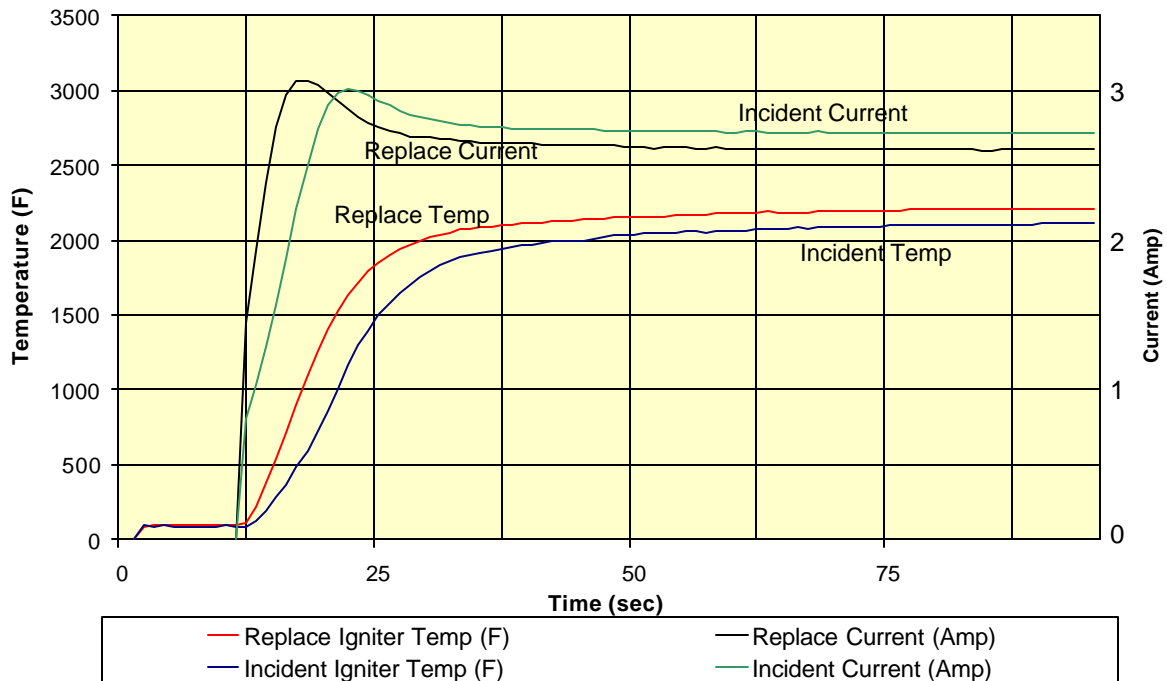
In Figure 7, the graph shows a comparison between the original incident igniter and a new, factory replacement igniter for the Delayed-ignition range. In this bench test, the replacement igniter displays a somewhat faster rise in temperature and current, although the steady-state current is lower than the incident igniter. This limited comparison does not itself indicate that age is an underlying factor. In contrast, it does show that both igniters significantly exceed the gas combustion temperature (reaching maximums exceeding 2000 °F, 1100 °C). Further investigations into igniter aging are presented in the Igniter-aging Bench Test results.

Figure 7. Igniter Comparison, Incident and New

A change in the temperature-current characteristics of the igniter could result in the igniter drawing a current that actuates the gas valve before the igniter heats to T_{\min} . The characteristics of the Delayed-ignition igniter can be compared to the replacement igniter (Figure 7) and the aged spiral-type igniter #3 from the cycle tests (Table 3). The incident igniter heats up more slowly than the replacement igniter does-- perhaps a sign of the age of the incident igniter. Spiral igniter #3 exhibited the most change in temperature characteristics of the aged igniters. Indeed, spiral igniter #3 took 34 sec to reach T_{\min} , compared to 9 sec for the incident igniter, when installed in the Delayed-ignition range. However, the more important gas valve delay was 11 sec after T_{\min} for spiral igniter #3 compared to 11 sec for the incident igniter. This indicates that the two igniters have comparable gas valve delays and hence margins of safety. The rate of temperature rise of the igniter does not appear to diminish the key timing characteristic between the gas valve and the igniter.

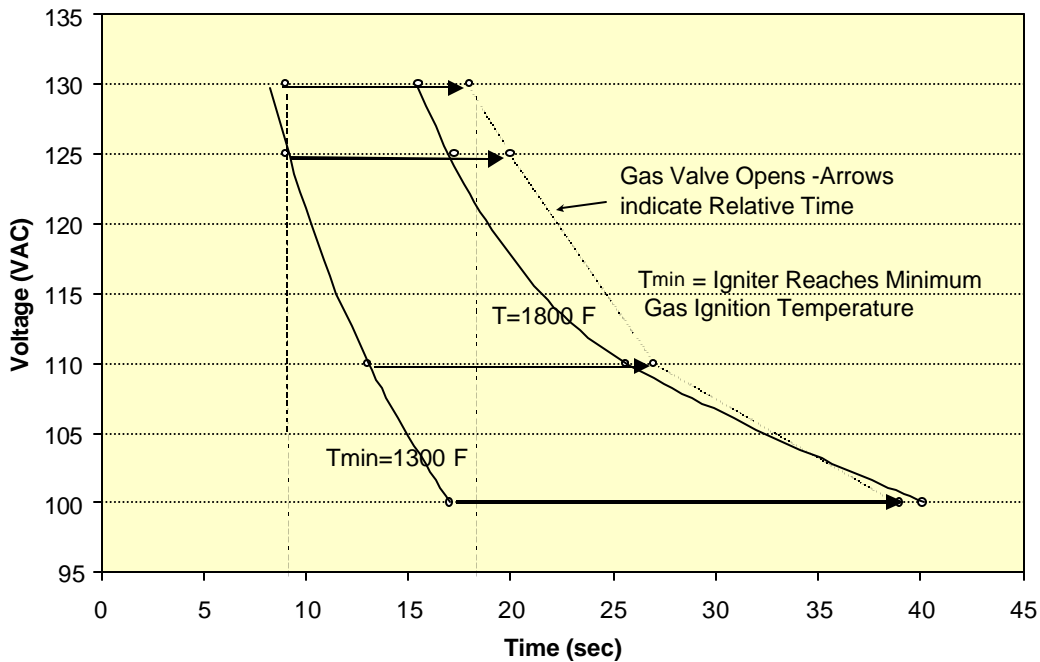
Figure 8 shows, for the initial combustion cycle, the effect of voltage on the igniter temperature and the time delay of the gas valve. In the figure, each arrow indicates a separate test at a selected voltage. Arrow length indicates the gas valve time delay, which is the time to open after the igniter reaches T_{min} . Two lines of constant temperature are included: $T_{min} = 1300\text{ }^{\circ}\text{F}$ and $T = 1800\text{ }^{\circ}\text{F}$. The latter was selected for convenience of comparison. For example, at 130 V, the igniter reached T_{min} at 9 sec and then the gas valve opened at 18 sec: the delay is 9 sec. Times to reach T_{min} increased with decreasing voltage, as expected. Delay times for gas valve operation also increased with decreasing voltage, from 9 sec at 130 V to 22 sec at 100 V (39 sec minus 17 sec). The effect was less pronounced for the steady-state cycles (not shown) where the range was from 8 sec at 130 V to 15 sec at 100 V. The gas valve did not open at all at voltages below the range of 79 to 85 V. These oven tests indicate that, while voltage affected ignition sequence, the opening of the gas valve always followed the igniter preheating to T_{min} .

Figure 8. Affect of Voltage on Ignition Sequence

Tests were conducted to determine if ignition timing varied with varied conditions. In fact, all the parameters had some effect on the timing. The voltage tests show that the overall combustion time schedule increases for lower voltages and decreases for higher voltages. In decreasing, the gas valve opens sooner. In the worst case at 130 V, the gas valve opened 8 sec after the igniter reached combustion temperature, T_{\min} (Figure 8). To compare, in the normal 110-125 V operating range, the time is 11 sec to 14 sec. For gas to escape without combustion, the valve should open *before* the igniter reaches T_{\min} . The graph in Figure 8 does not suggest any convergence of the delay times in any reasonable voltage range. Evidence does not support voltage variation as a factor that would adversely affect ignition timing.

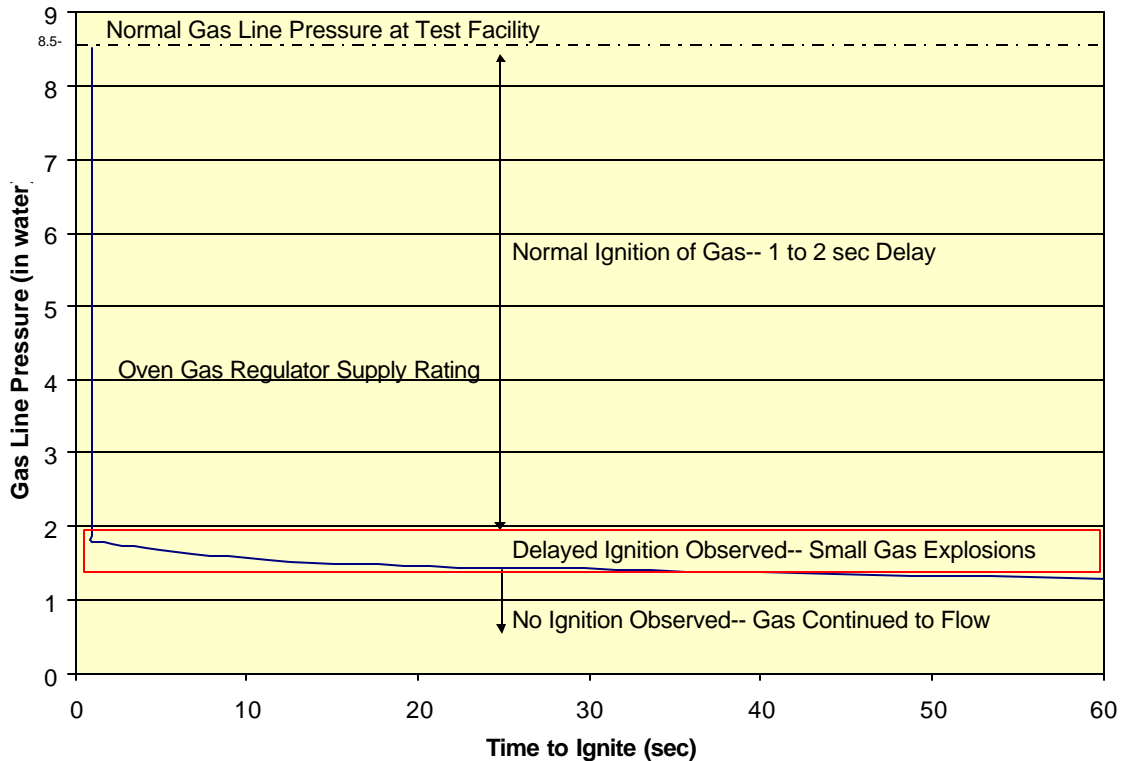
Figure 9 shows the effect that gas line pressure has on ignition timing. The oven's gas regulator input and output ratings were 0.5 psi (3400 Pa) and 4 in w.g. (water gauge³) (1000 Pa), respectively. From the normal gas line pressure at the test facility, 8.5 in w.g. (2100 Pa), down to about 2.0 in w.g. (500 Pa) combustion within the oven is normal. Between 1.5 and 2.0 in w.g. (370-500 Pa), delays in ignition of about 60 sec resulted in small explosions within the oven. Below 1.5 in w.g. (370 Pa), no explosions were noted although gas continued to flow throughout the remaining 4 minutes of testing. The oven is capable of operation at low gas pressures; those below the 4 in w.g. (1000 Pa) output rating. Lower pressures will not compress an internal spring and will not force the regulator closed. Lower gas line pressures should not affect the operation of the oven gas valve, which operates through electrical heating. These tests demonstrate a possible source for gas escaping without combustion. The scenario requires a nominal gas supply pressure that is not normally found in homes.

Figure 9. Affect of Gas Pressure on Ignition

The range's gas regulator acts to buffer higher line pressures and supplies gas to the burner at no greater than the rating of 4 in w.g. (1000 Pa). Lower gas line pressures were investigated since they do affect regulator output pressures to the oven burner. Testing on the Delayed-ignition range indicated that gas line pressures below the regulator rating would result in low-pressure flows to the burner. Line pressures down to about 2 in w.g. (500 Pa) resulted in normal ignition timing and combustion for the broiler burner. Below that pressure, however, gas would not ignite consistently and either ignition was delayed or no ignition occurred. The flow of non-combusted gas into the oven box caused intermittent explosions in the 1.5 to 2.0 in w.g. (370-500 Pa) range. Below that range, no combustion occurred in the 4-minute tests but gas continued to flow. Because the oven has a self-proving ignition system, gas flow continued as long as the oven thermostat called for heating. Without combustion, the thermostat continuously energized the ignition circuit, heating the igniter and keeping the gas valve opened. These low gas line pressures would not be normal, and would be expected to trigger a service call. However, low supply pressures to the oven are conceivable with the possibilities of intermittent service and constricted or long runs of gas piping leading to the range. These factors were possible, but were not reported for this incident range.

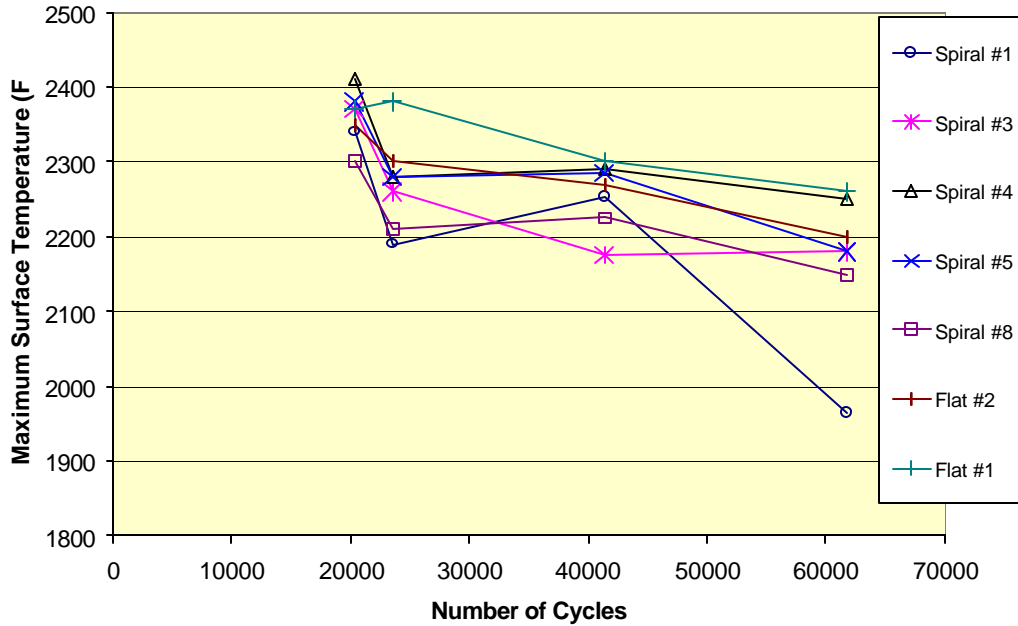
Figure 11 shows that the maximum temperature decreases approximately 150 to 350 °F (65-176 °C) for the six spiral-type igniters and about 100 to 150 °F (38-65 °C) for the two flat-type igniters over the 61,000 cycles⁵.

Figure 11. Effect of Igniter Cycling on Temperature

⁵ Bench testing was delayed for one year at 20,000 cycles. The abrupt change of slope at 20,000 is due, in part, to a change of instrumentation.

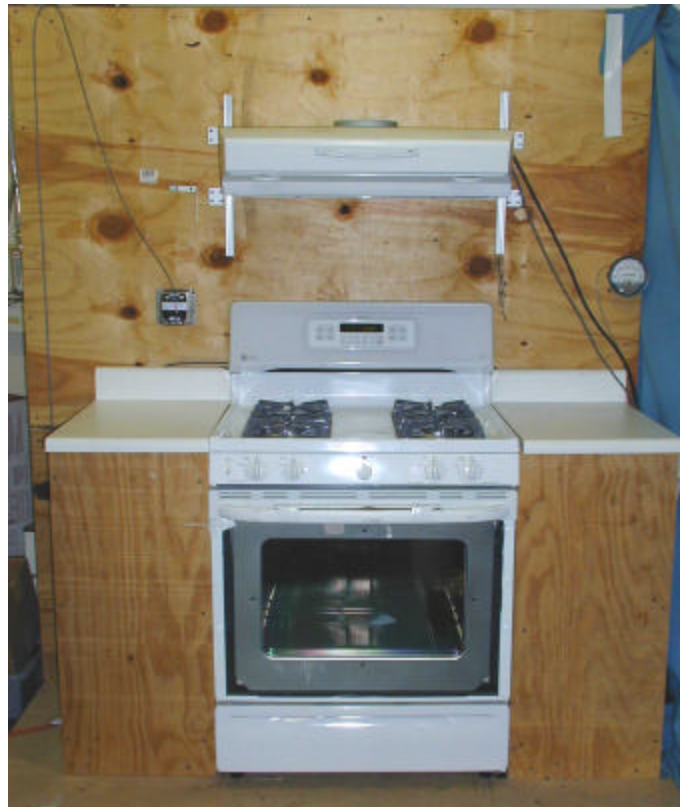
A gas range was purchased (Figure-12). This is the range model described in the Suction-draft incident. The oven has two burners with spiral-type igniters.

Figure 12. Gas Range and Range Hood used in Suction-Draft Tests

The Suction-draft test range and range hood were installed in the mock kitchen with similar clearances to those in the investigation report: Range had zero side clearances from the cabinetry and zero rear clearance to the wall; range hood was installed 23.5 in (600 mm) above the range top.

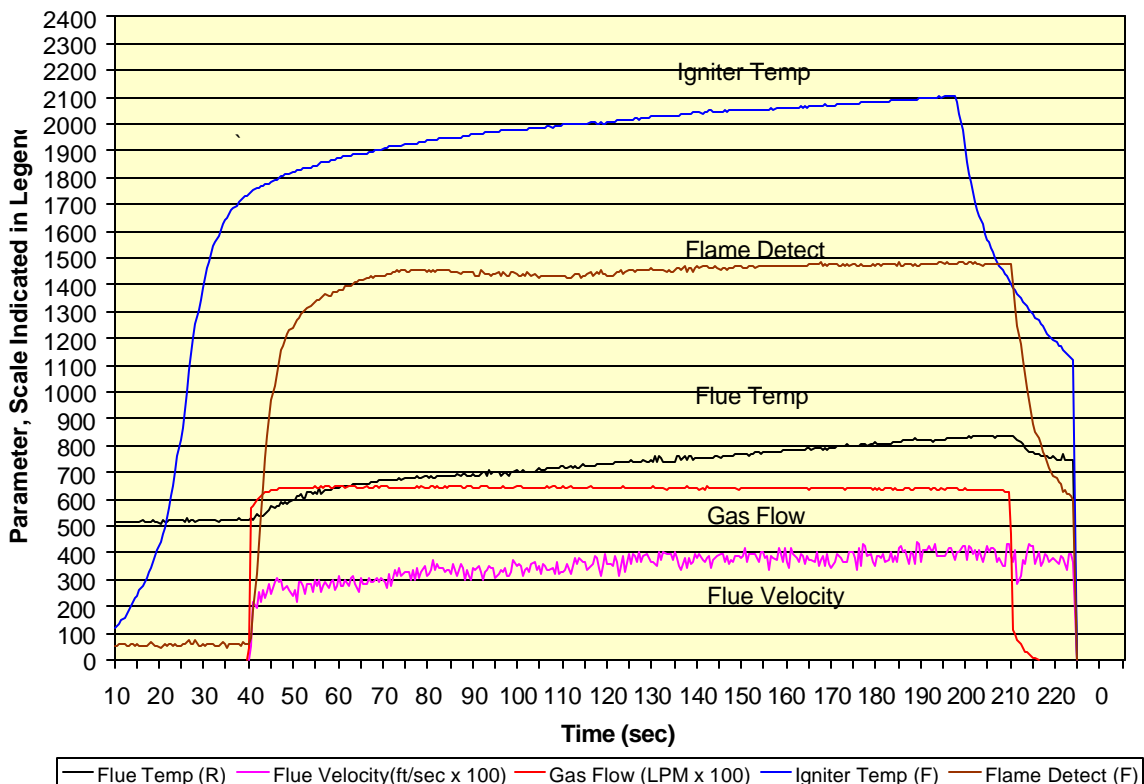
Figure 13 shows a typical baseline test of the broiler burner of the Suction-draft range, without the range hood in operation. The gas valve opens at 40 sec, 12 sec after the igniter temperature reaches the nominal gas ignition temperature of $T_{\min} = 1300^{\circ}\text{F}$ (700°C). Combustion is evident as the Flame Detect graph rises after the gas valve opens. [Note that Flame Detect is intended to show presence of flame and is not an accurate measure for rate or temperature.] The flue gas velocity immediately rises to 3 ft/sec (1.0 m/s) and continues to rise to 4 ft/sec (1.2 m/s) as the flue temperature also rises. Note that the flue velocity and temperature reach steady state at about 6 ft/sec (1.8 m/s) and 1200°R (670°K), respectively. This baseline test indicates that the products of gas combustion are sensed (Flue Temperature and Velocity) immediately following ignition (Flame) and that the flue gases continuously exit the flue.

Figure 13. Baseline Test of Suction-Draft Oven

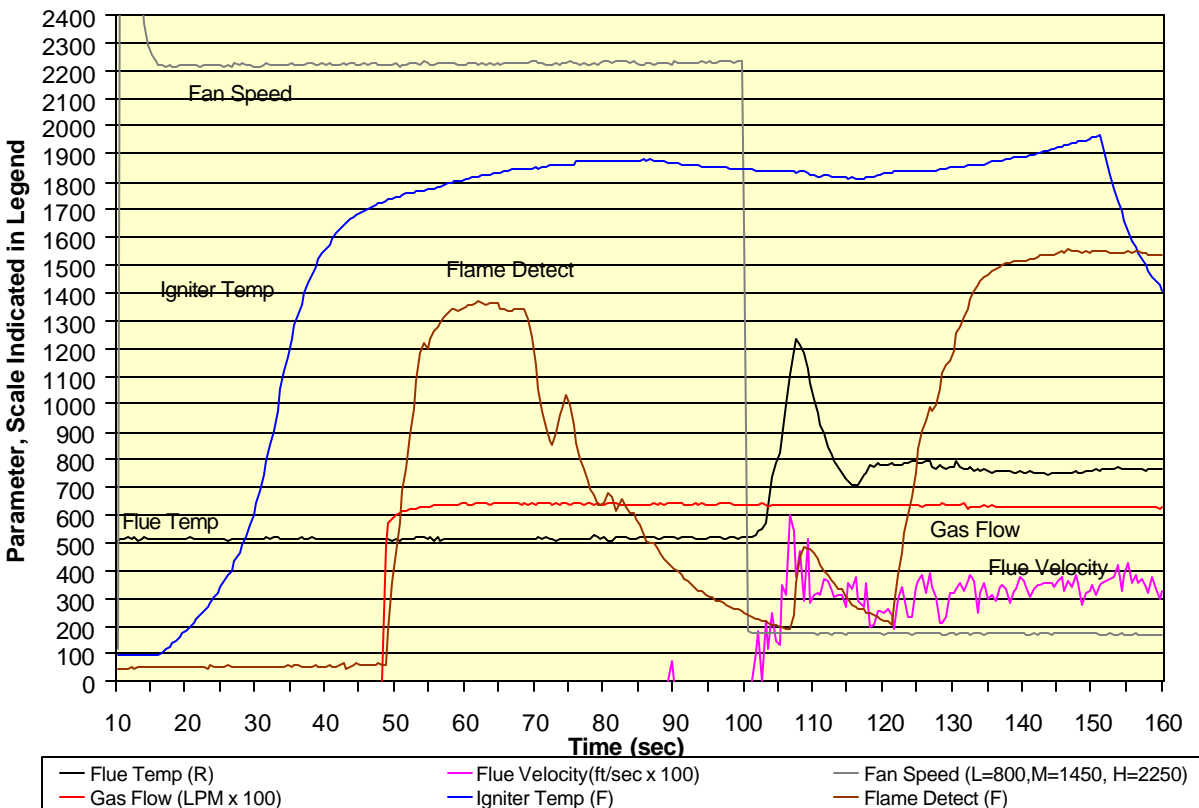
Figure 14 shows Run 10 of the test matrix, the reported conditions present in the investigated incident. The range hood fan speed is high and the oven starts cold. The igniter heats up normally and a flame is detected after the gas valve opens at 48 sec. However, there is no flue temperature rise or flue gas flow. At about 68 sec (20 sec later), the Flame Detection weakens and drops rapidly. At about 100 sec, the fan is turned off. Ignition then re-establishes and normal combustion resumes. Calculated from the graph, approximately 4 to 5 liters (0.14 to 0.18 ft³) of non-combusted natural gas are discharged into the oven box in this 52-sec period. These tests, incident and baseline, confirm that the range hood fan interrupted normal combustion. This incident scenario test indicated a potential hazard in the collection of natural gas within the oven. In the reported incident, the victim opened the oven door and then gas suddenly combusted - indicating a collection of gas, as demonstrated in this test.

Figure 14. Test of Suction-Draft Range and Range Hood at High Fan Speed

In the incident, the victim turned the range hood on high speed, then turned on the oven broiler. He then opened the oven door a short time later and a fireball from the oven burned his face. Comparison of baseline tests with no fan and tests recreating the incident conditions (run 10, Table 4) indicate that the fan caused the improper ignition within the oven. Figure 14 showed that although gas is initially ignited, combustion is not maintained. Also revealing is that there is no flue velocity – no flow, which would normally rise abruptly after ignition (Figure 13). Outward flow from the flue indicates that combustion of the natural gas is occurring. Inspection of the range hood indicated that the air is discharged towards the oven flue. This suggests that the range hood fan is pressurizing the flue, effectively blocking the exit of flue gases. With combustion stopped, the thermostat continued to call for heat and supplied current through the self-proving ignition circuit. This maintained the igniter above combustion temperatures and kept the gas valve open. There is no other feedback to the ignition system and the gas valve remained open and poured gas into the oven box, which later ignited.

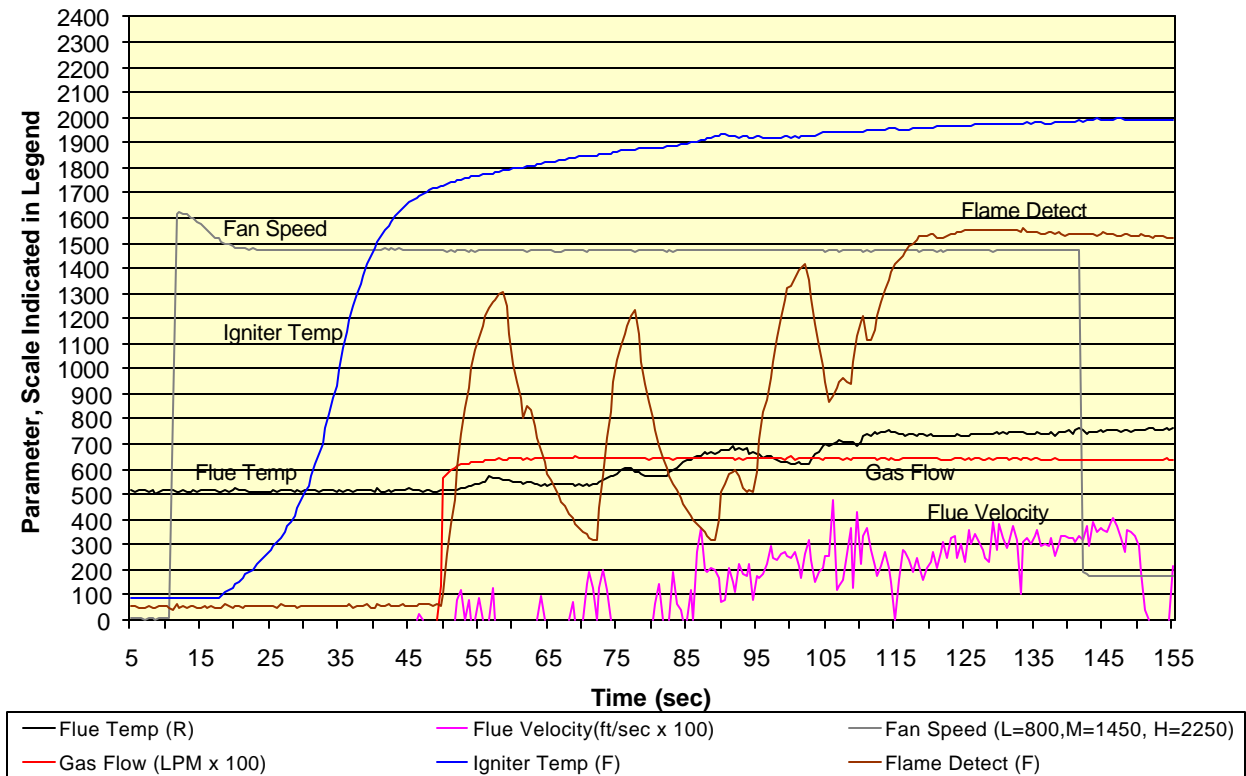
Additional tests were run at different speeds and clearances. Figure 15 is a test conducted at a medium (number 2) fan speed, but is otherwise similar to Run 10. The effect of the range hood fan on ignition at medium speed begins as in Run 10. However, in a 40-sec transition to stability, the faltering flame recovers and the flue gas velocity (flow) rises to normal combustion levels. Diminished flue gas velocity indicates incomplete or halted combustion since the flue is the one exit for the gas products of combustion.

Figure 15. Test of Suction-Draft Range and Range Hood at Medium Fan Speed

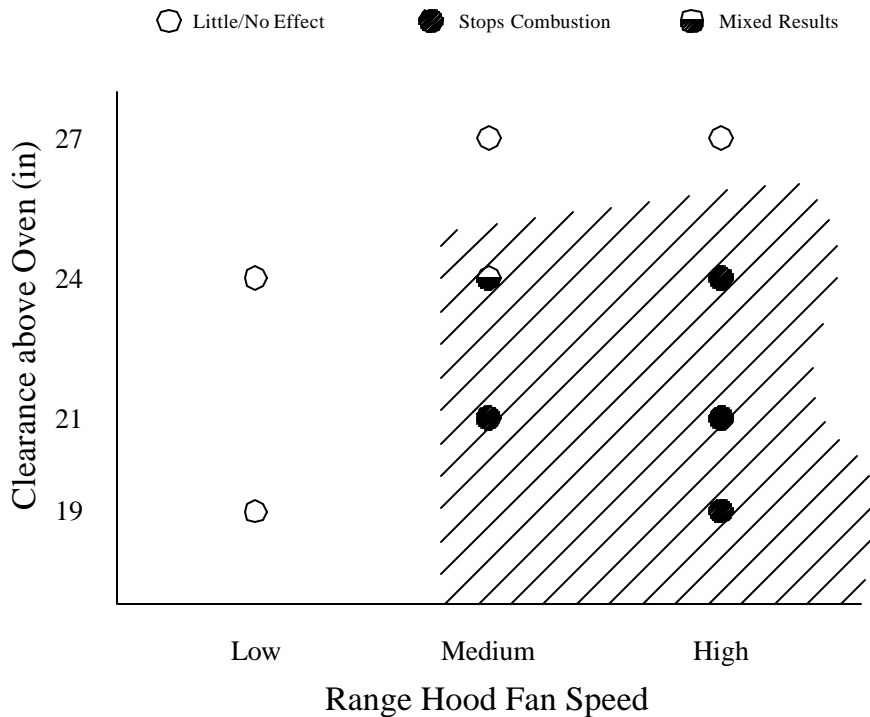
The results of all Suction-draft tests are summarized in the effects chart of Figure 16. Clearance is plotted against fan speed. The other two factors were fixed at a hood-oven sequence and with no warm-up (cold oven). The chart shows that ignition/combustion problems were not present at the lowest fan speed or at a clearance of 27-in (690-mm). The medium speed test run of Figure 15 is the transitional case and is represented as a half-filled circle in Figure 16. The shaded area signifies conditions in which combustion problems resulting in gas accumulation were documented.

Shaded area indicates gas accumulation.

Figure 16. Clearance and Fan Speed Effect on Combustion

Other tests at differing parameters indicate that a combination of fan speeds and clearances exists in which oven combustion fails. This zone comprises medium and high fan speeds and clearances of 23.5 in (600 mm) and below. Additionally, the hazardous external flare-up is sensitive to the timing in opening the oven door. Tests indicate that external flare-ups occur when the door is opened at approximately one minute after the gas valve opens. After about one minute, normal combustion slowly establishes following a warming of the flue by the consumption of accumulated gas by internal flare-ups. Apparently, the warmed flue creates enough convection to counter the pressurization by the range hood fan.

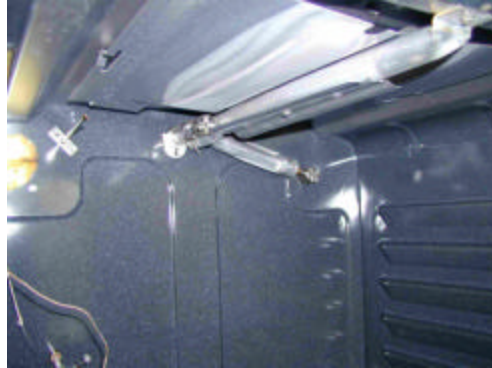
Figure 17 is a view inside the range with normal lighting. Figures 18 and 19 document the typical effect of the range hood on the Suction-draft range when the broiler and range hood are on at the same time. The test conditions are similar to those in the incident (IDI 010418HCC2409) and test run 10: High fan speed with the hood mounted 23.5 in (600 mm) above the range.

**Figure 17. View inside Suction-Draft Range
Showing Broiler Igniter and Burner**

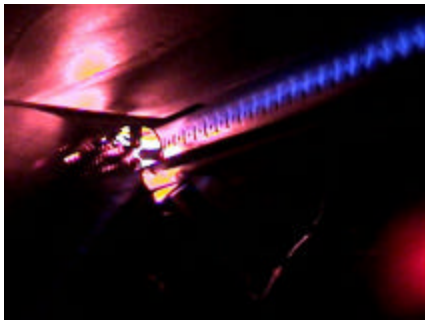
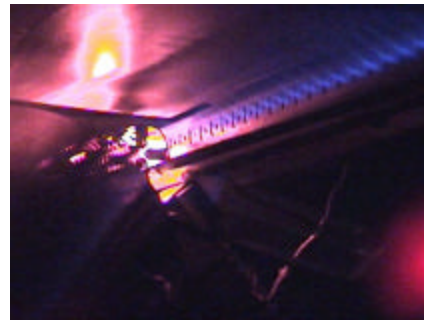
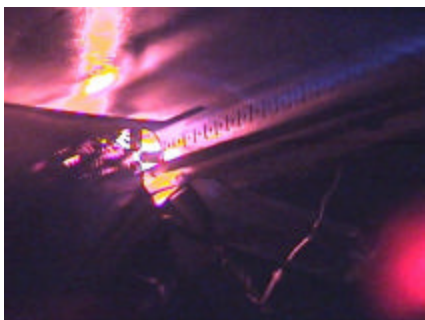
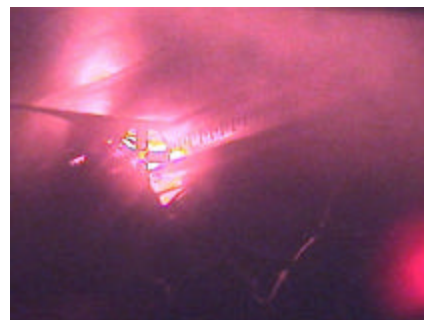
In Figure 18, the gas starts with somewhat normal combustion (a), but within 1.5 sec the flame is pulled horizontally (b). After 3 sec, the flame is nearly out (c). The flame is out at 6 sec but gas continues to flow (d). Moisture condenses and clouds the oven window.

a) T=0, Gas Valve Opens

b) T=1.5 seconds

c) T=3 seconds

d) T=6 seconds

Figure 18. Start Sequence of Suction-Draft Broiler with Fan On

Videotaped images demonstrate the hazard to the user of the range. Figure 18 showed the burner flame extinguishing during the incident test. The flame is pulled away from the burner over a 3-sec period. When the flame is extinguished, the natural gas accumulates in the oven. Figure 19 showed the eruption of flame after the door is opened 78 sec after the gas first flows. A mixture of non-combusted gas within the oven and outside air comes into contact with the still-hot igniter, causing a sudden flare up. The victim's facial injuries in the incident are consistent with his position in front of the door.

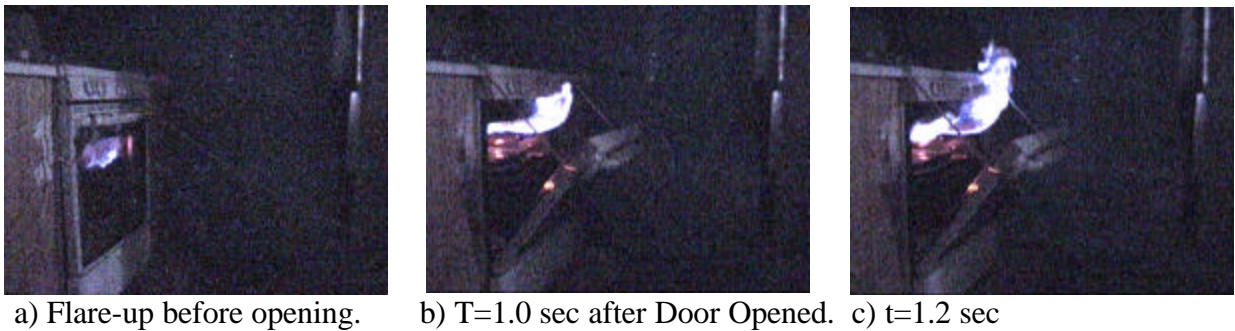
A series of tests was conducted in which the oven door was opened after failed combustion. The tests simulated the known conditions in the incident (Table 4, run 10) in which the victim opened the door after starting the fan and oven broiler. In conducting these tests, the delay time in opening the door was varied, beginning at 30 sec after the gas valve opened at $t_{\text{gas}} = 0$. Figures 19a through 19c show a sequence in a test with a large flare-up. In this test, Figure 19(a) occurs 88 sec after the broiler is turned on ($\Delta t_{\text{start}} = 88$ sec) and 56 sec after the gas valve opens ($\Delta t_{\text{gas}} = 56$ sec). The flare-up in Figure 19(a) is internal and was fueled by the accumulation of gas over that 56-sec period. The oven door is opened slowly ($\Delta t_{\text{gas}} = 78$ sec) using a long rope. [The diagonal lines in the images are restraint ropes]. Figure 19(b) shows a flare-up outside the oven box about 1.0 sec later. The column of flame reaches upward in Figure 19(c). The series of images in Figure 19 model the incident scenario as reported.

Figure 19. Opening Oven Door of Suction-Draft Range after Failed Combustion

Internal flare-ups first occurred in the range $25 \text{ sec} < \Delta t_{\text{gas}} < 60 \text{ sec}$. Repeated tests with varying delays in opening the door indicated that successive internal flare-ups occurred at quickening intervals and that they, along with the delay time, established a time window for a successful external flare-up. Based on test results, this time window was $54 \text{ sec} < \Delta t_{\text{gas}} < 78 \text{ sec}$ after the gas valve opened. Below this range, the initial ignition (e.g. Figure 14 at 60 sec) consumed some gas and there was less time for gas accumulation. Outside that range, the internal flare-ups consumed gas, which then slowly warmed the flue. The combustion within the oven then stabilized. Typically, to create an external flare-up, the door was opened before or immediately after the first internal flare-up.
