U.S. CONSUMER PRODUCT SAFETY COMMISSION
NOTICE OF INSPECTION

1. CASE NUMBER 940627CAA1585		2. INVESTIGATOR'S ID 8 0 5 7		3. OFFICE CODE 8 0 0		EPIDEMIOLOGIC INVESTIGATION REPORT	
4. INCIDENT DATE YR MO DAY 9 4 0 4 0 8		5. DATE IDI INITIATED YR MO DAY 9 4 0 6 2 7

6. SYNOPSIS OF INCIDENT OR COMPLAINT The waist length hair of a 10 year old female became entangled in the bottom drain of a backyard pool/spa as she performed a head stand within the spa. The entrapped victim's hair was cut away using scissors, the victim received mouth to mouth resuscitation and was revived. It appears the victim has fully recovered without injury.

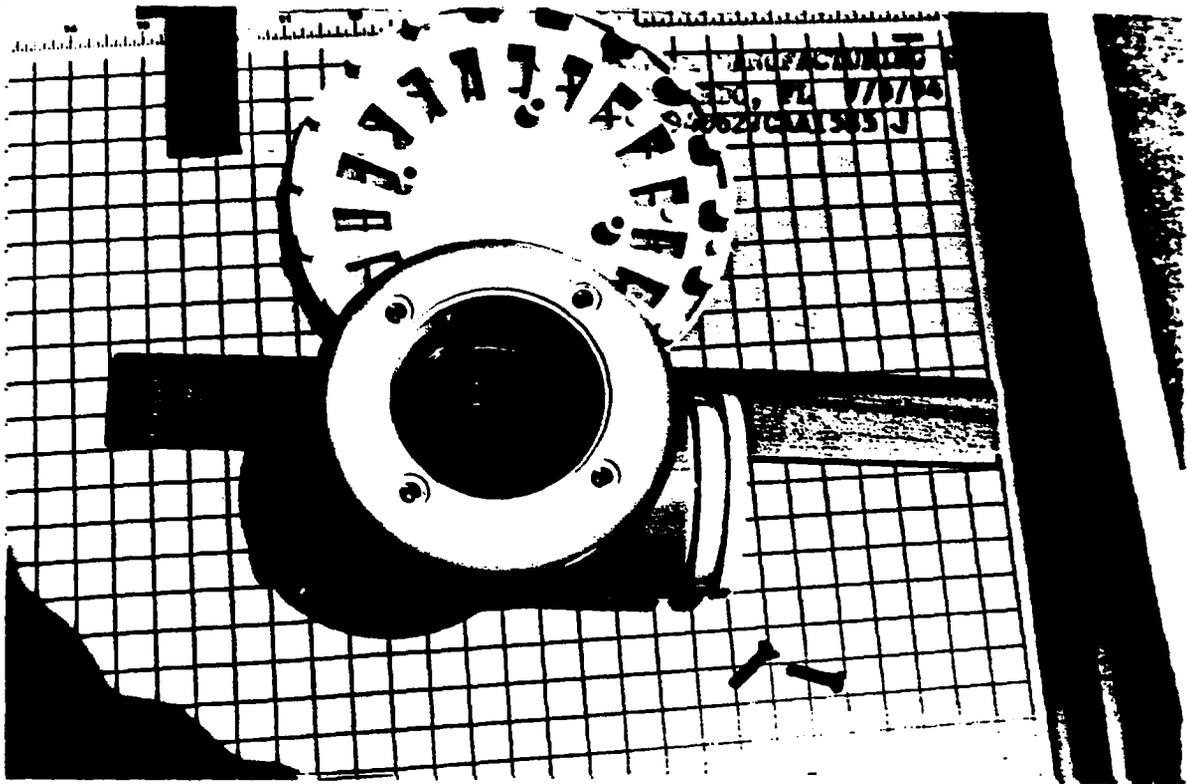
PHOTO 5 UNDERSIDE OF DOMED COVER THAT ATTACHES TO THE DOMED "TEE"

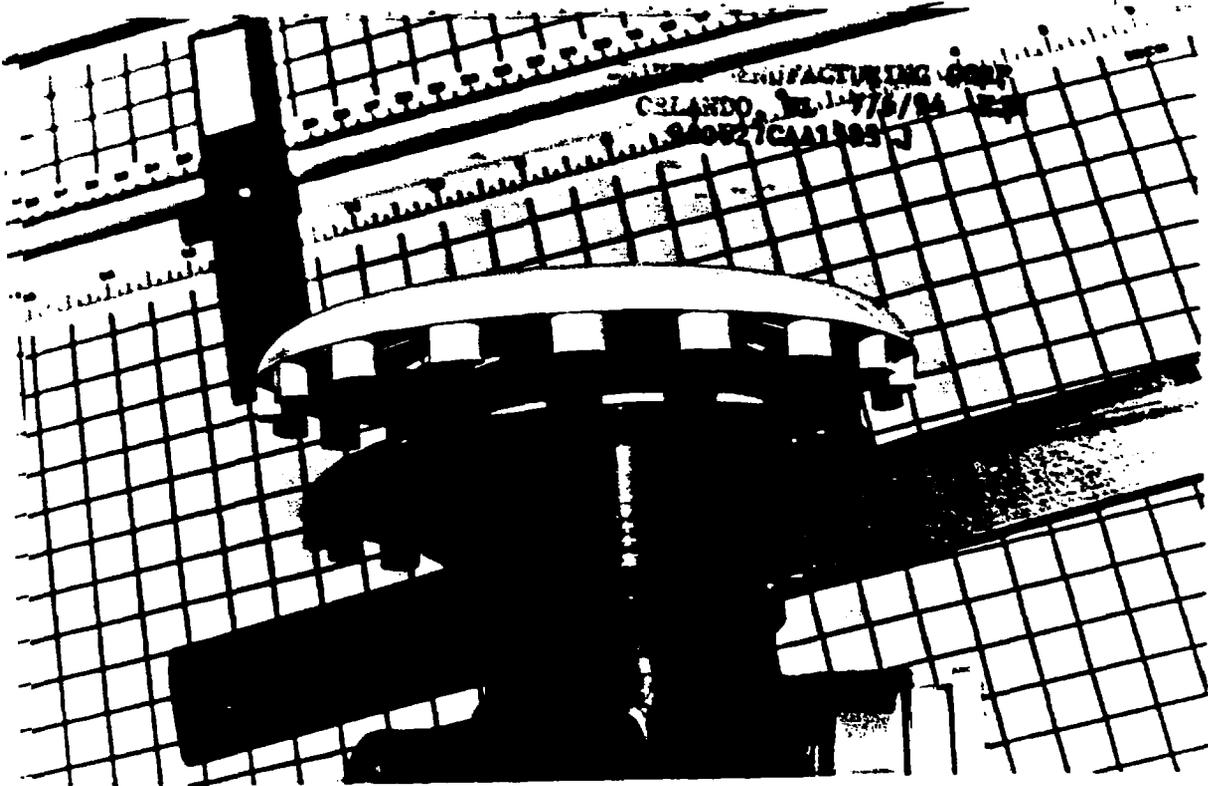
PHOTO 7 DOMED COVER SHOWN IN THE INSTALLED POSITION OVER THE "THRU FLOOR FITTING"

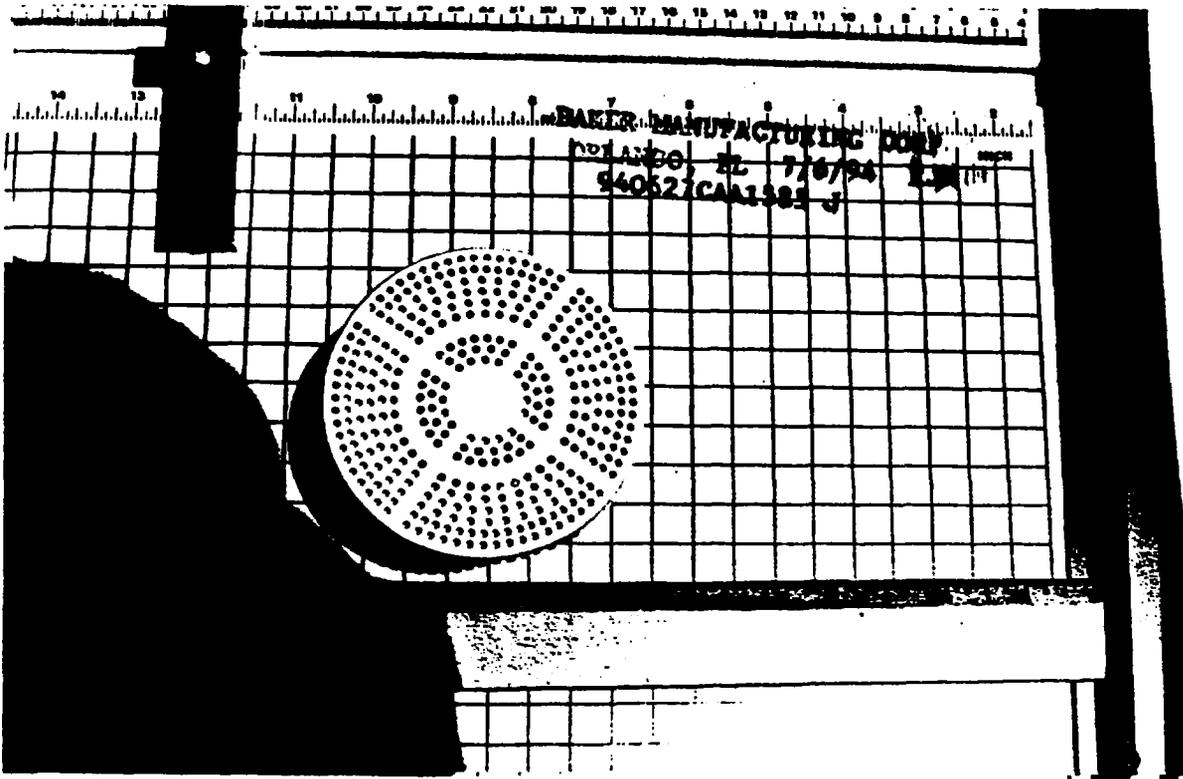
PHOTO 8 "SLIMLINE SUCTION FITTING ASSEMBLY" AS NOTED ON THE ATTACHED ,"10-6900" INSTRUCTION SHEET- ATTACHED. COVER AS INSTALLED ON THE SIDE WALL.

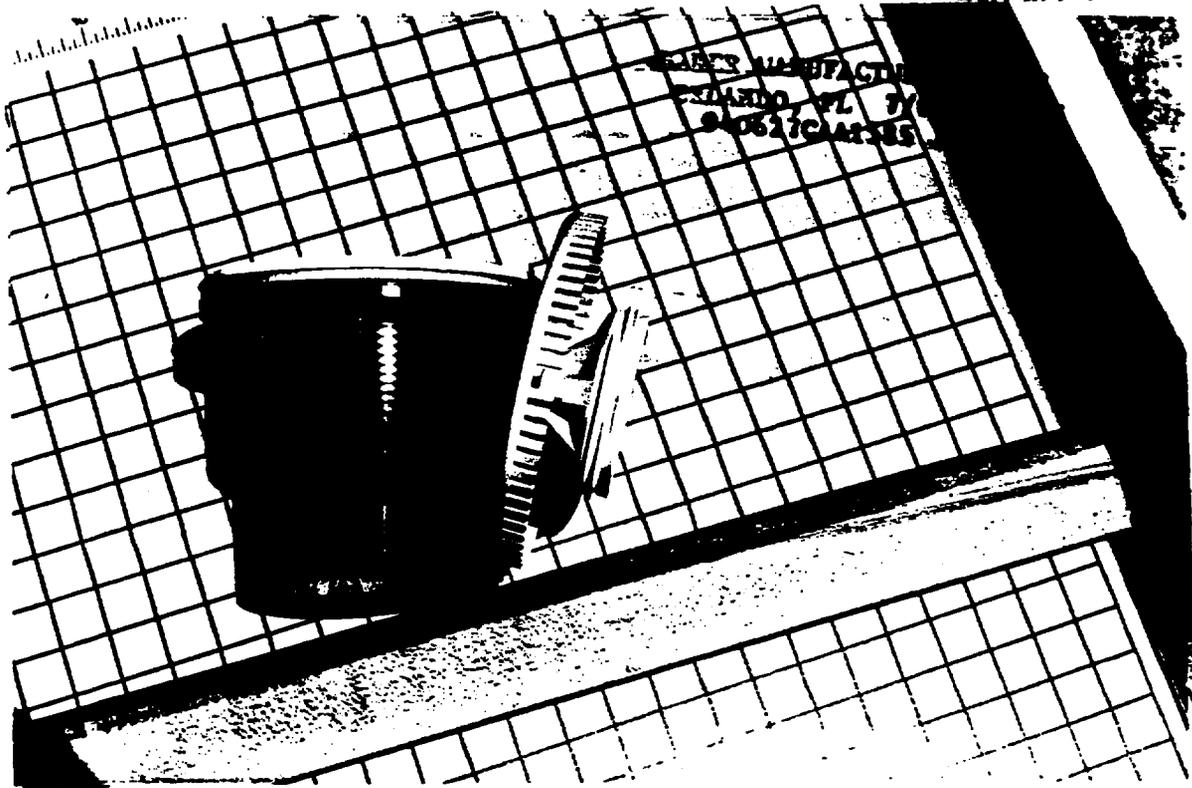
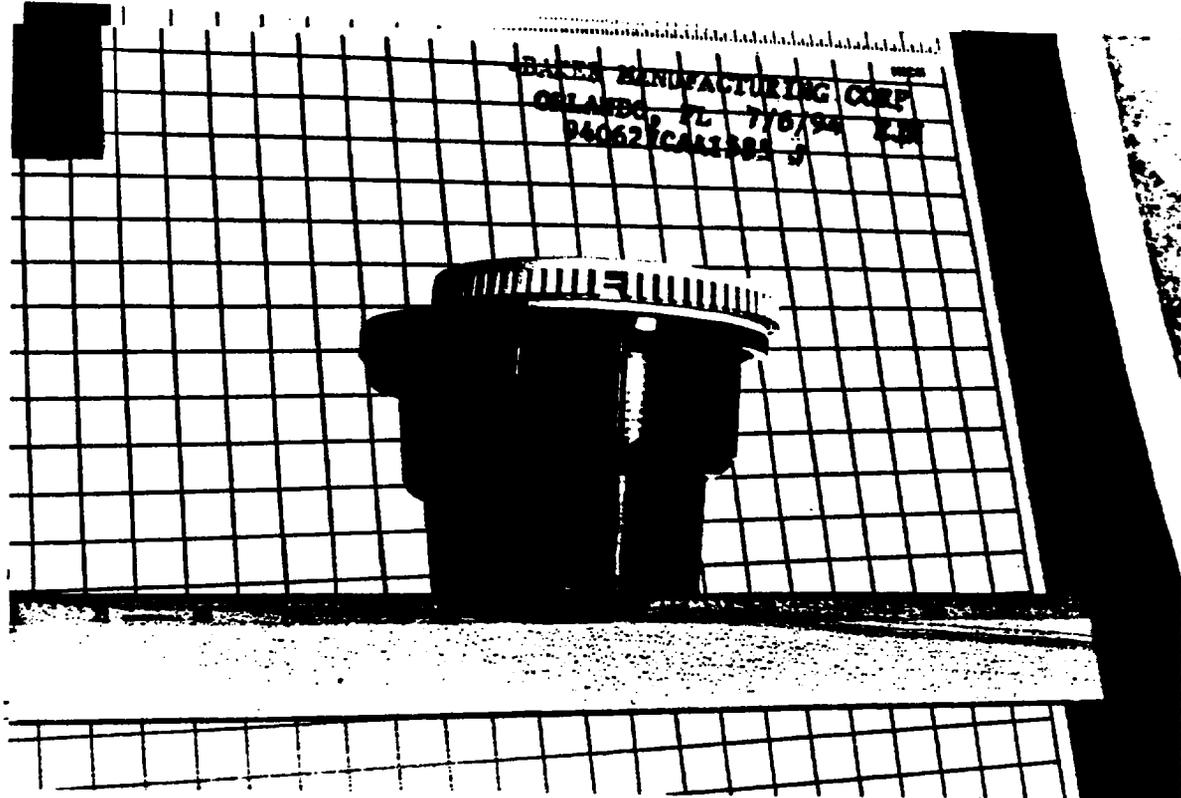
PHOTO 9 ABOVE FITTING SHOWN HERE WITH THE COVER OVER THE FITTING.
PHOTO 10 AS ABOVE WITH COVER SEPARATED FROM THE FITTING.

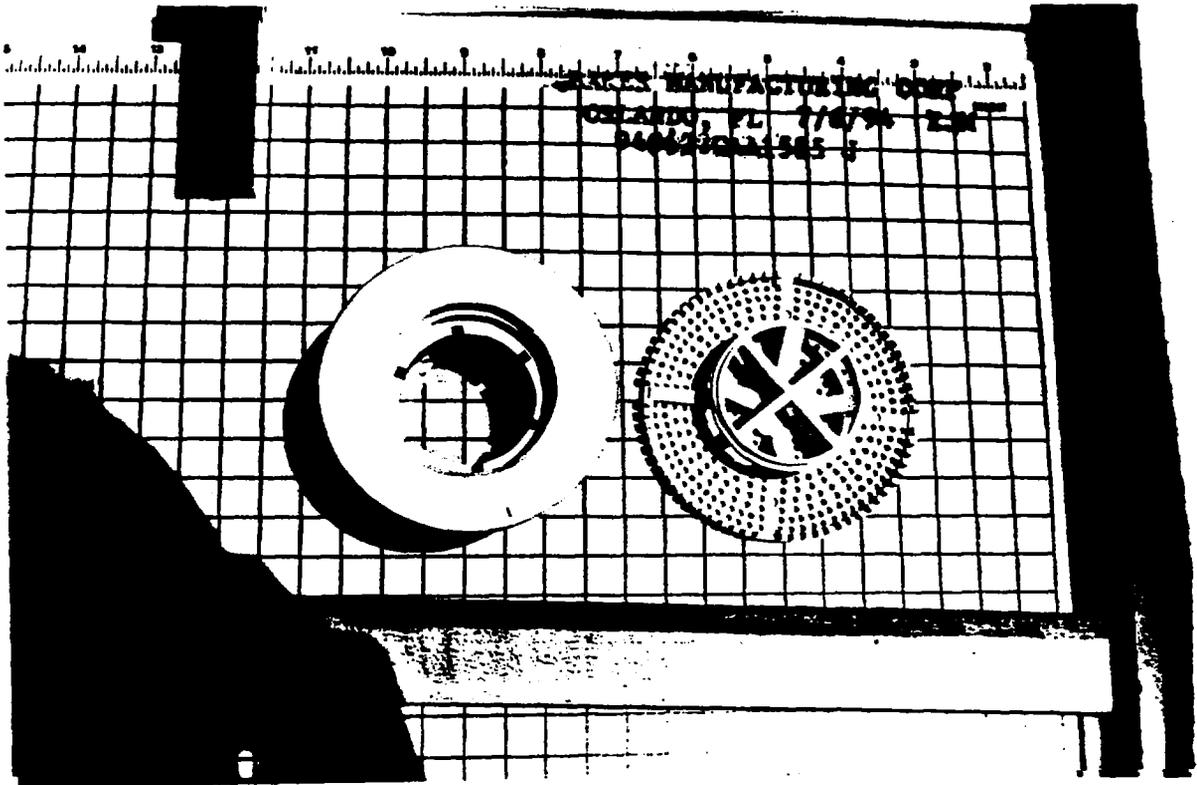
PHOTO 11 FITTING WITH UNDERSIDE OF COVER

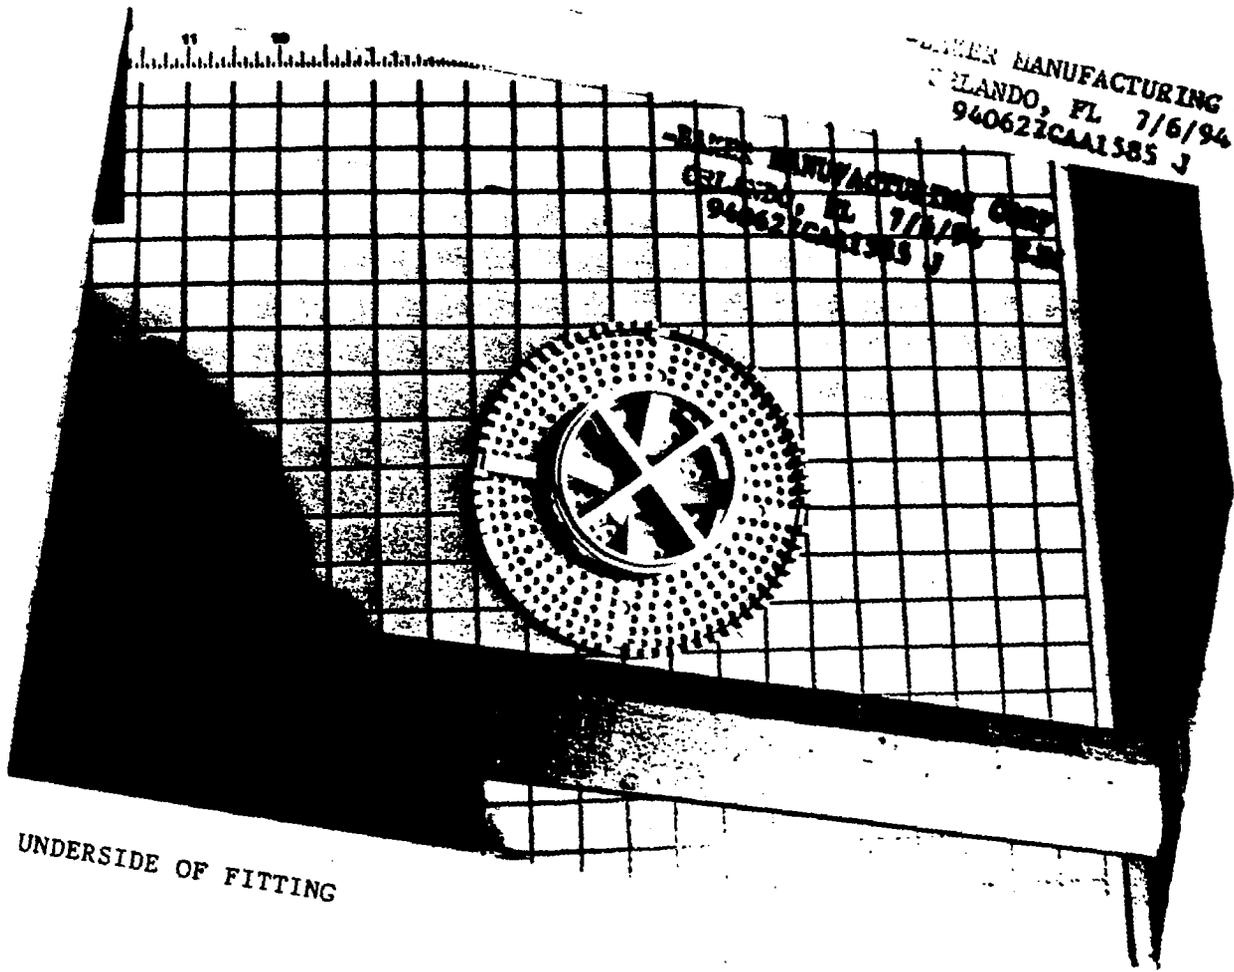
PHOTO 13 UNDERSIDE OF FITTING

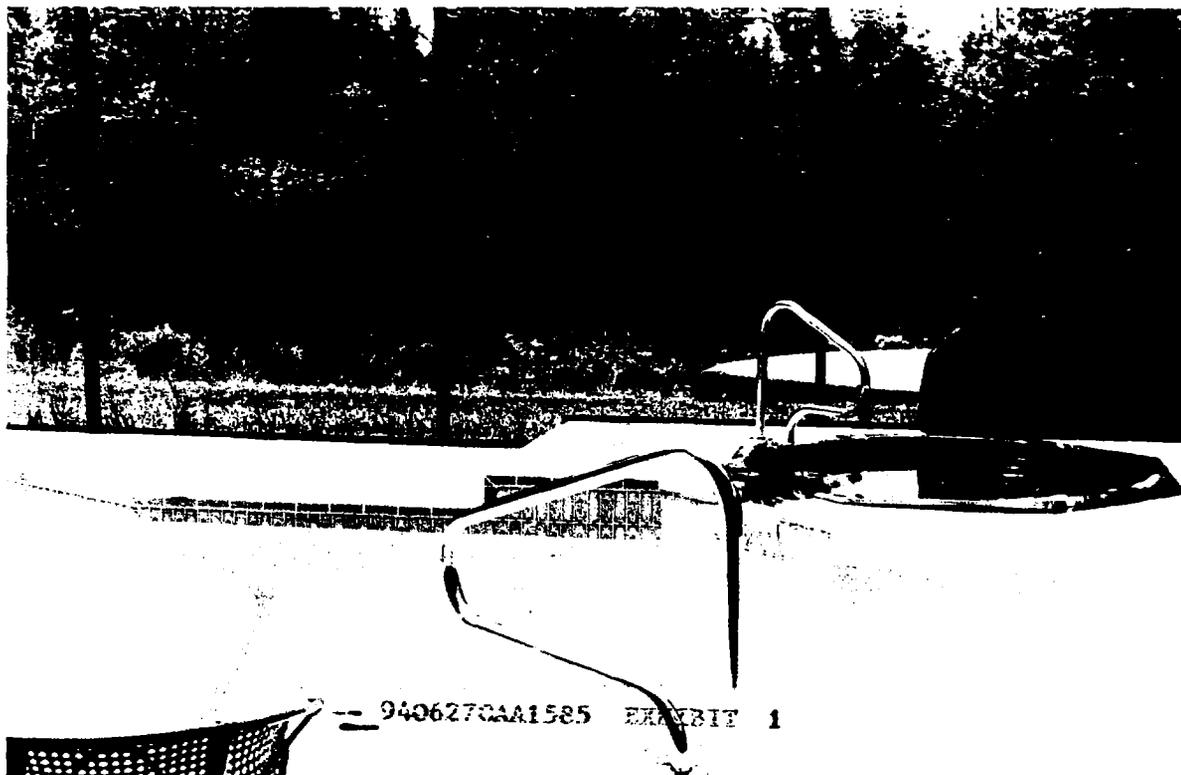
PHOTO 1 OVERVIEW OF THE SPA AND ITS ASSOCIATION WITH THE MAIN POOL. THE DESIGN IS SUCH THAT THE SPA SPILLS OVER INTO THE MAIN POOL, WATERFALL STYLE.

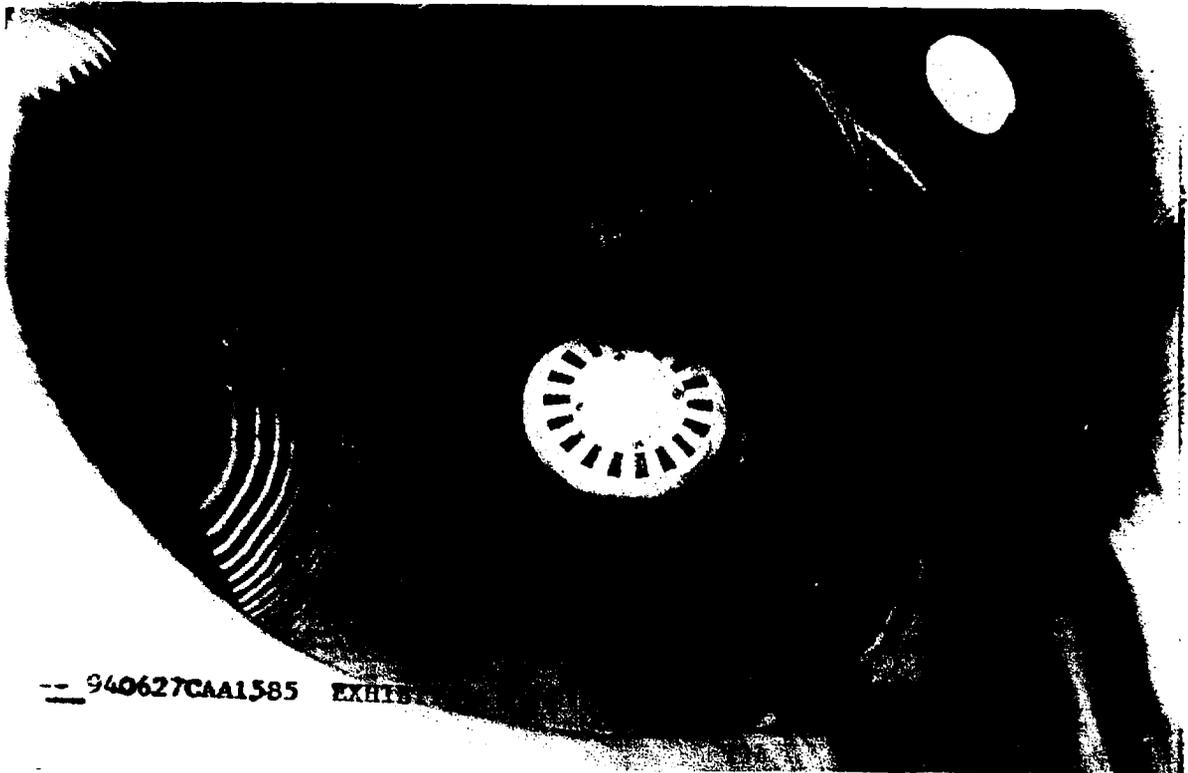
PHOTO 4 CLOSE-UP OF THE BOTTOM DRAIN WITH THE MODIFIED FIBERGLASS SCREENING INSERTED UNDER THE COVER.

As a precaution, and an attempt to prevent this type of accident in the future, the homeowner's husband has installed ordinary outdoor fiberglass screening between the bottom of the pool, and the pool drain cover. This retrofit was accomplished by removing the four screws in the drain, raising the cover, placing the screening over the open drain, and re-inserting the four screws back into their original position. Photographs of the spa, the pool, and the retrofitted drain are attached to this report as exhibit #1.

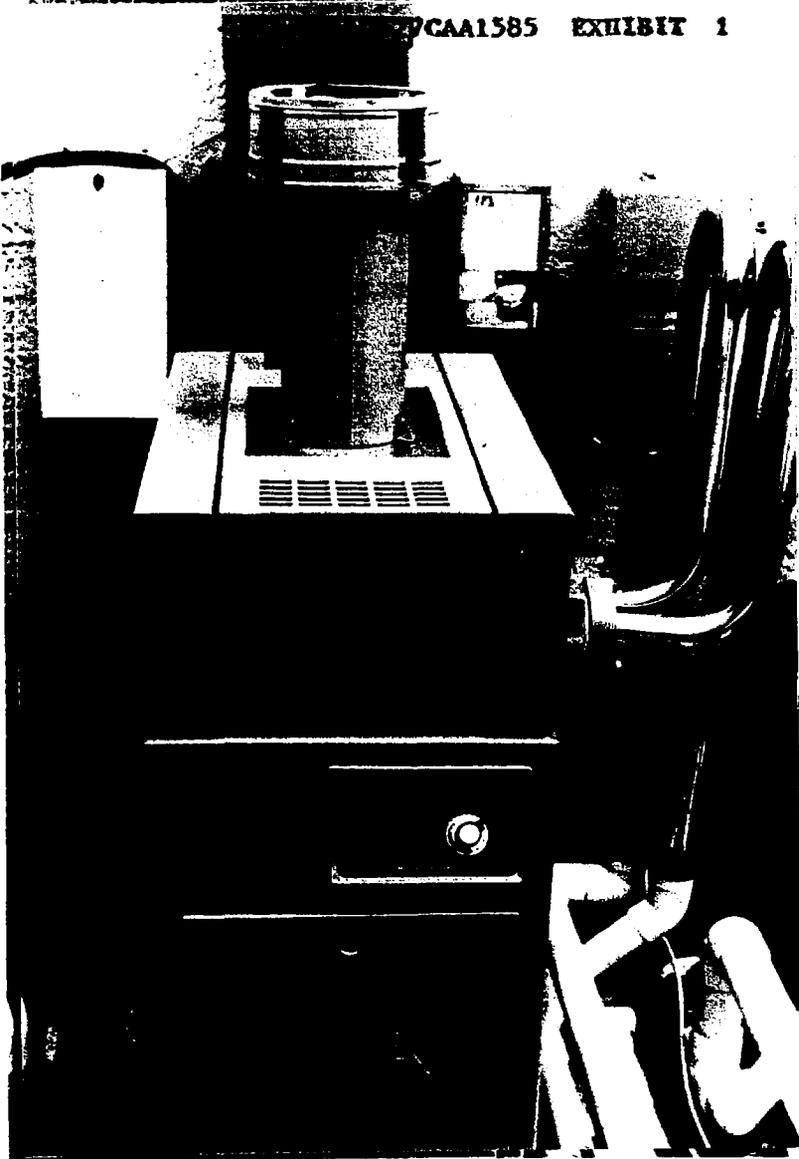
As can be seen in the photograph 5 the system has two separate pumps and filtration systems, with a system to the left side of the heater containing the 1 1/2 horsepower pump used in the spa, while the equipment on the right side of the photograph is a 1 horsepower pump used in the main pool. I did not see any indications that the branch circuit had ground fault interrupter circuit breakers.

PHOTO 5 (above) CONTROLS FOR THE SPA AND POOL, SHOWN HERE WITH THE HEATER IN THE CENTER THIS IS A TWO PUMP SYSTEM, WITH THE 1½ HP PUMP BEING USED FOR THE SPA AND THE 1 HP PUMP BEING USED FOR THE MAIN POOL. THE EQUIPMENT ON THE LEFT SIDE IS USED FOR THE SPA, THE EQUIPMENT ON THE RIGHT SIDE IS FOR THE MAIN POOL.

There are controls on the spa itself, and in a separate location, outside of the screened in pool/spa area. The electrical and water controls is depicted in photograph #5 of the attached exhibit. This is the area where the homeowner disconnected the circuit breaker.

The spa was an intricate part of the main pool and consequently was wired directly to the control section as noted in photograph 5.

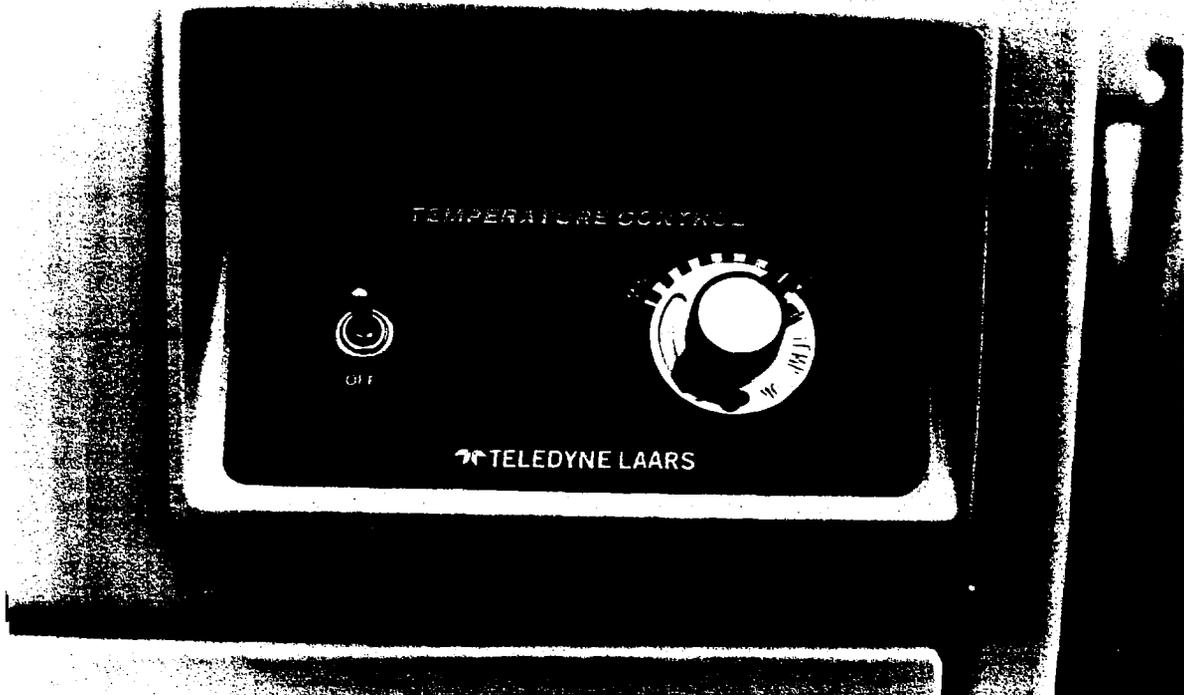
PHOTO 6 HEATER

The heater involved is a propane powered Teledyne Lab Series 1 as could be seen in photograph 6. A specification sheet for the Series 1 was not available, however a specification sheet for the Series 2 Model was obtained during the inspection of the Apollo Spa and Pool Co. and is attached to that inspection.

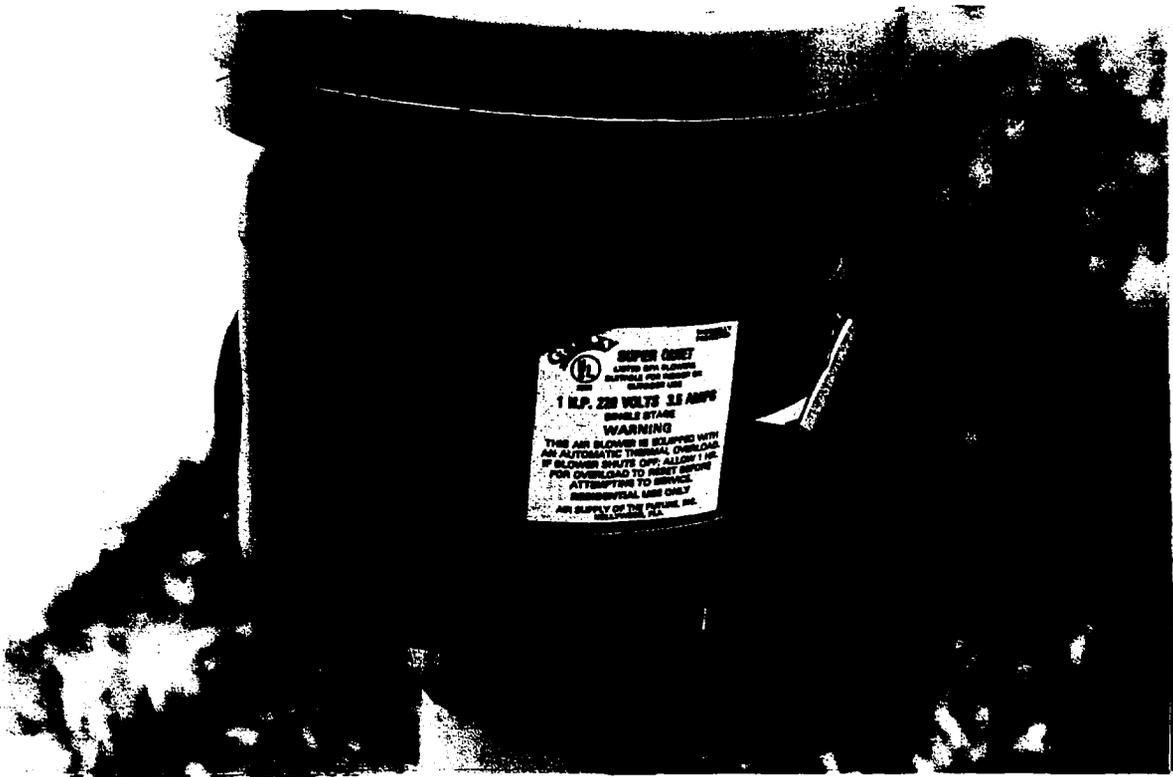
PHOTO 8 1 HP MOTOR FOR MAIN POOL. DUE TO PLACEMENT OF THE SPA MOTOR(1½ HP), IT WAS NOT PRACTICAL TO ATTEMPT TO PHOTOGRAPH THIS MOTOR.

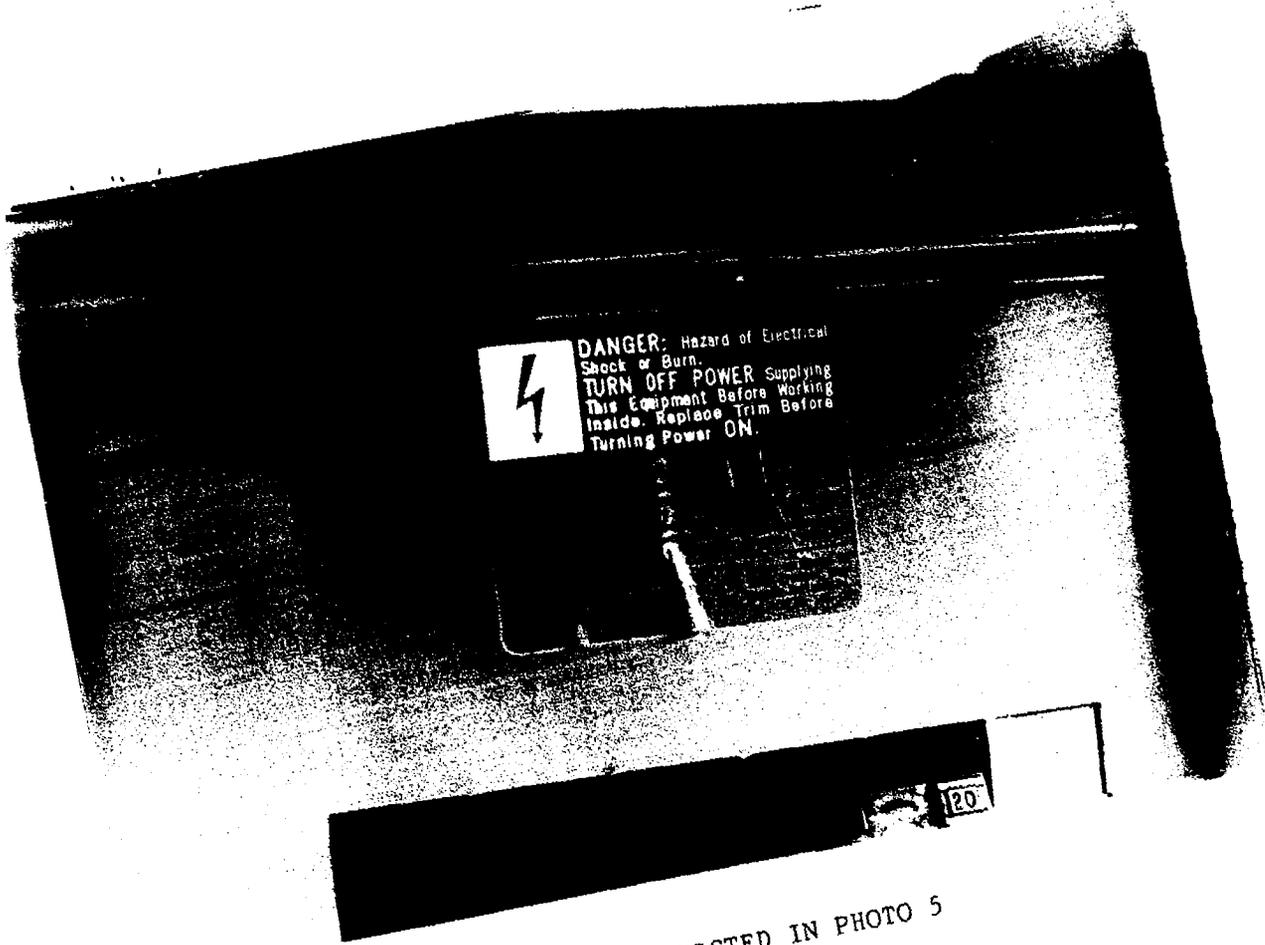
PHOTO 9 ELECTRICAL LOAD CENTER AS DEPICTED IN PHOTO 5
