CPSC Staff's¹ Statement on SEA Ltd.'s (SEA's) Report, "Study of Debris Penetration of Recreational Off-highway Vehicle (ROV) Proof-of-Concept (POC) Floorboard Guards"

*Study of Debris Penetration of Recreational
Off-highway Vehicle (ROV) Proof-of-
Concept (POC) Floorboard Guards*

**Vehicle Dynamics Division
7001 Buffalo Parkway
Columbus, Ohio 43229**

Study of Debris Penetration of Recreational Off-highway Vehicle (ROV) Proof-of- Concept (POC) Floorboard Guards

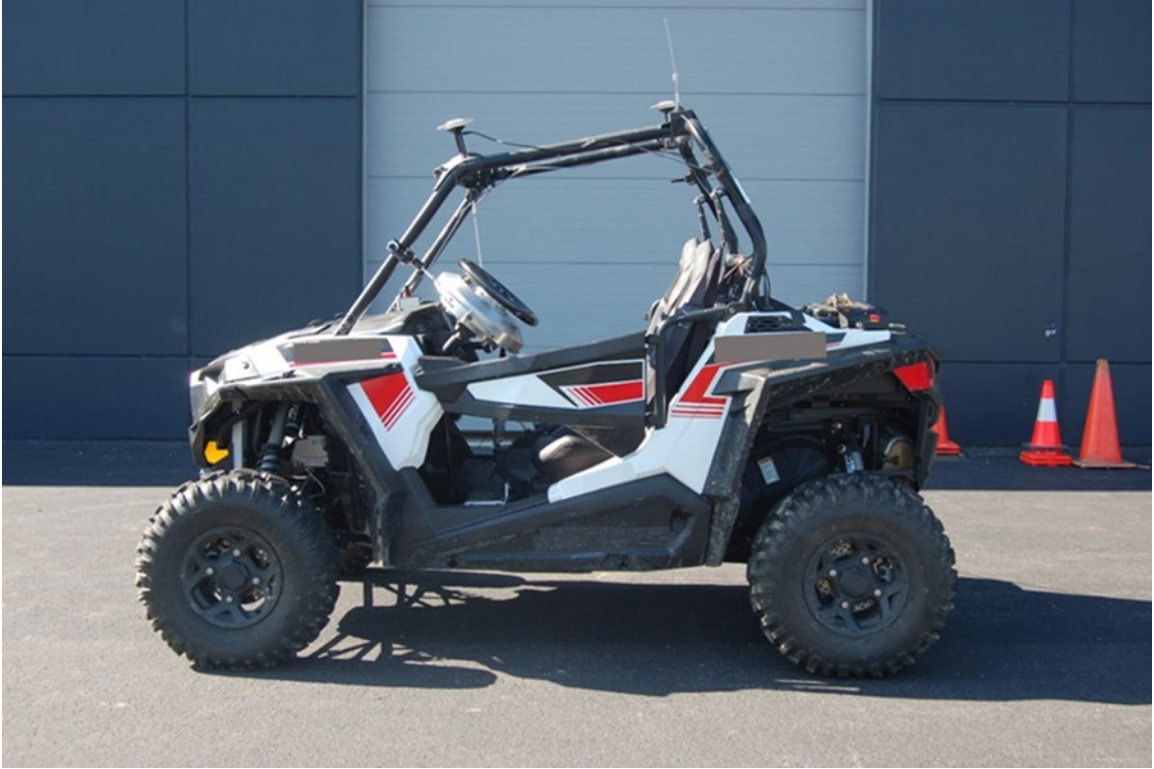
Figure 2 shows a side view of Vehicle A as instrumented for testing. The steering controller and antennas for the data system, GPS, and safety networks can be seen in the photo. The ATD electronics box and GPS/IMU needed for path following are in the rear cargo area of the vehicle. Figure 3 shows the brake and throttle robot mounted in Vehicle A. As the driving controls were on the driver's side of the vehicle, all impacts were to the passenger's side to prevent damage to the throttle and brake controls.

Figure 2: Side View of Test Vehicle A

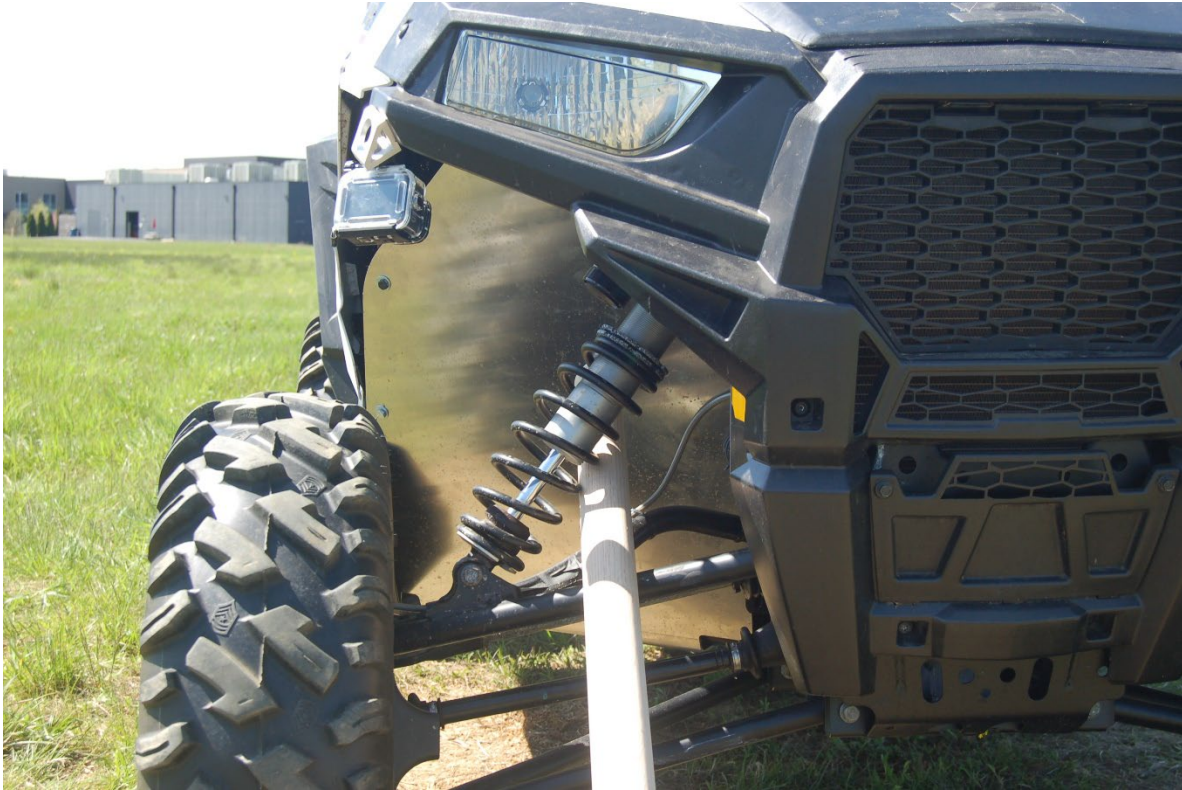
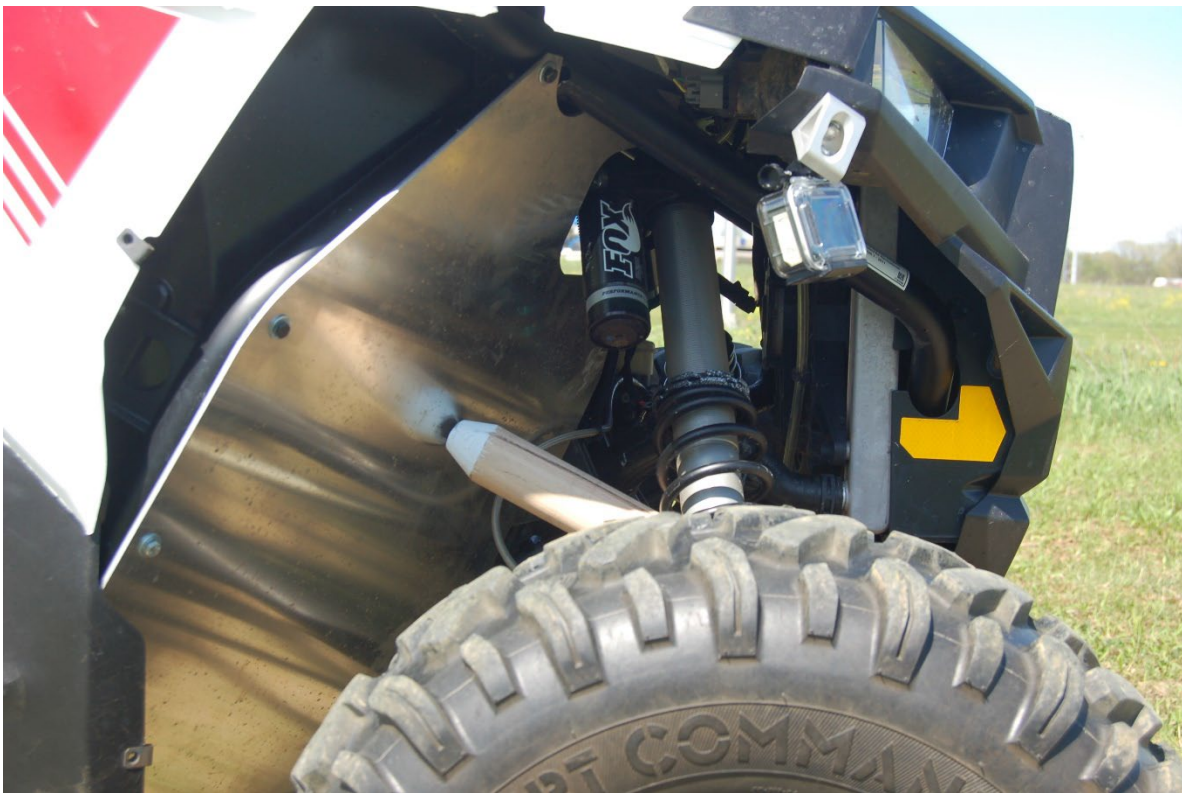
Figures 6 and 7 are front and side view photographs of the pre-impact stick alignment for Vehicle A Run 1. The tip of the stick is above the upper control arm and below the spring/shock absorber strut. As the vehicle moved forward, the tip of stick traveled past suspension components and impacted the guard. On impact, the tip of the stick deflected outward. As the tip of the stick was forced outward, the body of the stick was forced against the suspension (shock/spring) strut thus imparting a bending moment on the stick. The stick broke near the middle of its length. The broken end of the stick remained lodged in the suspension after the impact event.

Figure 6: Vehicle A Run 1 Pre-Impact Stick Alignment – Front View

Figure 7: Vehicle A Run 1 Pre-Impact Stick Alignment – Side View

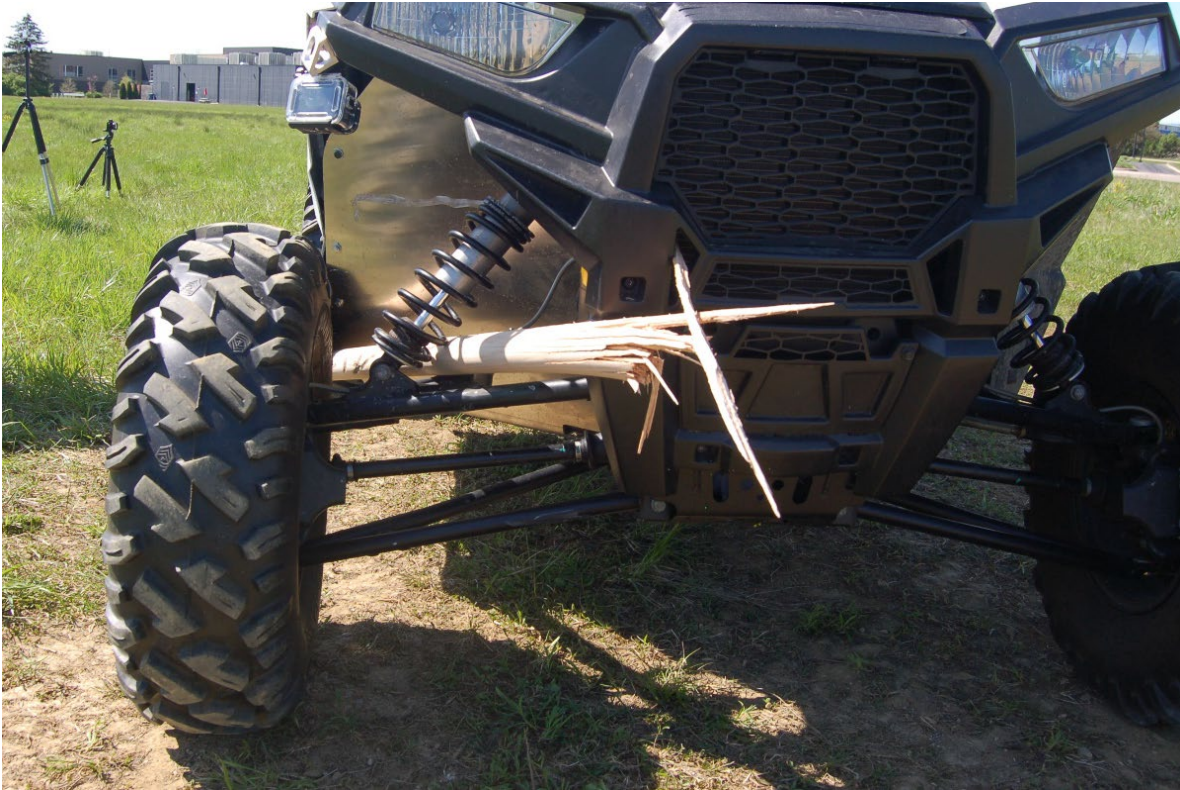
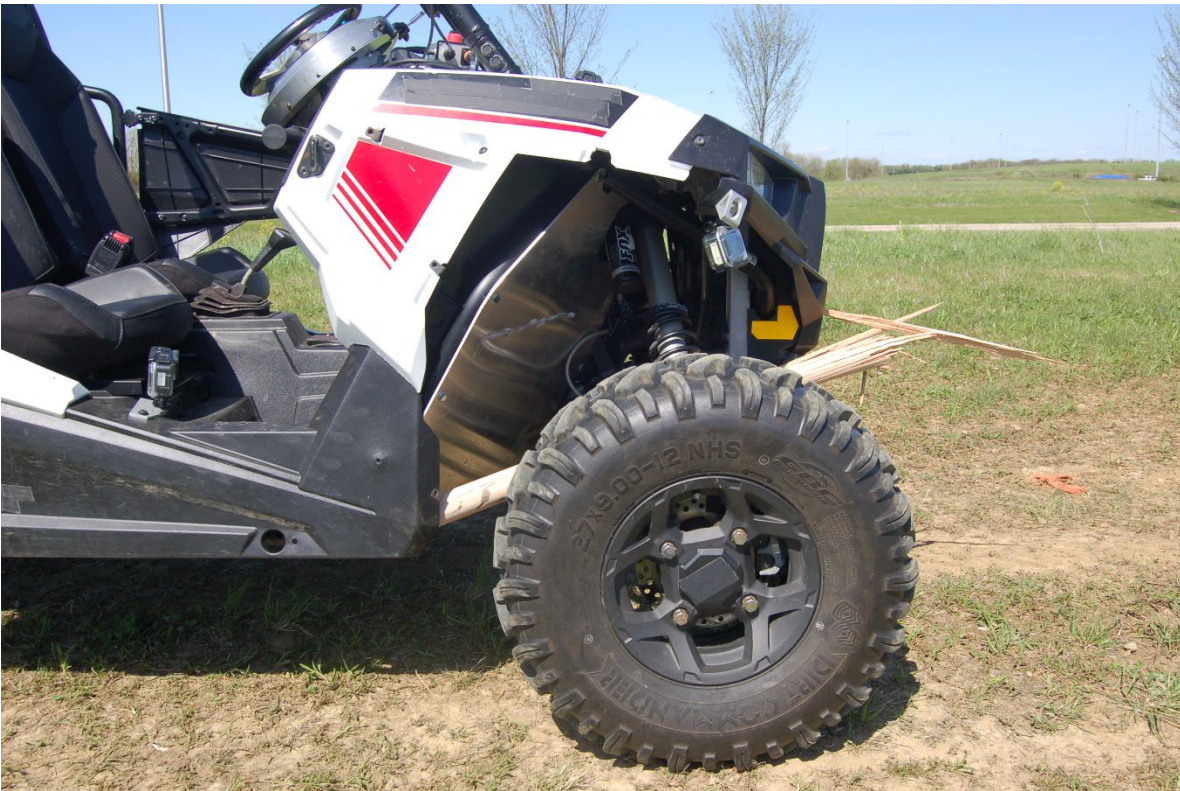
Figures 8 and 9 show post-impact views of the guard, and for this run they show the broken end of the stick lodged in the suspension.

Figure 8: Vehicle A Run 1 Post-Impact – Front View

Figure 9: Vehicle A Run 1 Post-Impact – Side View

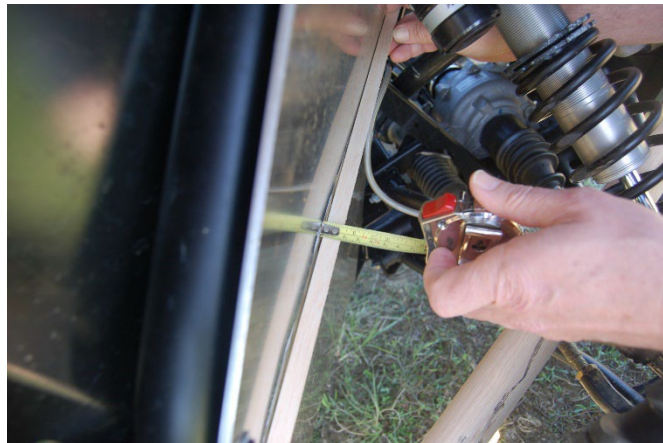
Maximum Guard Deflection: 1/8"

The tip of the stick traveled past suspension components and impacted the guard. On impact, the tip of the stick deflected outward. As the tip of the stick was forced outward, the body of the stick was forced against the suspension (shock/spring) strut thus imparting a bending moment on the stick. The stick broke near the middle of its length. The broken end of the stick remained lodged in the suspension after the impact event.

There was slight lifting/pitching and rolling of the vehicle body during this impact, but the front tires remained in contact with the ground throughout the run. There was minimal yaw disturbance (heading change of about 3 degrees) after impact, before the steering robot corrected the vehicle's path. The maximum vehicle deceleration (low passed filtered to 10 Hz) measured during this run was 0.94 g.

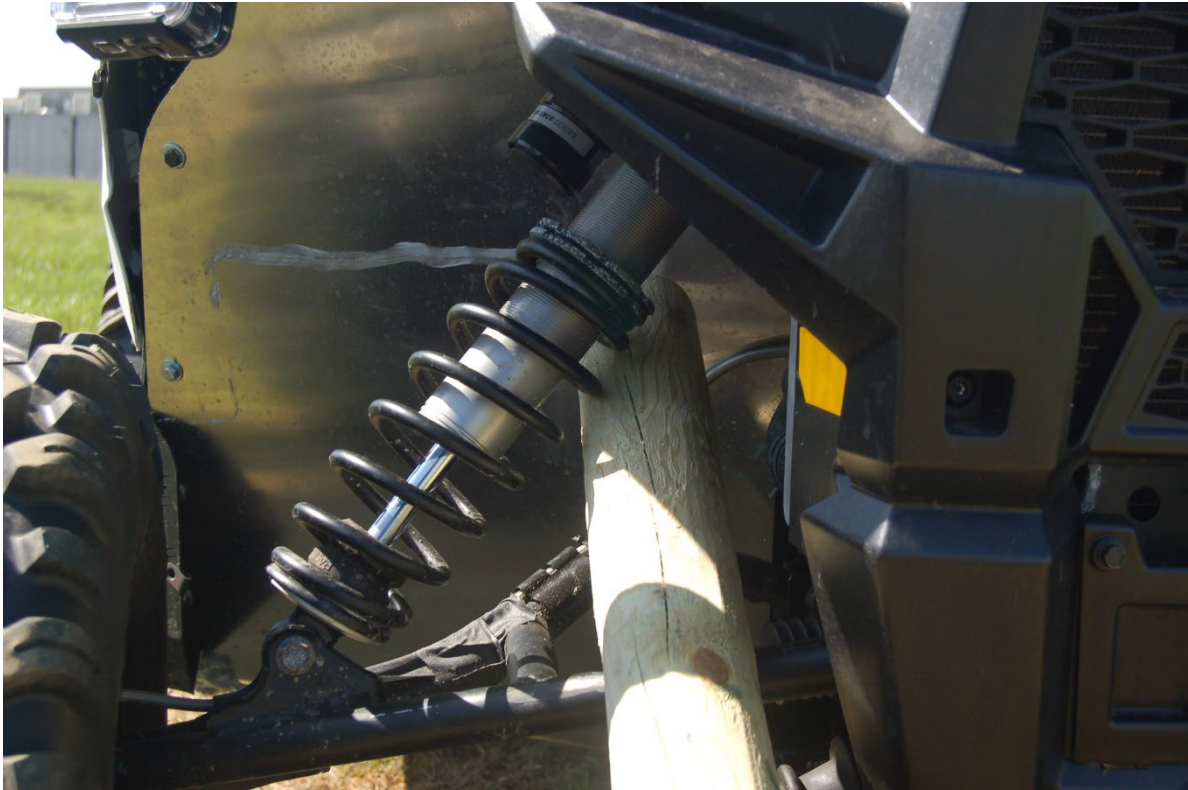
Figure 13: Vehicle A Run 2 Pre-Impact Stick Alignment – Front View

Run 2 for Vehicle A used the same impact speed and the same impact zone as Run 1. However, for Run 2 a 3" diameter pine stick was used. Figures 13 and 14 are front and side view photographs of the pre-impact stick alignment for Vehicle A Run 2.

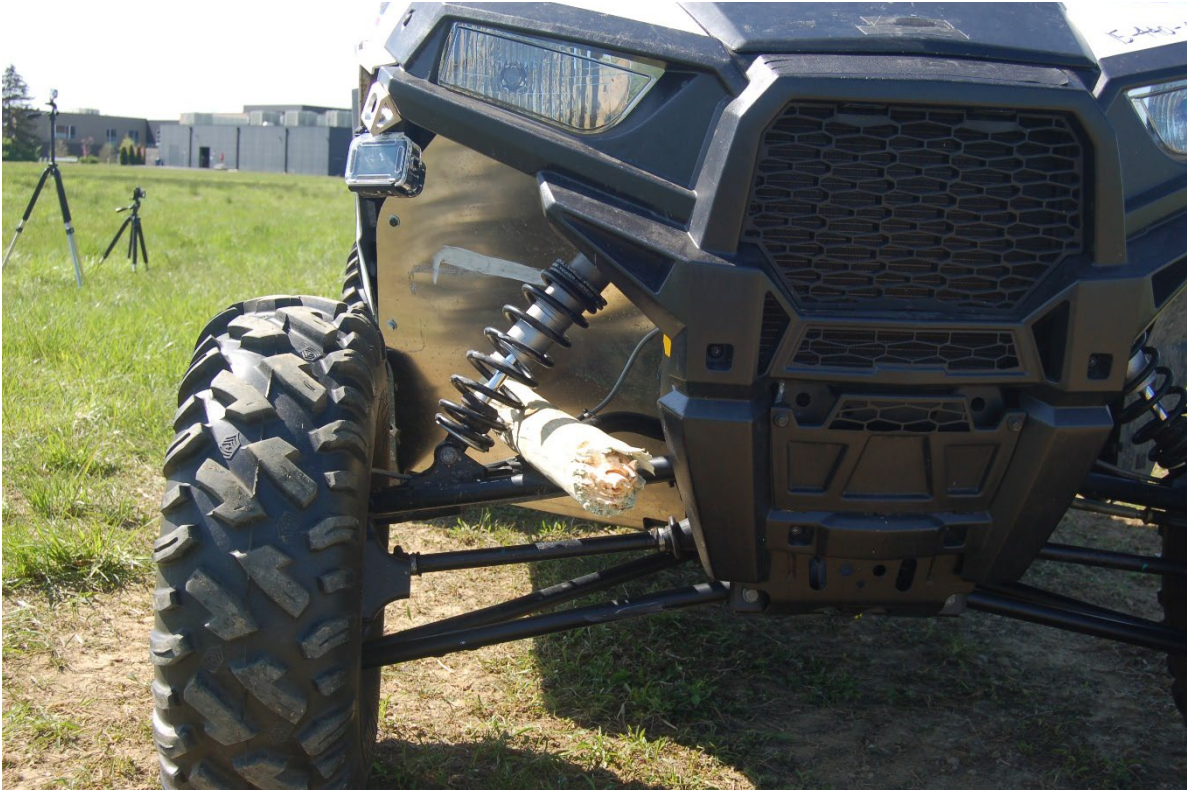
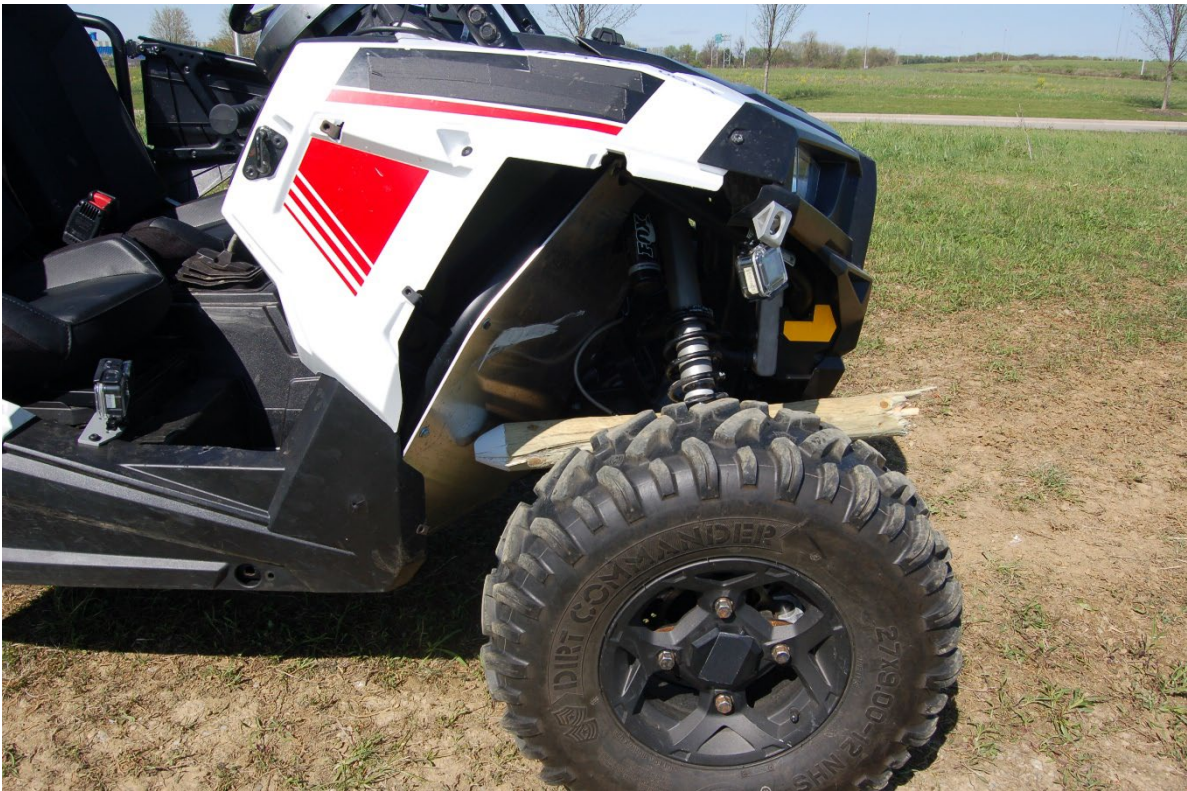
Figures 15 and 16 show post-impact views of the guard, and for this run they show the broken end of the stick lodged in the suspension.

Figure 15: Vehicle A Run 2 Post-Impact – Front View

Figure 16: Vehicle A Run 2 Post-Impact – Side View

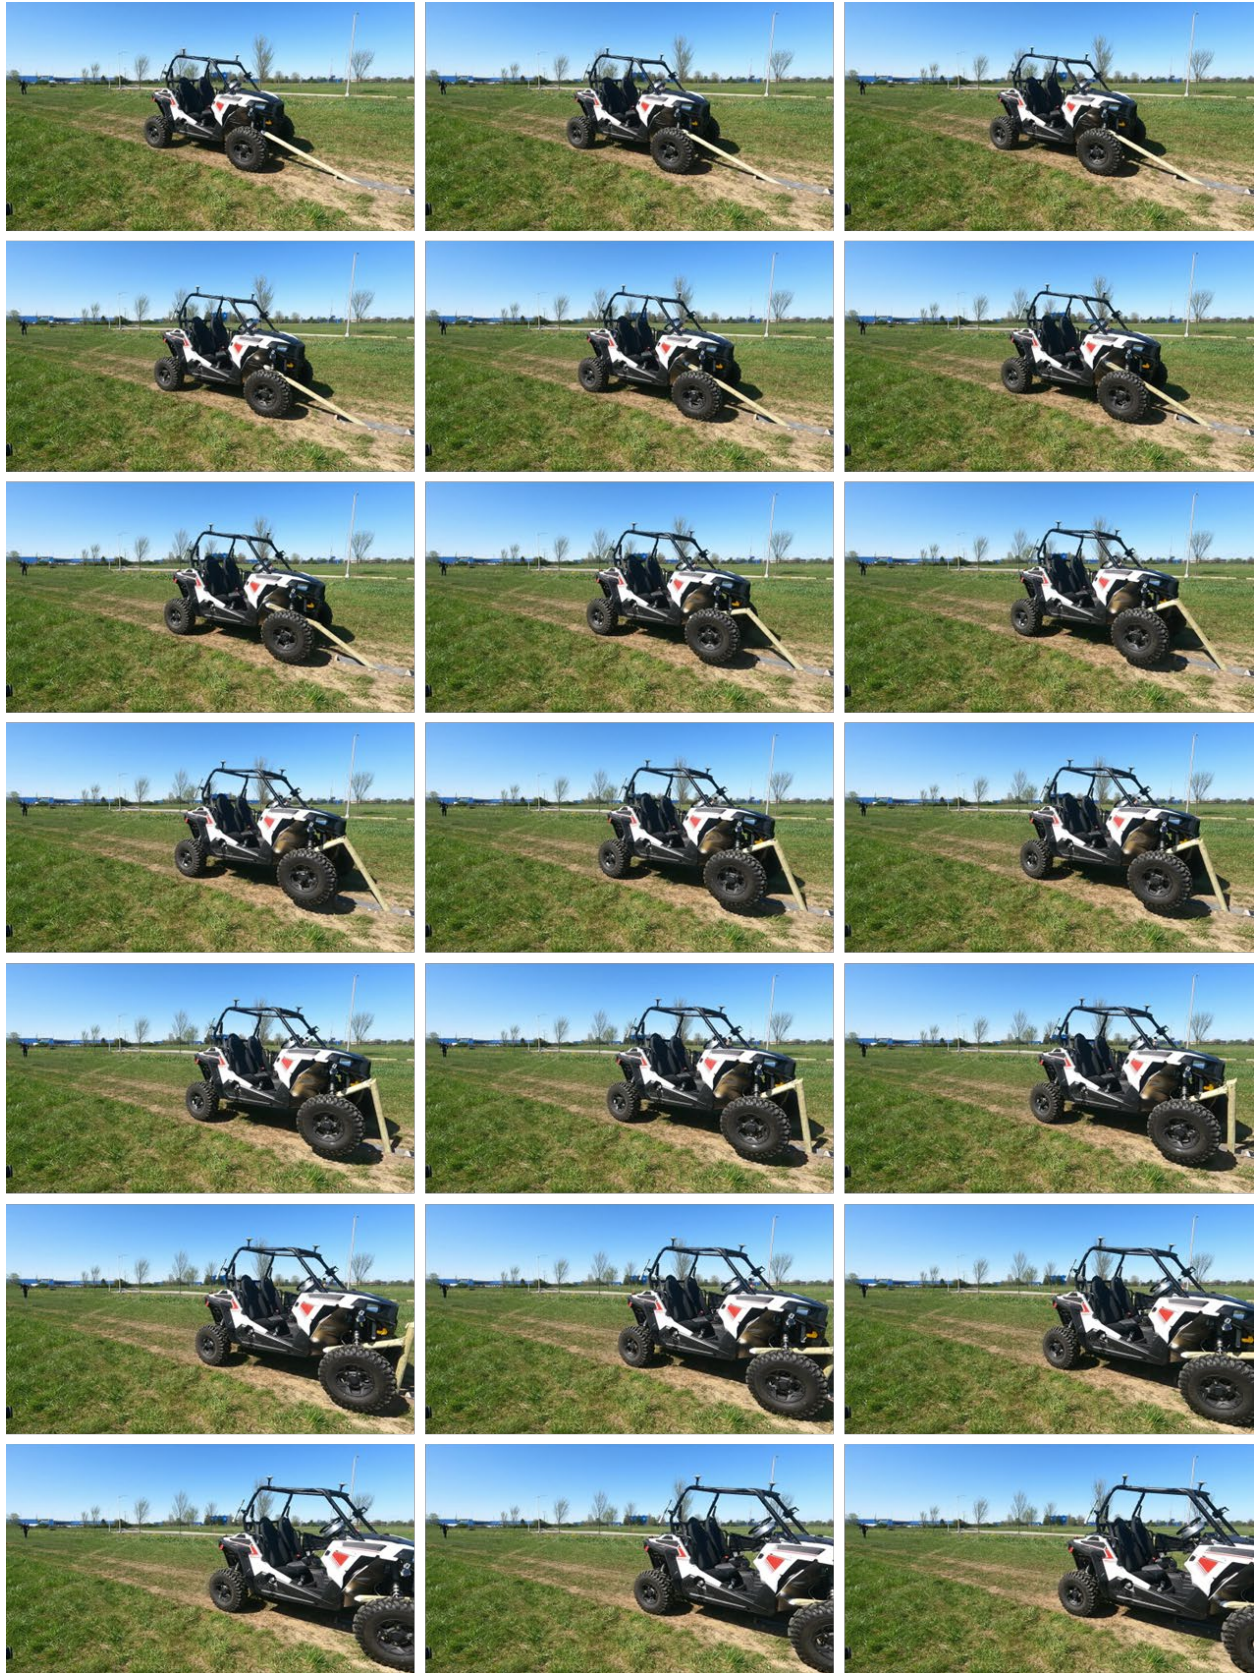
Figure 19 is a collection of images from the fixed off-board video camera, arranged to provide a time-lapse portrait of impact during Run 2. Table 2 contains a summary of Vehicle A Run 2. The table contains descriptions of the test configuration, a narrative regarding the test outcome, and a photo showing a measurement of maximum guard deflection.

Figure 19: Time Lapse Images of Vehicle A Run 2

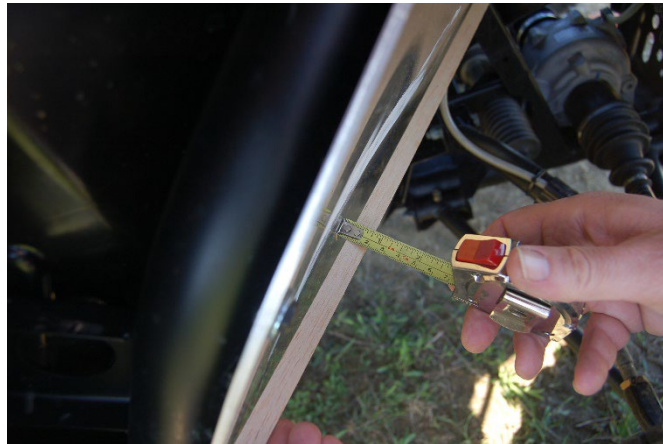
Maximum Guard Deflection: 1/4"

The tip of the stick traveled past suspension components and impacted the guard. On impact, the tip of the stick deflected outward. As the tip of the stick was forced outward, the body of the stick was forced against the suspension (shock/spring) strut thus imparting a bending moment on the stick. The stick broke near the middle of its length. The broken end of the stick remained lodged in the suspension after the impact event.

There was lifting of the vehicle body during this impact (pitch angle of about 3 degrees) and rolling to the left by about 3 degrees. The front tires lifted off the ground during this run. There was moderate yaw disturbance (heading change of about 8 degrees) after impact, before the steering robot corrected the vehicle's path. The steering robot steered to the left by almost 150 degrees during the path recovery. The maximum vehicle deceleration (low passed filtered to 10 Hz) measured during this run was 1.96 g.

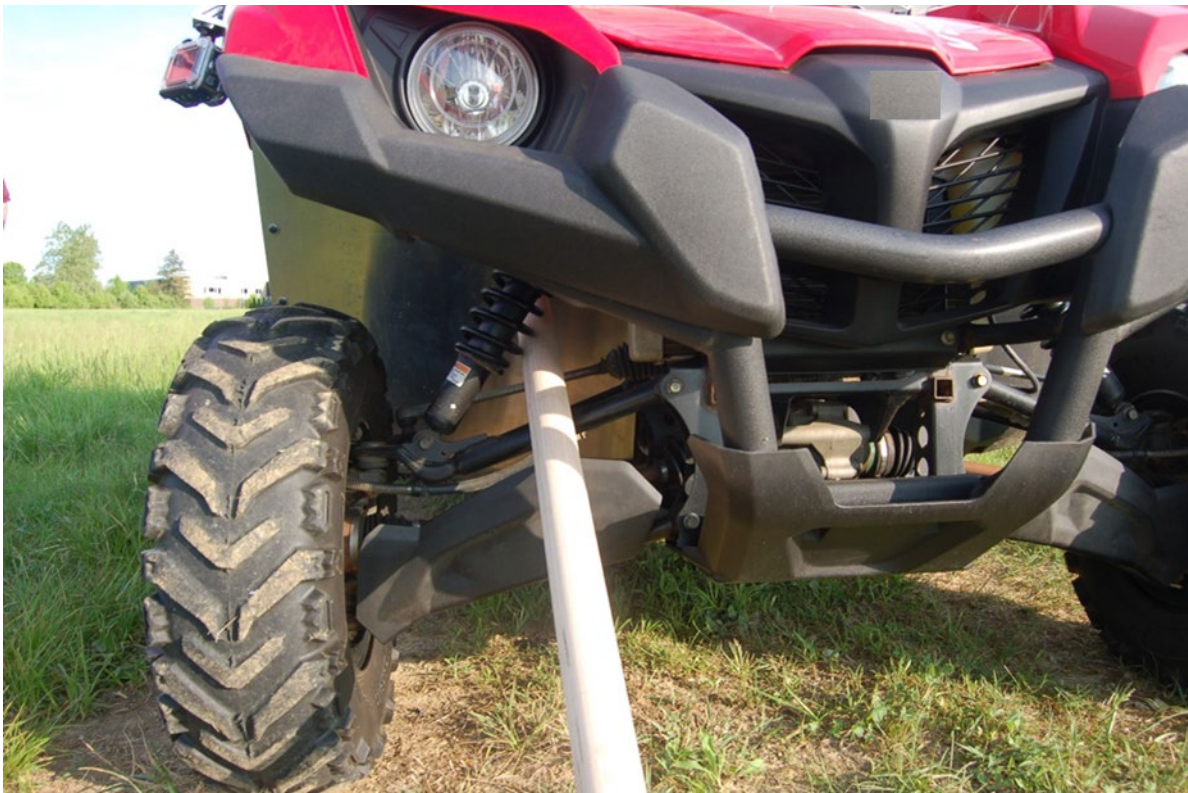
Figure 20: Vehicle D Run 1 Pre-Impact Stick Alignment – Front View

Pre-impact stick alignment photographs for Vehicle D Run 1 are shown in Figures 20 and 21. The impact zone used for this test is the same as the zone used for the tests on Vehicle A, with the tip of the stick above the upper control arm and below the spring/shock absorber strut.

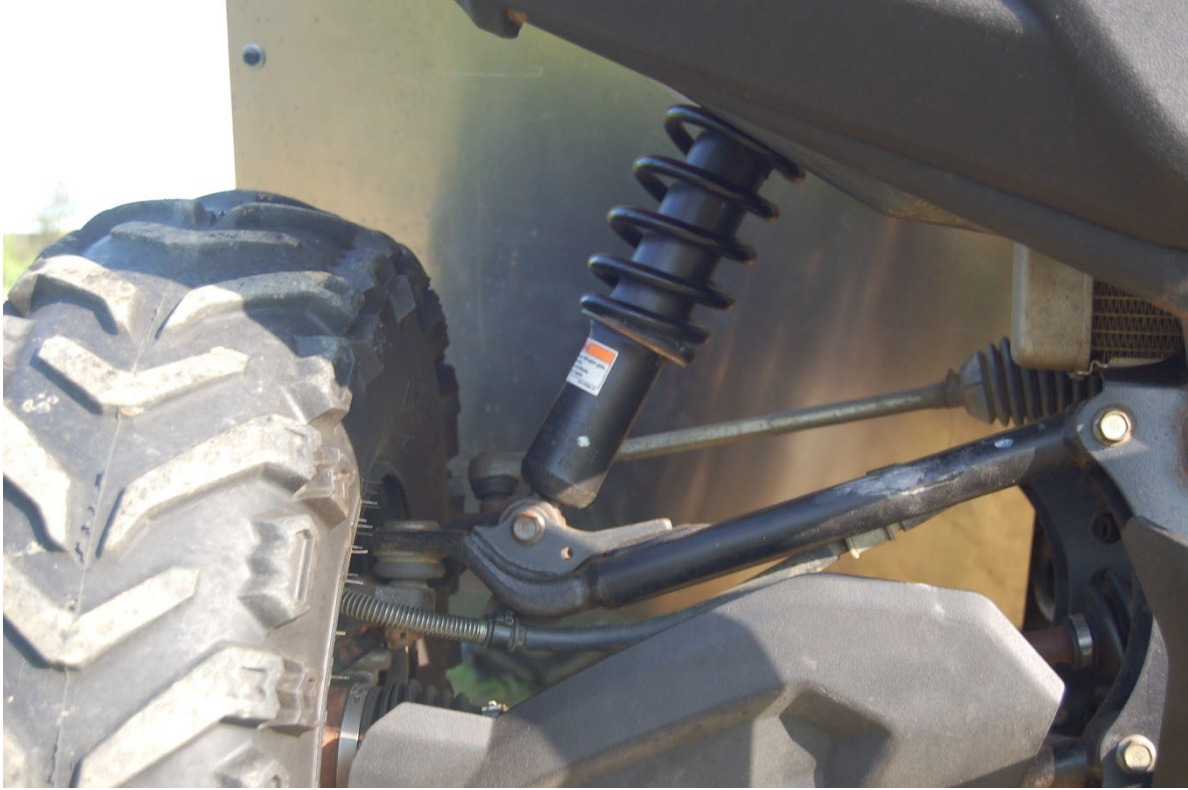
Figure 22: Vehicle D Run 1 Post-Impact – Front View

Figures 22 and 23 show front and side post-impact views of the guard.

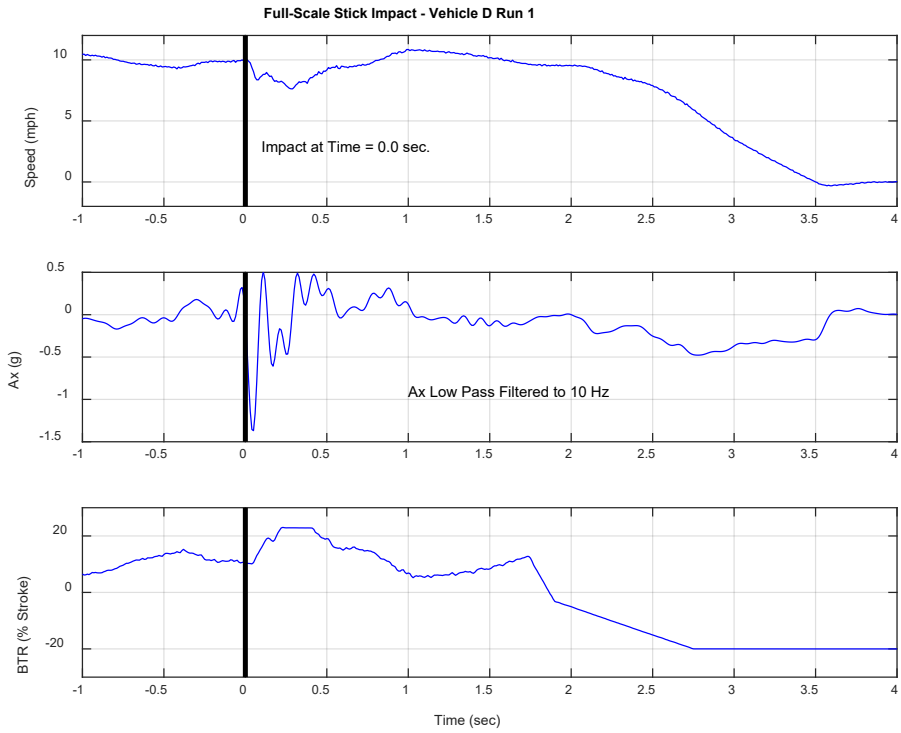
Figures 24 and 25 contain graphical results for Vehicle D Run 1. The impact speed for this run was 10.02 mph. The vehicle speed dropped initially because of the impact, that had a peak deceleration of 1.37 g. Notice that the BTR stroke increased immediately after the impact to compensate for the slight speed reduction caused by the impact. The throttle dropped and the brake applied starting at about 0.8 sec, the time when the vehicle traveled the brake trigger distance. The vehicle came to rest about 1.75 sec after the impact.

Figure 24: Vehicle D Run 1 – Speed, Ax, and BTR Position

Figure 25: Vehicle D Run 1 – Steer Angle, Heading, Pitch Angle, and Roll Angle

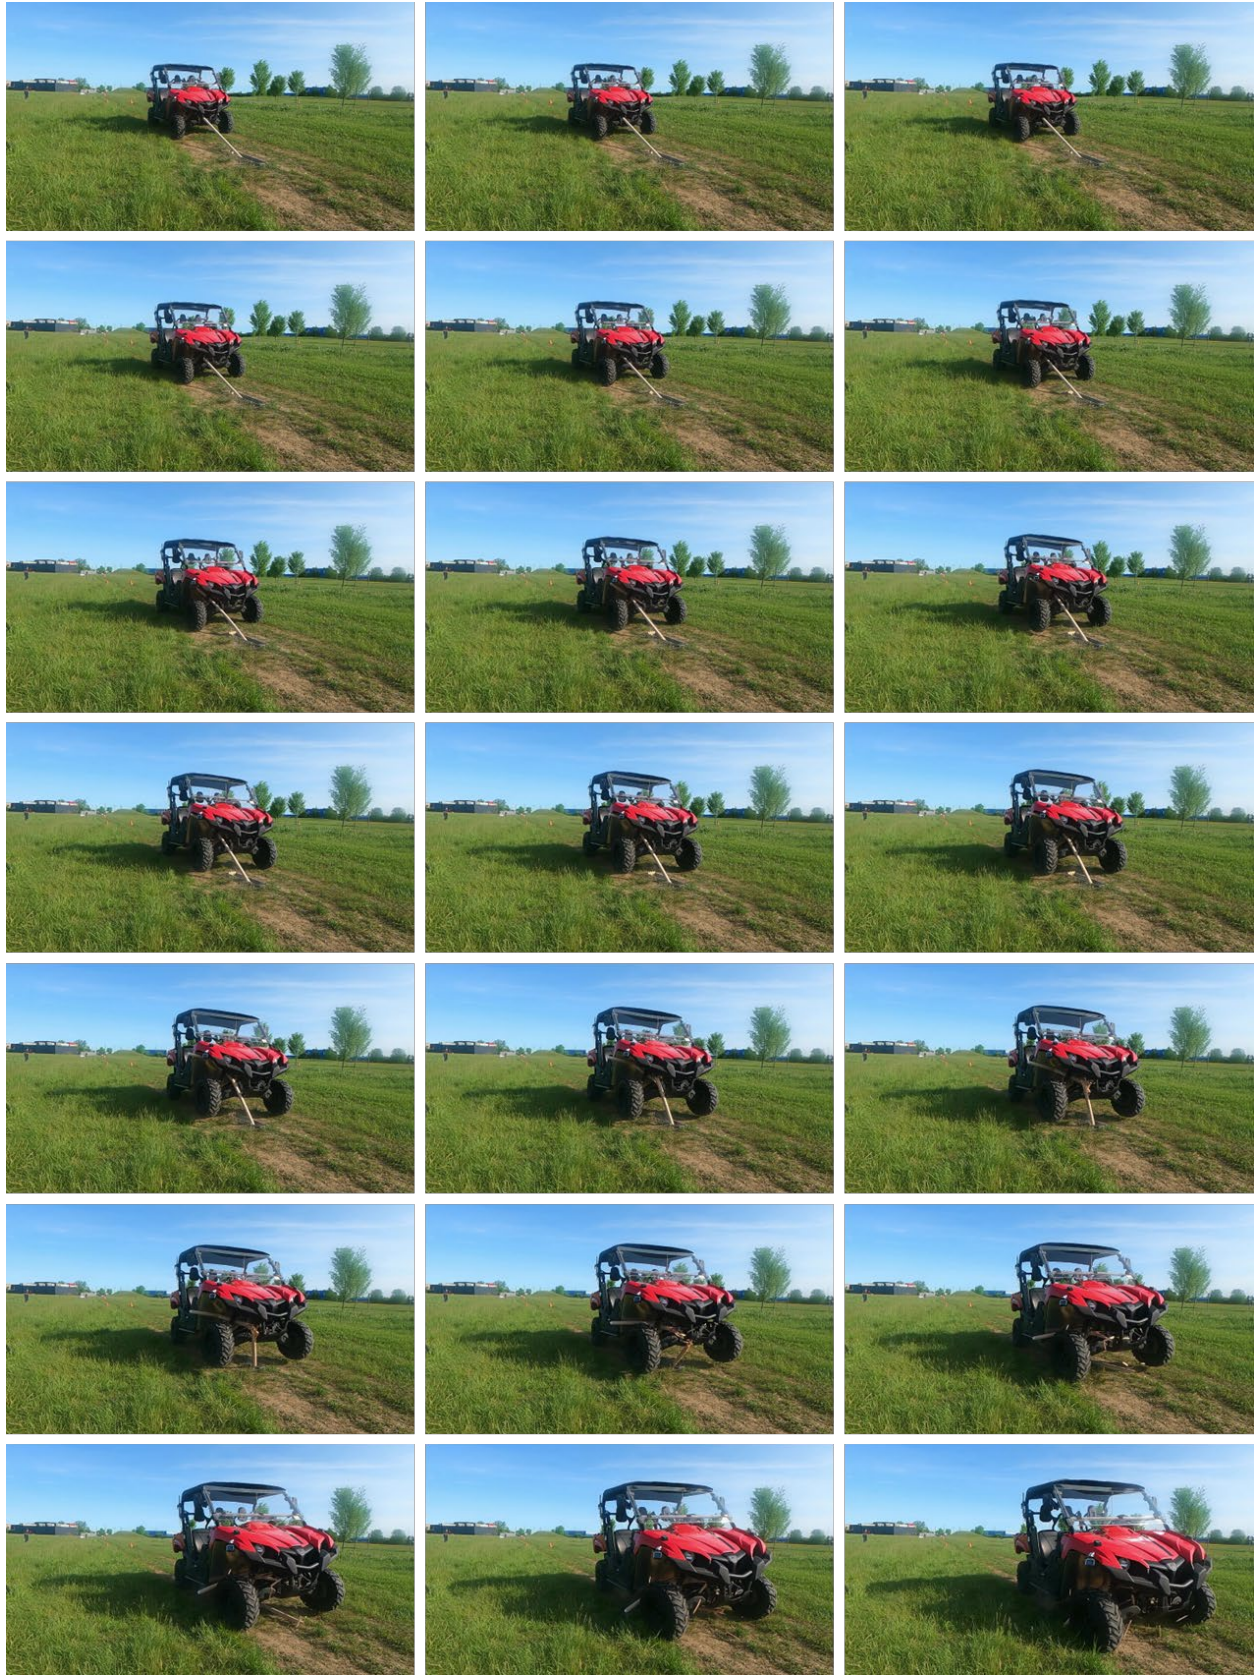
Figure 26 is a collection of images from the fixed off-board video camera, arranged to provide a time-lapse portrait of impact during Vehicle D Run 1. Table 3 contains a summary of Run 1. The table contains descriptions of the test configuration, a narrative regarding the test outcome, and a photo showing a measurement of maximum guard deflection.

Figure 26: Time Lapse Images of Vehicle D Run 1

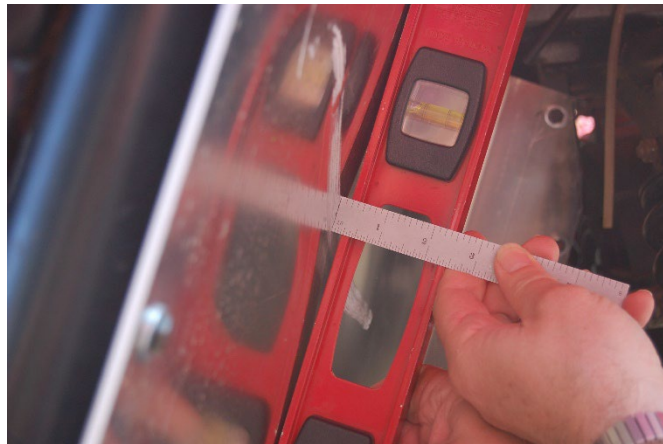
Maximum Guard Deflection: 3/16"

There was lifting of the vehicle body during this impact (pitch angle of about 4 degrees), and the front tires lifted off the ground during this run. There was moderate yaw disturbance (heading change of nearly 8 degrees) after impact, before the steering robot corrected the vehicle's path. The steering robot steered to the left by about 130 degrees during the path recovery. The maximum vehicle deceleration (low passed filtered to 10 Hz) measured during this run was 1.37 g.

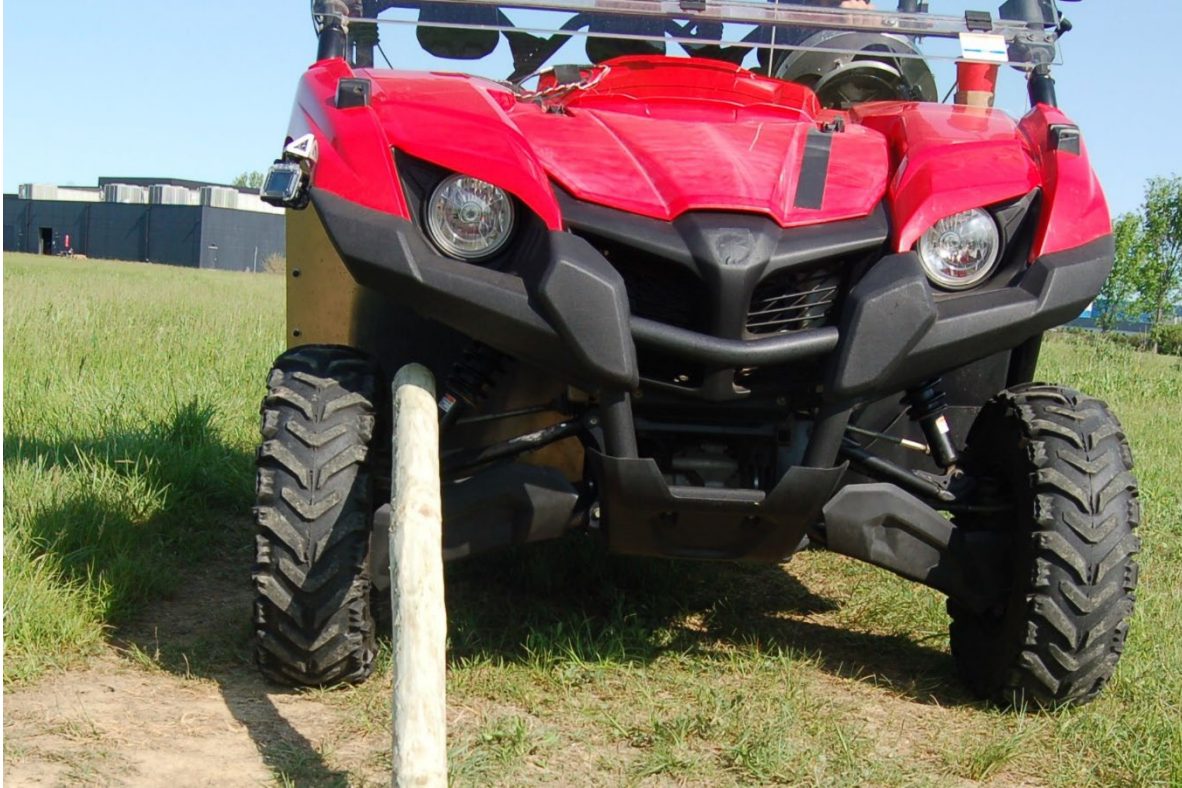
Figure 27: Vehicle D Run 2 Pre-Impact Stick Alignment – Front View

Vehicle D Run 2 used a nominal impact speed of 14.14 mph, a speed selected to double the energy of the impact over an impact at 10 mph. Run 2 used a 3" diameter pine stick, with the stick aligned to impact the upper and outer part of the guard, outside of the spring/shock absorber strut. Figures 27 and 28 are front and side view photographs of the pre-impact stick alignment for Vehicle D Run 2.

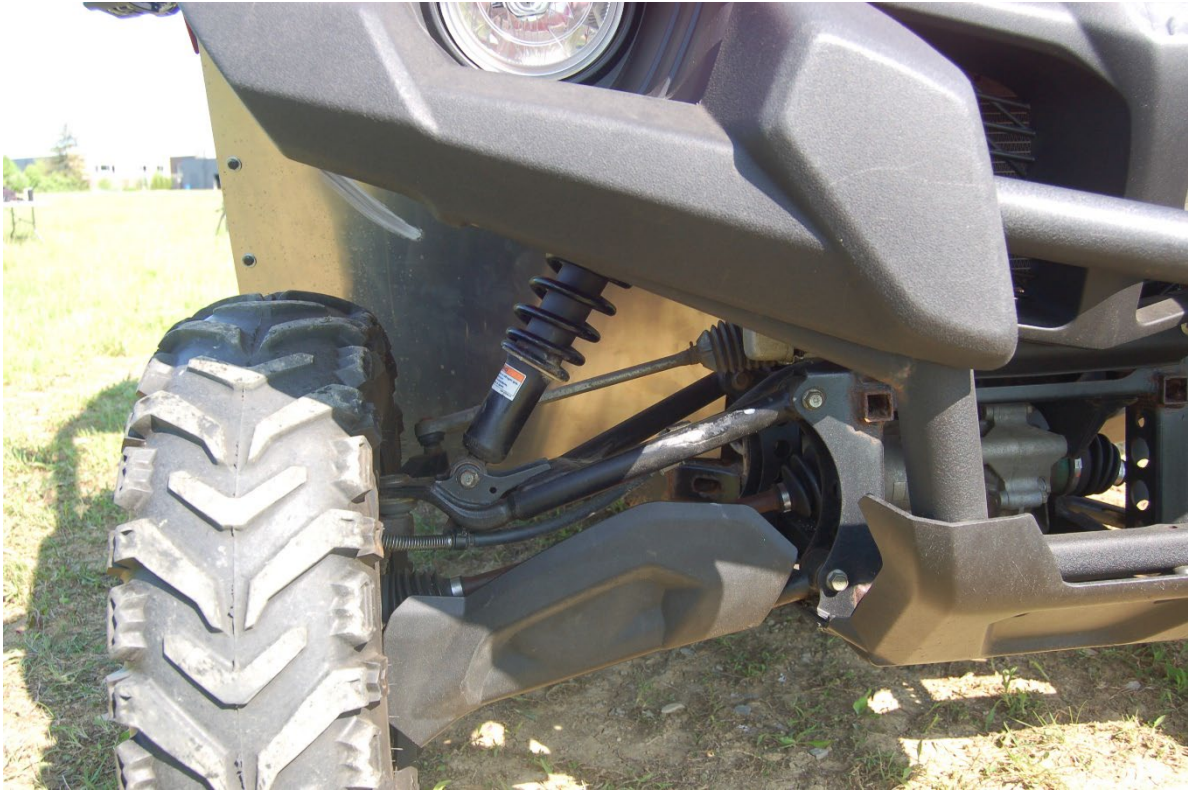
Figure 29: Vehicle D Run 2 Post-Impact – Front View

Figures 29 and 30 show post-impact views of the guard. The same guard that was used in Vehicle D Run 1 was used in this run. In the Figure 30 side view photo, the lowest, outside-most white paint mark from the tip of stick is from Run 2. The other white marking is from Run 1.

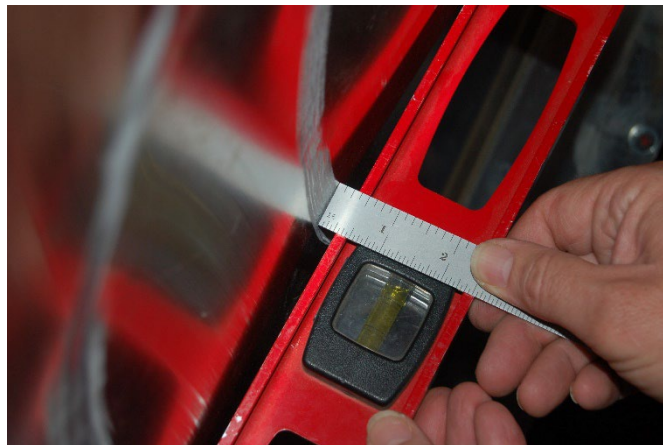
Maximum Guard Deflection: 7/32"

The stick shattered during this higher energy impact, and there was little disturbance to the motion of the vehicle because of the impact. The vehicle pitch angle, roll angle, and heading all changed less than about two degrees during this impact. The maximum vehicle deceleration measured during this run was 0.58 g, a value less than the maximum vehicle decelerations measured during the other runs conducted in this study.

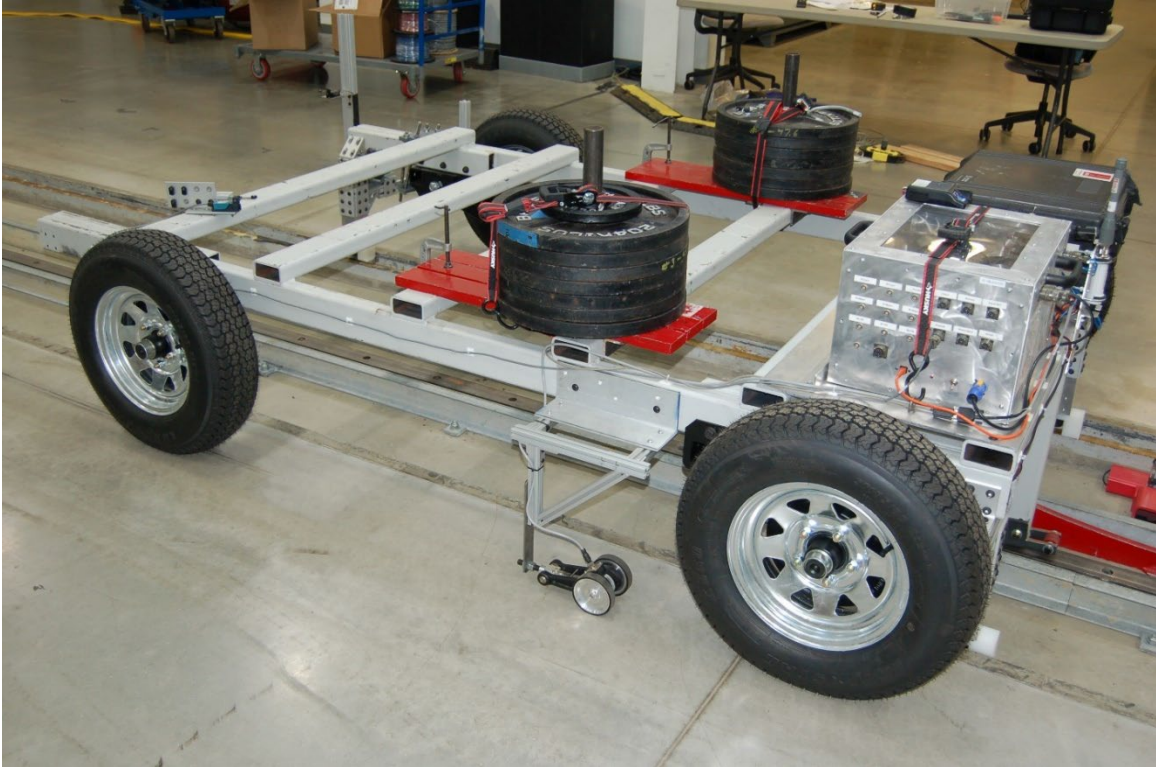
Figure 34: Sled Cart Used for ROV Debris Penetration Tests

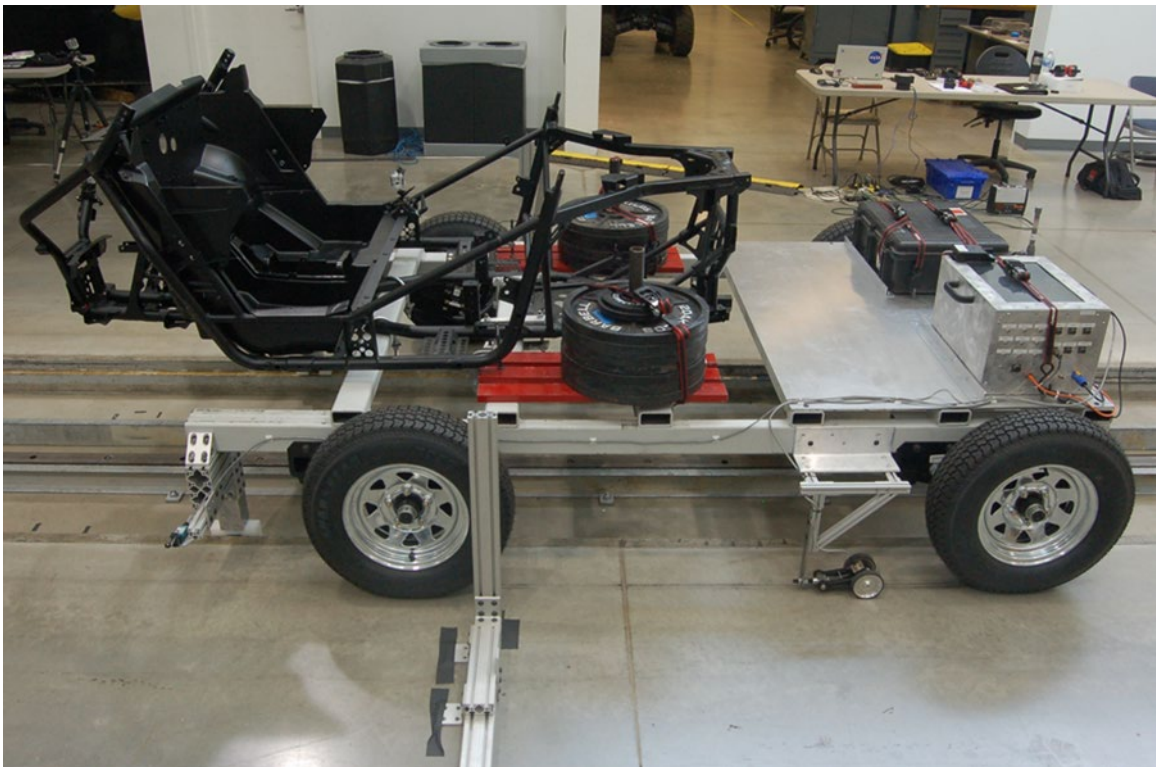
Figure 35: Sled Cart with OEM ROV Frame (Vehicle A) Attached

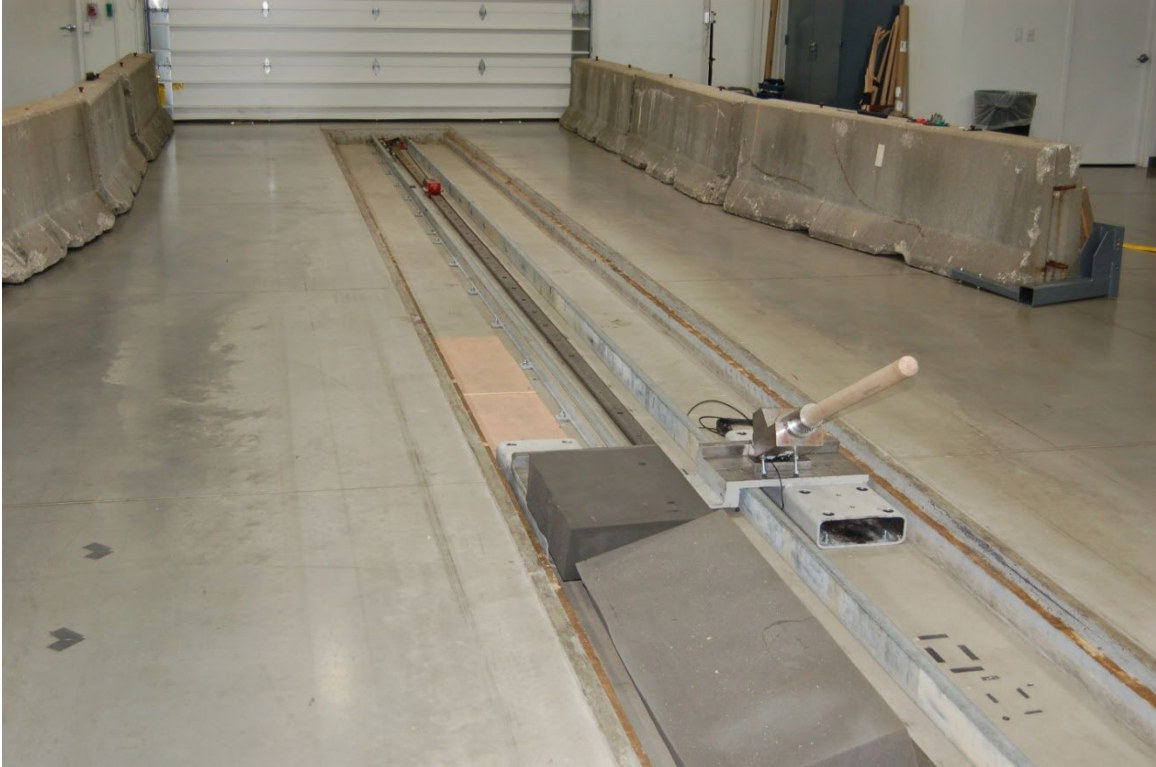
The initial vertical angle of the stick for all the sled tests was 25°, based on the estimated angle at penetration observed in the full-scale penetration tests performed in FY2021. For each sled test, the length of the stick was trimmed to achieve the impact point desired on the vehicle. The stick lengths listed in the sled test summary tables (Tables 6-21) include the four-inch length of stick that nests inside the stick holder. The desired impact point was selected based on the details of the particular floorboard/firewall and/or guard under study and based on the suspension components. For example, each vehicle's suspension design might allow a natural "ingress point" higher or lower, or closer or farther from the centerline of the vehicle, and the impact point was selected to be in this region. The length and lateral position of the stick were then selected to give this impact point, while maintaining a 25° vertical angle and a horizontal angle parallel to the rail.

Figure 36: Stick and Stick Holder Mechanism – View Looking Down the Sled Track

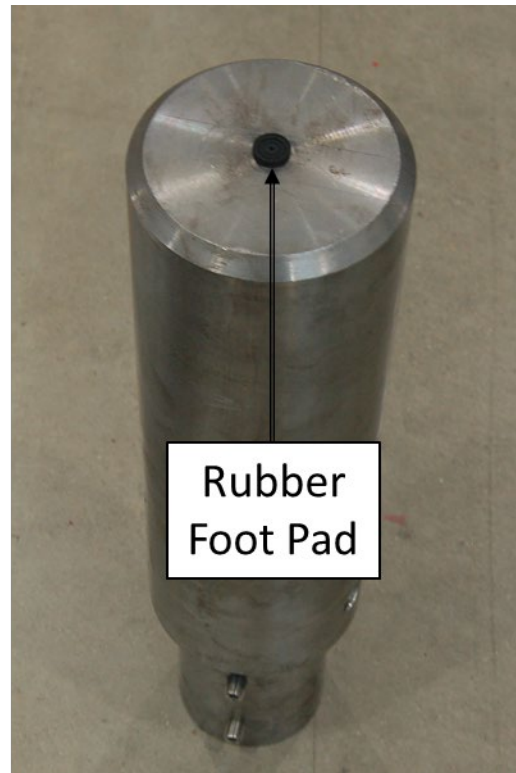
Figure 39: Load Cell Arrangement

Figure 38 shows the round stick holder slider partially removed from the round cavity into which it slides. This mechanism is used to support large forces in the axial direction of the stick. A load cell in the base of the cavity is used to limit the stick motion and to measure the force it takes to limit the motion. The load cell and the small rubber foot pad on the end of the slider that engages the load cell are shown in Figure 39.
