CPSC Staff's¹ Statement on SEA Ltd.'s (SEA's) Report, "Study of Debris Penetration of Recreational Off-highway Vehicle (ROV) Proof-of-Concept (POC) Floorboard Guards"

*Study of Debris Penetration of Recreational
Off-highway Vehicle (ROV) Proof-of-
Concept (POC) Floorboard Guards*

**Vehicle Dynamics Division
7001 Buffalo Parkway
Columbus, Ohio 43229**

Study of Debris Penetration of Recreational Off-highway Vehicle (ROV) Proof-of- Concept (POC) Floorboard Guards

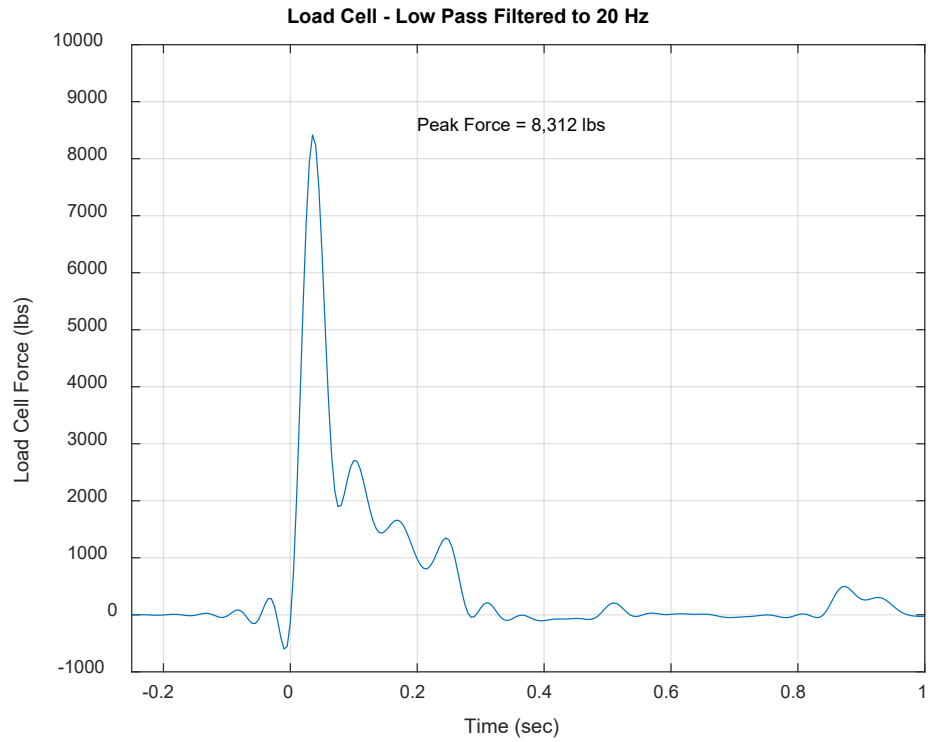
Figure 40: Measured Load Cell Force – Vehicle A – Run 1

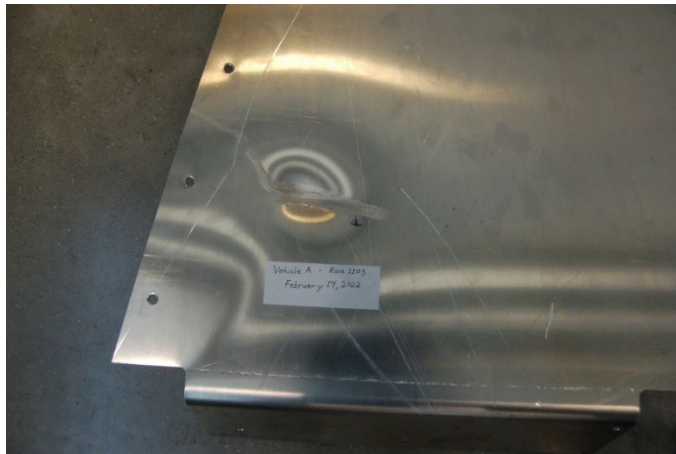
Table 7 (Continued): Vehicle A – Sled Impact Run #2

This guard was 0.160 inches thick, 6061-T6 aluminum plate. The path of the stick moved laterally across the guard seen in the upper photo. The middle photo shows the overall slight damage to the guard. The bottom photo shows the detail of the damage measurement, showing the depth of damage to be about 7/16 inch.

Slight guard deformation of 7/16 inch. There was no damage to the fasteners. The front of the cart lifted during impact and the cart yawed 7° clockwise.

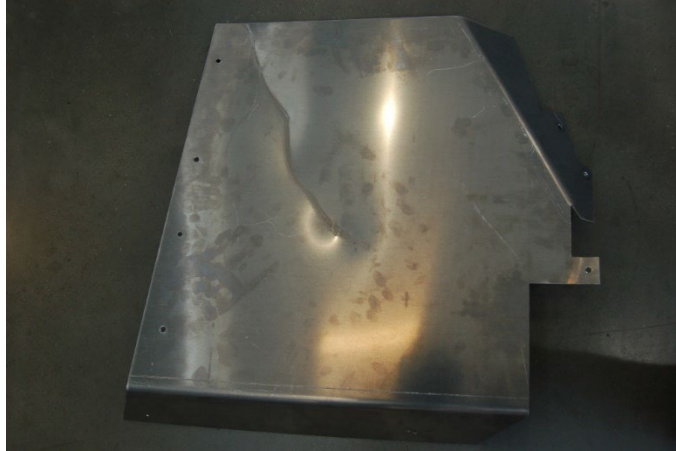
This guard is made of 6061-T6 aluminum plate 0.160 inches thick. The upper photo shows the track of the tip of the stick across the guard and the minimal deformation. The bottom photo shows the detail of the measurement of the guard deformation, about 3/8 inch.

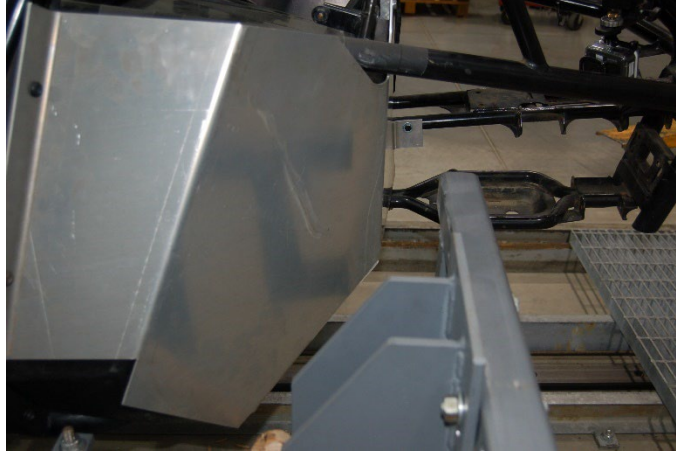
Table 12 (Continued): Vehicle C – Sled Impact Run #1

This guard is made of 6061-T6 aluminum plate 0.125 inches thick. The upper photo, taken while still attached to the vehicle, shows the overall damage, and the track of where the tip of the stick slid across the front of the guard in an upward and outward manner. The maximum deformation was $\frac{1}{4}$ inch, as shown in the lower photo.

Slight guard deformation of 1/4 inch. No damage to fasteners. Front of cart lifted during impact and the cart yawed 7° clockwise.

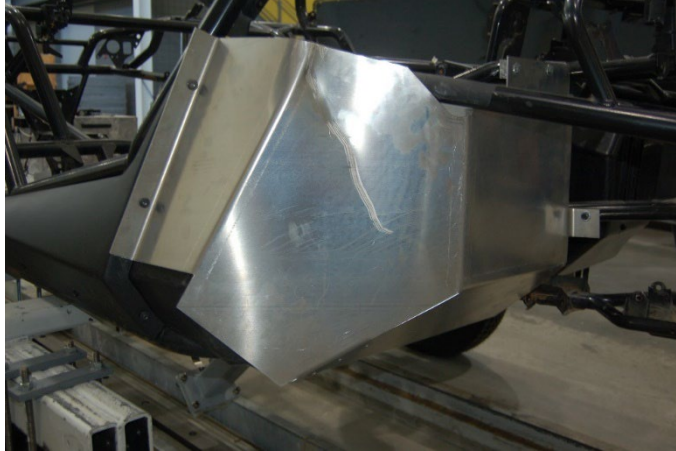
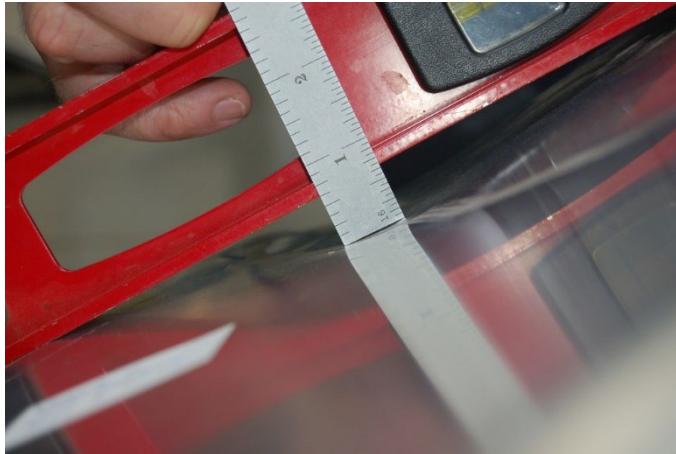
Table 13 (Continued): Vehicle C – Sled Impact Run #2

This guard is made of 6061-T6 aluminum plate 0.100 inches thick. The upper photo, taken while still attached to the vehicle, shows the overall damage, and the track of where the tip of the stick slid across the front of the guard in an upward and outward manner. The deflection caused by this run was 5/8 inch, as seen in the lower photo.

Slight guard deformation of 5/8 inch. Light damage (bending) to one of the guard attachment screws. Front of cart lifted during impact and the cart yawed 8° clockwise.

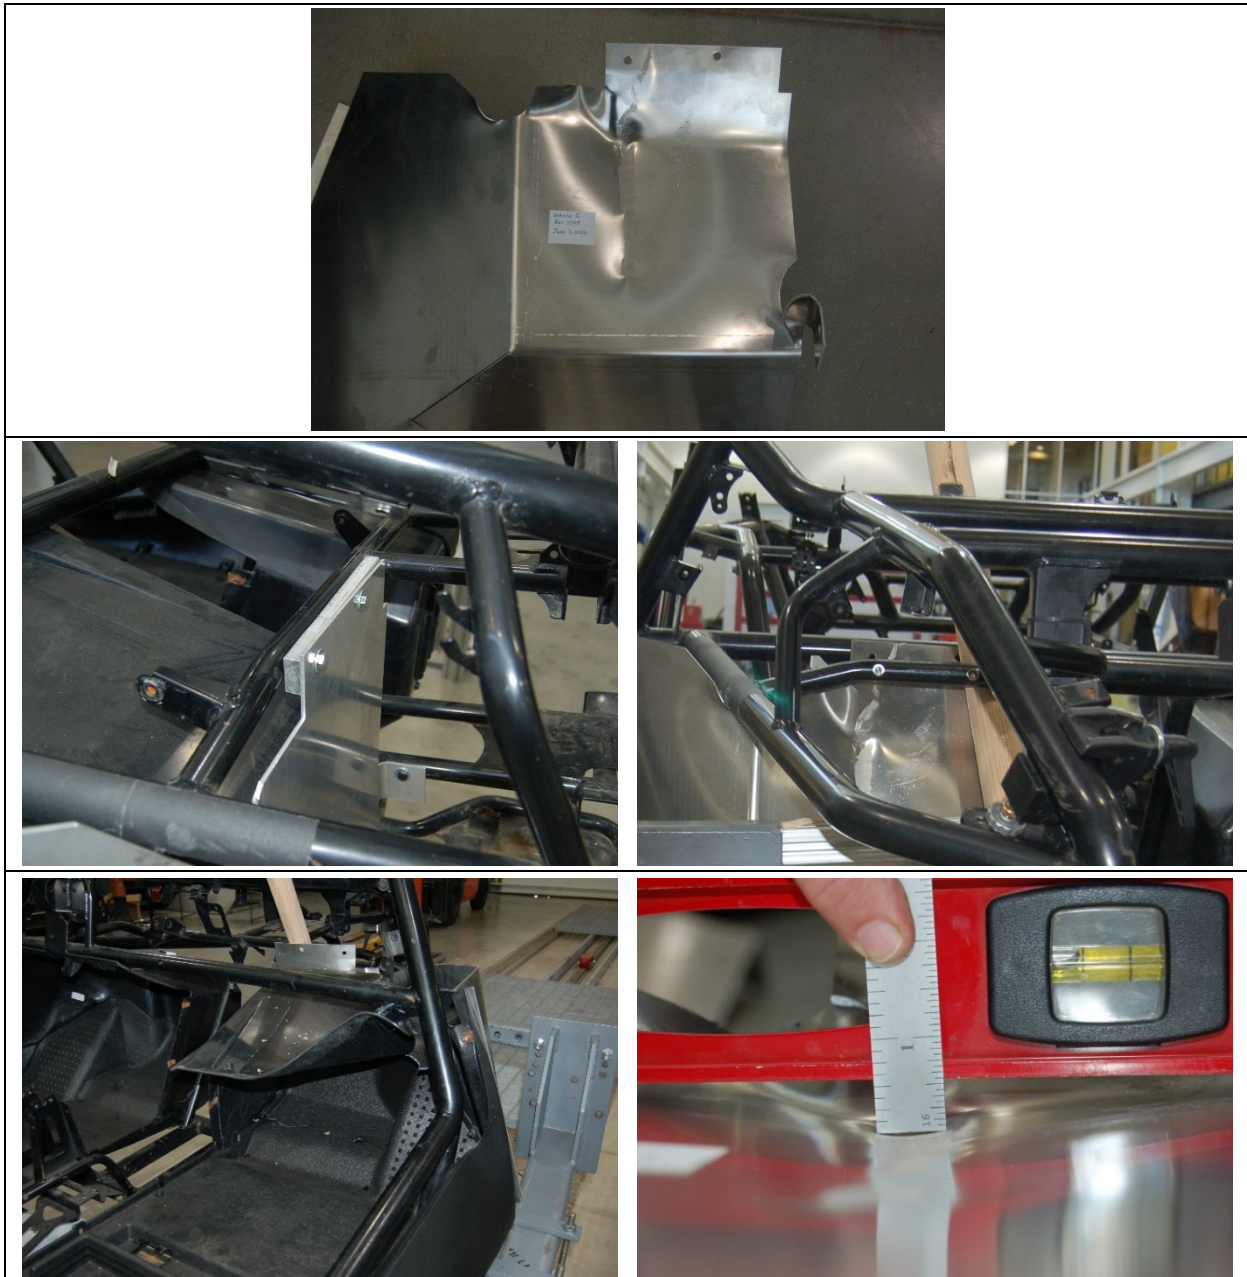
Table 14 (Continued): Vehicle C – Sled Impact Run #3

This guard is made of 6061-T6 aluminum plate 0.100 inches thick. The top photo shows the damage to the top of the guard and some ripped metal near the lower right side guard fastener location. The fasteners near the top of the firewall failed, and the top of the firewall was pushed into the occupant compartment. The middle left photo shows that a 1/4" thick spacer was used between the guard and OEM frame at the location of the two top fasteners. The middle right photo shows that the heads of 1/4"-20 screws broke off. A stronger fastening method, one without a standoff and/or using stronger screws or more screws, could have prevented this fastener failure. The bottom left photo shows the OEM firewall. There were also cracks in the lower left side and top right portion of the firewall. The deflection in the guard was 9/16 inch, and this measurement is shown in the lower right photo.

Guard deformation of 9/16 inch. Two guard fasteners at top of guard sheared, and the guard was damaged. The occupant compartment was penetrated slightly by the stick and by the plastic firewall that got pushed inward by the stick. The top two fasteners of the plastic firewall also failed, and there was damage (cracks in the plastic) to the firewall and footwell areas. The stick pushed upward with little lateral movement, and the cart did not yaw.

The POC guard that failed was one of the 0.100" thick aluminum guards, and the guard fasteners failed during this test (Vehicle C Run 3). The other test with a 0.100" thick aluminum guard did not have debris penetration. All tests with 0.125" aluminum and thicker guards did not have debris penetration.

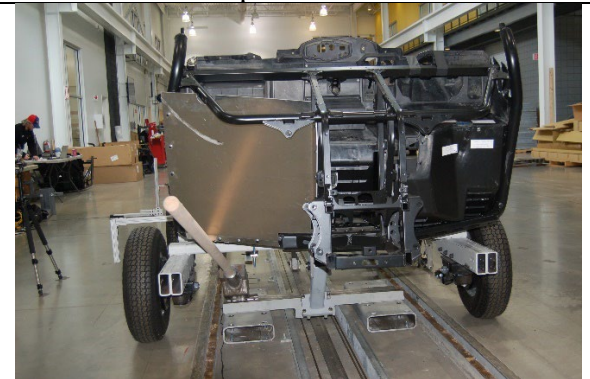
Post-Impact – Front View

Slight guard deformation of 5/16 inch. No damage to fasteners. Tip of stick slid up and outward on the face of the guard. Stick cracked near base (near its fixed end) but did not completely break. Cart yawed only slightly.

The upper photo shows the limited damage to the guard and the track of the tip of the stick across the guard, moving upward and outward. The lower photo shows the depth of damage to the guard, 5/16 inch.

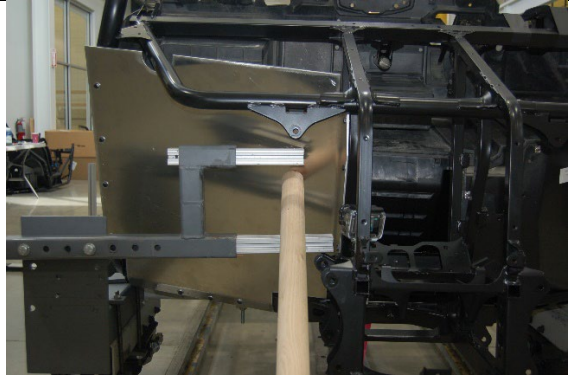
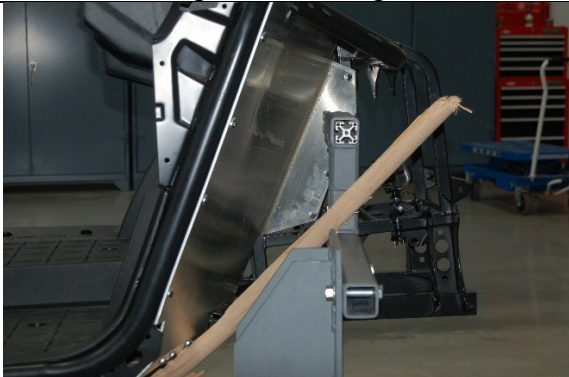
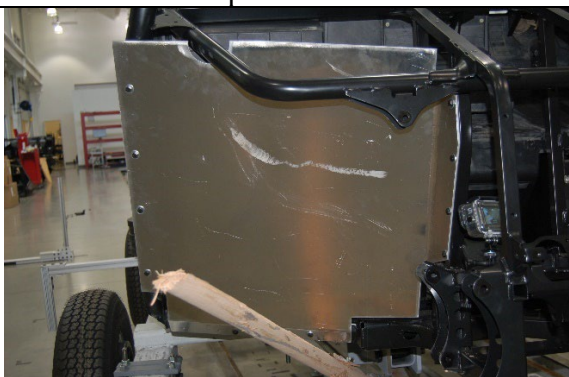
Table 17: Vehicle D – Sled Impact Run #3

<p>Configuration: POC Guard, 0.160 inches thick</p> <p>Nominal Impact Speed: 10 mph</p> <p>Actual Impact Speed: 10.19 mph</p> <p>Primary Impact Location: Inboard portion of guard, in area above inner end of upper control arm.</p> <p>10.0" Above Bottom of Floorboard 10.0" Right of Vehicle Centerline</p> <p>Stick Length: 69 3/4"</p> <p>Stick Penetration: No</p> <p>Peak Force at Base of Stick: 7,627 lb</p> <p>Run Outcome Narrative:</p> <p>Guard deformation of 7/8 inch. No damage to fasteners. Front of cart lifted during impact and the cart yawed about 8° clockwise.</p>

The upper photo shows the guard damage and the path of the tip of the stick across the guard, starting at the initial impact area near the inboard edge of the guard, and moving generally outward to the point of maximum damage. The depth of maximum damage is about 7/8 inch, as shown in the bottom photo.

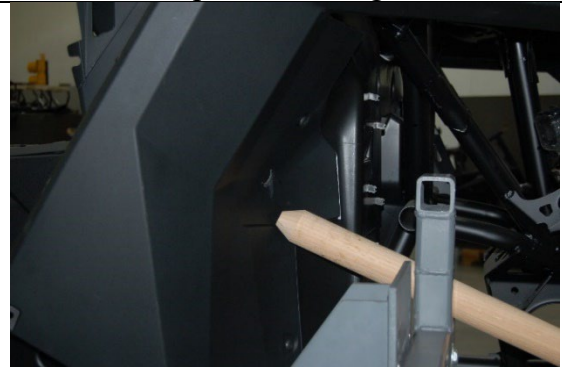
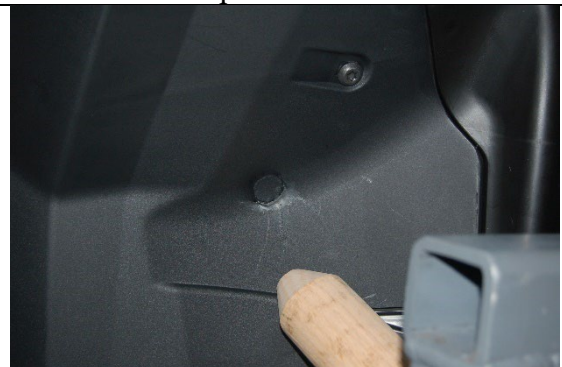
Table 19: Vehicle F – Sled Impact Run #2

The stick tip slid upward and outward to the limits of the C-brace. The impact caused a slight round indentation in the plastic, the size of the end of the stick.

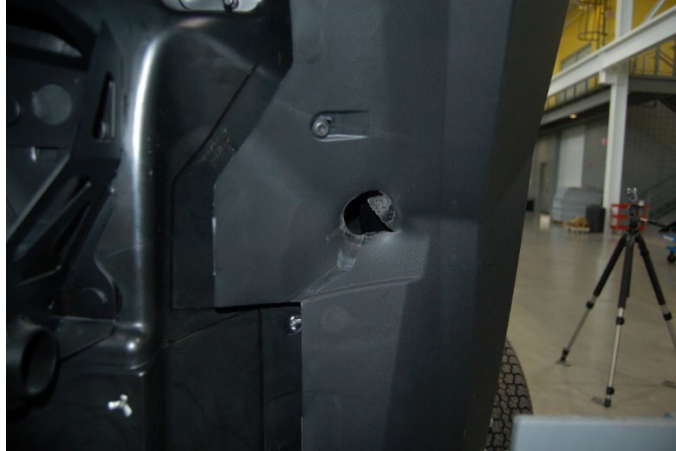
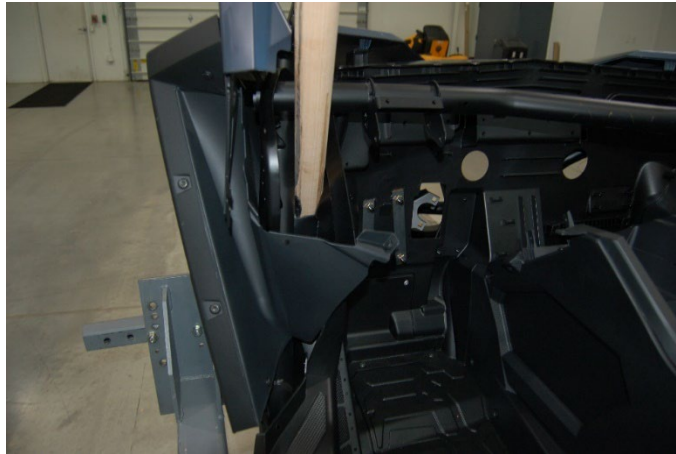
These photos show exterior and interior views of the firewall area post-impact. The interior view has the stick in place and the exterior view is with the stick removed. The round tight hole where the stick penetrated is clear in the exterior view. Also in the exterior view is the light scuff left as the stick slid across the outer surface of the firewall from the initial impact point to the point of penetration.

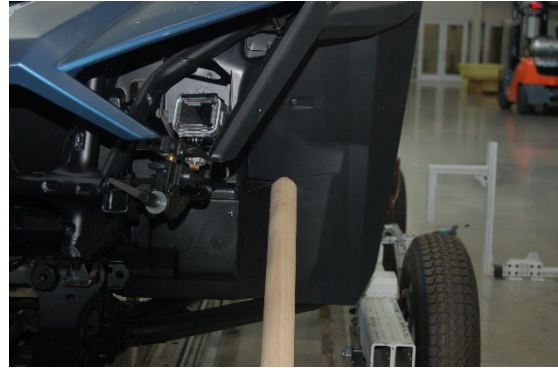
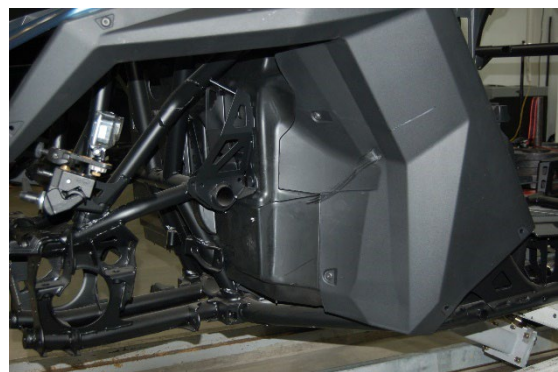
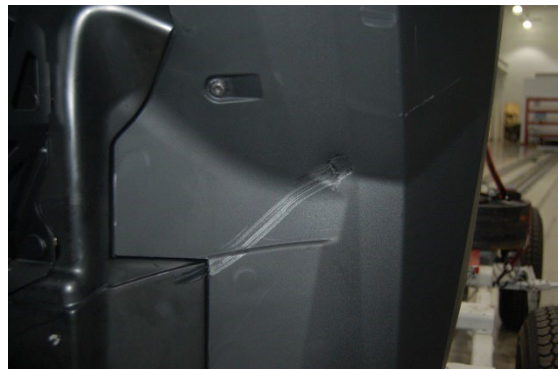
Table 20 (Continued): Vehicle F – Sled Impact Run #3

The stick tip slid upward and outward, until the tip of the stick became constrained by a frame member under the plastic. The stick made a 1" diameter dent in the plastic as it pushed against the frame member. This dent can be seen in the photo to the right. There was significant stick force, with significant vehicle lifting and yawing. The front wheels of the of cart lifted off the floor during impact and the cart yawed 9° counterclockwise.

This photo shows the vehicle frame after the plastic parts have been removed. Note the roughly 1" diameter dent in the side frame member, caused by the tip of the stick pushing through the plastic.

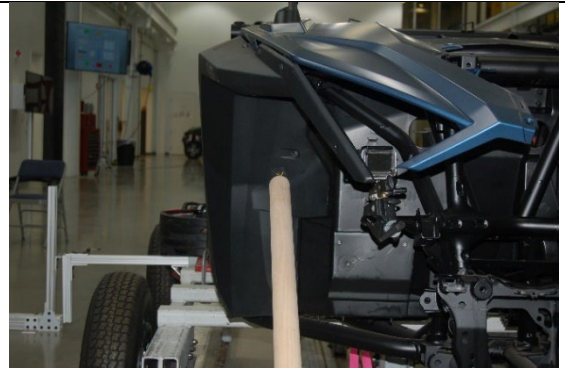
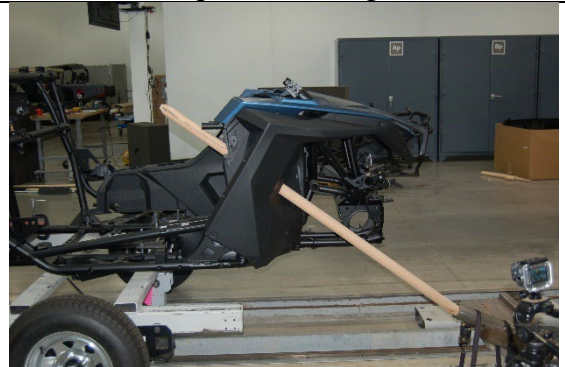
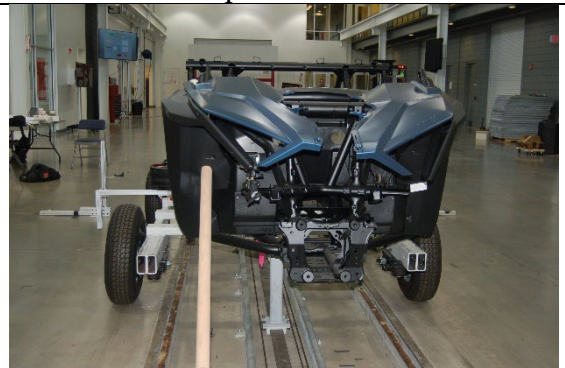
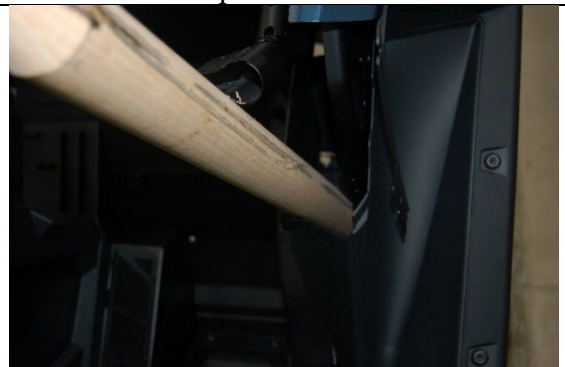
Table 21 (Continued): Vehicle F – Sled Impact Run #4

The stick did not slide but penetrated at the impact point. The stick penetrated the fender flare and pushed aside the main floor penetrating between the main floor and the vehicle frame.

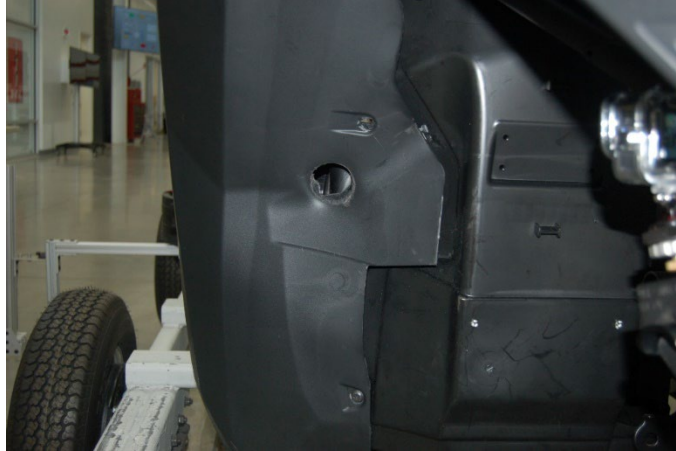
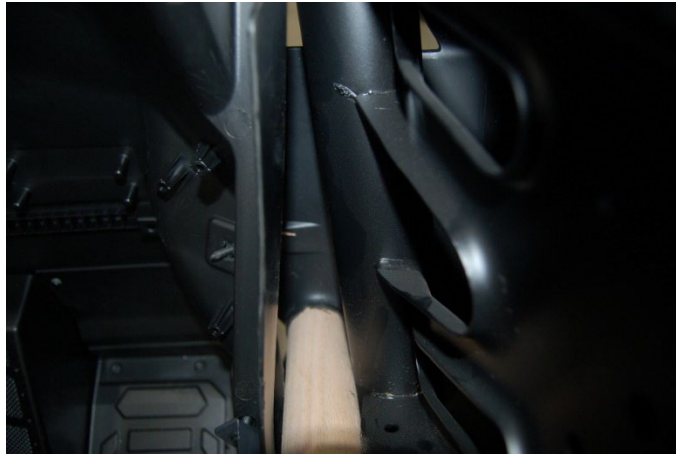
These photos show exterior and interior views after the impact. The exterior view is with the stick removed, the interior view with the stick in place. These photos show how the initial layer of plastic was penetrated, then the later layers of plastic were pushed aside to allow full penetration. The stick-holder base was restrained during this test and the stick penetrated at the point of impact.

The other three tests conducted on Vehicle F used the CPSC proposed test conditions of representative ROV GVW for the sled weight and an intended impact speed of 10 mph. These conditions generate a much higher impact energy of a little over 10,000 J. The OEM floorboard/firewall was penetrated in two of these three high energy tests. In the test when the stick did not penetrate, the tip of stick slid to a point where the tip of the stick became constrained by a vehicle frame member under the plastic. In two of these tests the C-brace was removed, but instead the stick was prevented from rotating in any direction, by securing the stick holder base with nylon straps.
