110420HCC1500

PRODUCT INFORMATION:

Product: John Deere Utility Vehicle

Model: XUV 6201 Gator

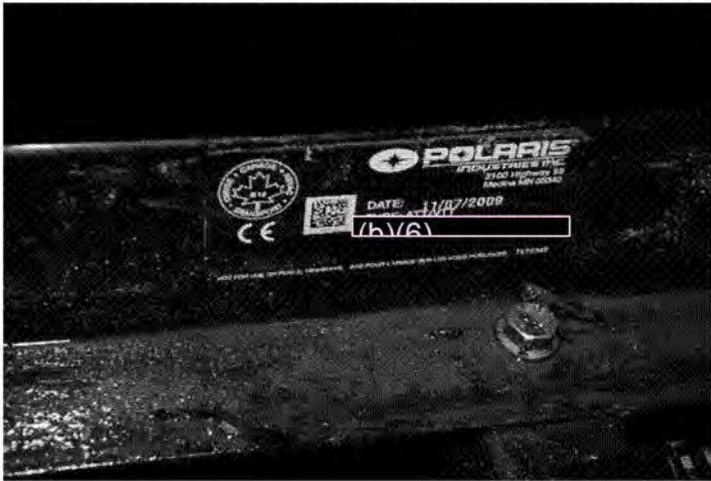
Photo 4: shows view of the manufacturer and VIN

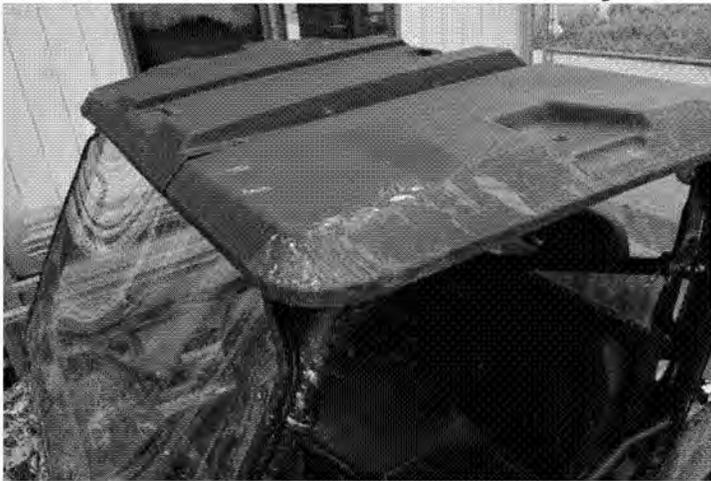
Photo 5: shows view of the damage sustained

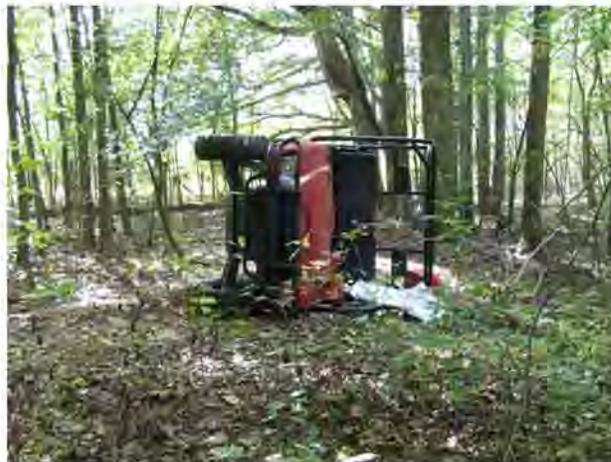
The two-seat vehicle's exterior color was red and black and it featured a mini-cargo bed and a metal rollbar cage. The utility vehicle was powered by a liquid-cooled, single-cylinder four-stroke engine (498cc). The drive train featured an "on-demand" automatic 2WD/4WD transmission. A photo of the overturned vehicle is below:

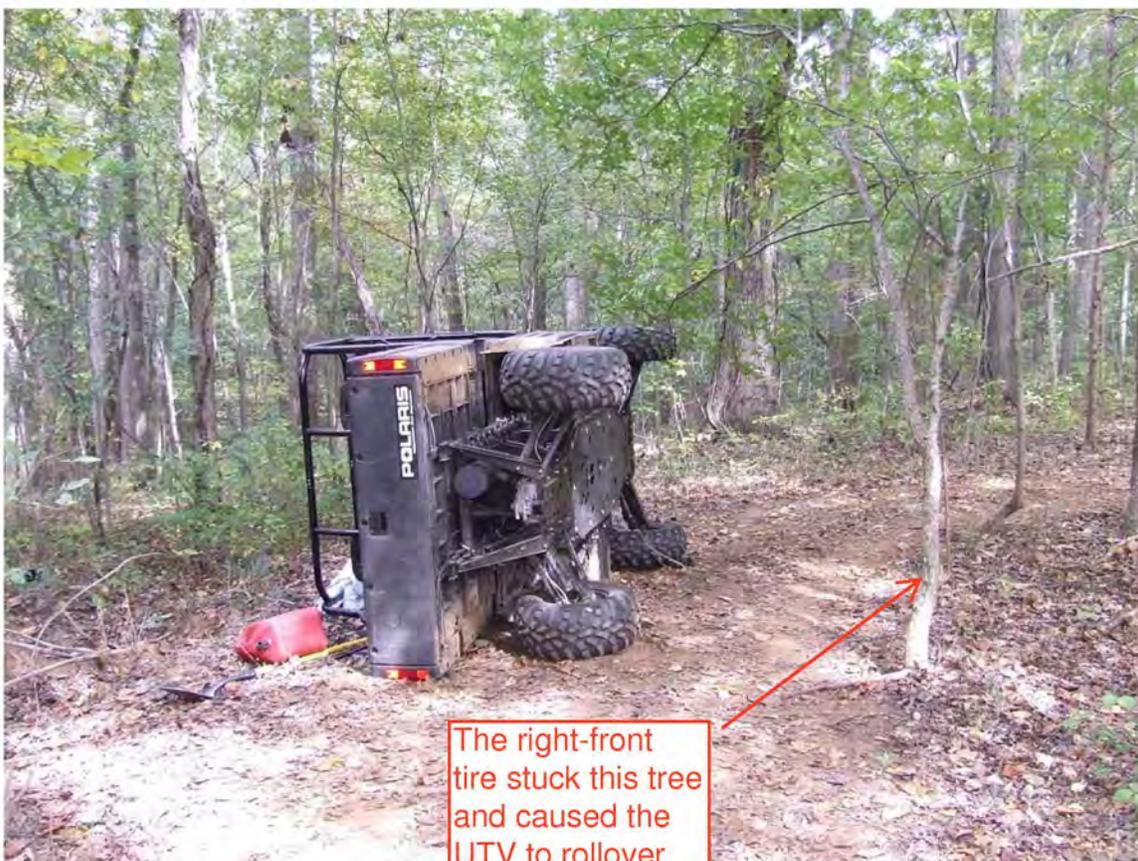
PHOTO A: Overall view of the Polaris Ranger 4 x 4 Utility Vehicle (VIN:EH500PLE2227238) that the 69-year old victim was driving when it rolled over.

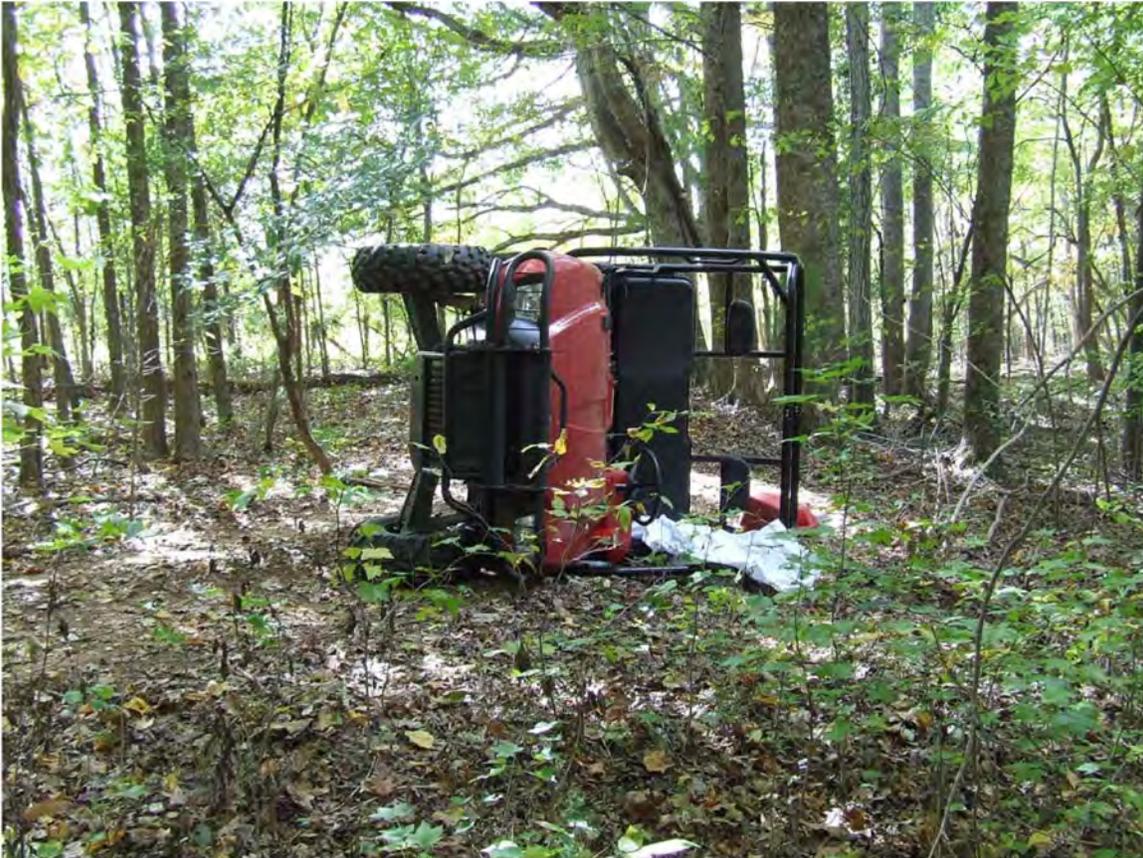
PHOTO C: Front view of the rolled over Polaris Ranger utility vehicle.
