SUMMARY OF FINDINGS:

Only official reports were received; therefore, all information contained in this investigation was obtained from those documents. According to the report, the incident occurred on May 19, 2012 at approximately 9:25 PM. The victim was driving a utility vehicle also known as a UTV.

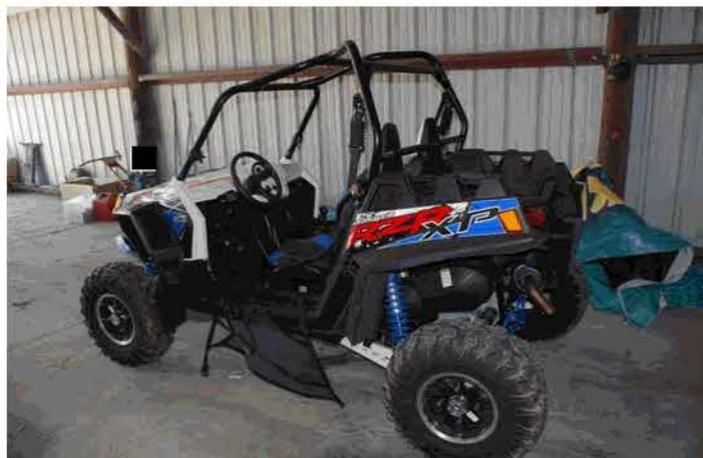
The product involved is a 2012 UTV with an automatic transmission and front and rear disc brakes. It was equipped with lap and shoulder belts and had a roll cage around the passenger area. It also had lights on the front and the rear of the UTV.

View of UTV involved in this incident

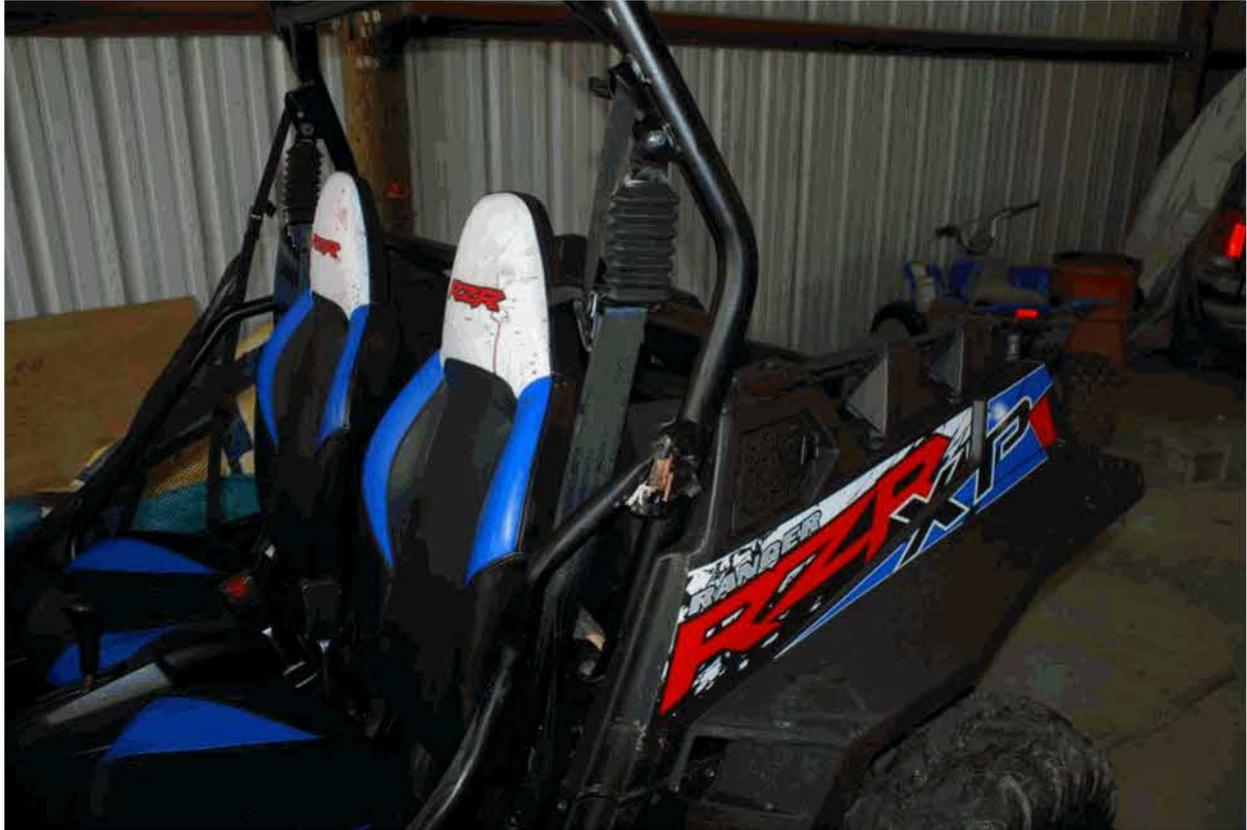
Photo 15 – View of the damage on the driver's side of the UTV where it hit the tree

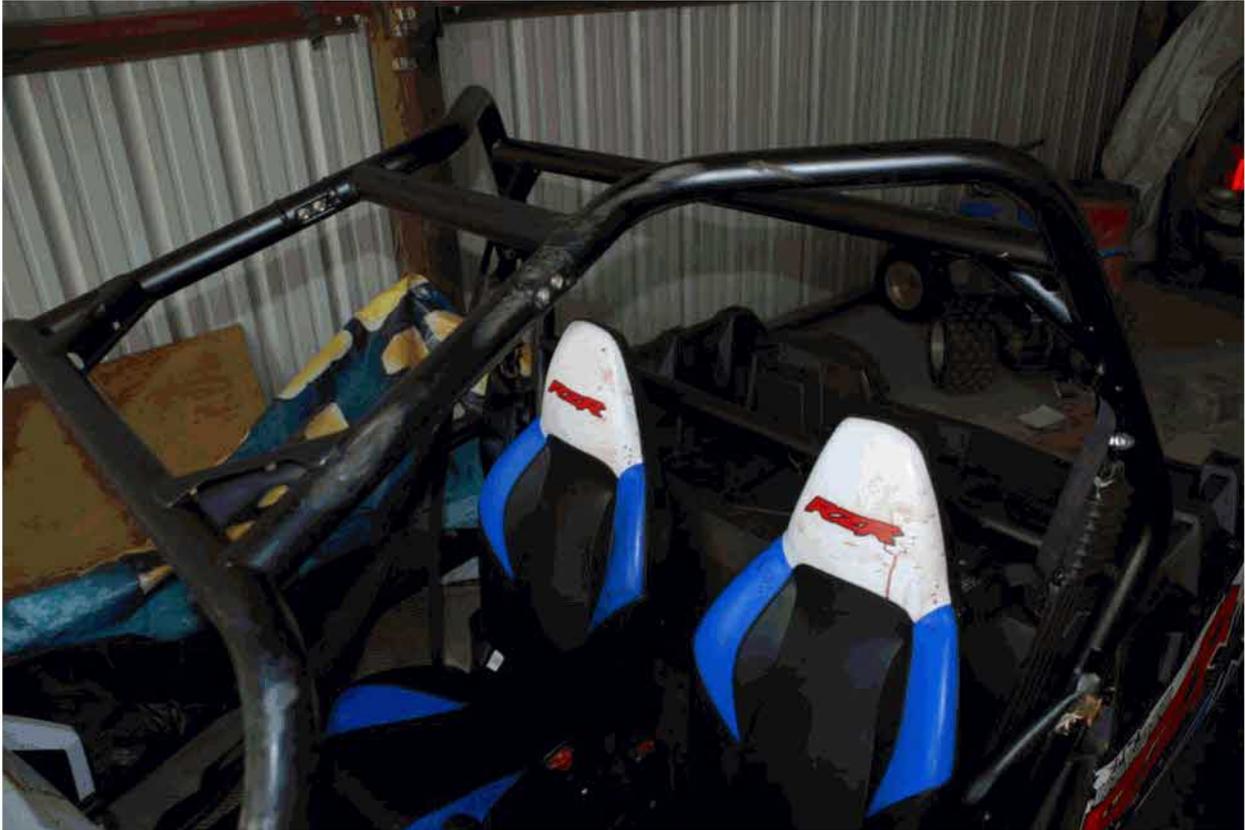
Photo 17 – View of the damage to the roll bar on the driver's side of the UTV.

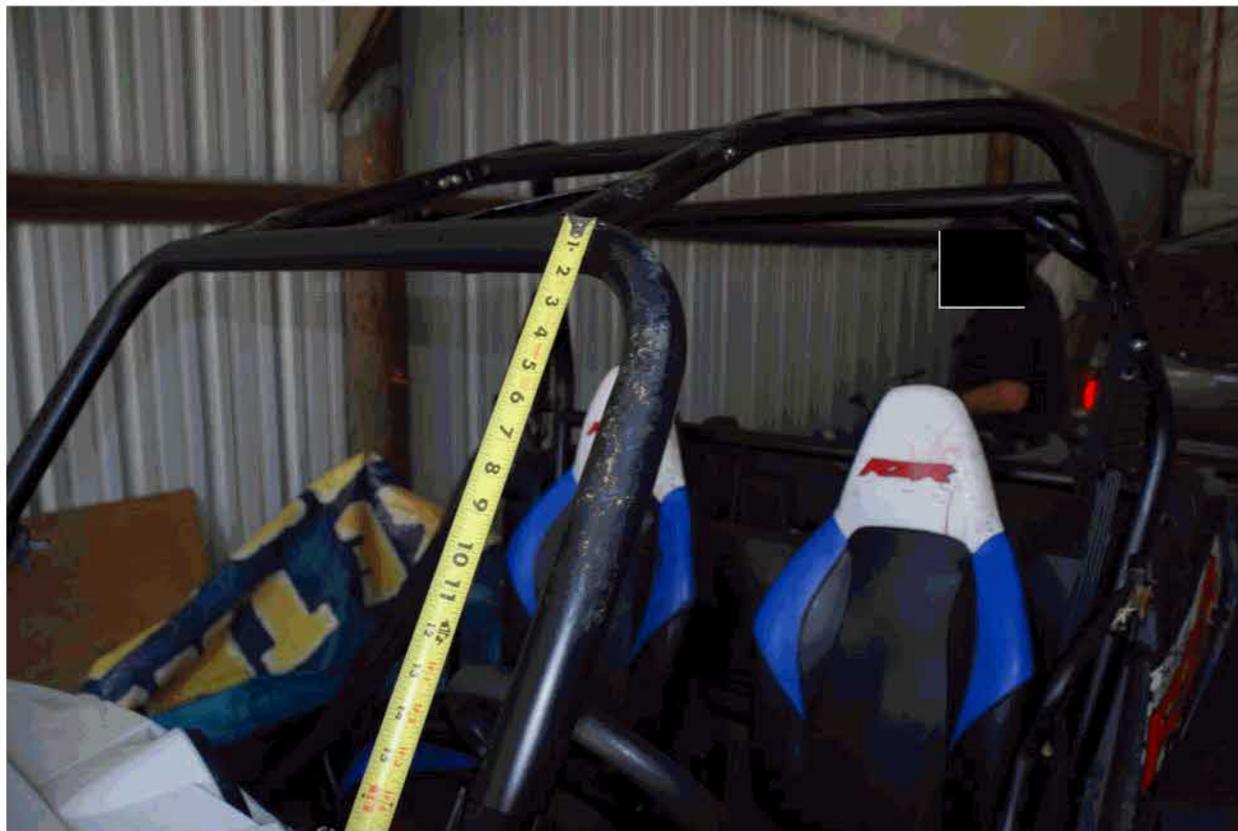
Photo 18 – Another view of the damage to the roll bar on the driver's side of the UTV

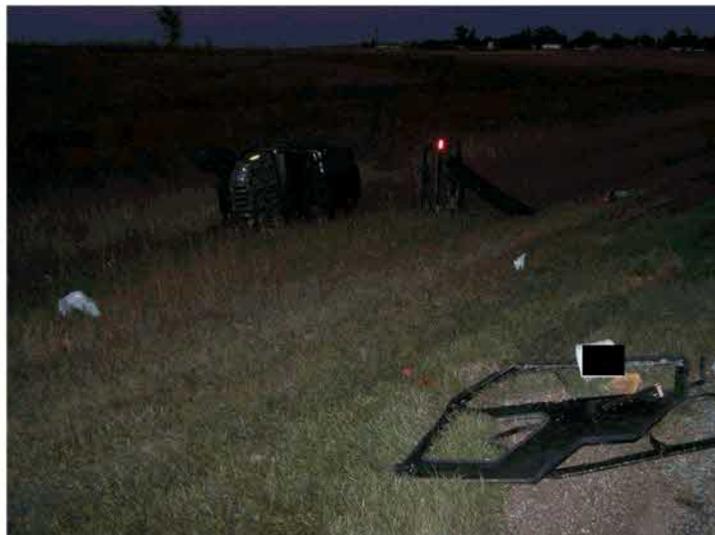
The driver had traveled about one quarter mile down a paved road when it appeared that he lost control of the UTV and then overcorrected. Photographs of skid marks on the road are included in Exhibit "A". As a result, the UTV rolled over on top of the road ejecting the driver. The UTV continued to roll over and came to rest facing the opposite direction and lying on the driver's side. The utility box separated from the unit during the incident. Following is a photograph taken at the scene of the UTV following the incident.

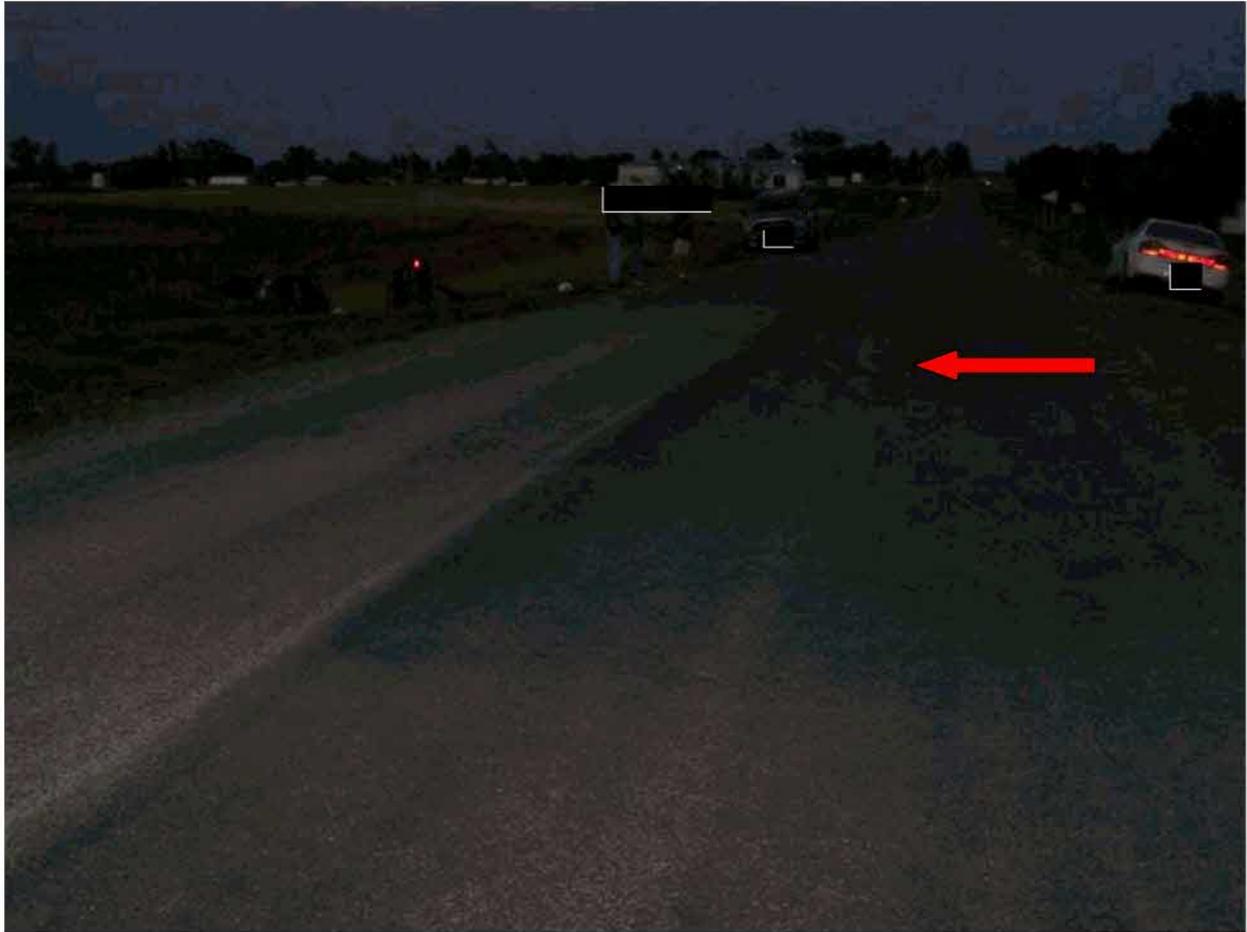
IDI 130104HCC2306 – Exhibit “A” – 2011 Arctic Cat 700 Prowler – Accident scene and skid marks on pavement.

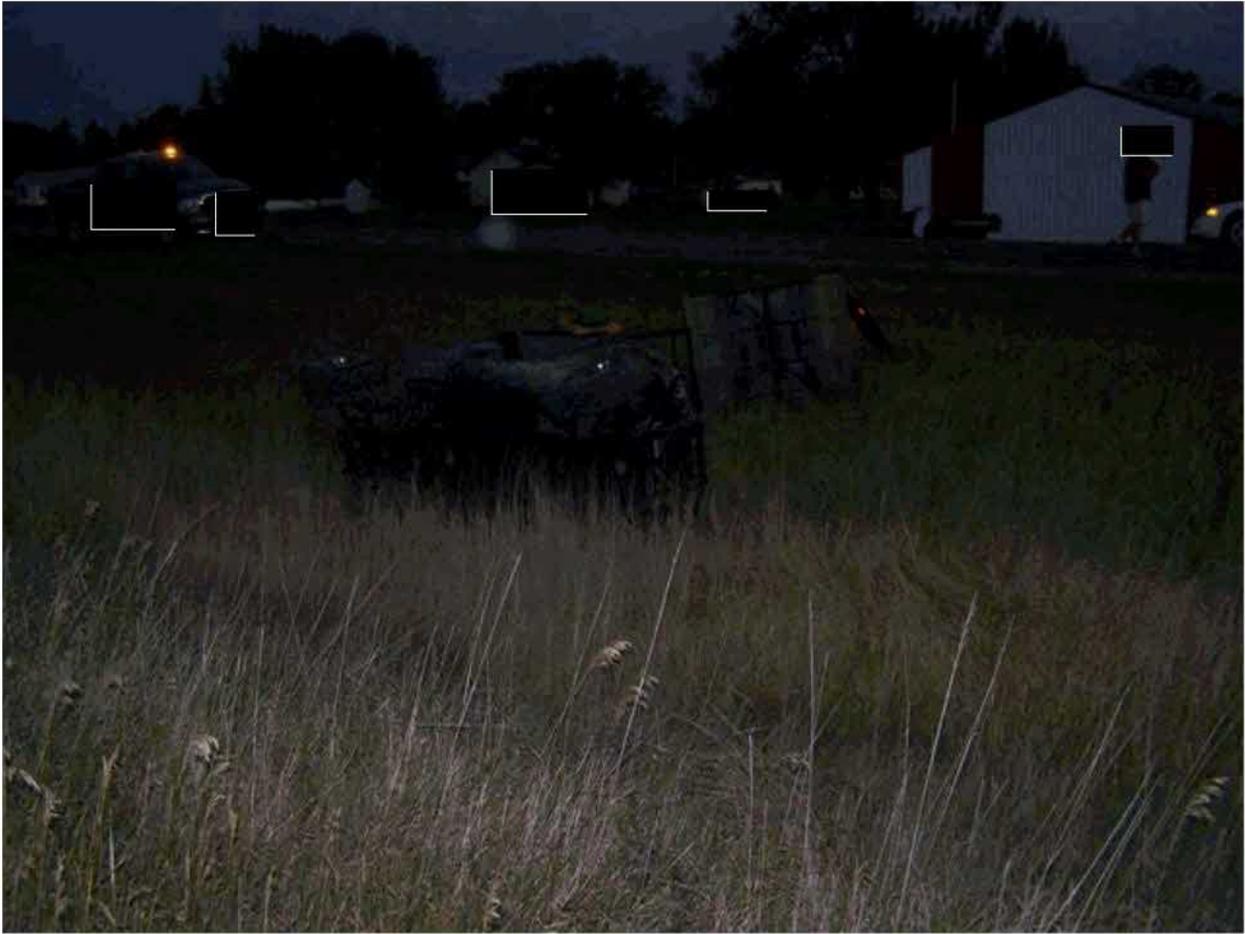
IDI 130104HCC2306 – Exhibit “A” – 2011 Arctic Cat 700 Prowler UTV – Accident scene and where UTV came to rest.

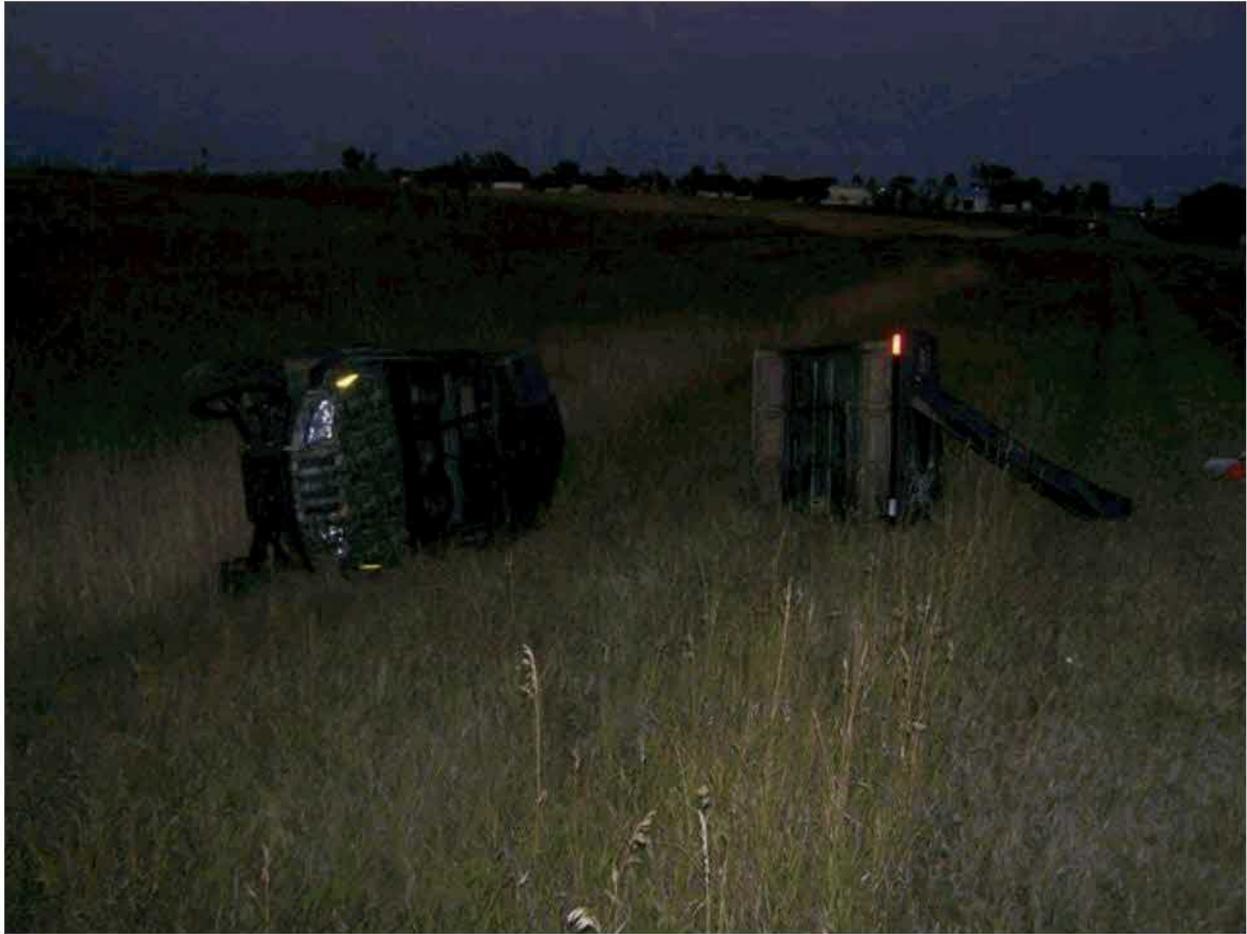
IDI 130104HCC2306 – Exhibit “A” – 2011 Arctic Cat 700 Prowler UTV – Accident scene and where UTV came to rest.

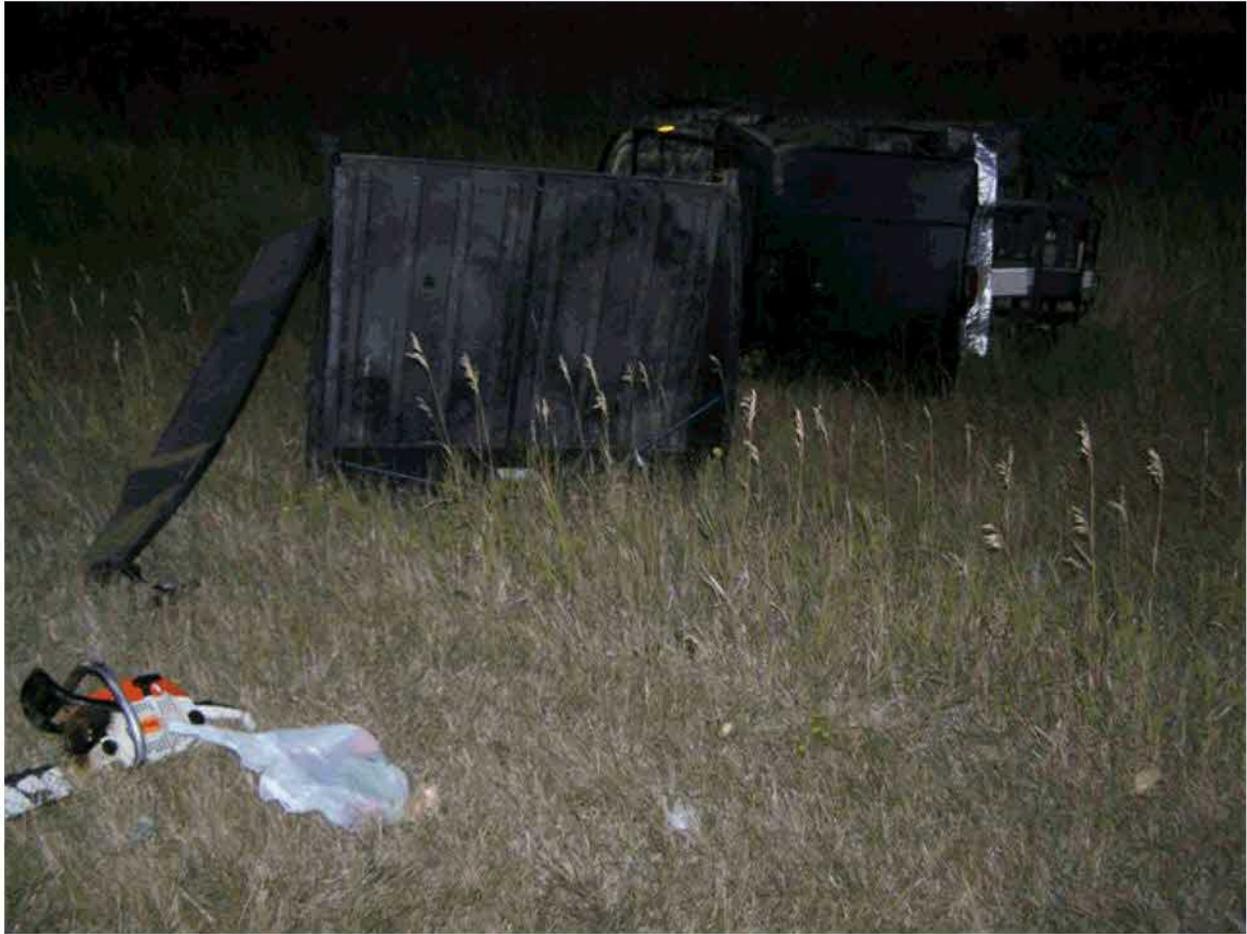
IDI 130104HCC2306 – Exhibit “A” – 2011 Arctic Cat 700 Prowler UTV – Accident scene and where UTV came to rest.

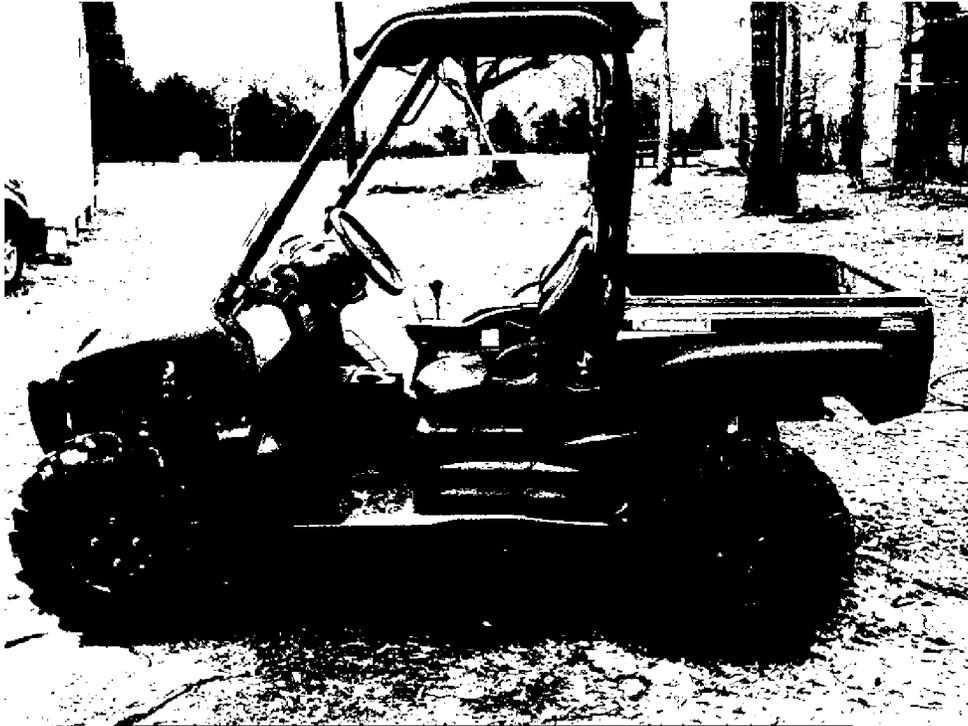
A-1

Consumer photo - Side view of incident vehicle

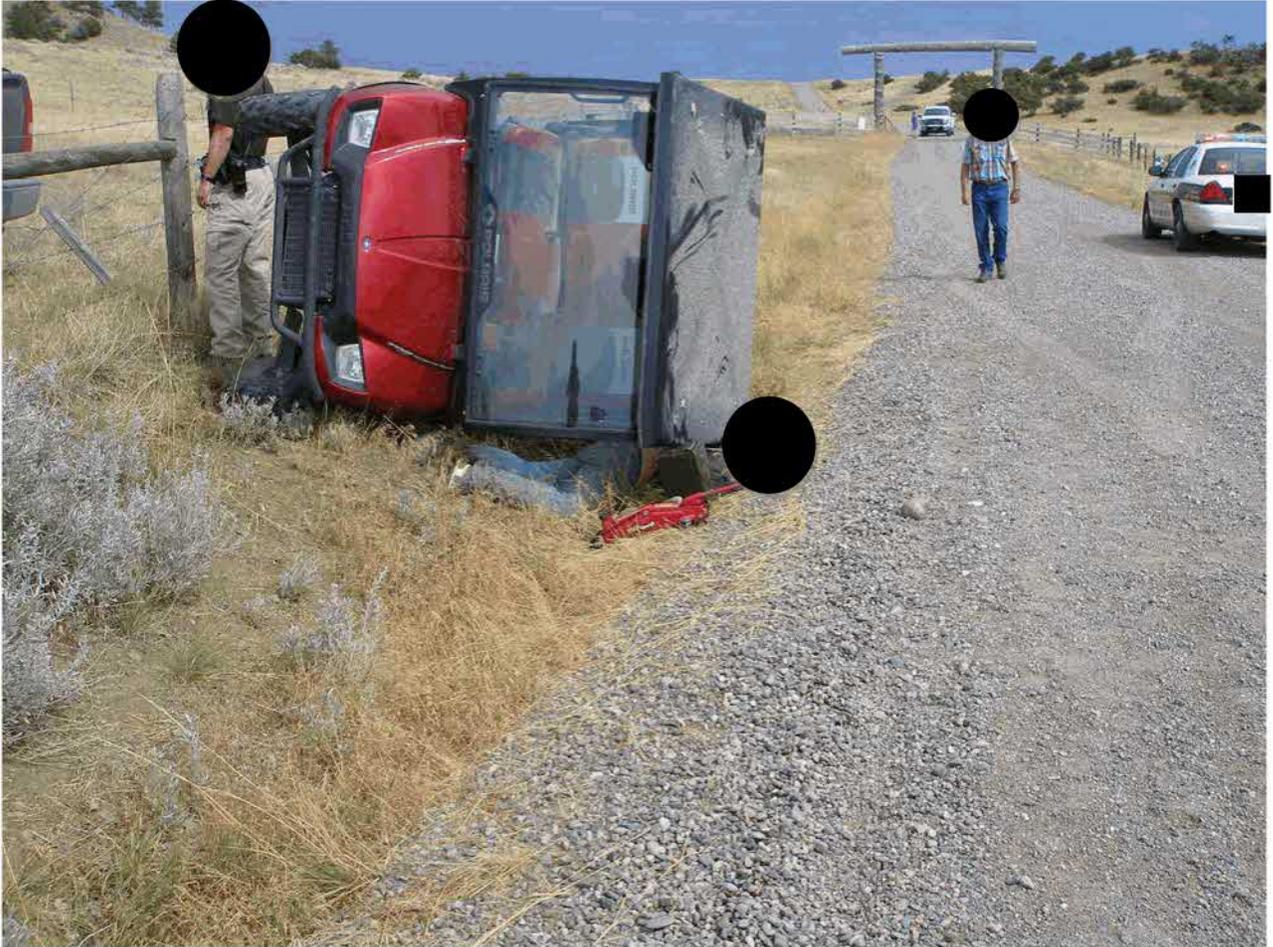
Exhibit A-1 below shows how the UTV was found by first responders. The cattle guard can be seen at the top of the photo.

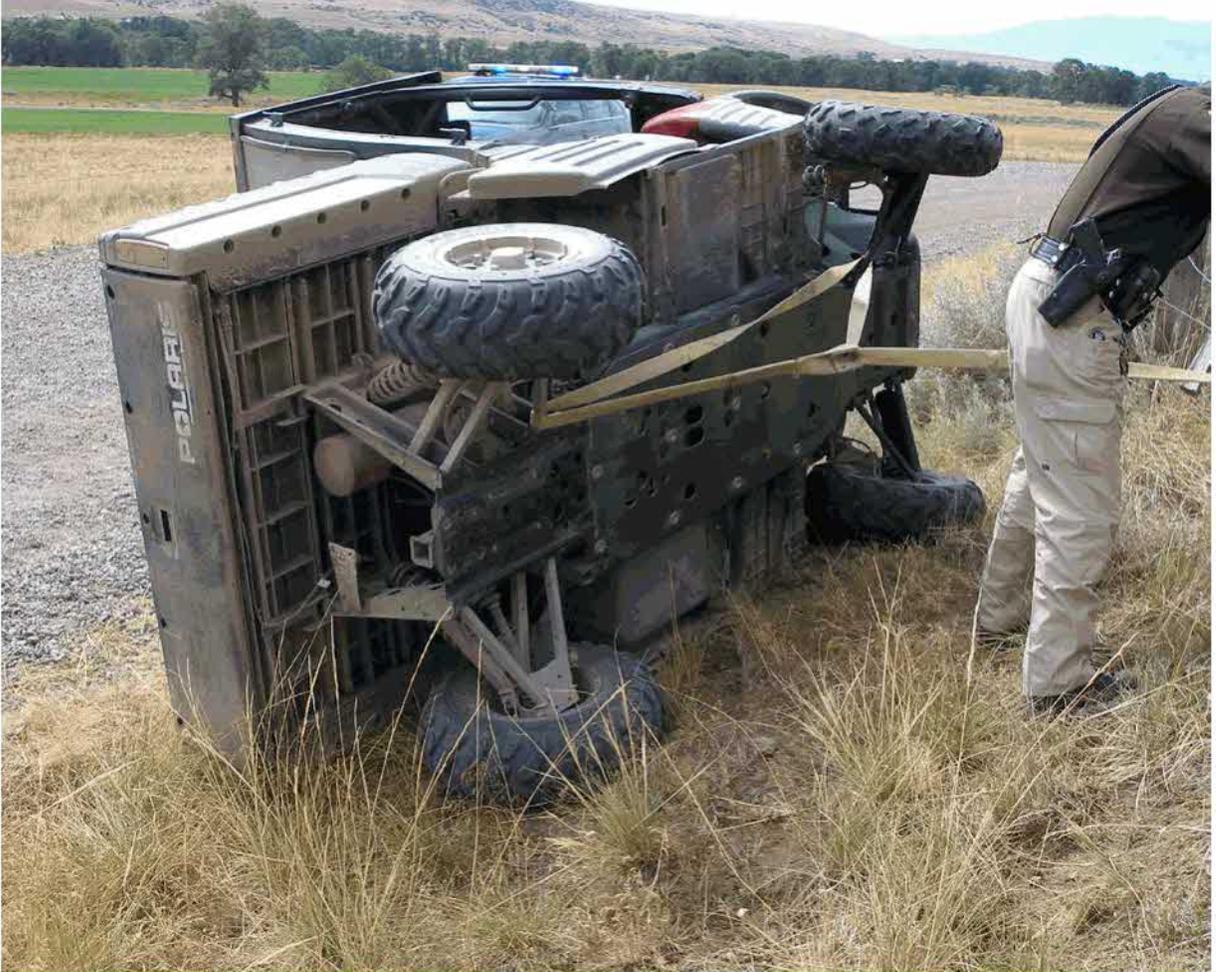
Exhibit A-2 below shows the bottom of the UTV.

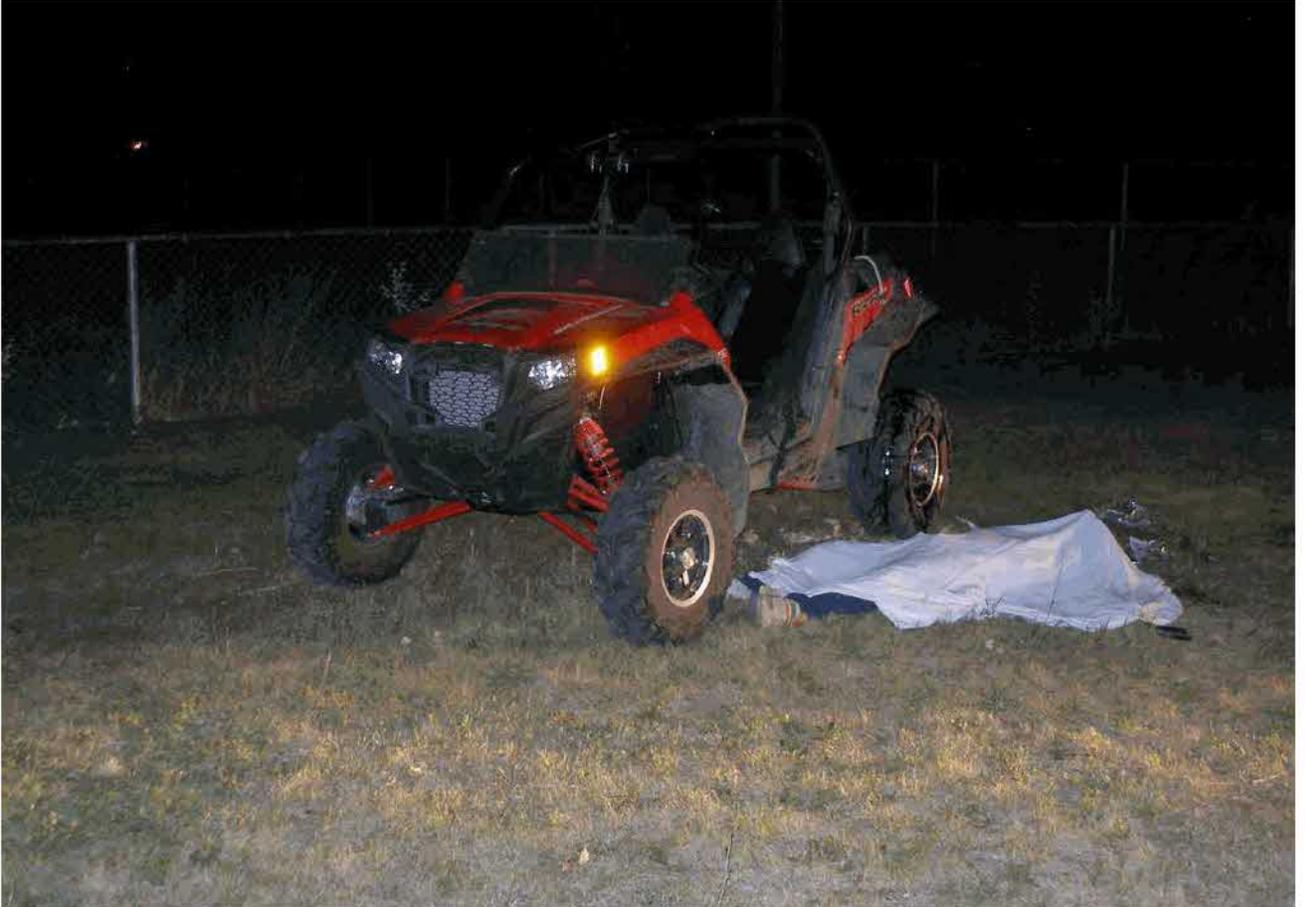
Exhibit A-1 shows the incident ATV after being lifted off the victim.

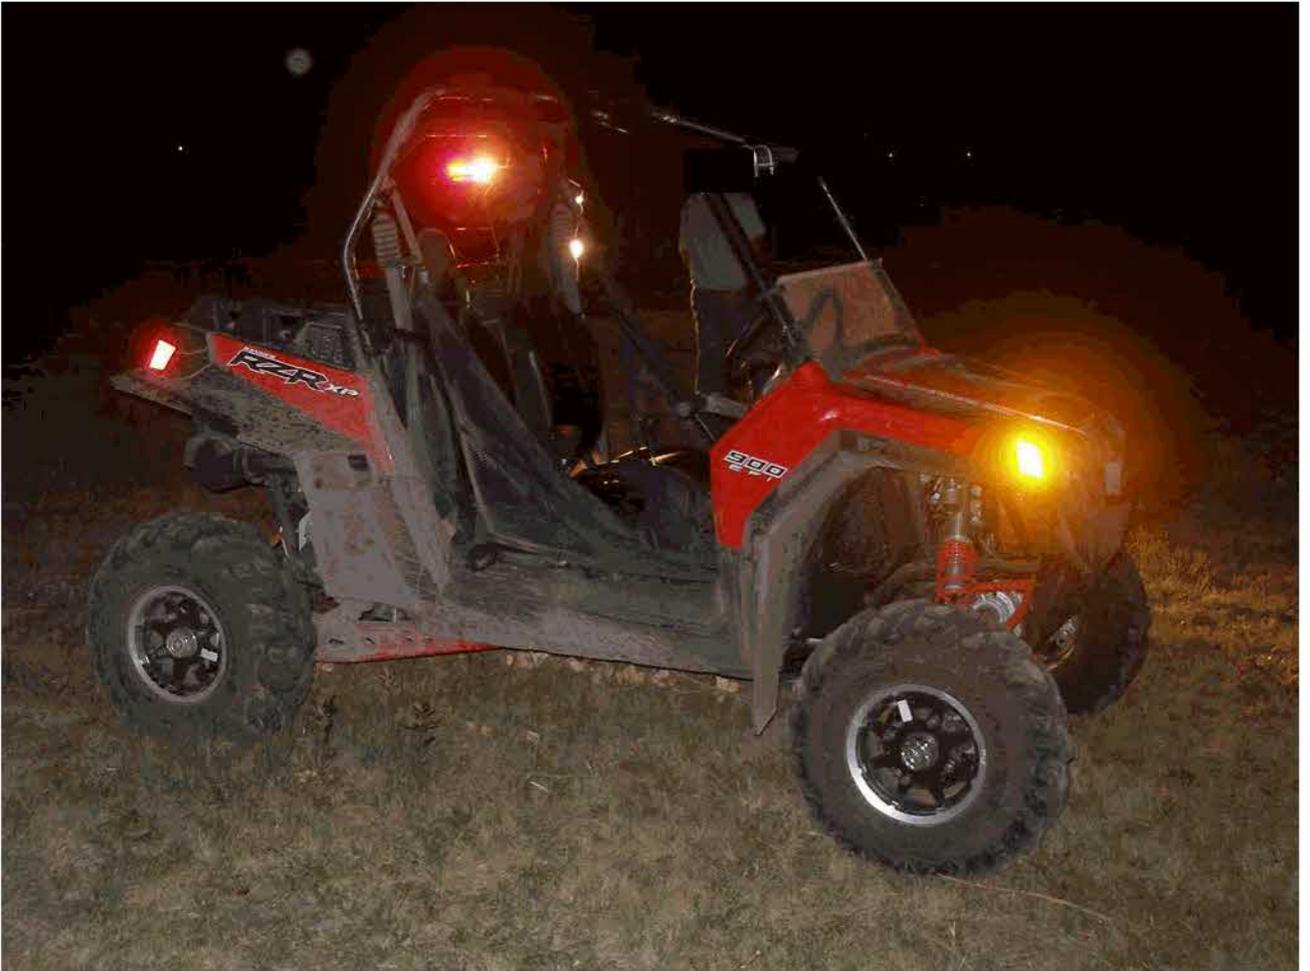
Exhibit A-2 shows a close-up of the incident ATV.

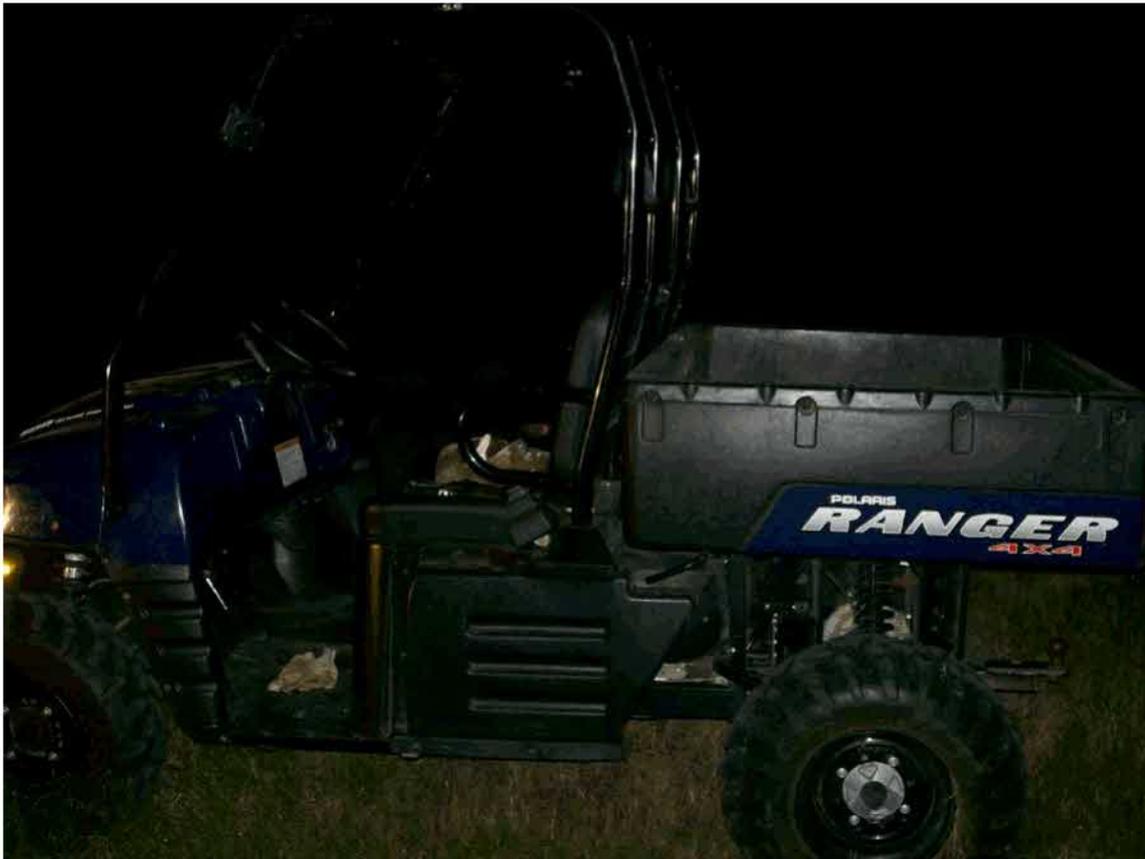
Police photo of the UTV involved in this incident.

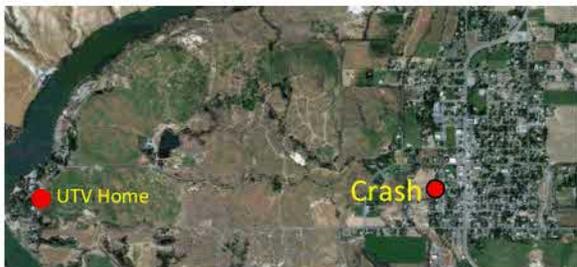
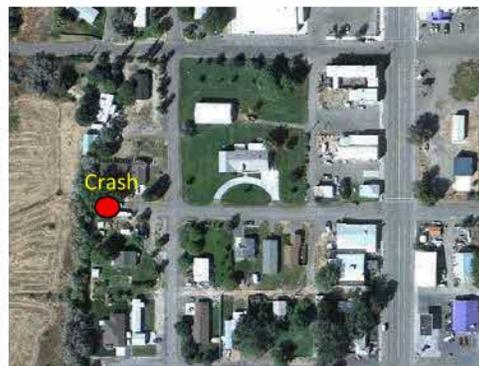
The vehicle was being driven west bound on a paved roadway that dead ends into an irrigation canal. (Photo Below)

The irrigation ditch runs perpendicular to the end of the road and the UTV was driven straight into the ditch and stopped such that it was basically wedged between the banks of the canal with the front and rear of the UTV touching each bank of the canal.

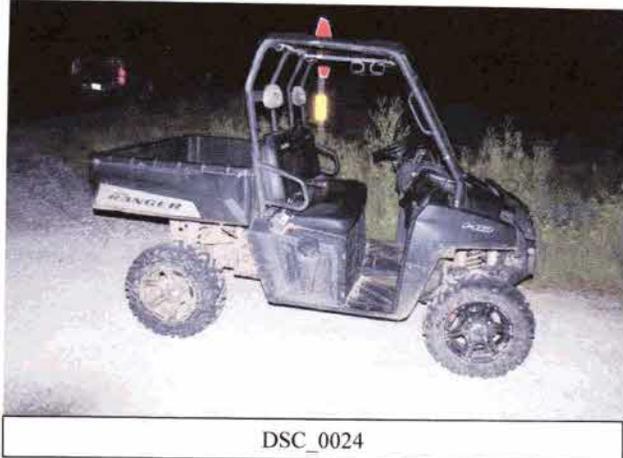
Other than some possible cosmetic damage, Vehicle #1 was undamaged in the crash.
