1. Task Number 130402HCC2551		2. Investigator's ID 9091		EPIDEMIOLOGIC INVESTIGATION REPORT
3. Office Code 840	4. Date of Accident YR MO DAY 2013 02 02	5. Date Initiated YR MO DAY 2013 04 05

SUMMARY OF FINDINGS

2012 Polaris Ranger 800 XP – black and white in color

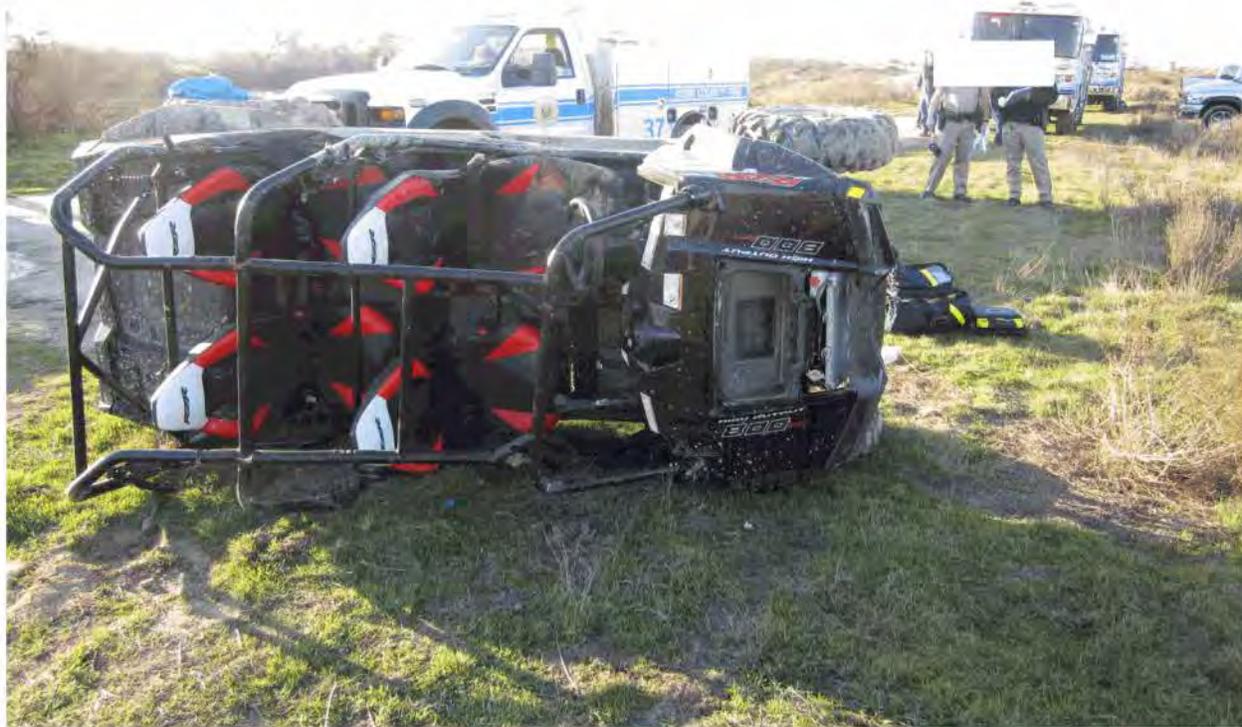
Photo 1: Taken by CHP, labeled by CPSC investigator. Incident UTV equipped with lap and shoulder harnesses.

“lap and shoulder harnesses which appeared to be retracted and not in use at the time of the collision. Helmets were not worn by any occupant of the vehicle at the time of the collision.”

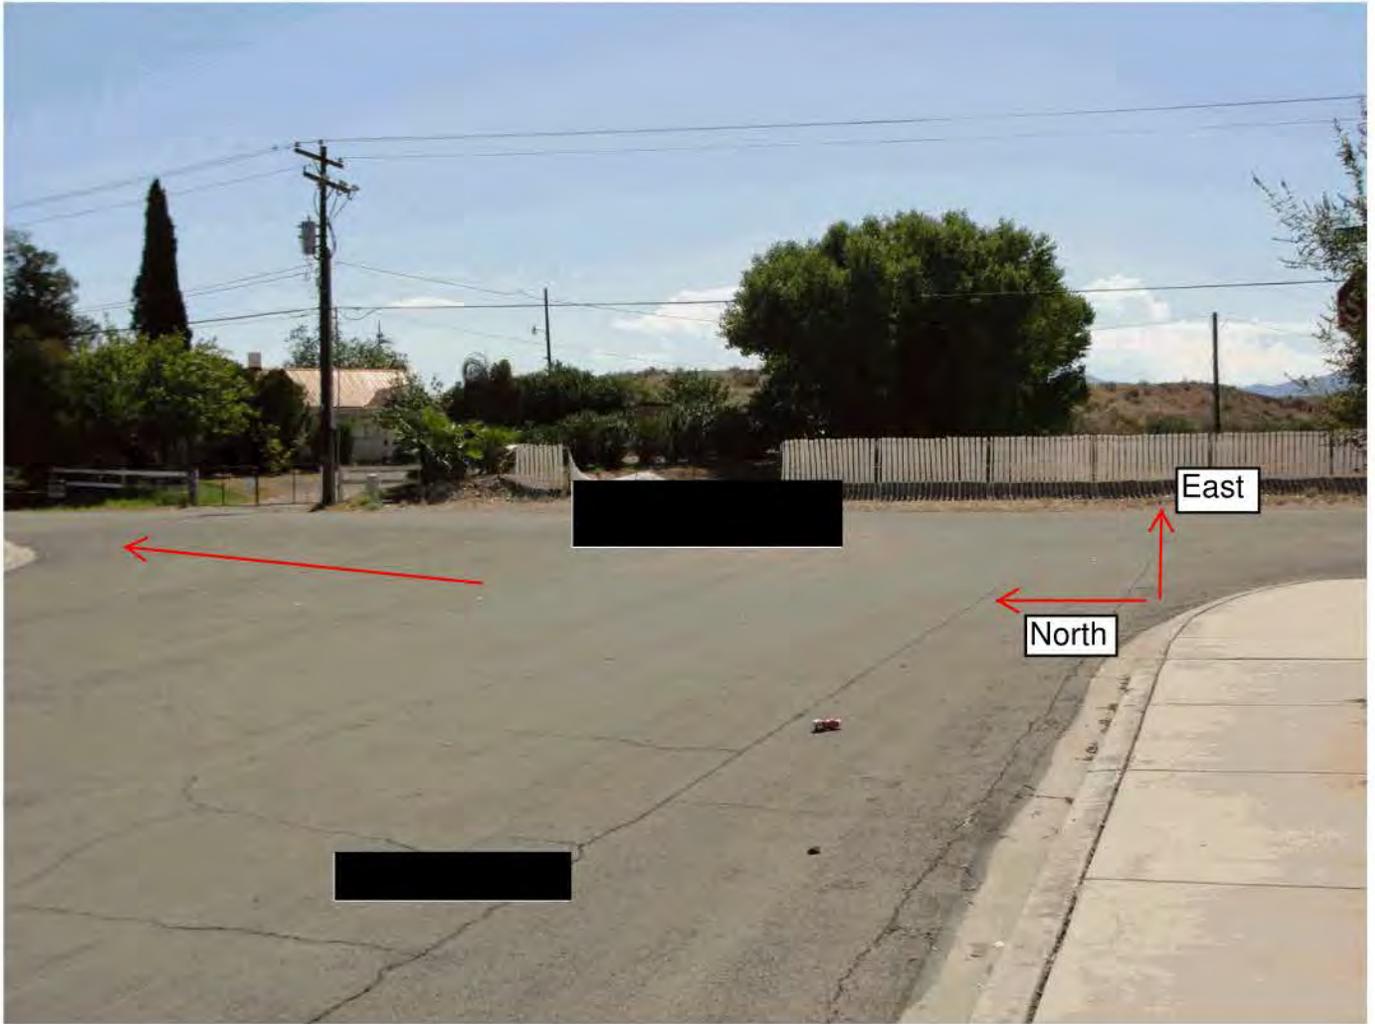
Photo 1 of 1- Incident scene. Per the Coroner's Report Victim made the left hand turn and lost control.
