1. Task Number 080122HNE3081		2. Investigator's ID 8925		EPIDEMIOLOGIC INVESTIGATION REPORT
3. Office Code 810	4. Date of Accident YR MO DAY 2008 01 19	5. Date Initiated YR MO DAY 2008 01 23

6. Synopsis of Accident or Complaint UPC none				
<p>Victim #1, a 9-year-old male, was riding in a 4-wheeled utility vehicle in a field. He was accompanied by 3 other victims 10-year-old females. They were not wearing any protective gear, such as helmets. He attempted to do a doughnut (go in a circle), made a sharp turn, lost control and the utility vehicle rolled over. The victims were ejected, but the vehicle landed on him. He sustained a fatal injury. His cause of death was due to head and chest trauma. The females were not severely injured. They were taken to a hospital, where they were treated and released.</p> <p style="text-align: right;"><u>MFR/PRVLR NOTIFIED</u> COMMENTS: <input type="checkbox"/> YES <input checked="" type="checkbox"/> NO <input type="checkbox"/> OVERRULED; <input type="checkbox"/> ATTACHED <input checked="" type="checkbox"/> EXCISIONS/FOIA EXS. <u>Sec. 3, 6</u> <input checked="" type="checkbox"/> DO NOT RE-NOTIFY <input type="checkbox"/> RE-NOTIFY 08/16/08 <u>GR</u><

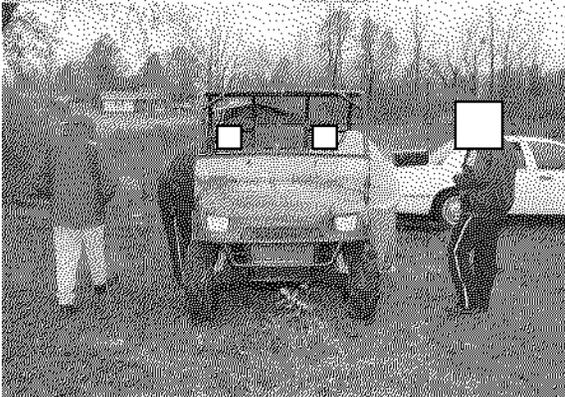
Photo 2: shows front side view of the utility vehicle

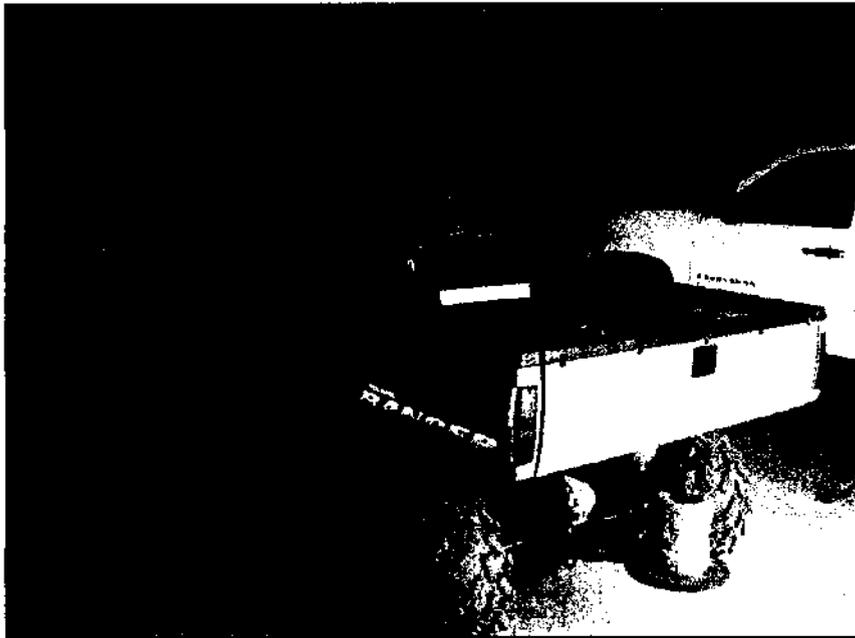
PHOTO #1: This photo shows the storage space for the ATV in the family's garage.

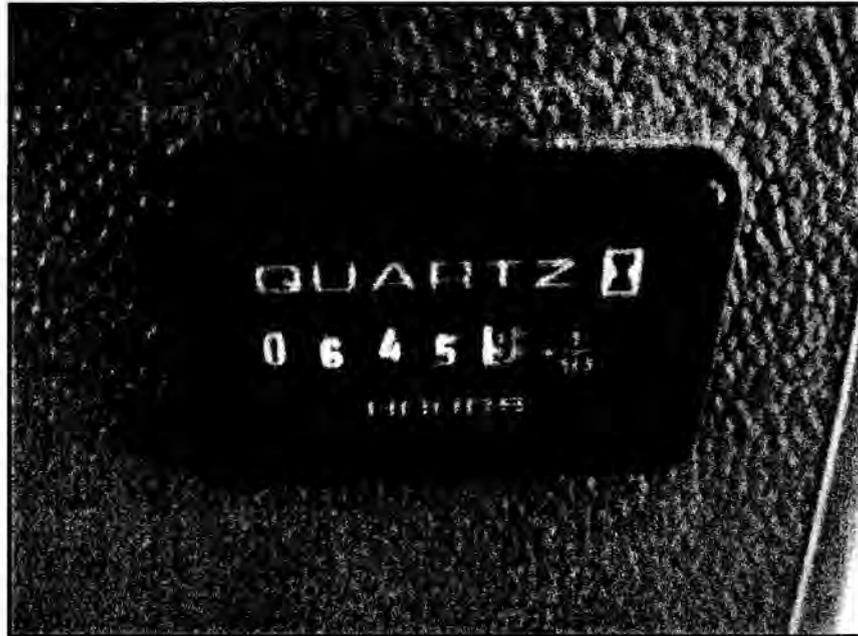
PHOTO #23: This photo shows the hour counter on the ATV and indicates that the machine has 645 hours on it.

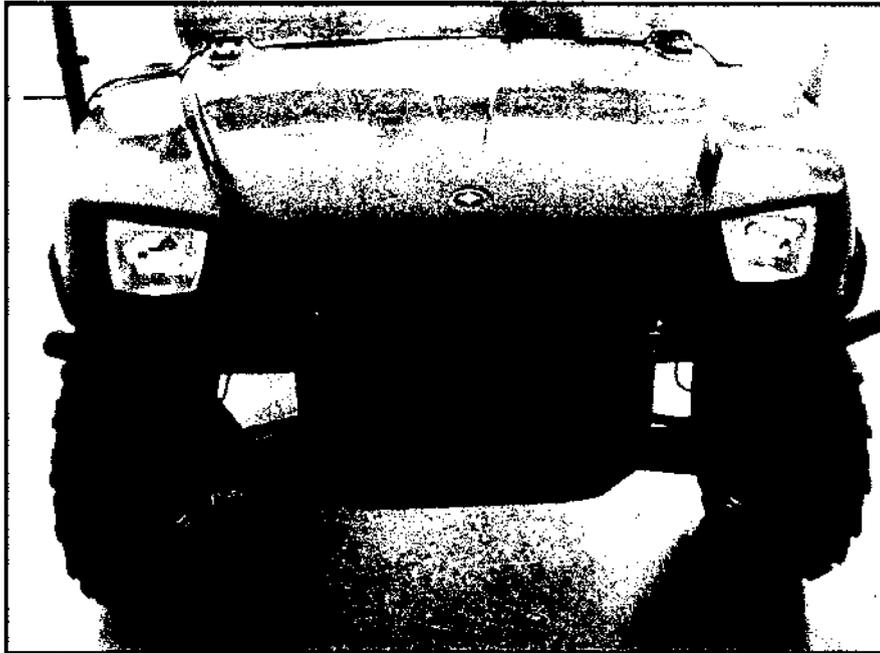
PHOTO #28: This photo shows the front end of the incident ATV after the repairs were made.

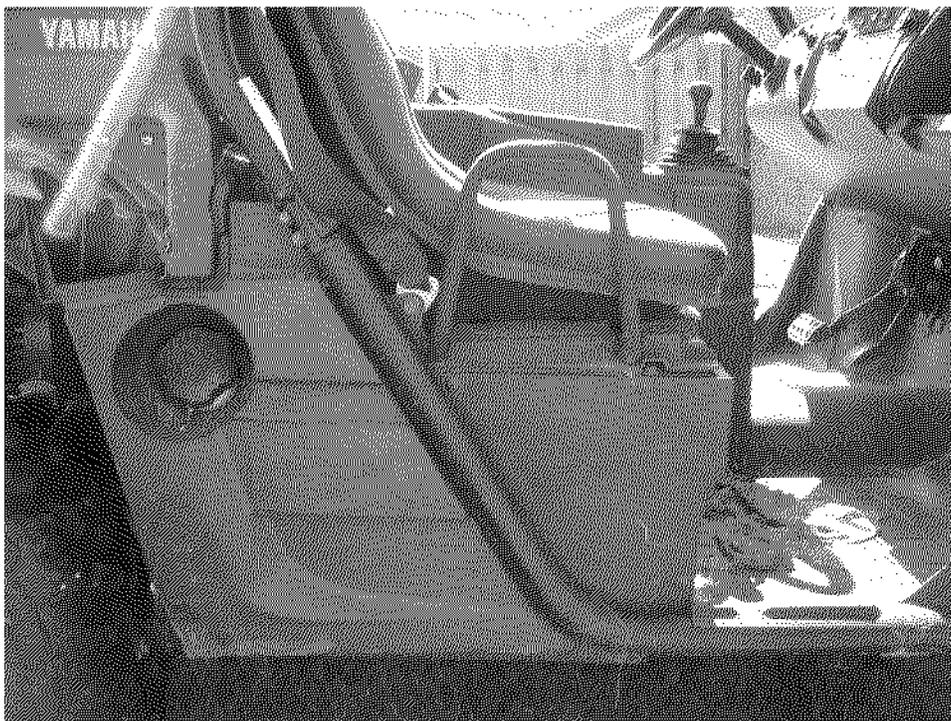
Photo F: Passenger side damage and floor board opening

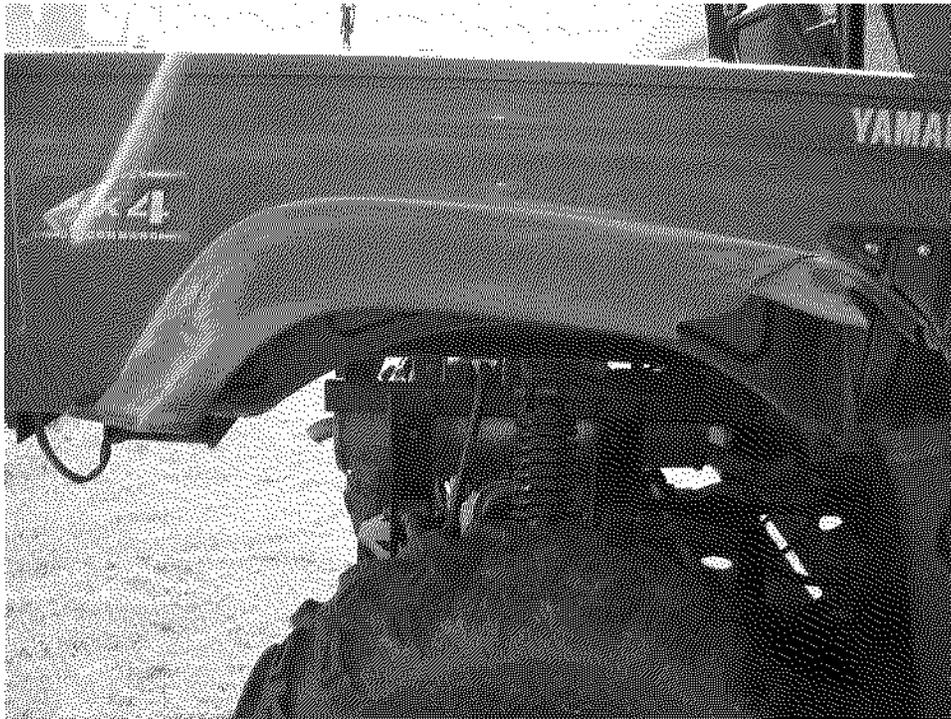
Photo G: Passenger side damage

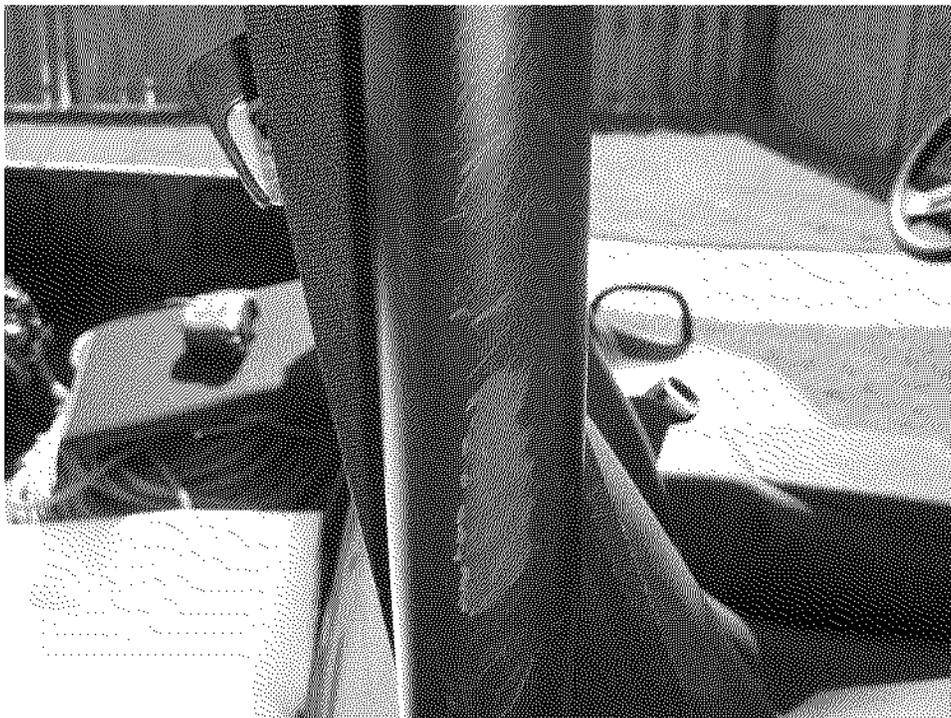
Photo H: Damage on passenger side roll bar

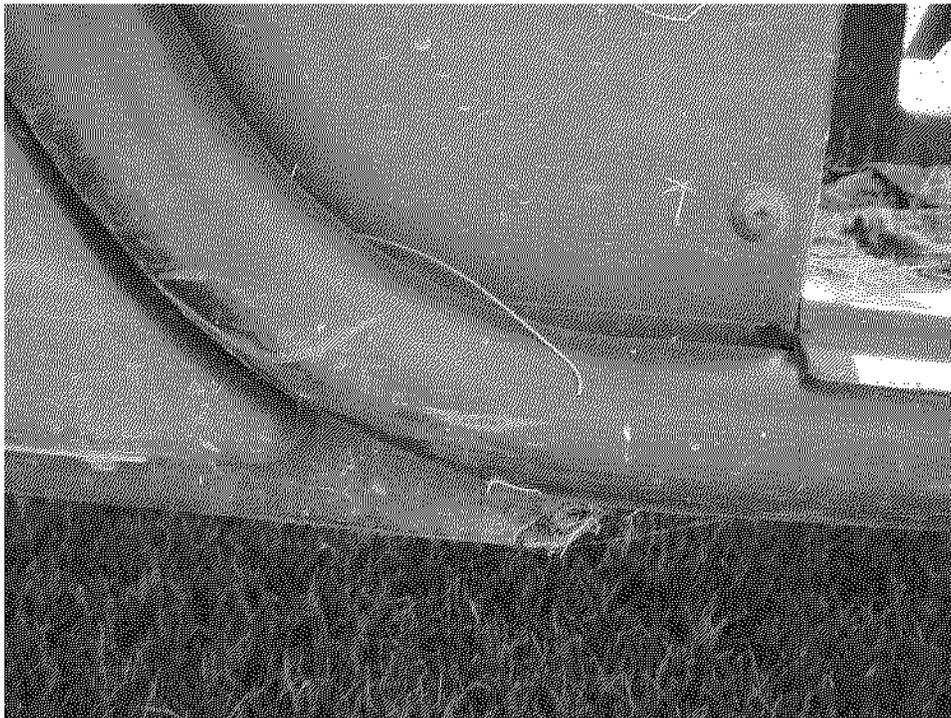
Photo J: Damage on passenger side

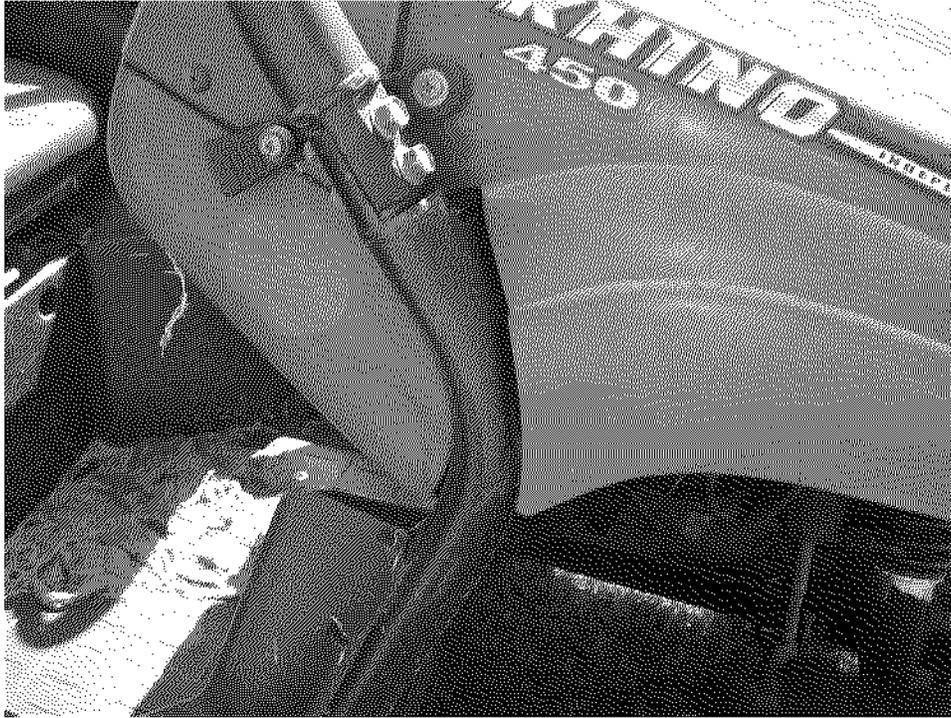
Photo K: Damage on Passenger side and name decal
