This In-Depth investigation (IDI) was initiated by CPSC based on a news article involving the operation of a Utility Vehicle (UTV). This incident involves the death of a 9-year-old male who was a passenger in the vehicle.

INCIDENT NARRATIVE:

PRODUCT IDENTIFICATION:

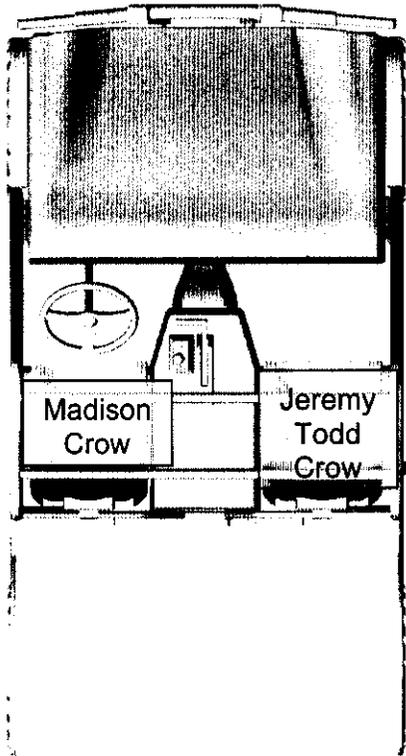
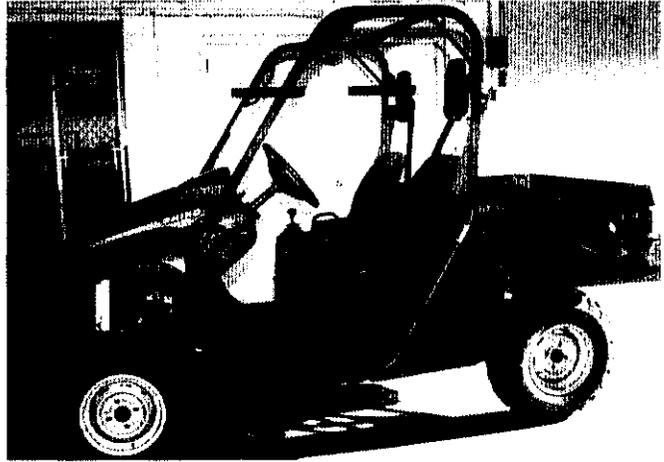
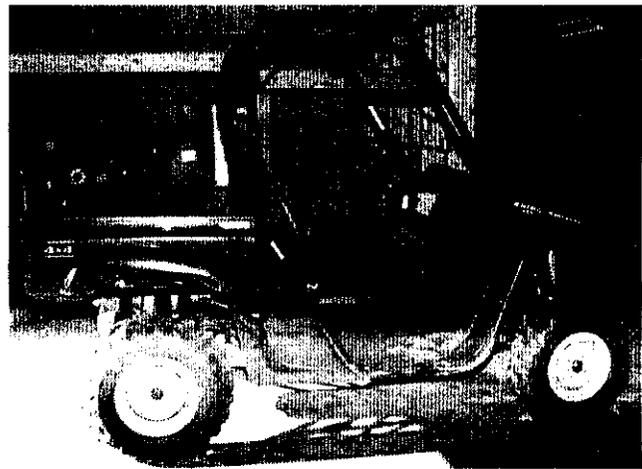
Figure 1:
Seating Chart and Subject Vehicle
Photographs

The Crow subject vehicle was inspected on October 31, 2007 at The Engineering Institute by Alex Roberts and Cord Guthrie. The subject vehicle is a red Yamaha Rhino 450. The vehicle emission control sticker indicates that the engine displacement is actually 421 cubic centimeters. The VIN as found on the left side frame rail near the rear suspension mounts is 5Y4AJ19Y67A009409.

GENERAL OBSERVATIONS: The vehicle exhibits very little overall damage and is operational. The vehicle was driven between The Engineering Institute high-bay and our indoor storage facility next door (about 100 feet apart) a few times and seemed to operate normally. Also, Andy Irwin indicates in his reconstruction report that "operation of the vehicle was completed in all modes of travel." (pg. 5) There are light scratches on the right side of the roll cage consistent with a ¼, passenger side leading rollover accident.

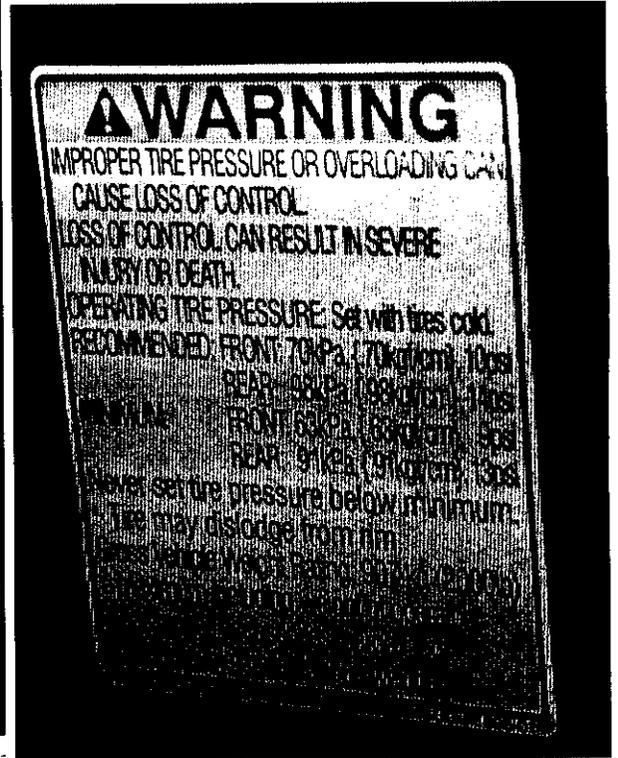
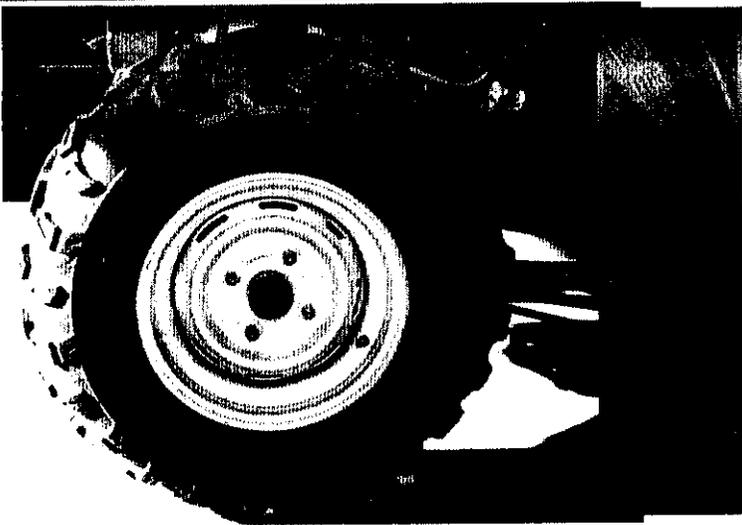
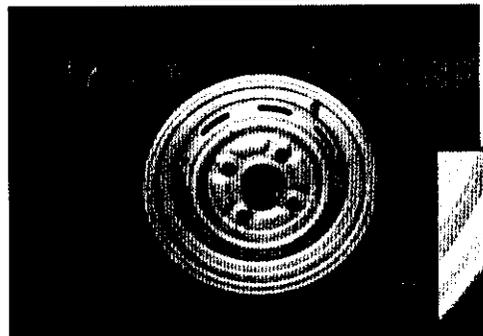
Figure 2: Tire Pressure Recommendations, Left Rear Tire (left) and Left Front Tire (right)

TIRES & WHEELS: The recommended tires for this vehicle are Maxxis 25X8-12NHS type M951Y for the front and Maxxis 25X10-12NHS type M952Y for the rear. The owner's manual and a warning sticker below the driver's seat recommend tire pressures of 10 psi in the front and 14 psi in the rear. However, the Yamaha Motorcycle and Scooter Set-Up and Predelivery Checklist that was with the owner's manual instructs that the person checking the vehicle "adjust pressure according to specific assembly manual." The person who filled out the paperwork indicated that the tire pressure was set to 10 psi front and 10 psi rear. The signature on this sheet appears to be *Frank G.*

- Left Front: This tire is a Maxxis 25X8.00-12NHS. The tire shows little wear. The tire is inflated to 8 psi. The wheel size is 12X6.0AT-TSY. All lug nuts are present.
- Left Rear: This tire is a Maxxis 25X10.00-12NHS. The tire shows little wear. The tire is inflated to 11 psi. The wheel size is 12X7.5AT-TSY. All lug nuts are present.
- Right Rear: This tire is a Maxxis 25X10.00-12NHS. The tire shows little wear. The tire is inflated to 12 psi. The wheel size is 12X7.5AT-TSY. All lug nuts are present.
- Right Front: This tire is a Maxxis 25X8.00-12NHS. The tire shows little wear. The tire is inflated to 8 psi. The wheel size is 12X6.0AT-TSY. All lug nuts are present. There is a small amount of grass or straw between the wheel flange and tire. With the valve stem represent the 12 o'clock position, this debris is at approximately 12 o'clock and 7 to 8 o'clock.

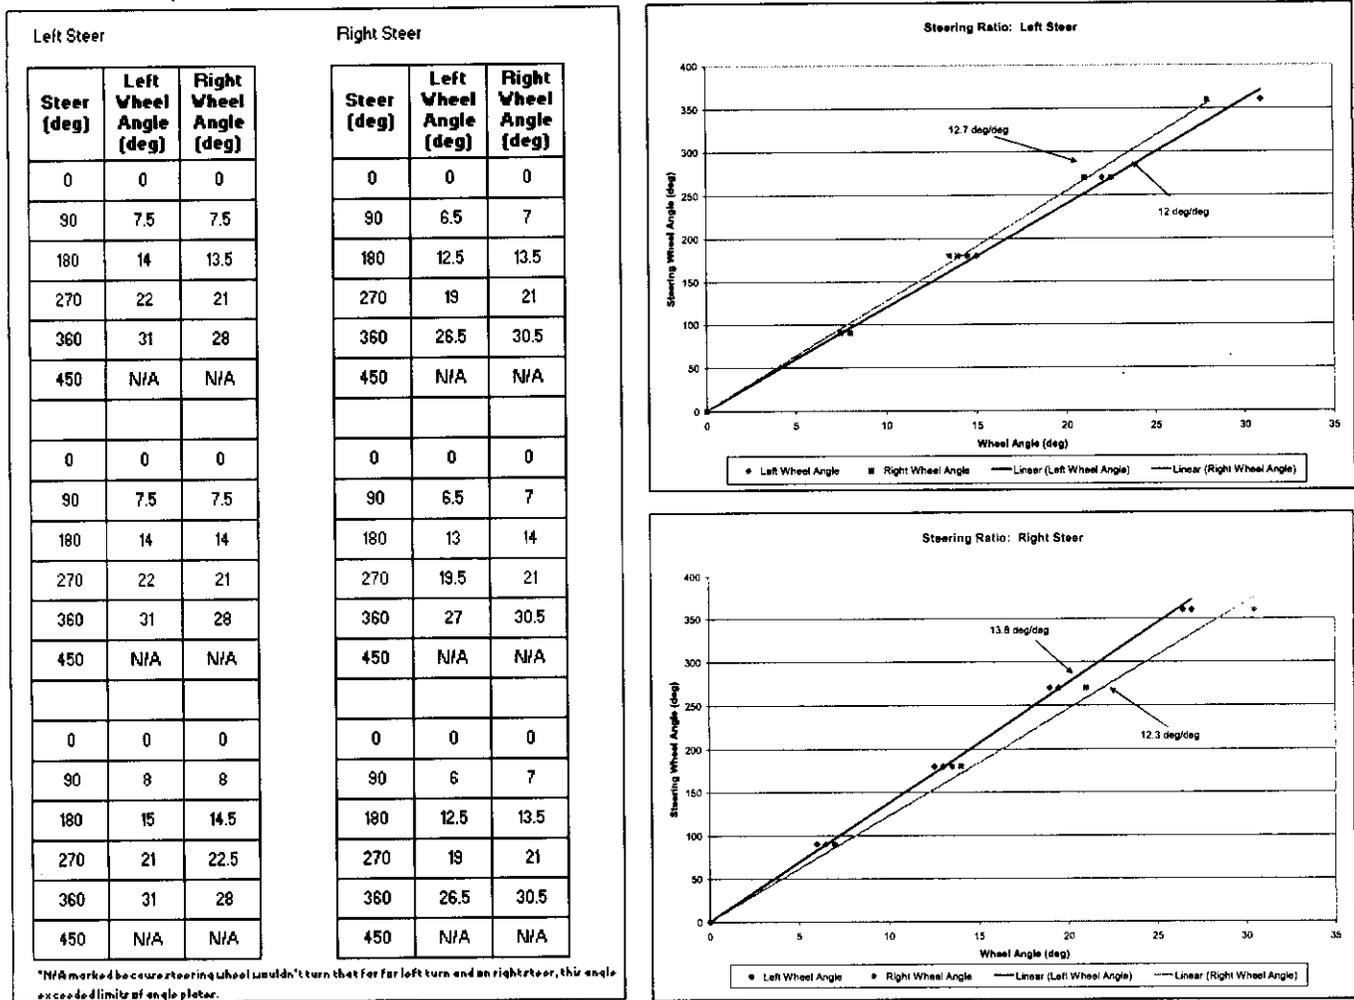
Figure 3: Steering Ratio Data

STEERING: The vehicle's steering ratio was measured by placing the front tires on angle plates. These plates measure the angle of the tires. By turning the steering wheel in increments of 90 degrees and measuring the left front and right front tire angle, the steering ratio can be determined. The plates did not return to zero after the first measurements performed the day of the inspection. Therefore, this was repeated on March 10, 2008. Left and right steers were performed three times each on the 10th to check for consistency. The table below and the plots indicate the results of the March 10th testing.

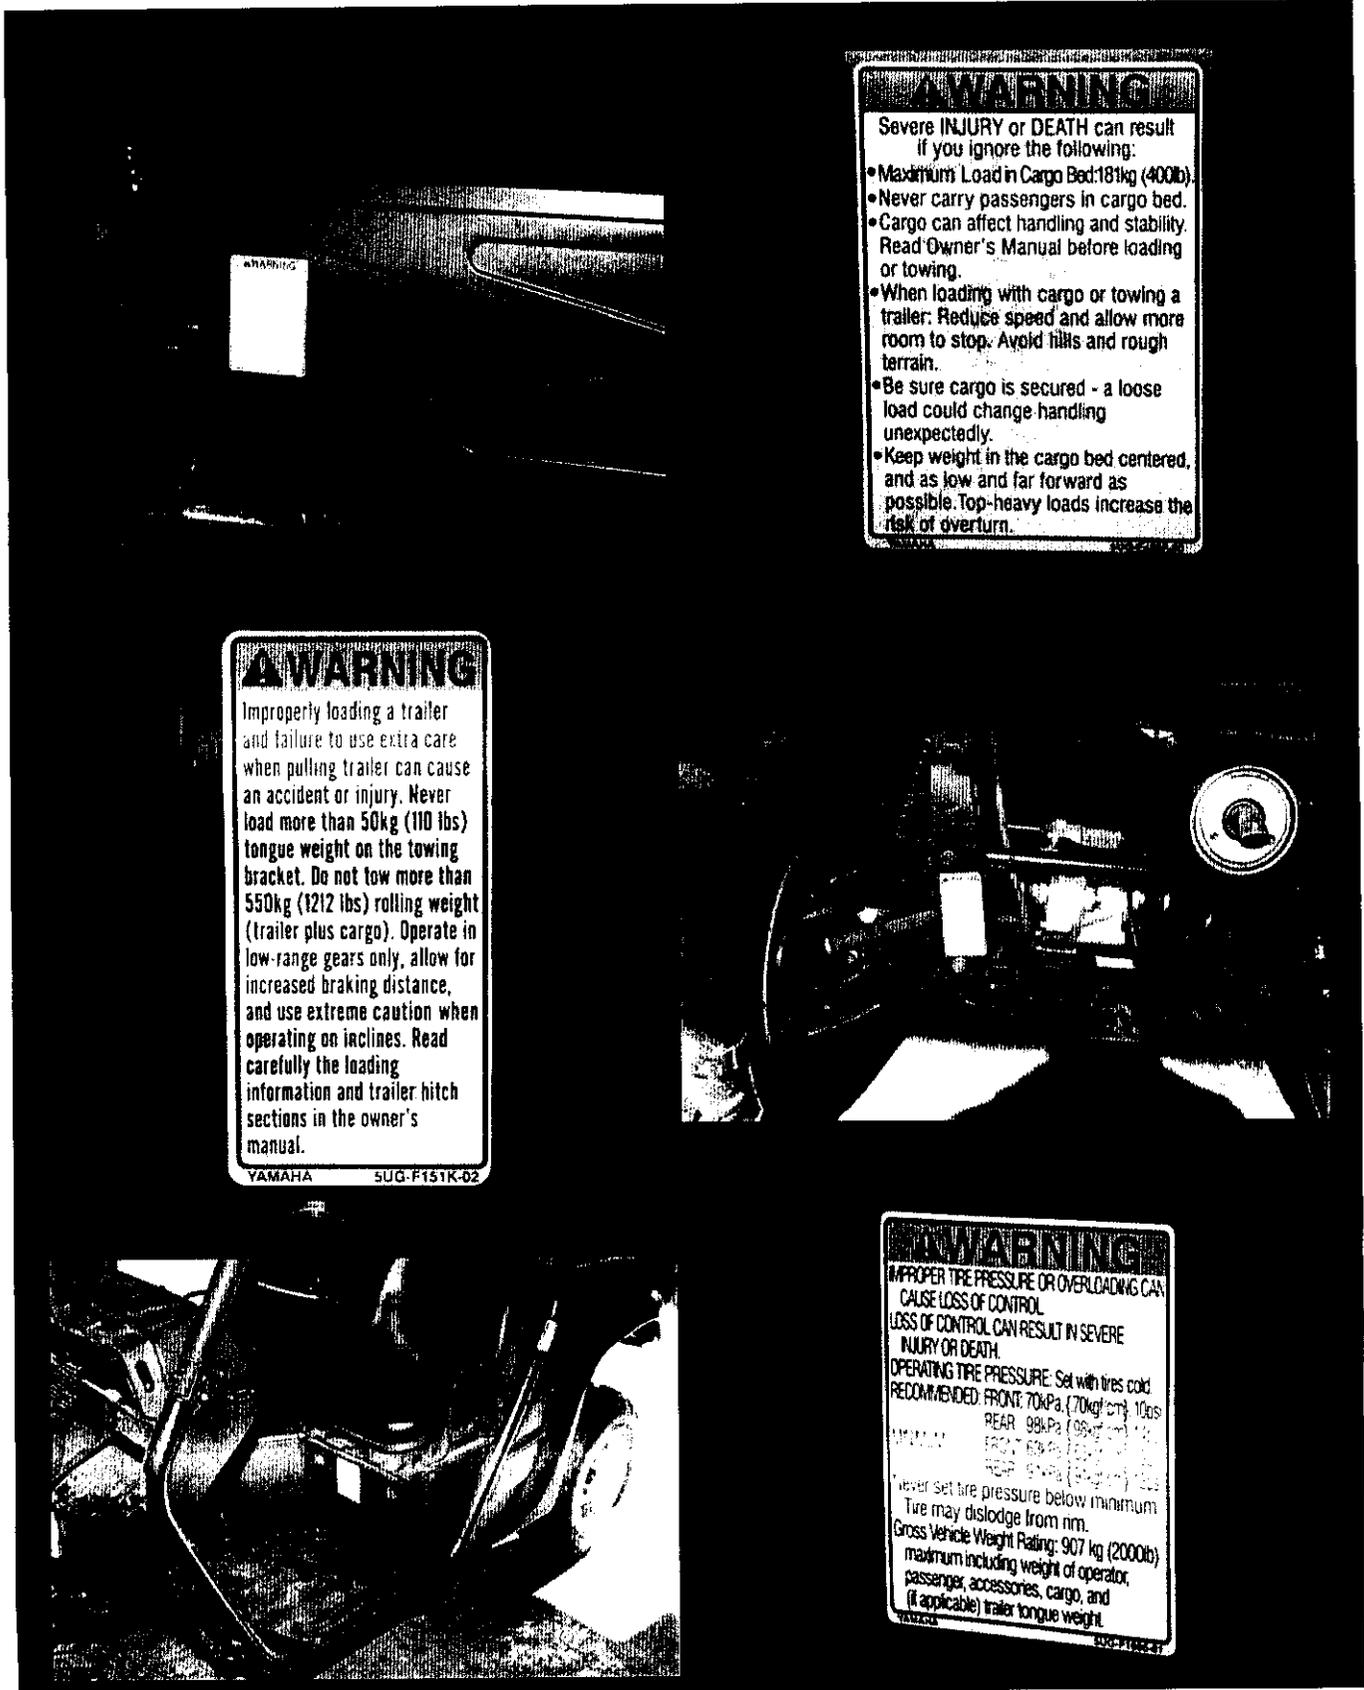
Figure 5: Additional Warnings Stickers

WARNINGS: The following photographs illustrate the warnings found on this vehicle.

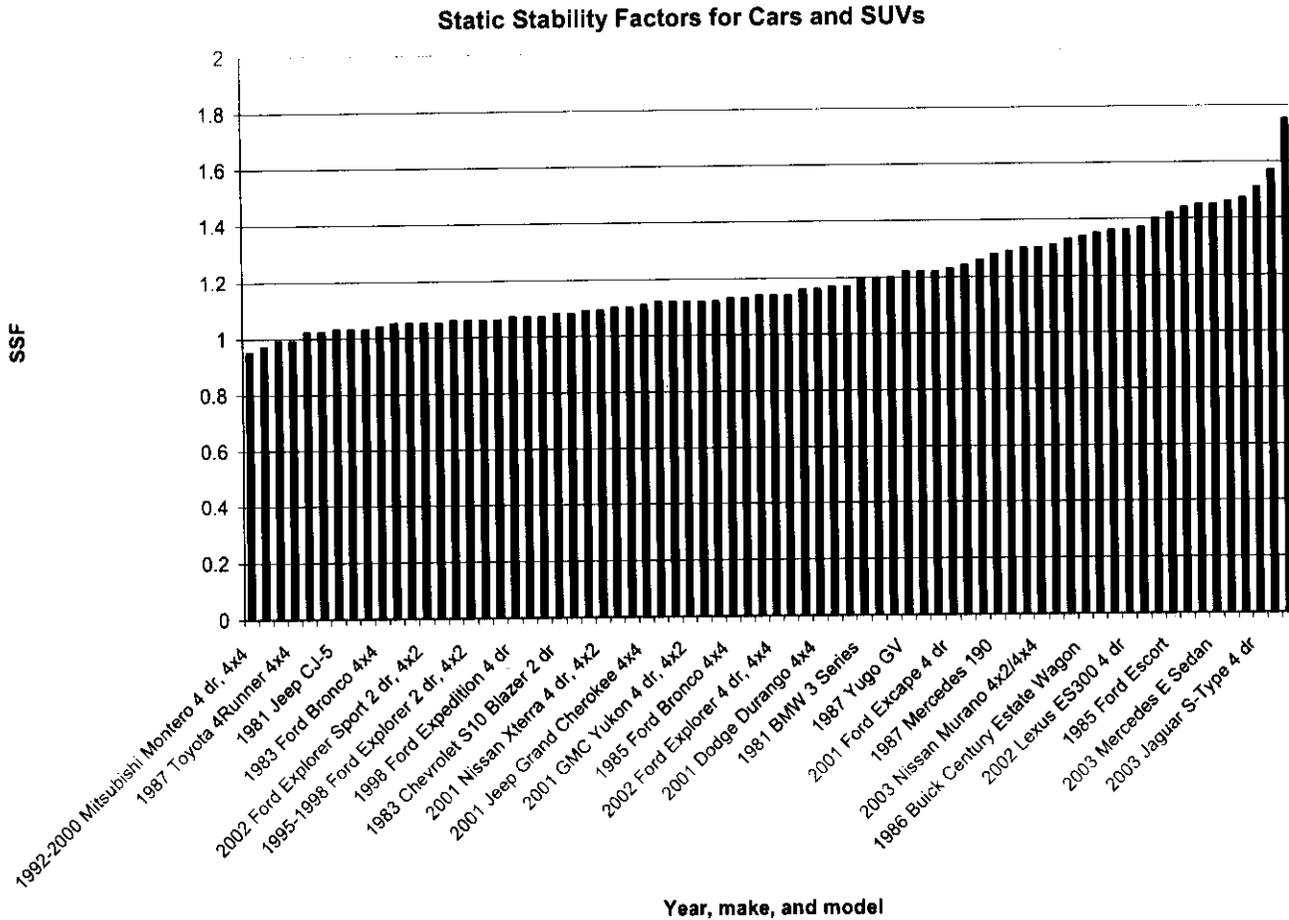
Figure 8: SSF for Various Cars and SUVs

According to the National Highway Traffic Safety Administration (NHTSA), "One of the primary means of assessing rollover risk is the static stability factor (SSF), a measurement of a vehicle's resistance to rollover." [4] The SSF is expressed in units of G's. The plot below was created using the SSF numbers listed by NHTSA in this report.

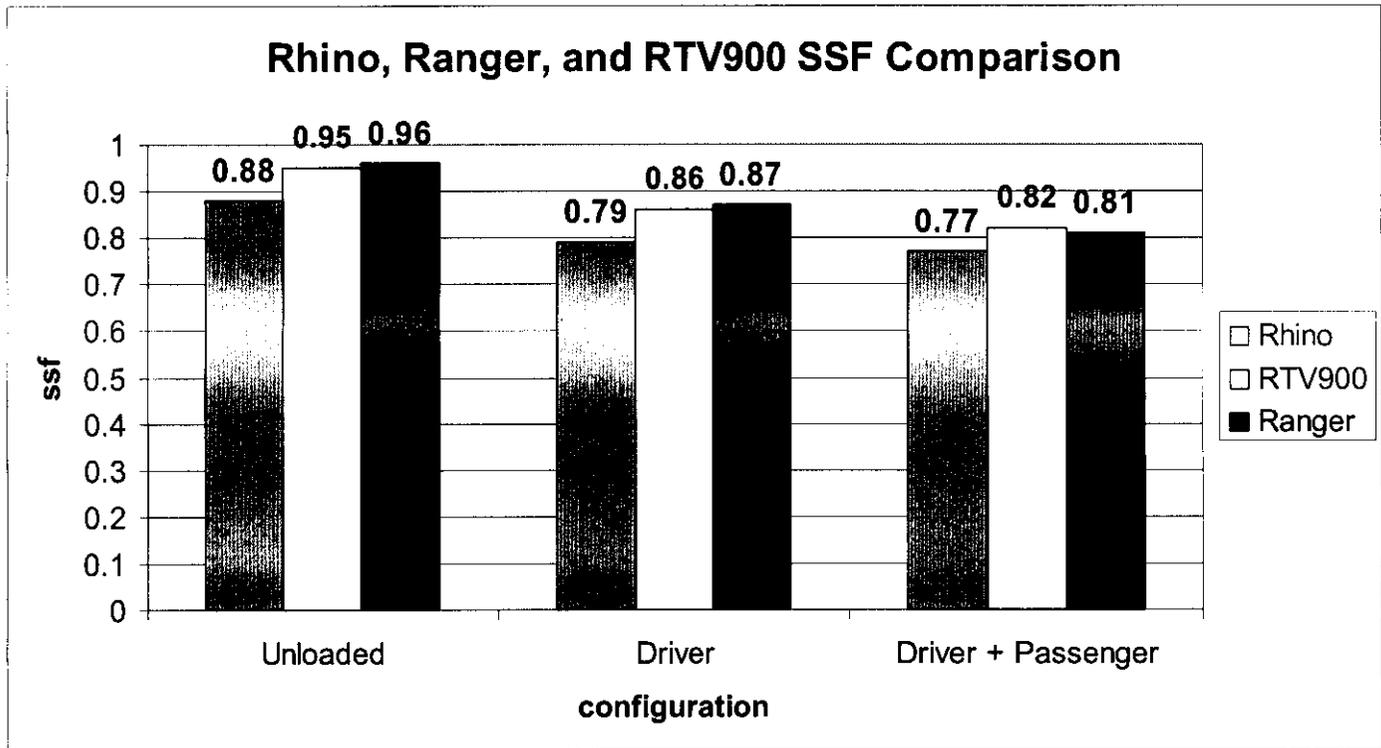
Figure 12: Comparison of Yamaha Rhino, Polaris Ranger, and Kubota RTV900 SSFs for Various Loading Configurations

The fact that the Ranger’s track is wider than the Rhino resulted in the Ranger having a significantly higher SSF unloaded. The higher seating position of the occupants, however, resulted in the vehicles being more comparable with driver plus passenger. The Kubota’s track was not as wide as the Ranger, but its center of gravity was lower. It also had higher SSFs than did the Rhino. Figure 12 shows a direct comparison between the results from the three vehicles.

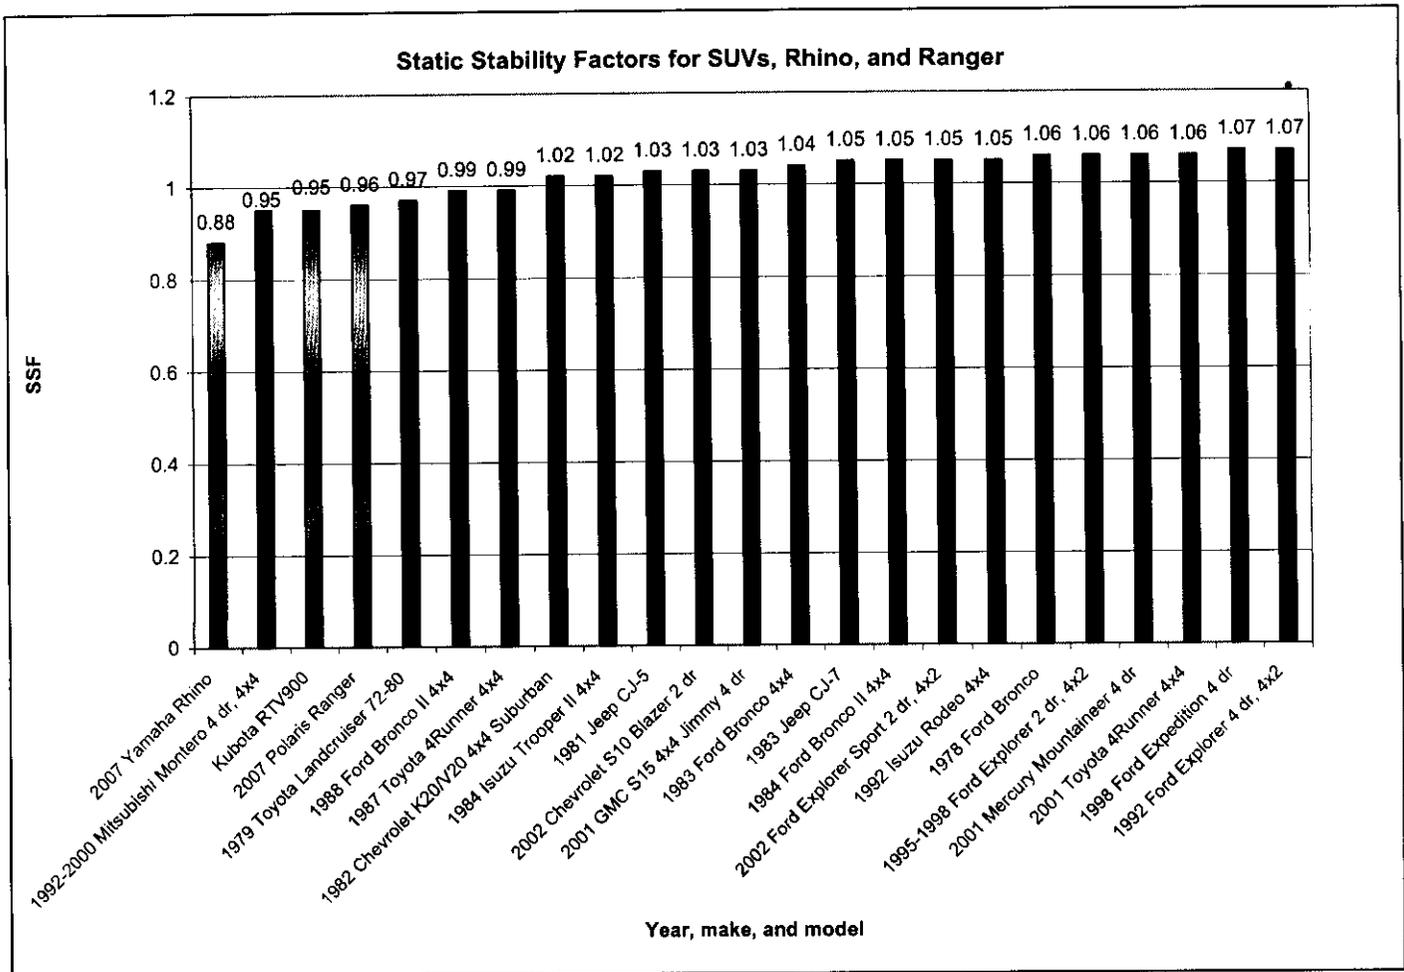
Figure 13: SSF of Rhino, Ranger, and RTV900 Plotted with SSFs of SUVs

The numbers reported by NHTSA for the SSFs of the vehicles in their study were established with the vehicles unloaded. Therefore, as a direct comparison, the Ranger, Rhino, and RTV900 SSFs unloaded will be plotted along with several SUVs. The SSF of the Yamaha Rhino is lower than any vehicle reported by NHTSA, while the Ranger has a SSF that is higher than the 1992-2000 Mitsubishi Montero 4X4 while the Kubota’s unloaded value was equal to the Mitsubishi.

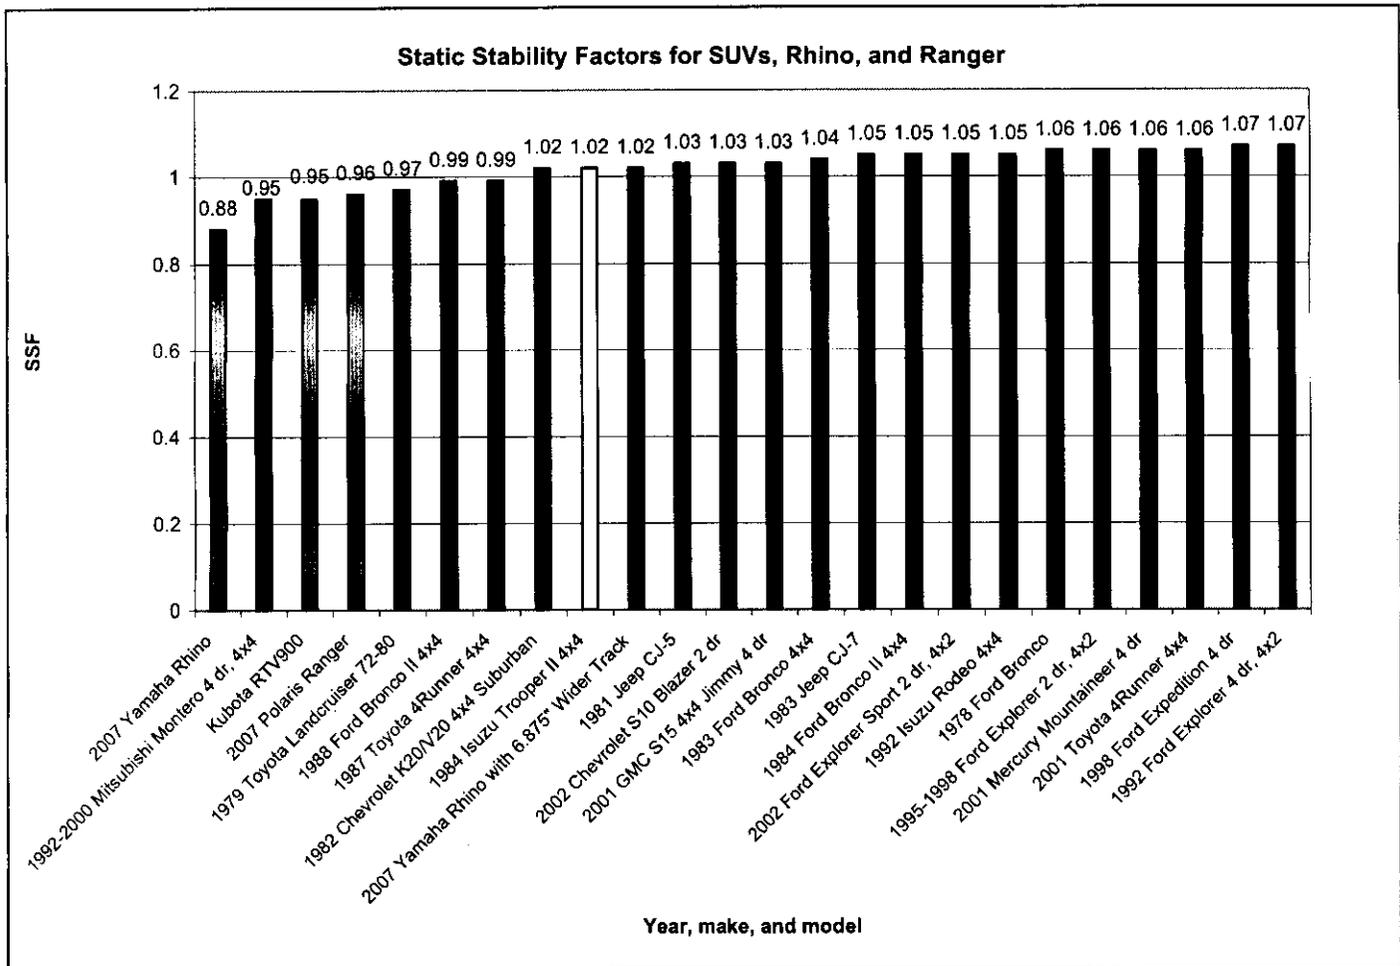
Figure 14: SSFs for SUVs, Rhino, Ranger and Theoretical Modified Rhino

Also, with this increased track, the vehicle's SSF when loaded with two, 160 lb occupants would increase to 0.88 assuming the center of gravity height measured in the tilt table testing with two occupants did not change. This value of 0.88 is the equivalent to the unloaded Yamaha Rhino as designed.

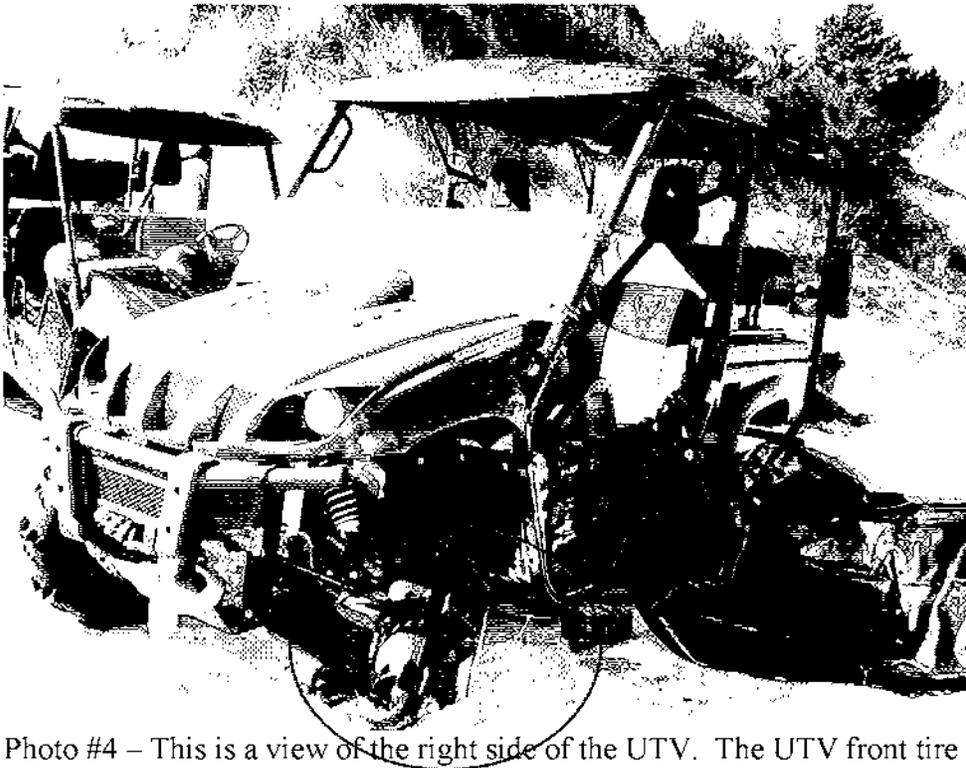
Photo #4 – This is a view of the right side of the UTV. The UTV front tire was severely damaged during the incident.

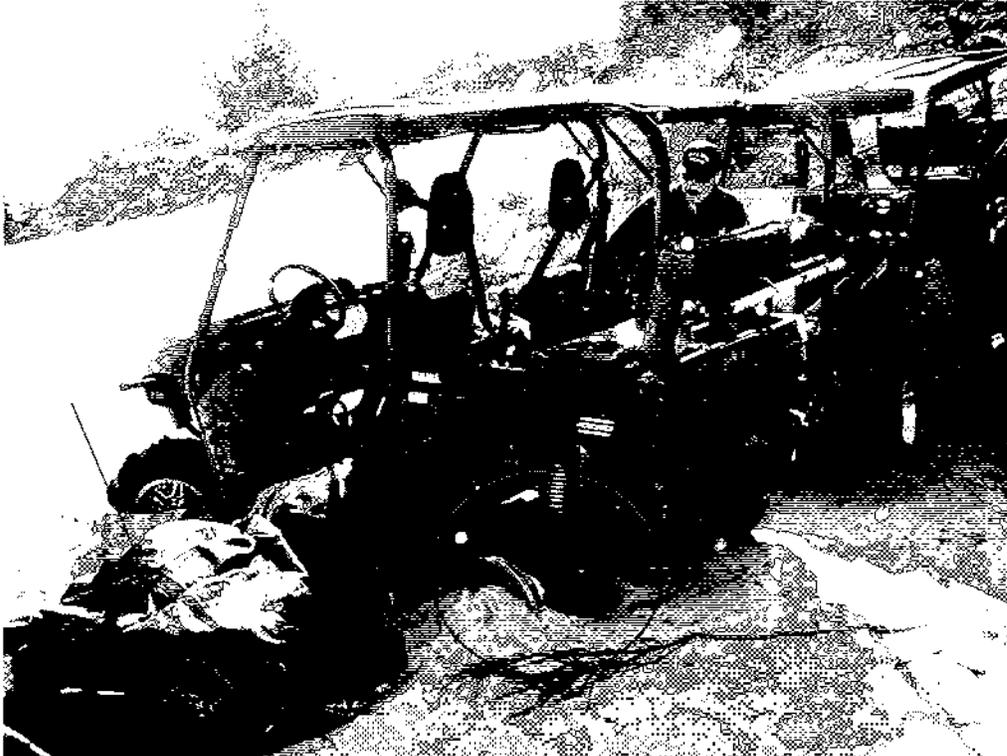
Photo #5 – This is a view facing the right rear end of the ATV. The victim was placed under a black tarp. The rear tire was also damaged.

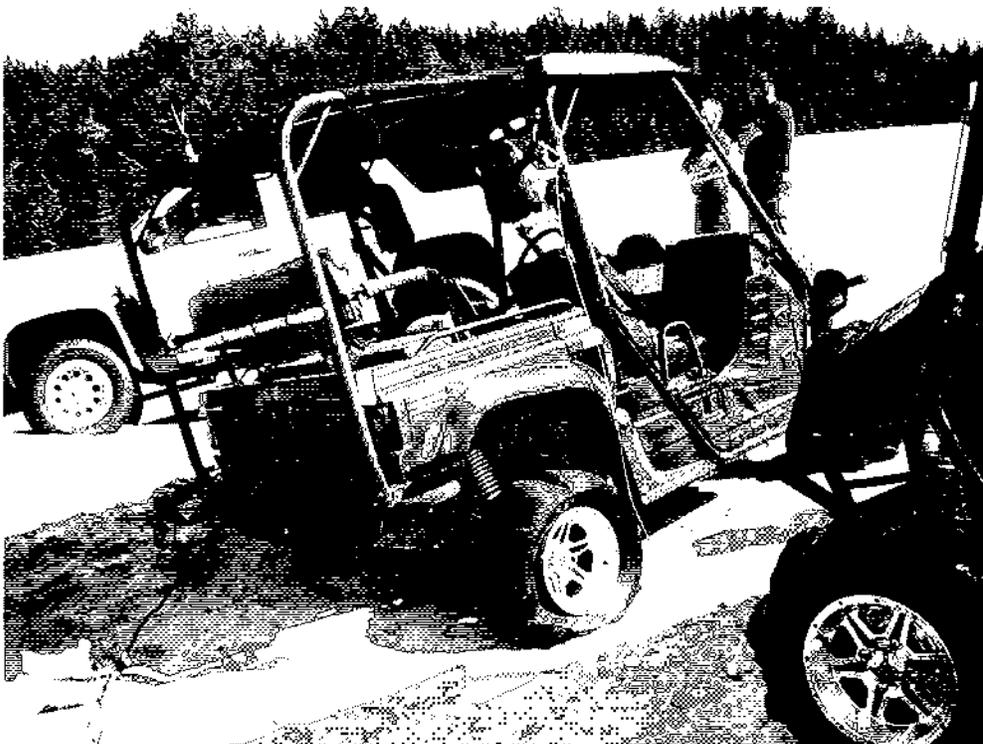
Photo #6 – This view is of the left rear side of the ATV. The rear tire was flattened during the incident.

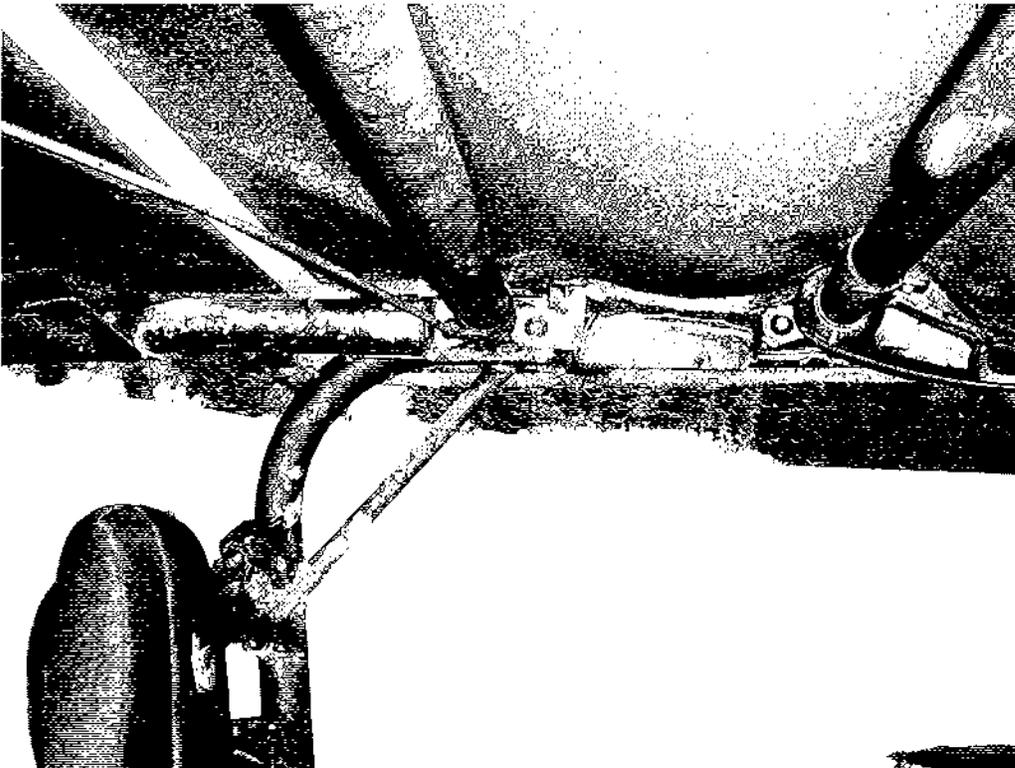
Photo #14 – This is a view of the roll bar from the inside of the UTV. The blood transfer was caused by the contact between the victim's head and the roll bar.

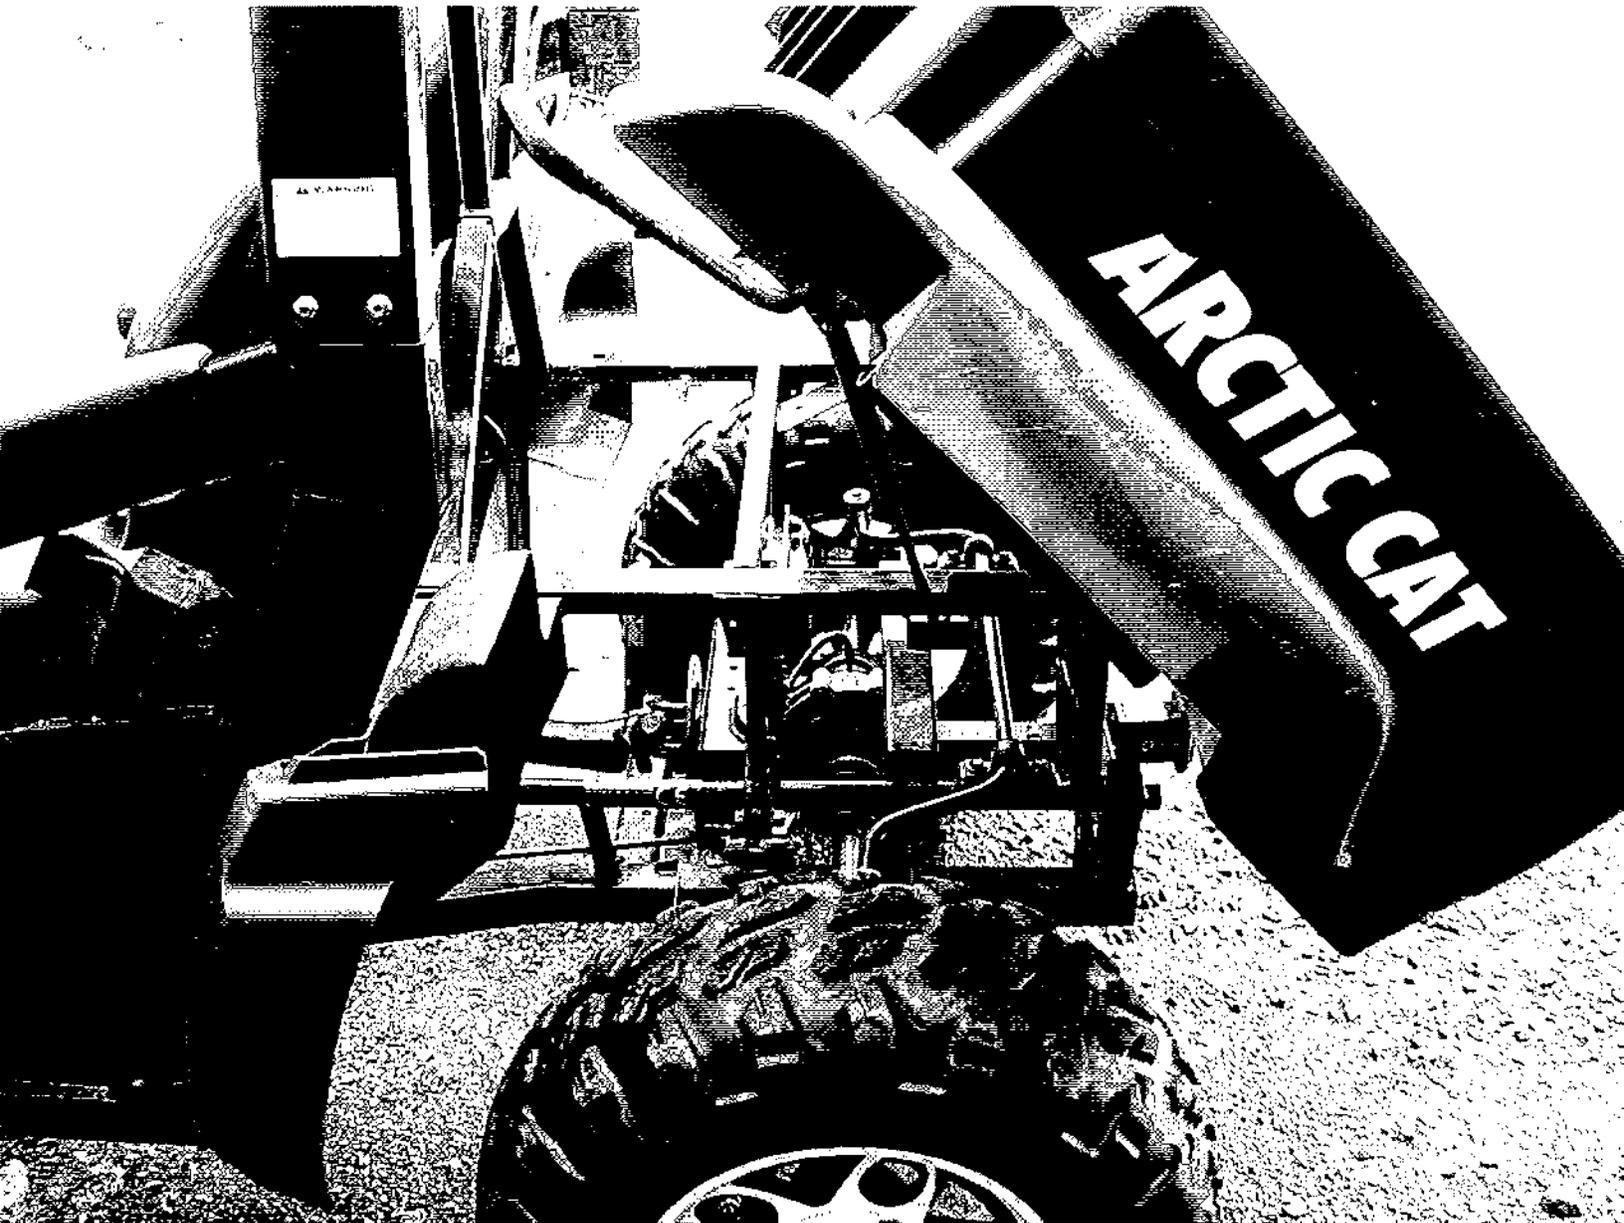
090407CCC2512

Shows the back hood in the open position. The complainant has removed the engine and drive shaft. Both engine blew and transmission failed after 200 miles use after dealer working on brakes and drive shaft.

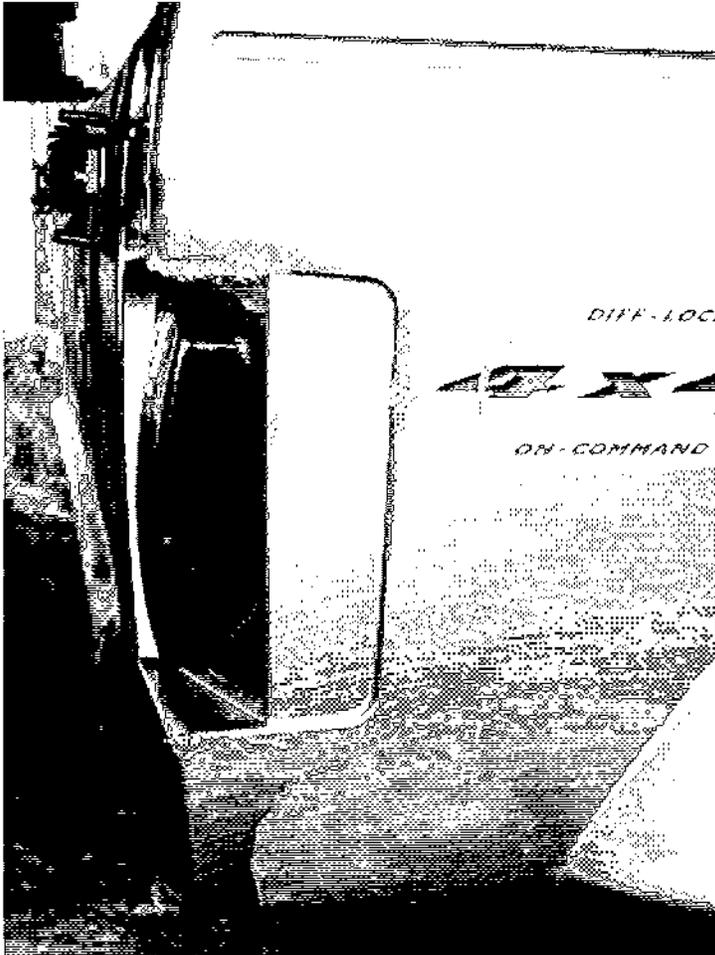
090507CCC2613. Exhibit B. Photograph 1. The damage sustained to the back of the vehicle as a result of it tipping.
