1. Task Number 090602HCC2657		2. Investigator's ID 2343		<b>EPIDEMIOLOGIC INVESTIGATION REPORT</b>
3. Office Code 840	4. Date of Accident YR MO DAY 2009 04 25	5. Date Initiated YR MO DAY 2009 06 04

6. Synopsis of Accident or Complaint UPC A 47 year old male was riding his 40Wheel ATV when he lost control, rolled it and was subsequently ejected, suffering fatal head wounds. The victim was operating the ATV in a city park that natural resource investigators stated is not conducive to ATV operation. Their report indicated that based on the evidence at the scene, the victim drove his ATV northbound down a grassy hill and then westbound onto a paved parking lot. The victim was not wearing a helmet and had a blood alcohol level of 0.138 g / 100 ml. The cause of death was severe head trauma.				
<p><u>MFR/PRVLBR NOTIFIED</u></p> <p>COMMENTS: <input type="checkbox"/> YES <input checked="" type="checkbox"/> NO</p> <p><input type="checkbox"/> OVERRULED: <input type="checkbox"/> ATTACHED</p> <p><input checked="" type="checkbox"/> EXCISIONS/FOIA EXS. <u>3, 25C, 6</u></p> <p><input checked="" type="checkbox"/> DO NOT RE-NOTIFY <input type="checkbox"/> RE-NOTIFY</p>

**IDI 090602HCC2657**

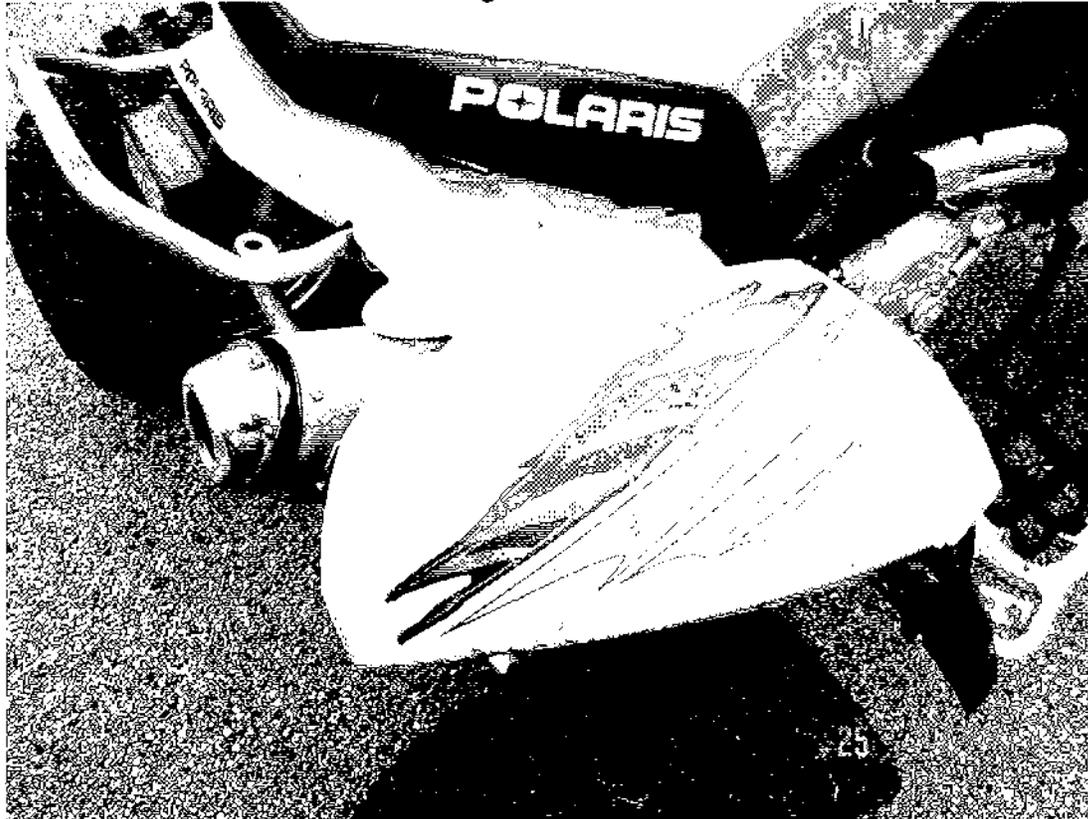
- The right handbrake was broken off the ATV's right handlebar. There were also fresh scuff marks on the ATV's right front and rear fenders, as well as the handlebar and the end of

Exhibit E 19 – Scuff marks on right rear fender and exhaust pipe of ATV

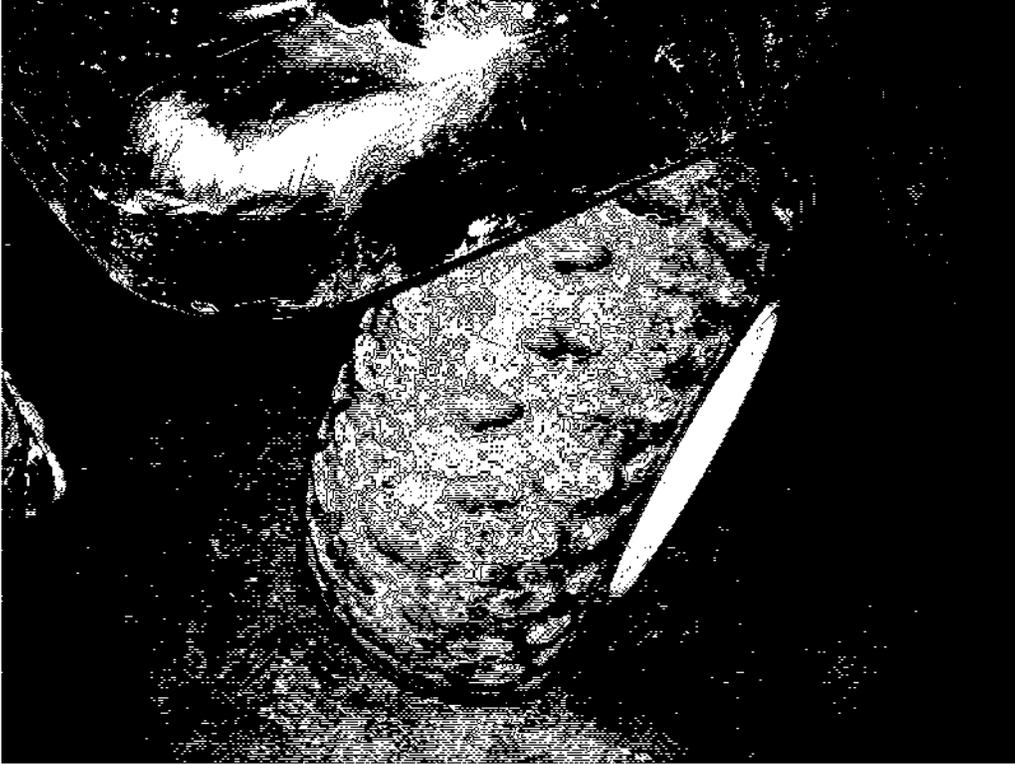
Photo 7: One of the front tires. The front tires were in fair condition with minimal tread.

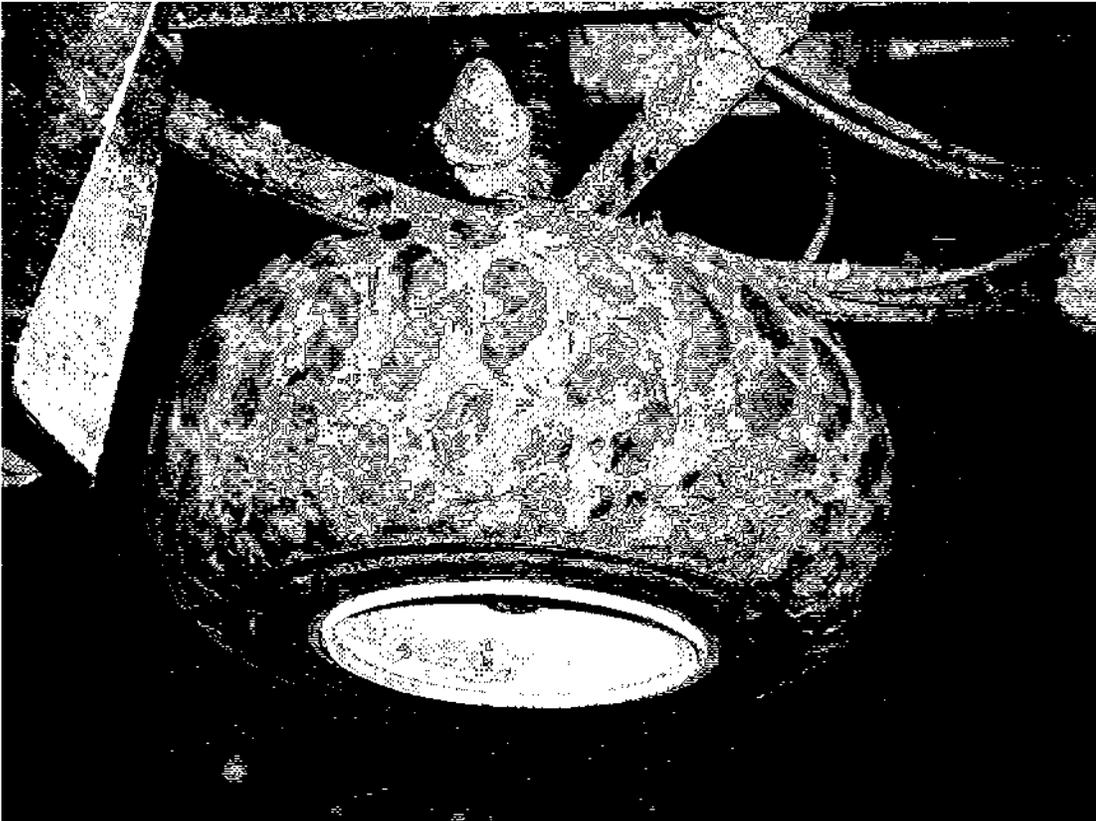
Photo 8: One of the rear tires. The rear tires were in poor condition and nearly bald within the center portion of the tires.

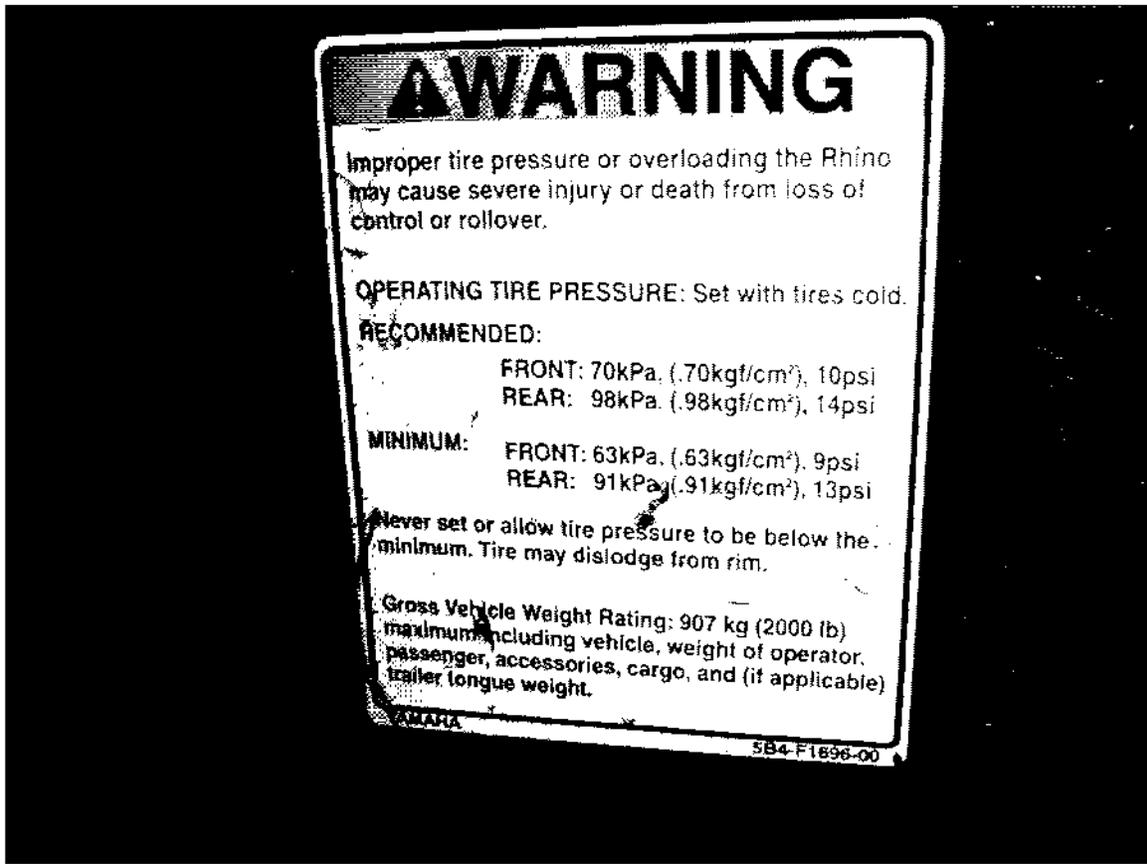
Exhibit 1.13: Warning Label affixed to Incident UTV  
IDI # 090608CNE4481

Label reads in part, "\*\*\*\*\*WARNING\*\*\*Improper tire pressure or overloading the Rhino may cause severe injury or death from loss of control or rollover.\*\*\*OPERATING TIRE PRESSURE: Set with tires cold.\*\*\*RECOMMENDED:\*\*\* FRONT: 70kPa, (.70kgf/cm<sup>2</sup>), 10psi\*\*\*REAR: 98kPa, (.98kgf/cm<sup>2</sup>), 14psi\*\*\*MINIMUM:\*\*\*FRONT: 63kPa,(.63kgf/cm<sup>2</sup>), 9psi\*\*\*REAR: 91kPa (.91kgf/cm<sup>2</sup>), 13psi\*\*\*Never set or allow tire pressure to be below the minimum. Tire may dislodge from rim.\*\*\*Gross Vehicle Weight Rating: 907 kg (2000 lb) maximum including vehicle, weight of operator, passenger, accessories, cargo, and (if applicable) trailer tongue weight.\*\*\*YAMAHA\*\*\*"

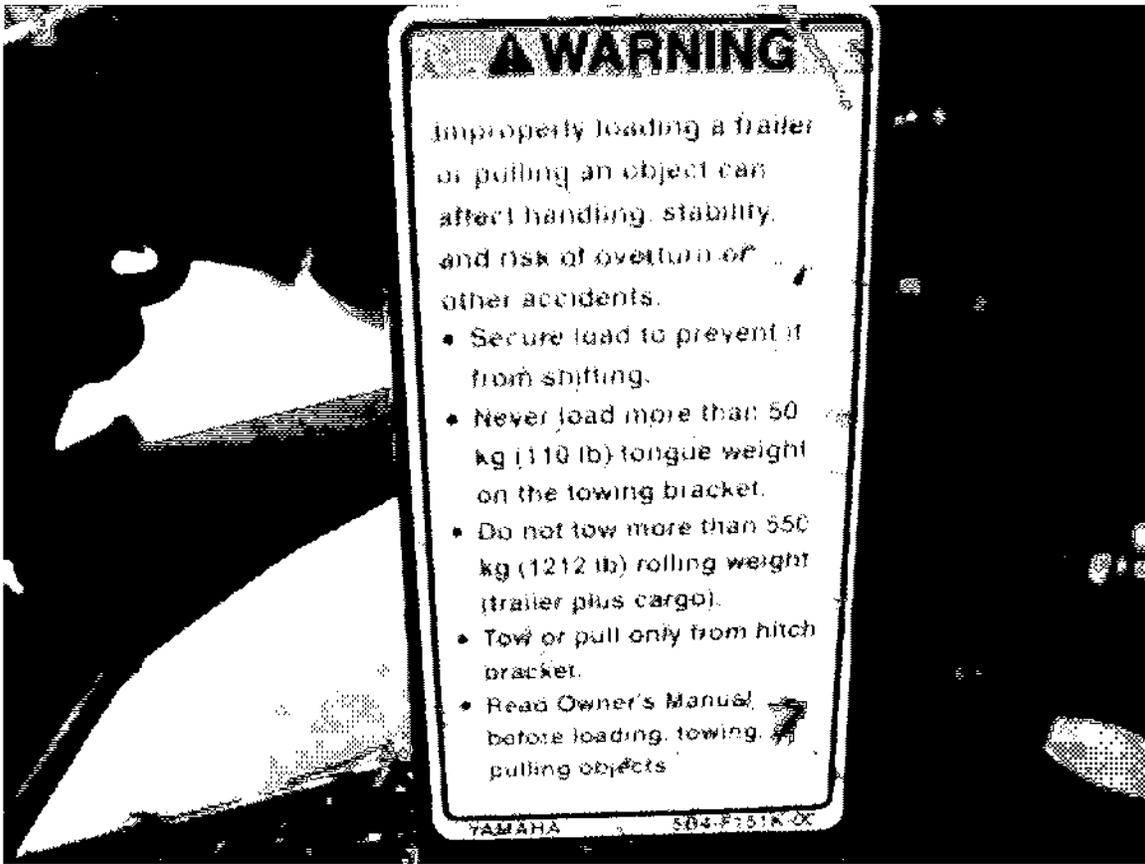
Exhibit 1.25: Label affixed to Incident UTV  
IDI # 090608CNE4481

Label reads in part, "\*\*\*\*!\*\*\*WARNING\*\*\*Improperly loading a trailer or pulling an object can affect handling, stability, and risk of overturn or other accidents.\*\*\*Secure load to prevent it from shifting.\*\*\*Never load more than 50 kg (110 lb) tongue weight on the towing bracket.\*\*\*Do not tow more than 550 kg (1212 lb) rolling weight (trailer plus cargo).\*\*\*Tow or pull only from hitch bracket.\*\*\*Read Owner's Manual before loading, towing\*\*\*pulling objects.\*\*\*YAMAHA\*\*\*\*"

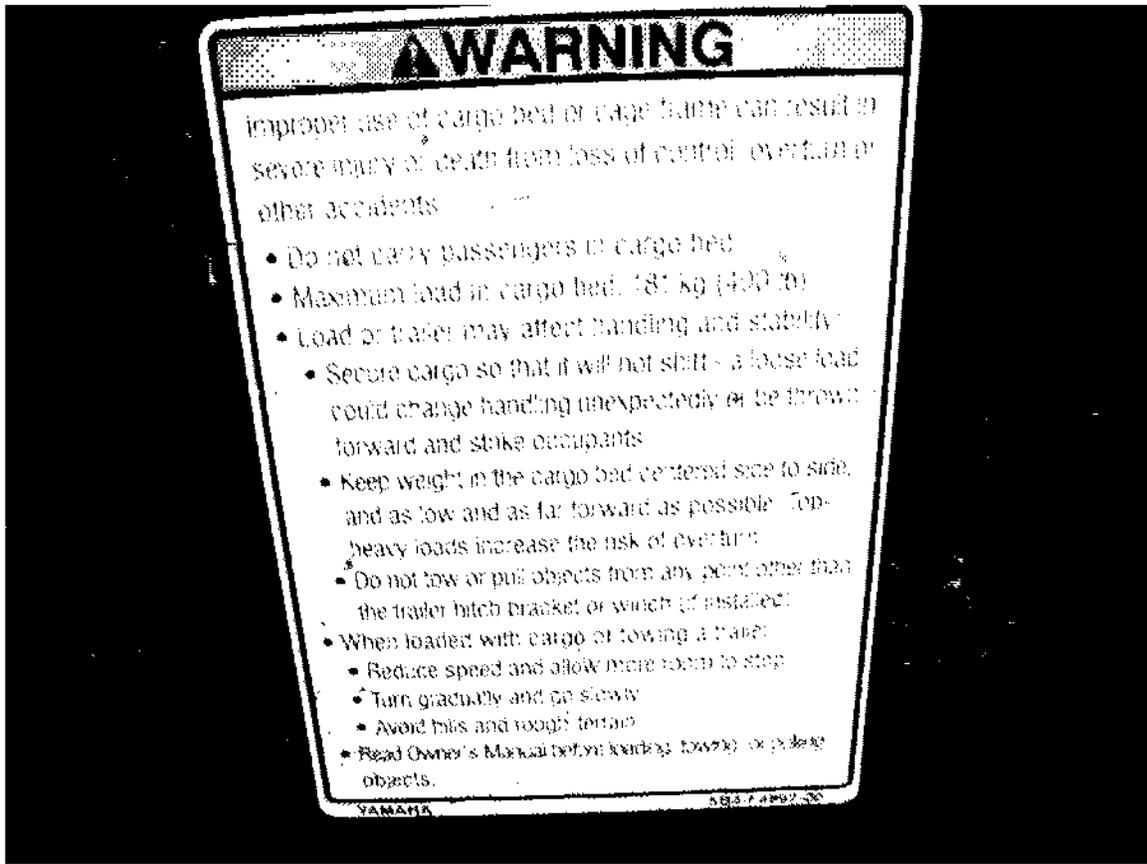
**Exhibit 1.40: Label affixed to Incident UTV  
IDI #090608CNE4481**

Label reads in part, **“\*\*\*!\*\*\*WARNING\*\*\*Improper use of cargo bed or cage/frame can result in severe injury or death from loss of control, overturn or other accidents.\*\*\*Do not carry passengers in cargo bed.\*\*\*Maximum load in cargo bed: 181 kg (400 lb).\*\*\*Load or trailer may affect handling and stability:\*\*\*Secure cargo so that it will not shift – a loose load could change handling unexpectedly or be thrown forward and strike occupants.\*\*\*Keep weight in the cargo bed centered side to side and low and as far forward as possible. Top-heavy loads increase the risk of overturn.\*\*\*Do not tow or pull objects from any point other than the trailer hitch bracket or winch (if installed).\*\*\*When loaded with cargo or towing a trailer: \*\*\*Reduce speed and allow more room to stop.\*\*\*Turn gradually and go slowly.\*\*\*Avoid hills and rough terrain.\*\*\*Read Owner’s Manual before loading, towing or pulling objects.\*\*\*YAMAHA\*\*\*”**
