All information contained in this report, was obtained through telephone contact with the County Sheriff's Department and the State Medical Examiner's office. I reported this incident with an online news reports (source document).

Early in the morning at about 12:30 a.m., on August 29, 2009, a 42-year-old male and his 43-year-old wife were in a moving UTV being operated by the husband. She was in the front, right passenger seat. A friend was in an ATV just ahead of them. They were all traveling in the dark on a public gravel road near a campground they were staying at, in northeastern Iowa.

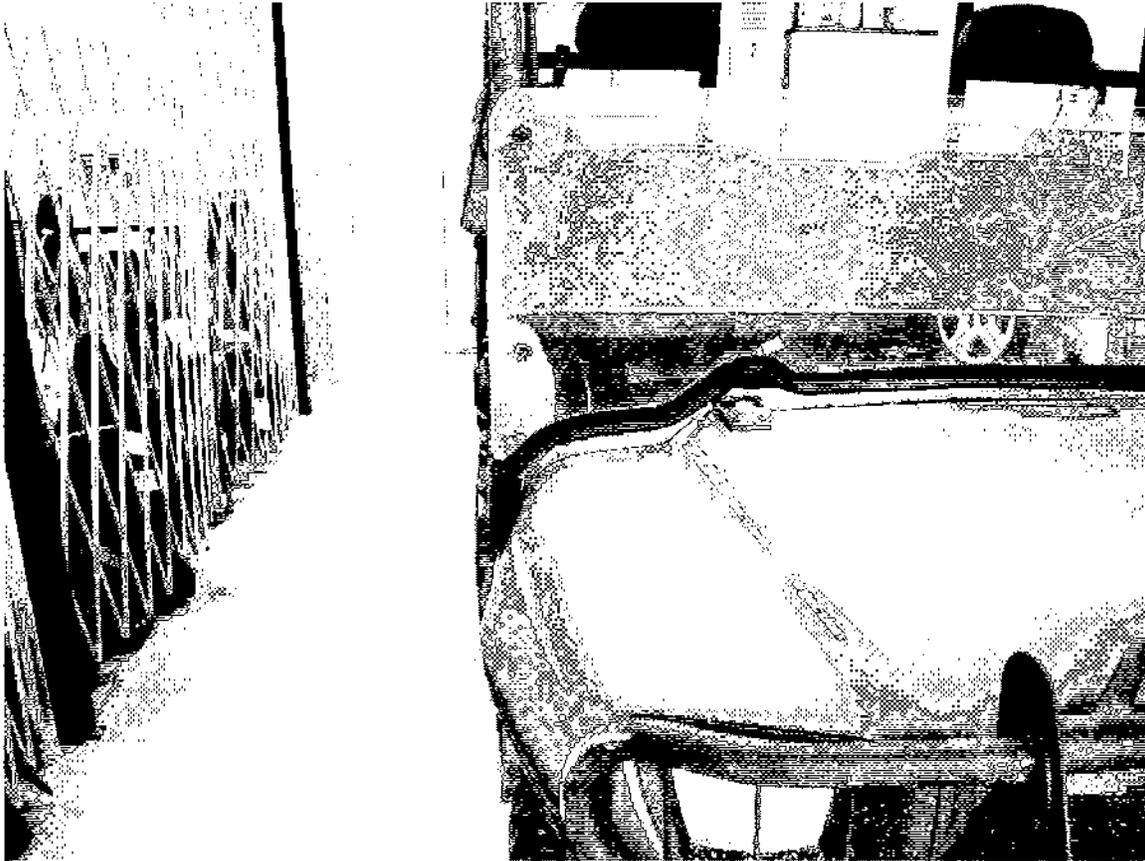
Exhibit C – 10 Police Photograph of front of Incident UTV. Information contained on front of vehicle states “700XP Elcetronic Fuel Injection”.

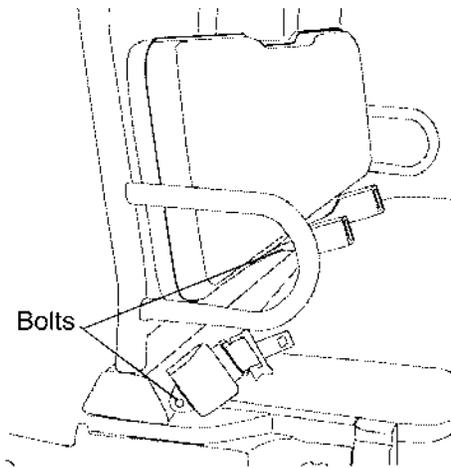
The *RANGER* seat belt is adjustable and should be adjusted for both the operator and passengers before driving. Although having the belt at 30° is typical for many people, it will not accommodate all body sizes and shapes. Make sure the seat belt is adjusted to the lowest possible lap position before riding.

1. To adjust, loosen the bolts.
2. Reposition both the buckle and retractor. Tighten the bolts.

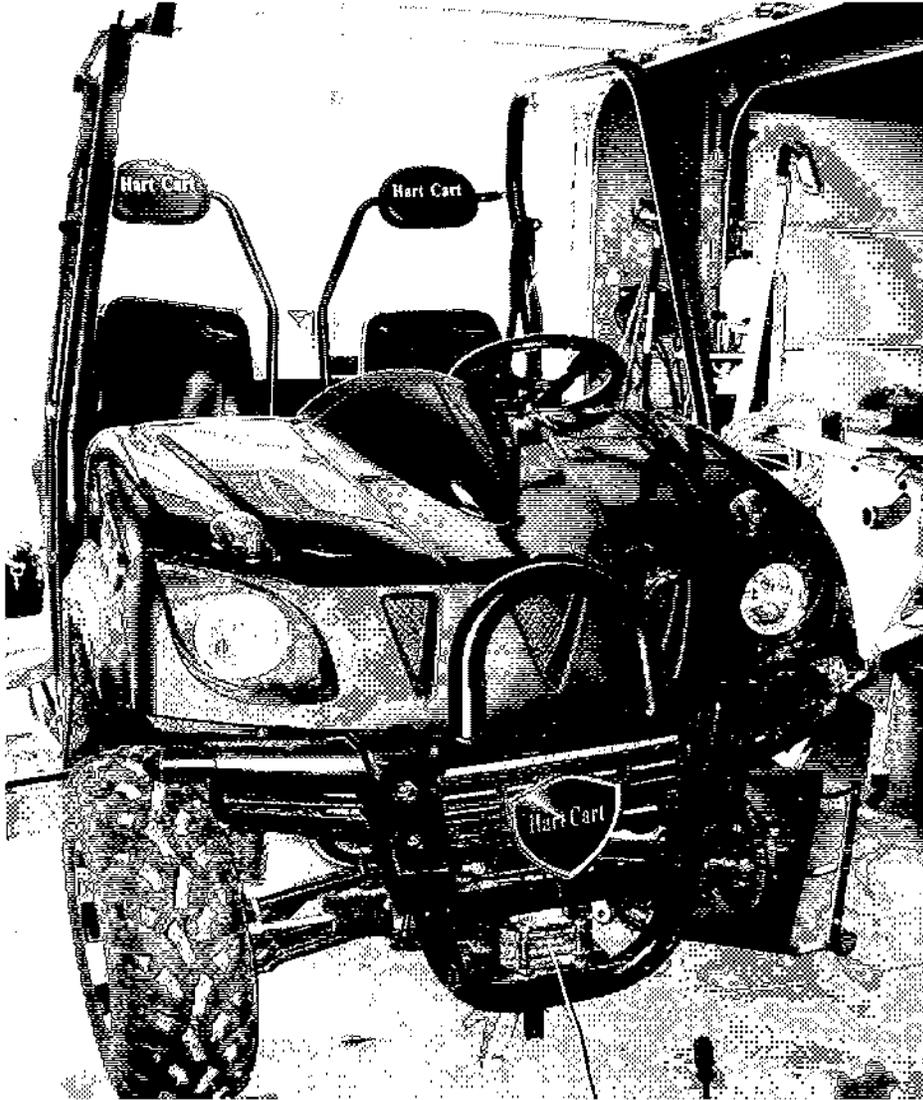
Photo of front of the UTV. Wench is located on front end. Left tire has been removed as owner is working on steering.

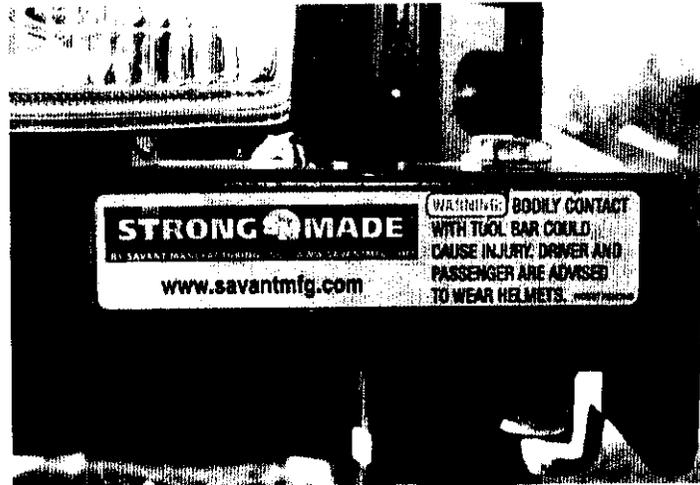
Photograph 8: Warning Label located inside the cargo bed between the two seats – “WARNING Severe INJURY or DEATH can result if you ignore the following: •Maximum Load in Cargo Bed: 181kg (400lb). •Never carry passengers in cargo bed. •Cargo can affect handling and stability. Read Owner’s Manual before loading or towing. •When loading with cargo or towing a trailer: Reduce speed and allow more room to stop. Avoid hills and rough terrain. •Be sure cargo is secured - a loose load could change handling unexpectedly. •Keep weight in the cargo bed centered and as low and far forward as possible. Top-heavy loads increase the risk of overturn. YAMAHA 5UG-K4897-00”

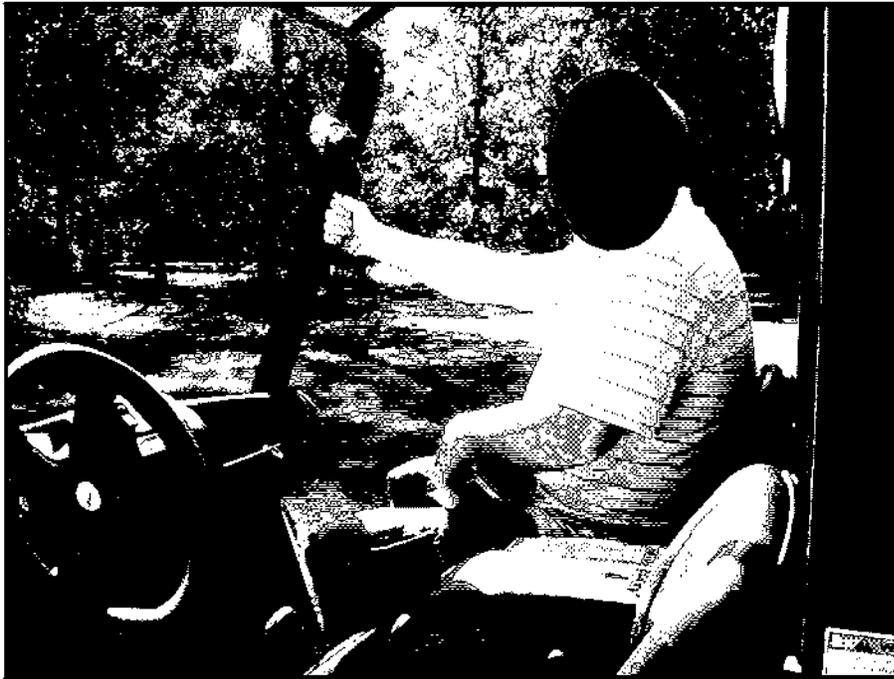
PHOTO #1: This photo shows the complainant holding the handle on the UTV as the passenger was doing immediately before the wheel fell off and he was injured.

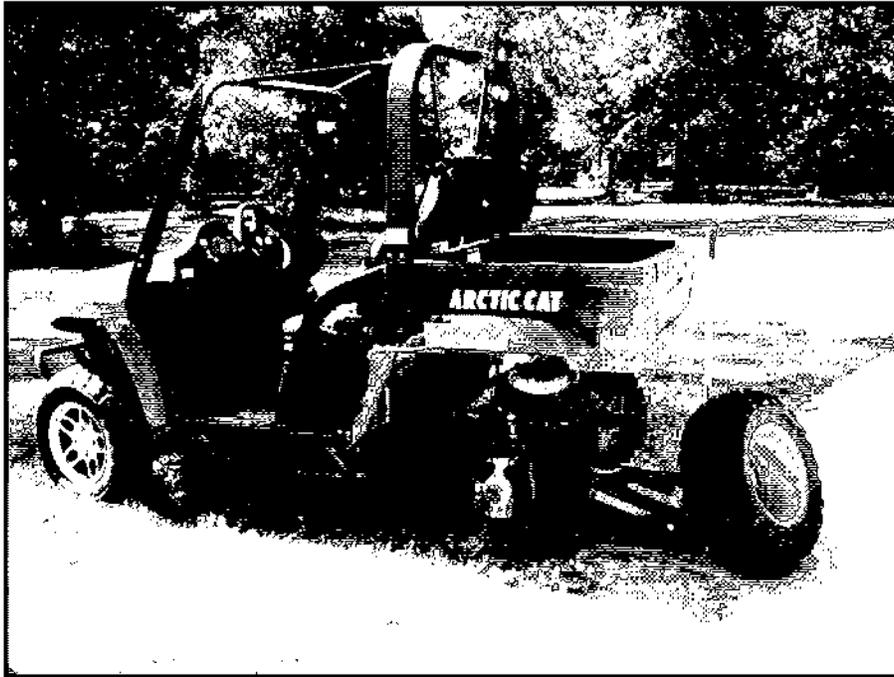
PHOTO #2: This photo shows the complainant's UTV in his driveway with the broken wheel.

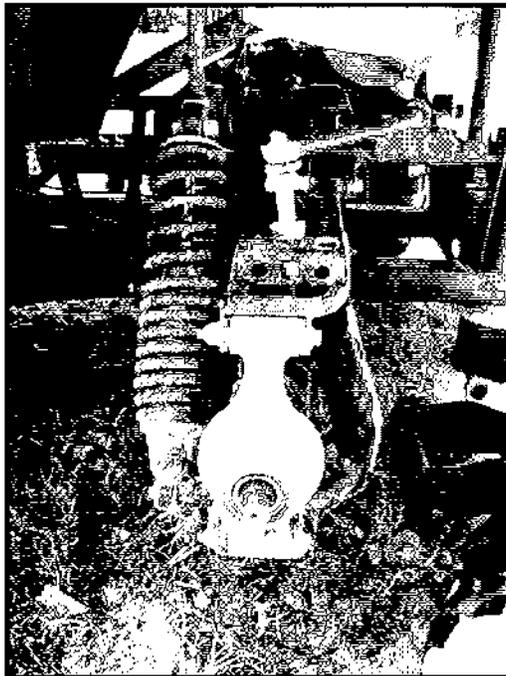
PHOTO #3: This photo shows the wheel and axle assembly with the shock.

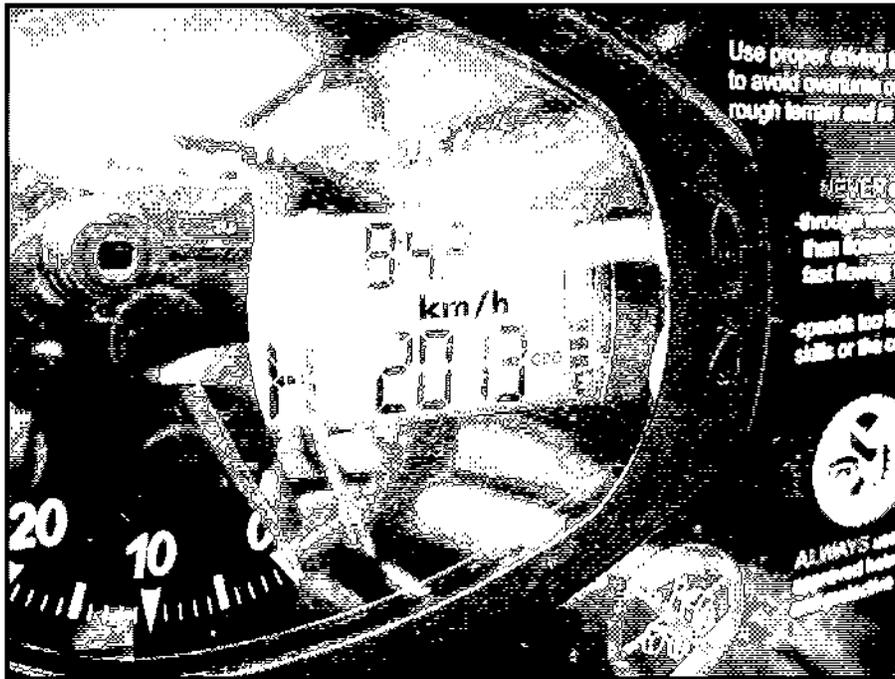
PHOTO #7: This photo shows the total hours on the UTV.

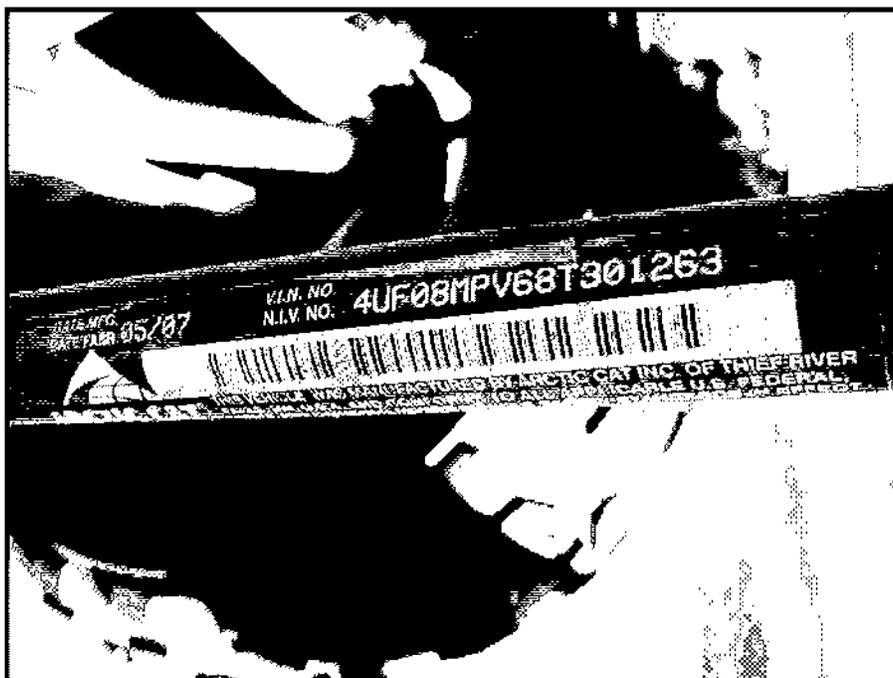
PHOTO #11: This photo shows the manufacture date and VIN number.

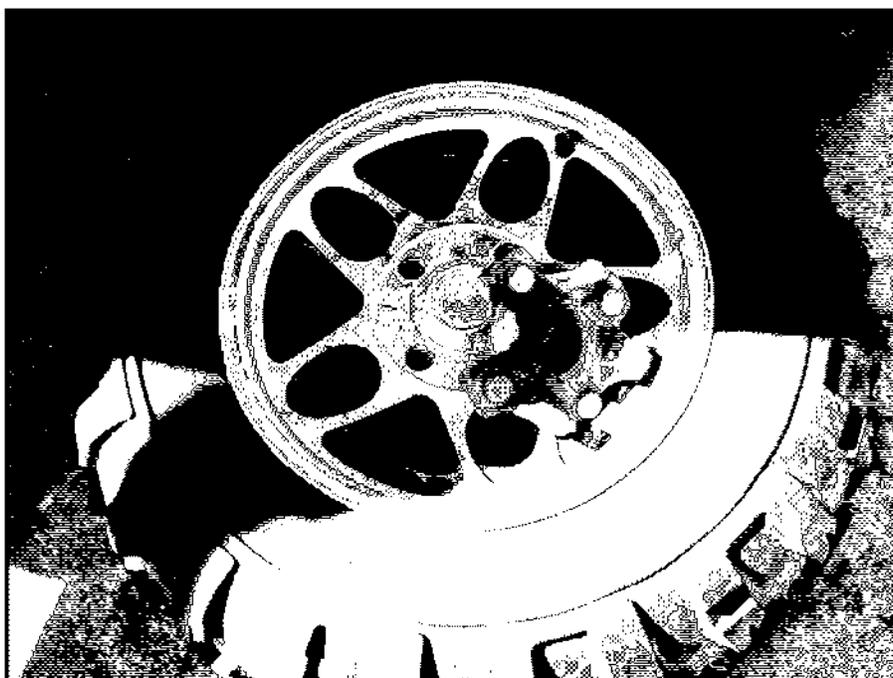
PHOTO #12: This photo shows the tires that were on the UTV.

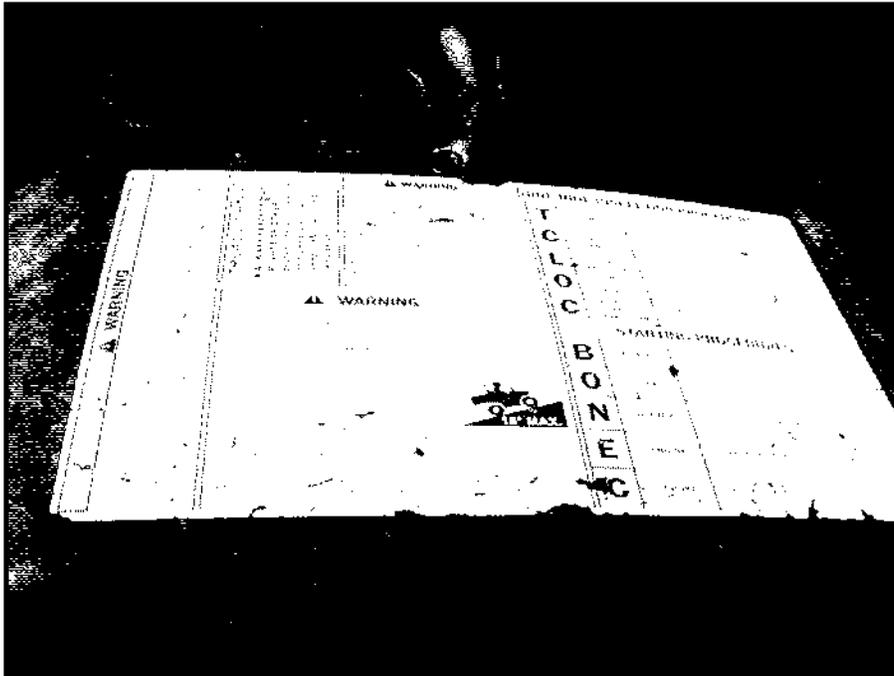
PHOTO #14: This photo shows the overall warning for the UTV and is broken down in Photos 15 through 19).

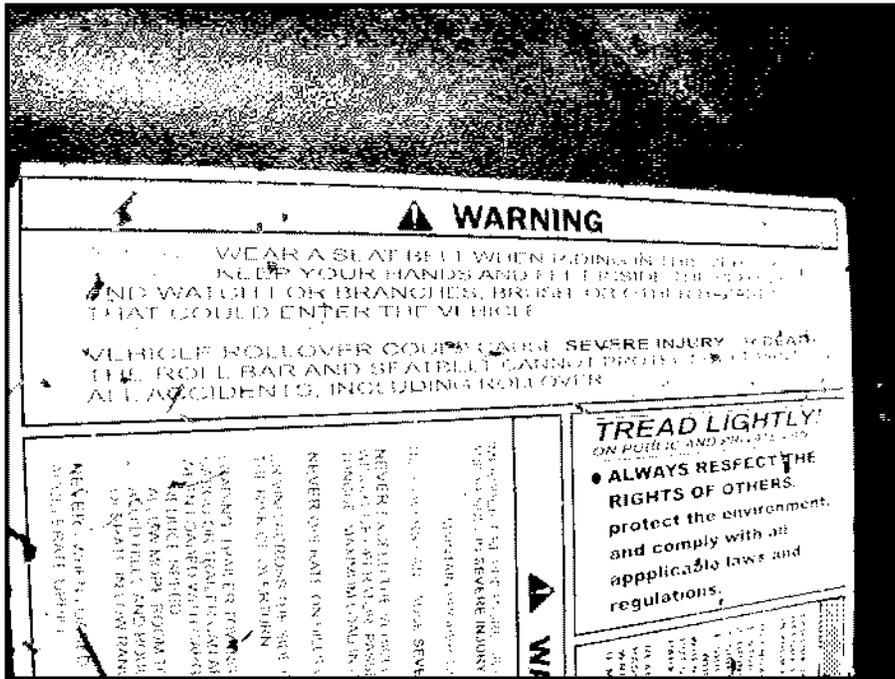
PHOTO #17: This photo shows the warning for the seat belt and that rollovers can cause severe injury.

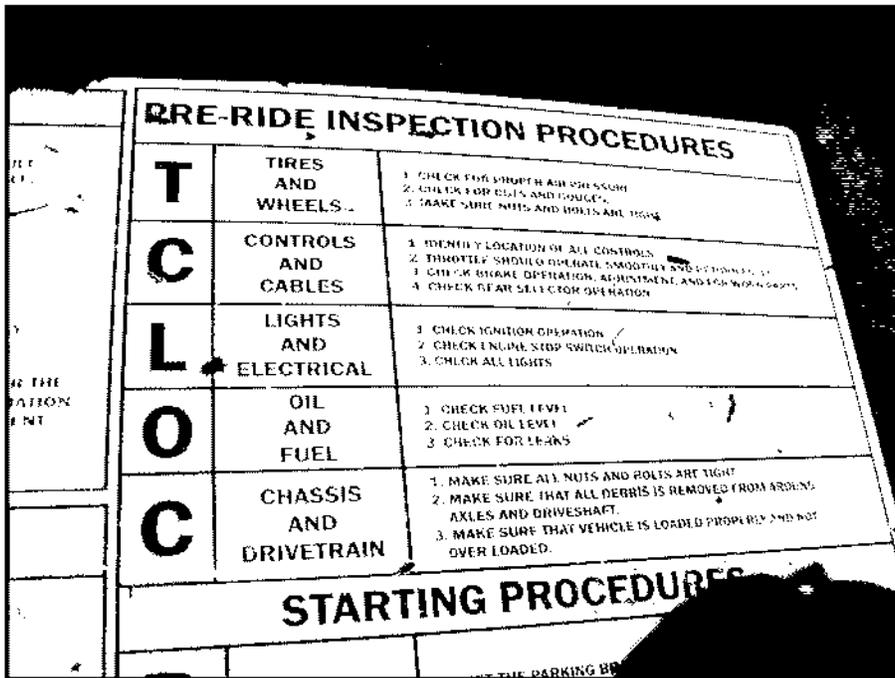
PHOTO #18: This photo shows the instructions for pre-ride inspection procedures.

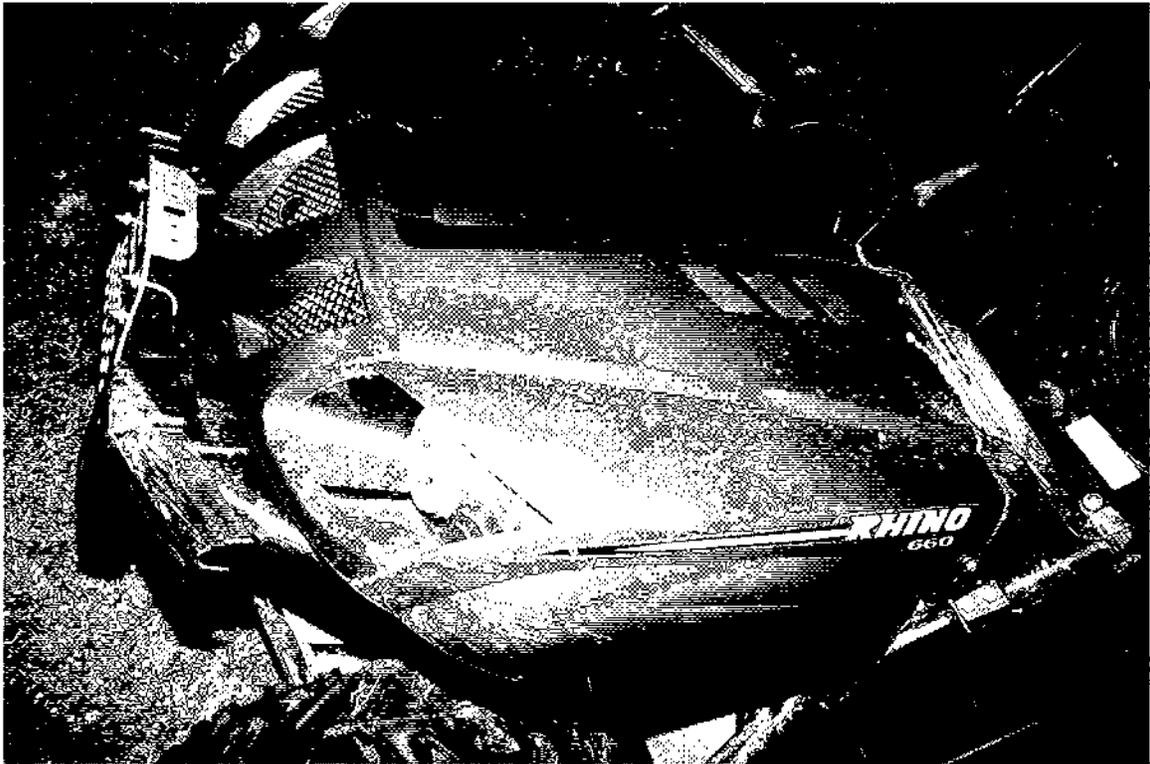
Photograph 22: Damage to front driver's side of incident UTV

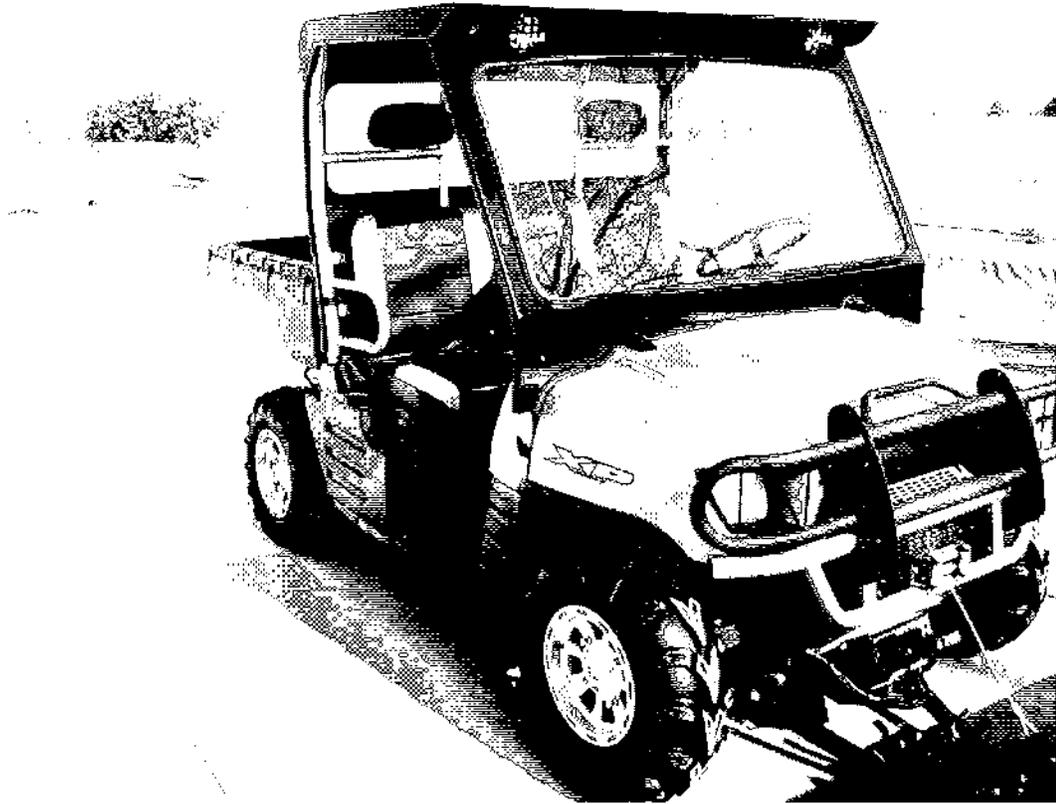
Exhibit B – 3 below shows the driver's side of the UTV.
