U.S. CONSUMER PRODUCT SAFETY COMMISSION

PRELIMINARY TEST RESULTS ON

LITHIUM BATTERIES

USED IN RESIDENTIAL SMOKE ALARMS

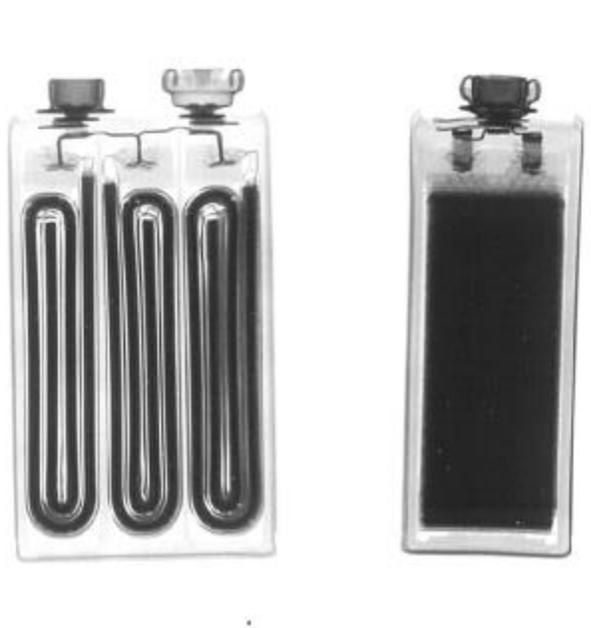
One of the batteries that caused a smoke alarm to emit a low battery chirping was x-rayed. The x-ray did not reveal any cause that would explain the premature low battery chirping. Figure 6 shows the x-ray of sample 8326-01. In the x-ray, the individual 3-volt cells can be identified.

Figure 6. X-Ray of Battery Sample 8326-01

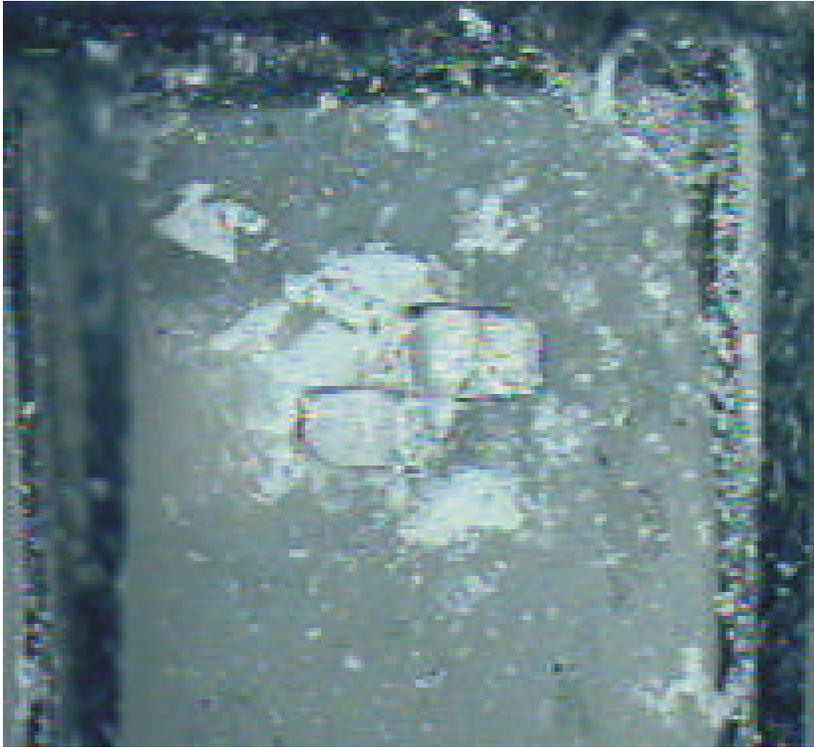
Figure 20 shows a close-up of the contact pins with and without the white deposits. Each cell consists of a positive (mesh) and negative (solid) contact pad. It was also noticed that only the solid contact pads on each cell had a thin film of white deposits. Figure 21 shows a close-up of one of the three solid contact pads with the thin film of white deposits.

Pin with  
White Deposits

Pin without  
White Deposits

Figure 20. Contact Pins with and without White Deposits
