1. Task Number 090204CCC1403		2. Investigator's ID 3385		<b>EPIDEMIOLOGIC INVESTIGATION REPORT</b>
3. Office Code 810	4. Date of Accident YR MO DAY 2006 11 24	5. Date Initiated YR MO DAY 2009 02 06

6. Synopsis of Accident or Complaint UPC 086792  A twenty-year old female was injured while riding as a passenger on a four wheel-drive utility vehicle. Her twenty-one year old brother was driving the vehicle on a paved road. He lost control while negotiating a left turn and the vehicle rolled-over several times. The vehicle rolled-over the victim's leg (fractured) which was treated on the following day. The driver was unharmed. They were wearing seat belts but no helmets.  <b>MFR/PRVLBR NOTIFIED</b> COMMENTS: <u>YES</u> <input checked="" type="checkbox"/> <u>NO</u> <u>OVERRULED;</u> <u>ATTACHED</u> <input checked="" type="checkbox"/> <u>EXCISIONS/FOIA EXS. Sec. 6</u> <input checked="" type="checkbox"/> <u>DO NOT RE-NOTIFY</u> <u>RE-NOTIFY</u> <i>[Signature]</i> 5/18/09

## BACKGROUND INFORMATION

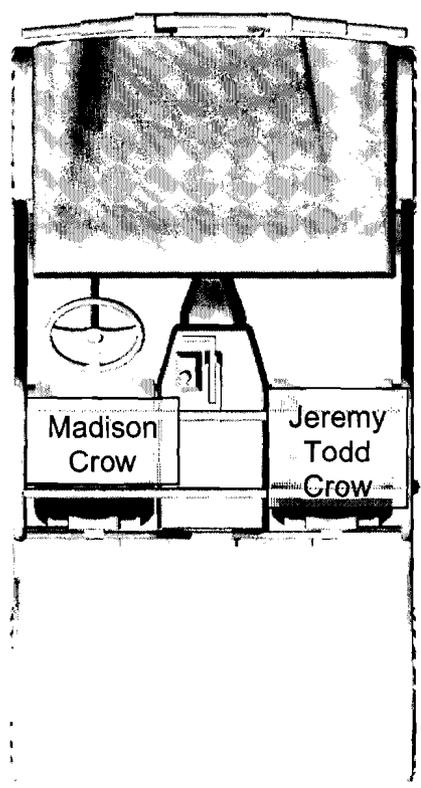
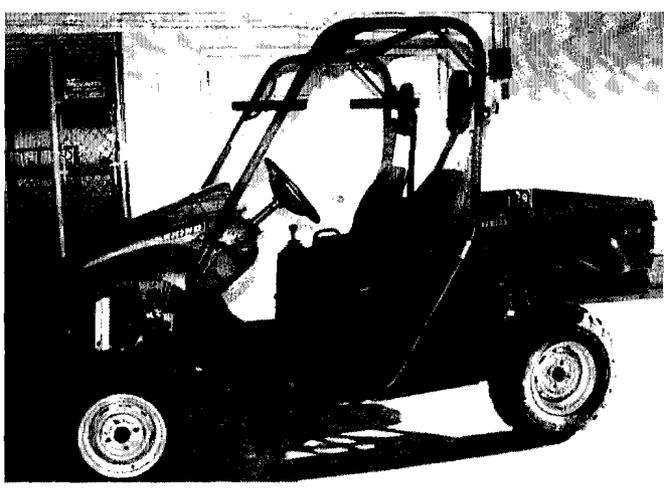
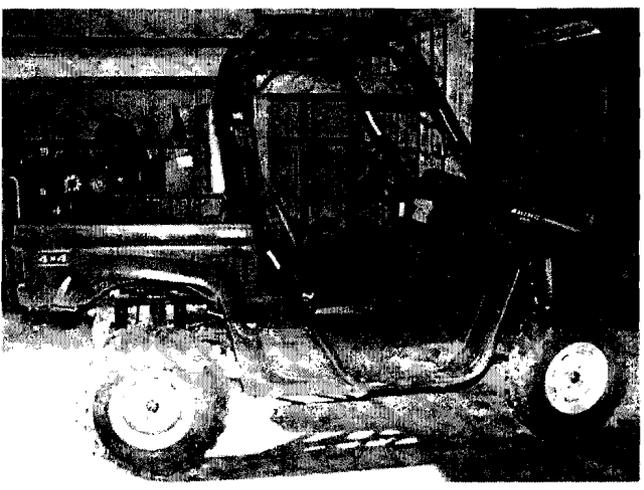
**Figure 1:**  
Seating Chart and Subject Vehicle  
Photographs

The Crow subject vehicle was inspected on October 31, 2007 at The Engineering Institute by Alex Roberts and Cord Guthrie. The subject vehicle is a red Yamaha Rhino 450. The vehicle emission control sticker indicates that the engine displacement is actually 421 cubic centimeters. The VIN as found on the left side frame rail near the rear suspension mounts is 5Y4AJ19Y67A009409.

**GENERAL OBSERVATIONS:** The vehicle exhibits very little overall damage and is operational. The vehicle was driven between The Engineering Institute high-bay and our indoor storage facility next door (about 100 feet apart) a few times and seemed to operate normally. Also, Andy Irwin indicates in his reconstruction report that "operation of the vehicle was completed in all modes of travel." (pg. 5) There are light scratches on the right side of the roll cage consistent with a ¼, passenger side leading rollover accident.

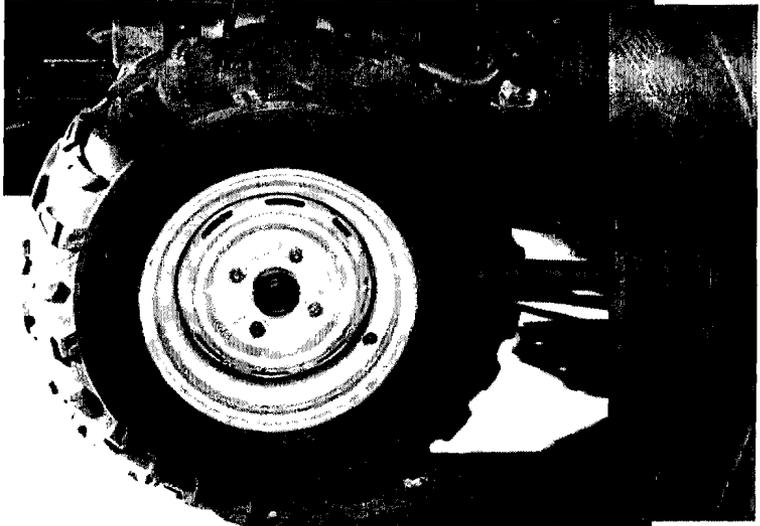
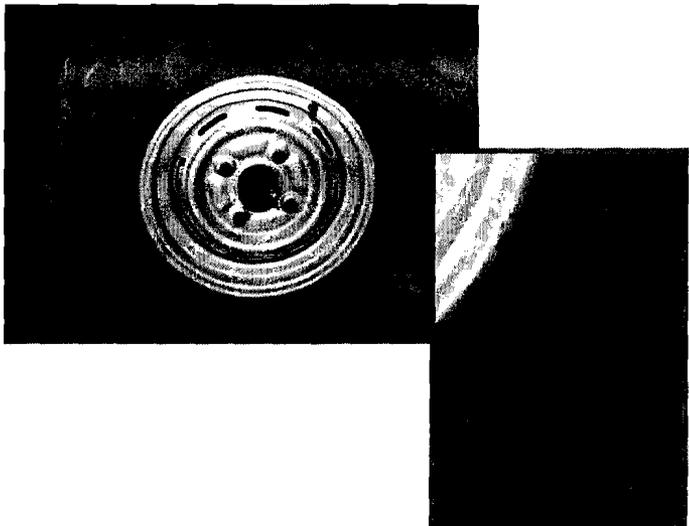
Figure 2: Tire Pressure Recommendations, Left Rear Tire (left) and Left Front Tire (right)

**TIRES & WHEELS:** The recommended tires for this vehicle are Maxxis 25X8-12NHS type M951Y for the front and Maxxis 25X10-12NHS type M952Y for the rear. The owner's manual and a warning sticker below the driver's seat recommend tire pressures of 10 psi in the front and 14 psi in the rear. However, the Yamaha Motorcycle and Scooter Set-Up and Predelivery Checklist that was with the owner's manual instructs that the person checking the vehicle "adjust pressure according to specific assembly manual." The person who filled out the paperwork indicated that the tire pressure was set to 10 psi front and 10 psi rear. The signature on this sheet appears to be *Frank G.*

- Left Front: This tire is a Maxxis 25X8.00-12NHS. The tire shows little wear. The tire is inflated to 8 psi. The wheel size is 12X6.0AT-TSY. All lug nuts are present.
- Left Rear: This tire is a Maxxis 25X10.00-12NHS. The tire shows little wear. The tire is inflated to 11 psi. The wheel size is 12X7.5AT-TSY. All lug nuts are present.
- Right Rear: This tire is a Maxxis 25X10.00-12NHS. The tire shows little wear. The tire is inflated to 12 psi. The wheel size is 12X7.5AT-TSY. All lug nuts are present.
- Right Front: This tire is a Maxxis 25X8.00-12NHS. The tire shows little wear. The tire is inflated to 8 psi. The wheel size is 12X6.0AT-TSY. All lug nuts are present. There is a small amount of grass or straw between the wheel flange and tire. With the valve stem represent the 12 o'clock position, this debris is at approximately 12 o'clock and 7 to 8 o'clock.

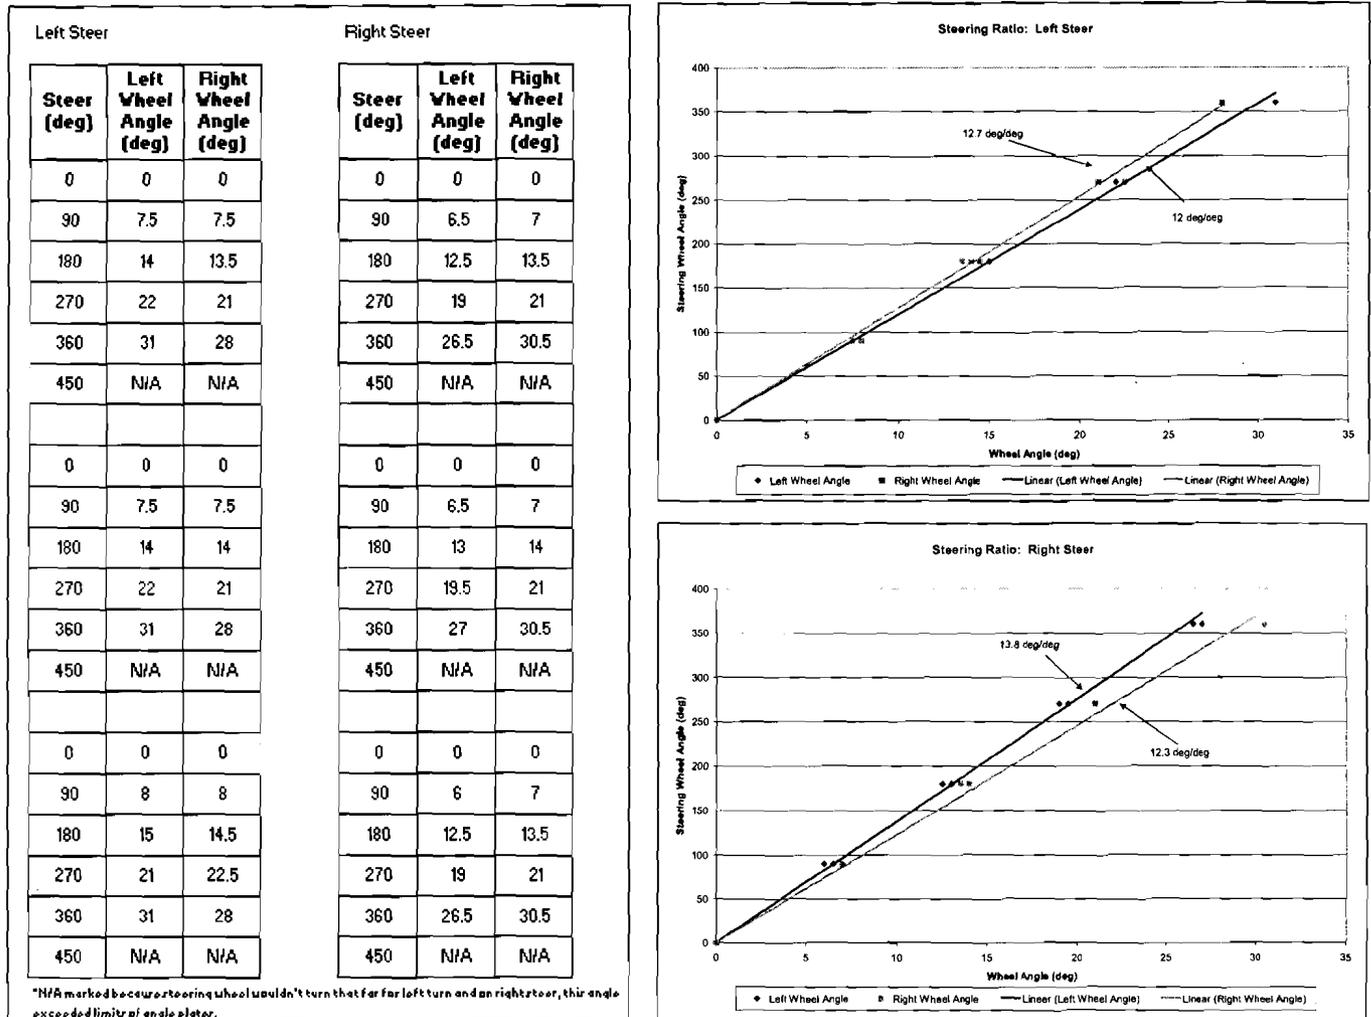
**Figure 3: Steering Ratio Data**

**STEERING:** The vehicle's steering ratio was measured by placing the front tires on angle plates. These plates measure the angle of the tires. By turning the steering wheel in increments of 90 degrees and measuring the left front and right front tire angle, the steering ratio can be determined. The plates did not return to zero after the first measurements performed the day of the inspection. Therefore, this was repeated on March 10, 2008. Left and right steers were performed three times each on the 10<sup>th</sup> to check for consistency. The table below and the plots indicate the results of the March 10<sup>th</sup> testing.

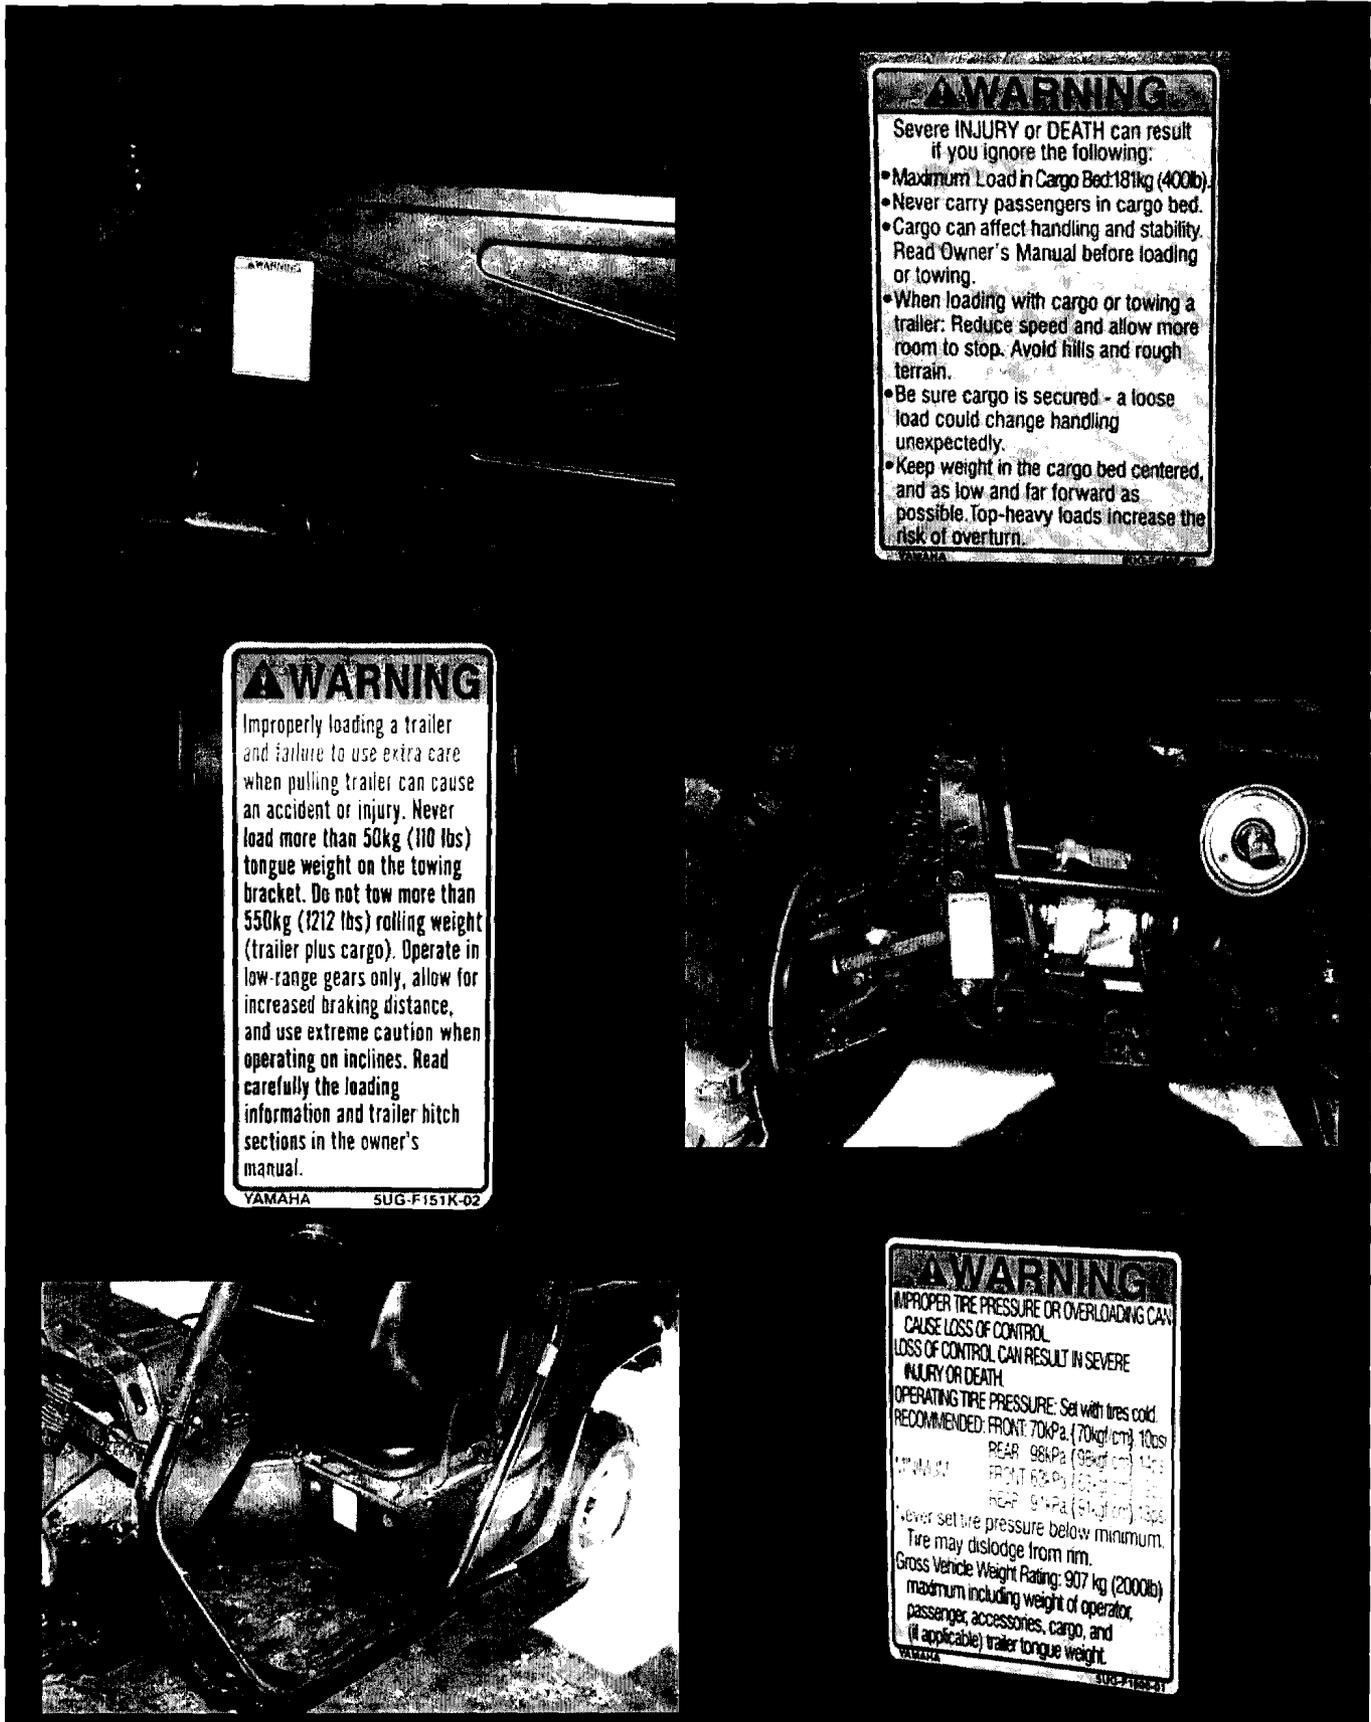
**WARNINGS:** The following photographs illustrate the warnings found on this vehicle.

**WARNING**

Severe INJURY or DEATH can result if you ignore the following:

- Maximum Load in Cargo Bed: 181kg (400lb).
- Never carry passengers in cargo bed.
- Cargo can affect handling and stability. Read Owner's Manual before loading or towing.
- When loading with cargo or towing a trailer: Reduce speed and allow more room to stop. Avoid hills and rough terrain.
- Be sure cargo is secured - a loose load could change handling unexpectedly.
- Keep weight in the cargo bed centered, and as low and far forward as possible. Top-heavy loads increase the risk of overturn.

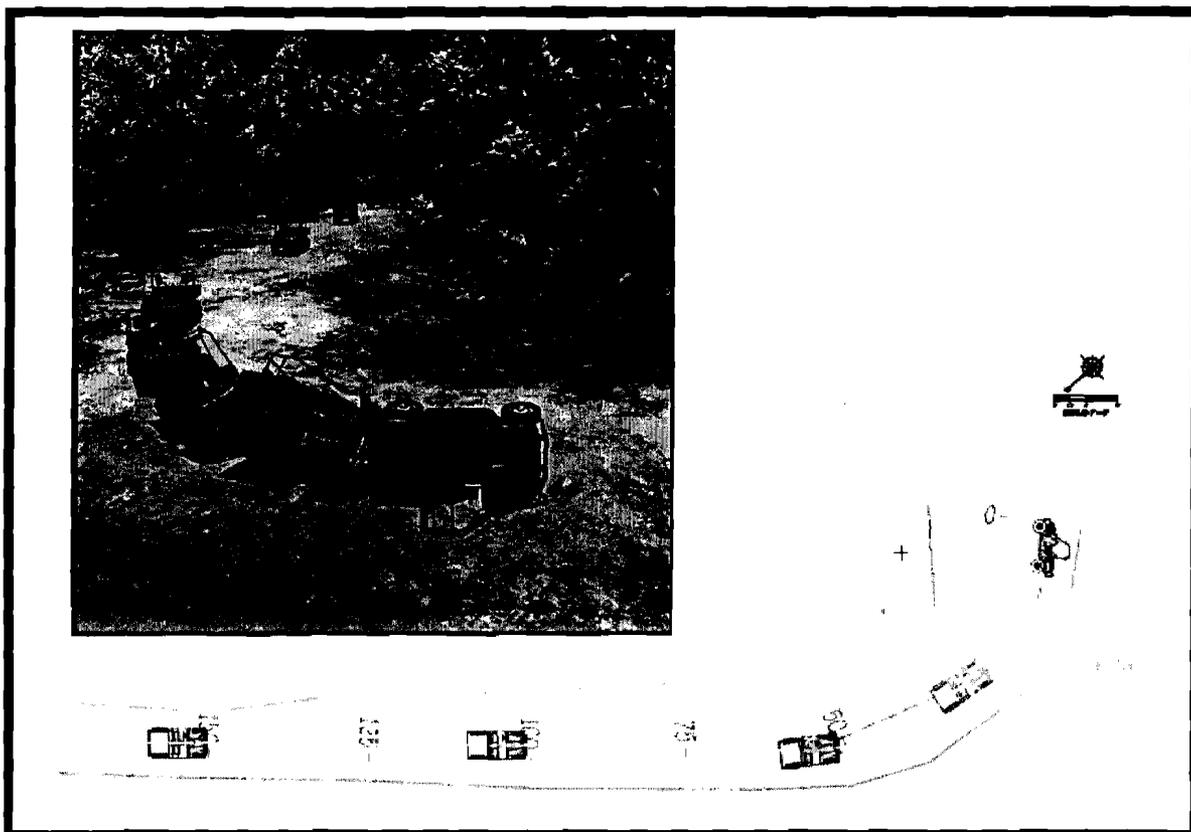
Figure 7: Reconstruction Diagram  
and Image

The accident sequence was reconstructed by Andy Irwin of Scientific Analysis. An illustrated overview is shown below.

Mr. Irwin established a "range of turn paths" based on information from Mr. Mattox. These paths consisted of turns of radii equaling approximately 22 feet, approximately 24 feet, and approximately 38 feet. Mr. Irwin calculated entry speeds of between 14 and 19 mph based upon these radii and the average deceleration developed during his brake skid testing (about 0.53 g's). According to the reconstruction report, there was minimal sliding after the rollover.

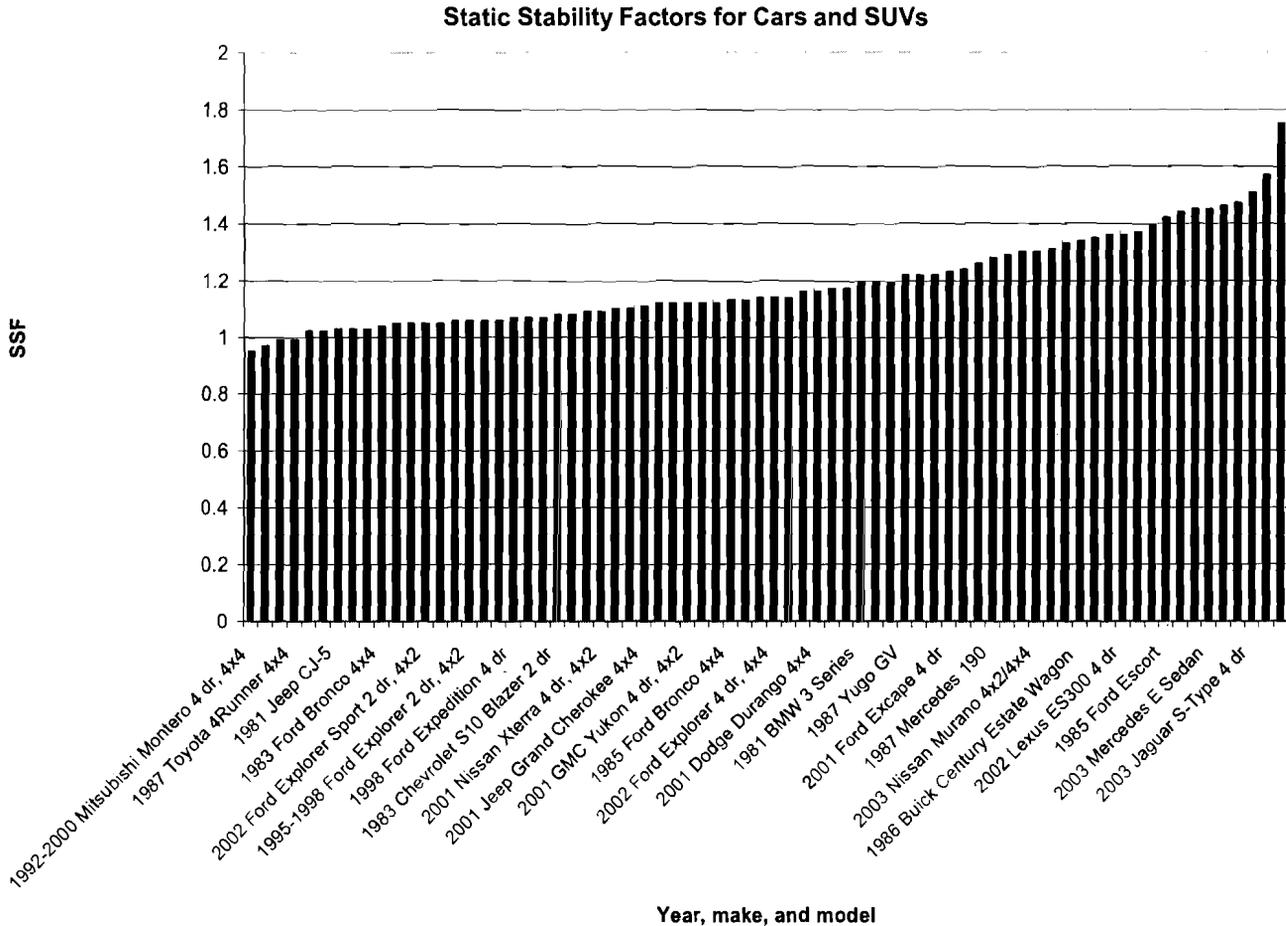
**Figure 8: SSF for Various Cars and SUVs**

According to the National Highway Traffic Safety Administration (NHTSA), "One of the primary means of assessing rollover risk is the static stability factor (SSF), a measurement of a vehicle's resistance to rollover." [4] The SSF is expressed in units of G's. The plot below was created using the SSF numbers listed by NHTSA in this report.

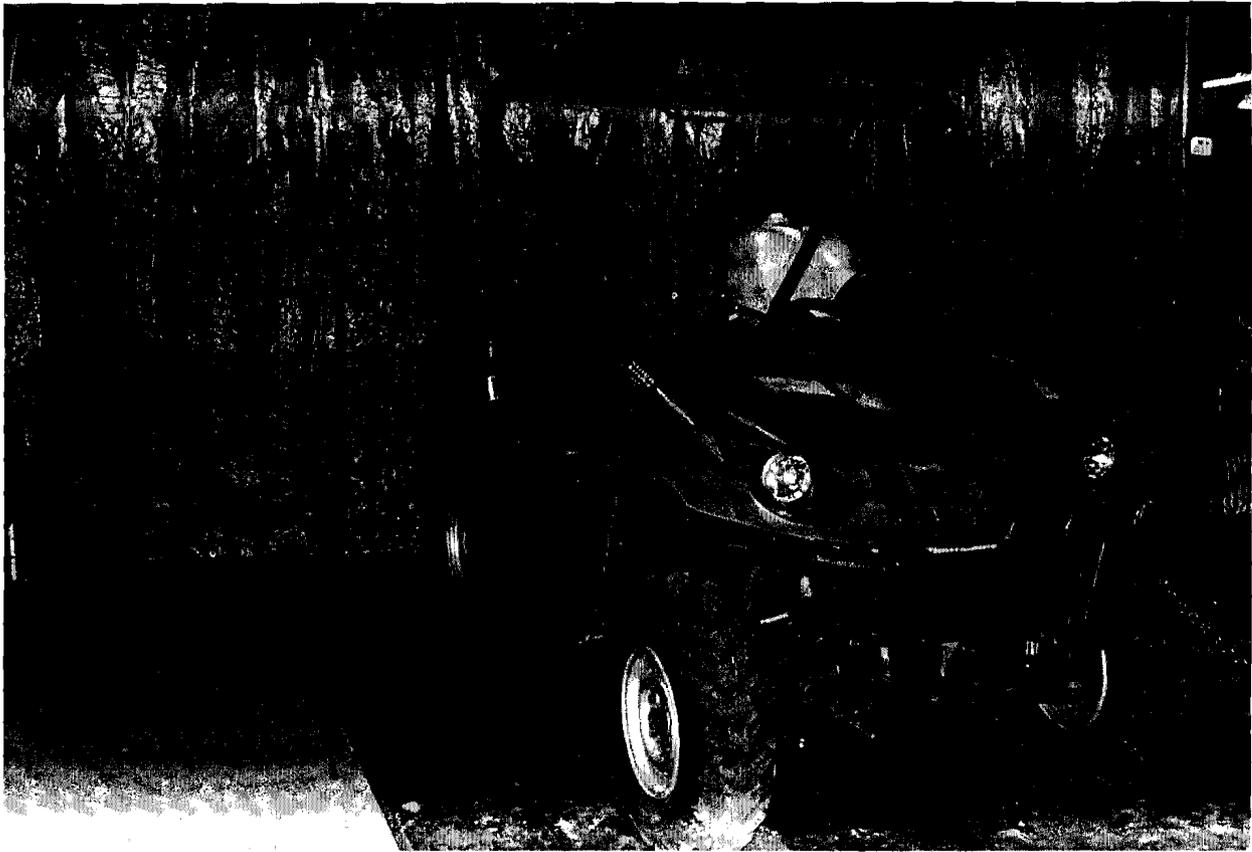
**Figure 9: Photograph of Rhino Test Set-Up**

The subject Yamaha Rhino was tested in four loading configurations. No fluids were added or removed from the vehicle prior to testing. The gas level, oil level, et cetera were in the "as received" states. The four loading configurations tested were vehicle only, vehicle plus 160 lb. driver, vehicle plus 160 lb. driver and passenger, vehicle plus 160 lb. driver and passenger and sand bags placed in the bed until the vehicle was loaded to near GVWR. All tires were set to 10 psi for all loading configurations per the recommendations of the Yamaha Set-Up and Predelivery Checklist.

For the vehicle only configuration, the weight of the vehicle was 1107 lbs. The slight lateral offset of the weight distribution was accounted for in the calculations of the center of gravity height by adjusting the  $t/2$  portions of the formula accordingly.

For this configuration, the average center of gravity height was found to be about 24.5 inches.

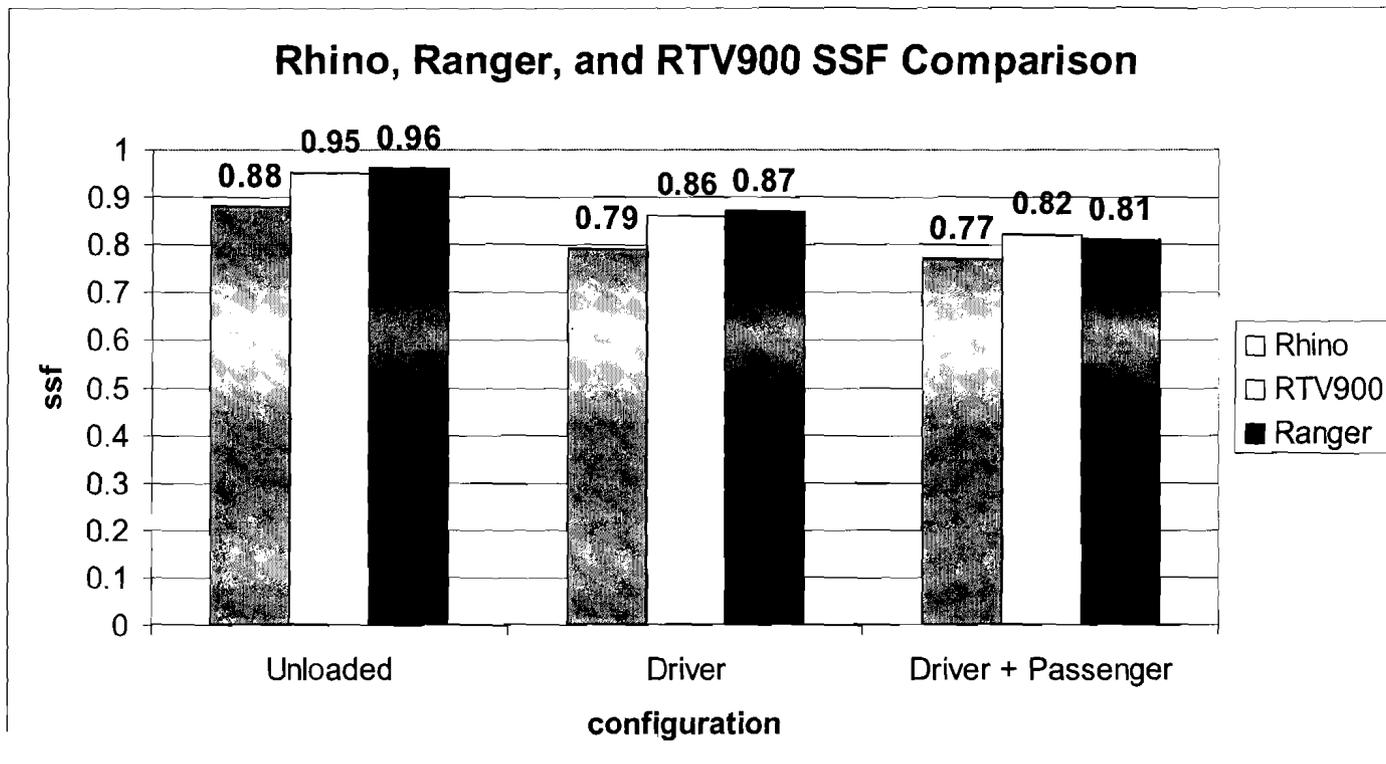
Figure 12: Comparison of Yamaha Rhino, Polaris Ranger, and Kubota RTV900 SSFs for Various Loading Configurations

The fact that the Ranger's track is wider than the Rhino resulted in the Ranger having a significantly higher SSF unloaded. The higher seating position of the occupants, however, resulted in the vehicles being more comparable with driver plus passenger. The Kubota's track was not as wide as the Ranger, but its center of gravity was lower. It also had higher SSFs than did the Rhino. Figure 12 shows a direct comparison between the results from the three vehicles.

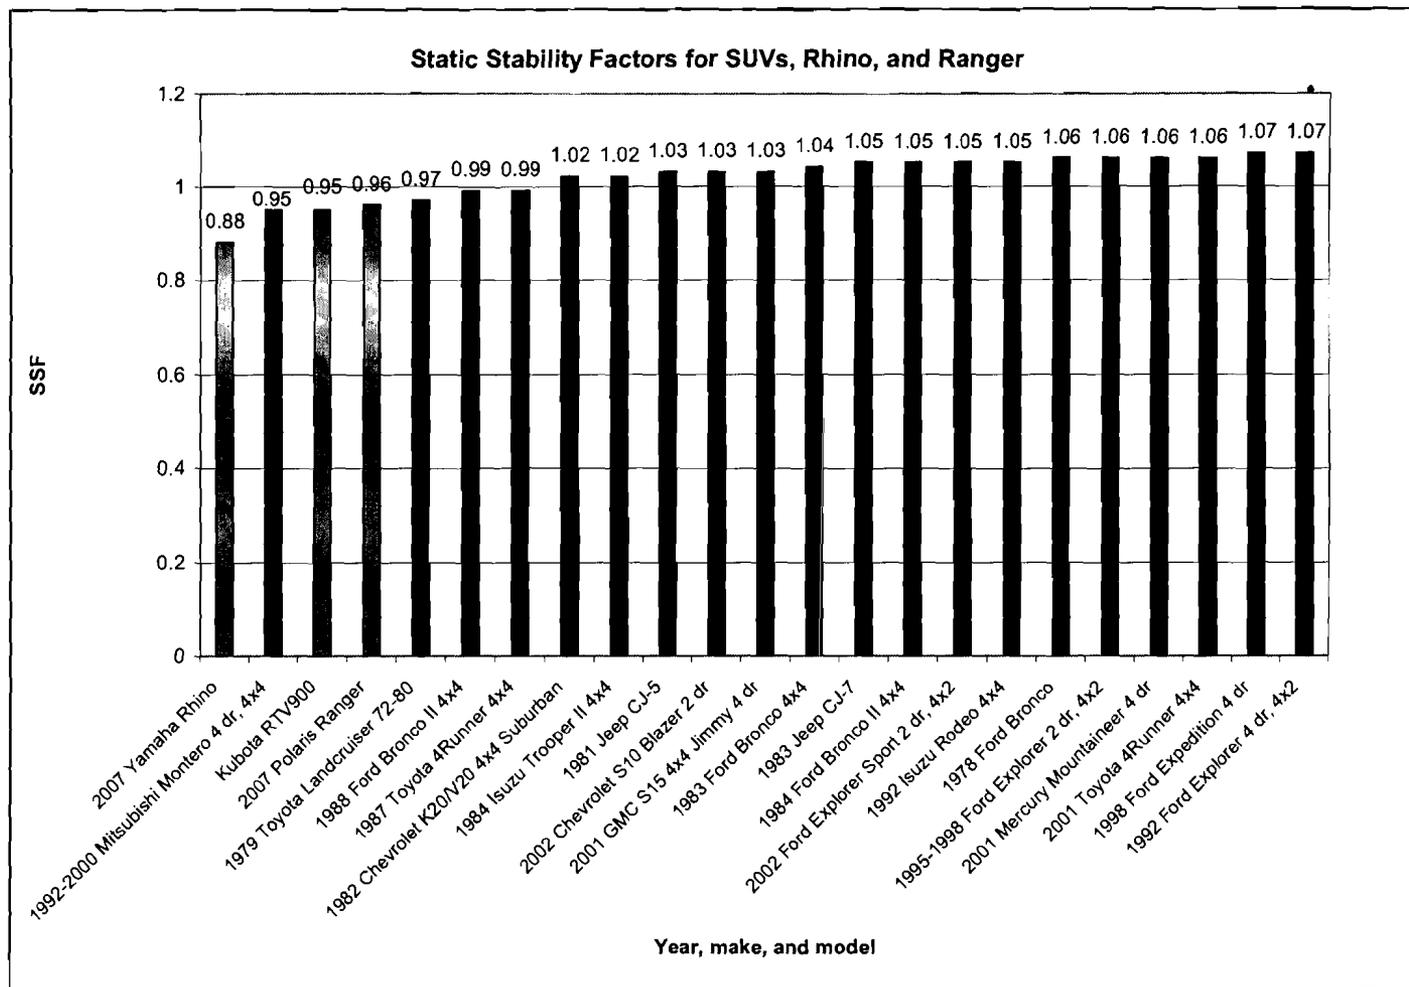
**Figure 13: SSF of Rhino, Ranger, and RTV900 Plotted with SSFs of SUVs**

The numbers reported by NHTSA for the SSFs of the vehicles in their study were established with the vehicles unloaded. Therefore, as a direct comparison, the Ranger, Rhino, and RTV900 SSFs unloaded will be plotted along with several SUVs. The SSF of the Yamaha Rhino is lower than any vehicle reported by NHTSA, while the Ranger has a SSF that is higher than the 1992-2000 Mitsubishi Montero 4X4 while the Kubota's unloaded value was equal to the Mitsubishi.

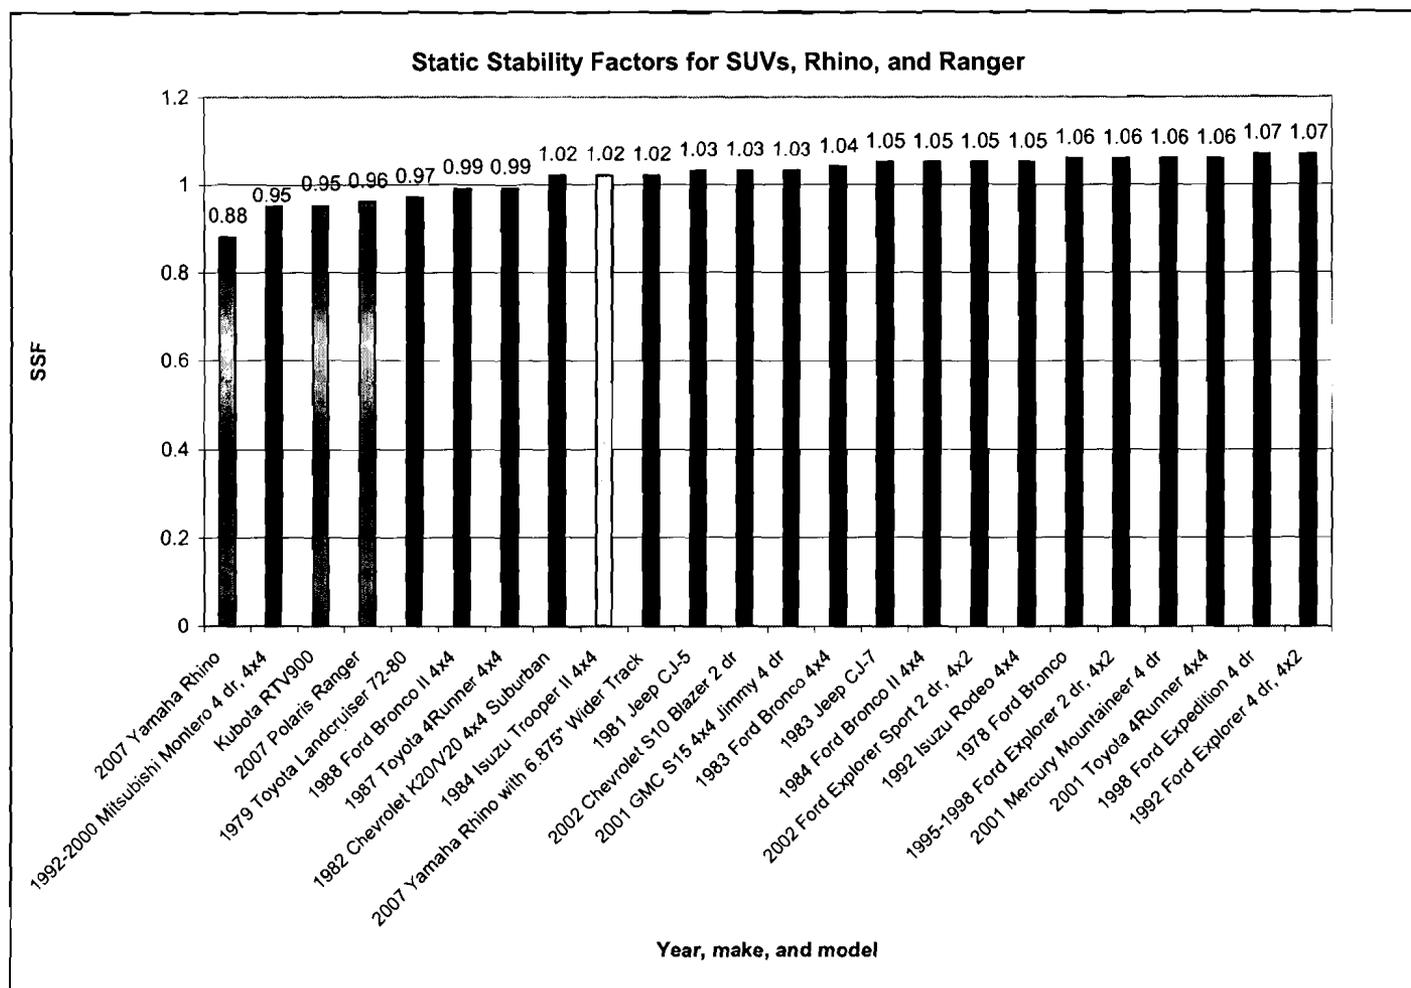
**Figure 14: SSFs for SUVs, Rhino, Ranger and Theoretical Modified Rhino**

Also, with this increased track, the vehicle's SSF when loaded with two, 160 lb occupants would increase to 0.88 assuming the center of gravity height measured in the tilt table testing with two occupants did not change. This value of 0.88 is the equivalent to the unloaded Yamaha Rhino as designed.

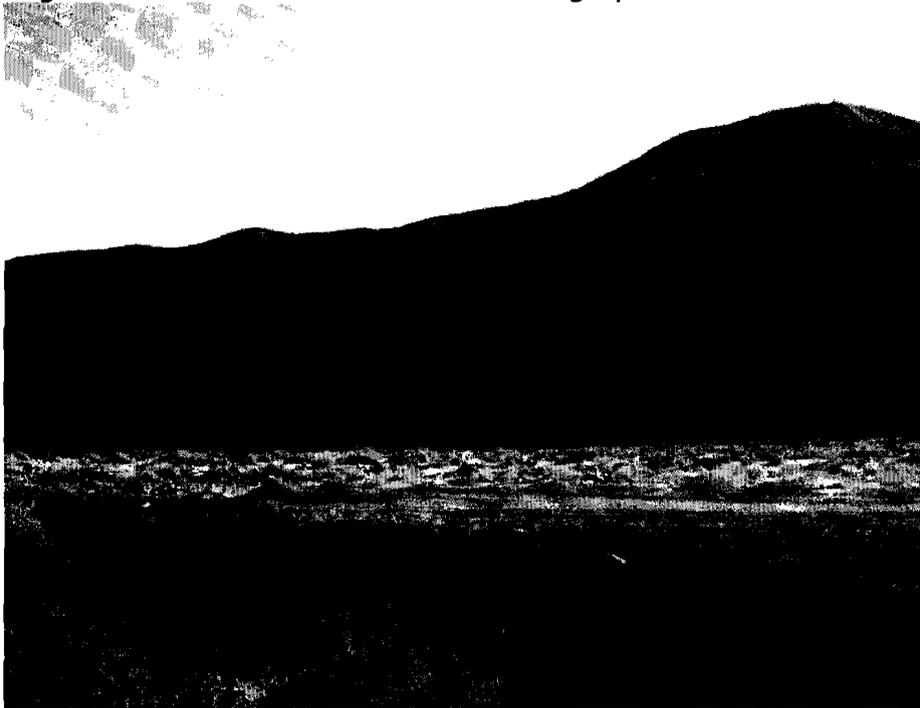
5.1 – View of steep embankment the victim was traversing down when she lost control and rolled.

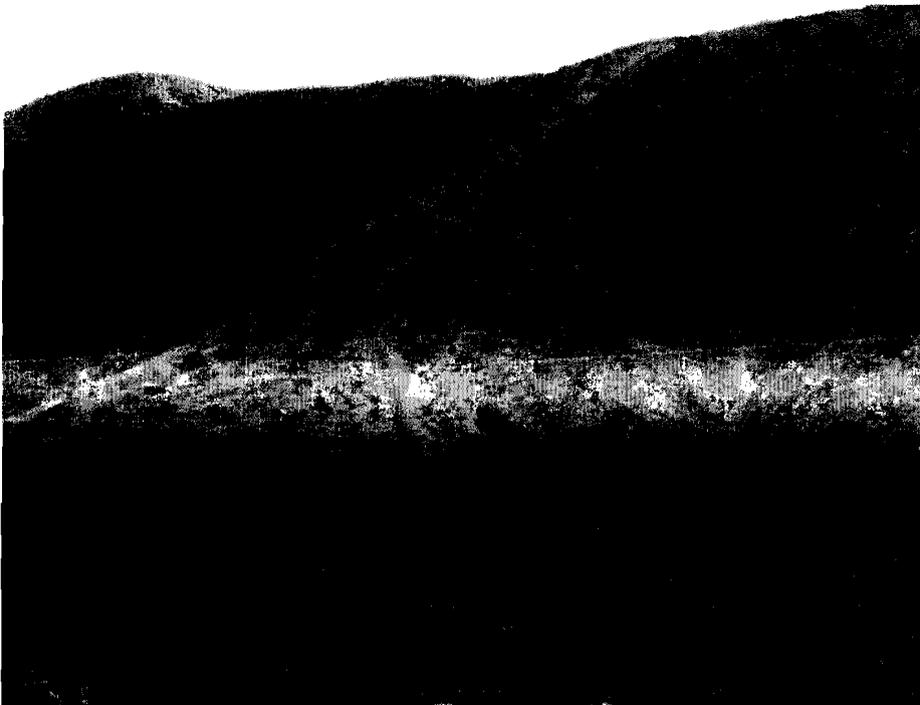
5.2 – Arrow points to approximate area the victim lost control and her UTV started to roll.

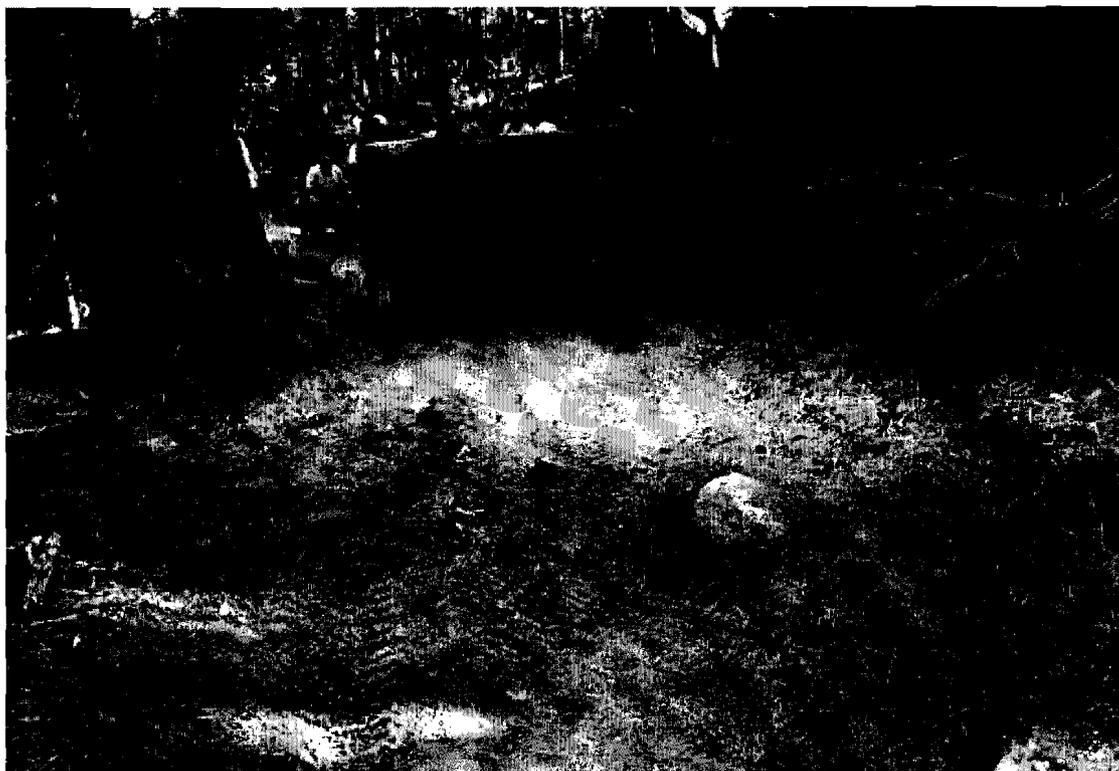
Photo #1 – View of the Utility Vehicle on its left side. View is facing the rear lower part of the UTV.

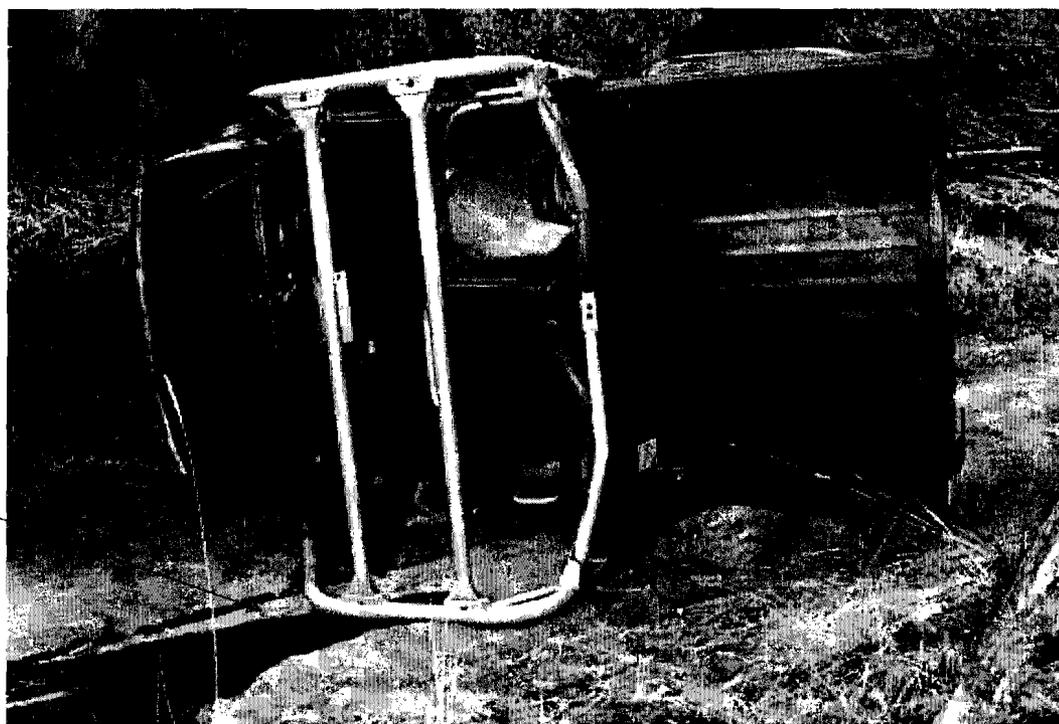
Photo #4 – View of the top side of the UTV. The arrow is pointing to where the victim was found with his head near the roll away bar of the UTV.

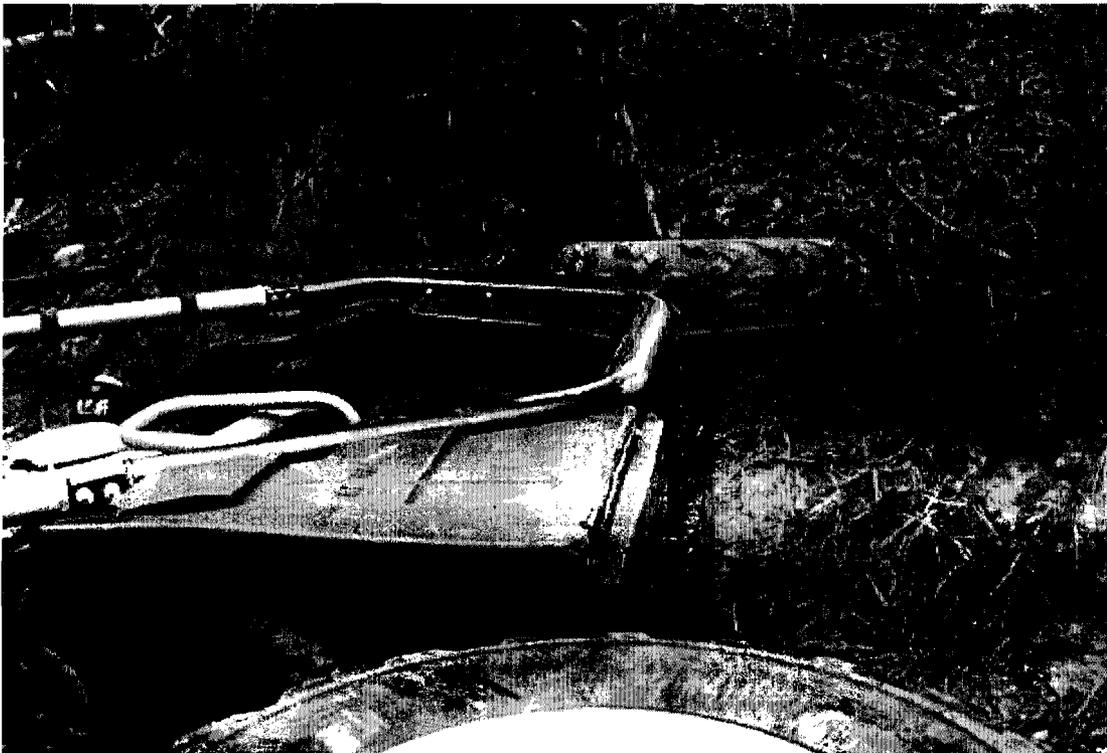
Photo #10 – This is a view of the right side of the UTV. The arrows are pointing to scrapes and scratches on the UTV.

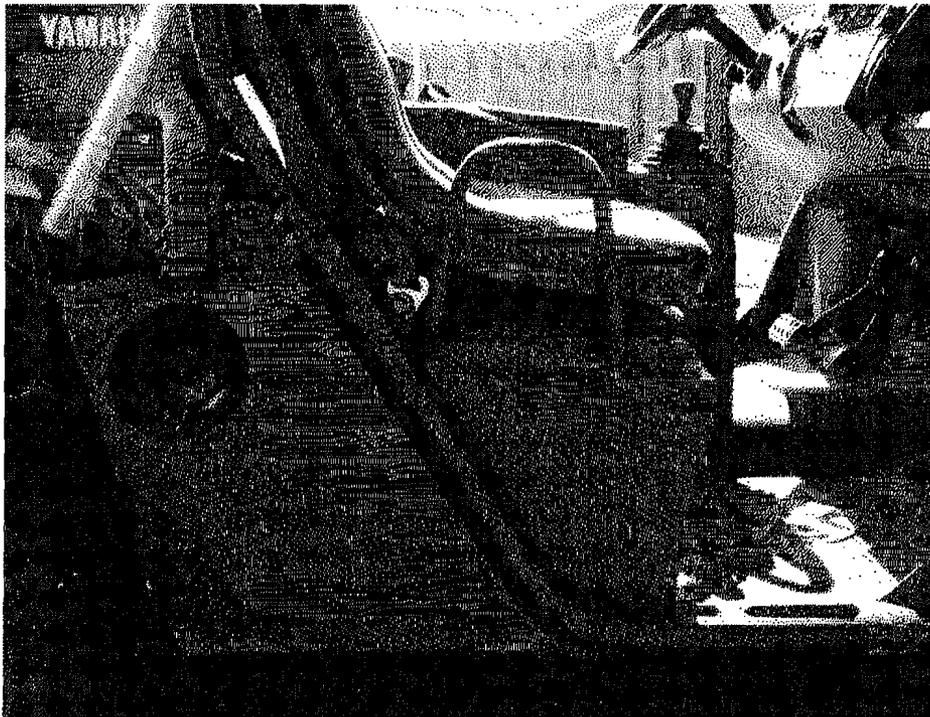
**Photo F: Passenger side damage and floor board opening**

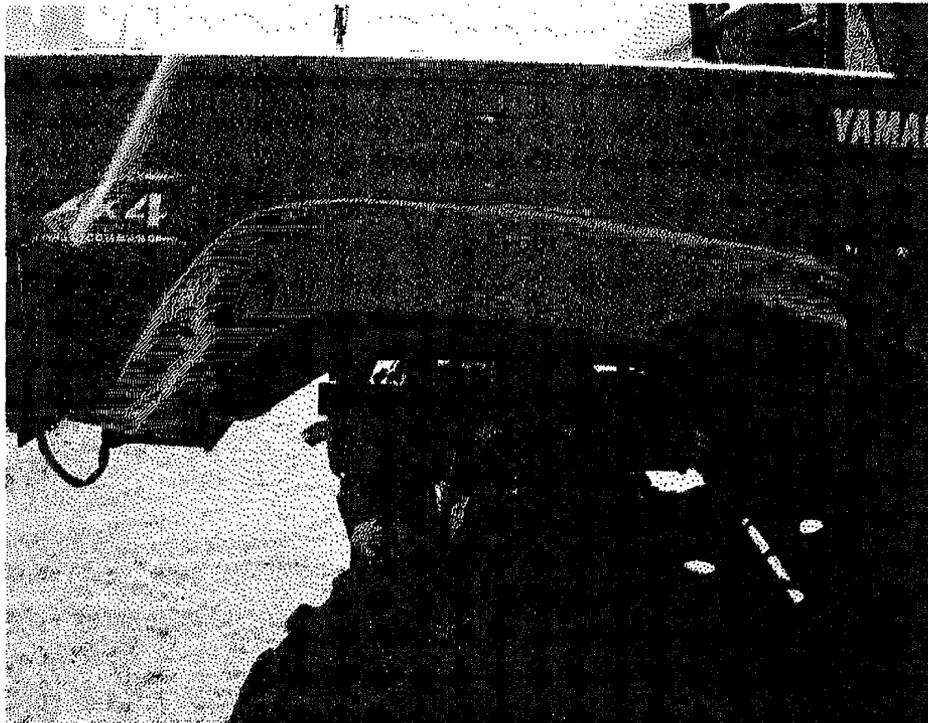
**Photo G: Passenger side damage**

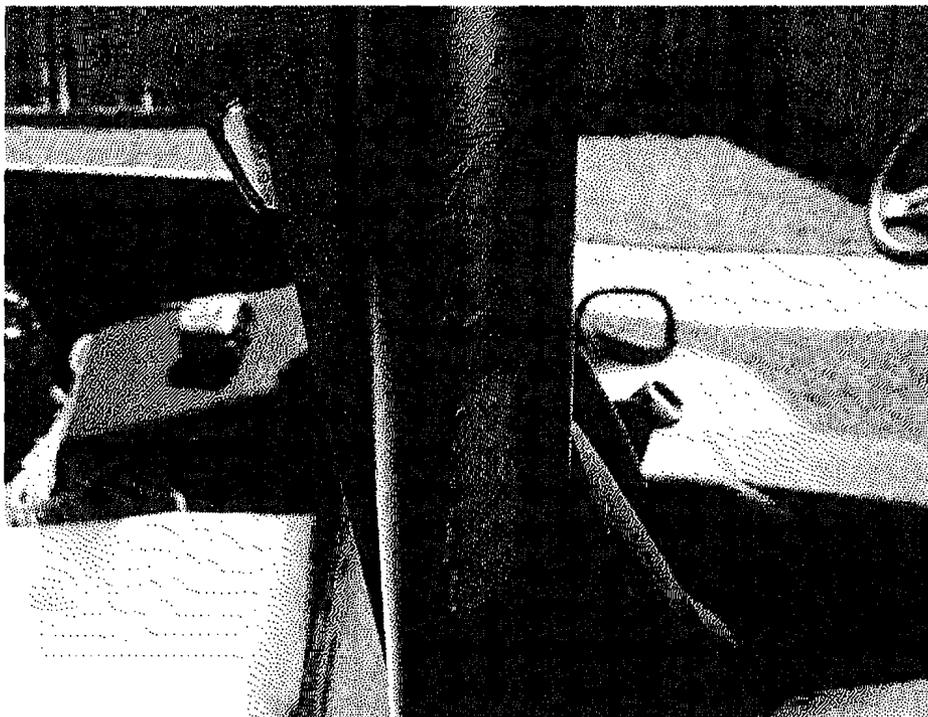
**Photo H: Damage on passenger side roll bar**
