Consumer Product Safety Commission (CPSC) Staff's Statement on Naval Surface Warfare  
Center, Carderock Division's ("NSWCCD") Report on "Evaluation of Cell-to-Cell Propagation in  
Lithium-Ion Batteries Containing 18650 Sized Cells"  
October 2019

NSWCCD-63-TR-2018/43

Platform Integrity Department

## Evaluation of Cell-to-Cell Propagation in Lithium-ion Batteries Containing 18650 Sized Cells

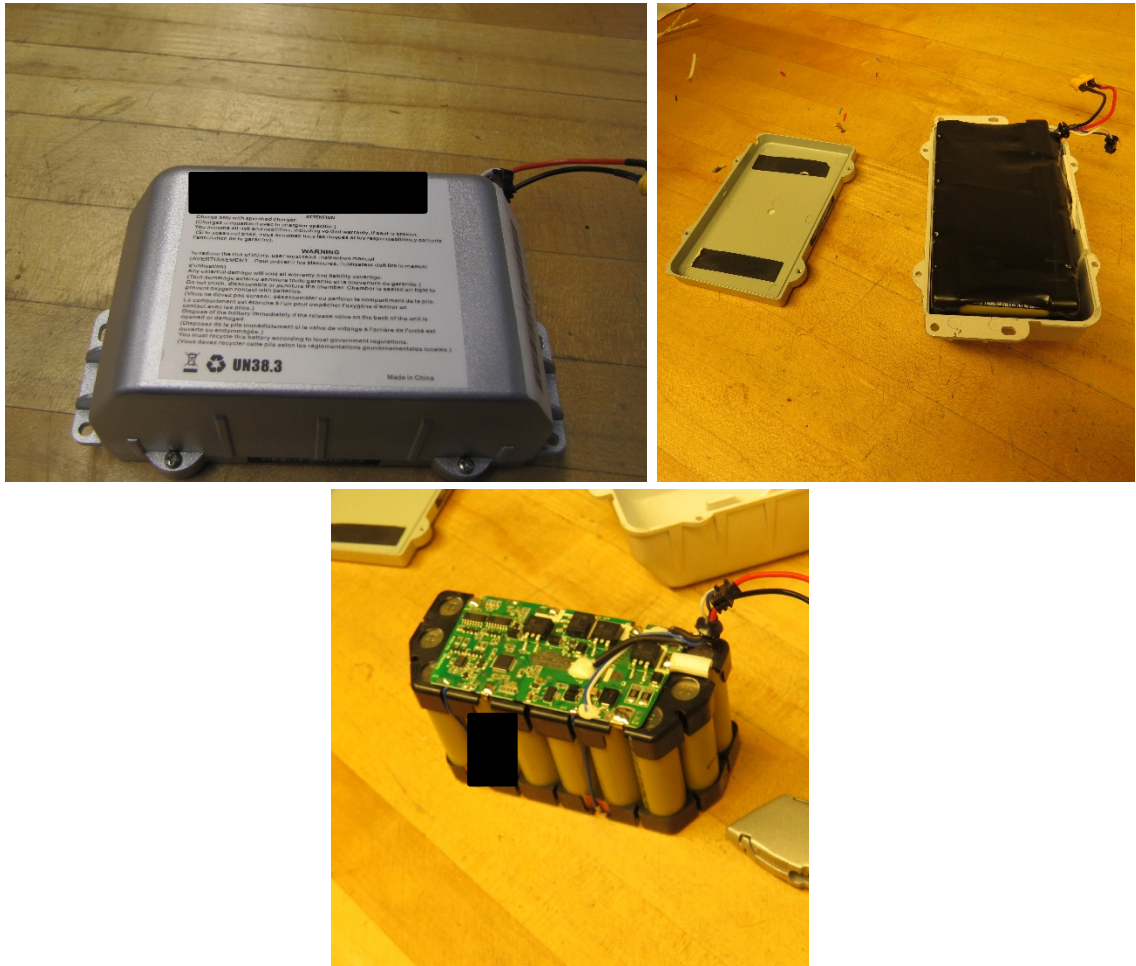
Pack B is similar in design to Pack A in that it contains multiple 18650 cells. However, Pack B utilized twenty cells of a much lower energy density and used pairs of cells in parallel which were then connected in series (10S2P, a total of 20 cells) to achieve a comparable energy content to Pack A (10S1P, a total of 10 cells). Pack B also included an aluminum housing intended to protect the cells and contain any battery failures (Figure 3). A pack-mounted electronics board is also present in Pack B, which as with Pack A is assumed to be a battery management system. However unlike Pack A, which allowed for direct measurement of the pack open circuit voltage (pack OCV) from the pack terminals, the external pack leads of Pack B had to be bypassed in order to determine the pack OCV, which implies the pack mounted electronics may be involved in preventing current flow unless certain external conditions are met. Previously observed failure events for this pack indicated that the aluminum housing can be ruptured as the result of battery failures, and the intention of this evaluation was to determine whether the housing had any influence on observed battery failures. Testing was conducted with and without the aluminum enclosure.

**Figure 3. Pack B, comprised of twenty Li-Ion ICR18650 cells in a 10S2P configuration**

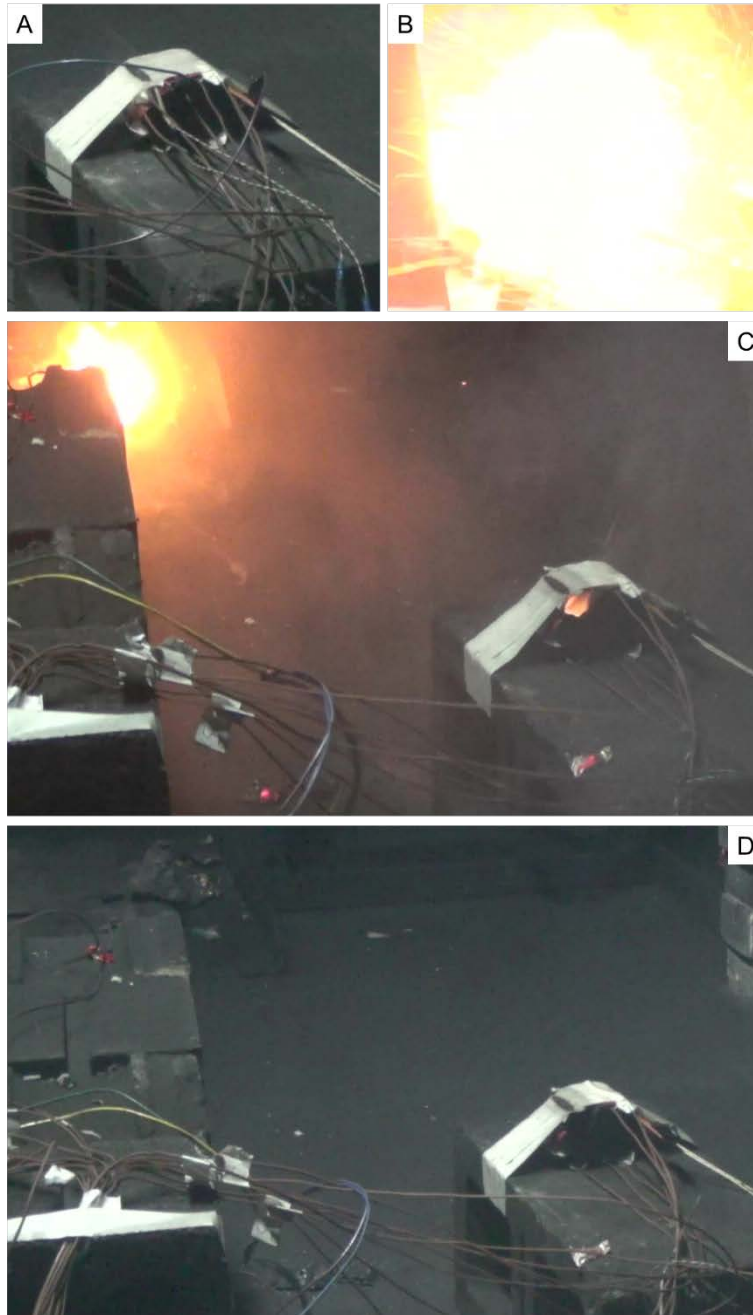
**Figure 35. Video screenshots from Pack D2 immediately prior to trigger cell failure (A), energetic failure of trigger cell resulting in sparks and flame (B), ejection of cell contents from trigger cell (C), remaining cells intact after trigger cell ejection (D)**

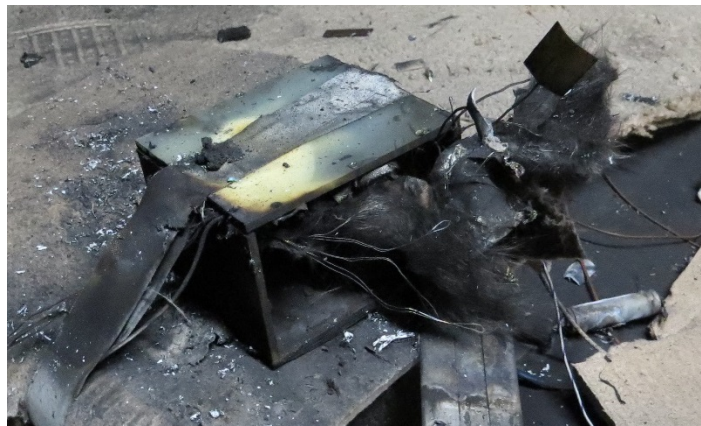
**Figure 44. Digital photograph of Pack E3 following propagating thermal runaway**
