U.S. CONSUMER PRODUCT SAFETY COMMISSION
4330 EAST WEST HIGHWAY
BETHESDA, MD 20814

131022HCC1048

This investigation was initiated from a manufacturer's batch report. The final report is under a prohibited disclosure sheet.

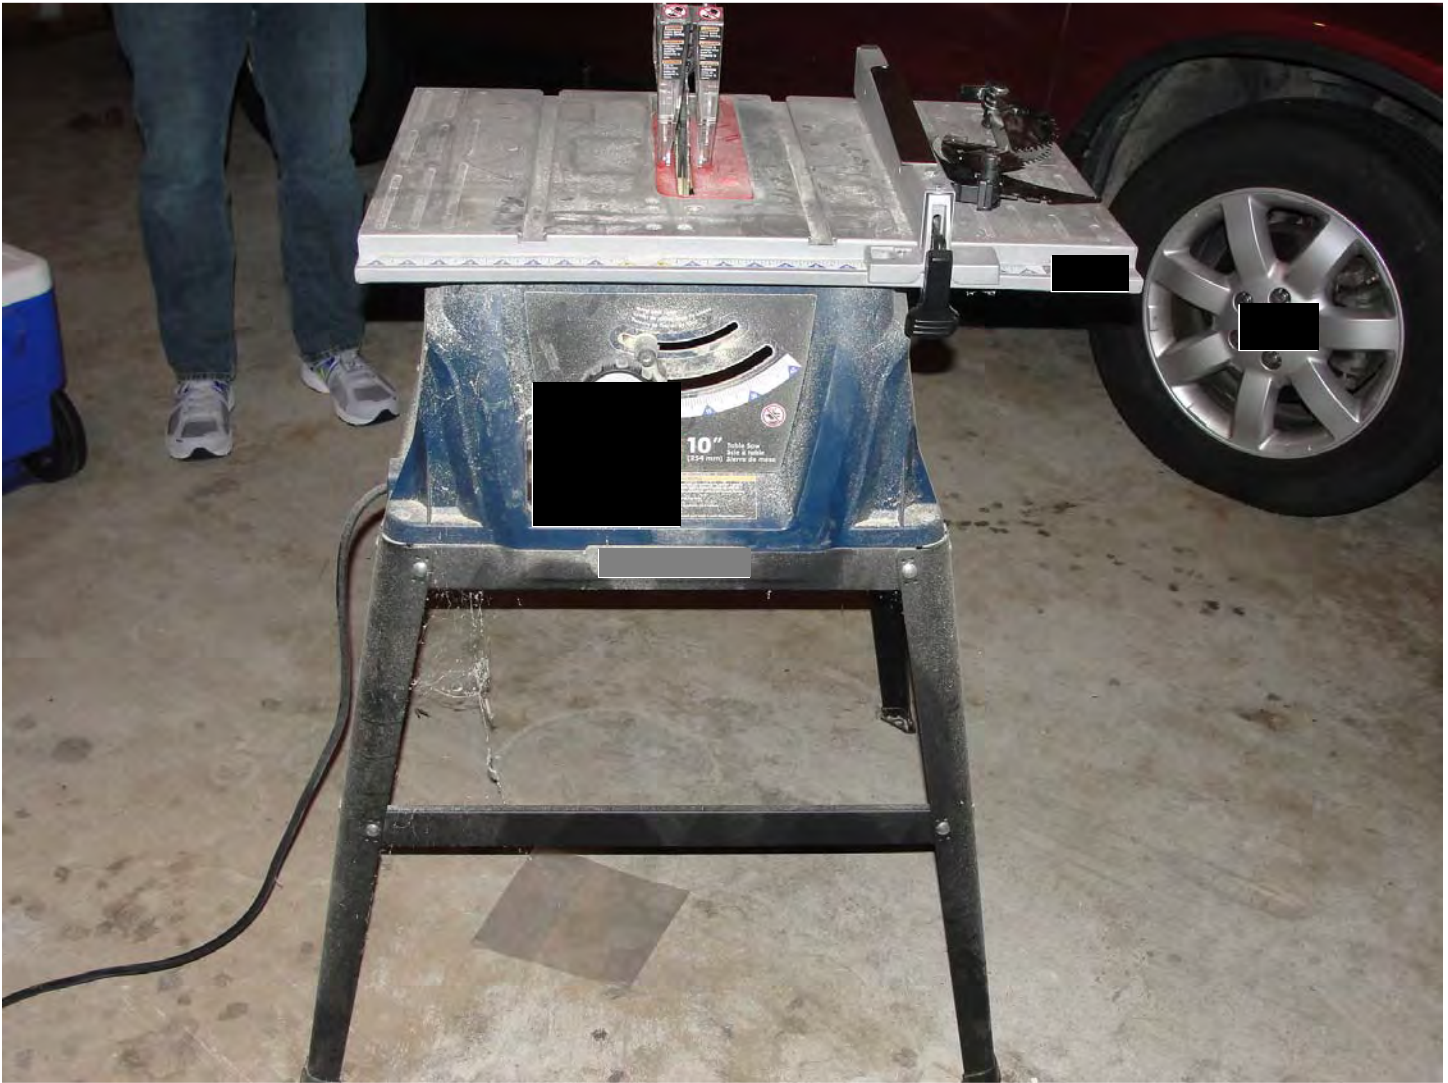
Photo 1: Overview of incident table saw with exemplar modular blade guard installed

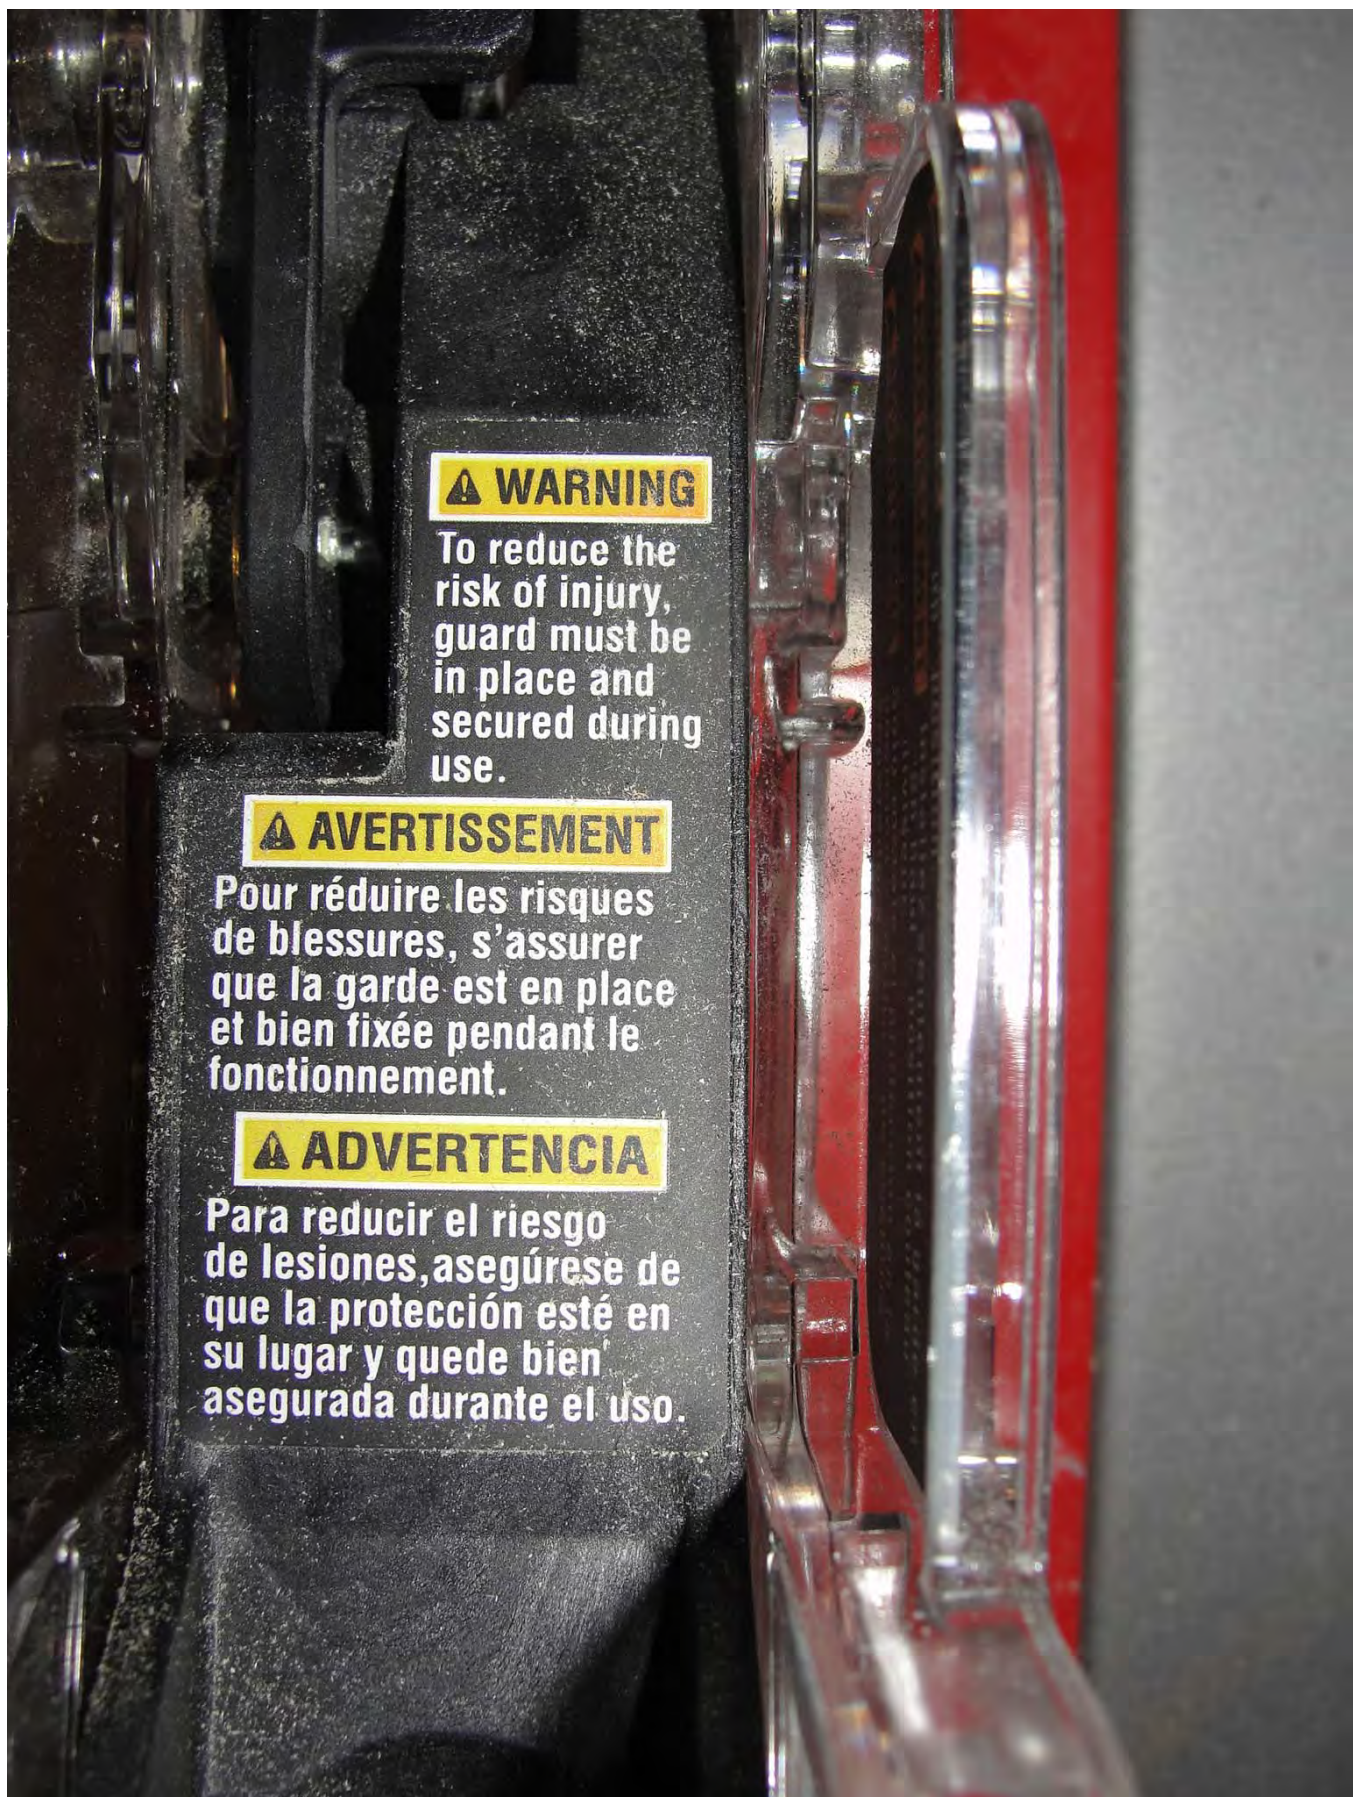
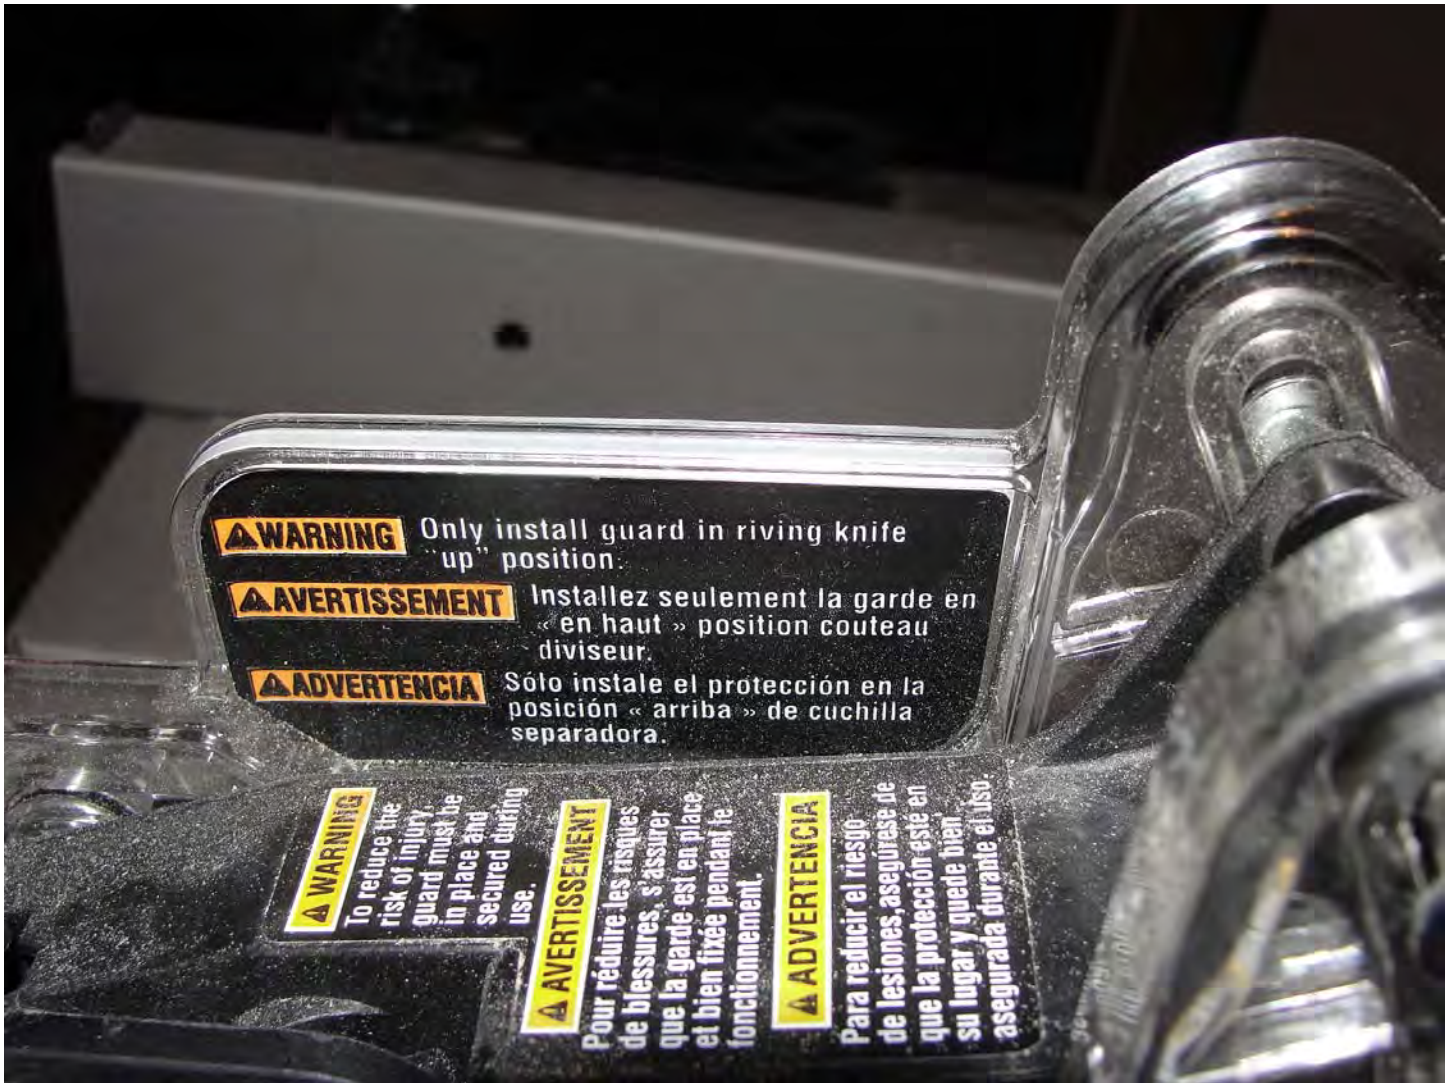
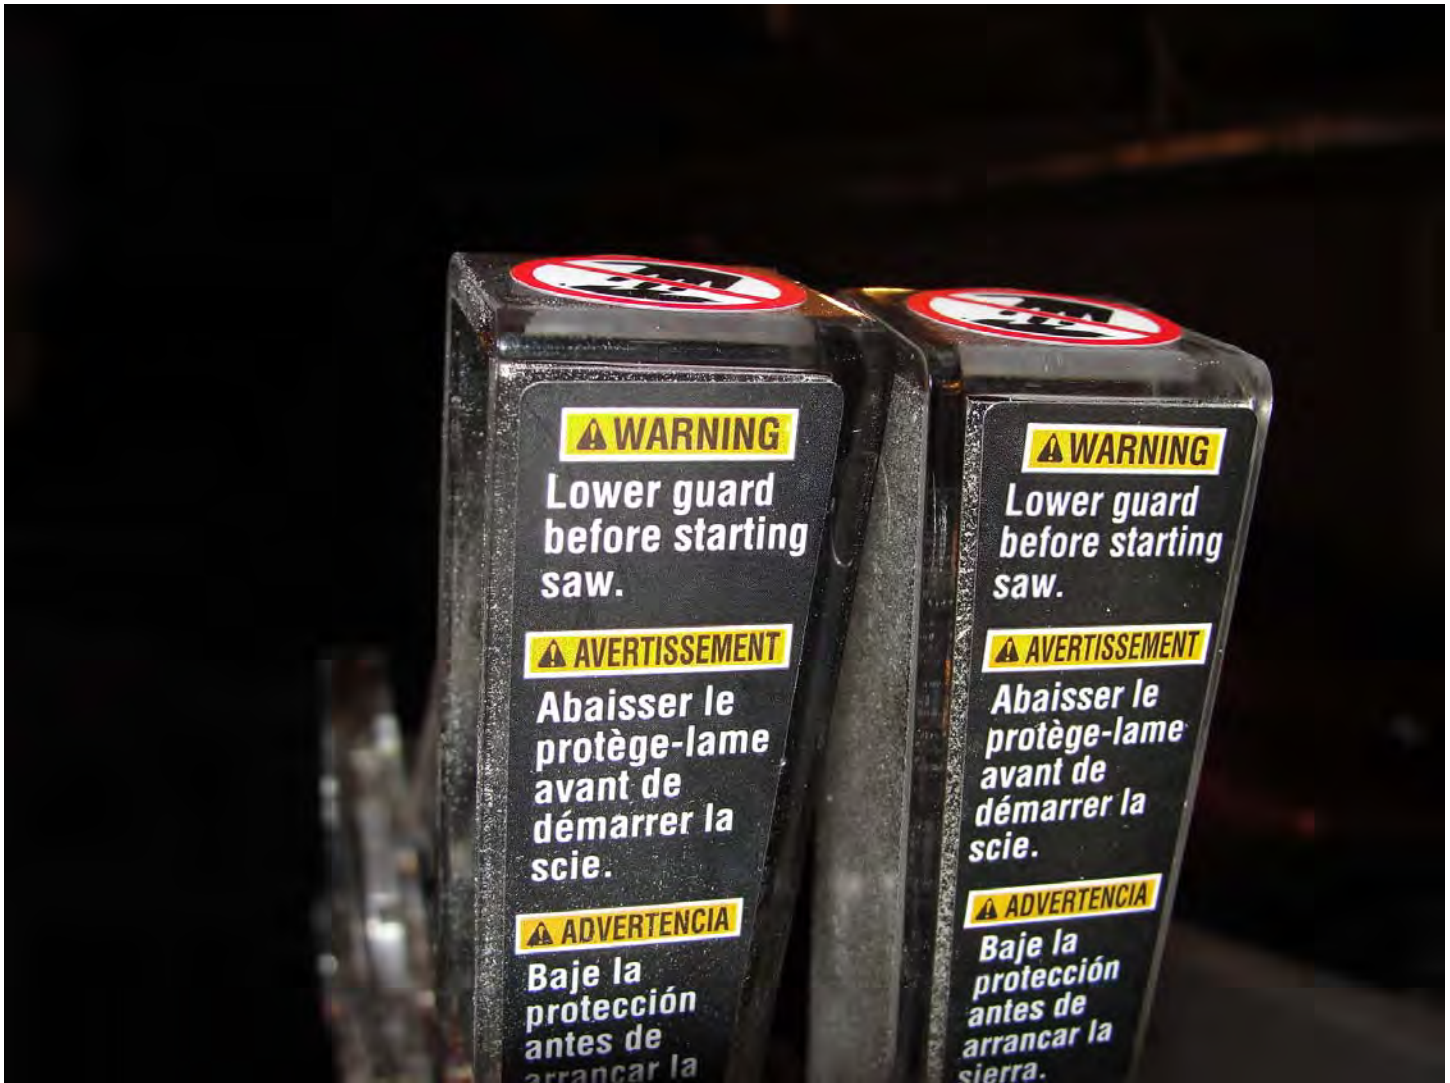
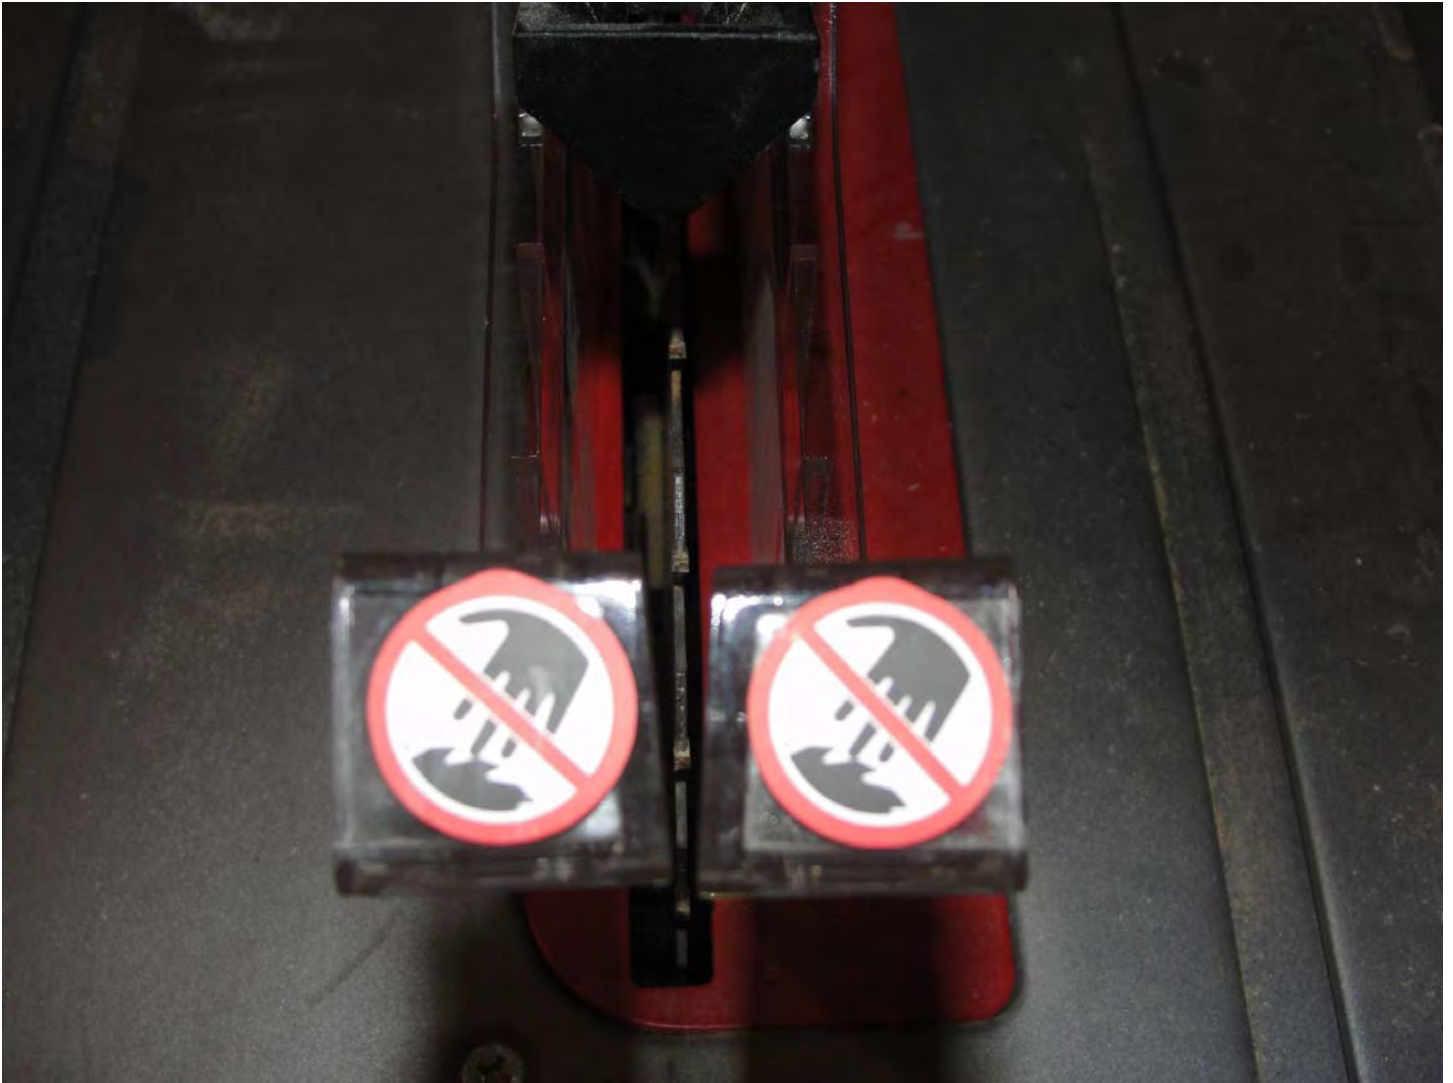
Photo 14: Labeling on exemplar modular blade guard

Photo 15: Labeling on exemplar modular blade guard

Photo 16: Labeling on exemplar modular blade guard

Photo 17: Labeling on exemplar modular blade guard

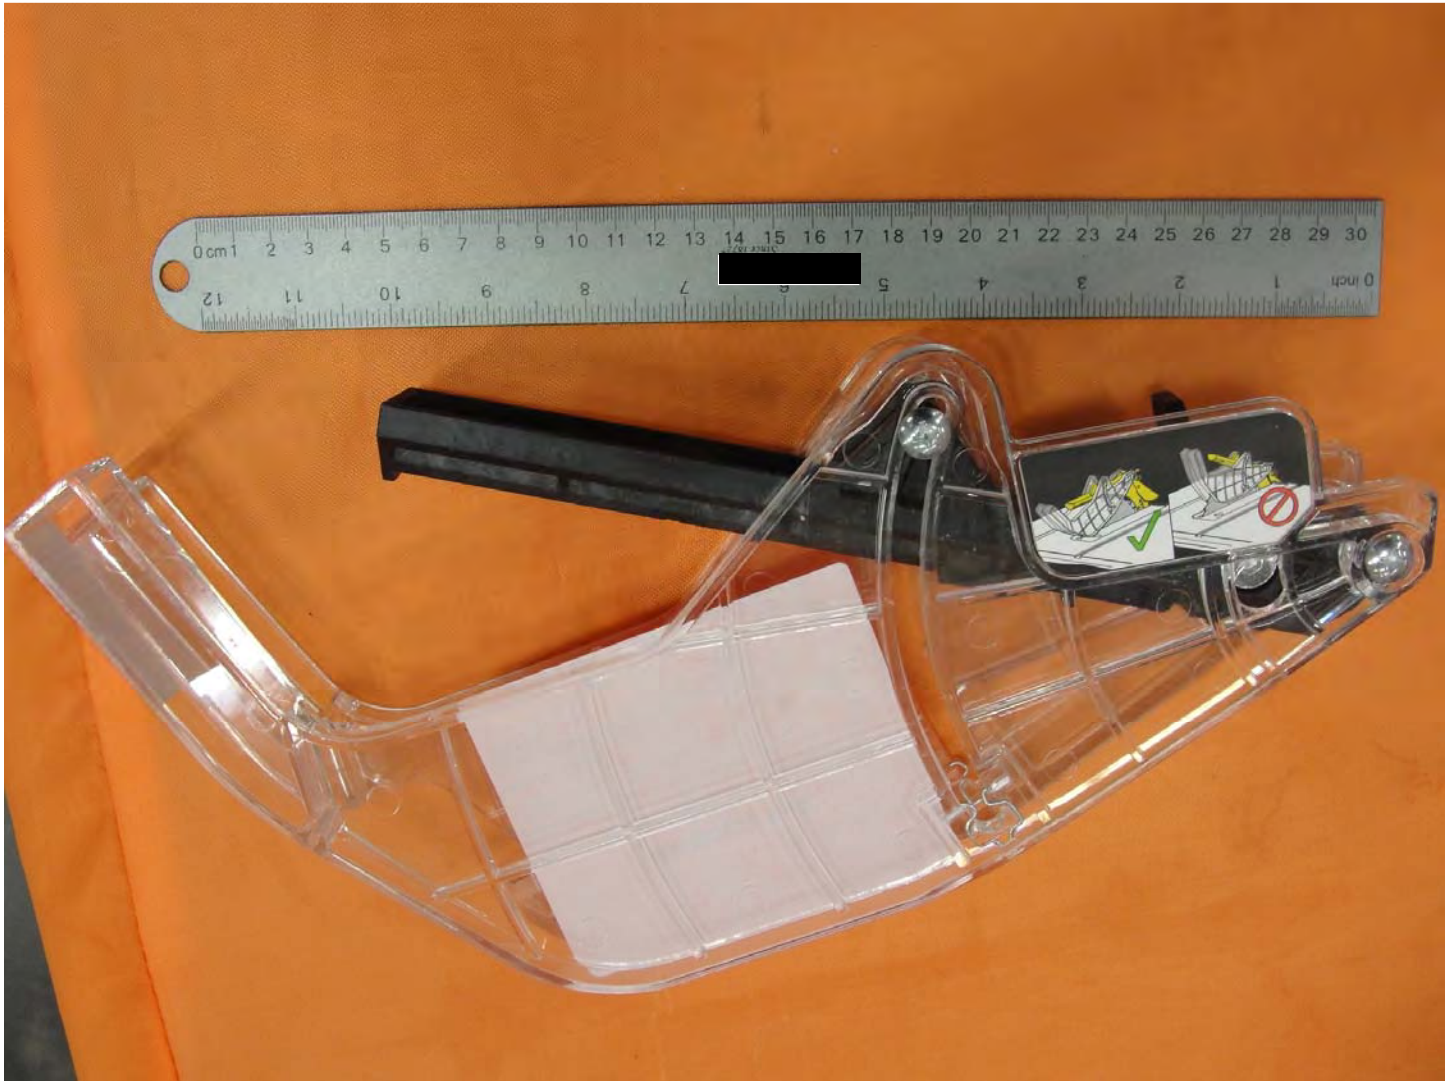
Photo 18: Overview of incident unit modular blade guard

Photo 19: Overview of incident unit modular blade guard

Photo 20: Overview of incident unit modular blade guard
