CPSC Staff's Statement on Southwest Research Institute's (SwRI's) Report,  
"Test Report – Gas Ranges"  
February 2016

# TEST REPORT

## GAS RANGES

SwRI® Document Number: 18.21642.01.100.FR1

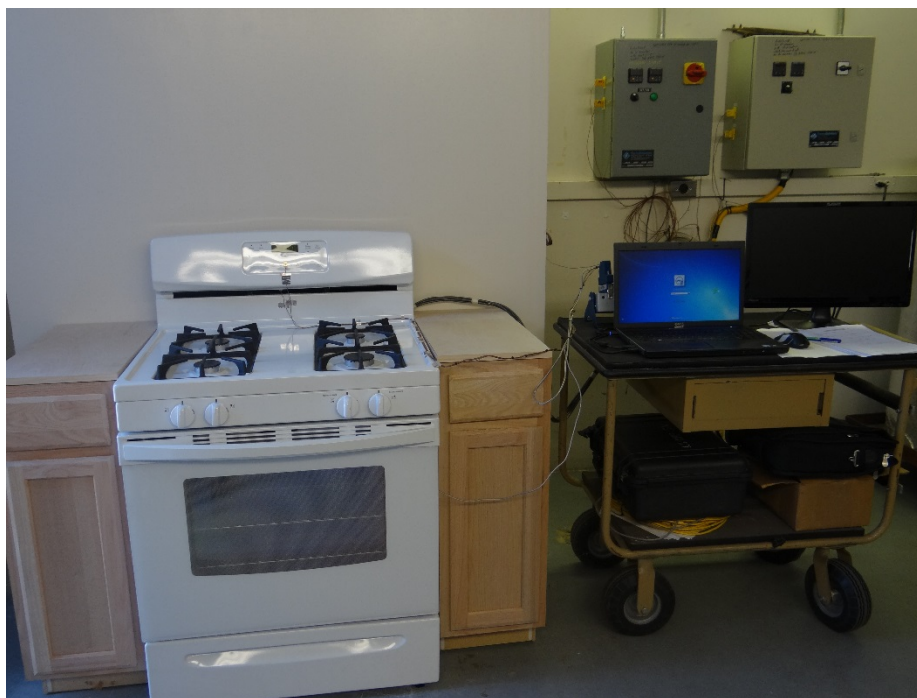
*Figure 7-1 Brand A Test Sample*

All test samples were purchased and shipped to SwRI by the CPSC in their original packaging. Figure 7-1 through Figure 7-3 are photographs of the test samples installed and prior to testing.

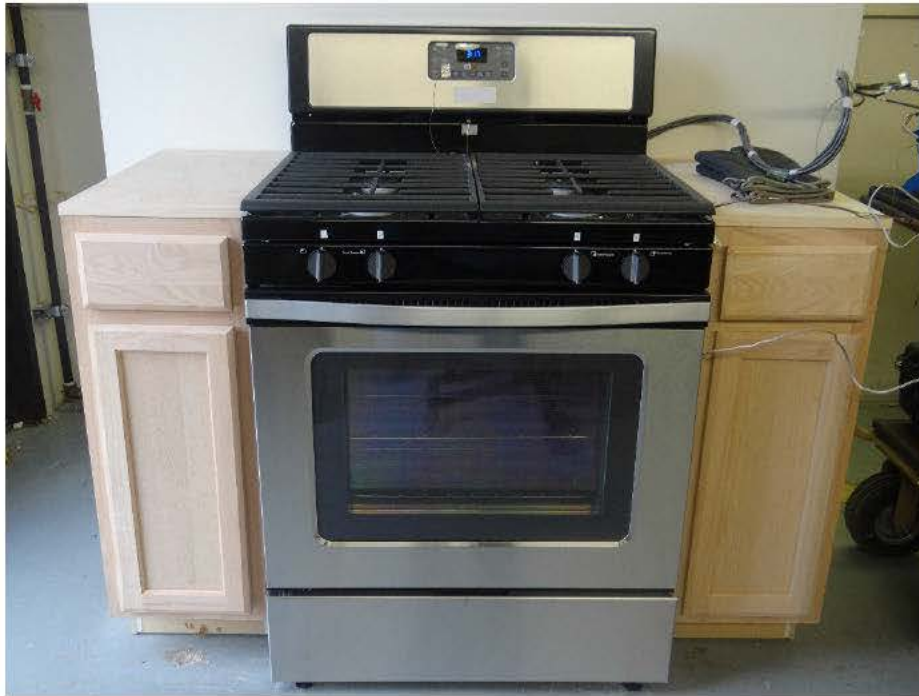
*Figure 7-2 Brand B Test Sample*

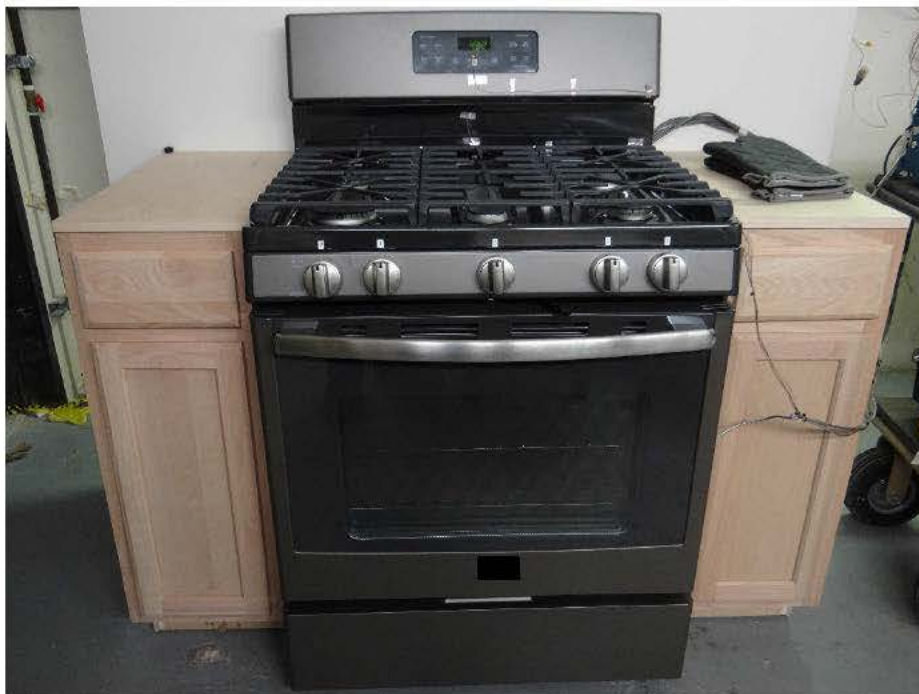
*Figure 7-3 Brand C Test Sample*

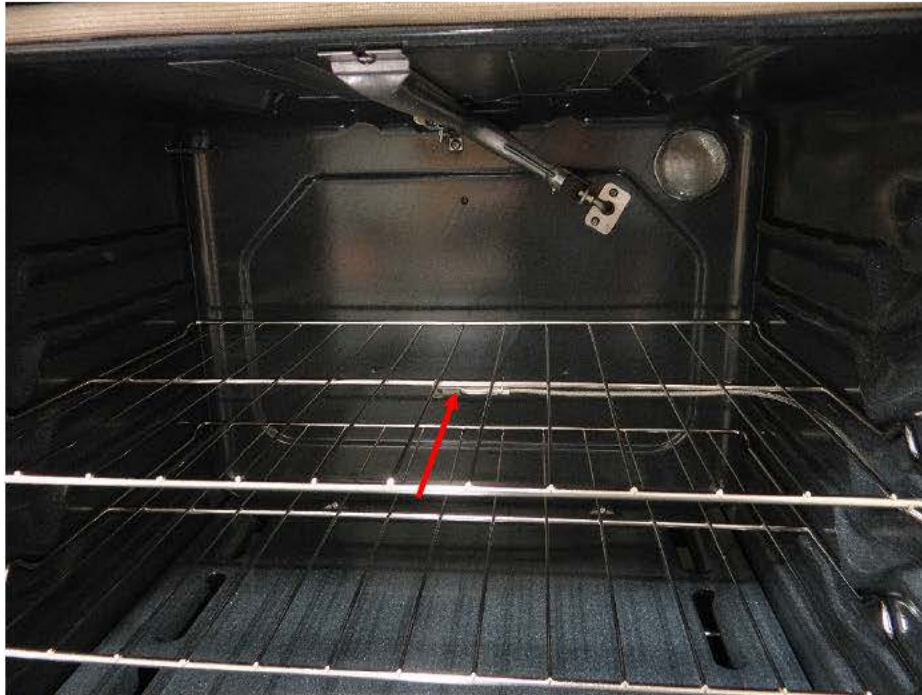
*Figure 8-3 Example of Thermocouple Oven Cavity Location/Brand B Test Sample*

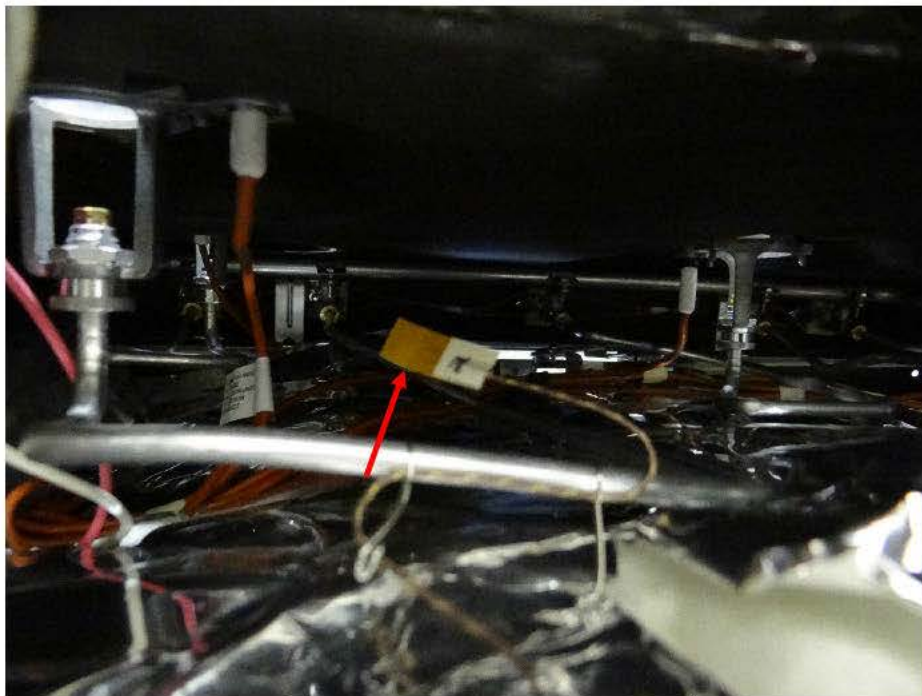
*Figure 8-4 Example of Thermocouple Oven Insulation Location/Brand C Test Sample*

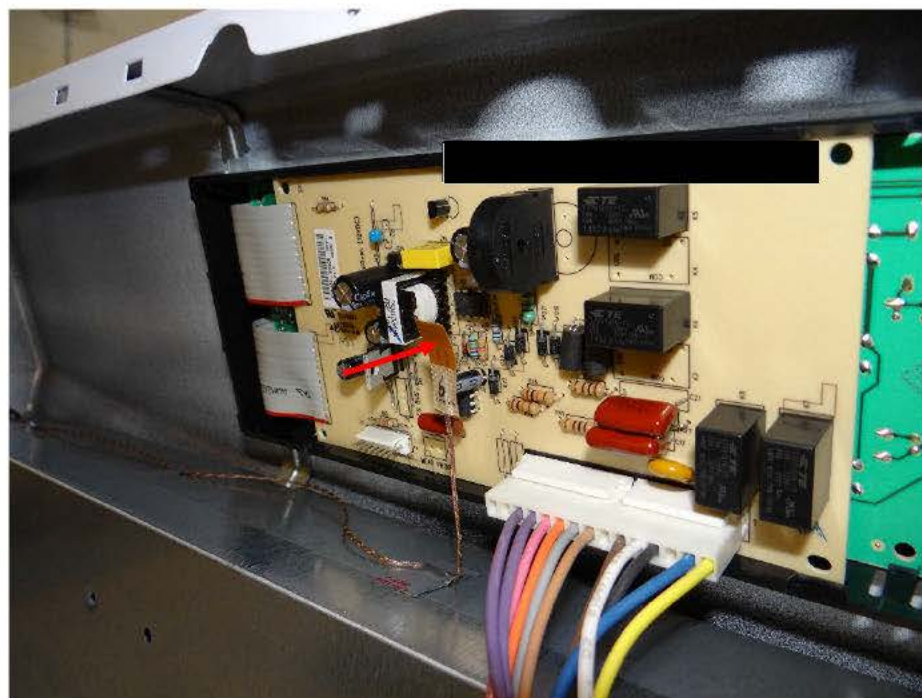
*Figure 8-6 Example of Thermocouple Main Circuit Board Location/Brand A Test Sample*

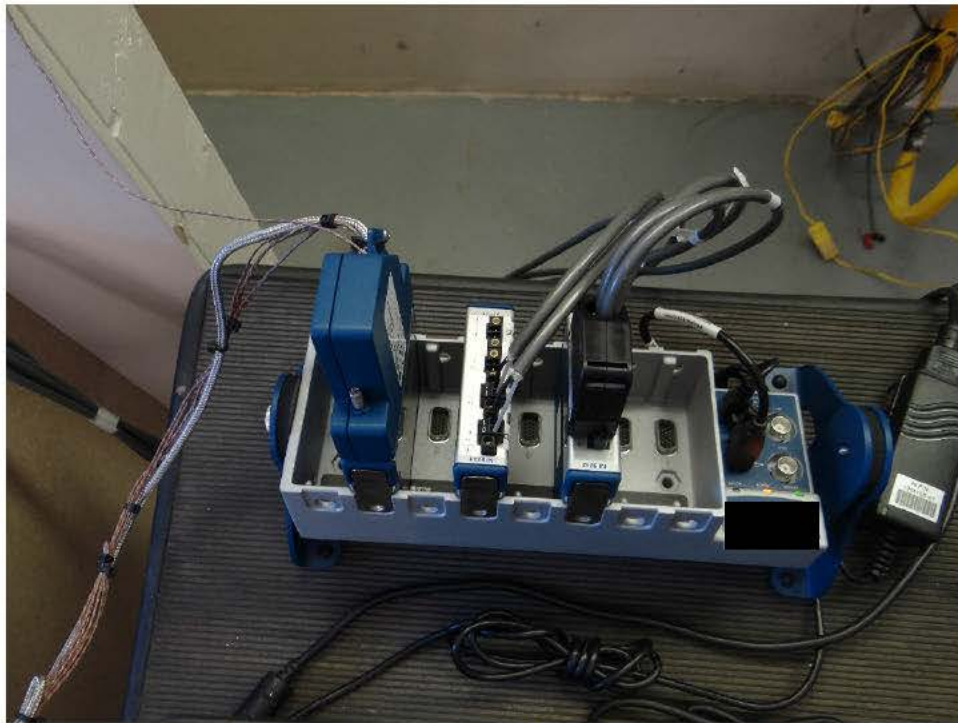
*Figure 9-1 National Instruments Data Acquisition Chassis and Modules*

A National Instrument (N.I.) chassis was used to host NI 9242 and NI 9239 modules selected to monitor and record the electrical noise pulses produced by the range's ignitors on the oven controller board electrical inputs.

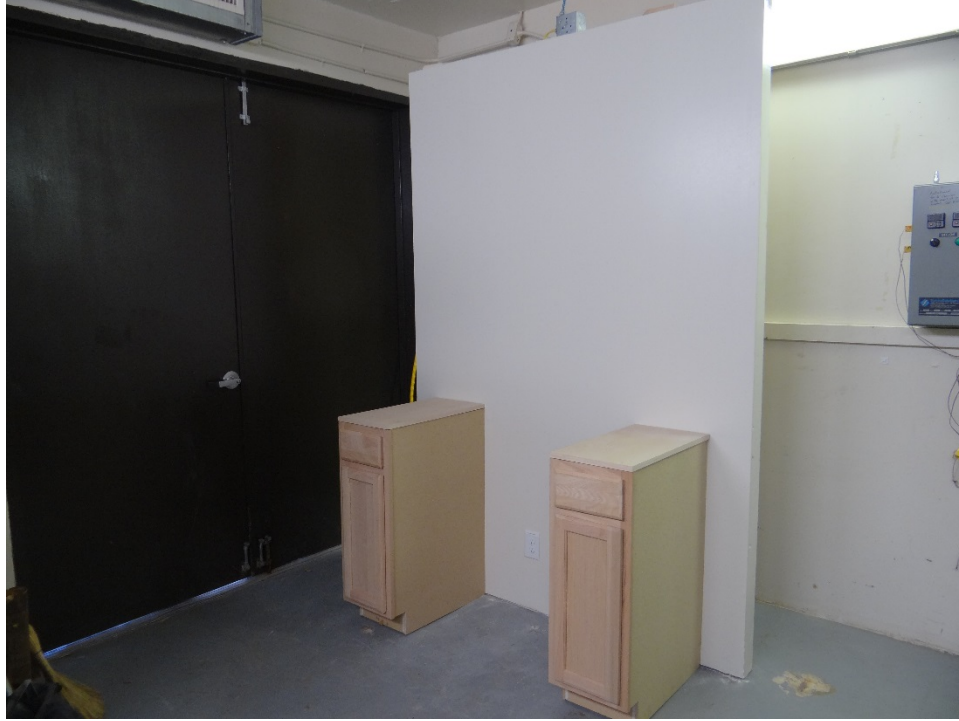
*Figure 10-1 Wall/Cabinet Setup in Test Cell*

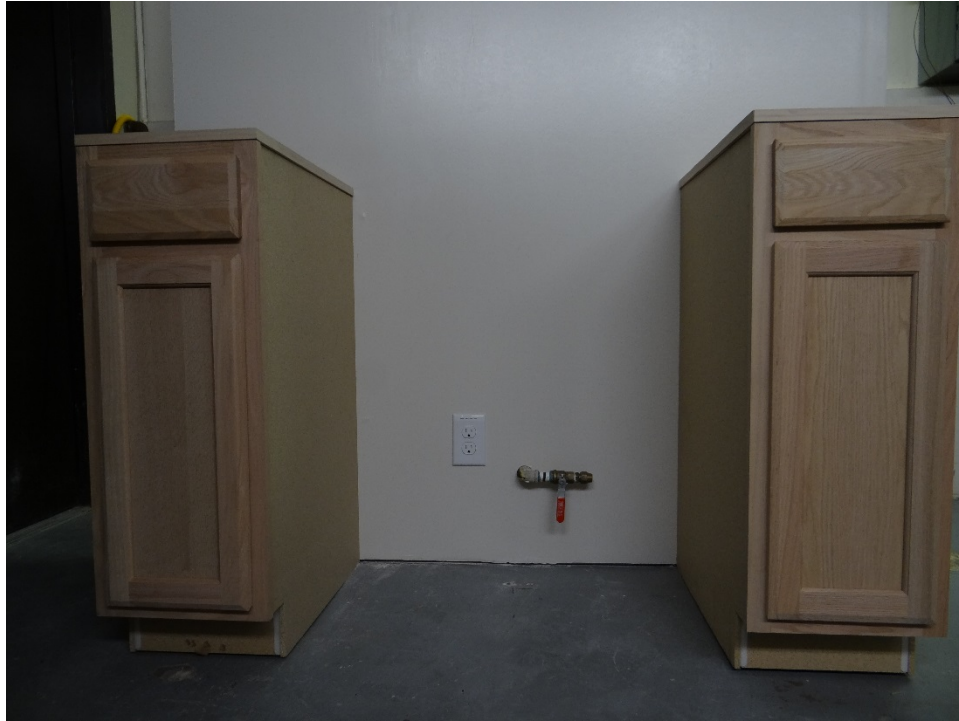
*Figure 10-5 Gas Supply and Electrical Outlet Location for Gas Range Test Samples*

Three models of gas ranges were supplied by the CPSC for testing. These ranges were connected, one at a time, to gas and electrical utilities in accordance with local codes. The gas ranges were installed against a wall constructed to simulate a typical consumer installation location (see Figure 10-1 and Figure 10-2) including a base cabinet installed on either side of the gas range. Dimensional drawings of the test set up including the location of the gas delivery are given in Figure 10-3 and Figure 10-4. The drawings also include the location and materials used adjacent to the range to replicate typical cabinet and wall installation in consumers' homes. The sample ranges were installed in accordance with the owner's manual instructions. The location of the gas supply and electrical outlet are given in Figure 10-5.

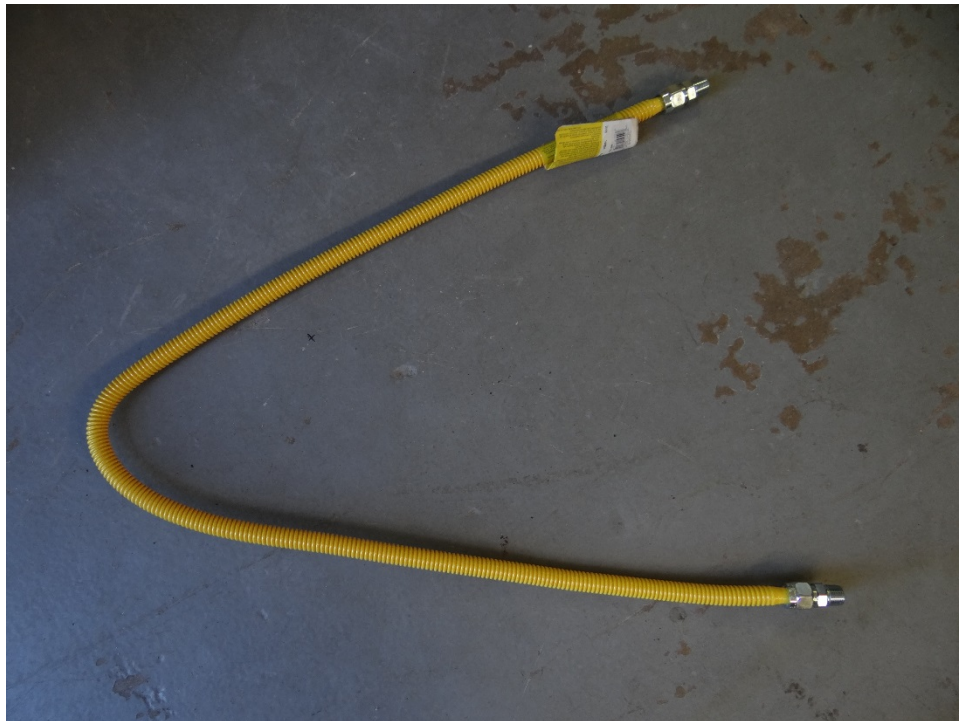
*Figure 10-6 CSA-rated Gas Connector*

The general natural gas pipe supply pressure was 6-14" W.C. The gas pipe to the appliance used a Canadian Standards Association (CSA) certified flexible metal appliance connector (see Figure 10-6). Each range was equipped with its own CSA-rated connector. The gas supply line was equipped with three shutoffs; one outside the test cell exterior wall, another accessible inside the test cell and to the left of the wall assembly, and the last at the wall stub-through.

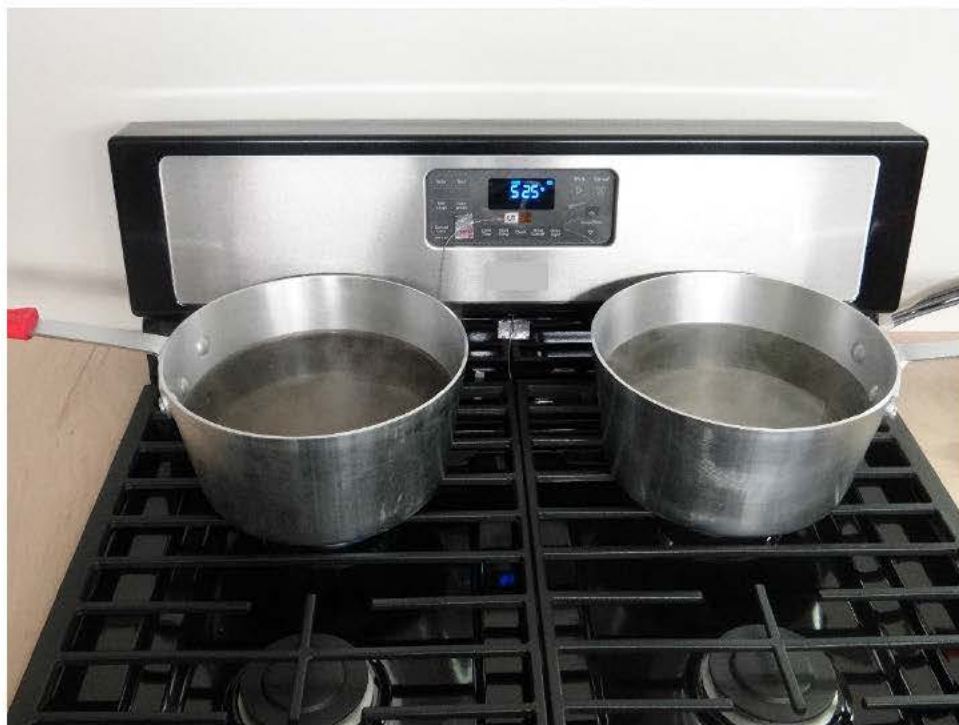
Figure 10-8 5-Quart Aluminum Pots filled with Water

During performance of the bake, broil, and self-clean tasks, each range was additionally heat-loaded with two 5-quart capacity (~8 inches in diameter) aluminum pots filled with tap water up to the handle lower rivet line. The pots filled with water are shown in Figure 10-8. Prior to the initiation of a bake, broil, or self-clean task, the two rear burners were started and adjusted to medium-high setting on the respective cooktop burner gas control knob, and allowed to pre-heat the water for a period of time prior to continuing with the task. The burners were left on for the duration of each task, and the water in each pot was replenished as needed to keep the water within about an inch of the handle rivet line.

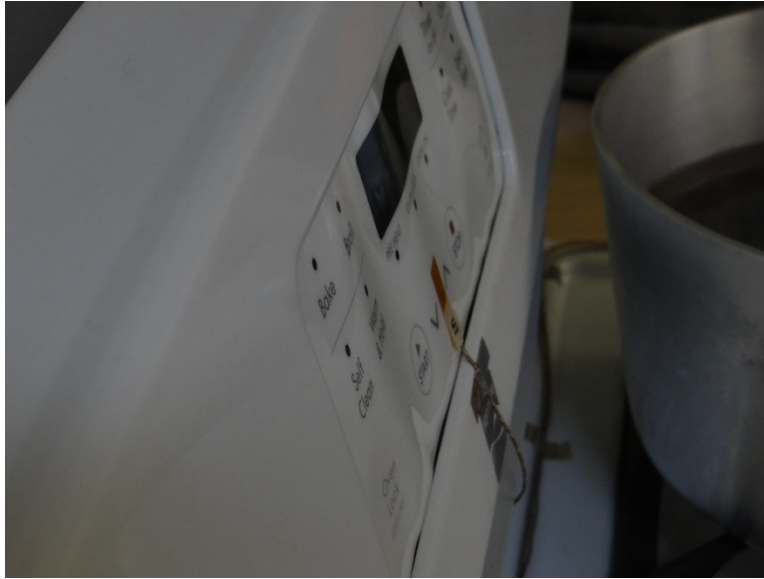
*Figure 12-1 Warping of Touch Panel Membrane for Brand A Gas Range during Testing*

The Brand A oven control touch panel warped during high temperature exposure, but returned to its original condition following removal of heat. No other visible changes were observed during or after testing for any of the gas ranges.

The Brand A gas range exhibited some warping of the touch panel membrane during Task A, B, and C testing, but the warping was no longer observed after the heat was removed (see Figure 12-1 and Figure 12-2). No other observations were made regarding changes to the condition and functionality of any oven control panel, circuit board, wiring, or other assembly components that are visible with the back covers removed.

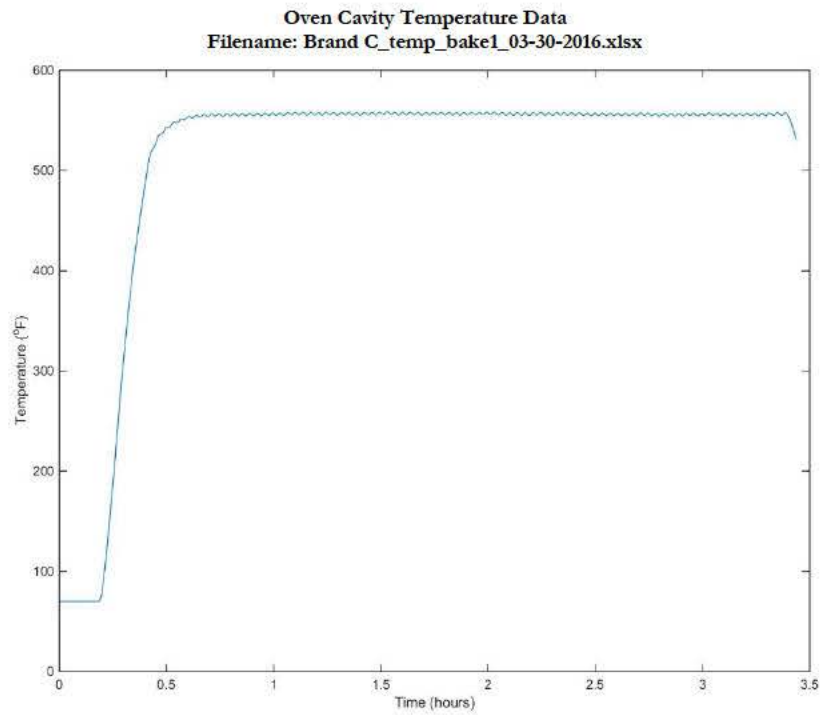
Figure 12-4 Example of Oven Cavity Temperature during Bake Task

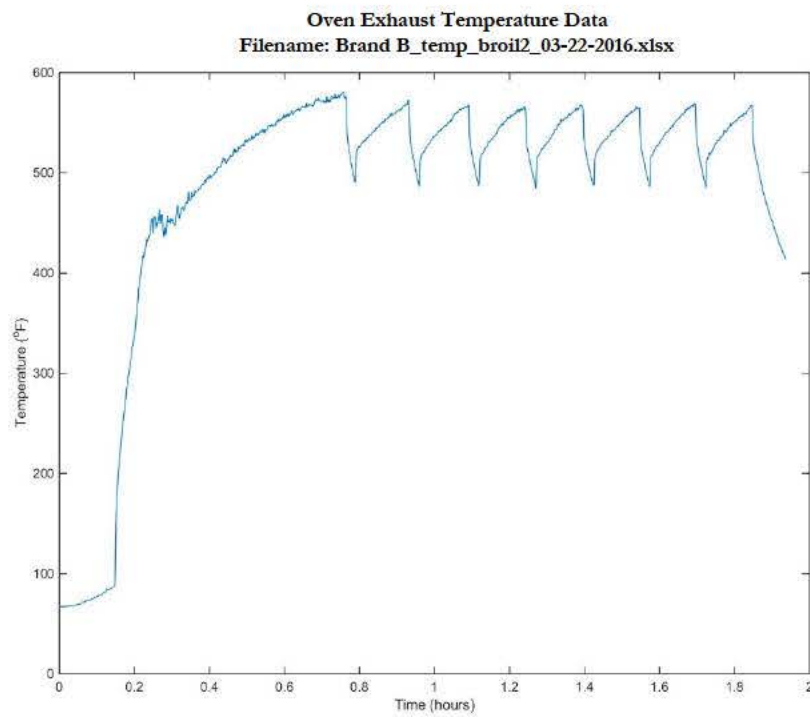
Figure 12-5 Example of Oven Exhaust Temperature during Broil Task

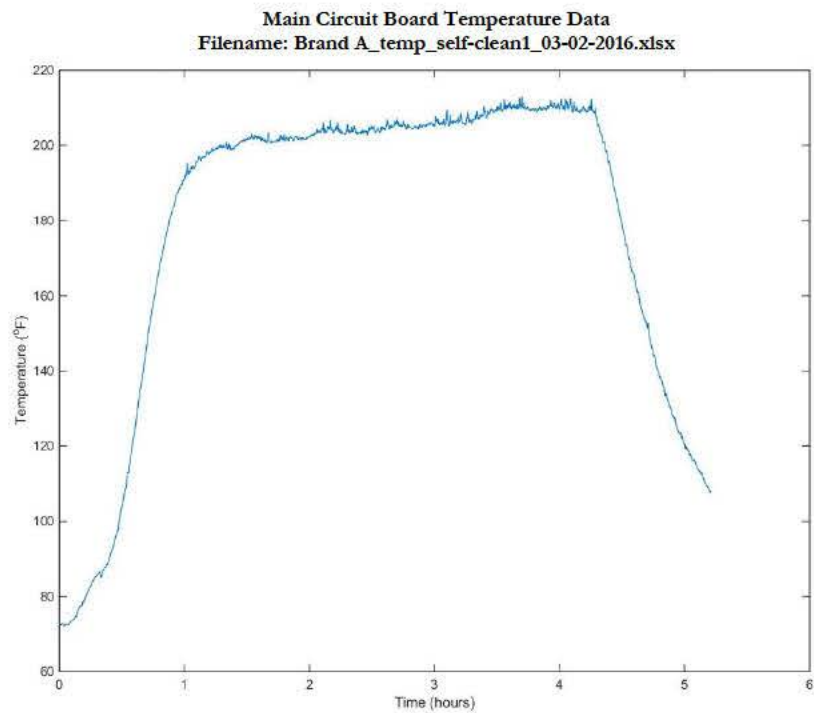
Figure 12-6 Example of Main Circuit Board Temperature during Self-Clean Task

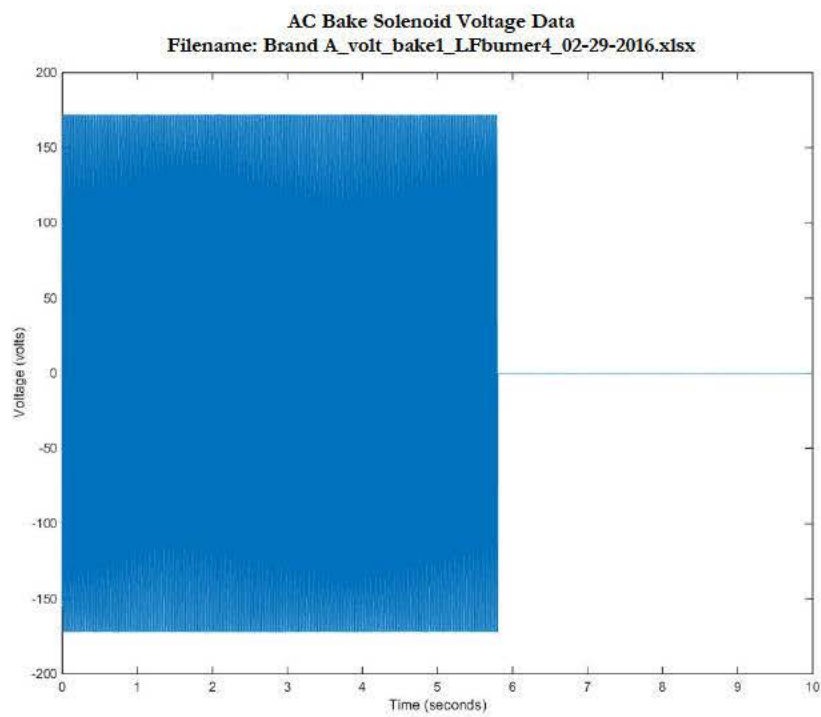
Figure 12-7 Example of AC Bake Solenoid Voltage Data during Bake Task

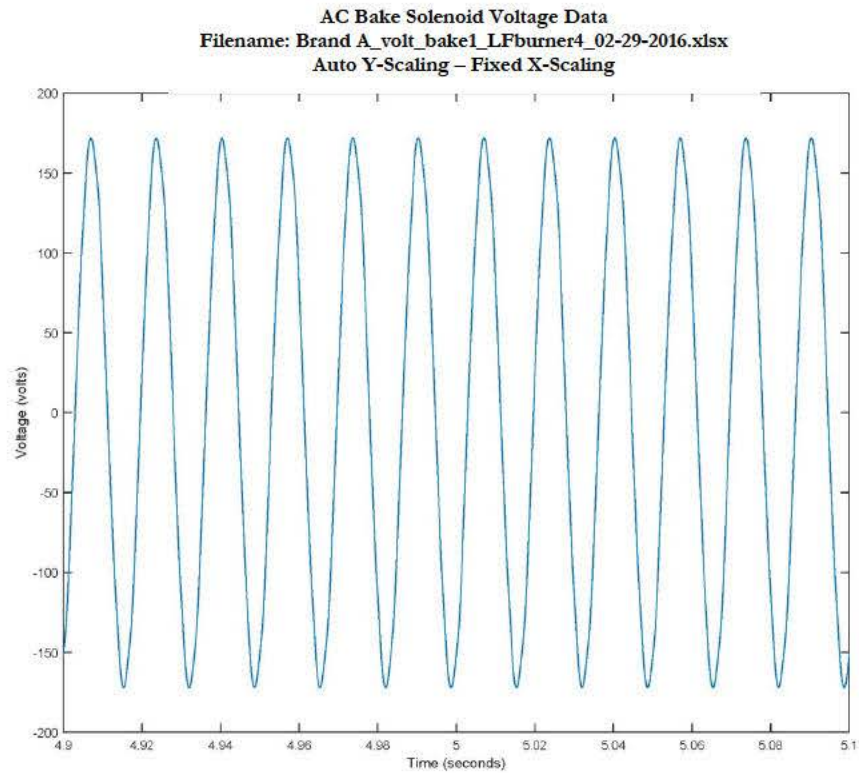
Figure 12-8 Expanded View of AC Bake Solenoid Voltage Data during Bake Task

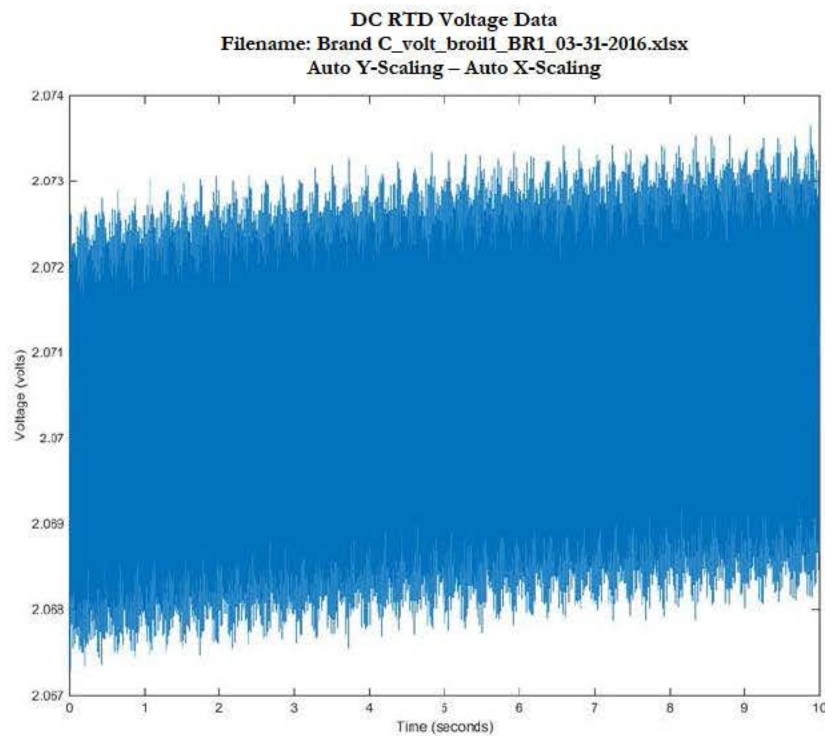
Figure 12-9 Example of RTD Voltage Data during Broil Task

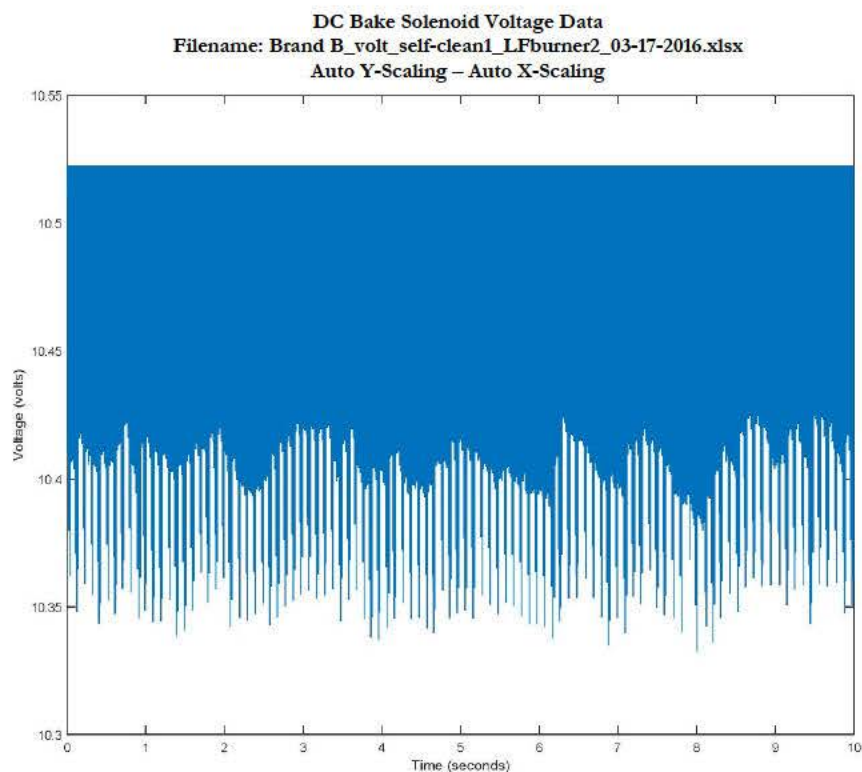
*Figure 12-11 Example of DC Bake Solenoid Voltage Data during Self-Clean Task*

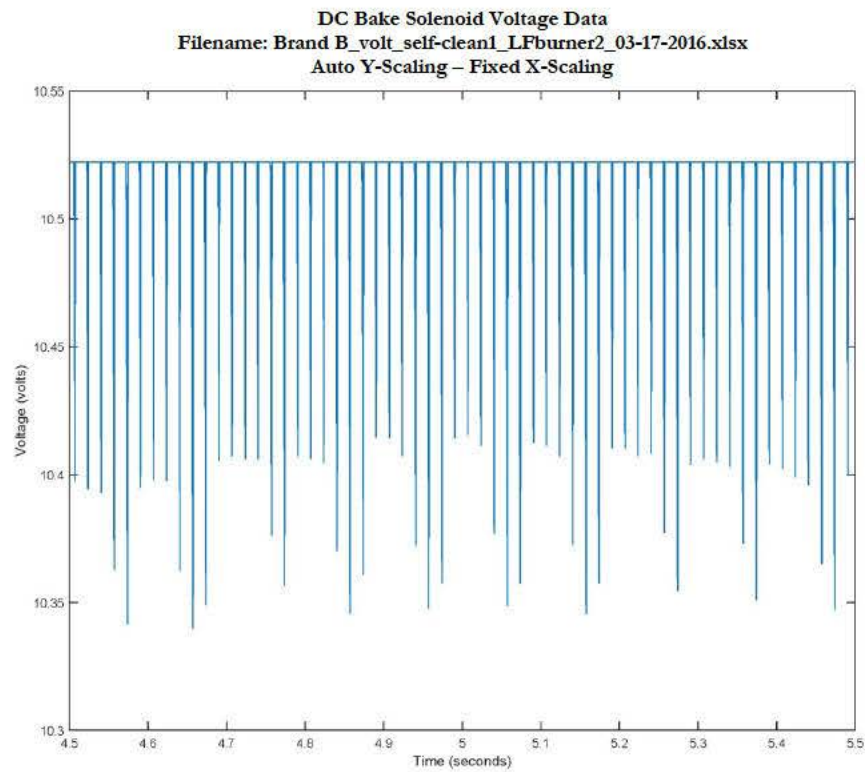
*Figure 12-12 Expanded View of DC Bake Solenoid Voltage Data during Self-Clean Task*
