Stationary Generators:

The Carbon Monoxide Poisoning Hazard and Recommendations for Mitigation

June 3, 2025

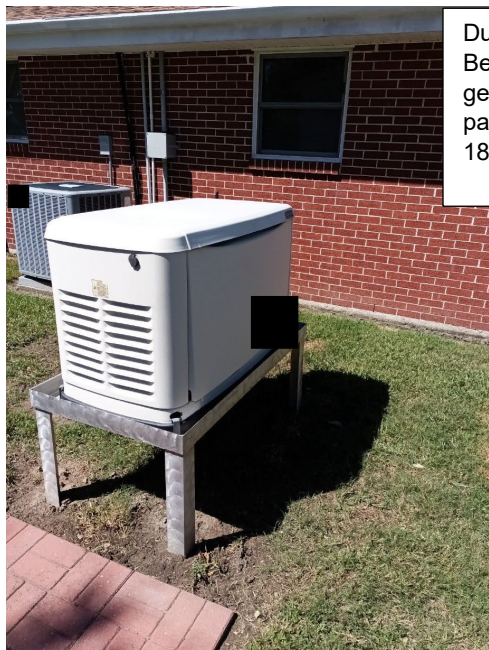
Figure 4. Photos of Three Stationary Generators Referred to in Table A.2.

During the incident, the generator's exhaust was facing the house. Before the incident, the consumer had covered the soffit vents near the generator and thinks that the CO entered the soffit vents under his patio cover. After the incident, the consumer had the generator rotated 180 degrees, as shown in the photo on the left.
