CPSC Staff Statement on the
Southwest Research Institute Report,
“Internal Cabinet Temperature Evaluation of Three Models of Commercially Available Resistive
Element Clothes Dryers”
July 2015

INTERNAL CABINET TEMPERATURE EVALUATION OF THREE MODELS OF COMMERCIALY AVAILABLE RESISTIVE ELEMENT CLOTHES DRYERS

FINAL REPORT Consisting of 59 Pages

SwRI® Project No.: 01.20741.01.001
Test Dates: December 10–12, 2014, and January 19–26, 2015
Report Date: May 1, 2015

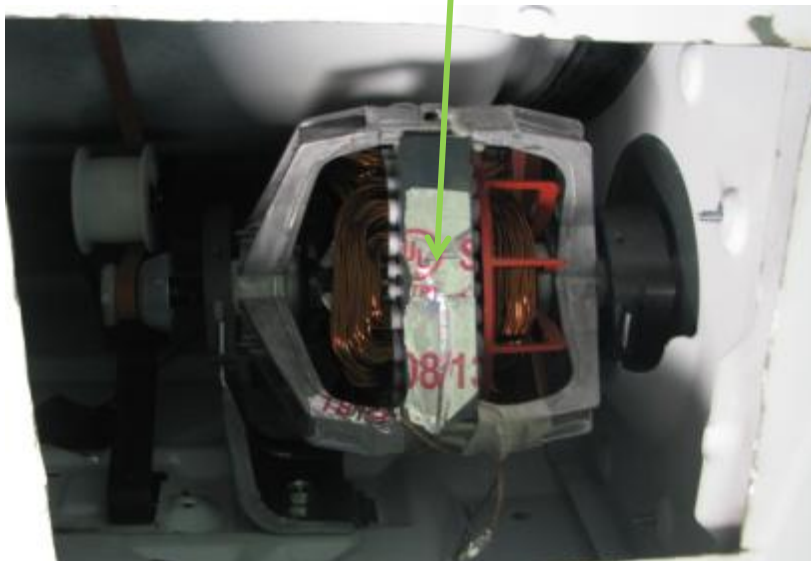
TC 8
Motor temp (located
behind the blower).

Figure A-5. Dryer 1: Location of TC 8
