**CPSC Staff's<sup>1</sup> Statement on SEA Ltd.'s Report,  
"Vehicle Characteristics Measurements of Riding Mowers"**

# *Vehicle Characteristics Measurements of Riding Mowers*

*Results from Tests on Four 2021 Model Year Vehicles*

for:  
Consumer Product Safety Commission

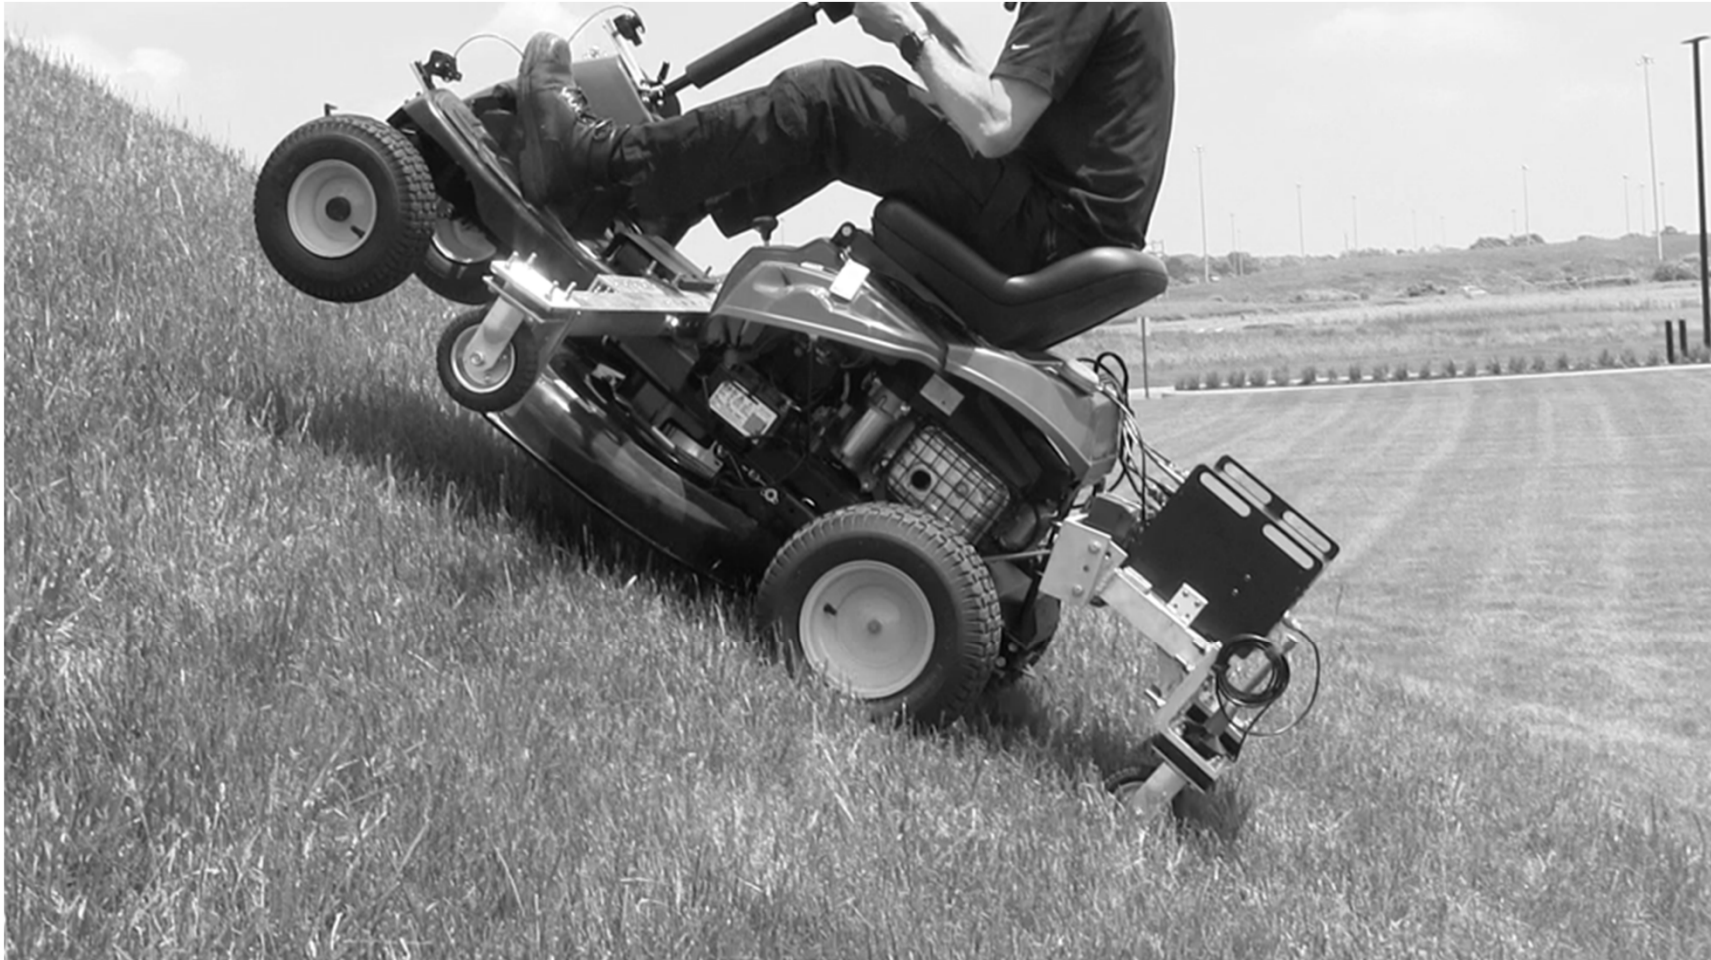
Vehicle A – Rearward Tip-up on to Outriggers  
(Sudden Acceleration on a 25 deg Grass Slope)

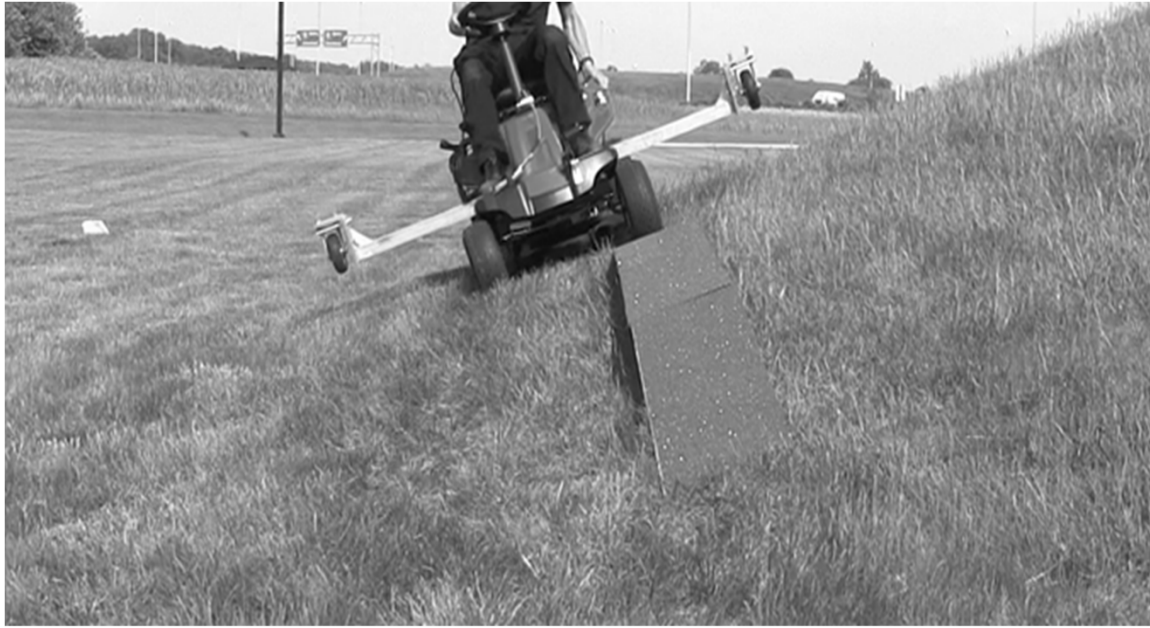
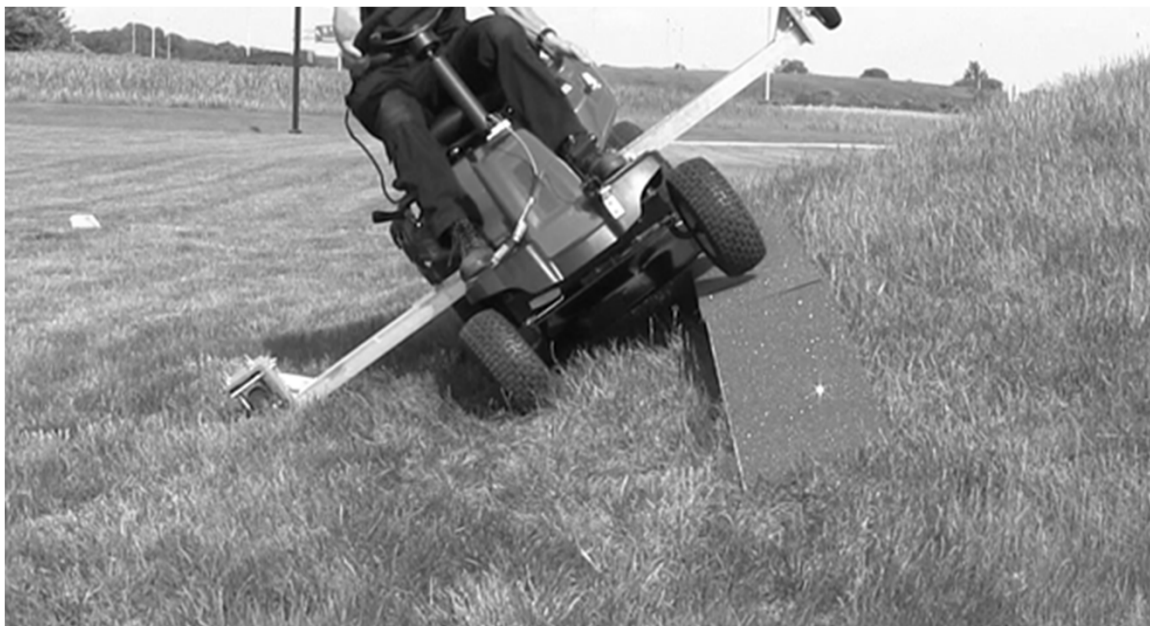
Vehicle A – Lateral Two Wheel Lift  
(Driving On To 7" Tall Ramp on 20 deg Side Slope)

Vehicle On Approach To Ramp

Two Wheel Lift

Vehicle Stopped and Resting  
on Outrigger

Ultimately a maneuver that involved driving onto a ramp on a cross slope was deemed to be a good maneuver that would result in lateral tip up and that would be reproducible. The 20° grass-covered slope was used as the cross slope, and a 12-inch wide, 7-inch-tall wooden ramp topped with anti-slip tape (profile dimensions shown on Figure 4) was used. The graphical results from this test are shown on Page 10, and video images showing the approach to the ramp and the two-wheel lift outcome from this test are on Page 11.

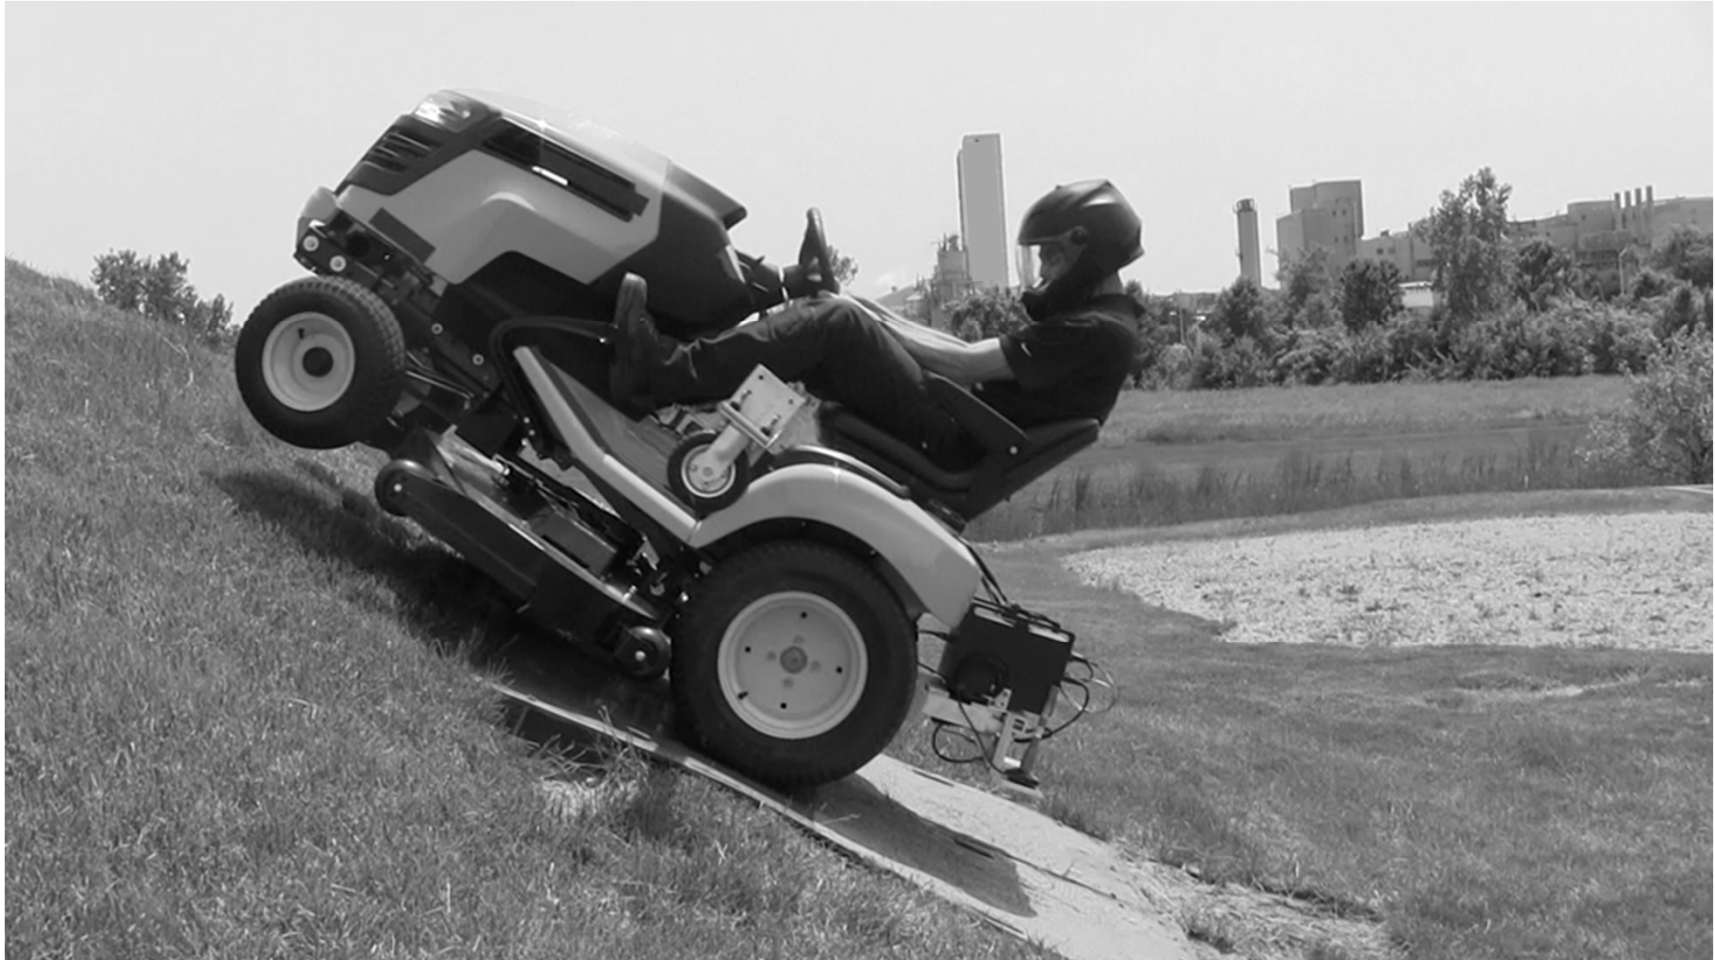
Vehicle B – Rearward Tip-up to 40 deg Pitch Angle  
(Sudden Acceleration on a 30 deg High Friction Slope)

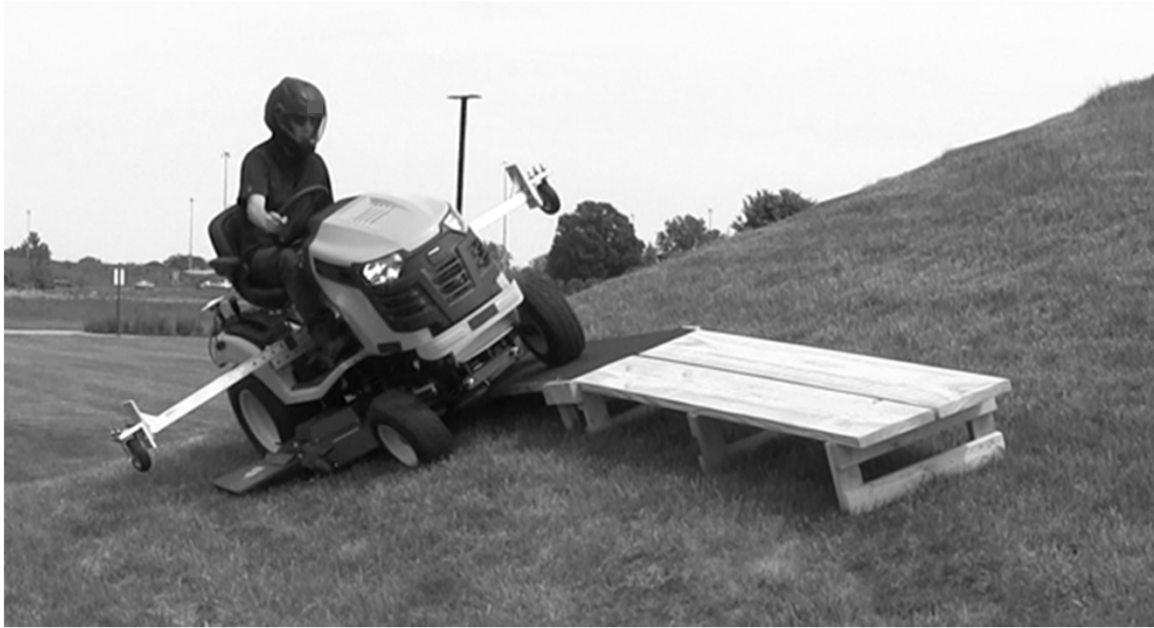
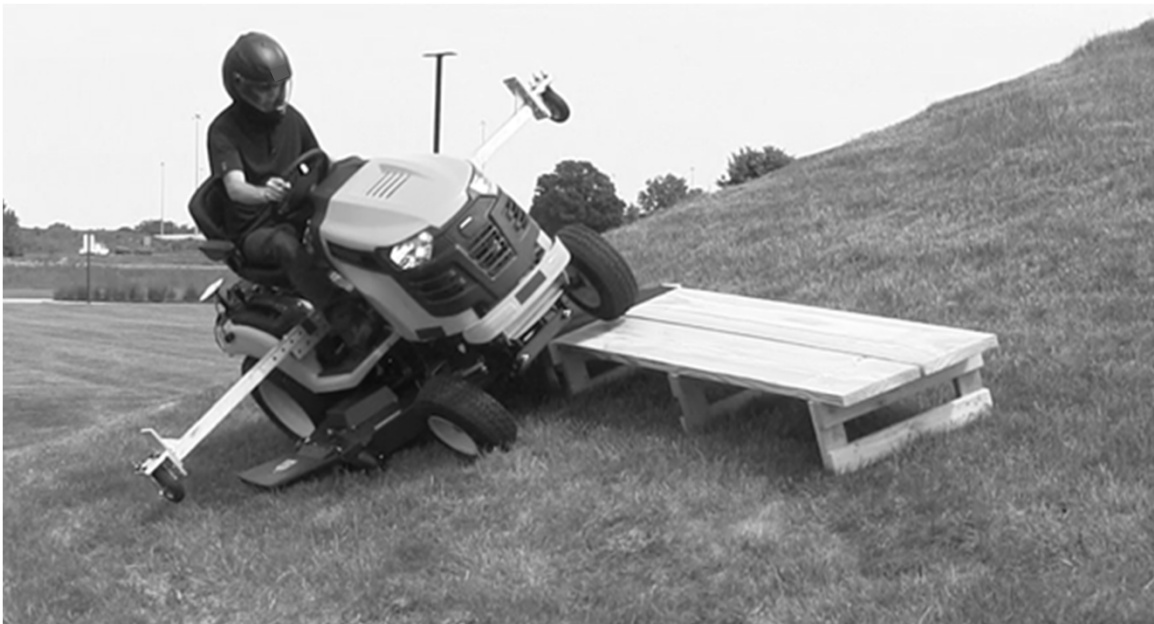
Vehicle B – Lateral Two Wheel Lift  
(Driving On To 11½” Tall Ramp on 20 deg Side Slope)

Vehicle Part Way Up Ramp

Two Wheel Lift

Vehicle Stopped and Resting  
on Outer Edge of Mower Deck

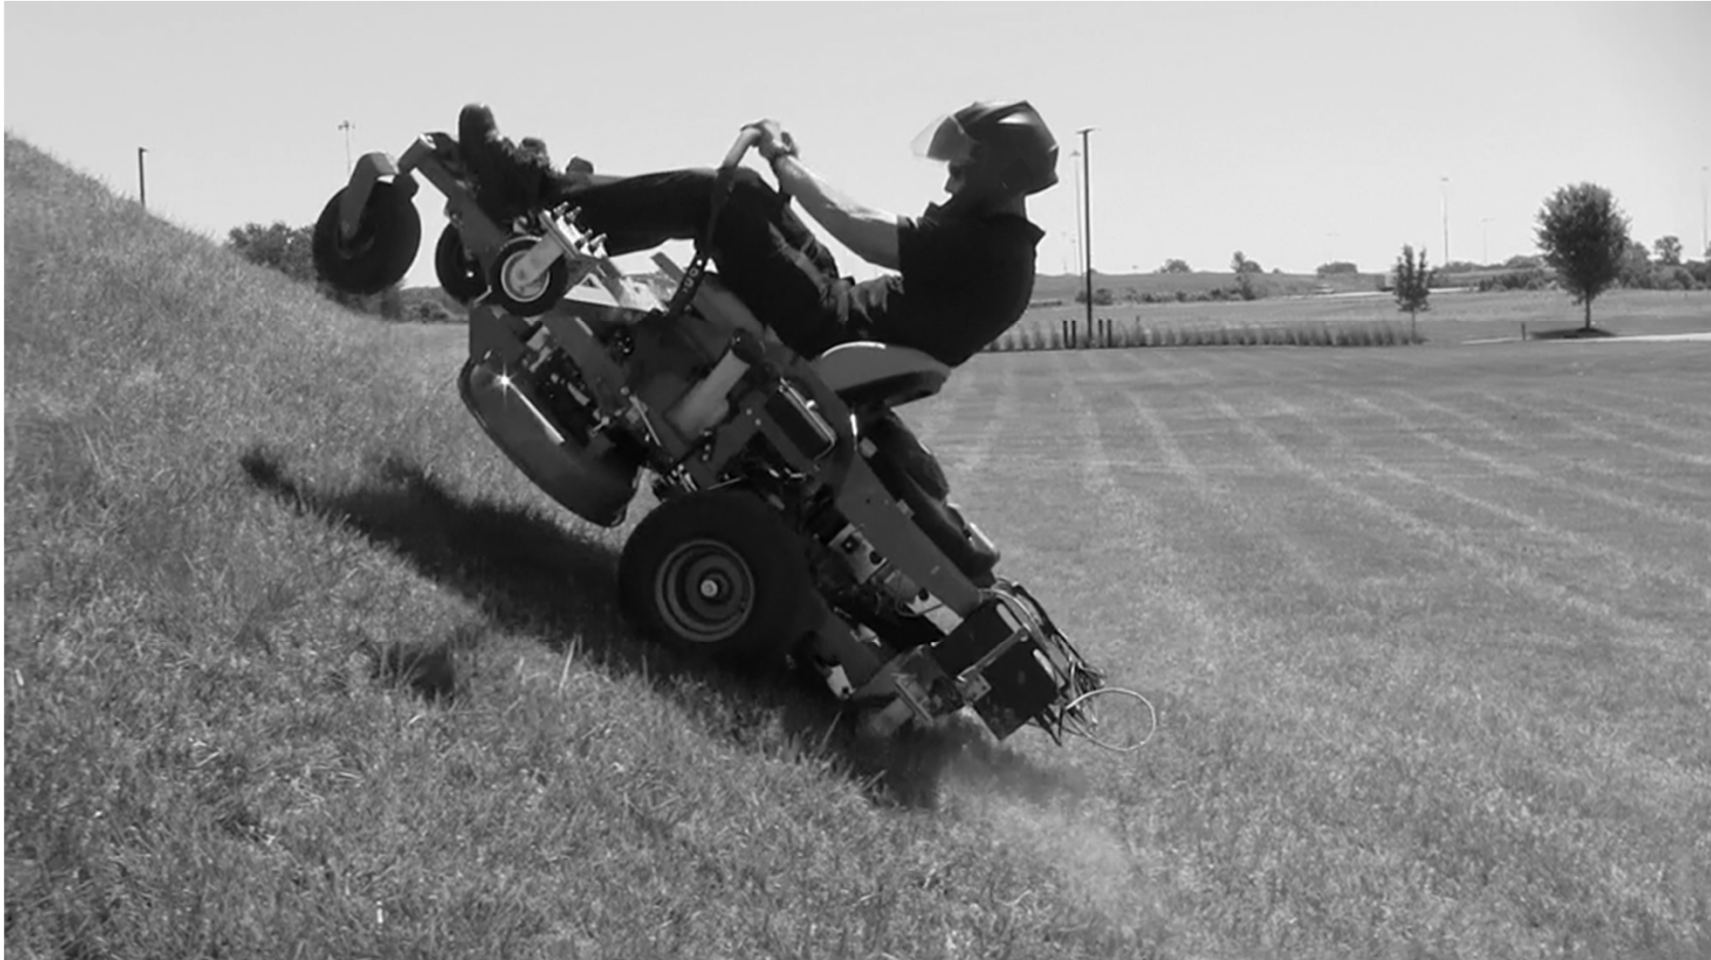
Vehicle C – Rearward Tip-up on to Outriggers  
(Sudden Acceleration on a 25 deg Grass Slope)

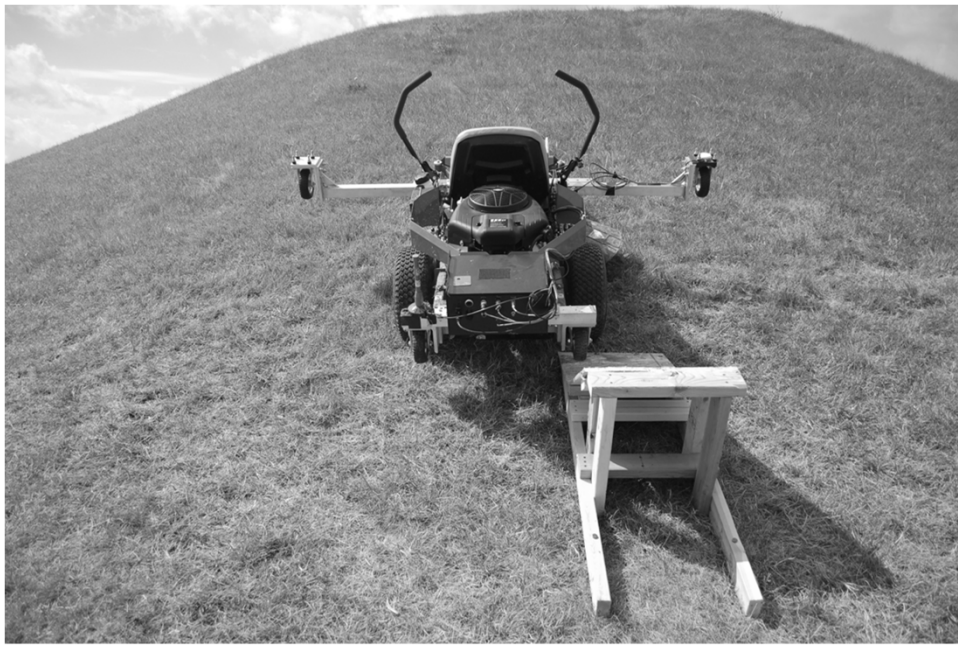
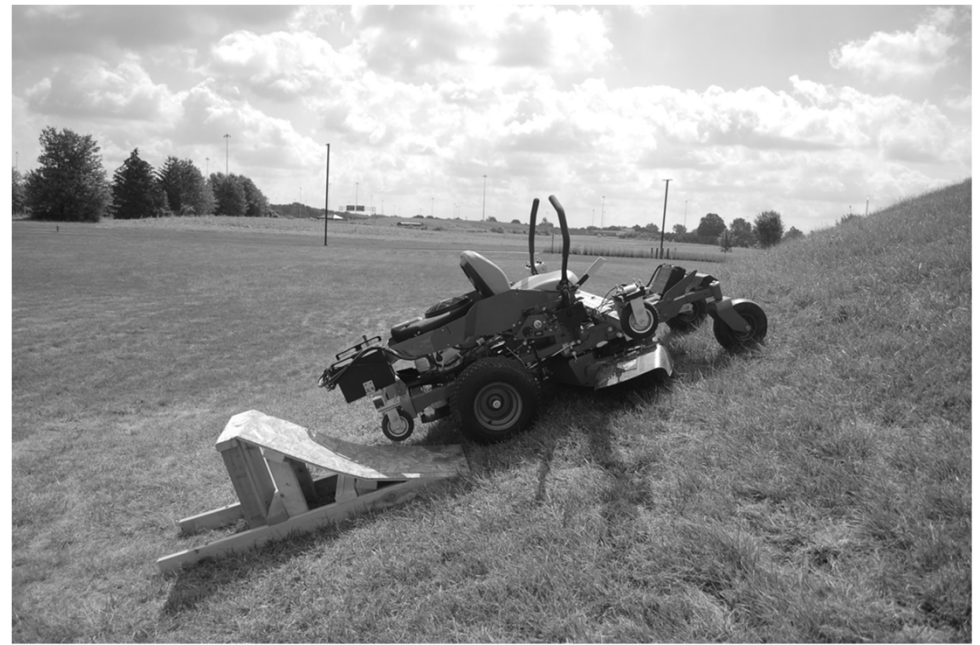
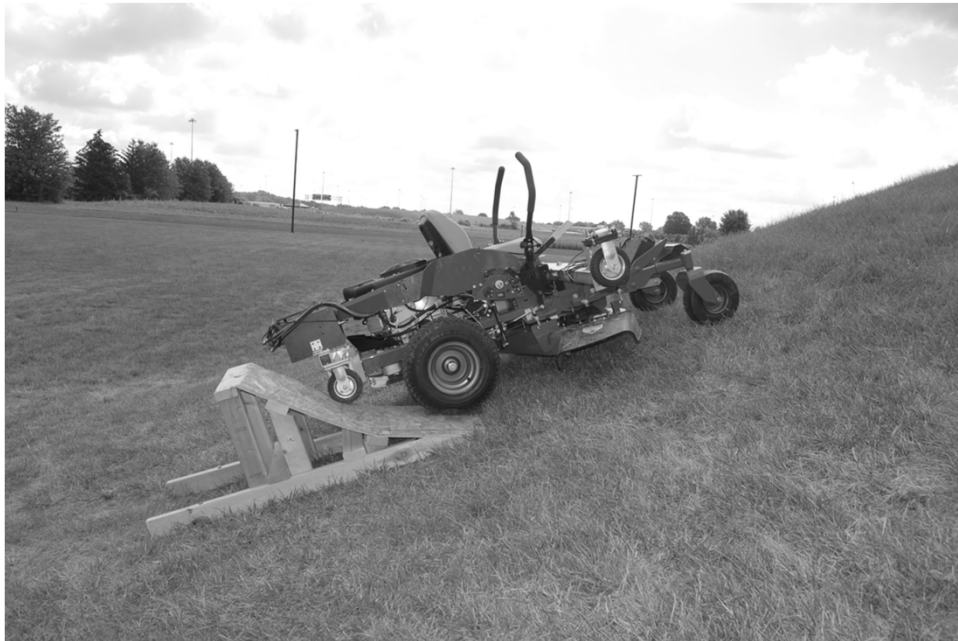
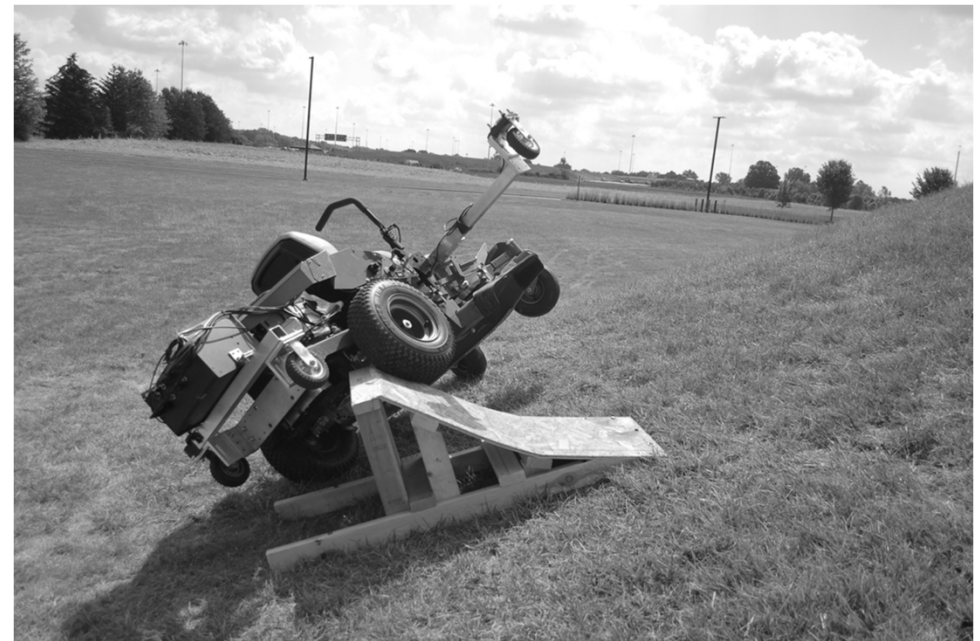
Vehicle C – Photo Sequence of Zero-Turn Mower Quasi-Lateral Tip-up

However, the quasi-lateral tip-up maneuver was demonstrated without using a human driver. Page 31 of Appendix B shows a sequence through portions of the quasi-lateral tip-up maneuver. Page 32 contains four photographs of the mower stopped with its upside tire near the top of ramp. Had the mower not been stopped, it could have overturned. It would have likely overturned if the lateral outriggers were not in place. There was no driver involved in recreating the conditions shown on Pages 31 and 32, rather the mower was manually slowly pushed into, and stopped at, the positions shown.

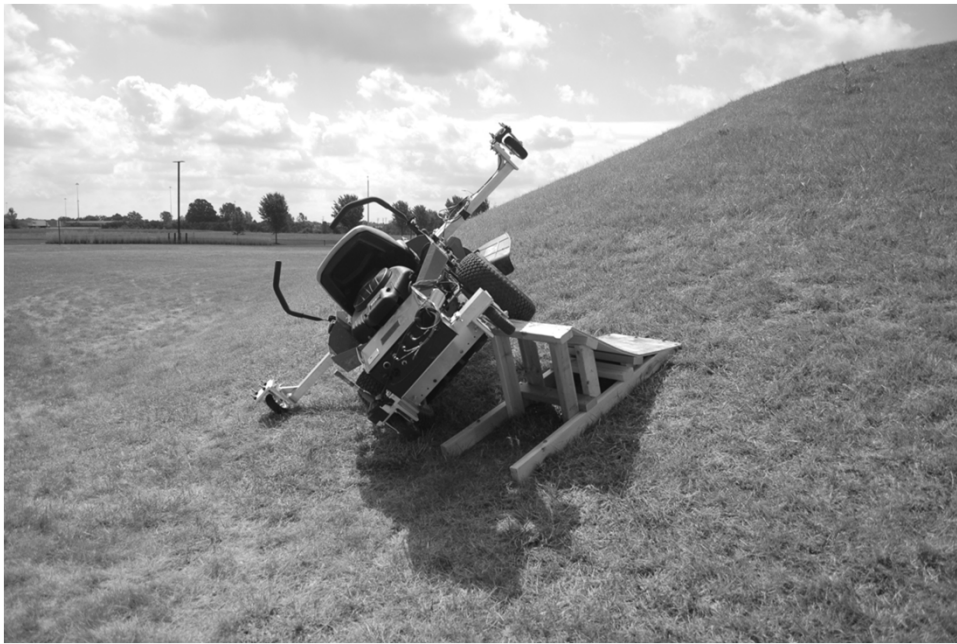
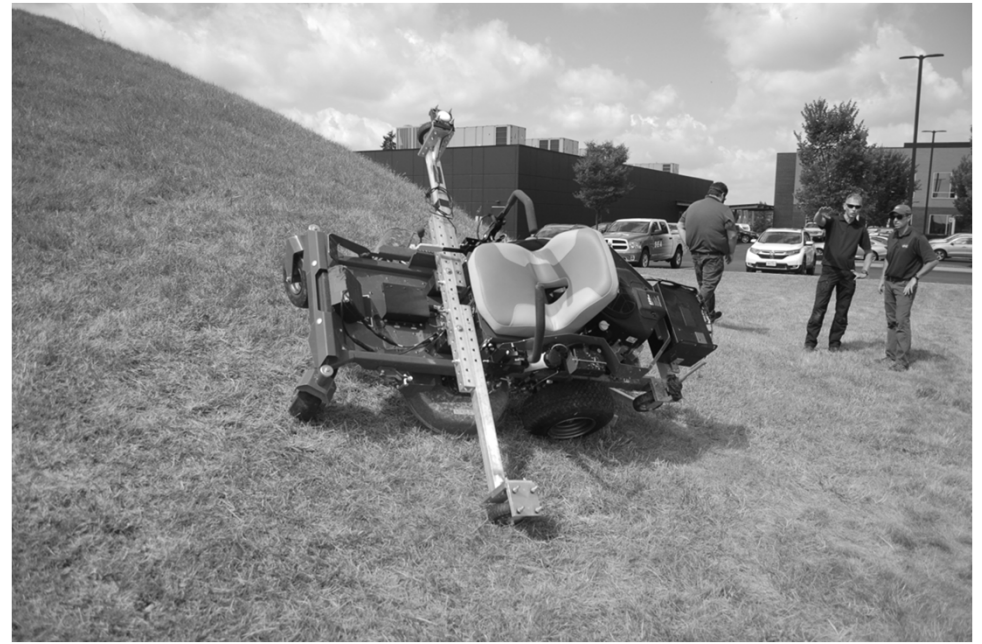
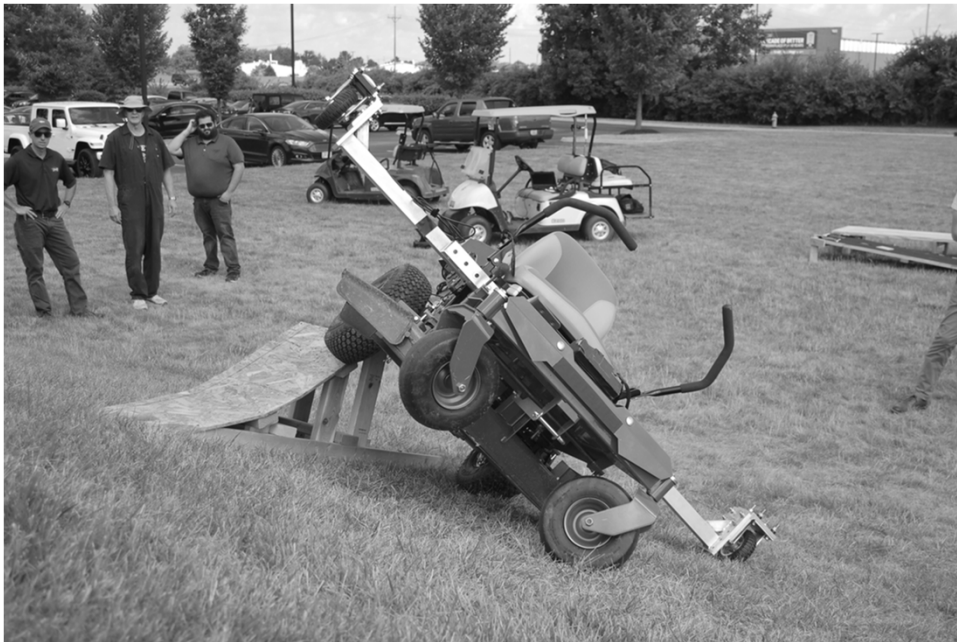
Vehicle C – Additional Photos of Zero-Turn Mower Quasi-Lateral Tip-up

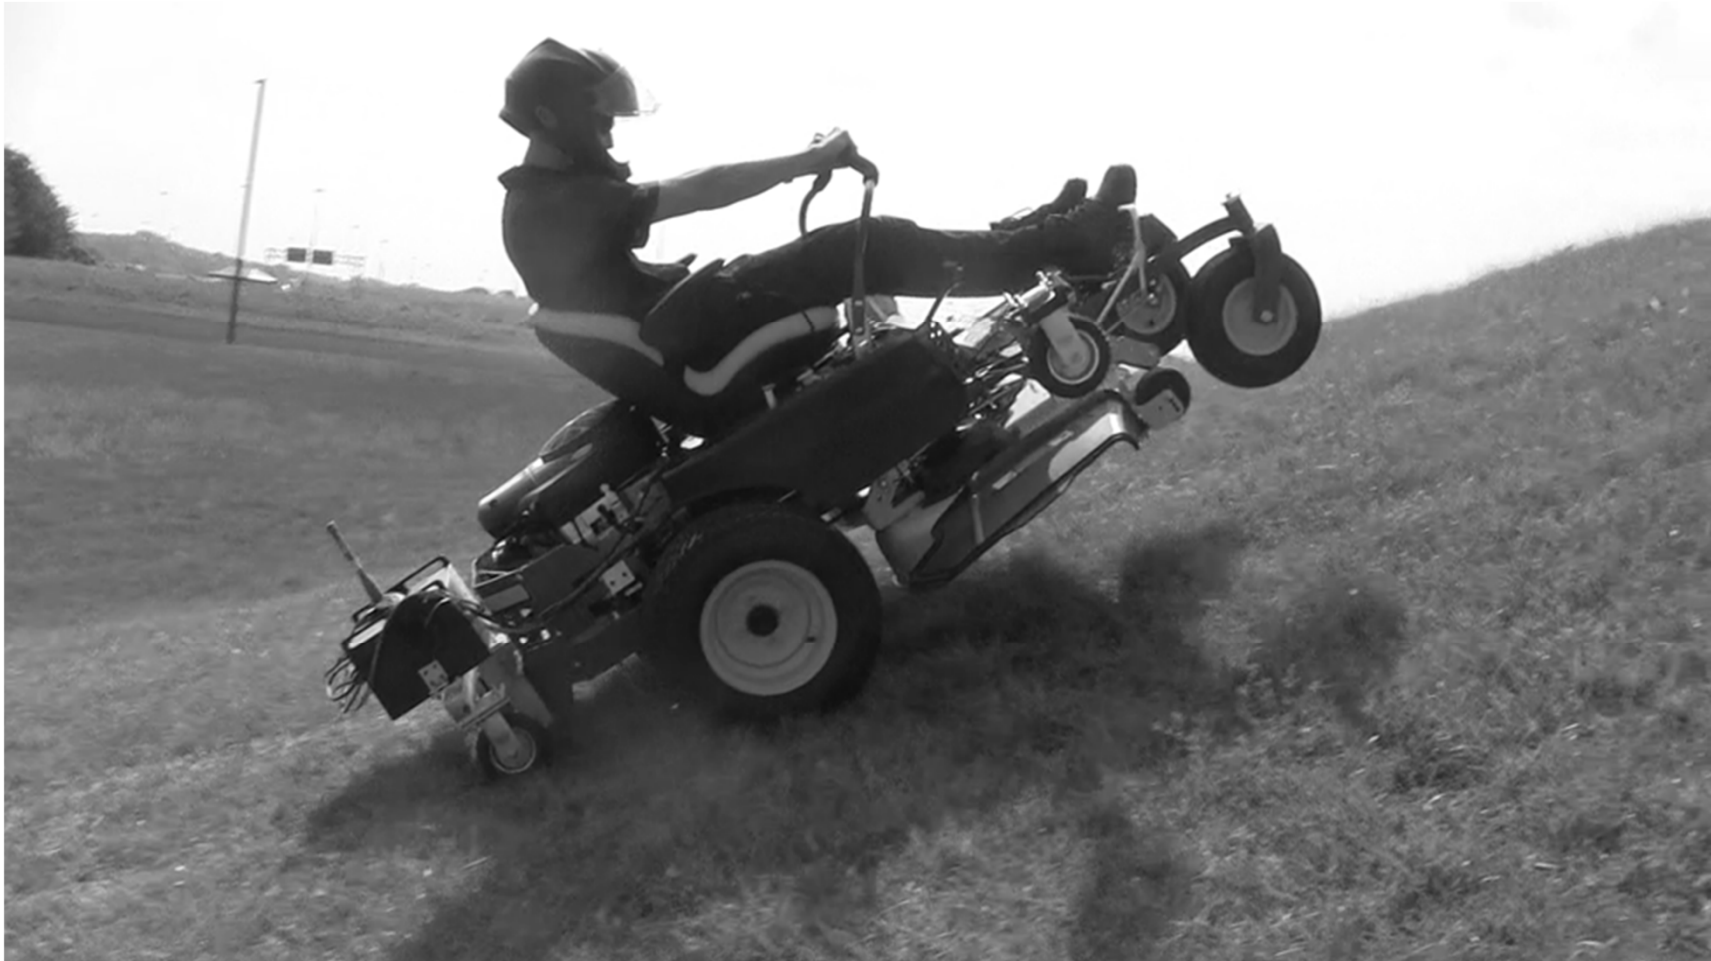
Vehicle D – Rearward Tip-up on to Outriggers  
(Sudden Acceleration on a 20 deg Grass Slope)

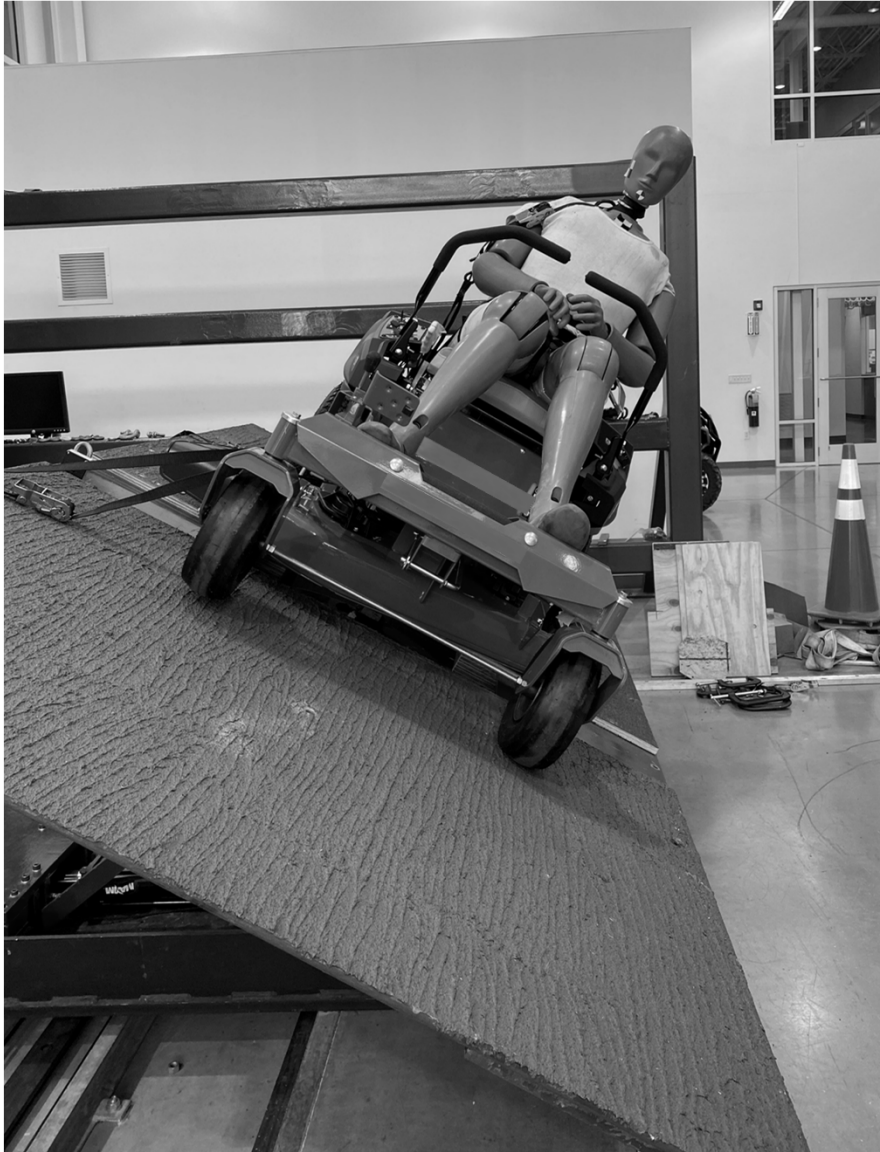
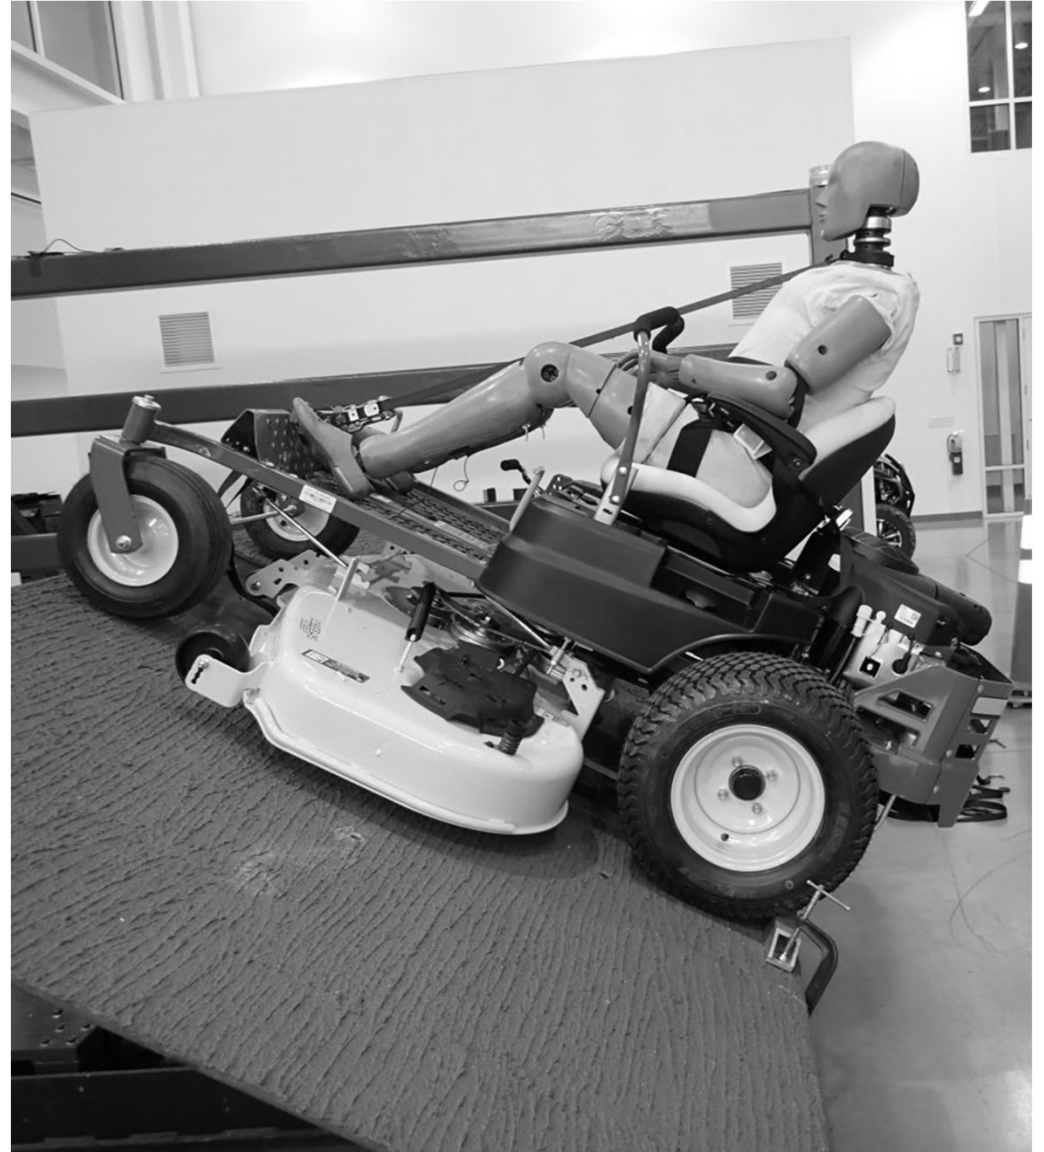
## Photographs of Mowers on SEA Tilt Table

Tilt Table tests were conducted in both loading conditions for all four vehicles, and tilts were conducted in four directions: left-side leading, right-side leading, front-end leading, and rear-end leading. Page 1 of Appendix C shows photographs of the small zero-turn mower in a lateral, left-side leading tilt and the large zero-turn mower in a longitudinal, rear-end leading tilt.

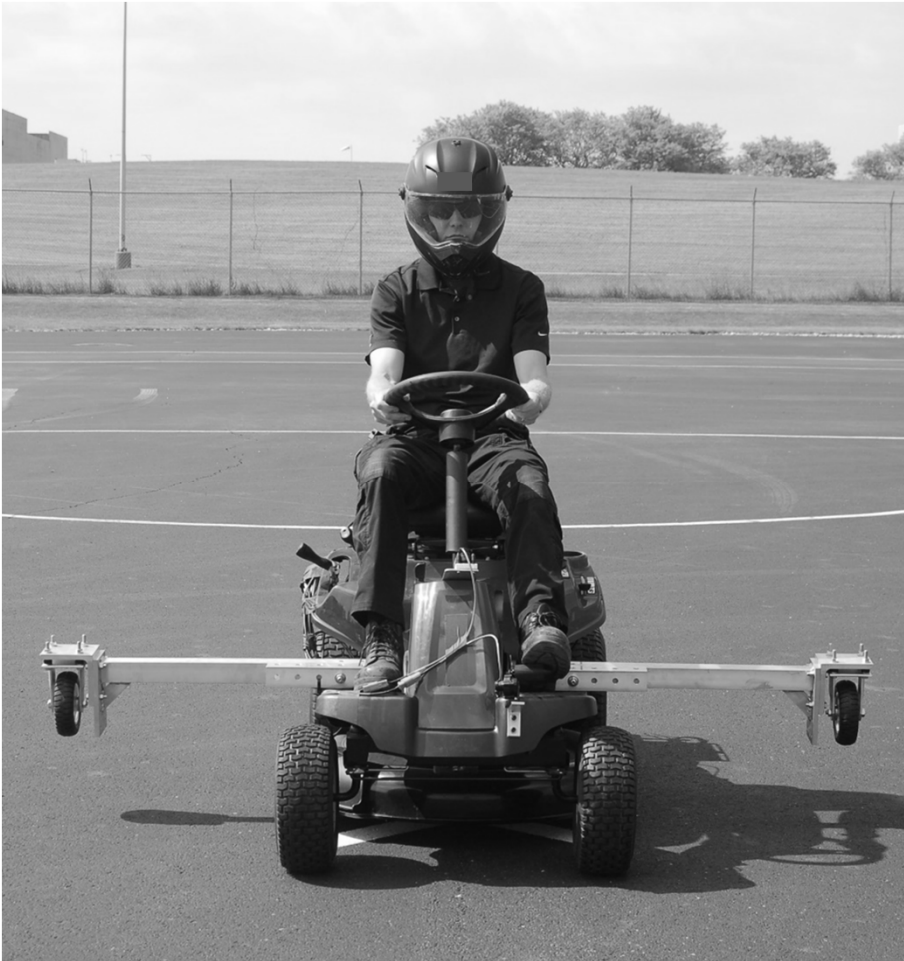
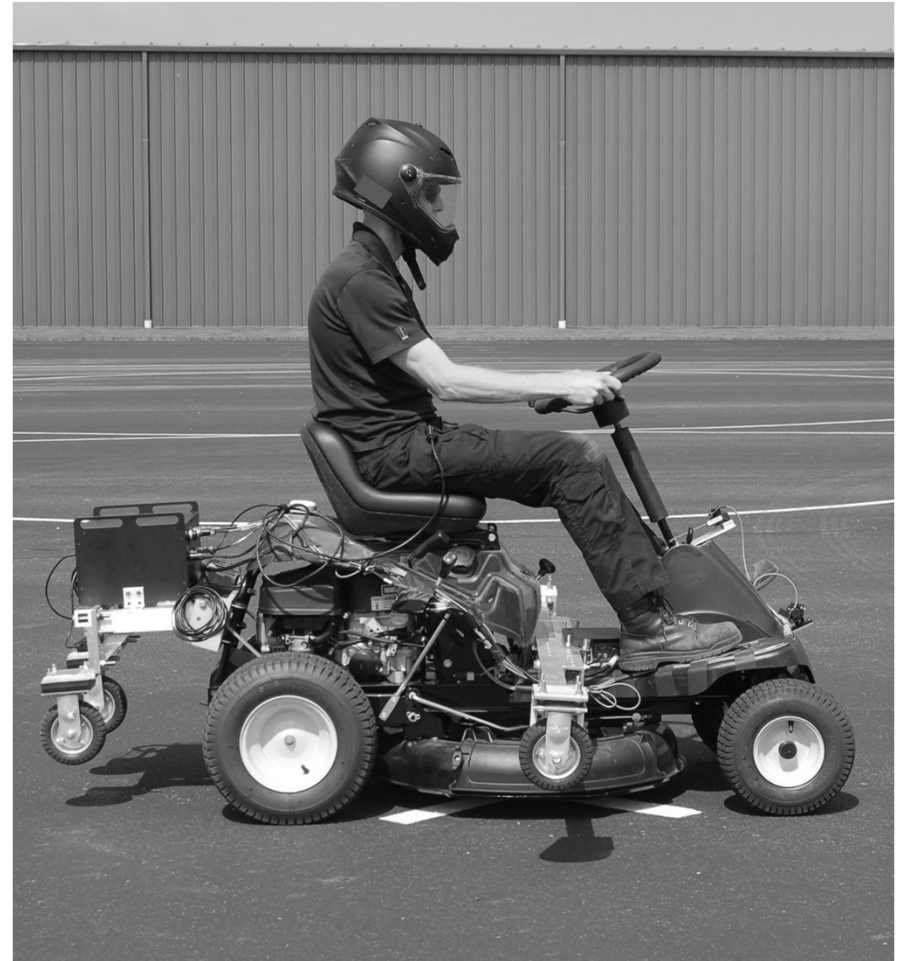
## Front and Side Views of Small Tractor Mower

The loading condition used for the dynamic testing is the Driver plus Instrumentation Loading condition. This loading condition is intended to represent the loading of a 95% male driver (weighing nominally 220 lb). Pages 2-5 of Appendix C contain front view and side view photographs of the four mowers in their as-tested configurations.

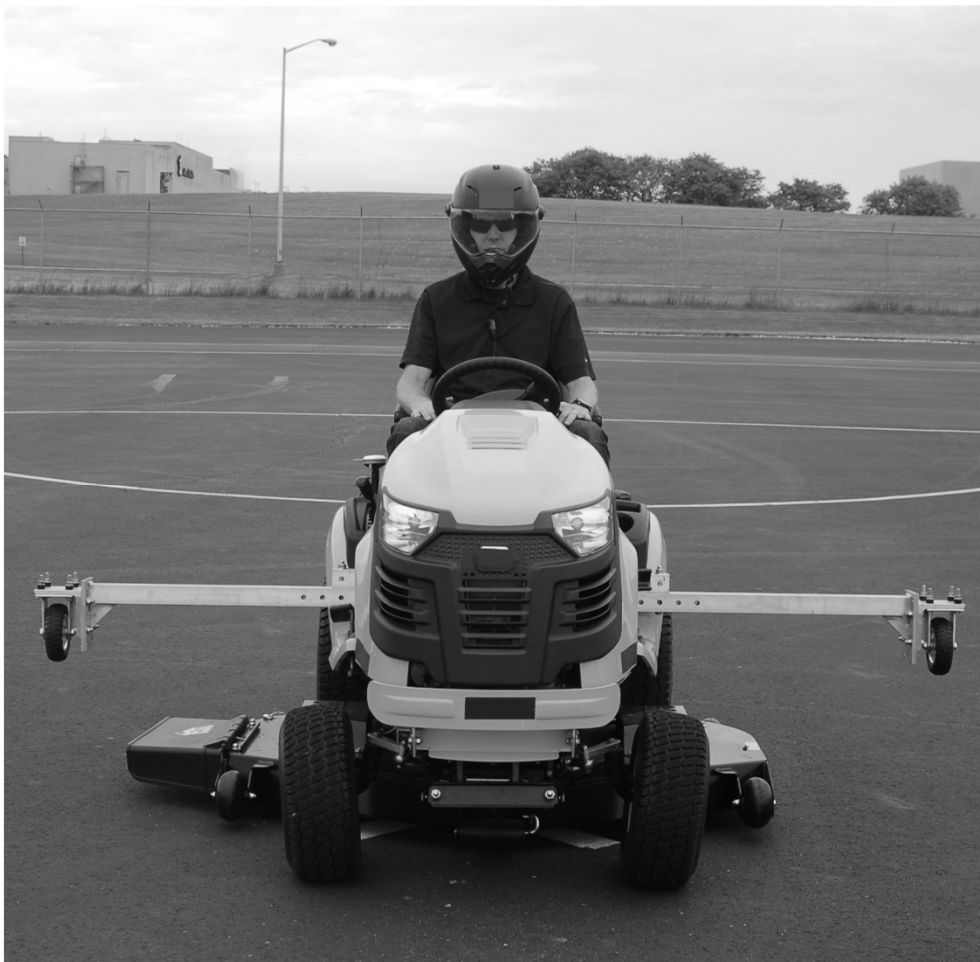
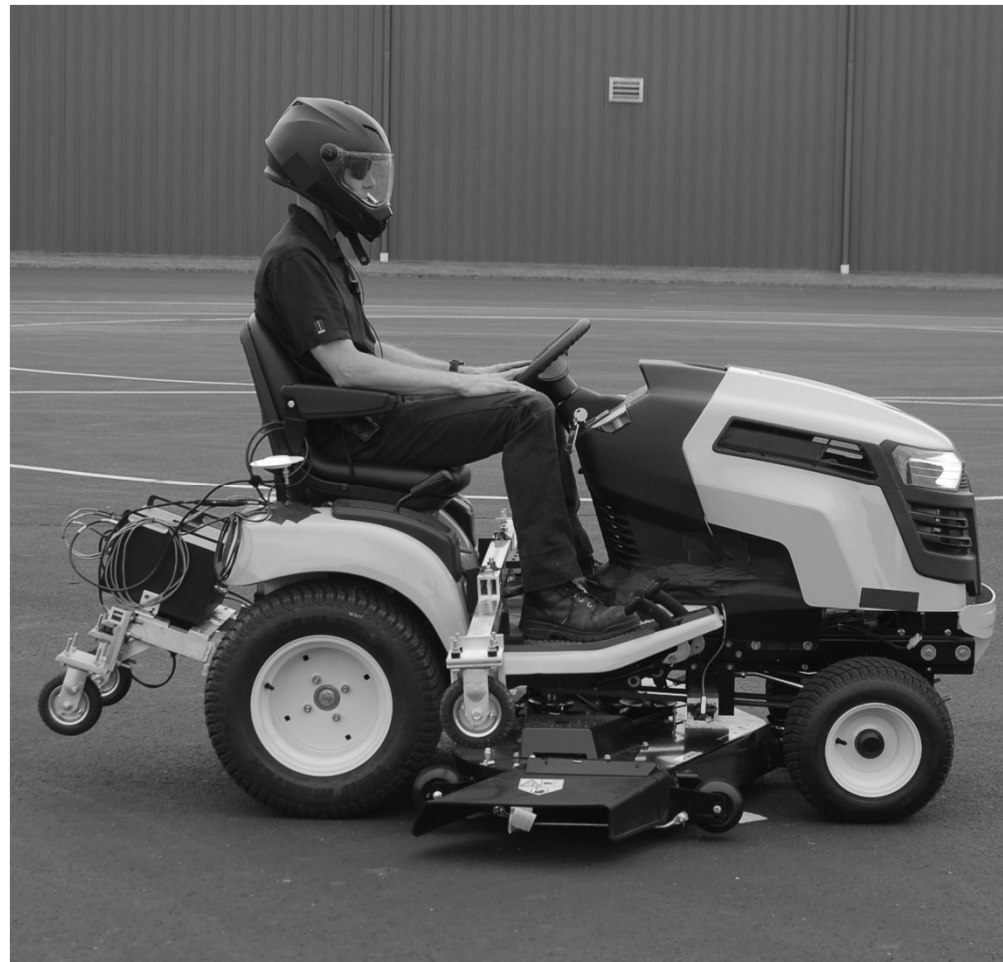
## Front and Side Views of Large Tractor Mower

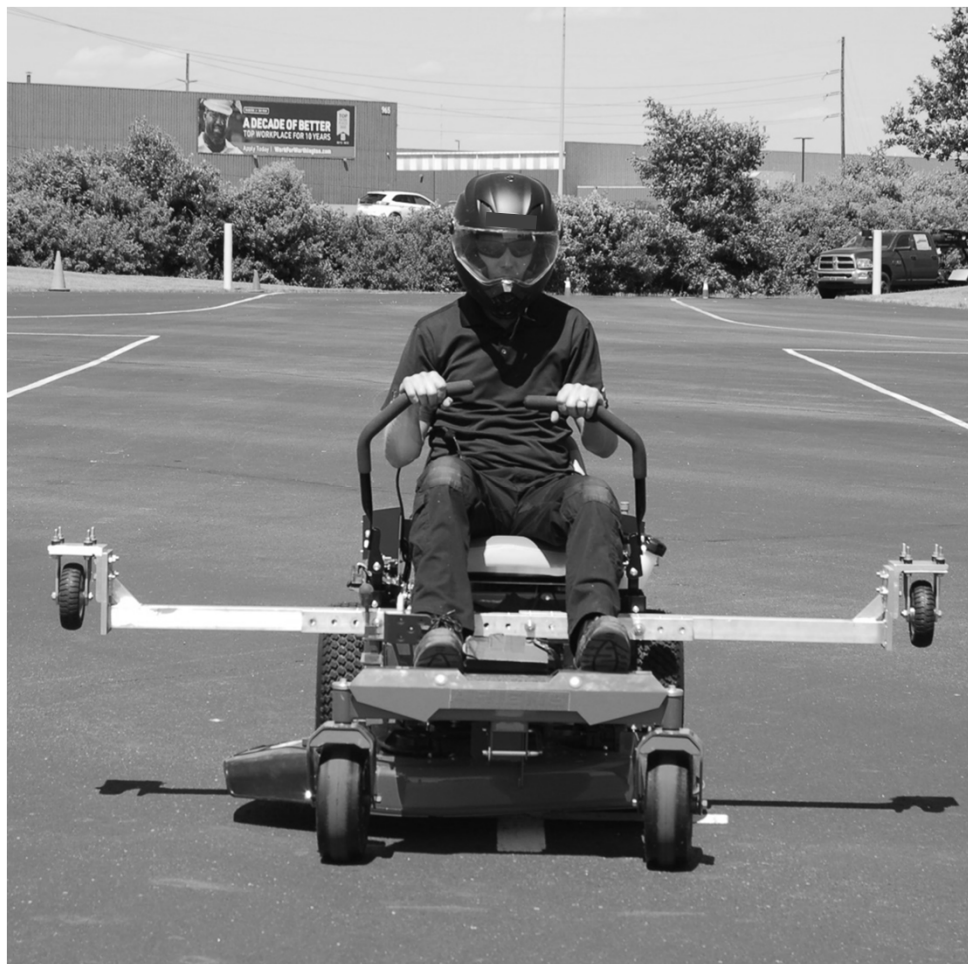
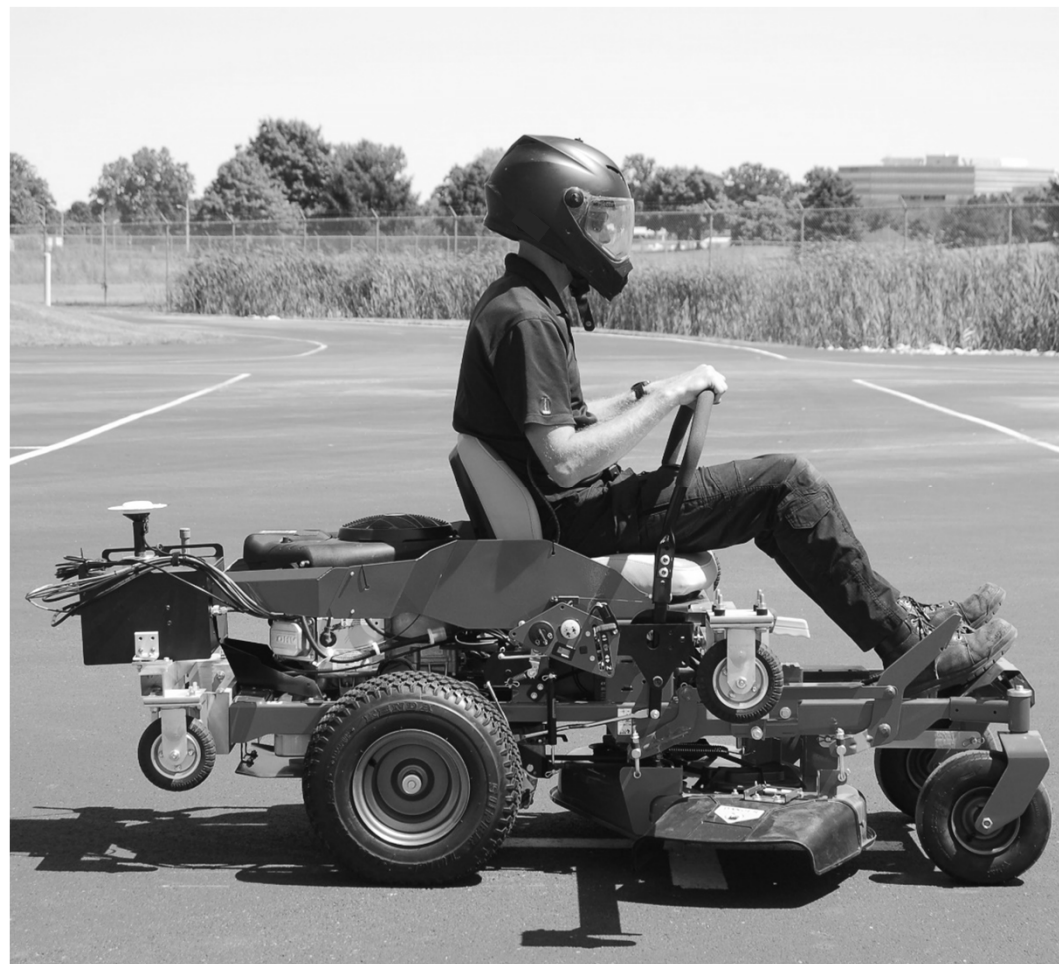
## Front and Side Views of Small Zero-Turn Mower
