**CPSC Staff's<sup>1</sup> Statement on SEA Ltd.'s Report,  
"Vehicle Characteristics Measurements of Riding Mowers"**

# *Vehicle Characteristics Measurements of Riding Mowers*

*Results from Tests on Four 2021 Model Year Vehicles*

for:  
Consumer Product Safety Commission

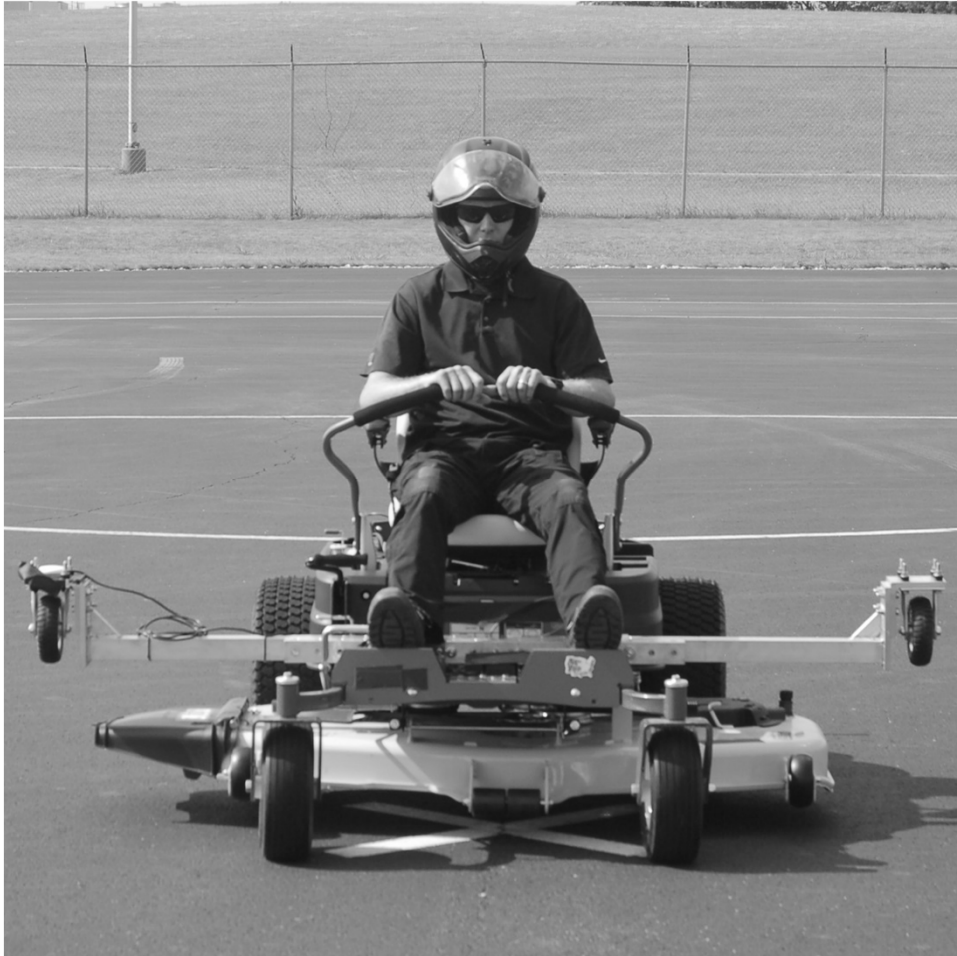
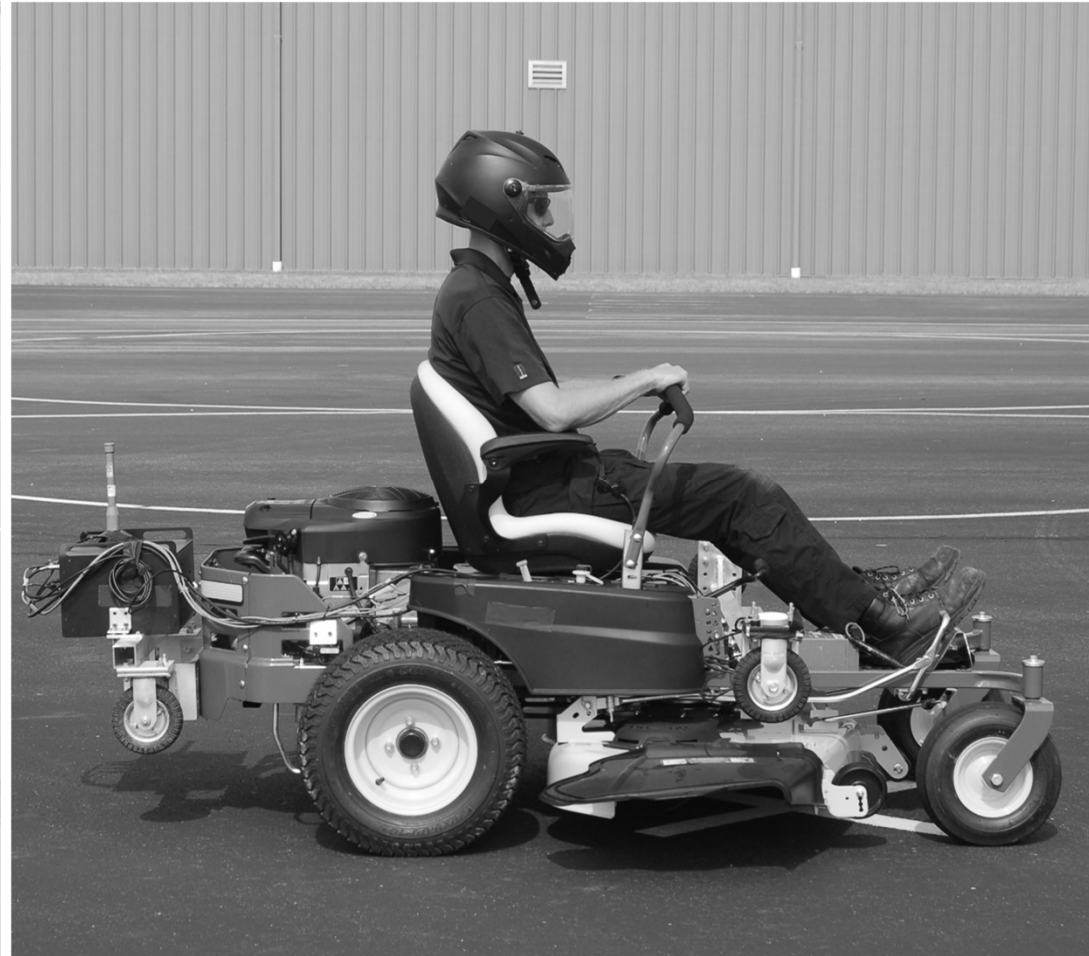
## Front and Side Views of Large Zero-Turn Mower

The loading condition used for the dynamic testing is the Driver plus Instrumentation Loading condition. This loading condition is intended to represent the loading of a 95% male driver (weighing nominally 220 lb). Pages 2-5 of Appendix C contain front view and side view photographs of the four mowers in their as-tested configurations.

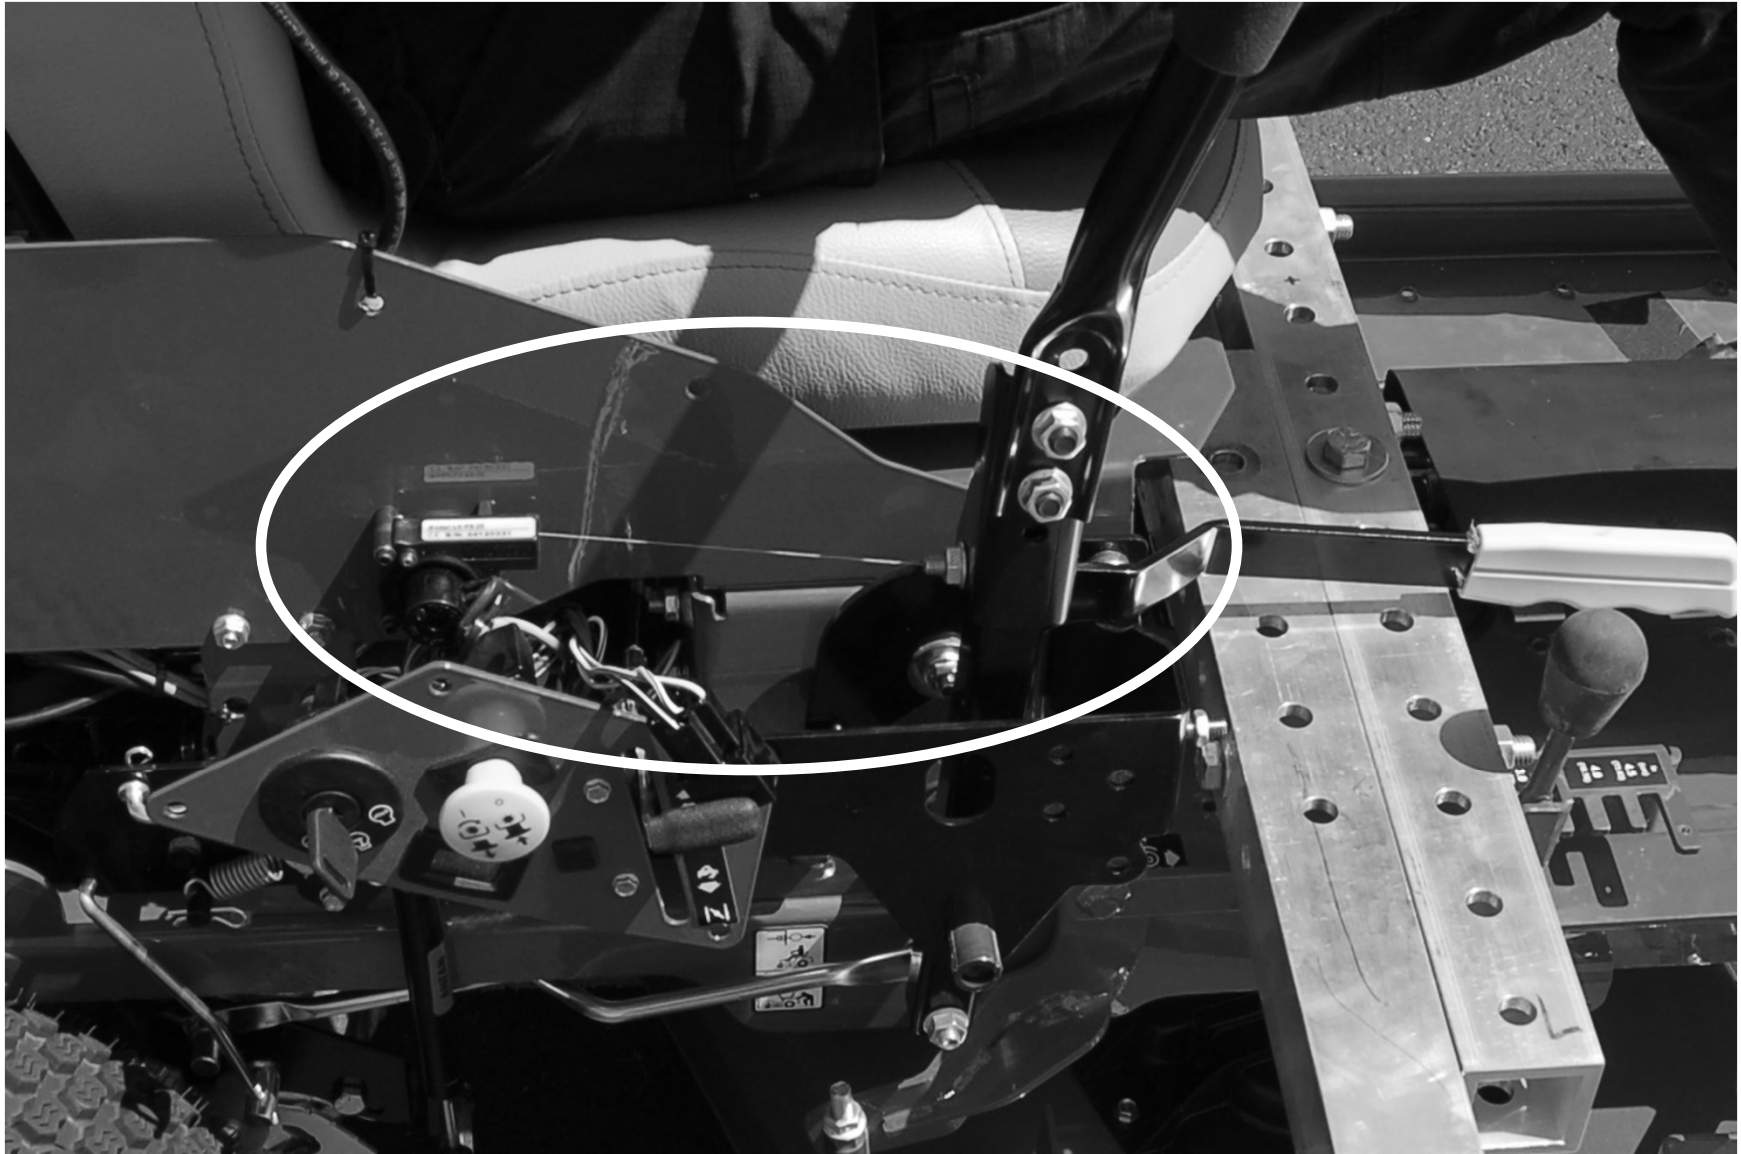
## Position Transducer Used to Measure (Right Side) Tiller Stroke on Zero-Turn Mower
