# **FIXED-POSITION ELECTRIC HEATERS**

## **FINAL REPORT ON FIXED-POSITION ELECTRIC HEATERS** January, 2002

Directorate for Engineering Sciences  
Randy Butturini

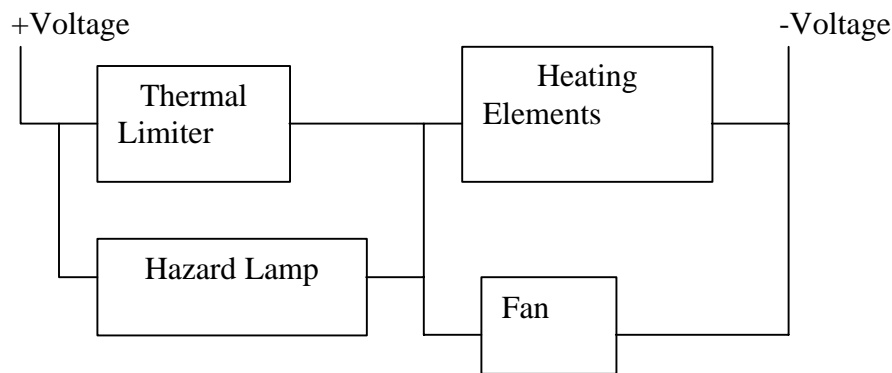
**Figure 1: Typical Heater Components**

Fixed-position electric heaters create heat by passing electric current through a heating element made of an alloy of nickel and chromium called nichrome. The nichrome heating element may be encased in a metal sheath packed with a magnesium oxide powder or may be exposed in an open-coil geometry. Typically, the heating element is mounted in a frame and is accompanied by a temperature-sensing thermal limiter to detect overheating. An alarm (typically a hazard lamp) is used to alert the consumer of the activation of the limiter. Some heater designs use a fan to force air across the elements as a means of increasing the convective heating rate. Figure 1 shows a block diagram of a typical fixed-position electric heater.

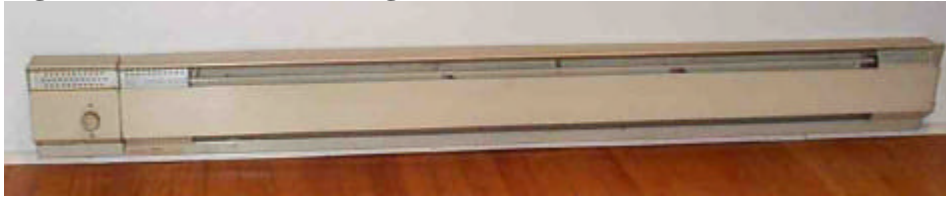
**Figure 2: Baseboard Heating Unit**

The three major types of fixed-position electric heaters are natural convection, forced-air convection, and radiant. Natural convection heaters rely upon heating a large surface area to warm nearby air and allow it to rise by convection from the heater into the room. Baseboard heaters are characteristic of natural convection heaters. This design has no fan or hazard lamp and relatively low temperatures on the heating element and convective fins. The heating element is almost always a sheathed design with the heating wire surrounded by a metal tube packed with electrically insulating but thermally conductive magnesium oxide powder. A few baseboard heaters use a fluid instead of the powder, and are called hydronic heaters. Baseboard heaters have openings at the bottom to allow cool air to enter and at the top allowing the warmed air to exit the heater. Figure 2 shows a typical baseboard heater. This particular unit has an optional thermostat at the left end. Figure 3 shows a section of a sheathed heating element design found in baseboard and some wall-insert heaters. The picture shows the convective fins attached to the sheath surface.

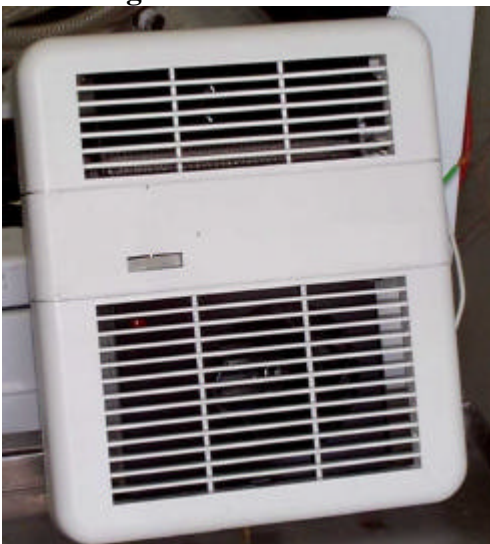
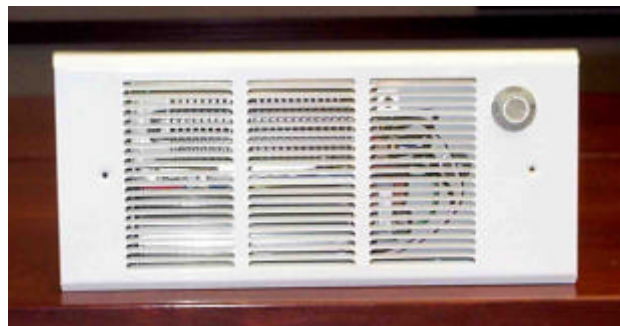
**Figure 4: Forced-Air Convection Heaters**

Forced-air convection heaters use a fan to blow air across a sheathed or open-coil heating element. The heating element is much smaller and hotter than a natural convection heating element of similar wattage due to the moving air's high heat transfer rate. Consequently, forced-air convective heaters are more compact than baseboard heaters. Forced-air heaters typically have louvered slots at the air input and exhaust areas to direct the air into and from the heater. Figure 4 shows some typical forced-air convection heater styles. Figure 5 is a picture of an open-coil heating element that has been removed from a heater. This element is a nichrome alloy wire with a higher resistance than copper conductors. This resistance causes the wire to heat throughout its length. The wire is a live, uninsulated component.

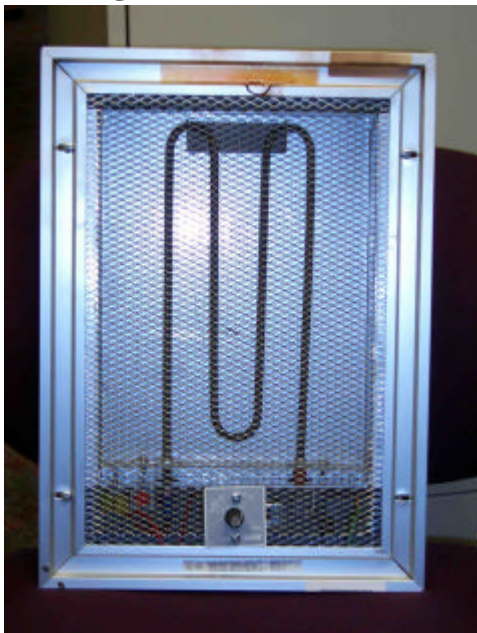
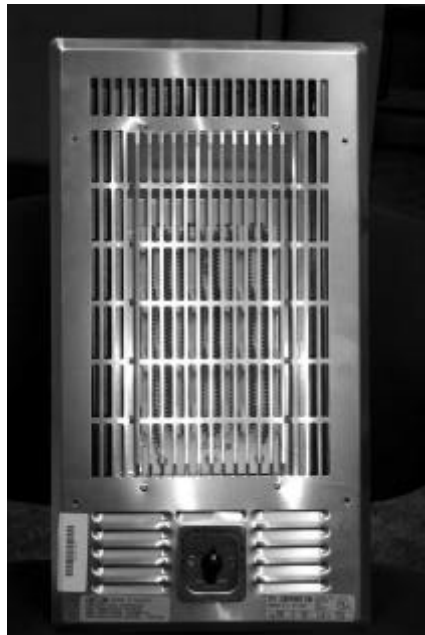
**Figure 6: Radiant Heater Designs**

Radiant heaters emit infrared radiation that impinges directly on an object to warm it instead of creating warm air. The heating element is typically hot enough to visibly glow. This is necessary to create a temperature difference between the heating element and the surroundings high enough to effect a sufficient heat transfer by radiation, rather than convection. Because a line-of-sight geometry is required for heat transfer, radiant heaters have a grid or mesh in front of the heating element rather than a set of louvers, which would reduce the radiation of heat. Further, because the radiation pattern from the heater tends to be dispersive, radiant heaters are typically installed in small rooms, like bathrooms, or in areas where a consumer is likely to be nearby and able to feel the radiation. Figure 6 shows typical radiant heaters.

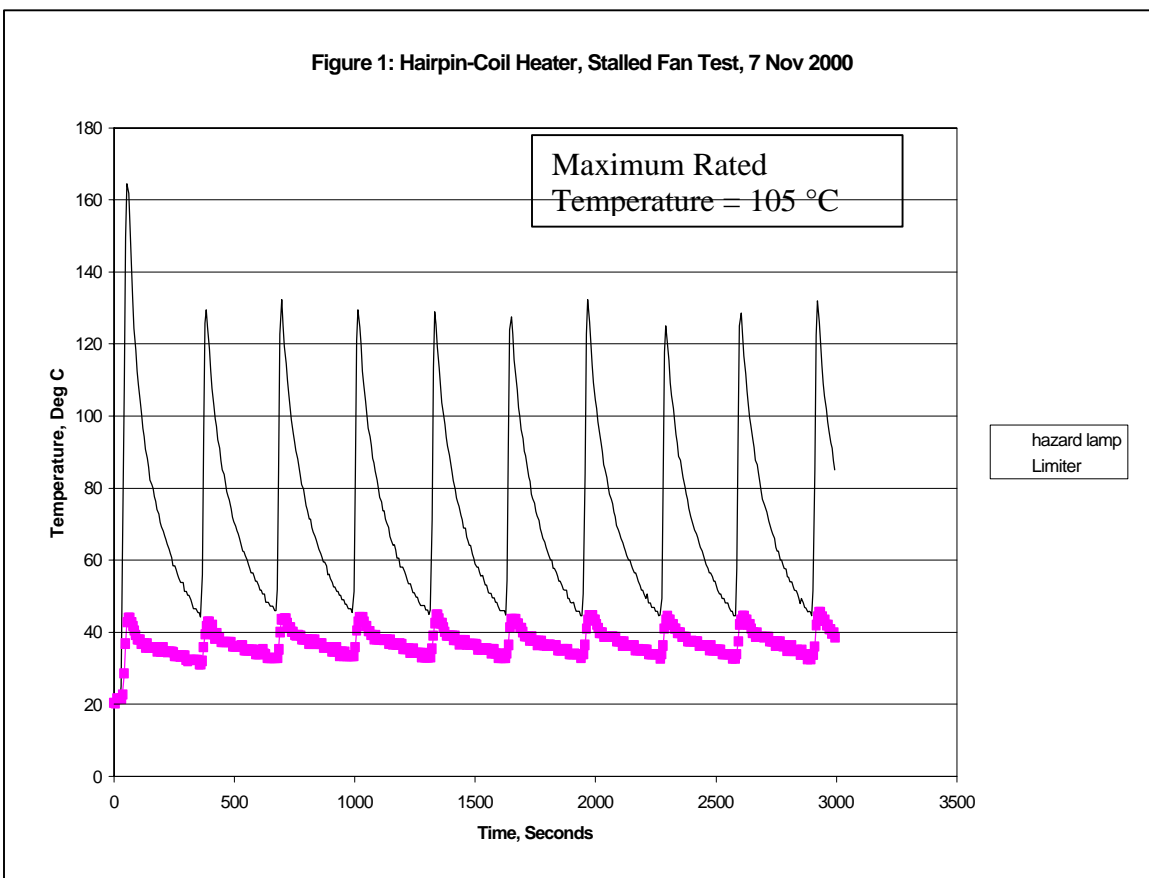
Figure 1 shows the temperatures of two internal locations of the one hairpin-coil heater, the area next to the auto-reset thermal limiter, and the area next to the hazard lamp. The heater's fan was stalled for this test. What this graph shows is that the temperatures around the limiter are above the maximum rated temperatures for the wiring insulation for a portion of each heating cycle.

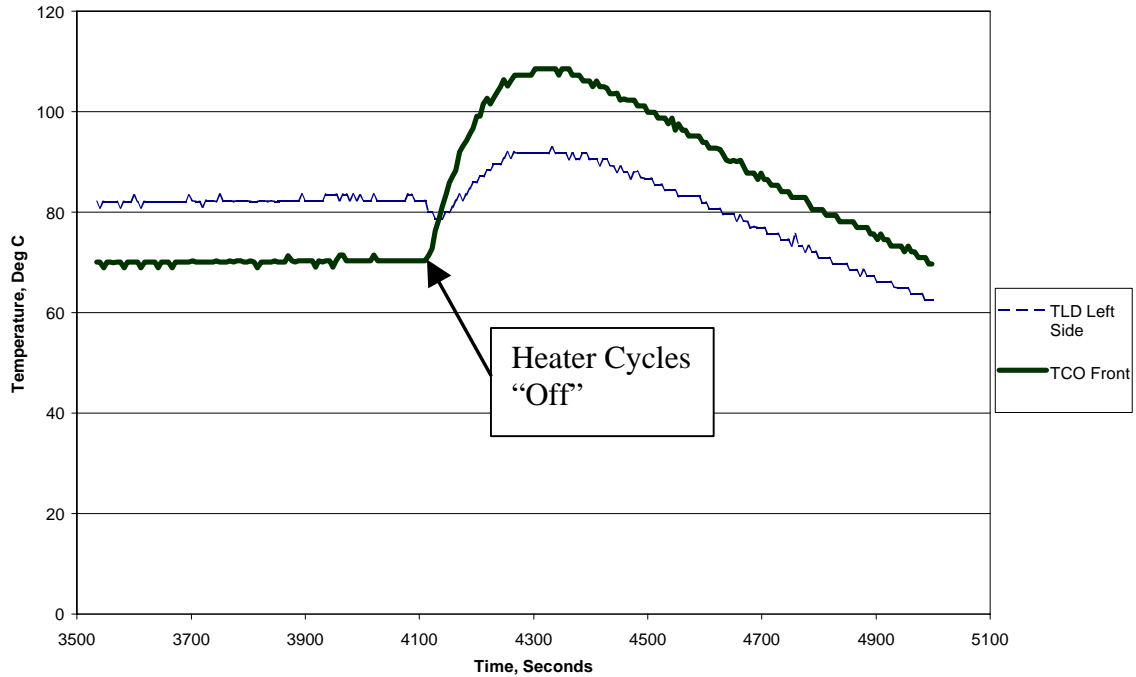
**Figure 2: Finned, Sheathed Heating Element.  
Normal Operation & Power Off Transients, 21 Nov 2000**

Figure 2 shows two internal temperatures of a finned, sheathed element heater, the area next to the auto-reset TLC on the left of the heater, and the area besides the thermal cut-off (TCO). In this test, the heater was operated normally (no blockage or stalled fan), then de-energized, as if the room thermostat had cycled the heater off. This data shows that each time the power is removed from the heater, there is an internal temperature rise. The temperature rise in the area of the TCO is sufficient to exceed the maximum temperature rating of the wiring insulation for about 3 minutes. Temperatures in the area of the TLC did not rise above the wiring insulation's rating.

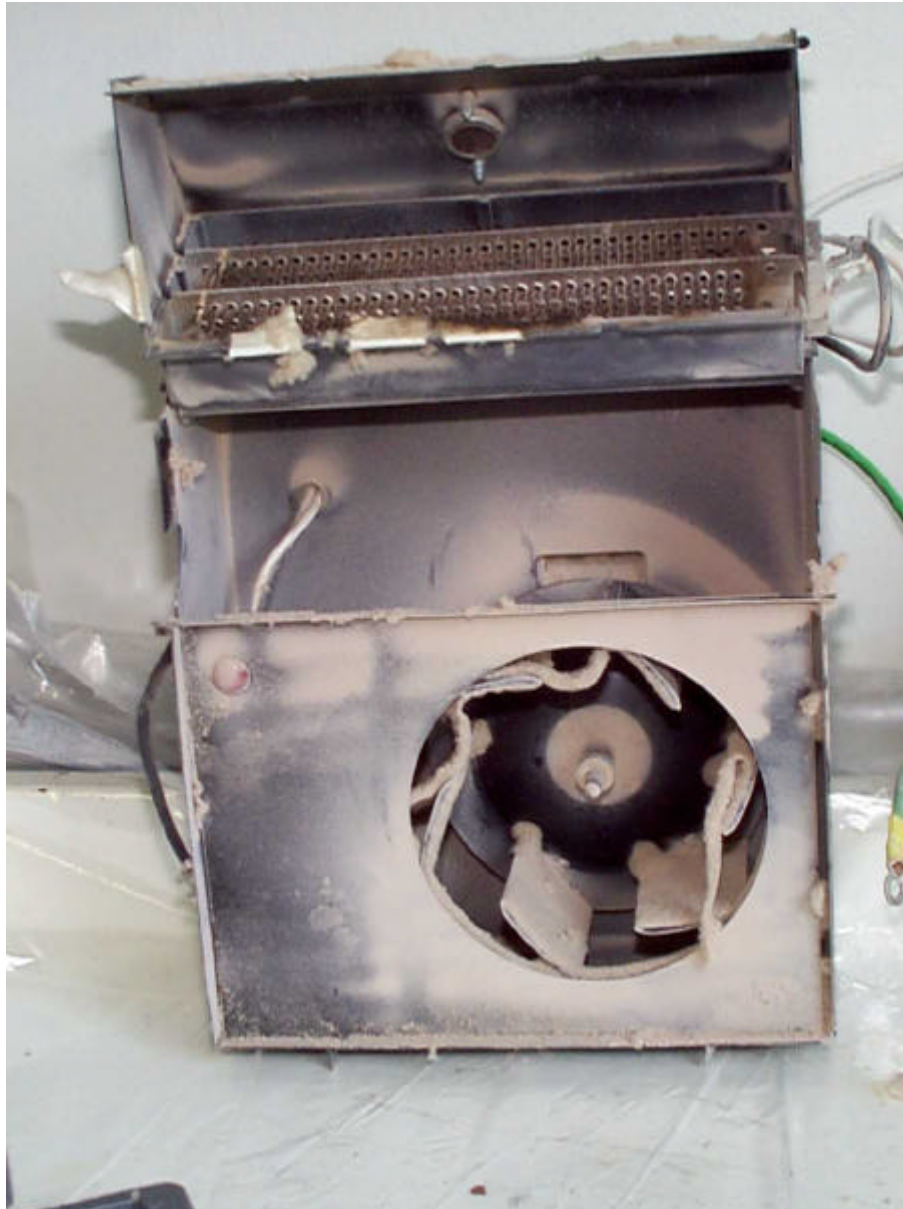
**Figure 3: Heater A With the Front Cover Removed**

The following pictures show the heating element and fan of this heater sample. Large accumulations of dust are obvious.

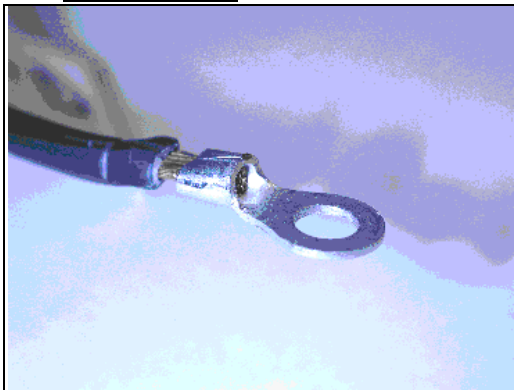
**FIGURE 3-2 - CRIMP DIE NOT PROPERLY ALIGNED (Connector #2-D)**
