Investigating the Utility of Global Positioning System (GPS) Technology to Mitigate the Carbon Monoxide (CO) Hazard Associated with Portable Generators – Proof of Concept Demonstration

June 2013

Division of Combustion and Fire Sciences
Directorate for Engineering Sciences

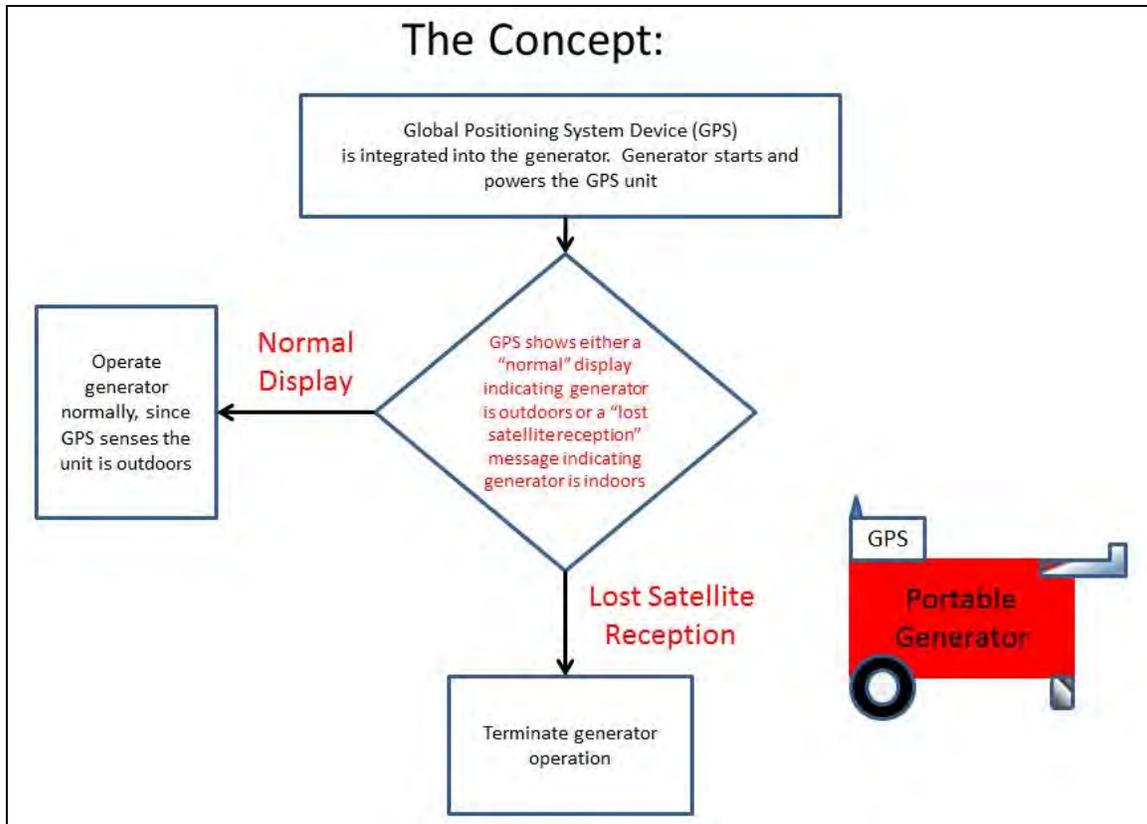
The graphic below shows how GPS receiver technology can be integrated into a portable generator to detect indoor operation and shut down the generator. The concept is rather simple: once the GPS receiver cannot track the required number of satellites (from which one can infer that the generator may be operating indoors), an actuation circuit will disable the engine from running. Otherwise, the indoor-outdoor detection system concludes that the generator is running outdoors and the generator will run as intended.

Figure 1 - Concept of GPS-Based Generator Shutdown System

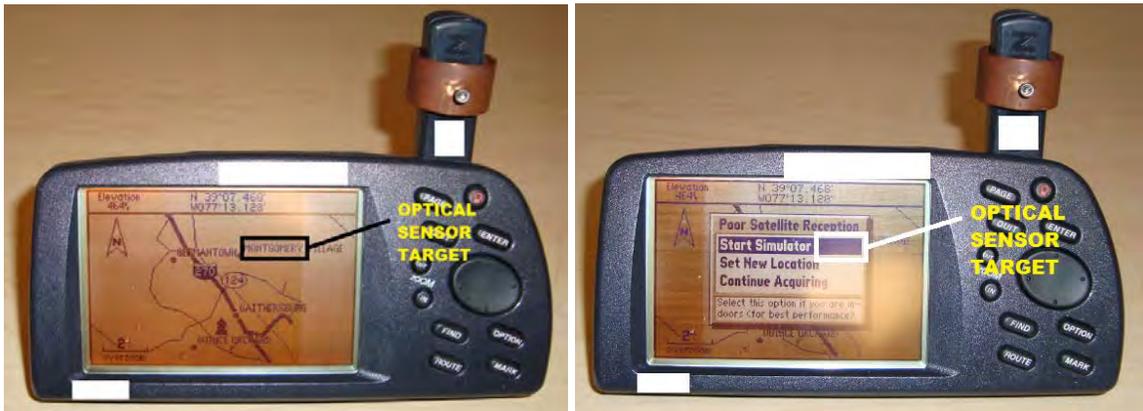
A section of copper tube was used to reduce the sensitivity of the 1998 GPS receiver antenna strength to obtain the optimum balance of “strong enough to detect outdoors” and “weak enough not to detect indoors.” While the copper tube was a somewhat better alternative to aluminum foil or mesh steel wire cage, the copper tubing had limitations. ESFS staff tried several lengths of tubing to fine-tune the amount of attenuation. Various evaluations were done using 17 mm and 15 mm long copper tubes. As noted previously, the only output for evaluation was either the presence or absence of an error signal on the GPS receiver’s screen displaying “Poor Satellite Reception.” After conducting many trials in various indoor and outdoor environments, such as an ESFS staff’s house and parks with heavy tree cover, it appeared that the 15 mm copper tube did not provide sufficient shielding. Ultimately, ESFS used the 17 mm copper tube. Further fine-tuning was attempted by positioning the 17 mm copper tube on different locations of the antenna (held in place with a set screw). After several trials (approximately five to six different positions on the antenna), the optimum position was obtained. Figure 2 shows the GPS receiver with the 17 mm copper tube in its optimum position. The GPS receiver shows an error message indicating “Poor Satellite Reception”, as illustrated in the right-side photograph of Figure 2 when the GPS receiver cannot track the required number of satellites. The change in luminosity (from light to dark) in the area inside the “optical sensor target” box (illustrated in Figure 2) is what is detected by the optical sensor to trigger the shutdown function.

Figure 2 - GPS Receiver with External Antenna and Copper Tube for Signal Attenuation;
 (Left): LCD Screen Does **Not** Show Error Message in this view
 (Right): LCD Screen Shows Error Message

To improve the receiver's ability to discriminate between indoor and outdoor locations, it was necessary to make the receiver less sensitive to satellite reception. ESFS staff chose to use the receiver intact as a "black box," rather than attempt to modify the proprietary internal components of the 1998 GPS receiver unit. Using the above approach greatly simplified concept evaluation. For example, if a new method or adjustment was made to attenuate the GPS receiver signal by partially shielding the antenna, the only output for evaluation was either the presence or absence of an error signal on the GPS receiver's screen displaying "Poor Satellite Reception."

Various signal attenuation approaches using metal shields on the receiver's antenna were evaluated: mesh steel wire cage, aluminum foil, and copper tubing. The above three materials are known for attenuating radio frequency signals. A fixed length of copper tubing gave promising results during the initial screening evaluations and was chosen as a shield.

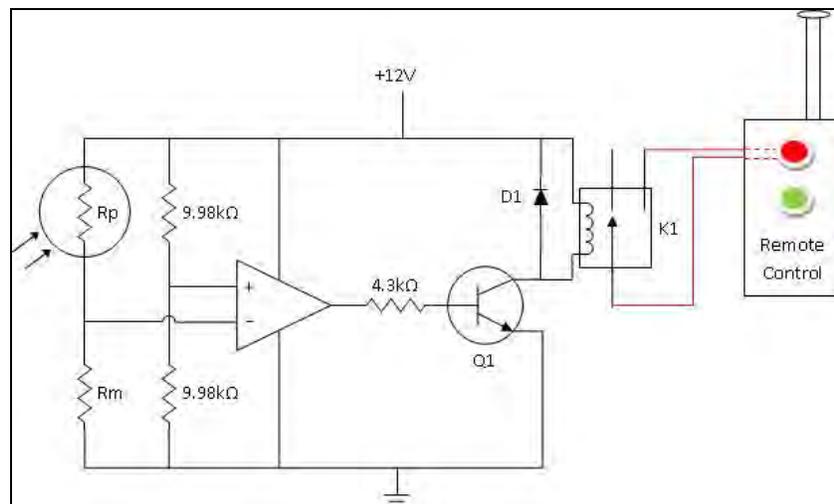
Figure 3 - Schematic Diagram for Photo Sensor Activation Circuit for Shutdown System

The photo resistor, R_p , senses the change in the brightness of the LCD panel when the “Poor Satellite Reception” message is displayed. This signal is sent to the operation amplifier (triangular shaped symbol in Figure 3) turning on transistor Q1, which, in turn, activates relay K1. The relay contacts of K1 were connected to the “lock” button on the remote control, and when activated, the remote control sends a signal to shut off the generator’s engine. Shutting off the generator is achieved by grounding the engine’s spark plug.

The demonstration system consists of three main components: the GPS receiver, the photo sensor activation circuit, and a portable generator. The generator, which was used in emissions testing for the CPSC staff study in reference [1], is hereafter referred to as “SO1” (short for shutoff generator 1). While the GPS receiver determined indoor or outdoor status, an actuation system was developed by Engineering Sciences, Division of Electrical Engineering (ESEE) staff that would interface the generator to the GPS receiver. A circuit that would recognize a change in state from normal GPS receiver operation (with satellite reception) to poor satellite reception was developed. This circuit was not integrated into the actual GPS receiver unit; rather a separate external circuit box was constructed. An error message that appears on the LCD screen was the trigger source. A relatively simple circuit was employed to sense the “Poor Satellite Reception” error signal on the GPS receiver’s screen and deactivate the generator as shown schematically in Figure 3. Figure 4 shows the fully assembled physical circuit layout.

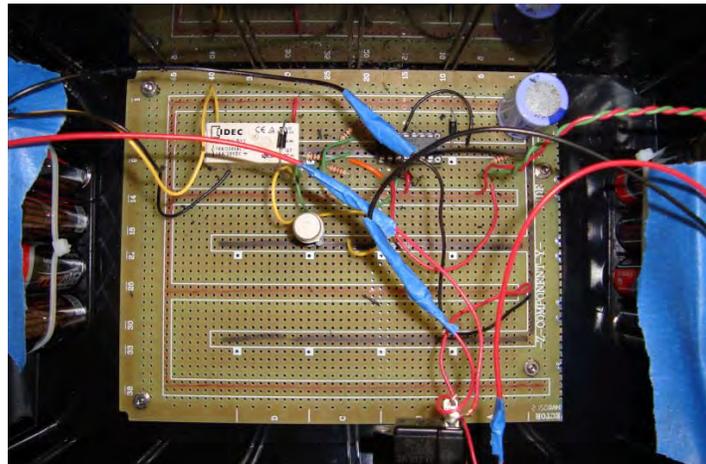
Figure 4 - Top View of Photo Sensor Activation Circuit

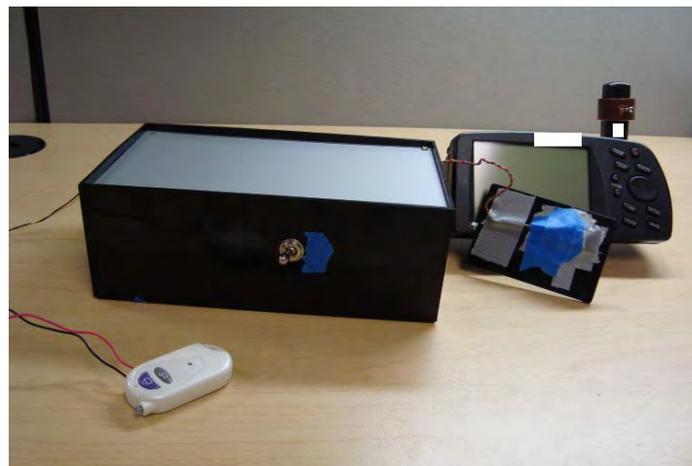
The SO1 prototype generator already had a remote engine shutoff switch installed, and it was activated by a remote controller. This feature was used quite often for the testing conducted at the National Institute for Standards and Technology (NIST) [1] to shut off the generator safely using the remote control feature. ESEE staff decided to make use of this existing generator shutoff feature. Figure 5 shows the components that comprise the shutdown system: modified GPS receiver, actuation circuit box, and remote controller.

Figure 5 - Components of the Shutdown System, from Left to Right: Remote Controller, Photo Sensor Activation Circuit Box, and GPS Receiver

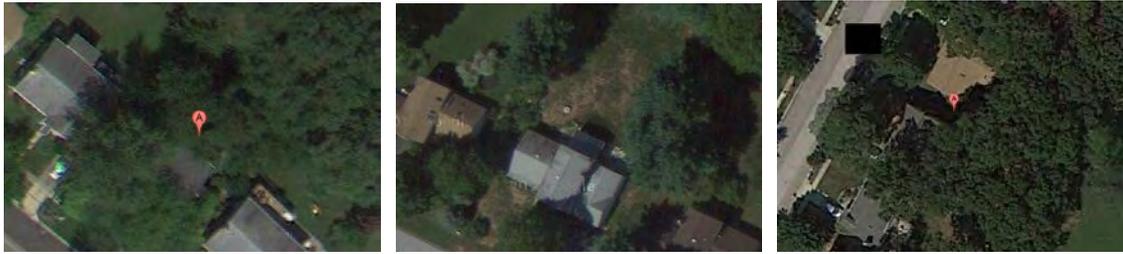
For indoor detection, a “YES” indicates that the GPS receiver generated a “Poor Satellite Reception” error message, which means that the GPS receiver correctly sensed indoor status. For outdoor detection, a “YES” indicates that the GPS receiver was able to obtain its location coordinates and did not generate an error signal, which means the GPS receiver correctly detected outdoor status. For outdoor detection, a “NO” indicates that the “Poor Satellite Reception” error signal appeared which means the GPS receiver incorrectly detected indoor status. As the data tables show, the GPS receiver unit did not have any problems detecting indoor status. However, the 1998 modified GPS receiver had difficulty detecting outdoor areas in three homes with dense tree cover. See Figure 6.

Figure 6 – Three homes that had difficulty receiving a satellite signal outdoors; left (Single family, detached one-level home, no garage); middle (4-car garage home—only had difficulty in the front yard); and right (1-car garage home—only had difficulty in the back yard).

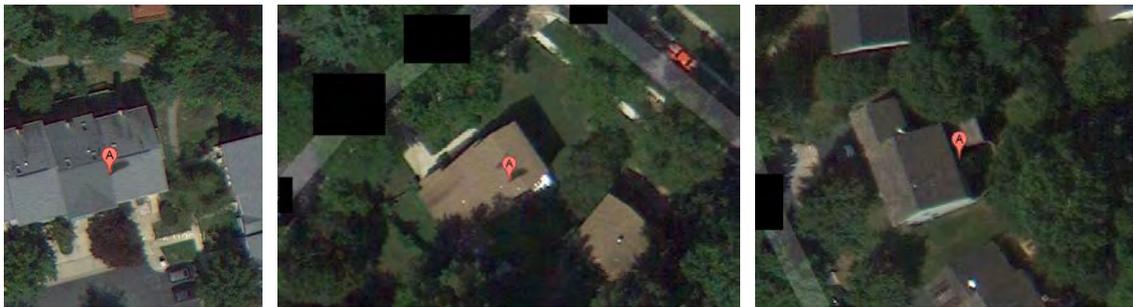
In contrast, homes with fewer trees did not exhibit problems obtaining a clear satellite signal outdoors. See Figure 7.

Figure 7 – Three homes that did not have difficulty receiving a satellite signal outdoors; left (townhouse); middle (1-car garage home); and right (2-car garage home).

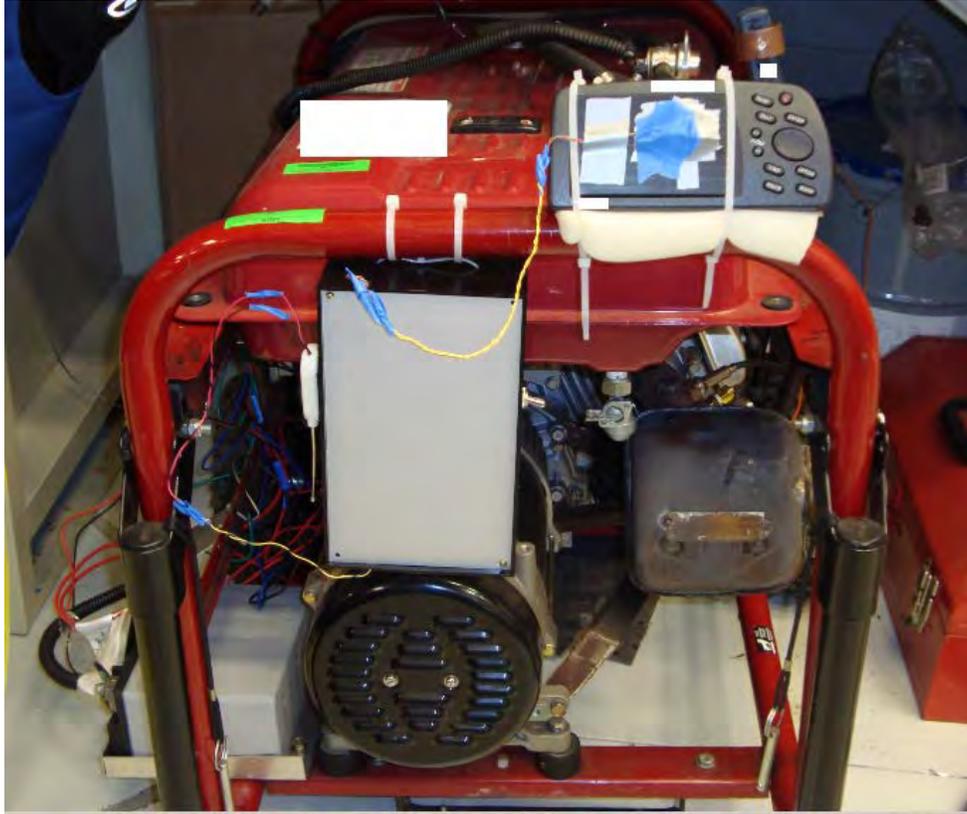
ESFS and ESEE staff verified the physical functionality of the shutdown system after installing the GPS receiver-photo sensor activation shutdown system onto the SO1 generator. This verification was independent of the indoor and outdoor GPS receiver evaluations. Using the GPS receiver-based shutdown circuit, ESFS and ESEE staff demonstrated successful shutdown of a generator within 2 minutes after having started the engine. This demonstration was conducted in the all-terrain vehicle (ATV) laboratory at NPTEC. All safety checks were conducted prior to running the verification, such as securing the generator to the floor and connecting the engine exhaust pipe to the exhaust snorkel. Figure 8 shows the generator fitted with the shutdown system. The successful shutdown system operation was captured on video.

Figure 8 - Shutdown System Fitted onto SO1 Generator at NPTEC

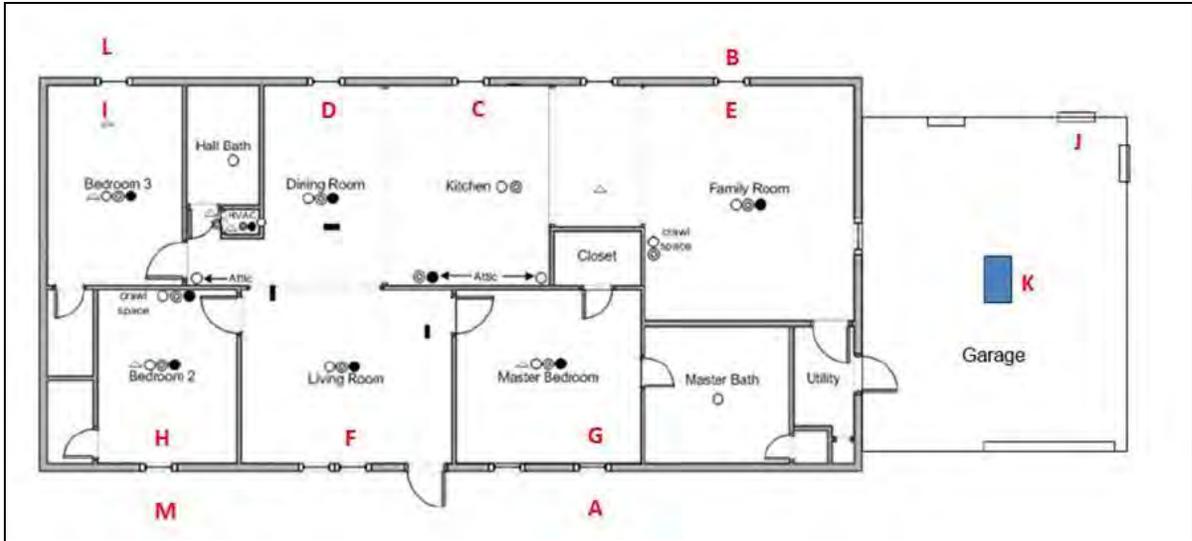
Figure 9 - Floor Plan of NIST Indoor Air Quality Building 423

INDOORS	
Room	Approximate Times (MM:SS) for “Poor Satellite Reception” Error Message to Display
Location K* – Middle of the Garage	5:13
Location J** – Window of the Garage	1:48 // 1:52 // 1:48 // 5:05 // 1:56
Family Room	1:42
Kitchen	1:09
Dining Room	1:34
Living Room	1:55
Master Bedroom	1:54
Bedroom 2	1:30
Bedroom 3	5:30
OUTDOORS	
Location	Approximate Times (MM:SS) for Indicating GPS Acquired All Necessary Satellites
Location A* – Grass field 15 ft from window	1:58
Location B* – Grass field 15 ft from window	3:09
Location L* – Grass field 15 ft from window	3:12
Location M* – Grass field 15 ft from window	1:42
<u>NOTES:</u>	
* Refer to the specific lettered locations in Figure 9	
** Since the garage area was of interest and with time permitting at the NIST facility, five trials were conducted at Location J

The results in Table 4 show that the GPS receiver unit was capable of distinguishing indoor from outdoor environments. The “indoor” times in Table 4 represent the time from the moment the GPS receiver unit was powered on, to when the “Poor Satellite Reception” error message appeared. The “outdoor” times represent the time from the moment the GPS unit is powered on, to indicating that the GPS receiver has acquired the minimum number of satellites for proper operation. The GPS receiver then displays its exact location, complete with longitude, latitude, and elevation coordinates. When the GPS receiver unit is powered on, a triangle with a question mark flashes continuously until either a location is determined or an error occurs (“Poor Satellite Reception” message appears). One caveat is that Building 423 had only a few surrounding trees. The perimeter of the building has grassy fields and open spaces.

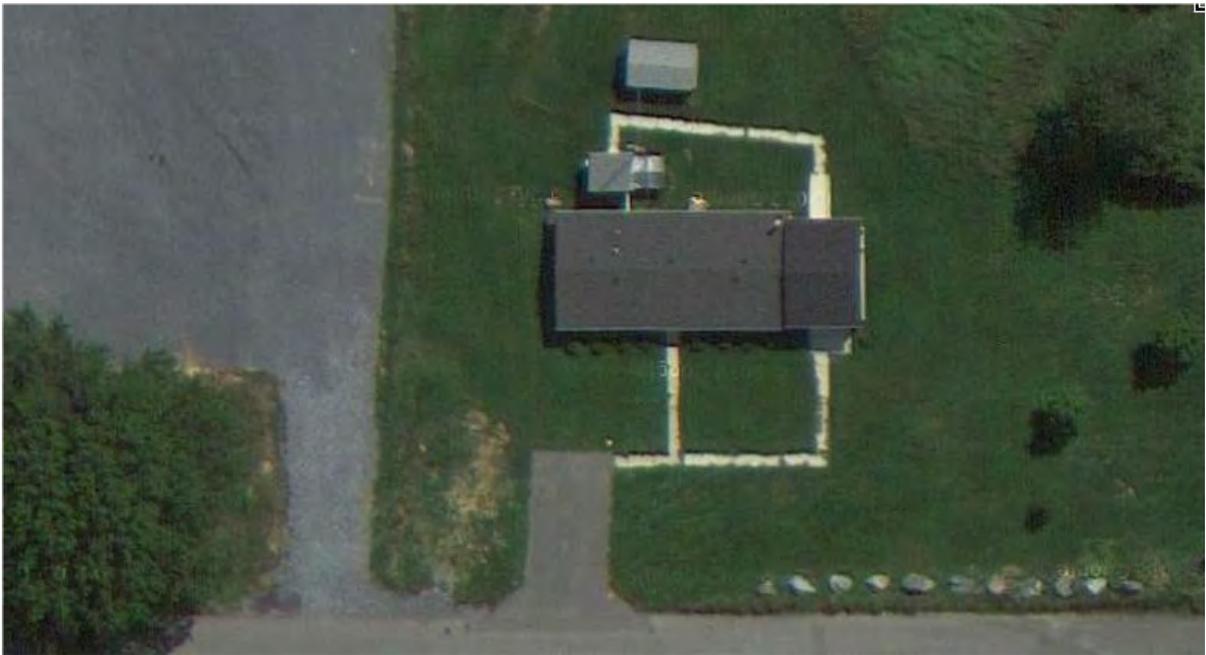
Figure 10 – Aerial View of NIST Building 423
